Martin's Creek II Mitigation Plan Cherokee County, North Carolina

EEP Project #: 92633

Michael Baker Engineering, Inc., NC Professional Engineering License # F-1084

9/22/10

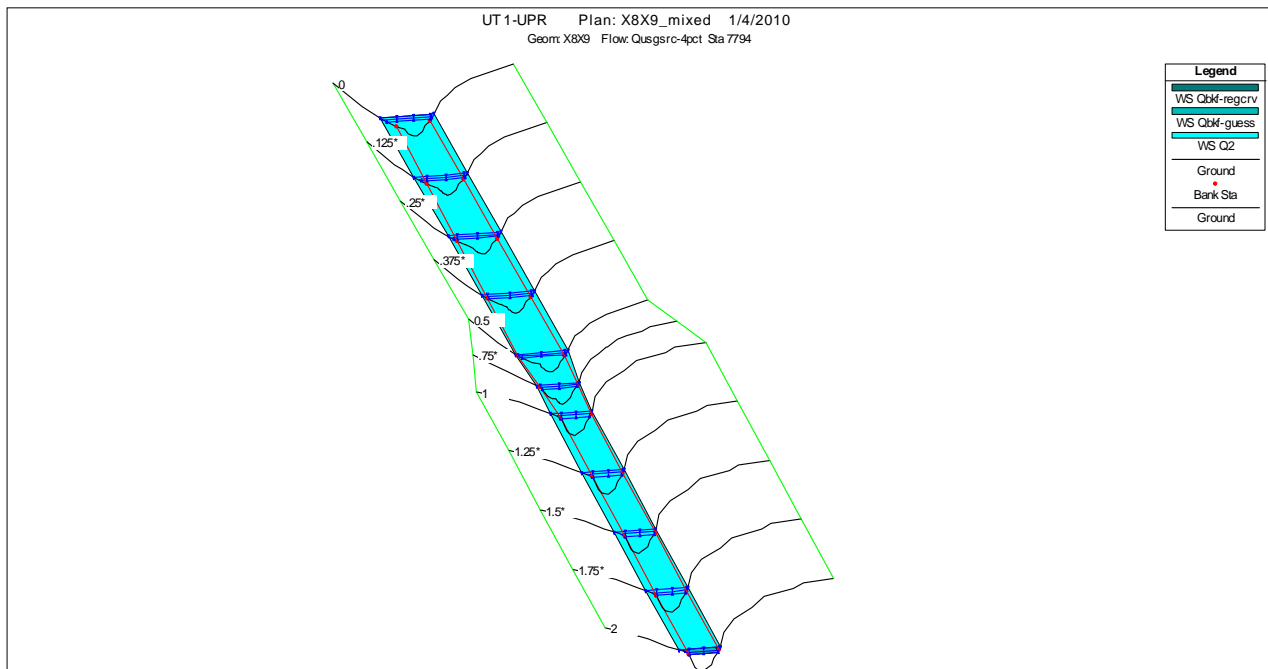
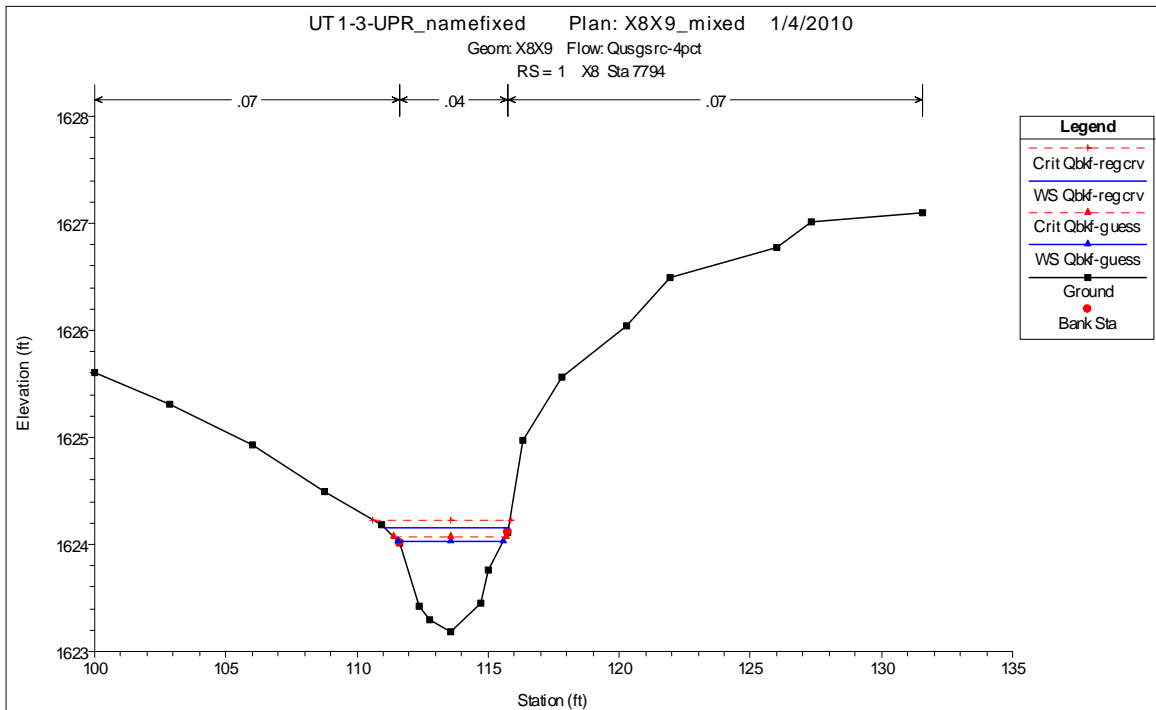
Figures 3.1 and 3.2 HEC-RAS Model Views for UT1-3 Upper, Water Surface Elevations for Design Flow (10 cfs) and the Mountain Regional Curve Flow (Q=14 cfs) (LOB=Left Top of Bank, ROB=Right Top of Bank)

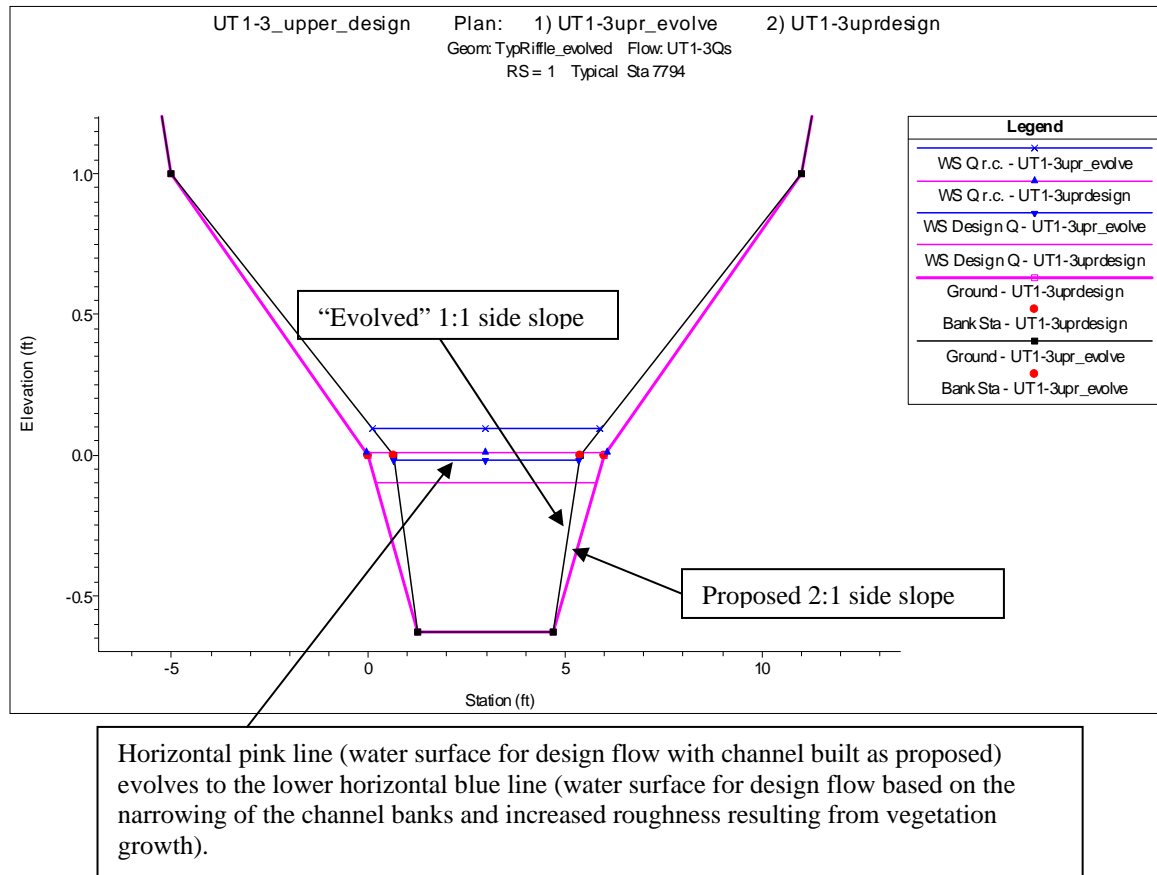
Figure 3.3 Sample Analysis of UT1-3 Upper Design Cross section for As-built Condition (2:1 side slope) Versus “Evolved” Condition (Where is has Narrowed to a 1:1 Side Slope) at Design Flow (10 cfs)

Using multiple sources of data increased our confidence in our ultimate conclusion. Baker used detailed cross sections with field-identified bankfull indicators, validation and interpretation of data with hydraulic modeling, research of empirical (USGS and Regional Curve) hydrologic and hydraulic data, and prior project information (i.e. mini-project curves) for small WNC Mountain drainages to conduct the analysis. All sources of data suggest that the bankfull discharge for the project tributaries should be lower than the published NC Mountain Regional Curve values.

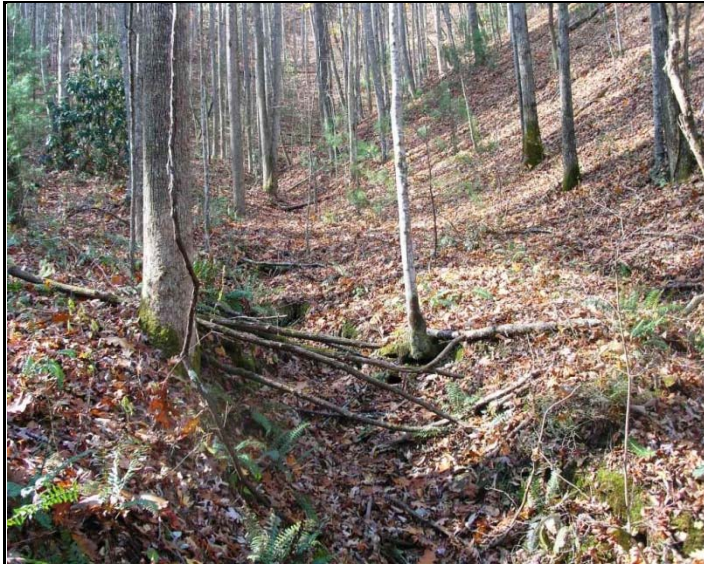
Well defined ephemeral channel typical of project tributaries.

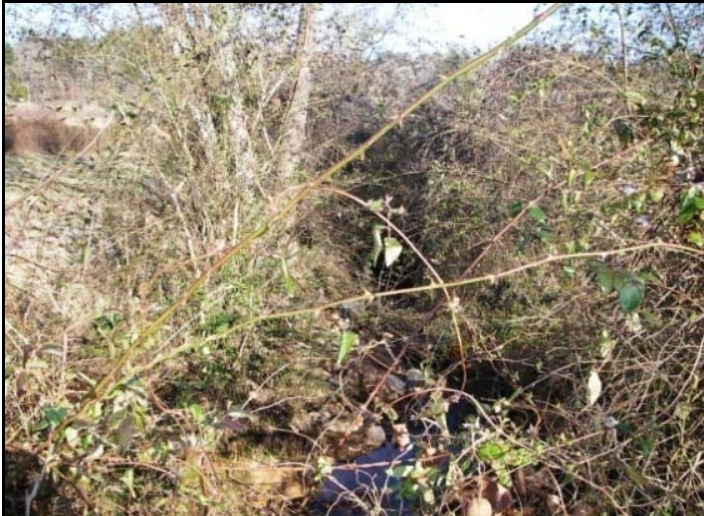
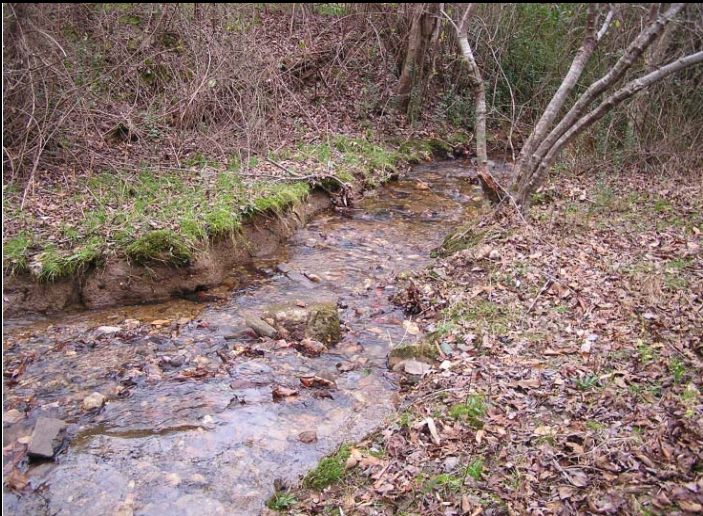
Invasive plant removal and bank repair are proposed along this reach of MC-UT1 upstream of the barn.

Streambank conditions along MC-UT1 near barn.

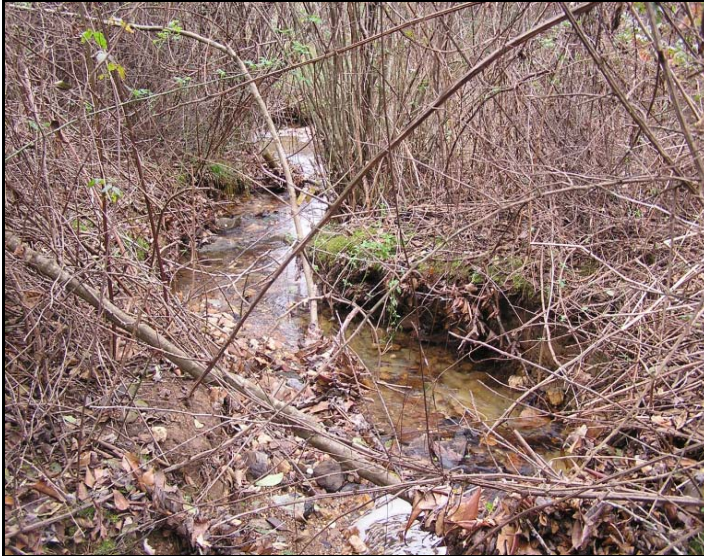
Instream view of riparian conditions along MC-UT1. Native vegetation will be replanted that promotes better bank stabilization

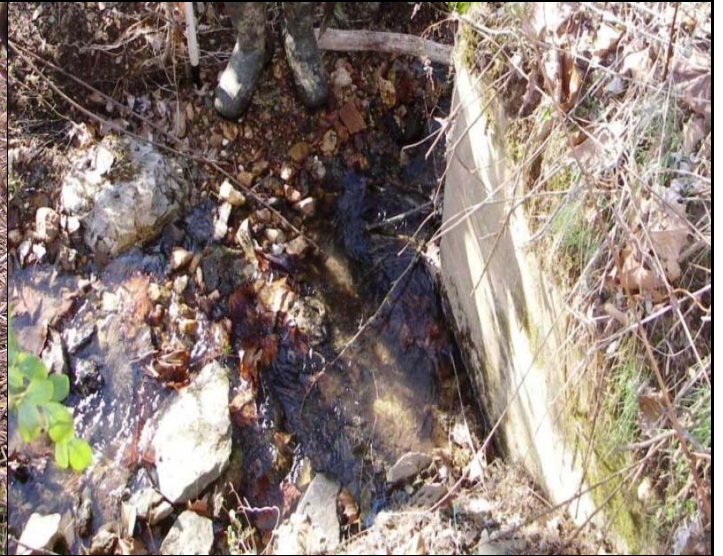
MC-UT1 makes a 90° turn into this box culvert near the barn.
