# FINAL MITIGATION PLAN

**Matthew Site  
Johnston County, North Carolina**

**Neuse River Basin  
HUC 03020201**

**DMS Project #: 100043  
Contract #: 7419  
USACE Action ID: SAW-2018-01256  
DWR Project #2017-0624  
RFP: 16-007279**

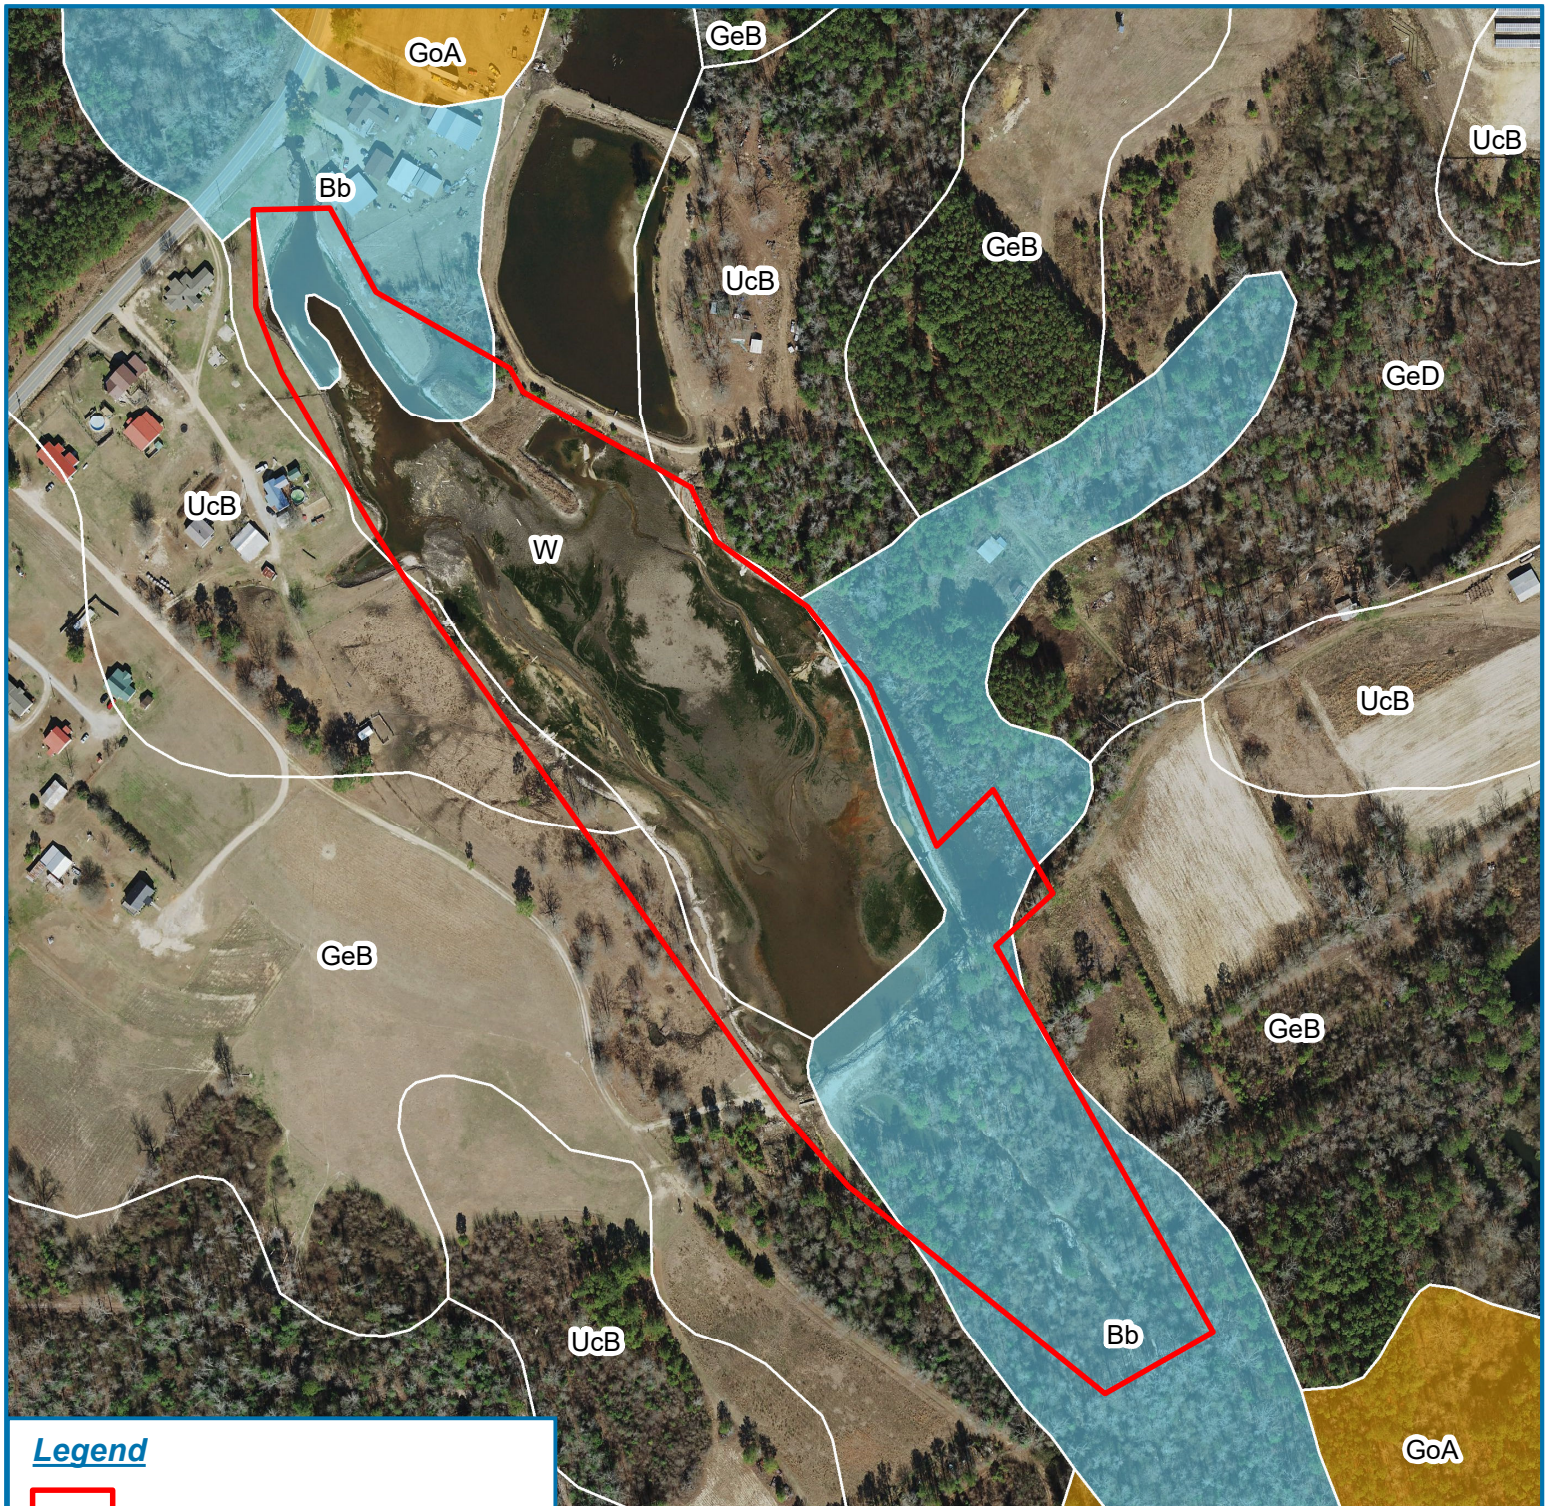
- Proposed Easement
- Hydric (100%)
- Predominantly Hydric (66-99%)
- Partially Hydric (33-65%)
- Predominantly Nonhydric (1-32%)
- Nonhydric (0%)

Project soils are mapped by the NRCS within the easement as Bibb sandy loam, Gilead sandy loam, and Uchee loamy coarse sand, and water (**Figure 5**). Bibb sandy loam makes up approximately 39 percent of the easement and is poorly drained and found on floodplains with minimal to no slopes. Gilead sandy loam makes up approximately 4.9 percent of the easement and is moderately well drained and found on ridges and marine terraces with two to eight percent slopes. Making up only 2.5 percent of the easement area is Uchee loamy coarse sand that is well drained and found on ridges and broad interstream divides on marine terraces with two to six percent slopes. The remaining 53.5 percent of the easement area, formerly the pond bottom, is mapped as water.

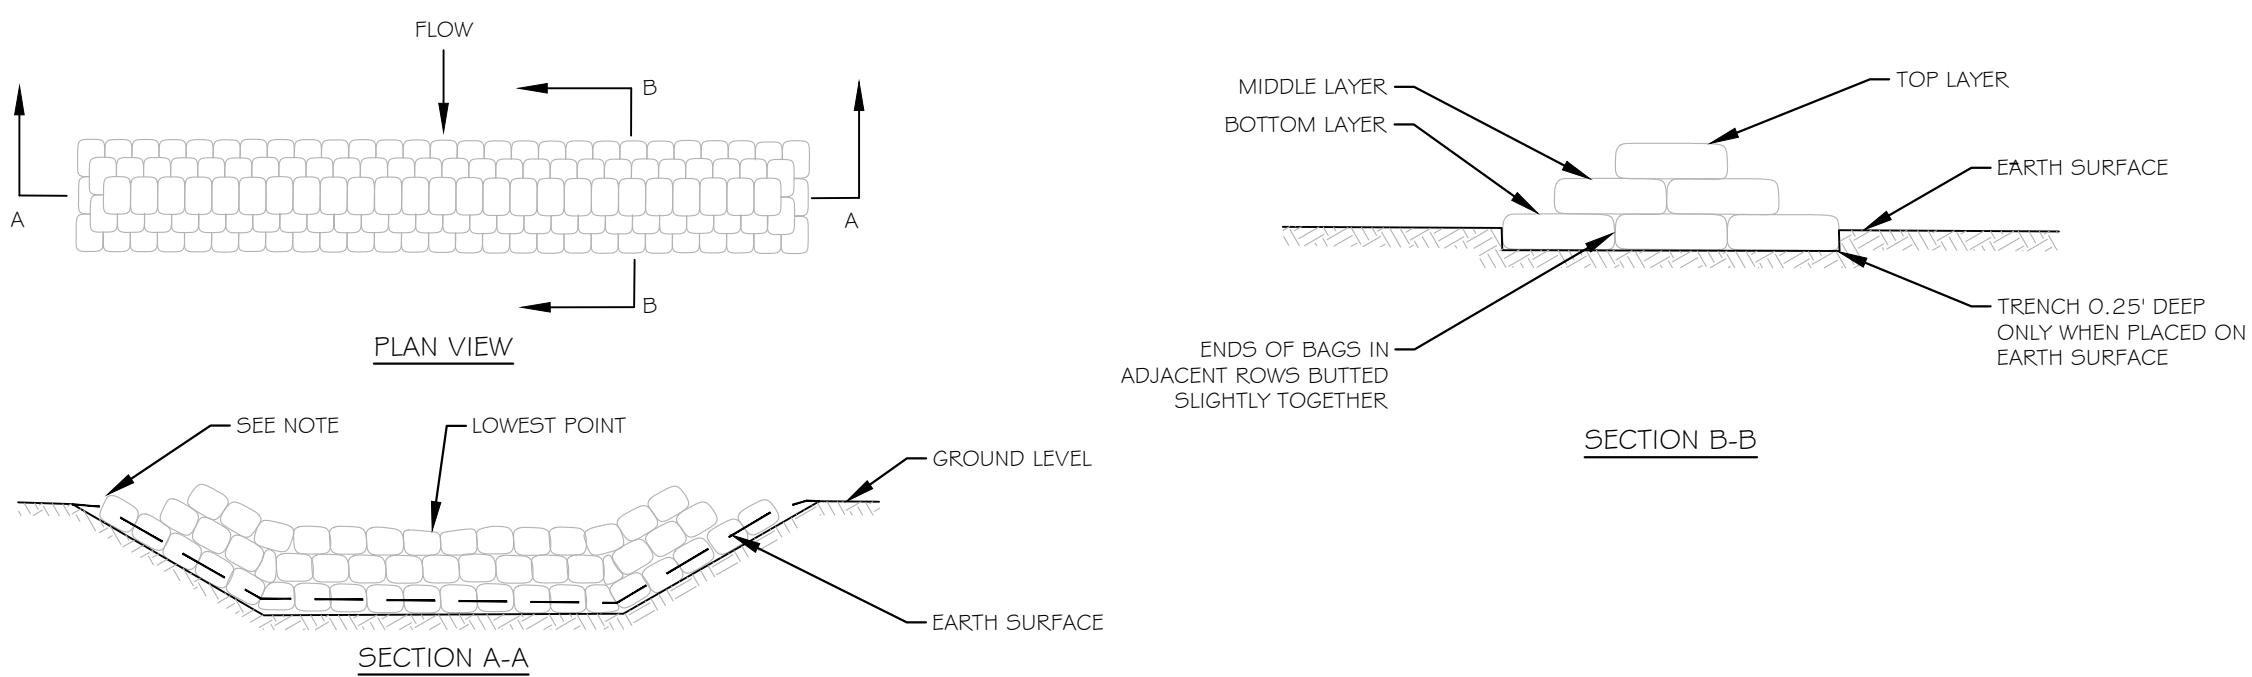
**SANDBAG IMPERVIOUS DIKE**

SANDBAG BARRIERS SHALL BE CONSTRUCTED OF THREE LAYERS OF SANDBAGS. THE BOTTOM LAYER SHALL CONSIST OF 3 ROWS OF BAGS, THE MIDDLE LAYER SHALL CONSIST OF 2 ROWS OF BAGS AND THE TOP LAYER SHALL CONSIST OF 1 ROW OF BAGS. THE RECOMMENDED DIMENSION OF A FILLED SANDBAG SHALL BE APPROXIMATELY 0.5 FT X 0.5 FT X 1.5 FT.

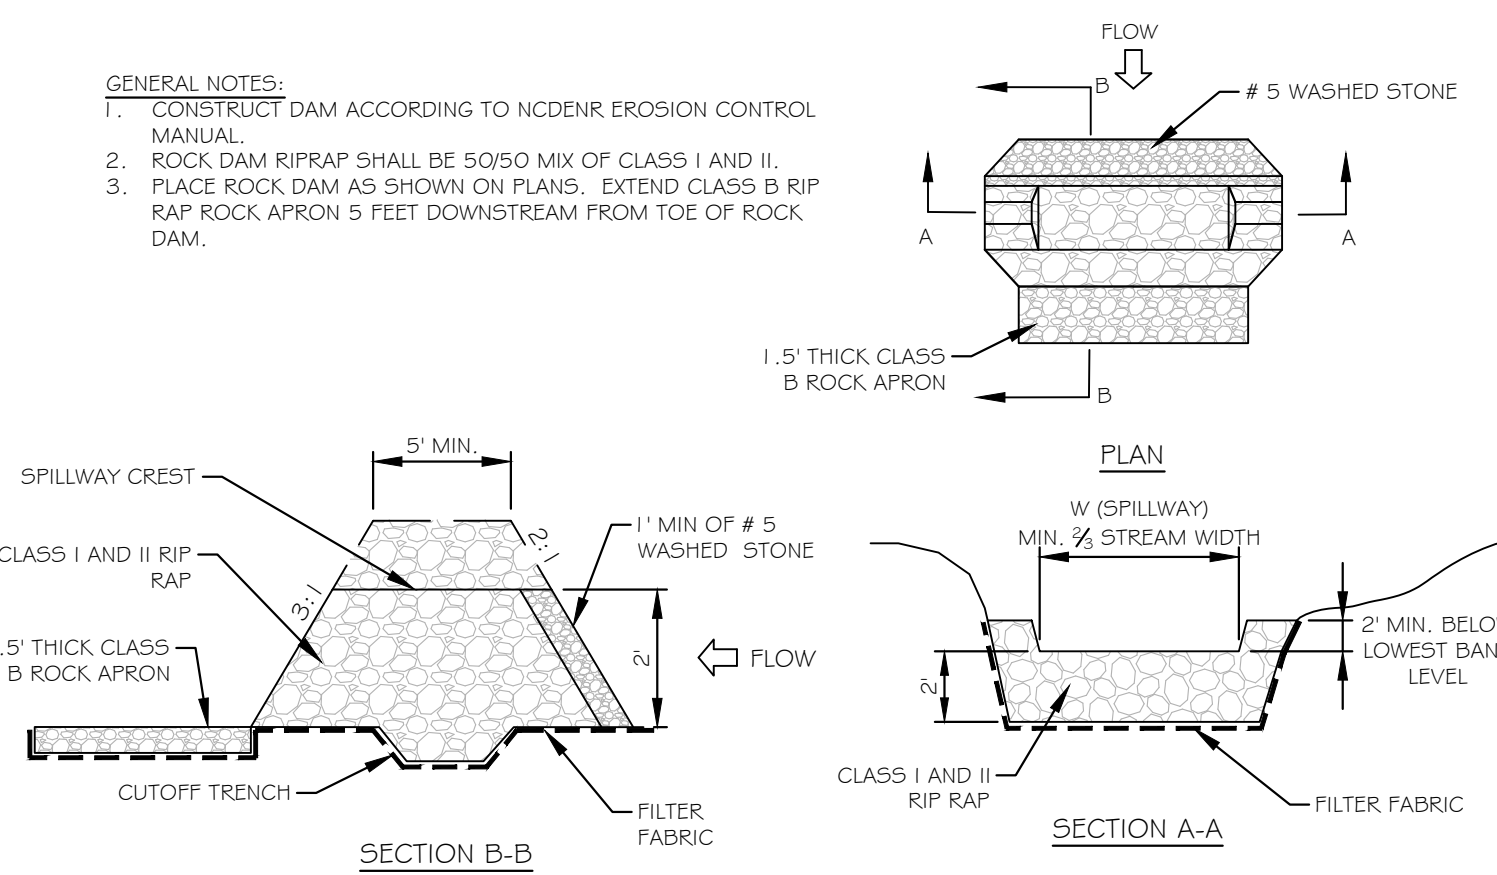
**TEMPORARY ROCK CHECK DAM**

- CONSTRUCT DAM ACCORDING TO NCDENR EROSION CONTROL MANUAL.
- ROCK DAM RIPRAP SHALL BE 50/50 MIX OF CLASS I AND II.
- PLACE ROCK DAM AS SHOWN ON PLANS. EXTEND CLASS B RIP RAP ROCK APRON 5 FEET DOWNSTREAM FROM TOE OF ROCK DAM.

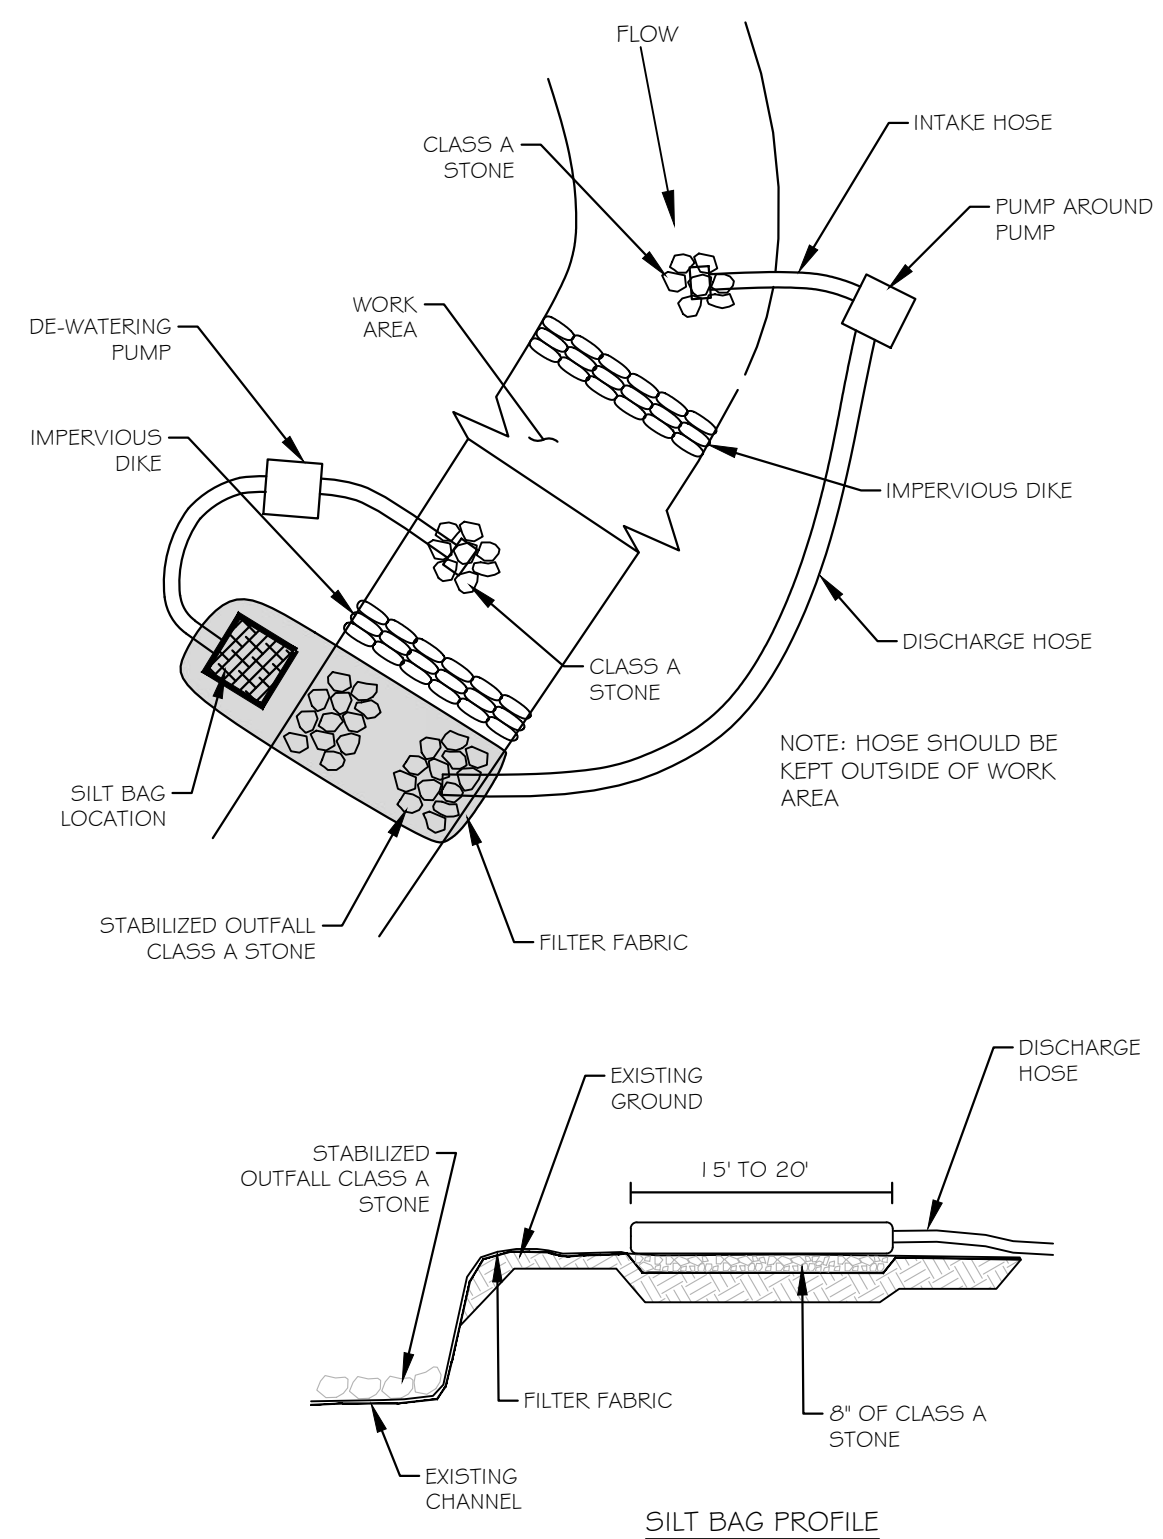
**PUMP AROUND & DEWATERING DETAIL**

- ONCE THE WORKING AREA IS COMPLETED, REMOVE ALL RIP RAP AND IMPERVIOUS DIKES AND STABILIZE DISTURBED AREAS WITH SEED AND MULCH.
- ALL WORK IN CHANNEL MUST BE COMPLETED BEFORE REMOVING IMPERVIOUS DIKE.

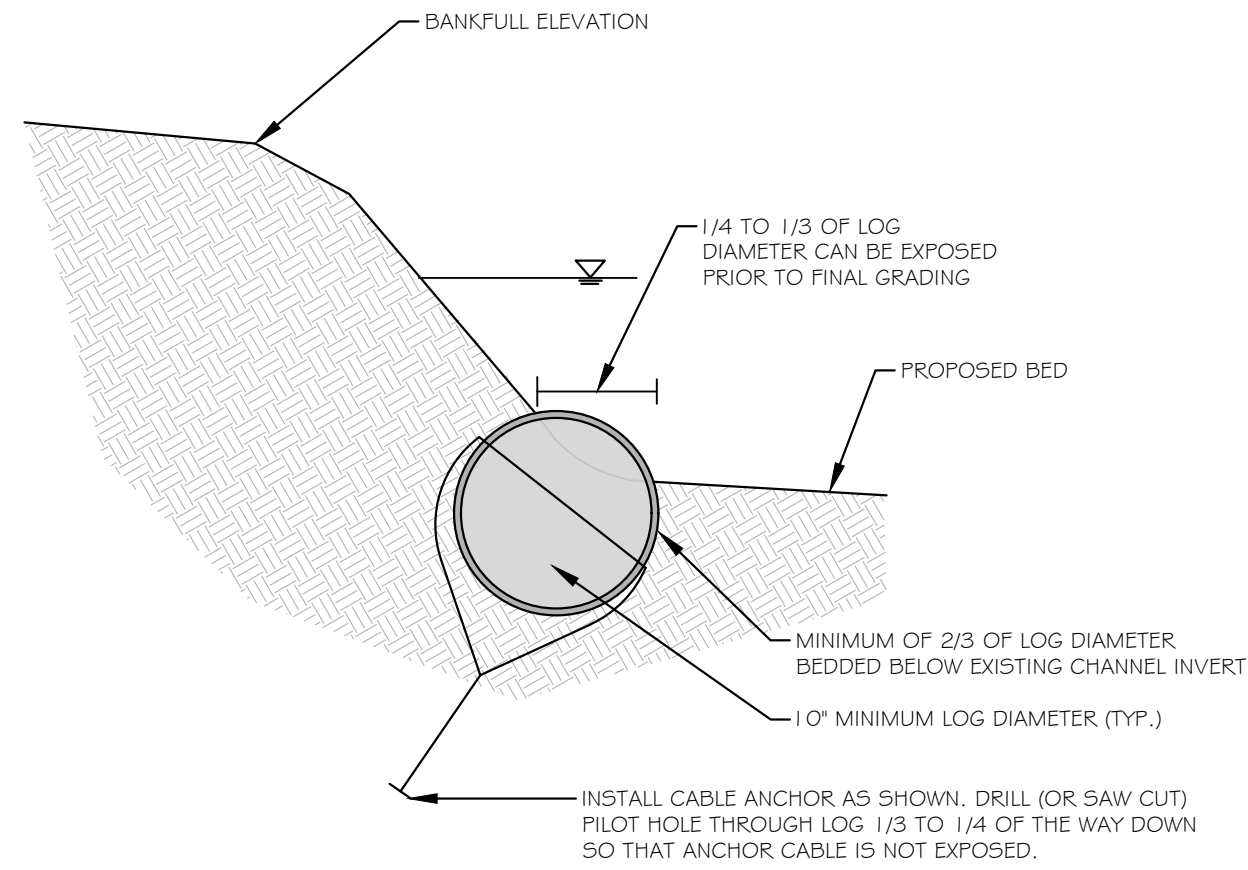
LOG TOE PROTECTION

- NOTES:
- LOGS SHOULD BE AT LEAST 10 INCHES IN DIAMETER, 5-8 FEET LONG, RELATIVELY STRAIGHT, AND HARDWOOD.
  - CABLE ANCHORS SHOULD BE PLACED 1' TO 3' FROM EACH END OF LOG. REBAR (5/8" MINIMUM DIAMETER, 3' MIN. LENGTH TYPICAL) MAY BE USED AS A SUBSTITUTION FOR CABLE ANCHORS PER DIRECTION OF ENGINEER.
  - IF REBAR IS USED, PRE-DRILL HOLES WITH 5/8" DRILL BIT.

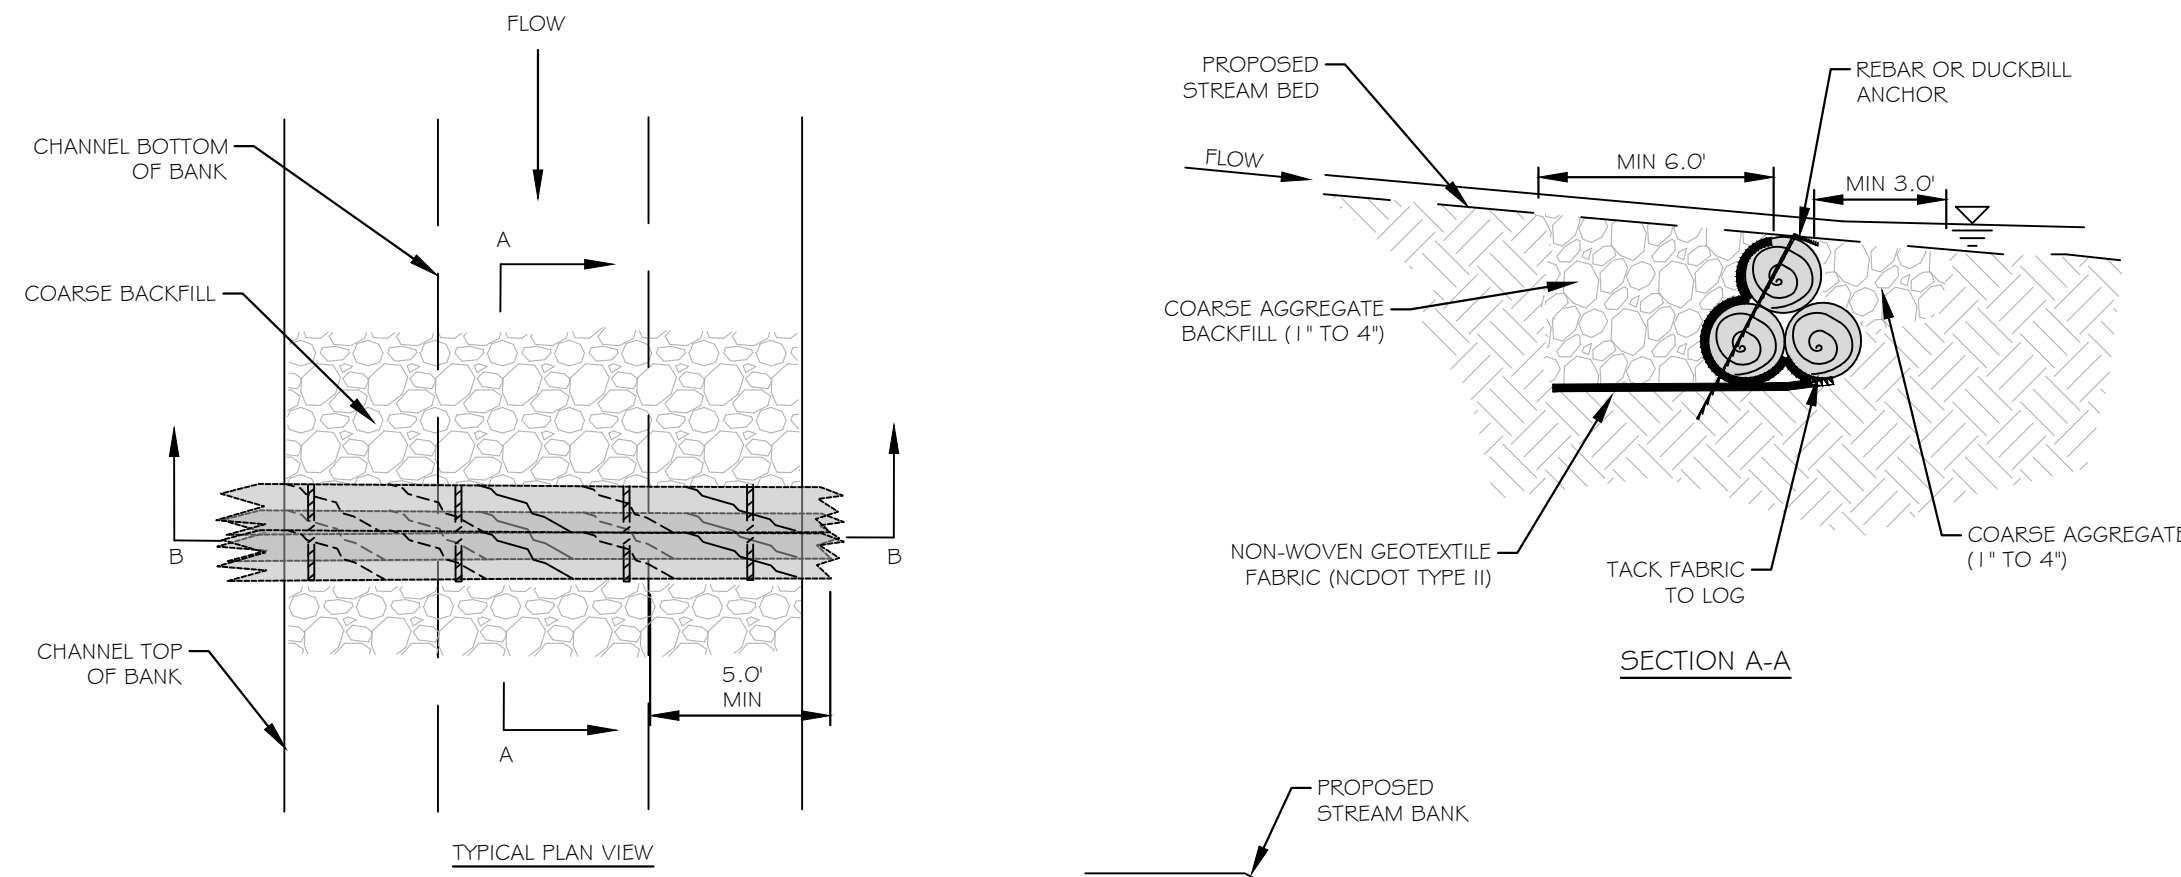
LOG GRADE CONTROL

- NOTES:
- LOGS SHOULD BE RELATIVELY STRAIGHT HARDWOOD AND RECENTLY HARVESTED.
  - LOG DIMENSIONS:  
MIN DIAM. = 1.0'; MIN LENGTH = 15'
  - NAIL FILTER FABRIC USING 3" 10D GALVANIZED COMMON NAIL EVERY 1.5' ALONG THE LOG
  - DUCKBILL ANCHORS MAY BE USED IN PLACE OF REBAR.

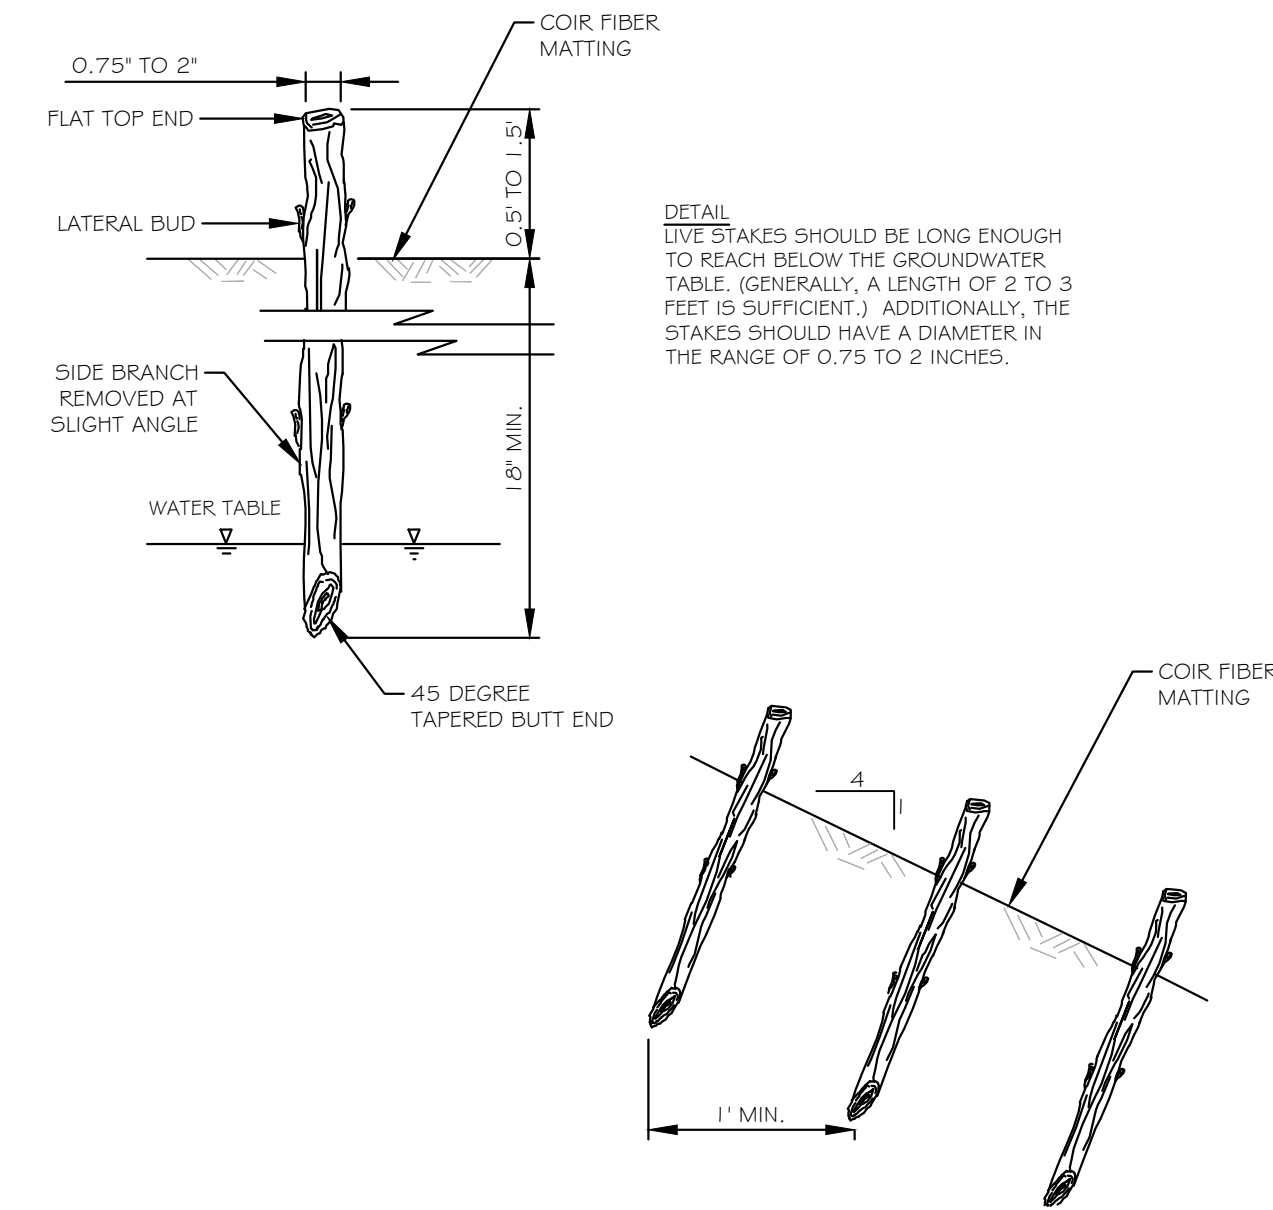
LIVE STAKE

- NOTE:
- ACCEPTABLE SPECIES INCLUDE BLACK WILLOW (SALIX NIGRA), SILKY WILLOW (SALIX SERICEA) AND SILKY DOGWOOD (CORNUS AMMOMULUM).
  - LIVE STAKES SHALL BE PLANTED IN AN AREA EXTENDING 3 FEET OUT FROM TOP OF BANK TO JUST BELOW BANKFULL.
  - LIVE STAKES SHALL BE SPACED 3 FEET APART, ALTERNATE SPACING.

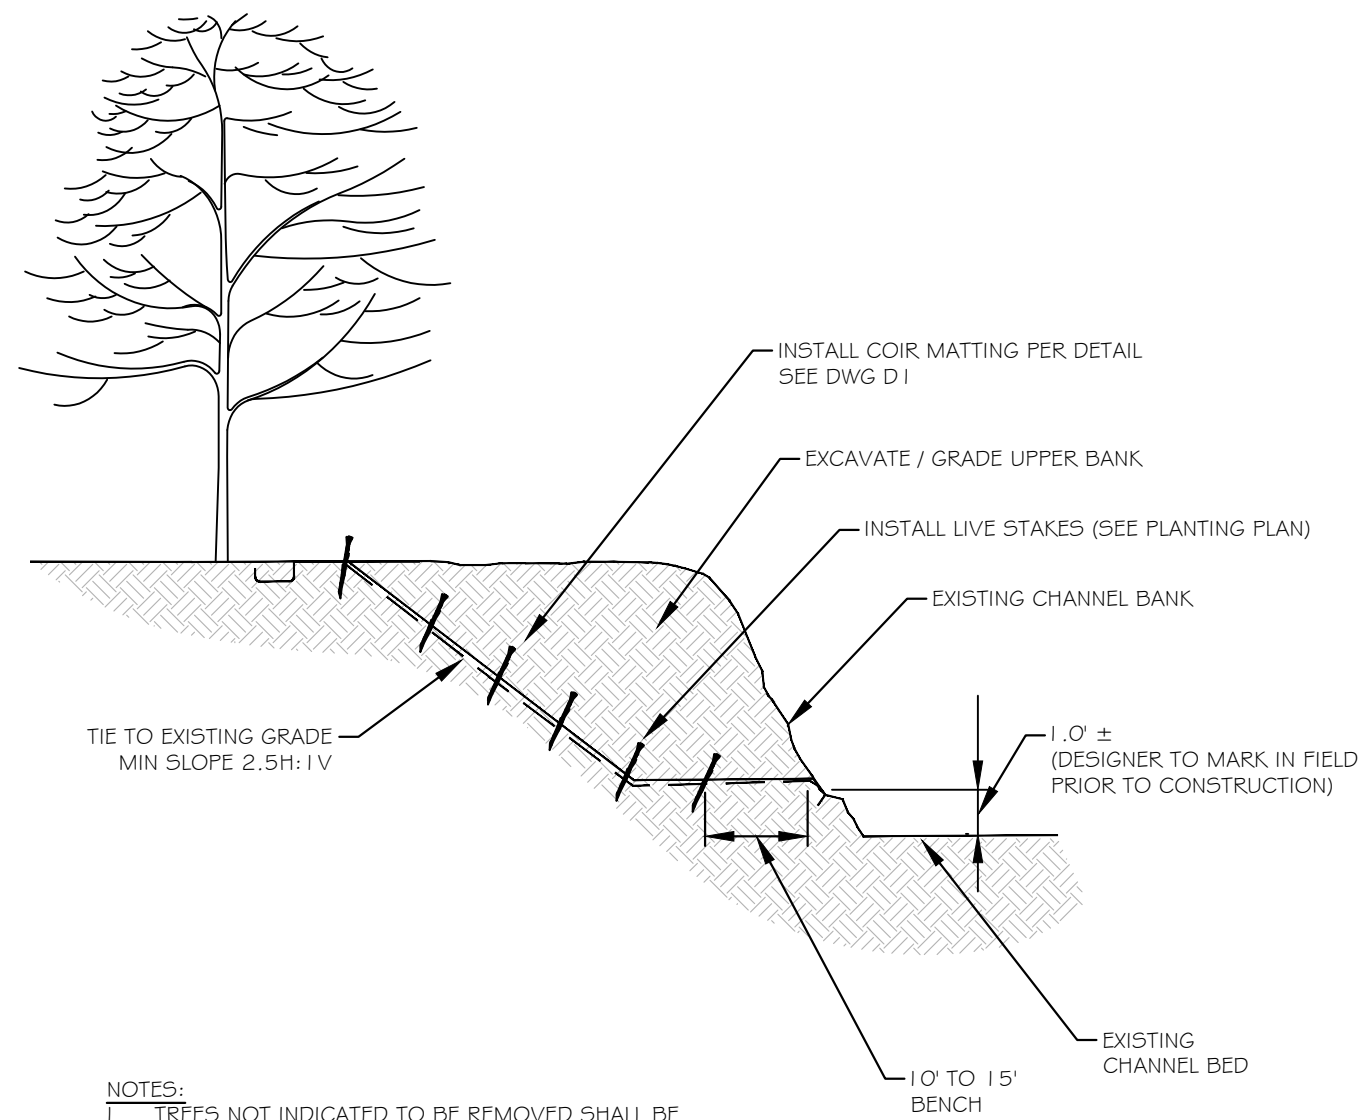
TYPICAL BANK GRADING

- NOTES:
- TREES NOT INDICATED TO BE REMOVED SHALL BE PROTECTED DURING CONSTRUCTION IN ACCORDANCE WITH PLANS.
  - SEED AND MULCH ALL BANKS PRIOR TO INSTALLING COIR MATTING.

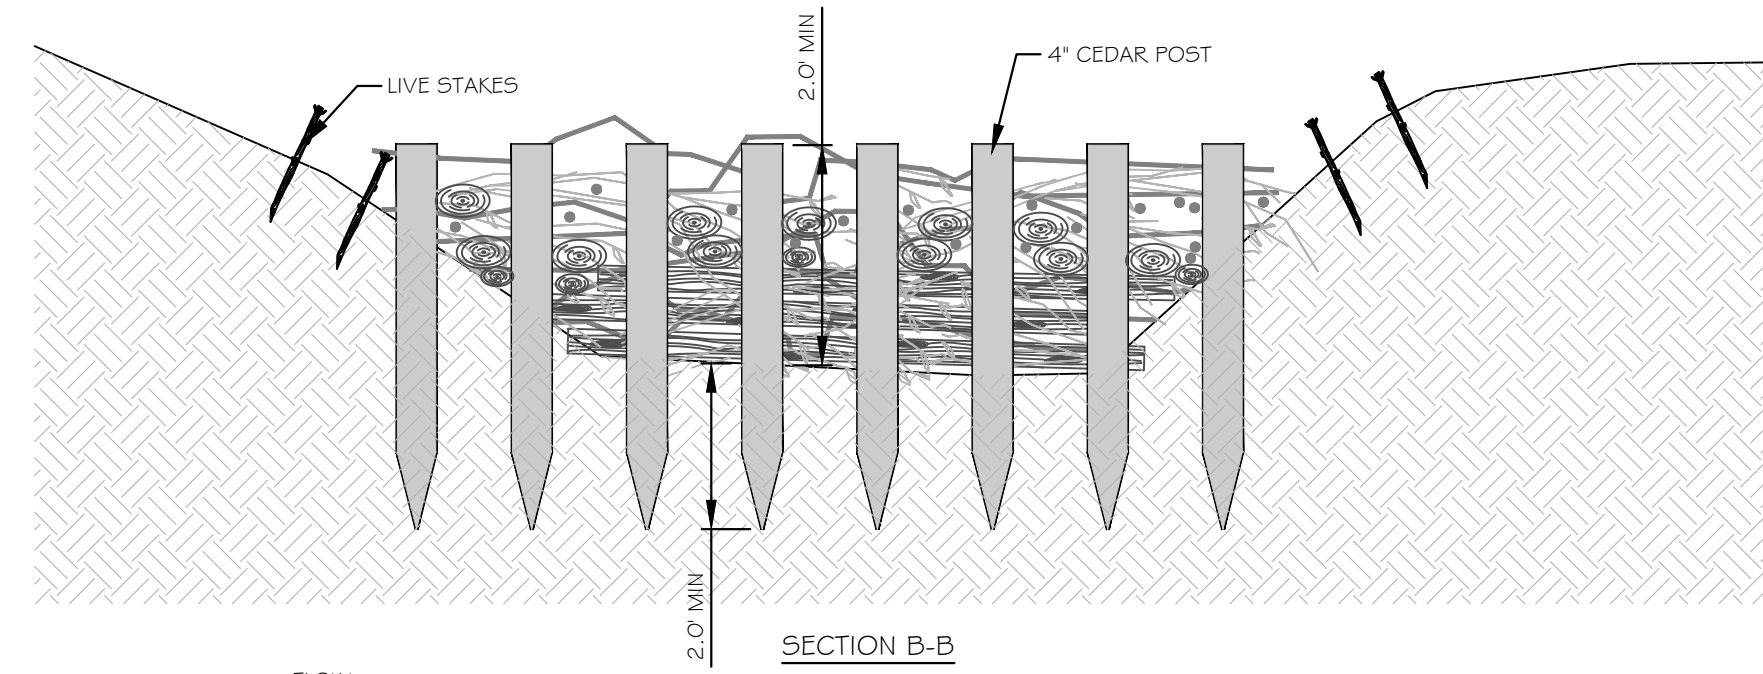
ENGINEERED SEDIMENT PACK (ESP)

- NOTES:
- DRIVE 2 ROWS OF 4" CEDAR POSTS ON MINIMUM 3' CENTERS PAST MINIMUM DEPTH AS SHOWN.
  - FILL THE VOID BETWEEN POST ROWS W/ AN EVEN MIX OF HARDWOOD LOGS, LIMBS, AND BRUSH AS SHOWN.
  - REDUCE POST SPACING AS NEEDED TO IMPROVE STRUCTURE STABILITY.

7. I'm pleased to see the engineered sediment packs considering the runoff coming off the adjacent pastures. Near STA 5+00 there was a large cattle wallow. Will this area be stabilized? Is there a potential for this area to degrade again with future cattle access and potentially impact the project in the future.

Two ESPs have been added to sheet S7 to address concentrated flow from the drainages observed on aerial imagery.

6. I'm pleased to see the engineered sediment packs considering the runoff coming off the adjacent pastures. Near STA 5+00 there was a large cattle wallow. Will this area be stabilized? Is there a potential for this area to degrade again with future cattle access and potentially impact the project in the future?  
This area is located outside of the easement and is a jurisdictional wetland. There are currently no plans to fill or stabilize this area since RES has no control. However, an ESP is proposed just inside the easement downstream of the depression that should address any potential runoff/sediment issues.

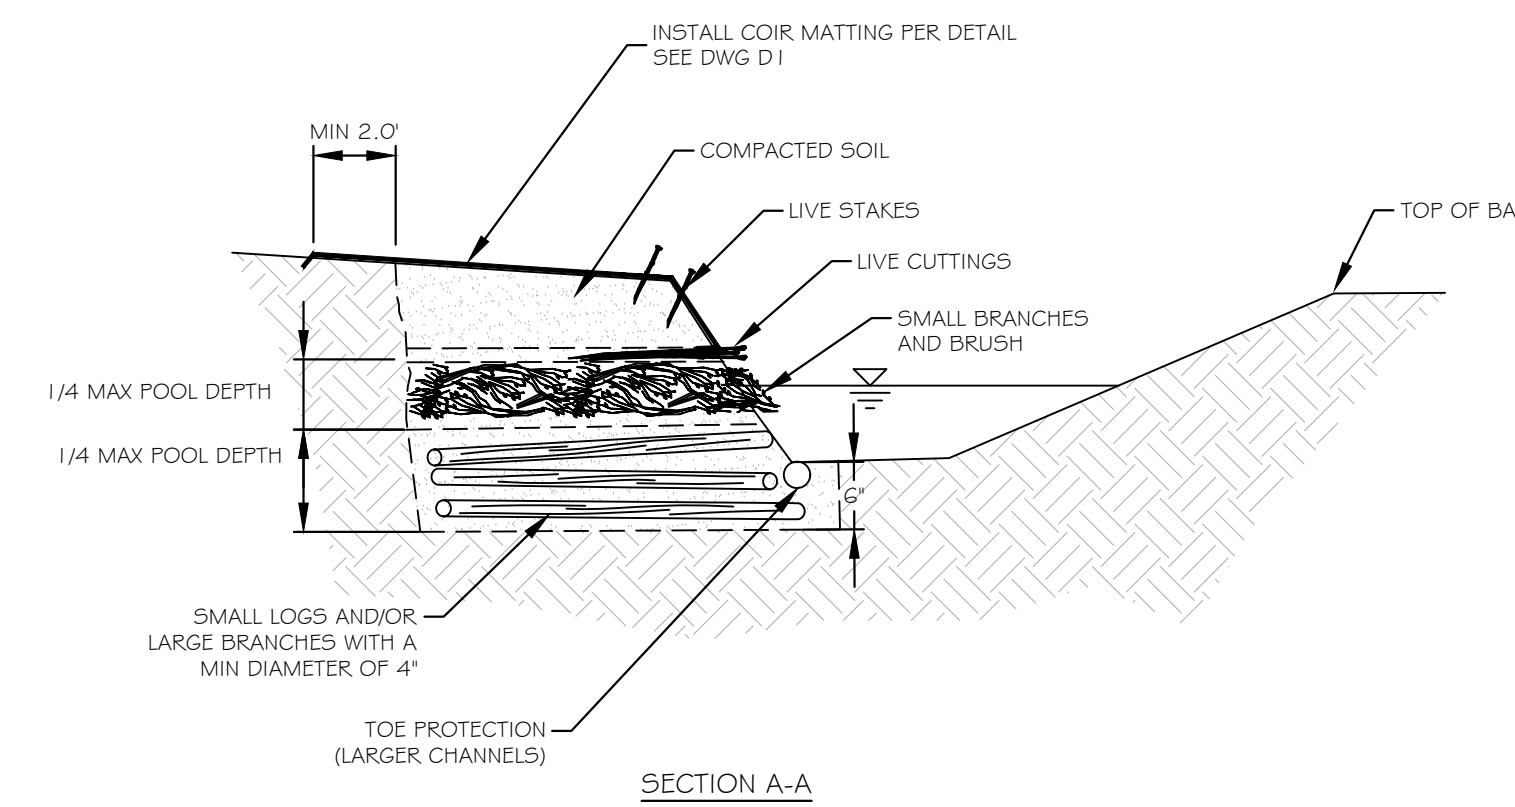
SECTION A-A

- NOTES:
- OVER EXCAVATE THE OUTSIDE BEND OF THE CHANNEL. PLACE LARGER BRANCHES AND LOGS IN A CRISS-CROSS PATTERN. LOCK IN PLACE WITH FILL COVERING 6 IN TO 18 IN OF THE LARGER BRANCHES/SMALL LOGS.
  - PLACE SMALLER BRANCHES AND BRUSH OVER THE LARGER BRANCHES/SMALL LOGS (HARDWOOD SPECIES ONLY) AND COMPACT LIGHTLY TOGETHER. BACKFILL AND COMPACT TO LOCK IN PLACE.
  - ACCEPTABLE LIVE CUTTINGS SPECIES INCLUDE BLACK WILLOW (SALIX NIGRA) AND SILKY WILLOW (SALIX SERICEA). WILLOW CUTTINGS SHOULD BE RINSED AT CUTTING POINT TO ALLOW BETTER ROOTING.
  - INSTALL EROSION CONTROL (COIR) MATTING OVER COMPACTED SOIL PER DIRECTION OF ENGINEER.
  - INSTALL 1 TO 3 ROWS OF LIVE STAKES ABOVE THE LIVE CUTTINGS LAYER PER DIRECTION OF ENGINEER.

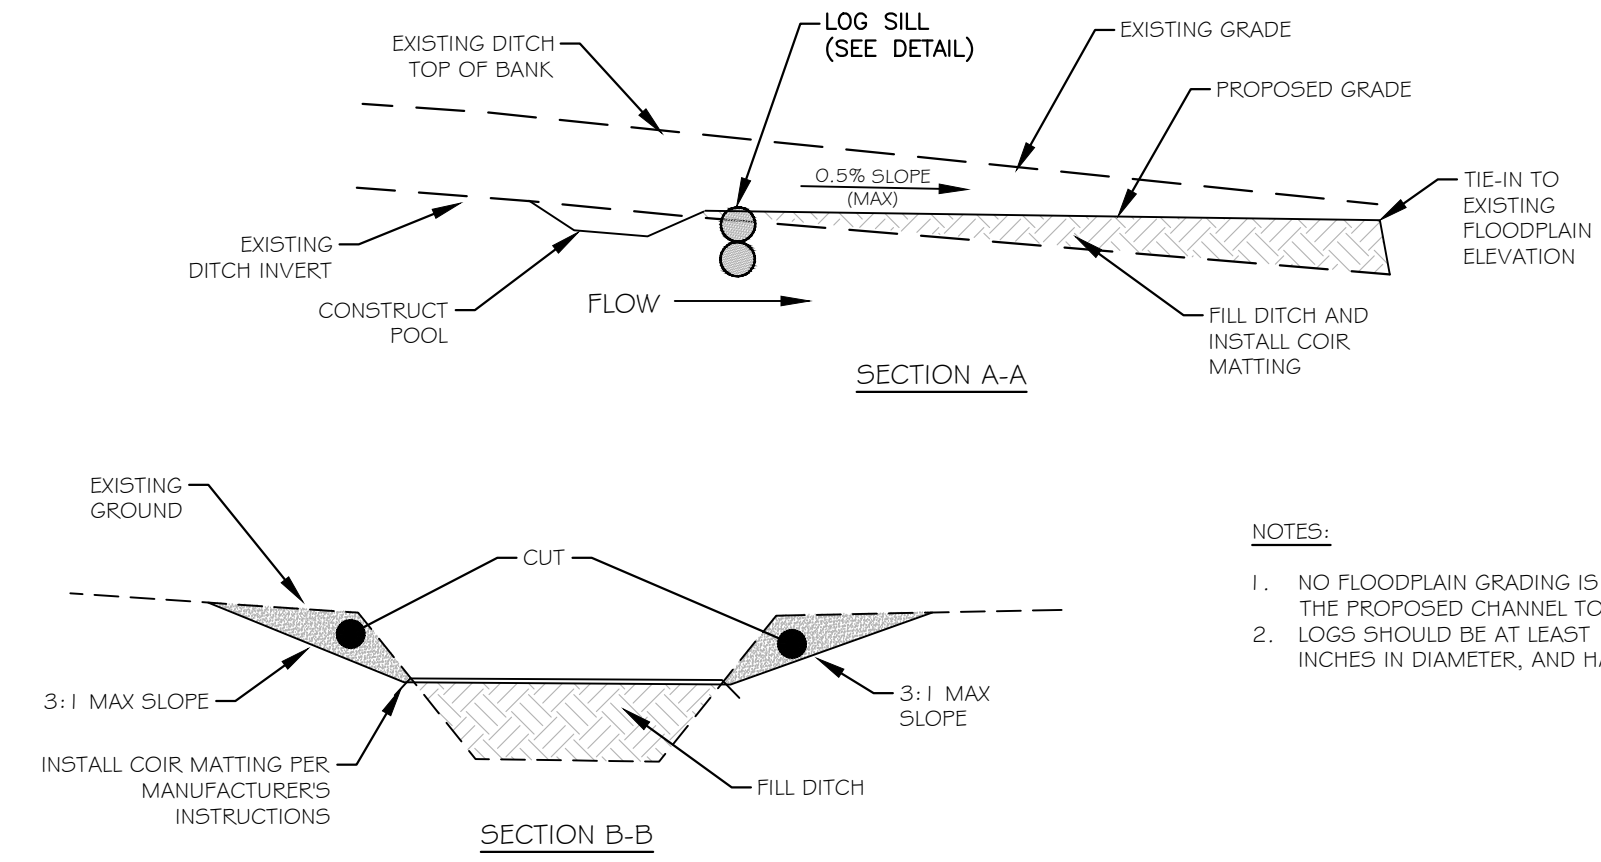
NOTES:  
1. NO FLOODPLAIN GRADING IS ALLOWED WITHIN 10 FT OF THE PROPOSED CHANNEL TOP OF BANK.  
2. LOGS SHOULD BE AT LEAST 10'-20' LONG AND AT LEAST 8 INCHES IN DIAMETER, AND HARDWOOD.

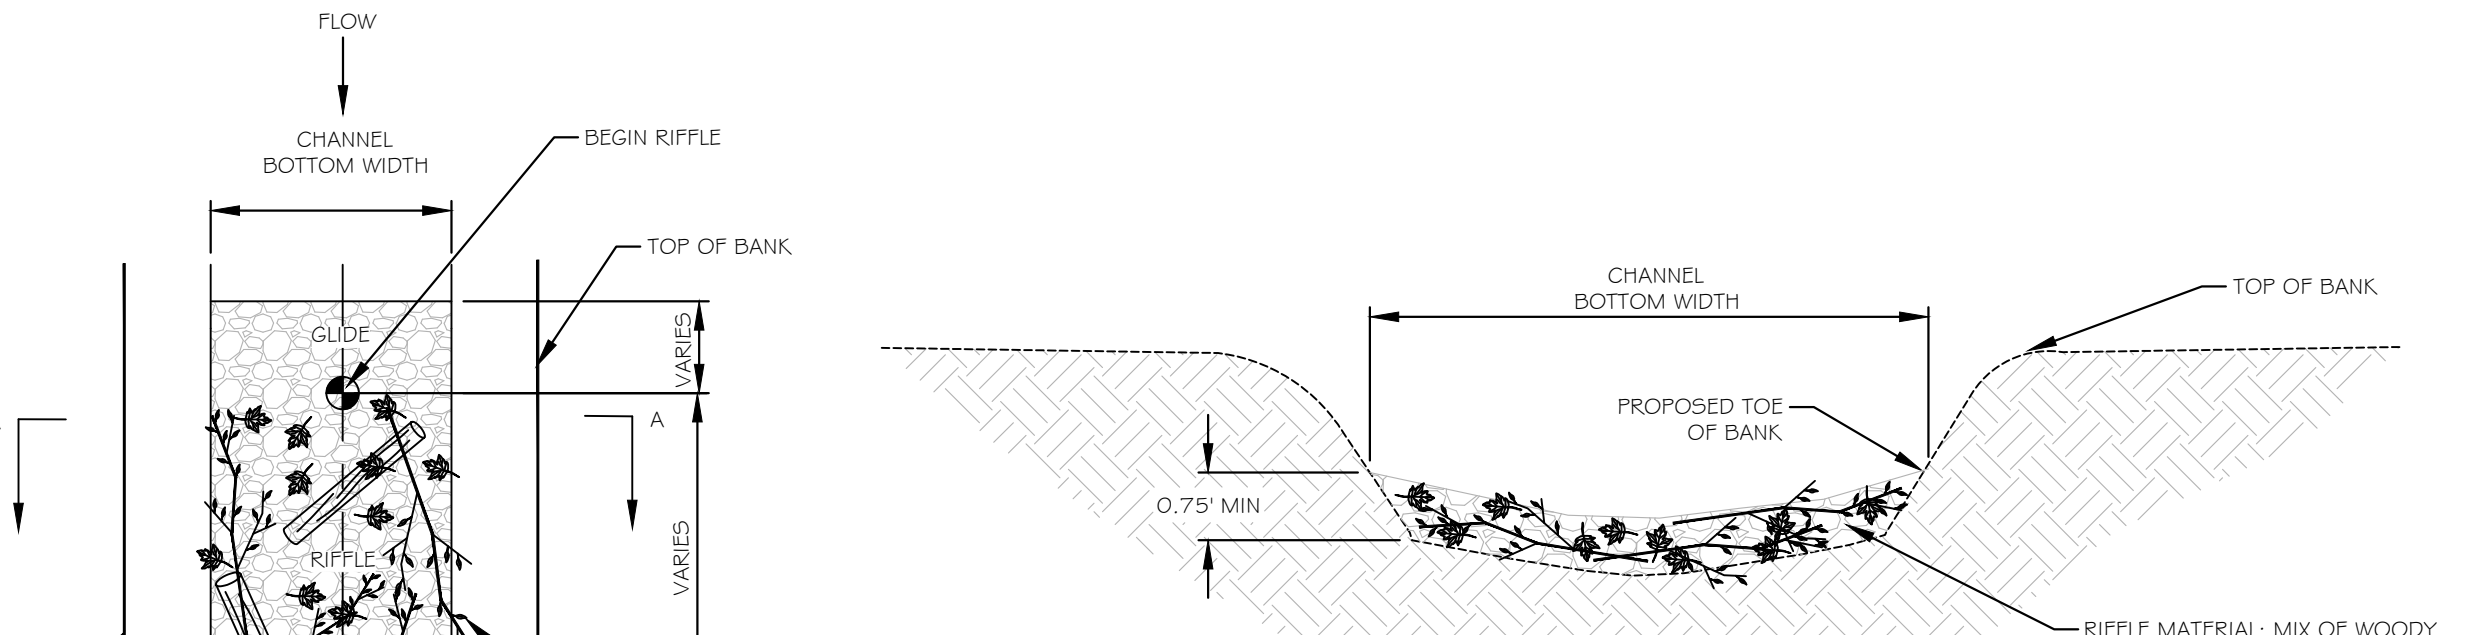
WOODY RIFFLE  
NTS

TABLE 1 - STONE COMPOSITION		
REACH	STONE SIZE	%
X1	NATIVE	25
	#5	50
	SURGE	25

6. Design Sheet E1- RES has a typical for a woody riffle (which is good!), however, it does not appear in the legend, nor does it appear on any of the design sheets. DWR strongly recommends that most of riffles be woody riffles.

10. **Design Sheet E1** - RES has a typical for a woody riffle (which is good!), however, it does not appear in the legend, nor does it appear on any of the design sheets. DWR strongly recommends that most of riffles be woody riffles.

Woody Riffle detail has been renamed Typical Woody Riffle. Callouts have been added to the Notes/Legend sheet to reflect its use in all riffle sections unless otherwise noted
