# FINAL MITIGATION PLAN

**Matthew Site  
Johnston County, North Carolina**

**Neuse River Basin  
HUC 03020201**

**DMS Project #: 100043  
Contract #: 7419  
USACE Action ID: SAW-2018-01256  
DWR Project #2017-0624  
RFP: 16-007279**

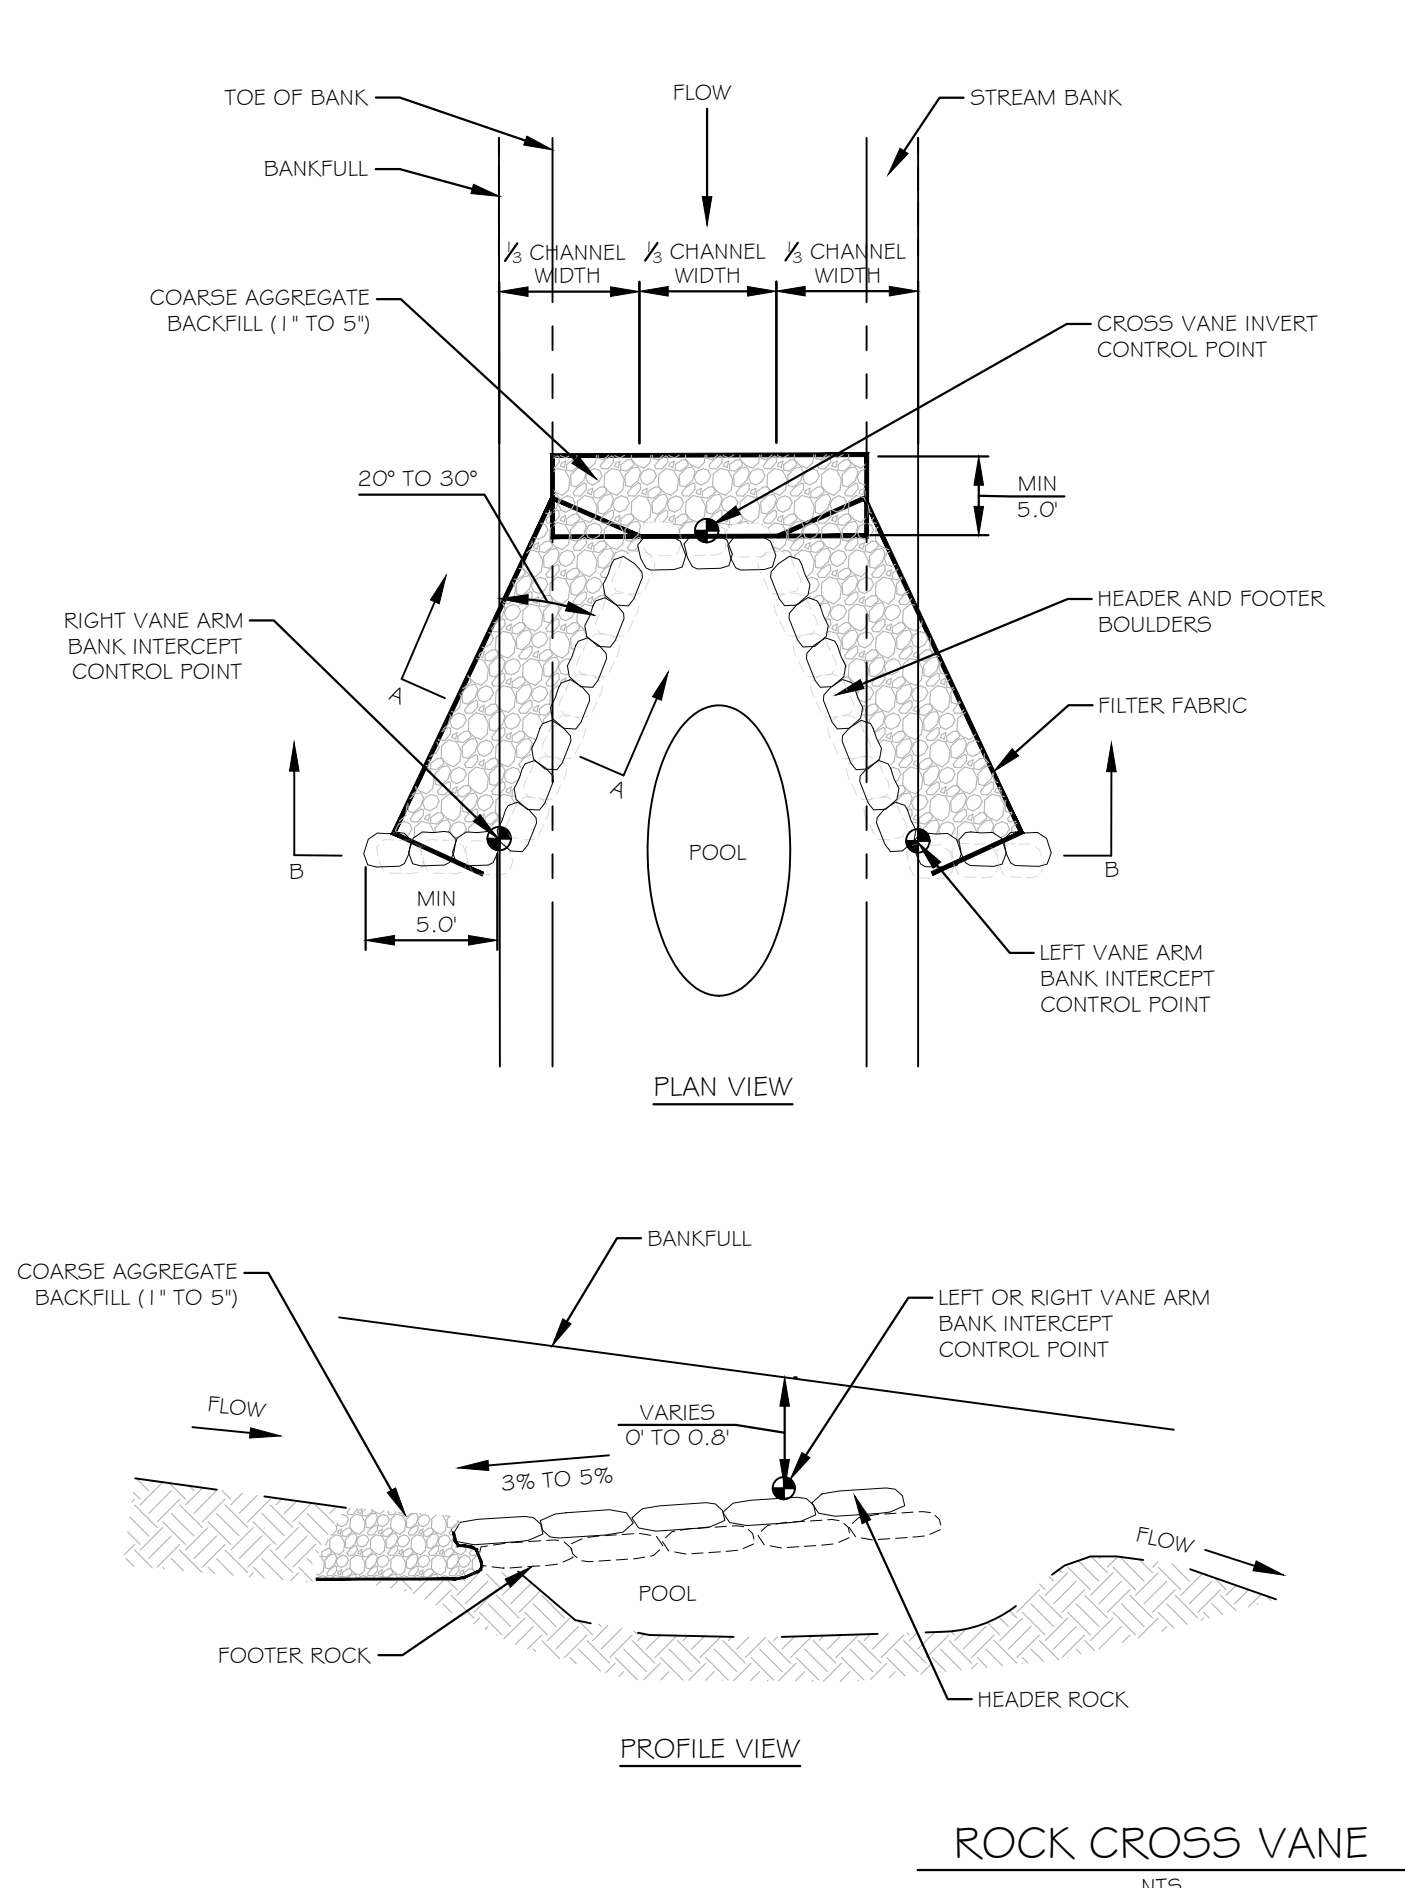
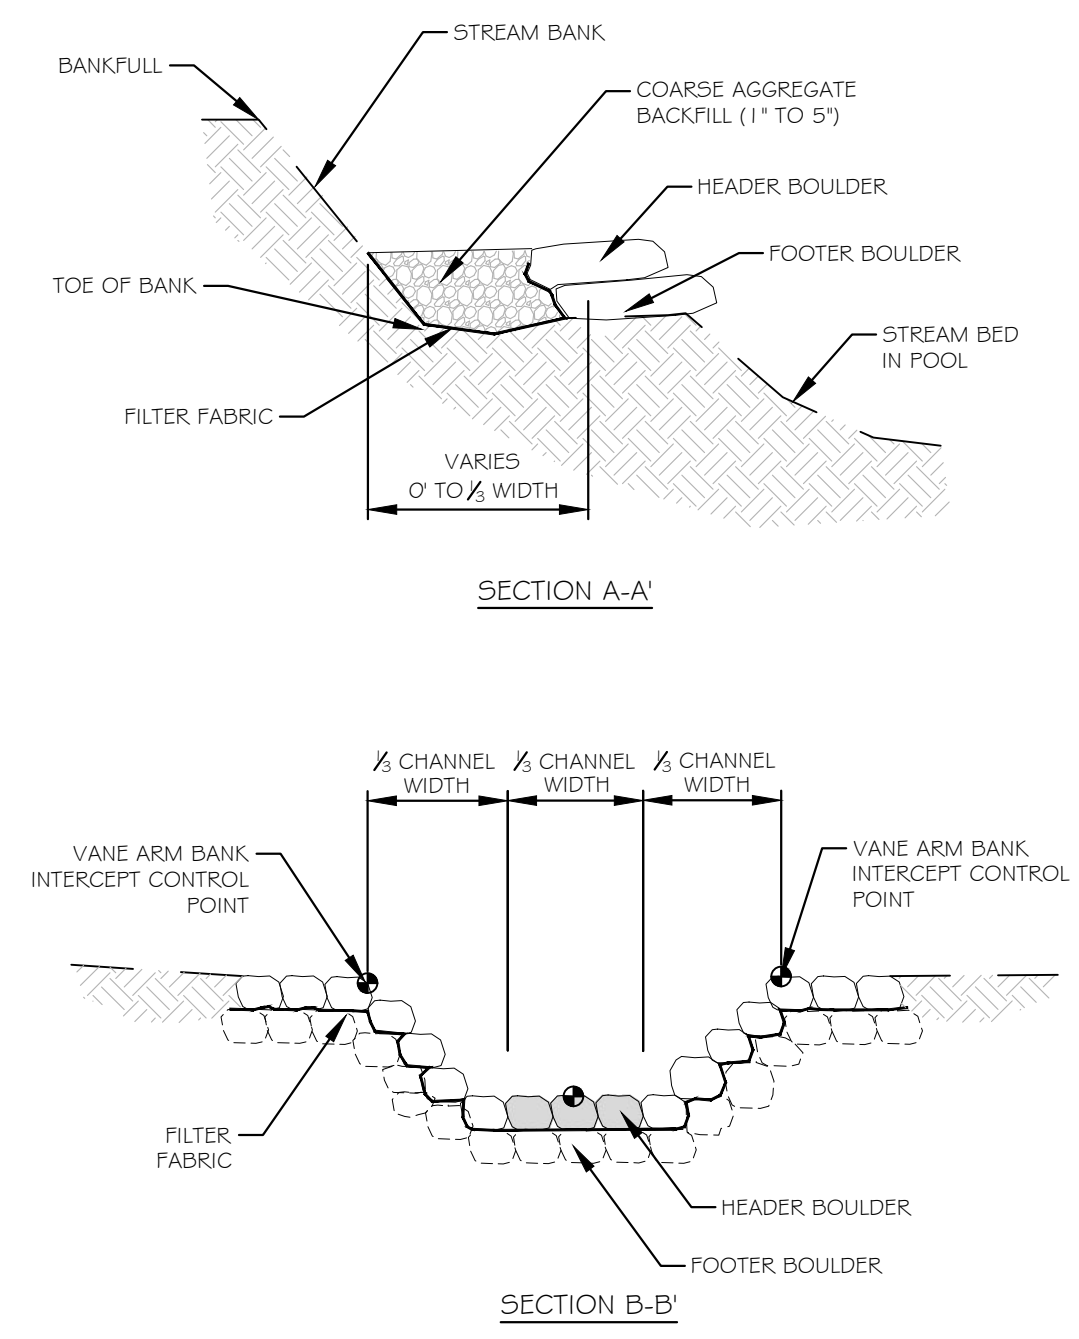
- NOTES:
- SEE STRUCTURE BOULDER SIZE TABLE FOR APPROXIMATE DIMENSIONS OF BOULDERS. THE UPPER LIMIT FOR BOULDERS SHALL BE APPROVED BY THE ENGINEER PRIOR TO INSTALLATION OF THE STRUCTURE.

- AS THE CROSS VANE IS CONSTRUCTED, THE CONTRACTOR SHALL CHINK ALL VOIDS BETWEEN THE FOOTER BOULDERS, AND BETWEEN THE FOOTER BOULDERS AND VANE BOULDERS. VOIDS SHALL BE CHINKED WITH SMALLER ROCK SUCH THAT NO VOIDS GREATER THAN FOUR INCHES IN SIZE WILL BE PRESENT.

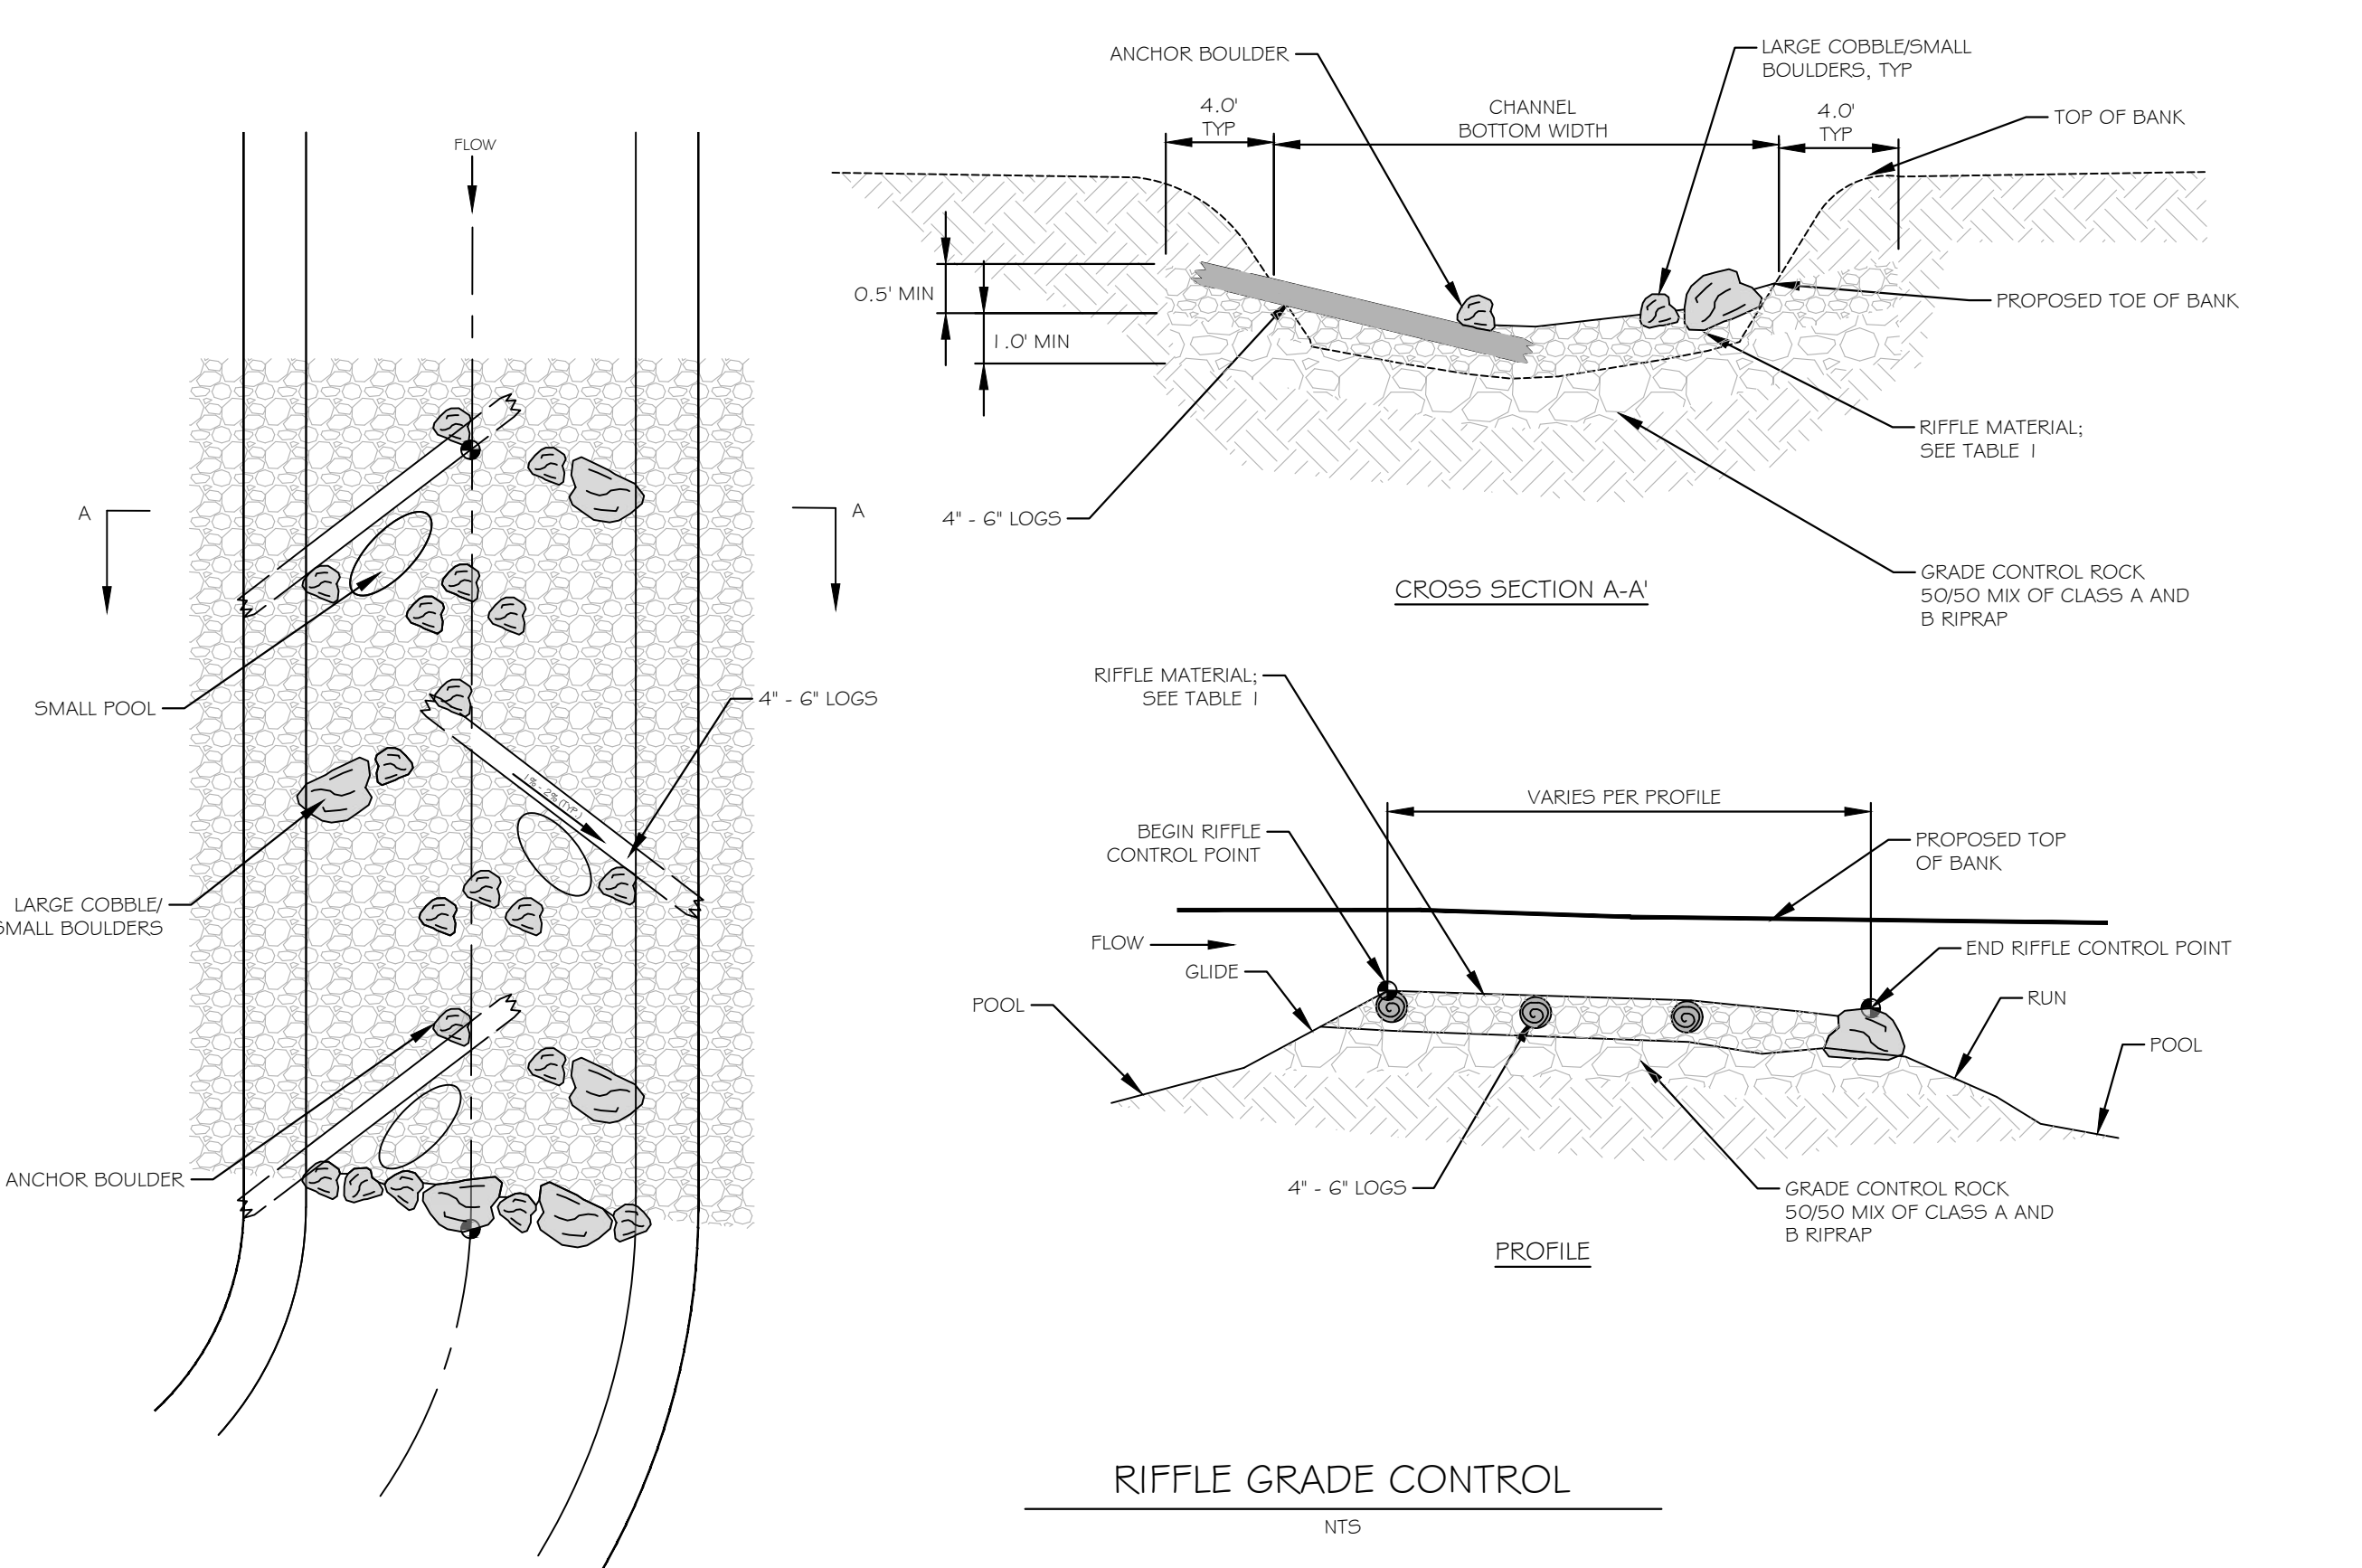
- NOTES:
- RIFFLE GRADE CONTROL STRUCTURES SHALL BE INSTALLED IN NEWLY GRADED CHANNEL SECTIONS, AS SPECIFIED BY THE DESIGNER.
  - ELEVATION CONTROL POINTS SHALL BE DESIGNATED AT THE BEGINNING AND END OF RIFFLE POINTS TO ESTABLISH PART OF THE PROFILE OF THE CHANNEL. SURVEY OF CONTROL POINTS SHALL BE REQUIRED TO ESTABLISH ACCURATE RIFFLE INSTALLATION WITH A TOLERANCE OF ±0.2'.
