MITIGATION PLAN

McCLENNY ACRES MITIGATION PLAN

Wayne County, NC
NCDEQ Contract No. 7423
DMS ID No. 100038

Neuse River Basin
HUC 03020201

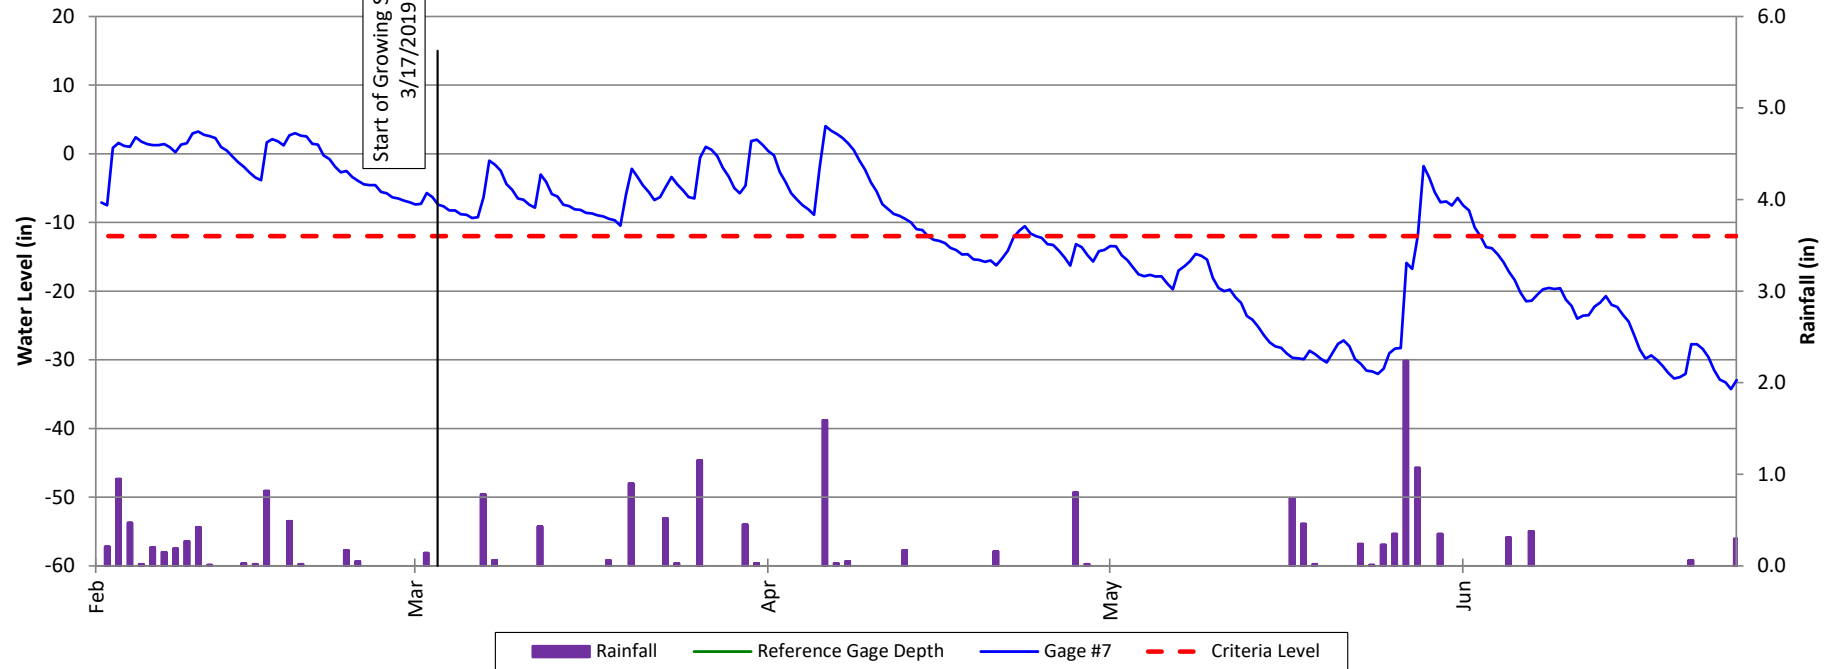
McClenny Groundwater Gage #7 Existing Conditions 2019

Five groundwater monitoring gauges (gauges 1 – 5) were installed on March 16, 2018. Six additional gauges (gauges 6 – 11) were installed on February 14, 2019. Gauge 3 malfunctioned beginning on July 17, 2018 and was replaced February 14, 2019. Gauges 1, 2, 5, 6, 7, 8, and 11 are located outside of the proposed DMS conservation easement, but are informative of site hydrology nonetheless. Gauge 4 is in an existing wetland and Gauge 5 is far from the mitigation areas. According to the 1974 soil survey, the growing season in Wayne County extends from March 17 to November 5 (232 days). Hydrographs of each gauge are included in Appendix 6.

Review of data from gauges 1-3 suggests that areas within the ditched agricultural field and gauges 9 and 10 west of UT3 do not currently exhibit a wetland hydrologic regime under normal rainfall conditions based on a consecutive saturation threshold of 14 days during the growing season (USACE, 2005). The rapid recession of groundwater tables observed is likely due to the effect of drainage ditches. The sudden and sustained increase in elevation of groundwater tables in late July and August is due to the combined effects of well above normal rainfall and beaver activity. Existing hydrology summary information is presented in Table 6 and groundwater hydrographs and precipitation analysis is in Appendix 6.
