**MITIGATION REPORT**

**FULL DELIVERY PROJECT TO PROVIDE WETLAND AND STREAM RESTORATION  
YADKIN RIVER BASIN CATALOGUING UNIT 03040201**

**MCDONALDS POND RESTORATION SITE  
Richmond County, North Carolina**

**JULY 2006**

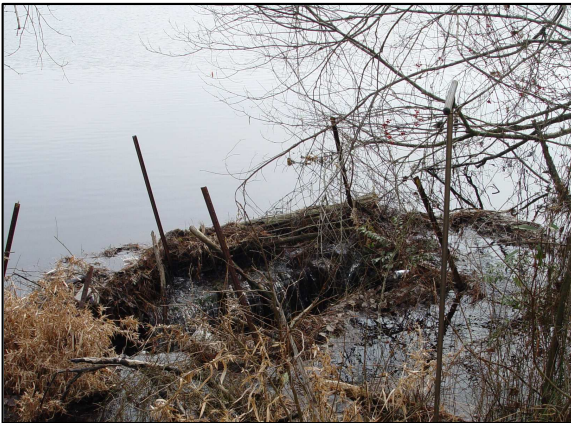
*Photo 1: Pond Drainage Inlet – Brick and mortar riser structure at the northern outfall channel located within the pond at the northern extent of the dam.*

The brick and mortar riser structure at the northern extent of the former dam channeled high water through multiple culverts and into an excavated/eroded ditch (hereafter referred to as the “northern outfall channel”) (Photos 1 and 2). The northern outfall channel extended parallel to the main channel of Falling Creek for approximately 500 feet before merging into overland flow through the center of the floodplain. The change in elevation from the outlet pipe to the bottom of the outfall channel was approximately 3 feet. The drop in elevation caused erosion and scouring of the outfall channel and subsequent deposition of excess sediment onto the floodplain down valley. This brick and mortar riser was serving as the primary discharge for the pond prior to dam removal.

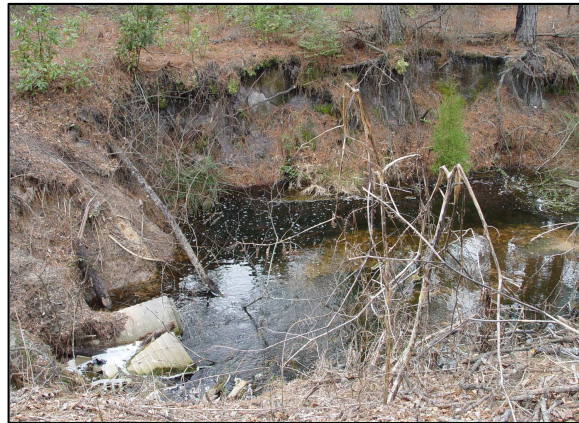
*Photo 2: Pond Drainage Outlet – Concrete culverts located at the northern outfall channel and adjacent eroded soil.*

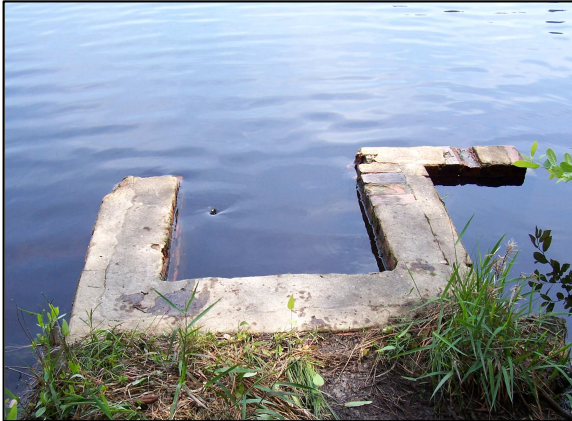
*Photo 3: Pond Drainage Inlet – Brick flash board riser leading to gate valve structures located near the center of the dam.*

The flash board riser/gate valve system formerly located near the center of the dam historically served as the primary water control structure for the pond (Photo 3). However, the gate valves were not operating immediately prior to dam removal due to infrequent use. This structure was comprised of three 8 inch diameter outlet pipes with traditional gate valves attached to each pipe outlet. The gate valves are denoted with red arrows in Photo 4.

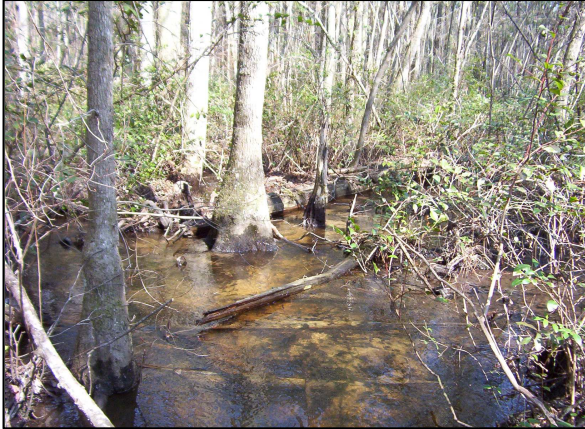
*Photo 5: Braided D-type stream section located upstream of the former pond near stream reference reach.*

Reference stream reaches in the area (both on-Site and off-Site) include both sinuous, single threaded E-type and braided, D-type streams (Rosgen 1996). Streams that occur in low-gradient valleys, as observed on-Site, are prone to perturbation (i.e., beaver and tree fall) and easily revert to braided systems. A combination of stream types (both E- and D-types) appear to be stable and represent the objective for restoration of natural stream processes in the footprint of McDonalds Pond (Photos 5 and 6).

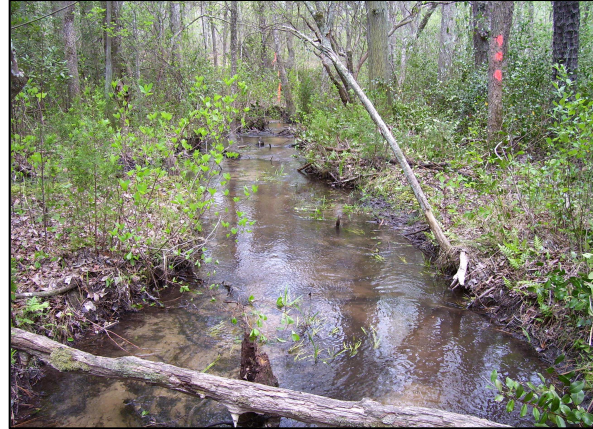
*Photo 6: Single threaded E-type stream section located upstream of the former pond within stream reference reach.*

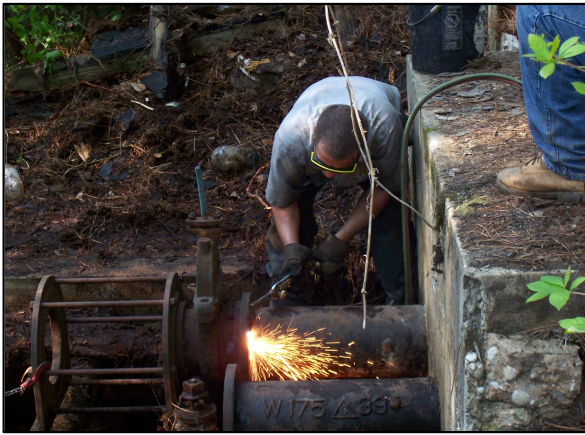
*Photo 7: Removal of two gate valves using an acetylene torch.*

The former pond was dewatered beginning in the late summer – early fall of 2005. Initial dewatering was accomplished through the opening of two of the three gate valves located near the center of the dam (Photo 7). In addition, a 4 inch PVC siphon was installed to assist with the rise in the pond pool elevation following storm events (Photo 8). By late January – early February 2006, the normal pond pool elevation of approximately 281 feet above mean sea level (MSL) (equaling approximately 18 acres) was lowered to approximately 275 feet above MSL (equaling approximately 5 acres). In early – mid February, the third and final gate valve was removed, which allowed for the pond pool elevation to be reduced to approximately 273 feet above MSL or approximately 3 acres by the end of late February 2006.

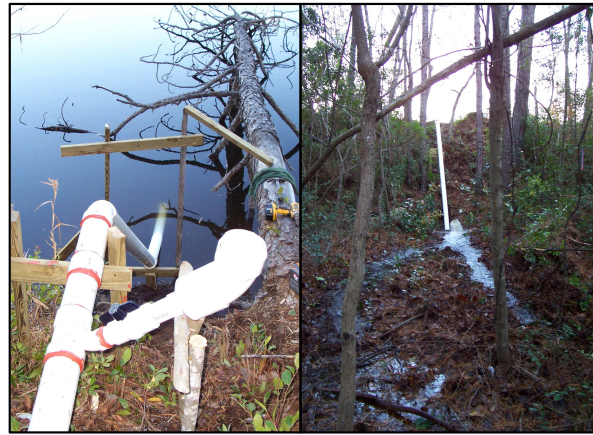
*Photo 8: 4 inch siphon system installed to assist with the control of pond pool elevation following storm events.*

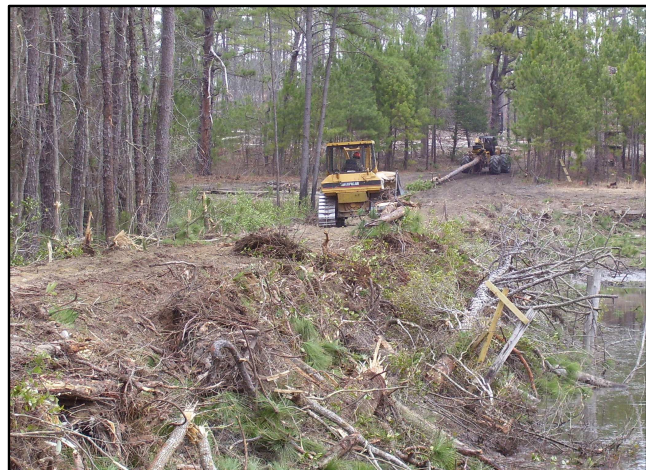
*Photo 9: Grapple skidder (background) and bull dozer (foreground) working in tandem to remove trees from the former dam.*

Following the clearing of vegetation from the dam, heavy equipment operated off of or within the footprint of the former dam during excavation activities, thereby minimizing the impact to adjacent intact forest and wetland soil. A portion of the excavated dam material was deposited into a segment of the northern outfall channel, moderately compacted, and graded to the elevation of the adjacent undisturbed soil. The remaining fill material was either graded onto existing IP dirt roads (upland sections outside of the easement area) or hauled to the nearest appropriate landfill.

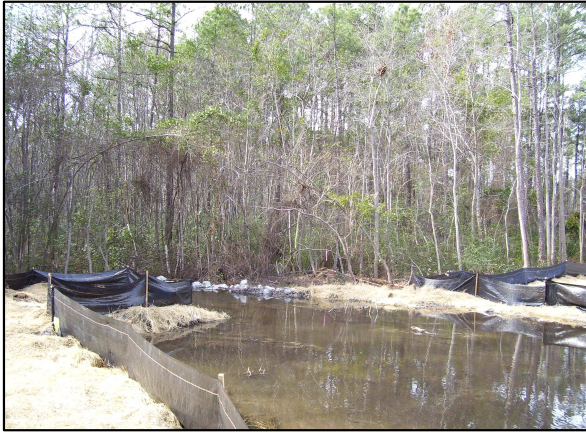
*Photo 10: Temporary silt fence, spread hay, and rip-rap located adjacent to new stream channel.*

Numerous Best Management Practices (BMPs) were undertaken to avoid impacts to aquatic resources in the vicinity of the former dam throughout the removal process, including: 1) the construction of silt fence and hay bale arrays to avoid sediment fluxes downstream during and after dam removal (Photos 10 and 11), 2) the placement of rip-rap directly below the former dam within the newly developed stream channel to stabilize soil and streambed (Photo 10), 3) the strategic placement of logging debris outside of the floodplain on slope soils to assist with site stabilization and to prevent trespass into the restoration area (Photo 11), and 4) the seeding of the dam and adjacent staging area with appropriate temporary herbaceous vegetation, which was later planted with appropriate tree species.

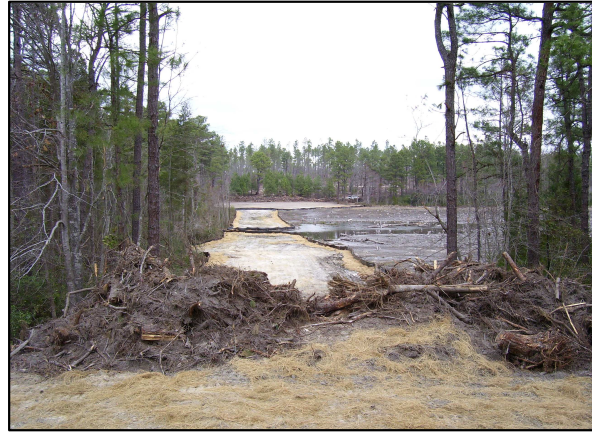
*Photo 11: View of former dam from south-side looking north at erosion control measures including logging debris, silt fence, and hay bales.*

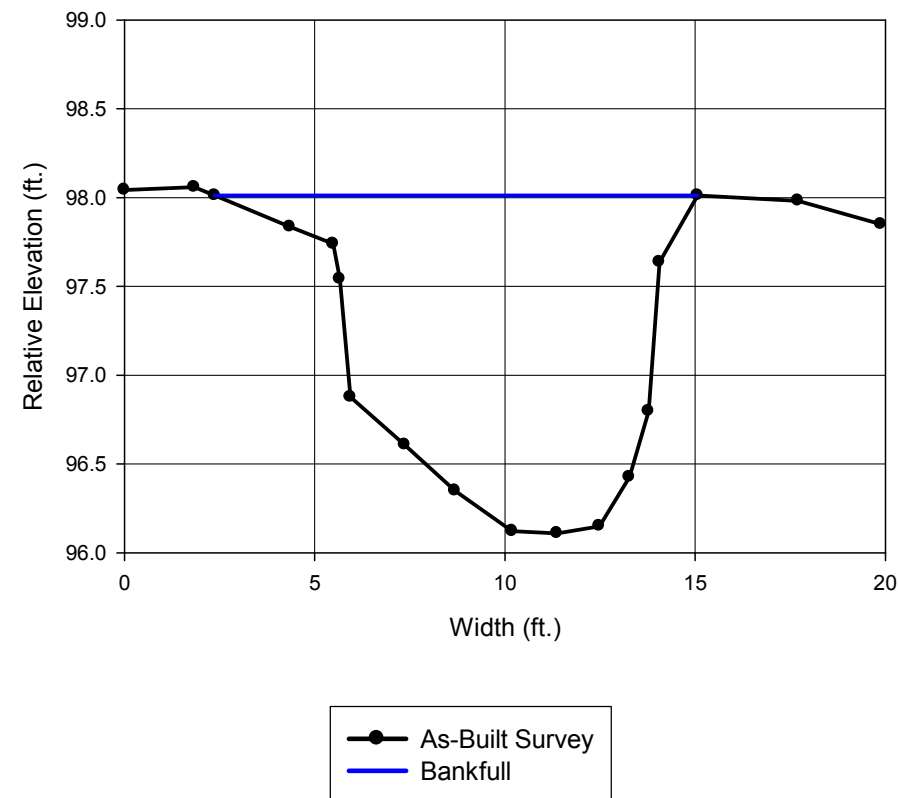
**Cross-Section Plot - Looking Downstream**

<b>Survey Date</b>	<b>Survey Weather</b>	<b>Field Team</b>	<b>Location</b>
Apr 06	Sunny	David Jones, Michael Gloden	Reference Reach 1 (XSR1)

The cross-sectional and longitudinal profile data for the site monitoring reaches presented in the Mitigation Plan are illustrated in Figures R1-R4 and Figure P1. These data were collected in April 2006 following the dam removal and represent site “as-built” conditions.

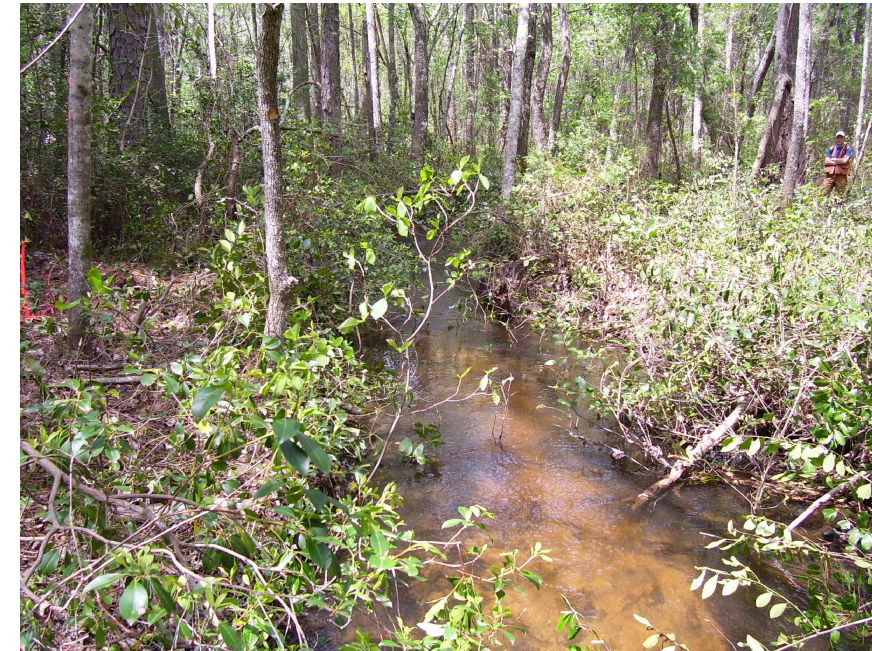
Reach 1 Cross-Section upstream looking downstream

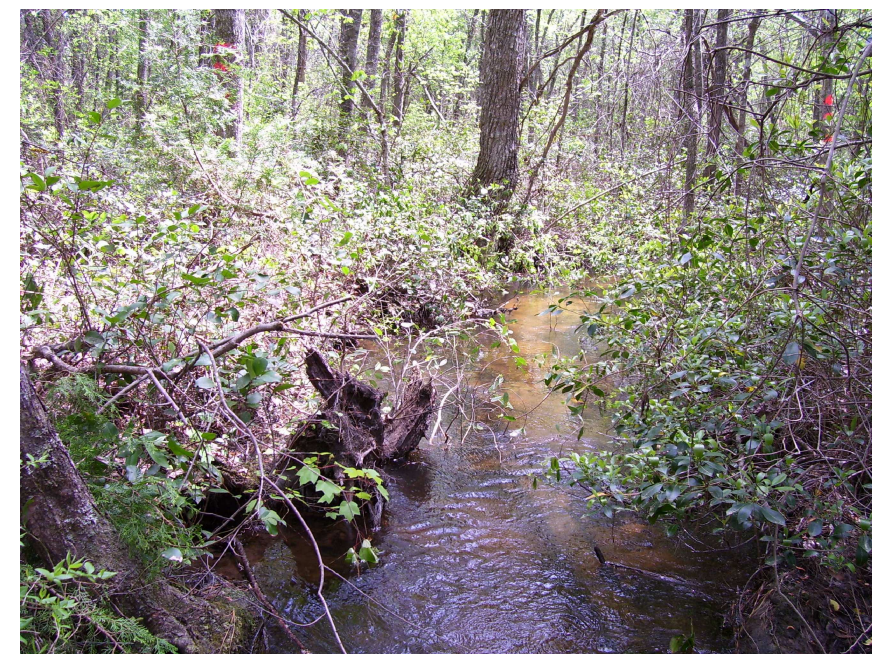
Reach 1 Cross-Section downstream looking upstream

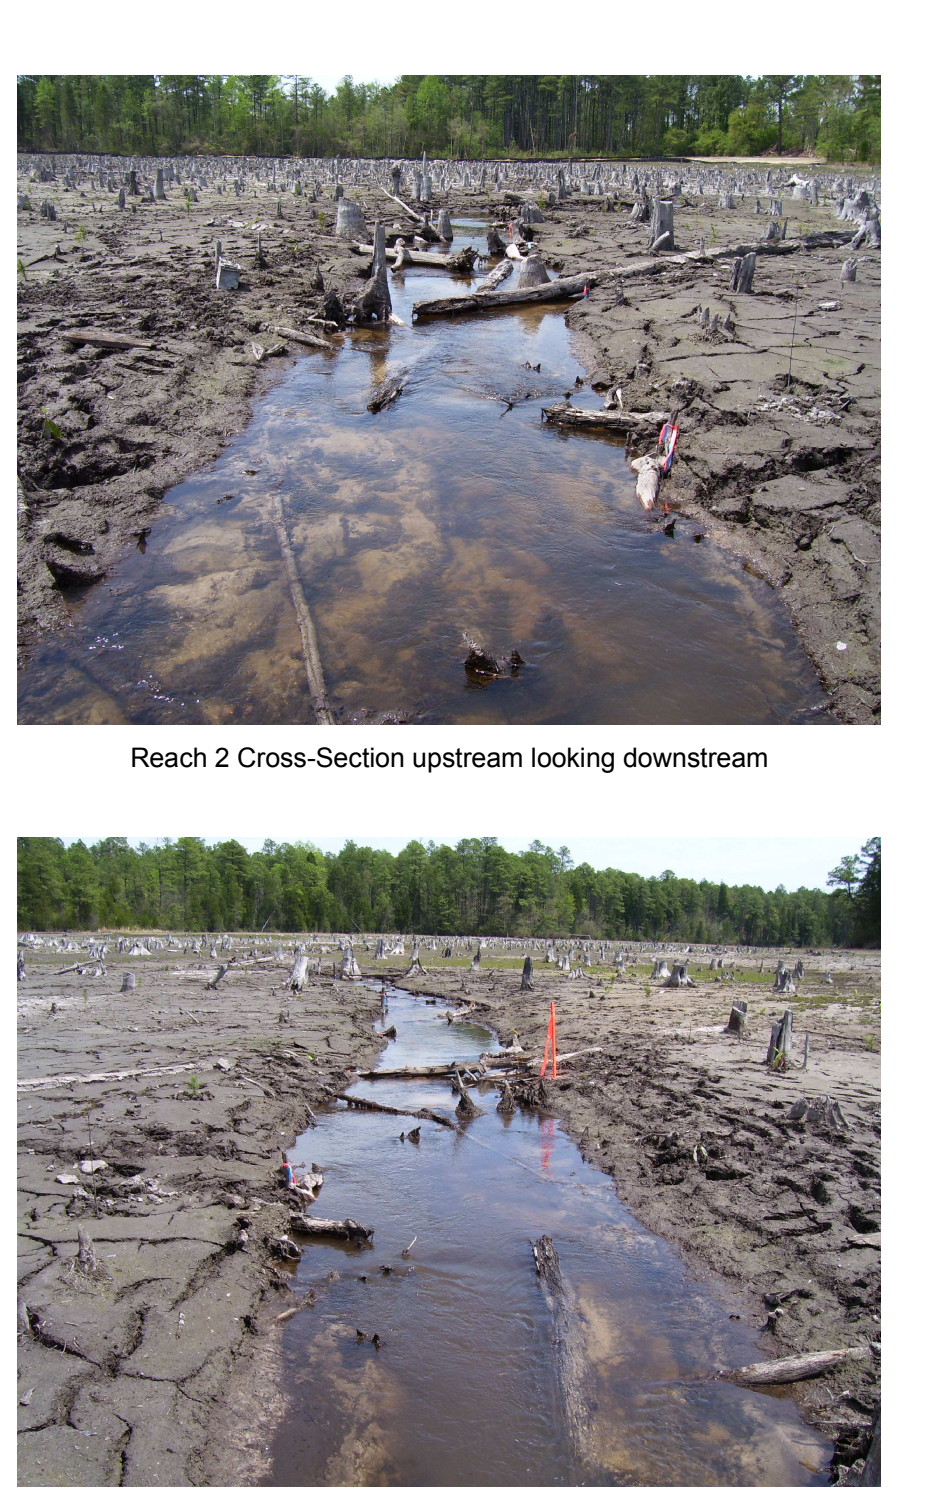
Reach 2 Cross-Section upstream looking downstream

Reach 2 Cross-Section downstream looking upstream

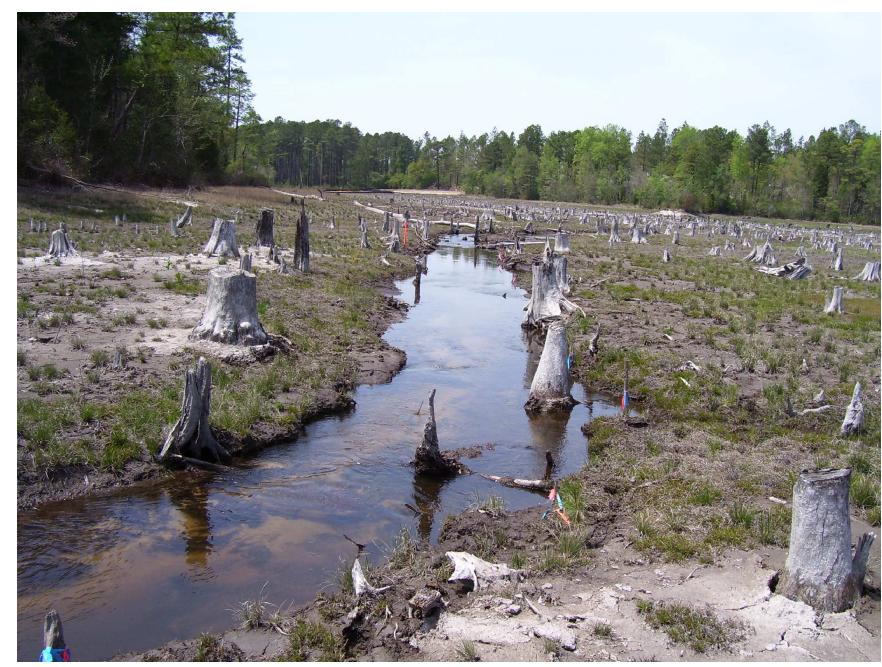
Reach 3 Cross-Section upstream looking downstream

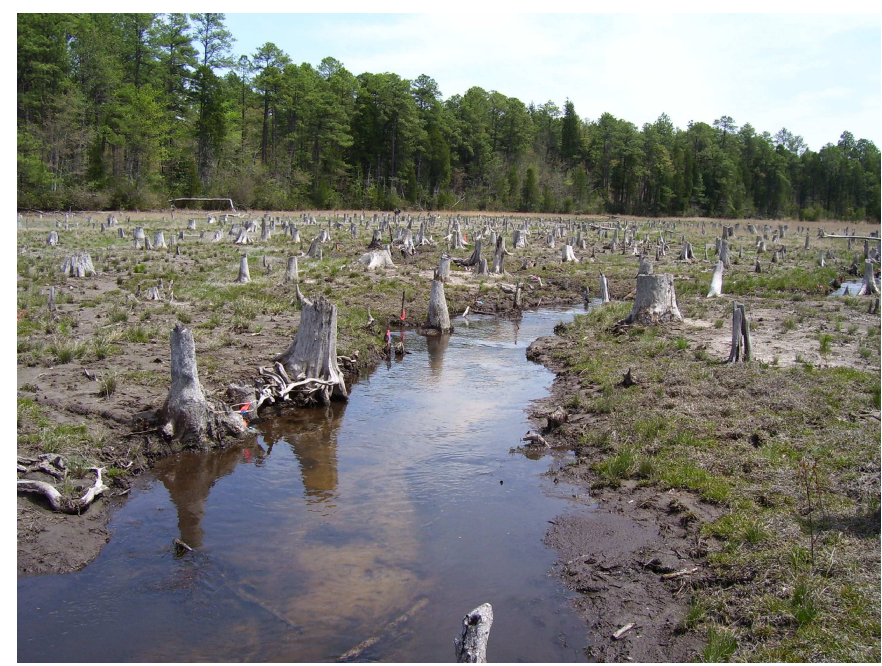
Reach 3 Cross-Section downstream looking upstream
