**McIntyre Tract:
Year Three Monitoring Report**

Brunswick County, NC

Prepared by:
Land Management Group, Inc.
Wilmington, NC

November 2003

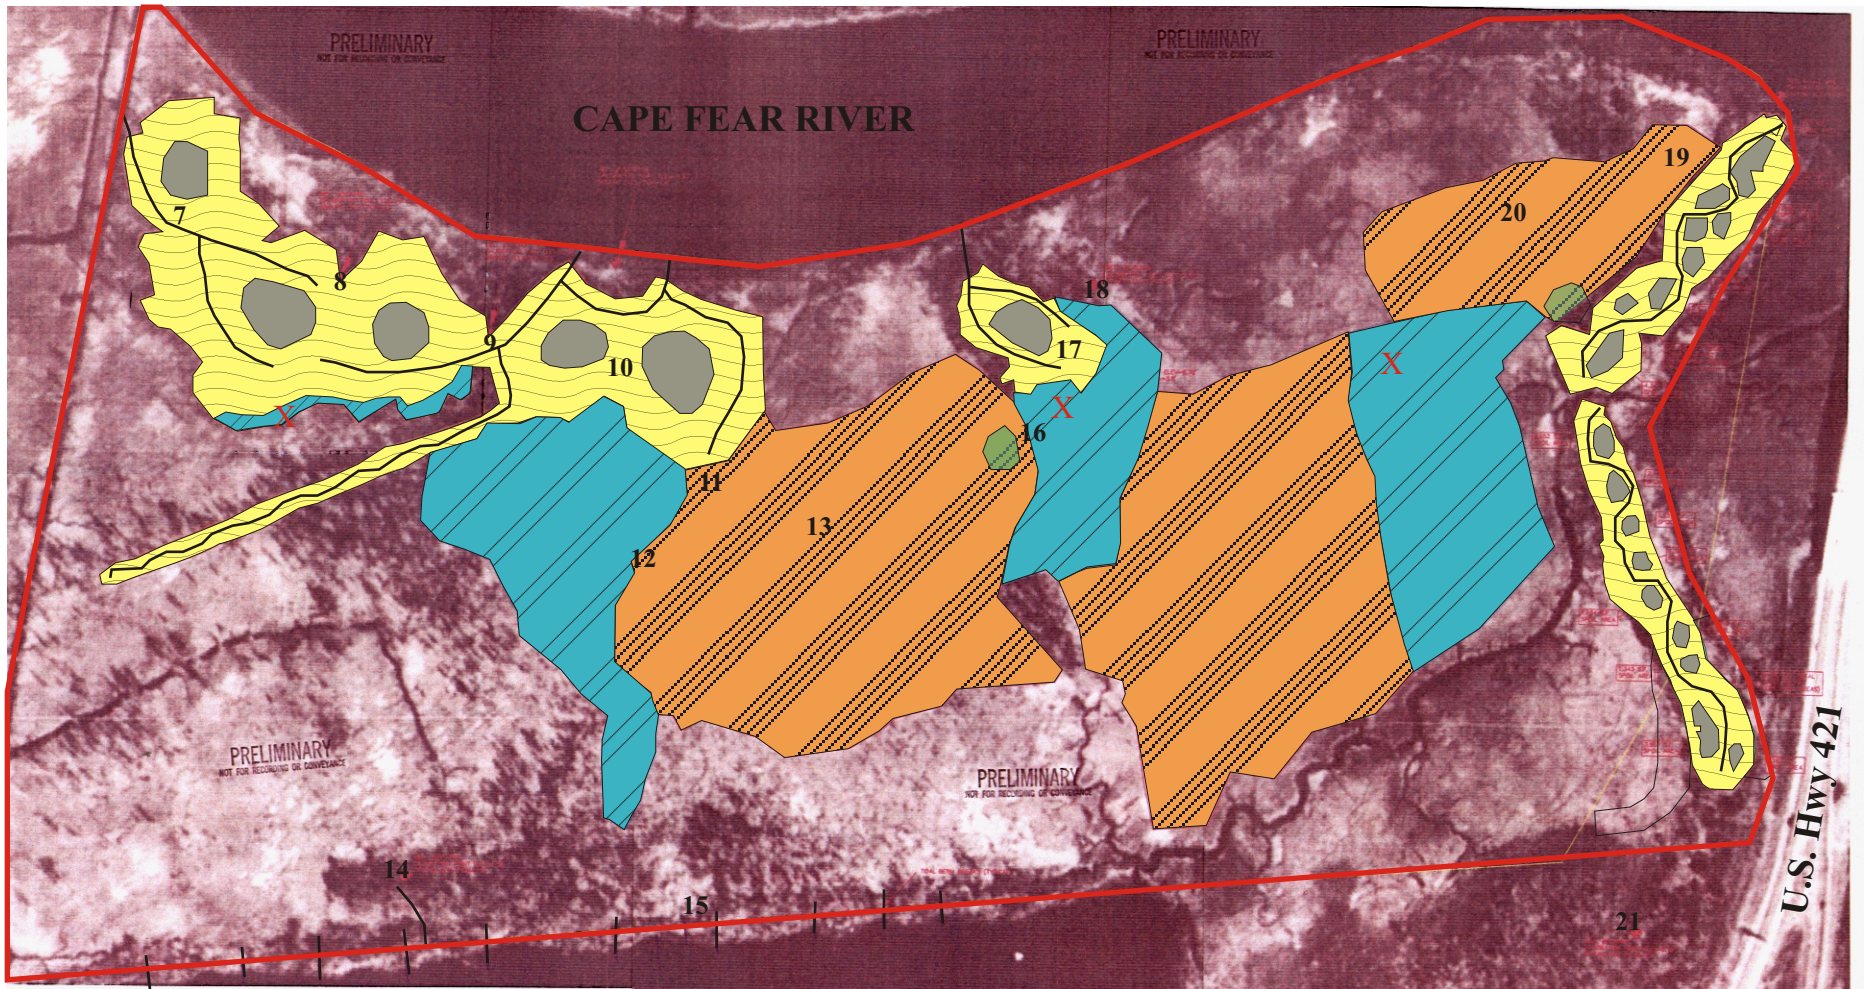
- Restored Cypress/Gum Swamp (12.3 ac)
- Restored Tidal Freshwater Marsh (25.12 ac)
- Restored Tidal Marsh/Shrub Scrub (17.02 ac)
- Spoil Pile (2.74 ac)
- Areas sprayed with herbicide in 2001 to eliminate *Phragmites*
- Cypress/Gum Vegetation Plot
- Created Tidal Creek
- # Gauge Location
- Project Boundaries

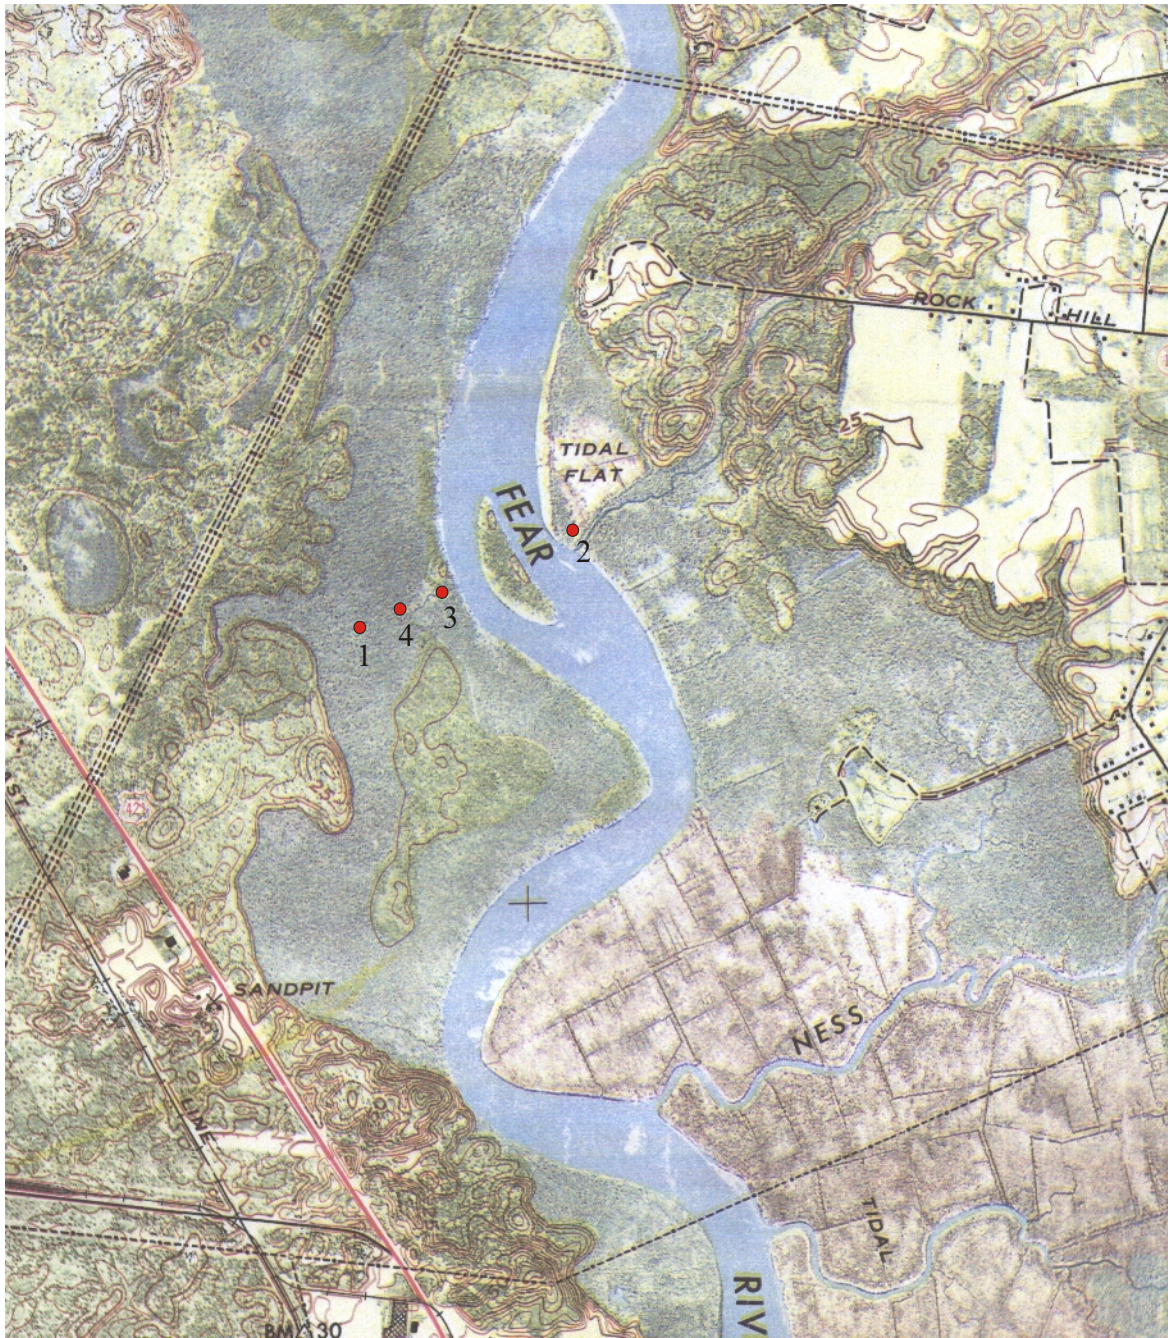
● Automated hydrology well

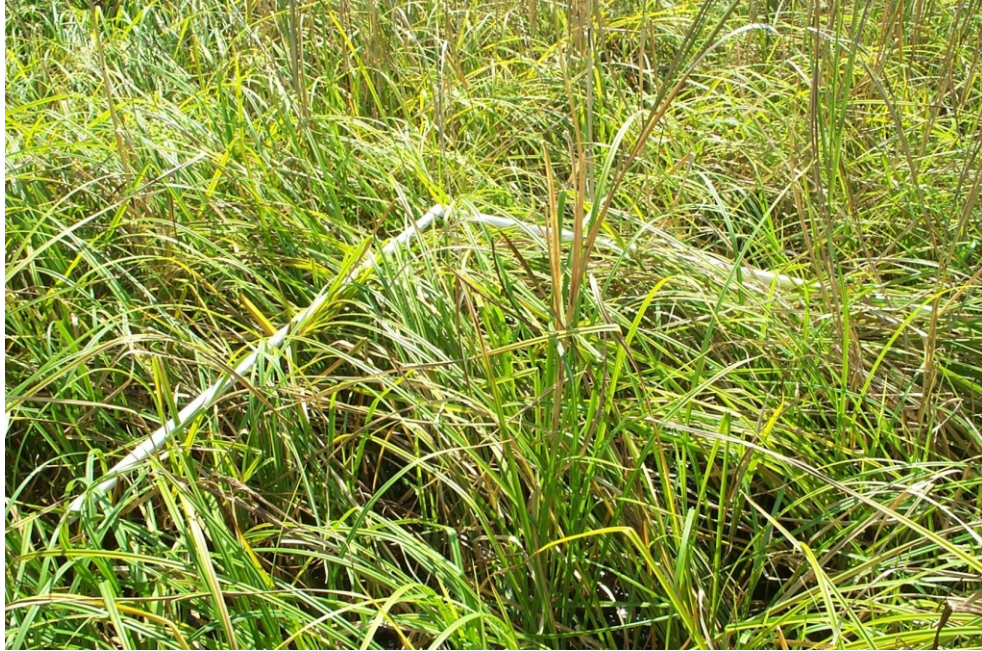
↓ Sawgrass within shrub scrub habitat.

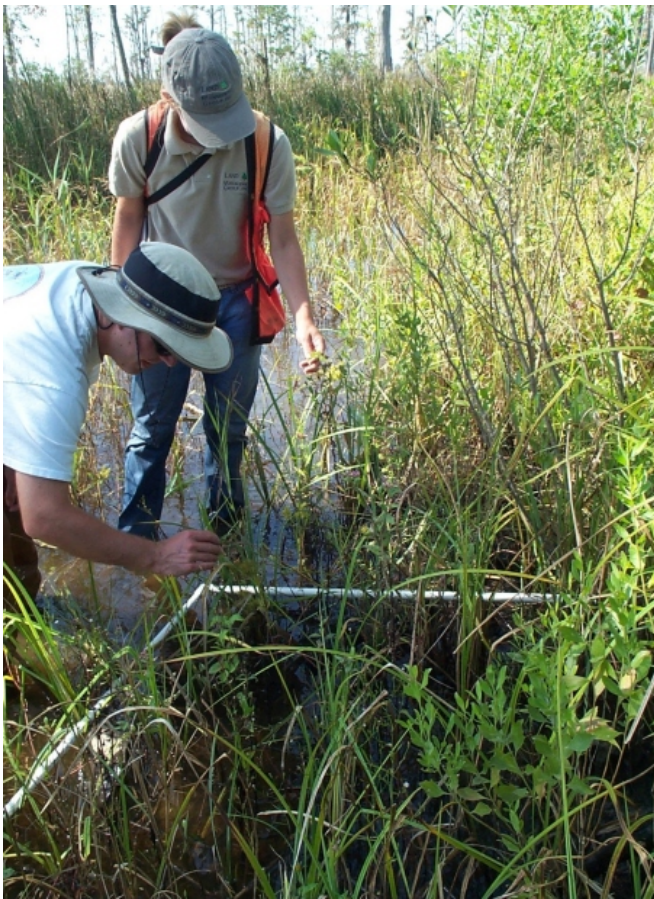
← Measuring vegetation within 1 m² plot.

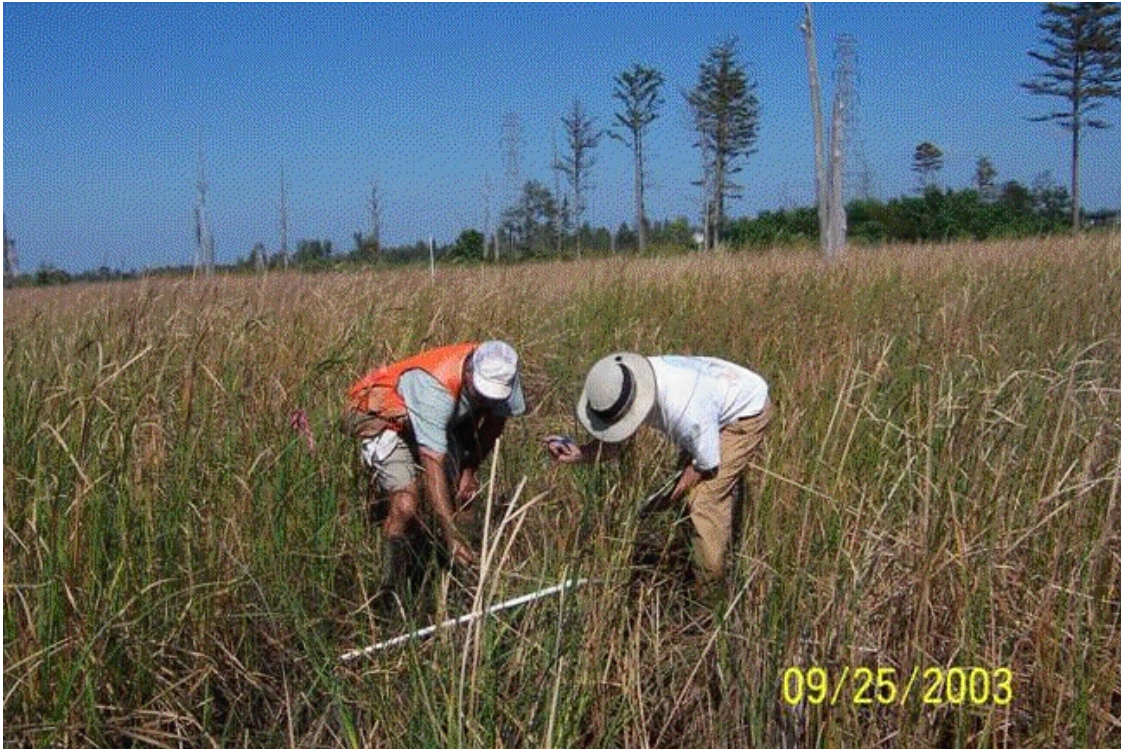
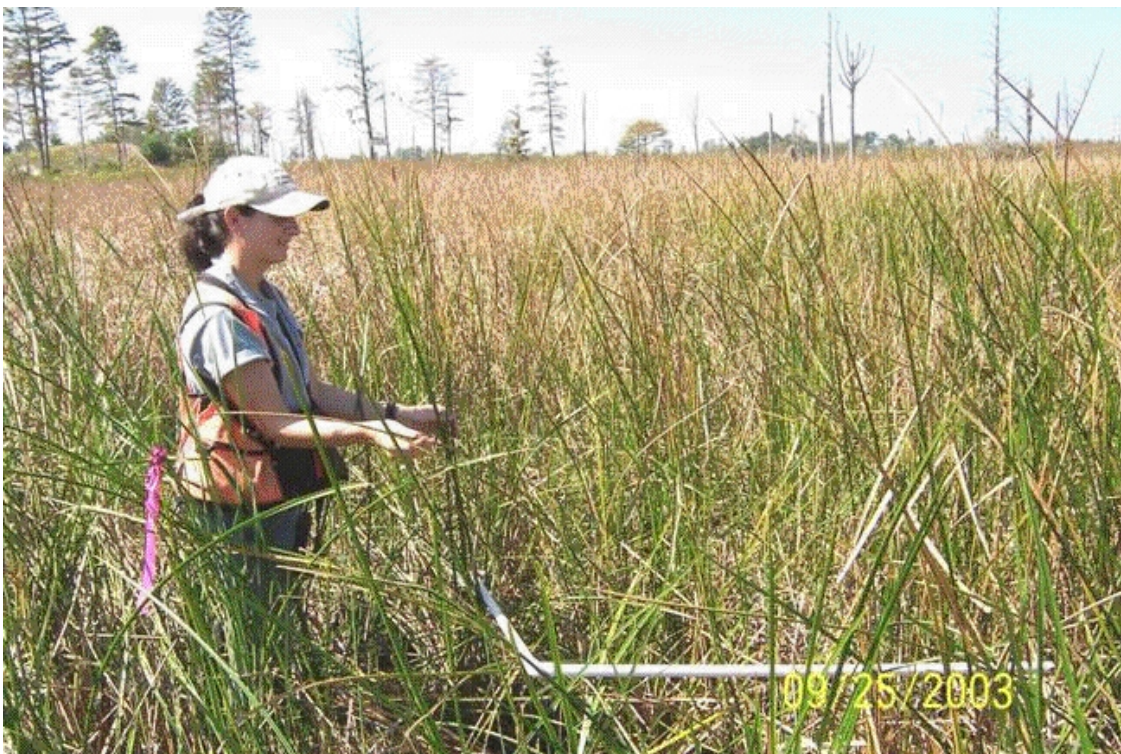
↓ Measuring vegetation within the freshwater marsh habitat.

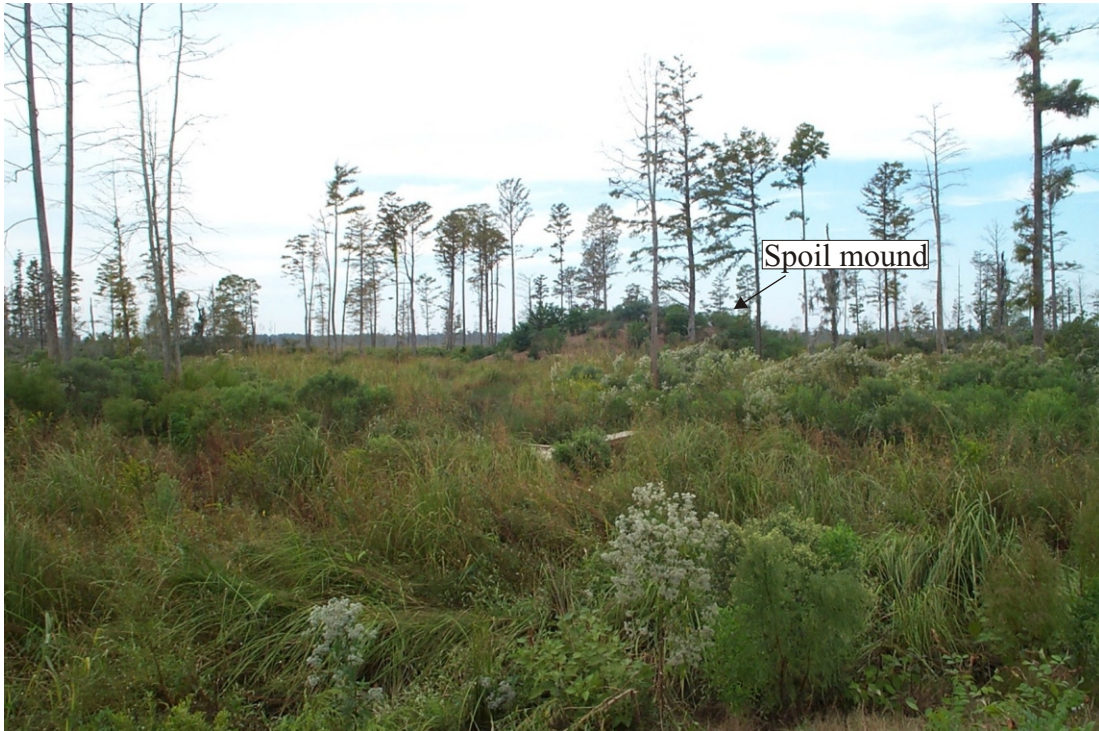
↓ Overview of site.

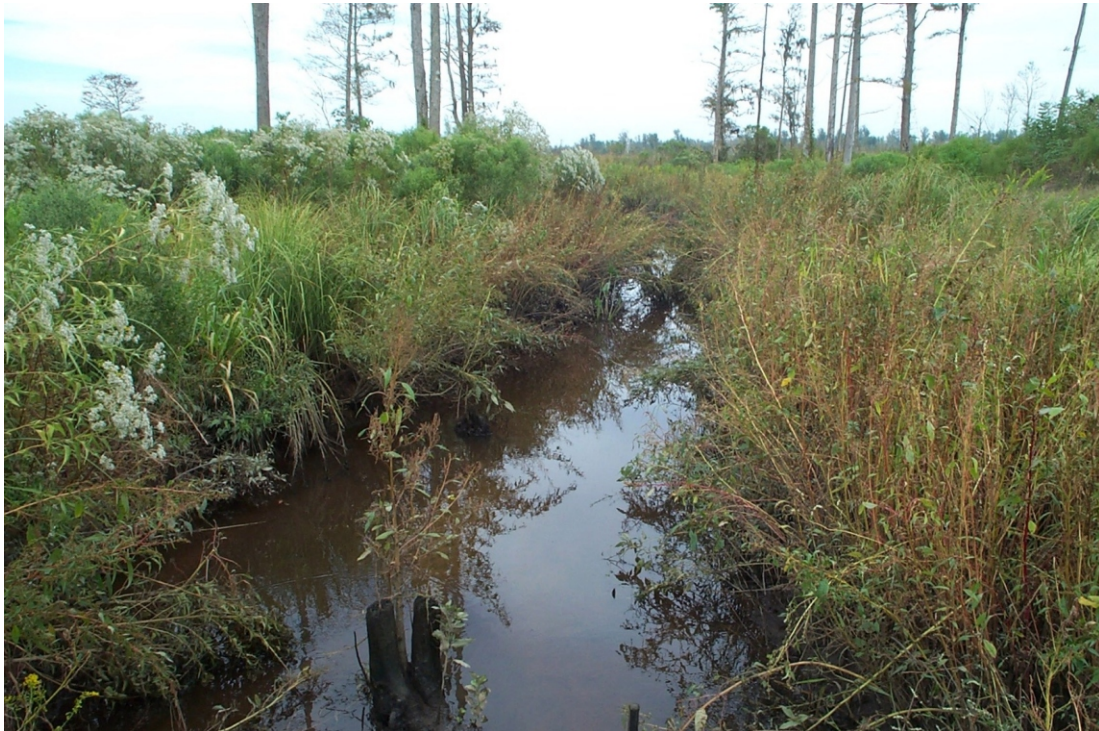
↓ View of tidal creek.

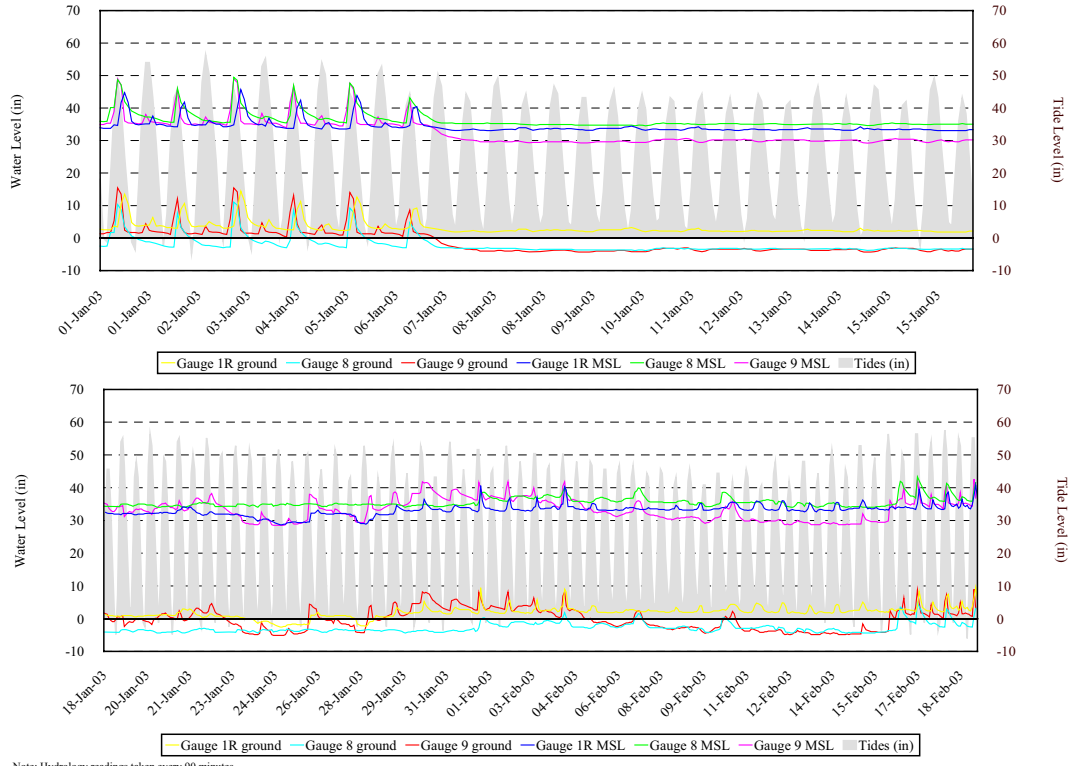
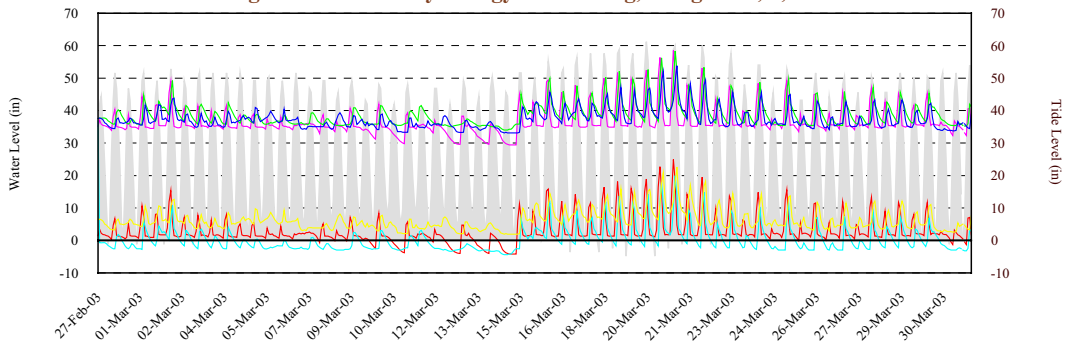
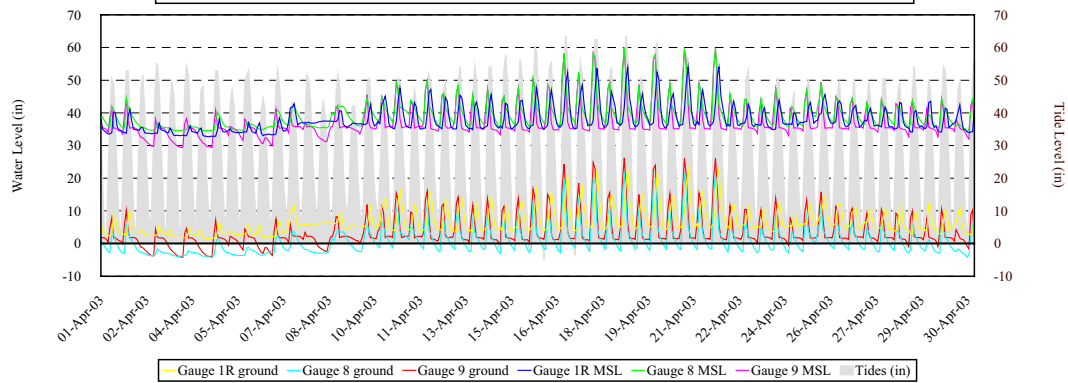
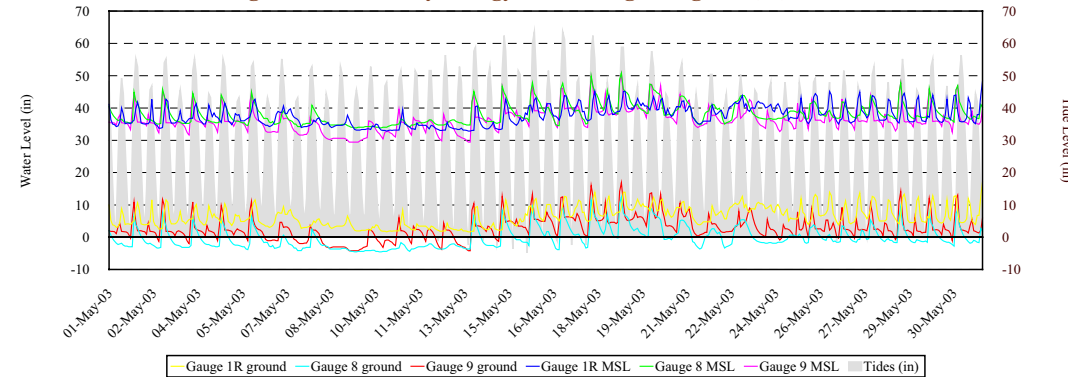
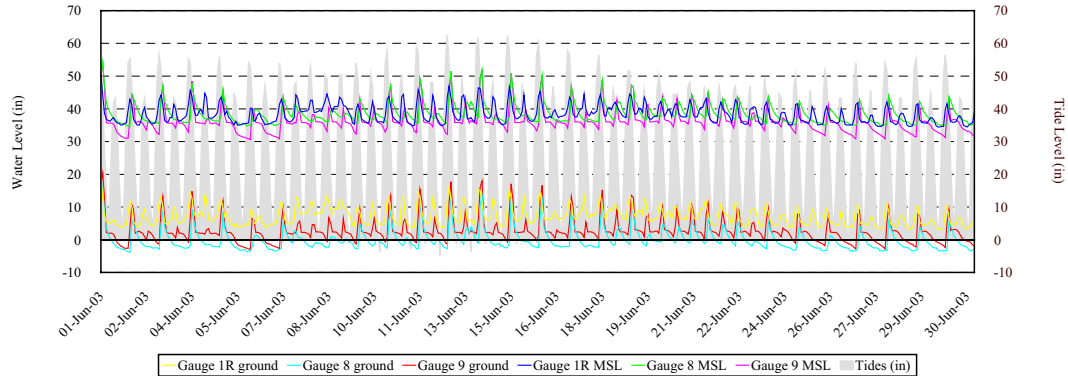
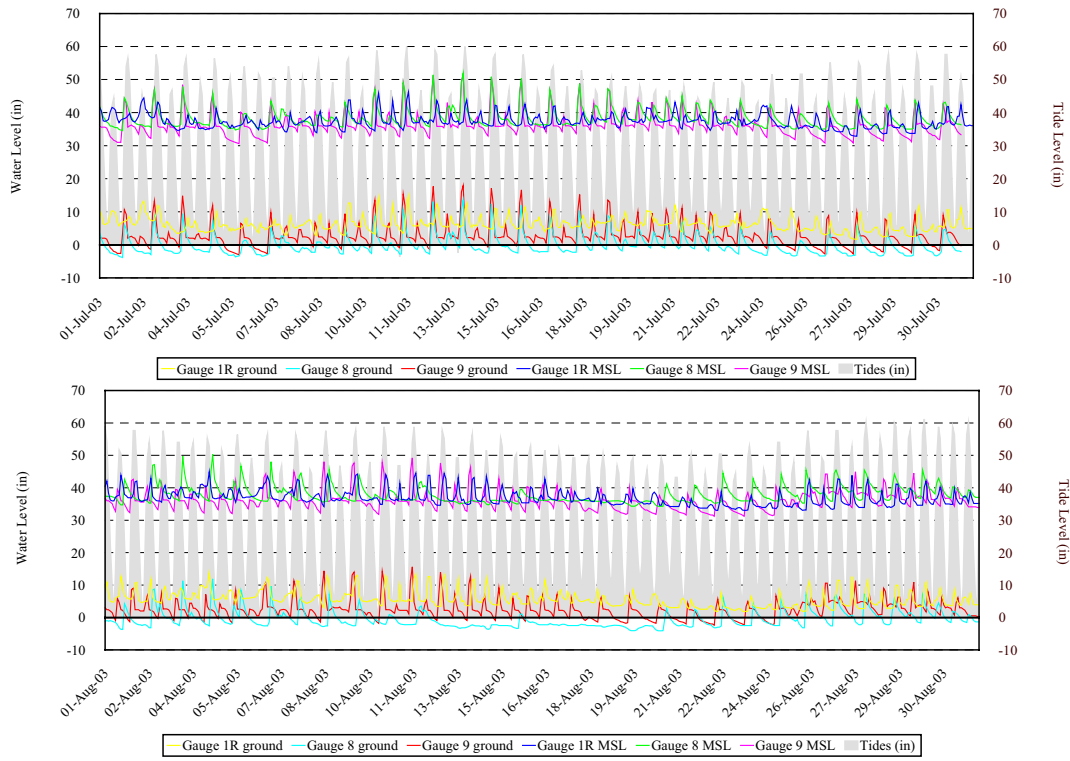
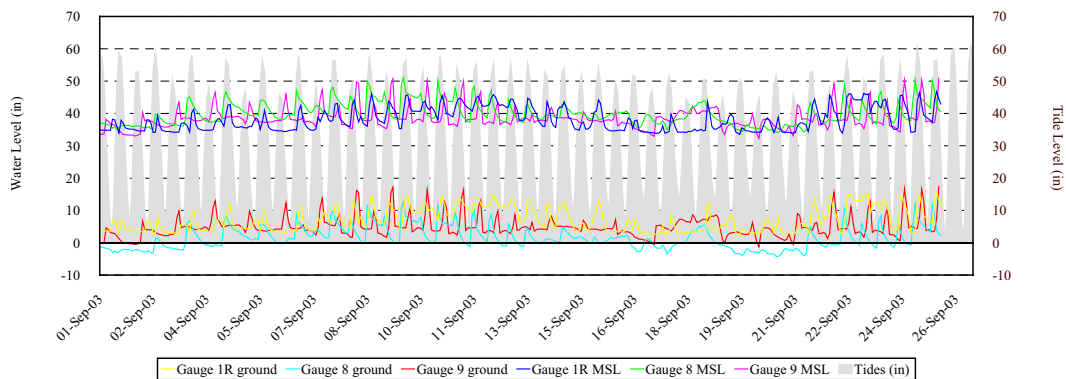
Figure B.1. Hydrology Monitoring, Gauges 1R, 8, and 9

Note: Hydrology readings taken every 90 minutes.
Tide data are from the Cape Fear River at Wilmington.

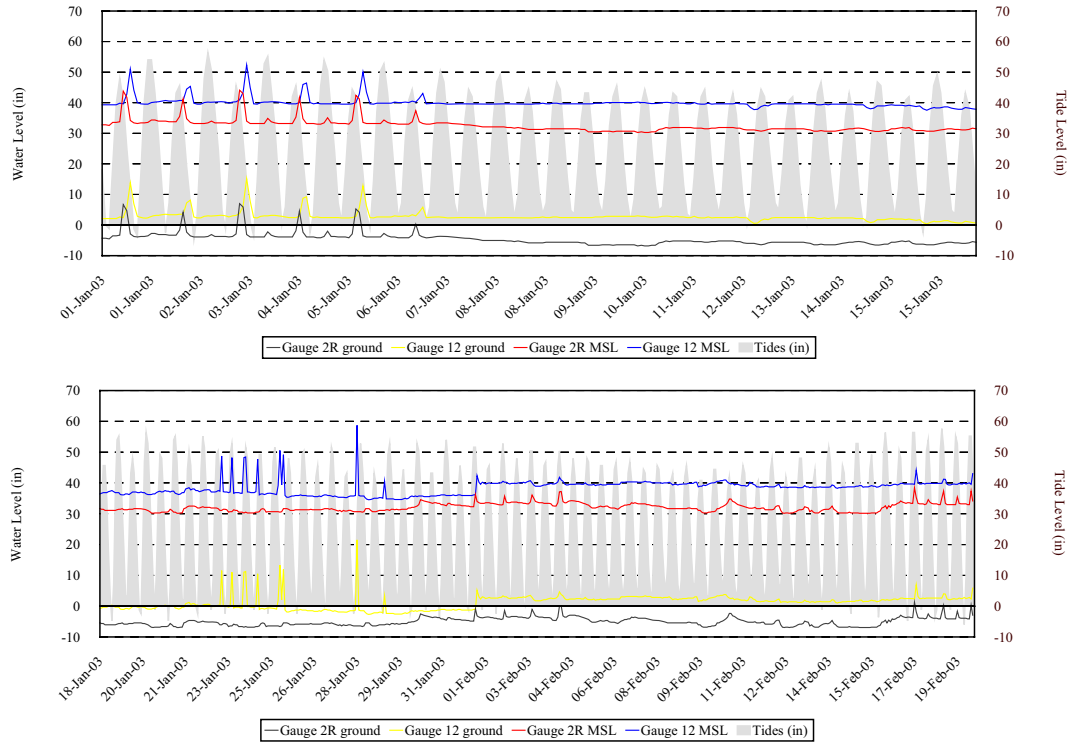
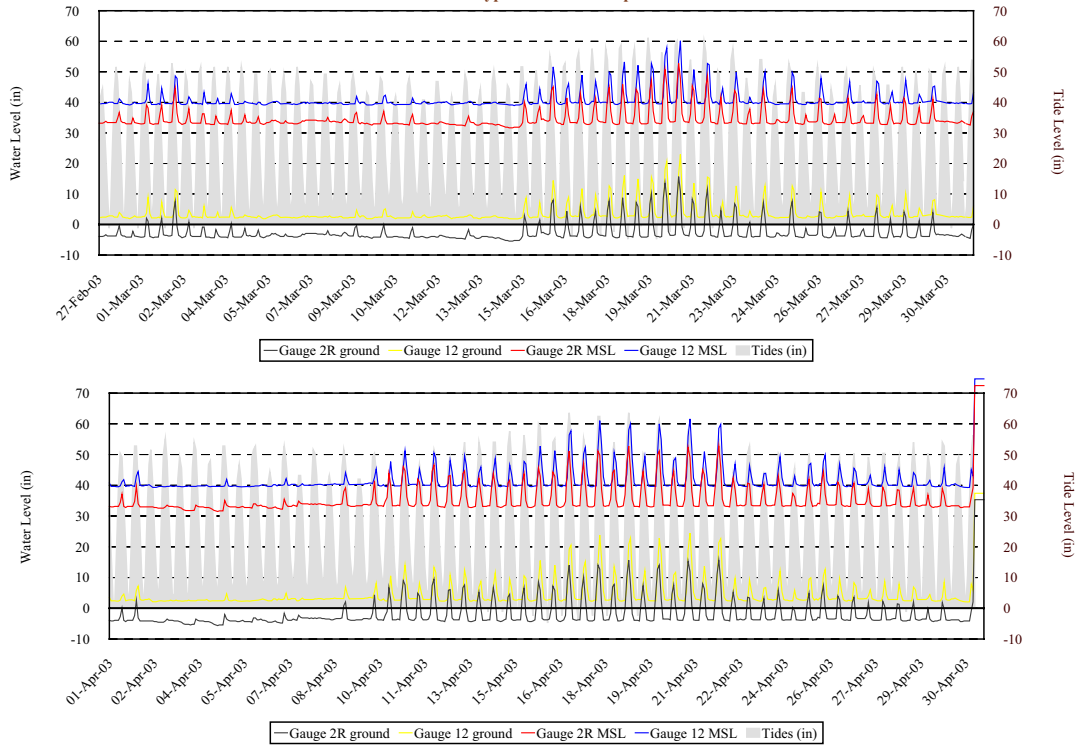
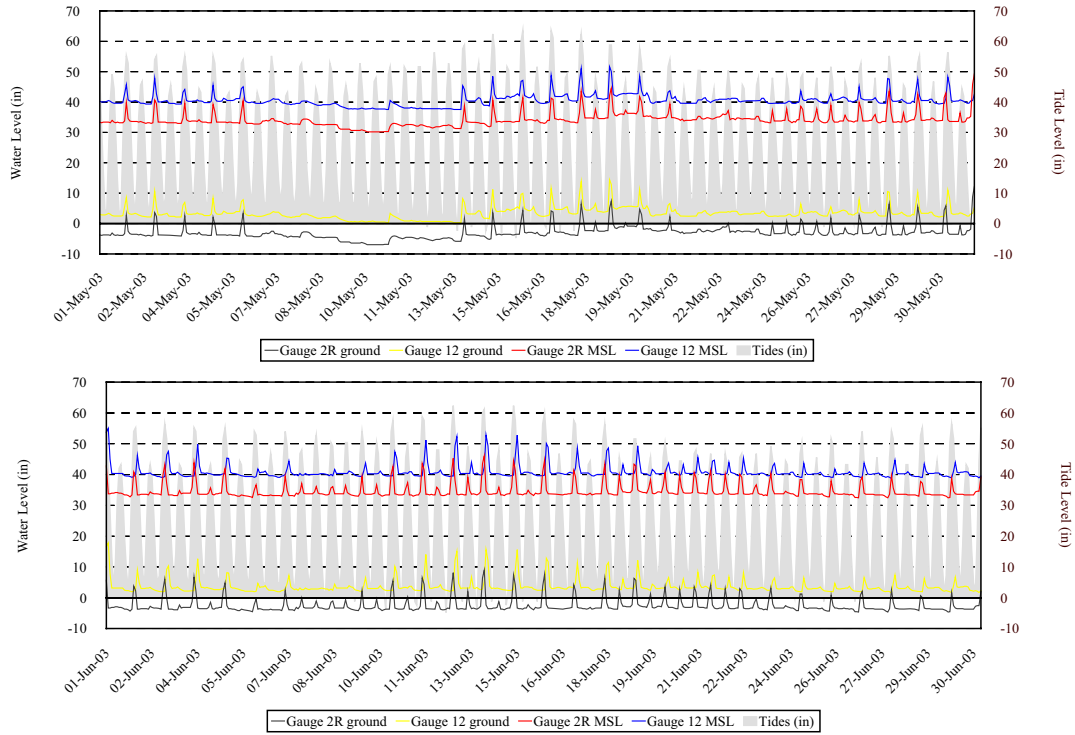
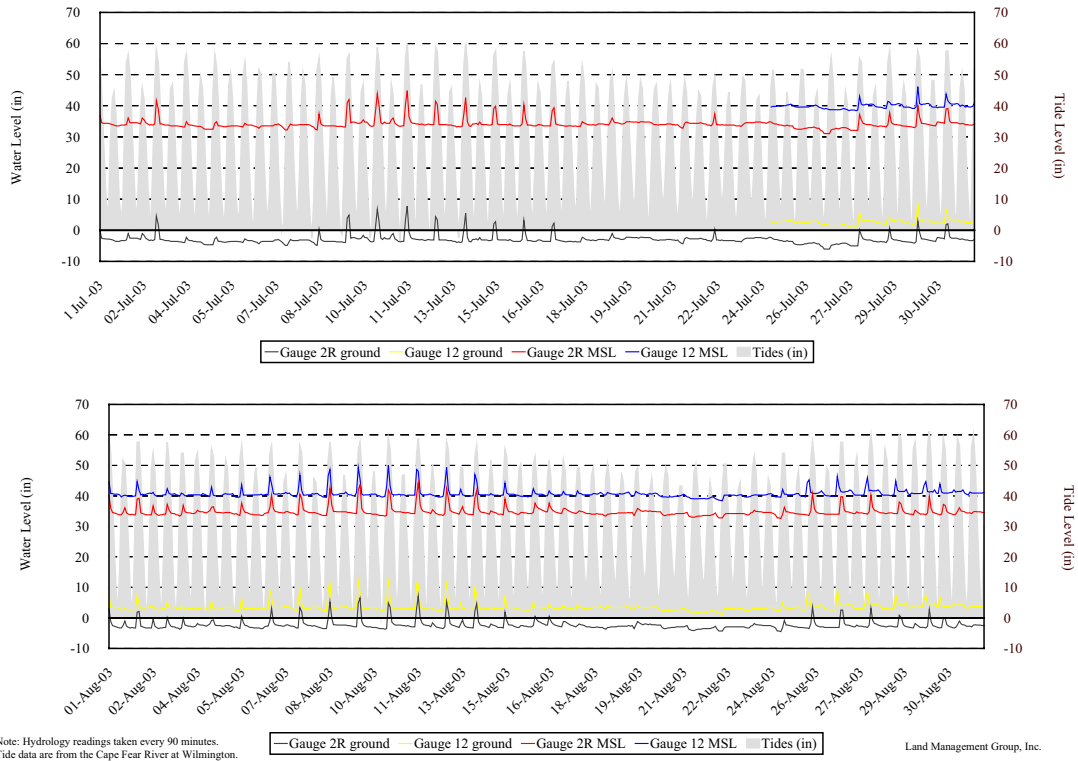
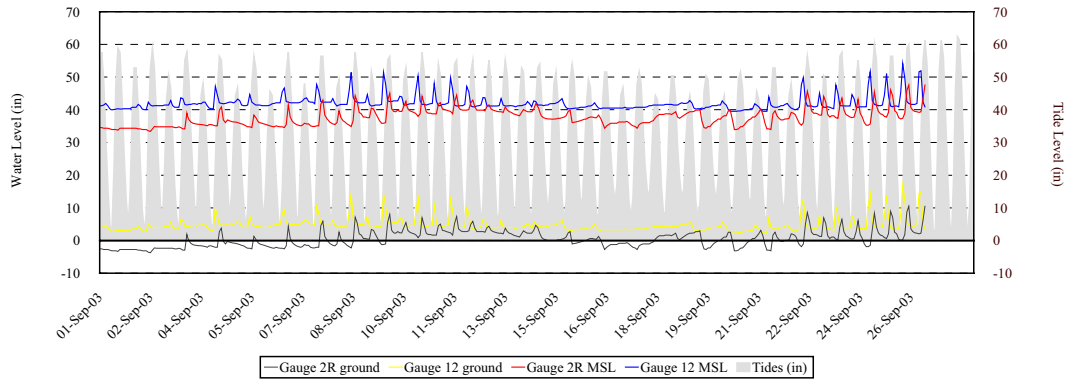
**Figure B.2. Hydrology Monitoring, Gauges 2R and 12
Cypress Gum Swamp**

Note: Hydrology readings taken every 90 minutes.
Tide data are from the Cape Fear River at Wilmington.

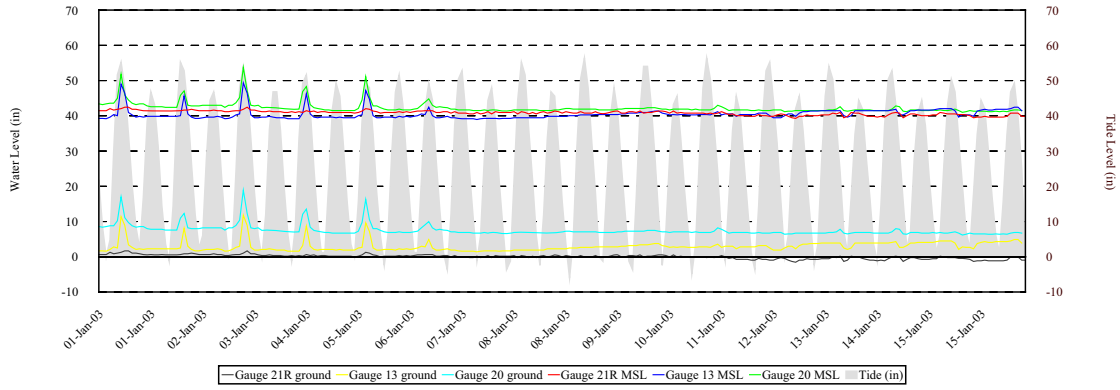
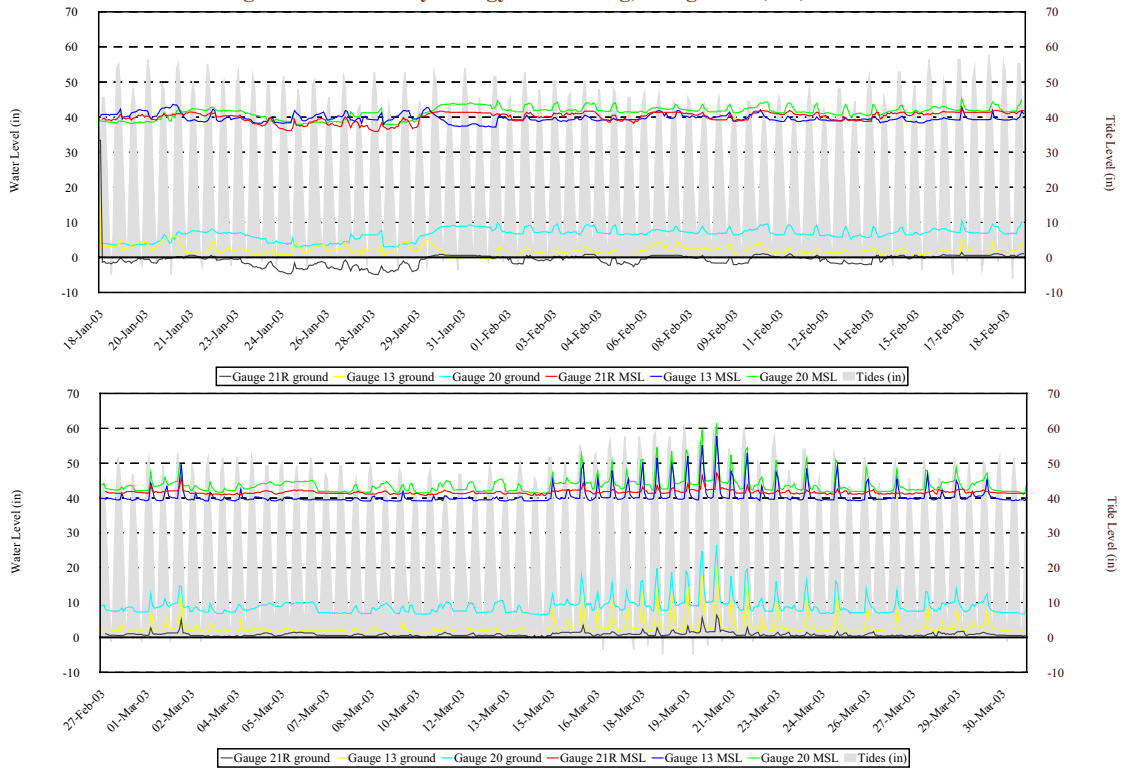
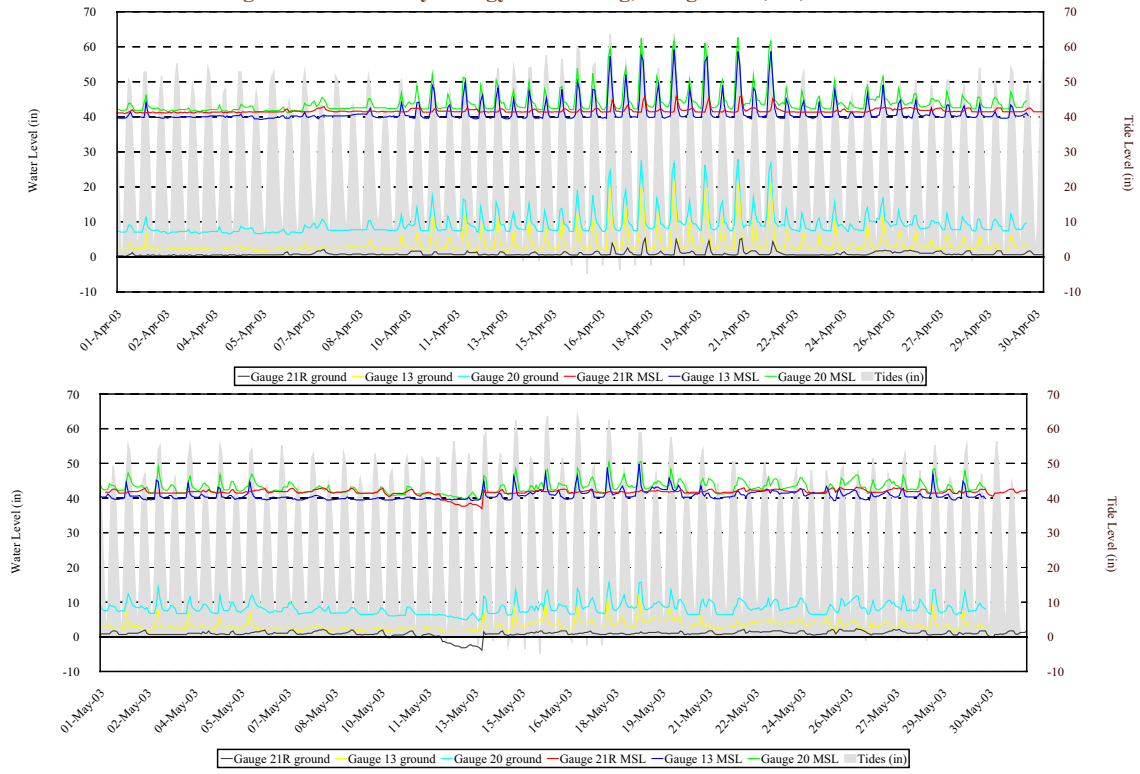
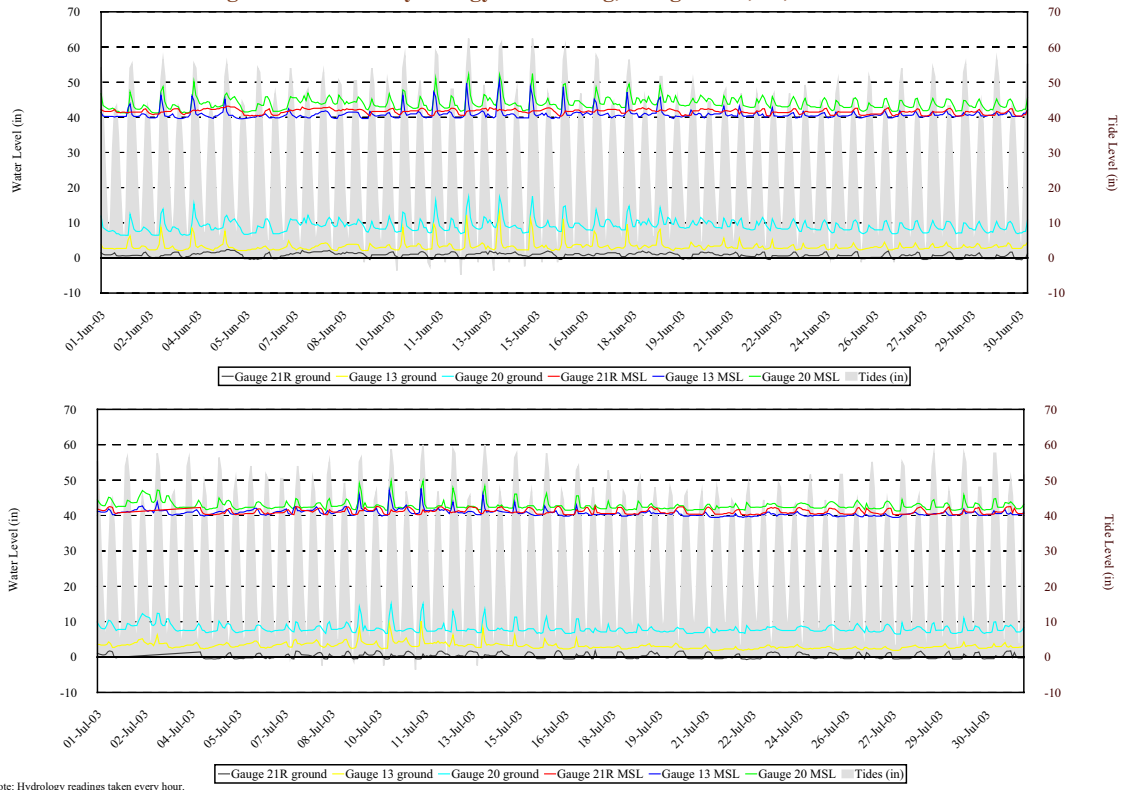
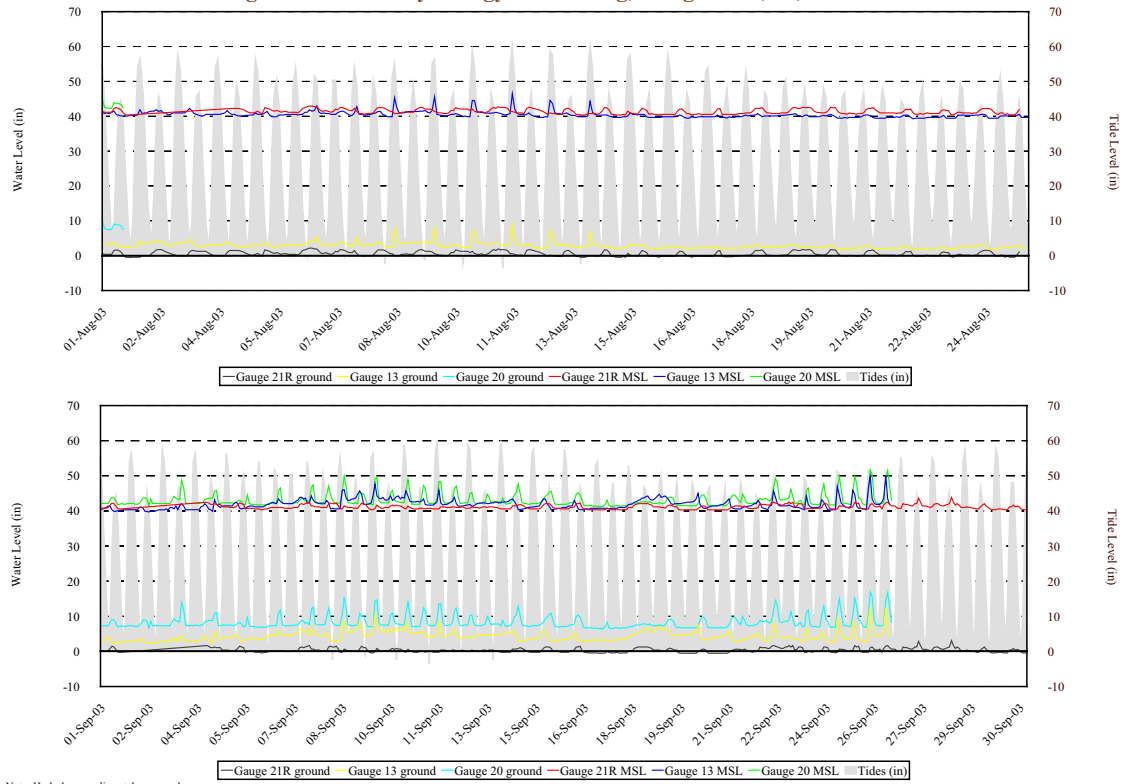
Figure B.8. Hydrology Monitoring, Gauges 21R, 13, and 20

Note: Hydrology readings taken every hour.
Tide data are from the Cape Fear River at Wilmington.
