**McIntyre Tract:
Year Three Monitoring Report**

Brunswick County, NC

Prepared by:
Land Management Group, Inc.
Wilmington, NC

November 2003

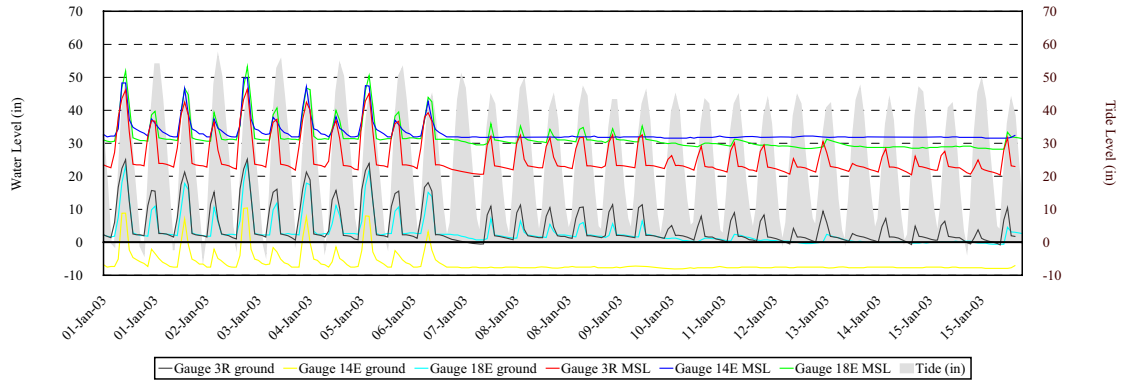
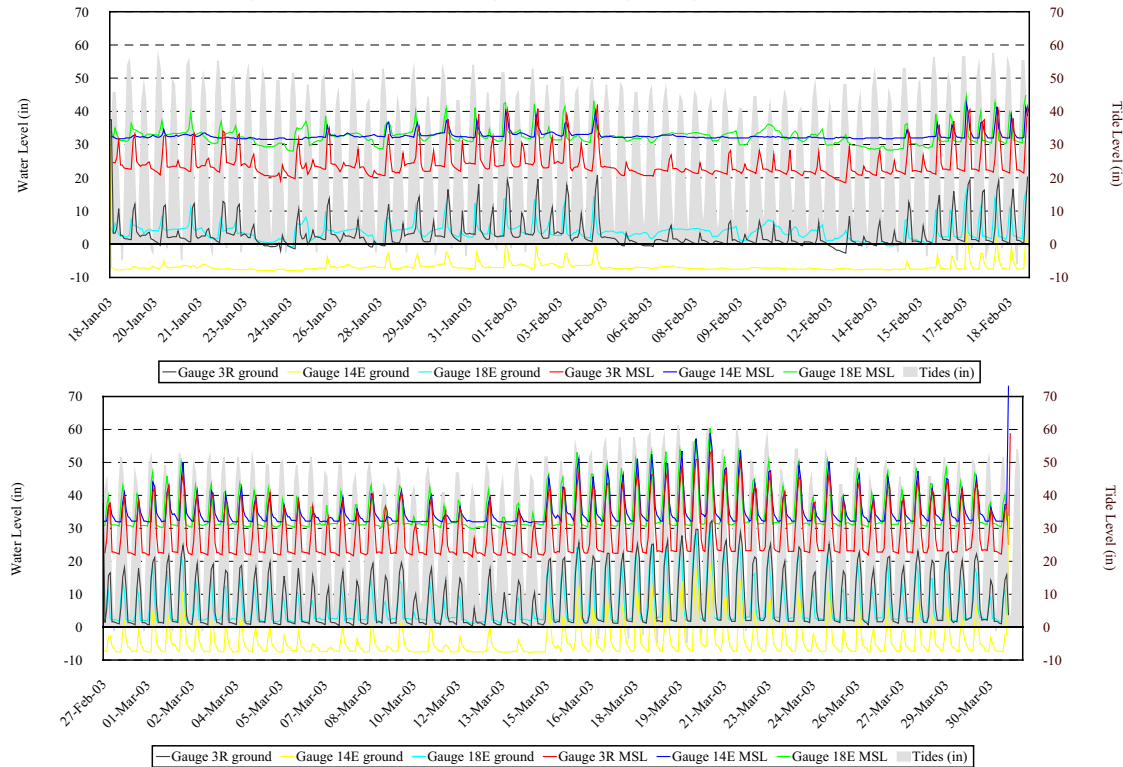
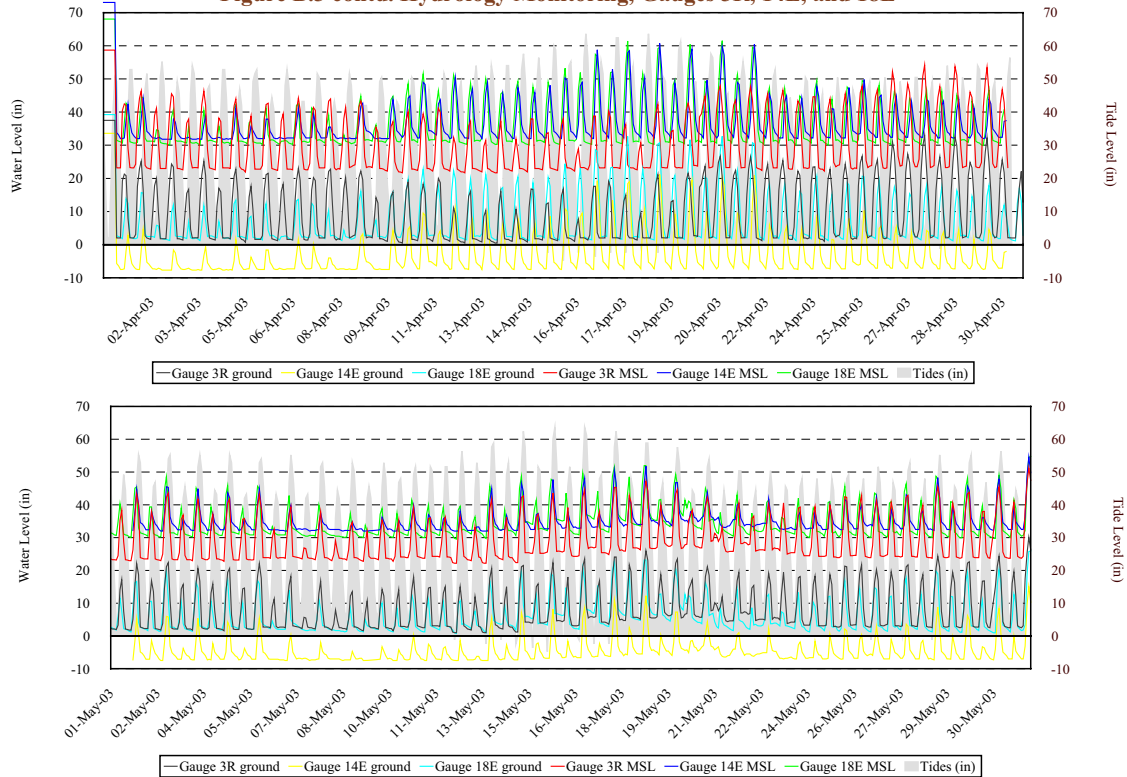
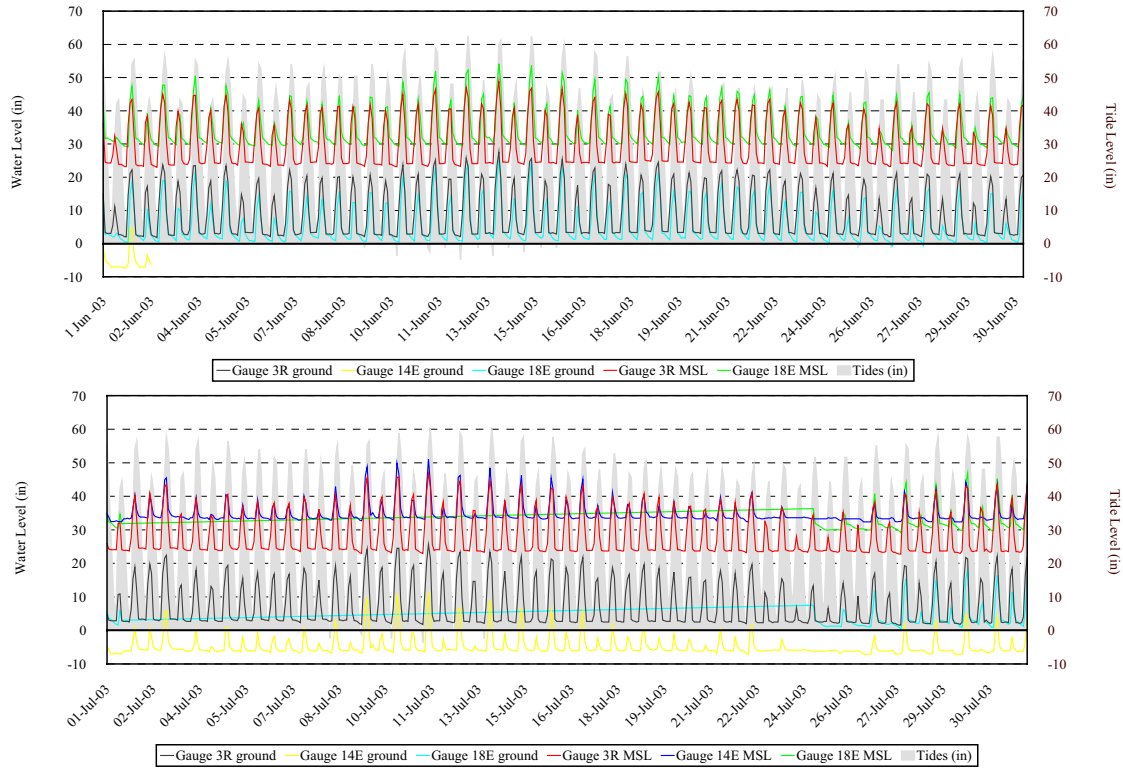
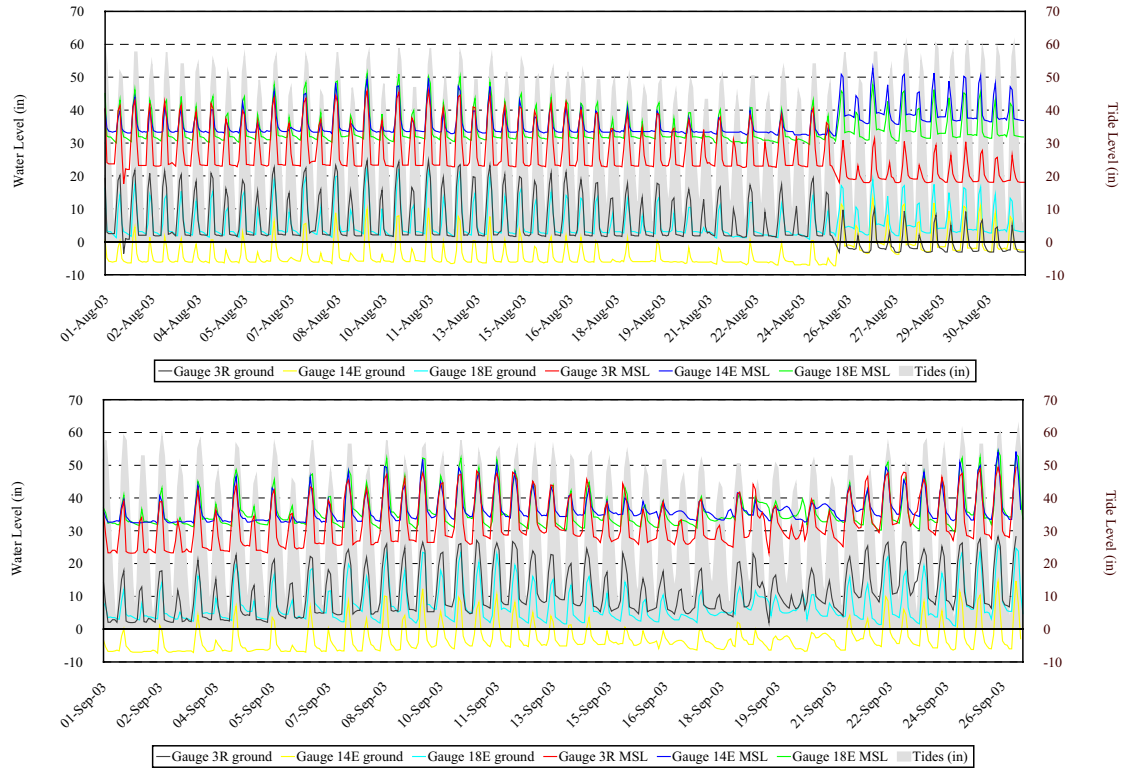
Figure B.3. Hydrology Monitoring, Gauges 3R, 14E, and 18E

Note: Hydrology readings taken every 90 minutes.
Tide data are from the Cape Fear River at Wilmington.

visible from the hydrographs in Appendix B that Gauge 14E did not form strong tidal peaks in January and part of February of 2003. This was noted by several other gauges within the site and reference areas and is due to abnormally low tides during this time period. Because 2002 post-construction data were significantly higher than pre-construction data for all six gauges (including 14E) and because the project area experienced abnormally low tides during the year three data period, it can be concluded that the mitigation activities significantly increased tidal flushing within the cypress gum swamp, tidal freshwater marsh, and shrub scrub enhancement areas.

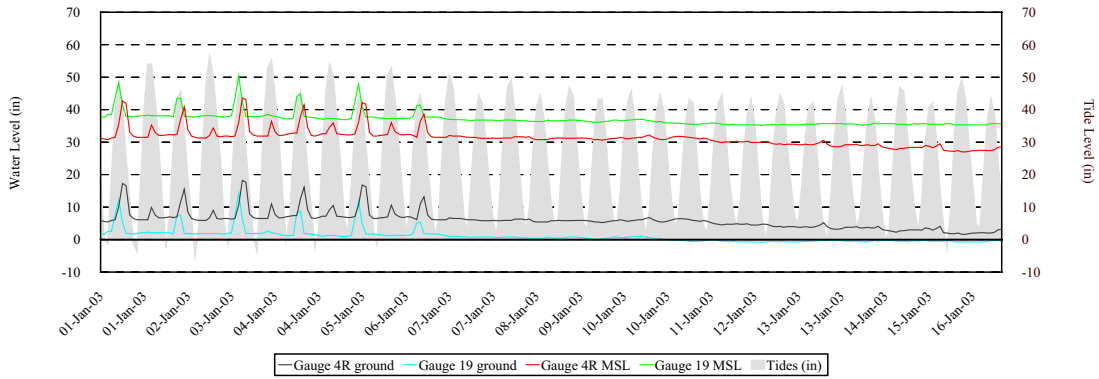
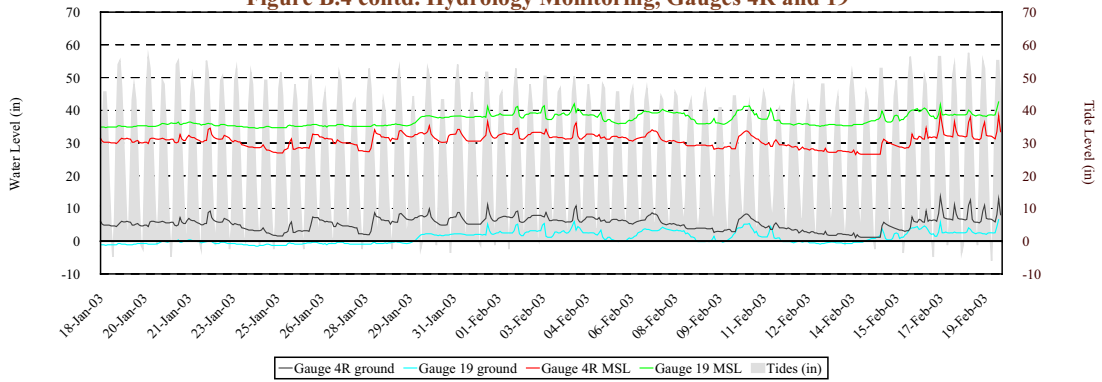
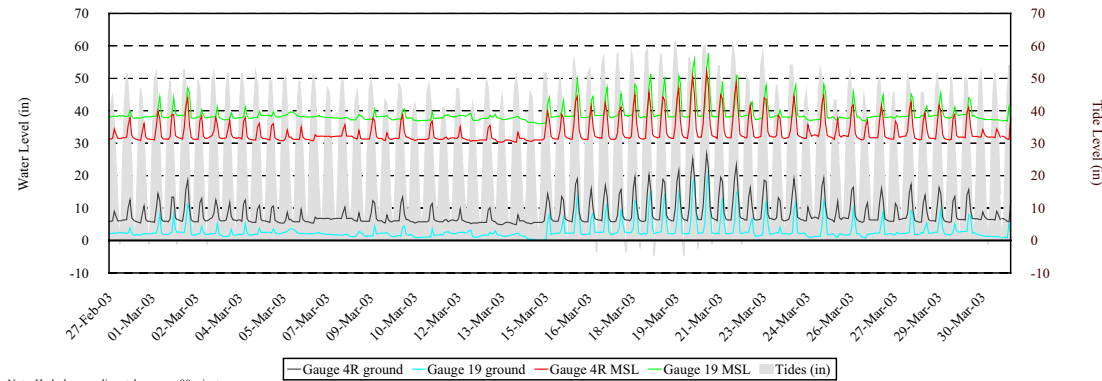
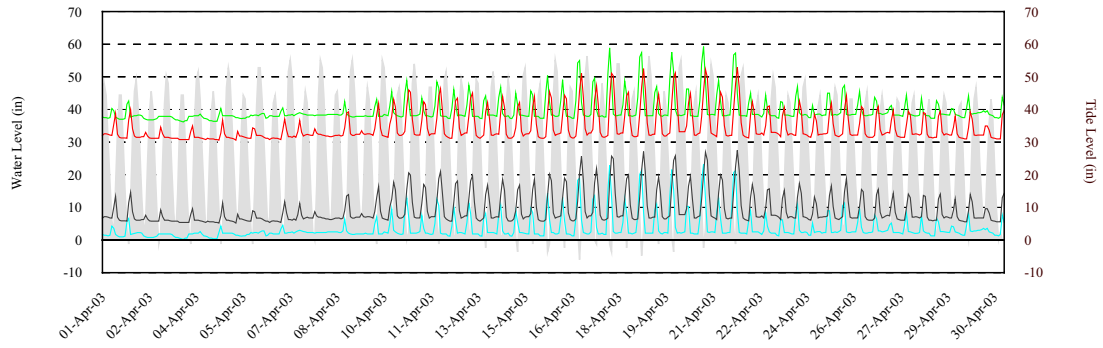
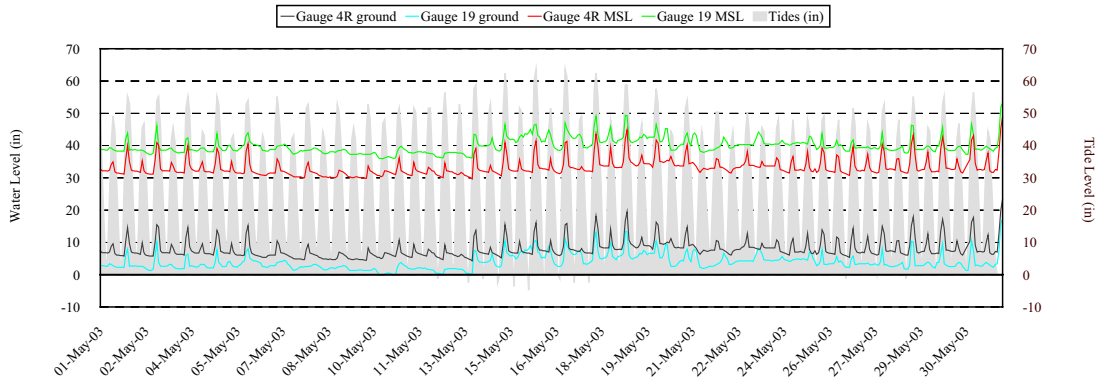
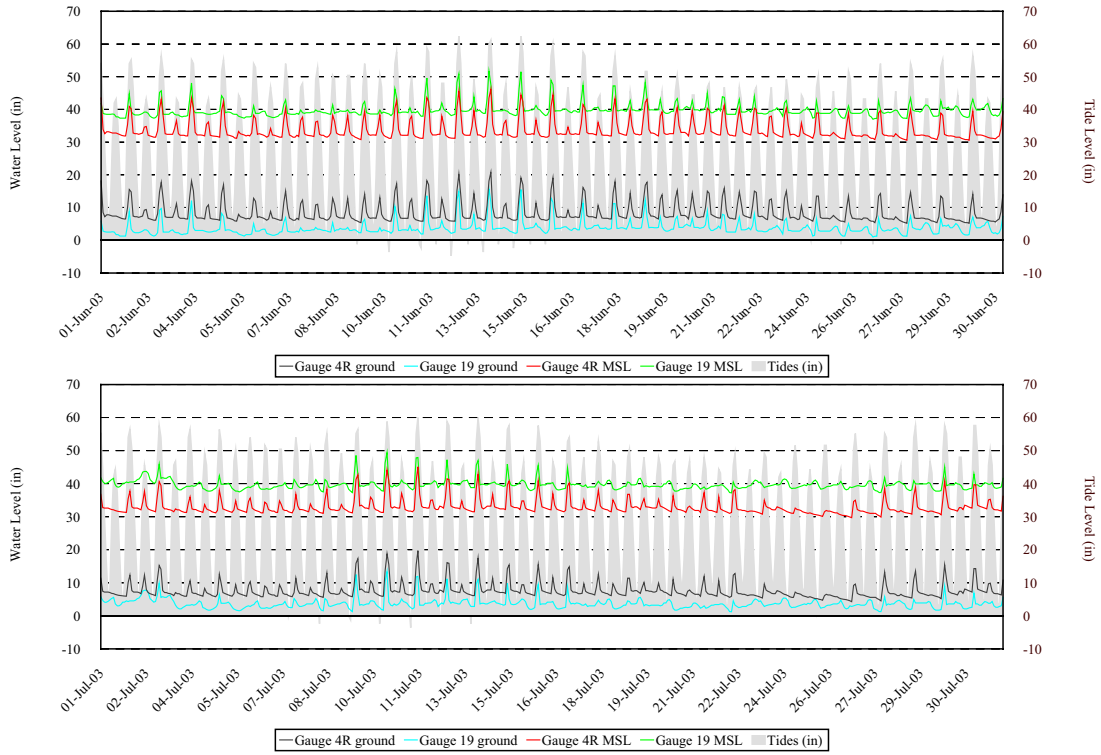
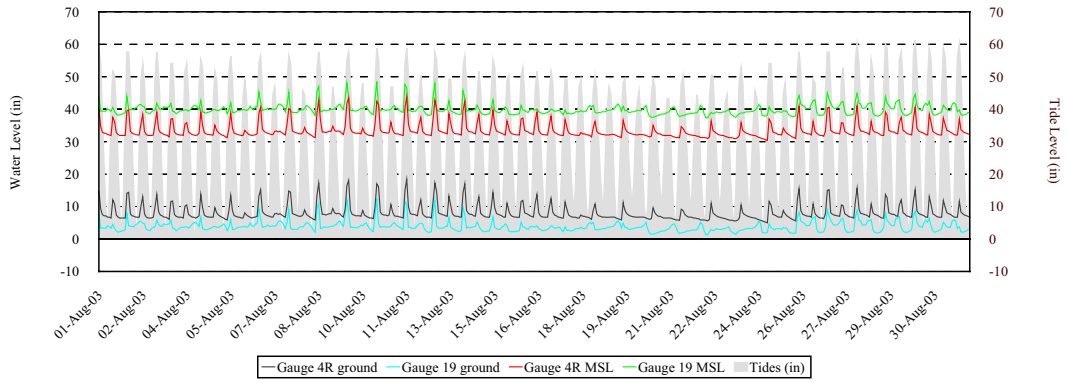
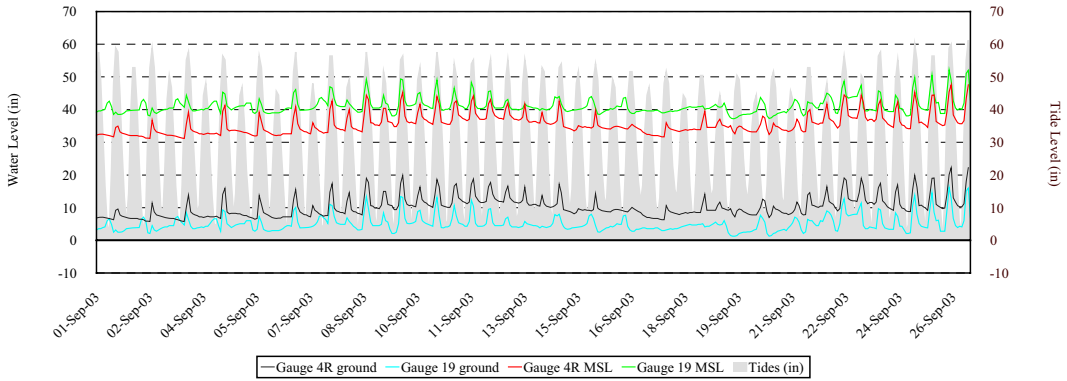
Figure B.4. Hydrology Monitoring, Gauges 4R and 19

Note: Hydrology readings taken every 90 minutes.
Tide data are from the Cape Fear River at Wilmington.

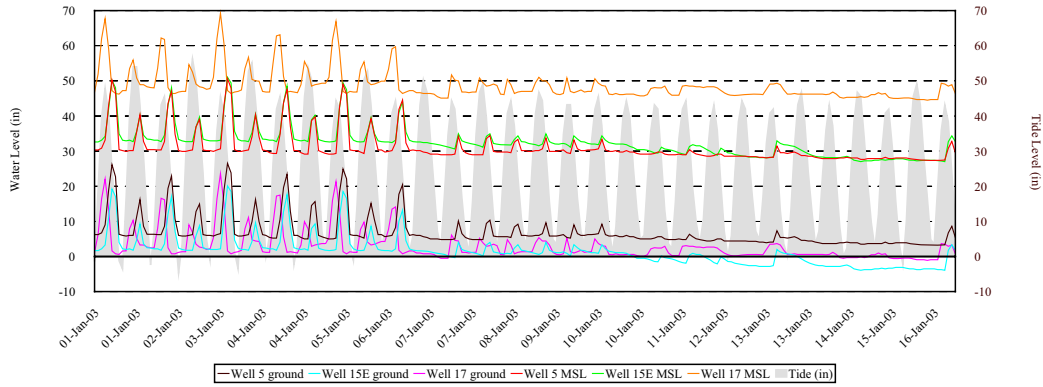
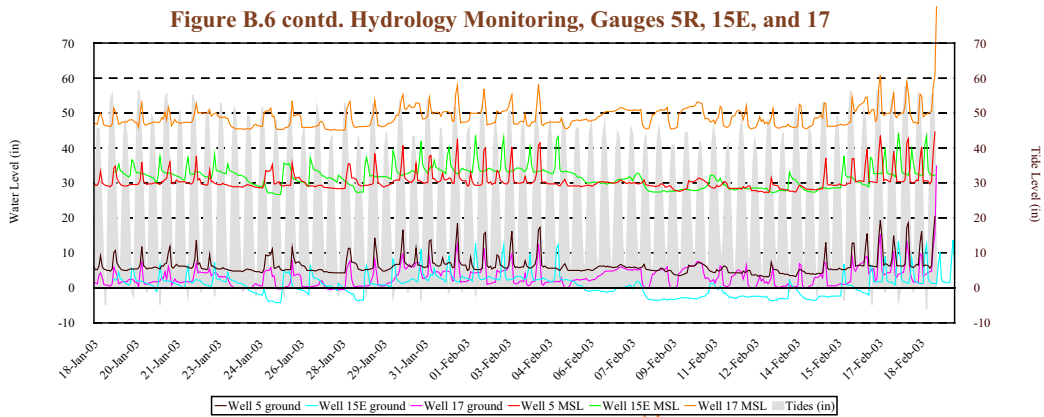
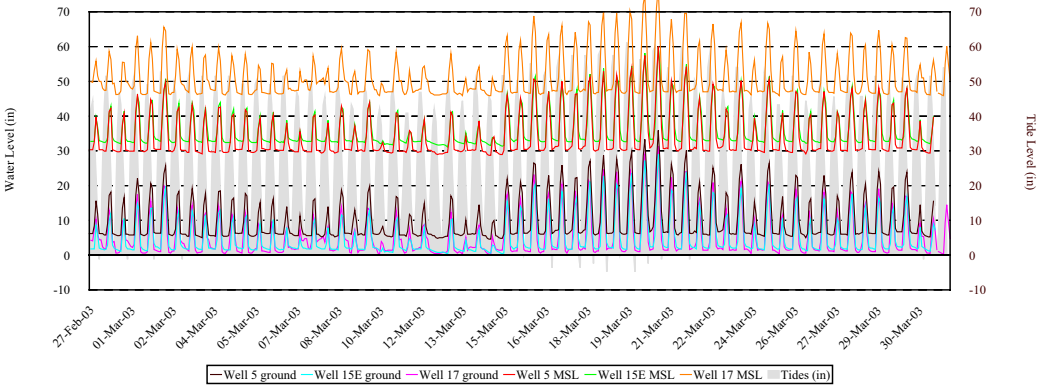
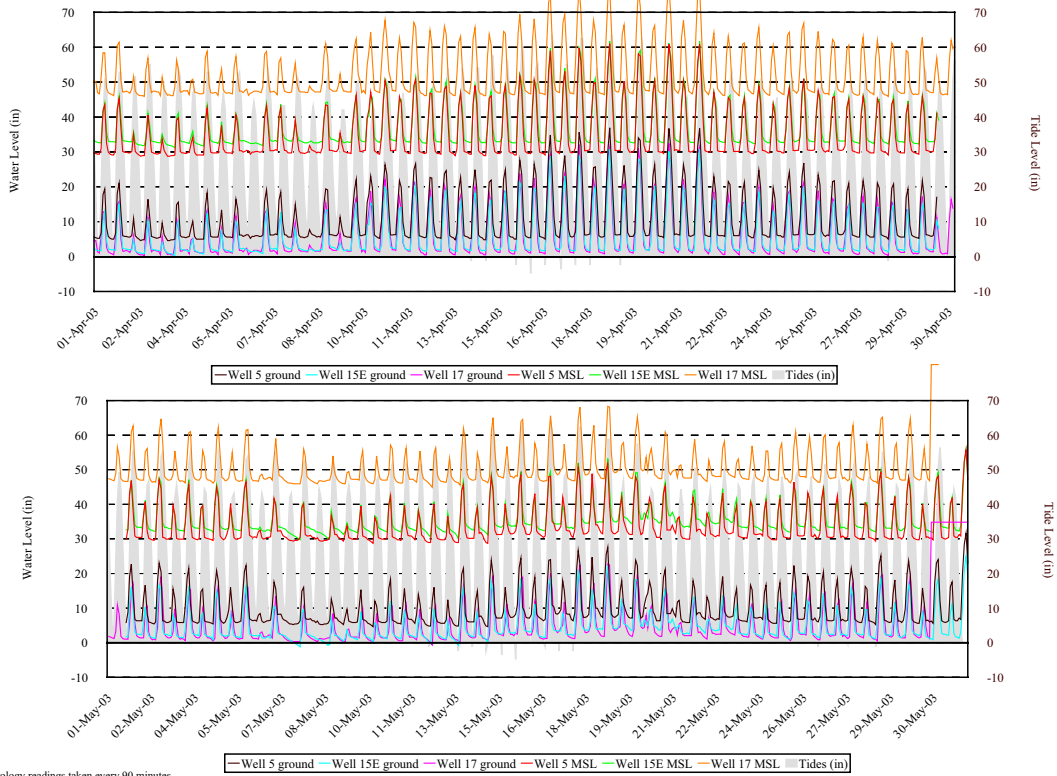
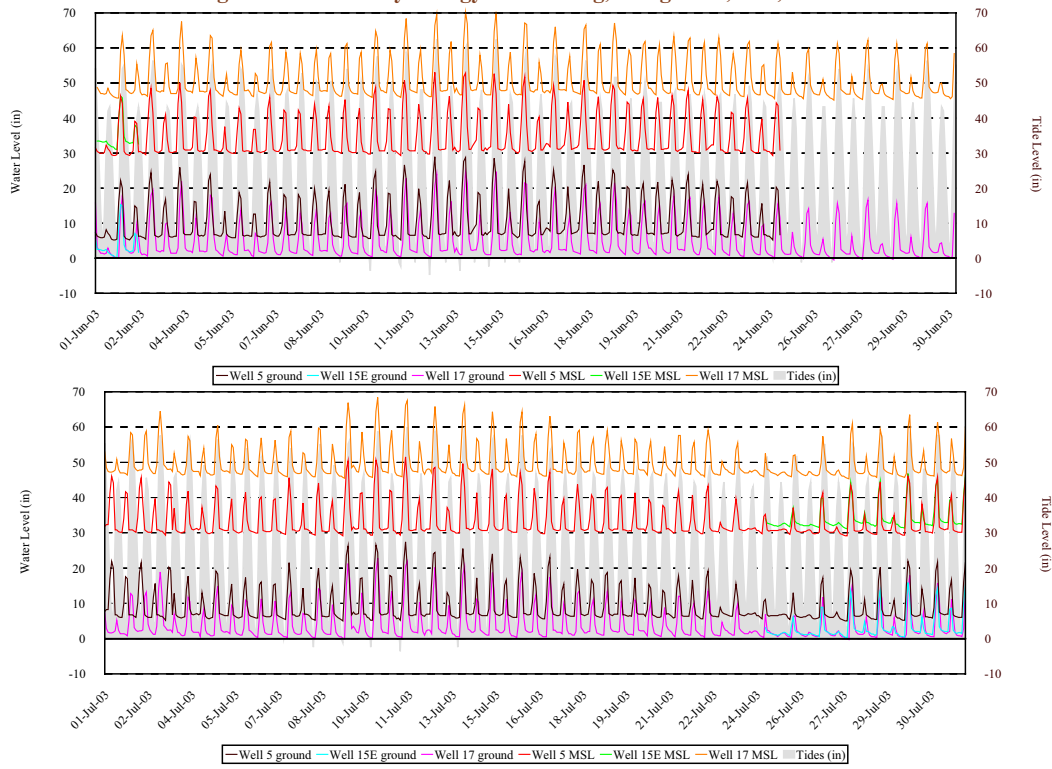
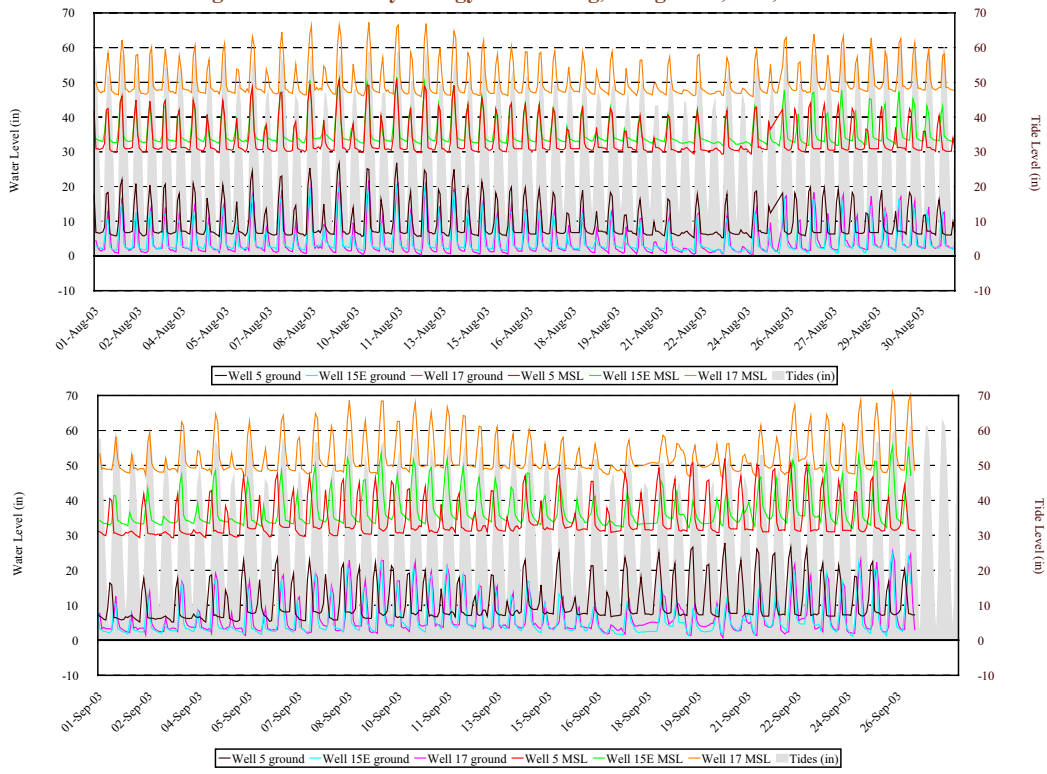
Figure B.6. Hydrology Monitoring, Gauges 5R, 15E, and 17

Note: Hydrology readings taken every 90 minutes.
Tide data are from the Cape Fear River at Wilmington.

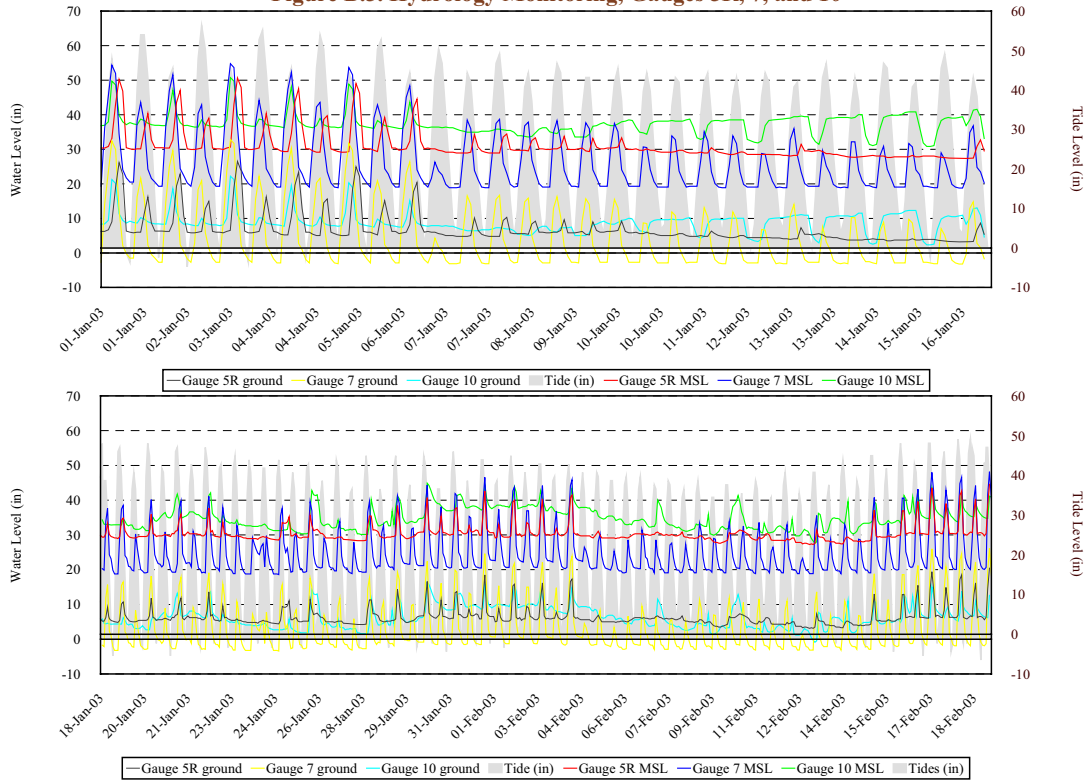
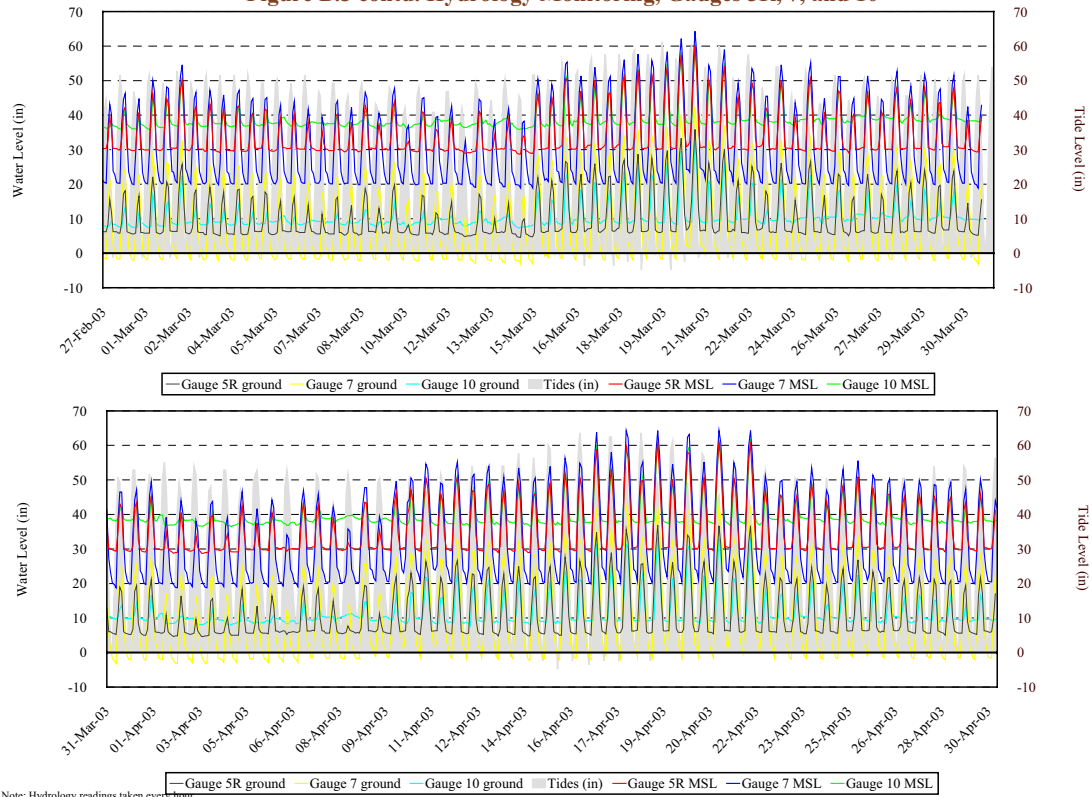
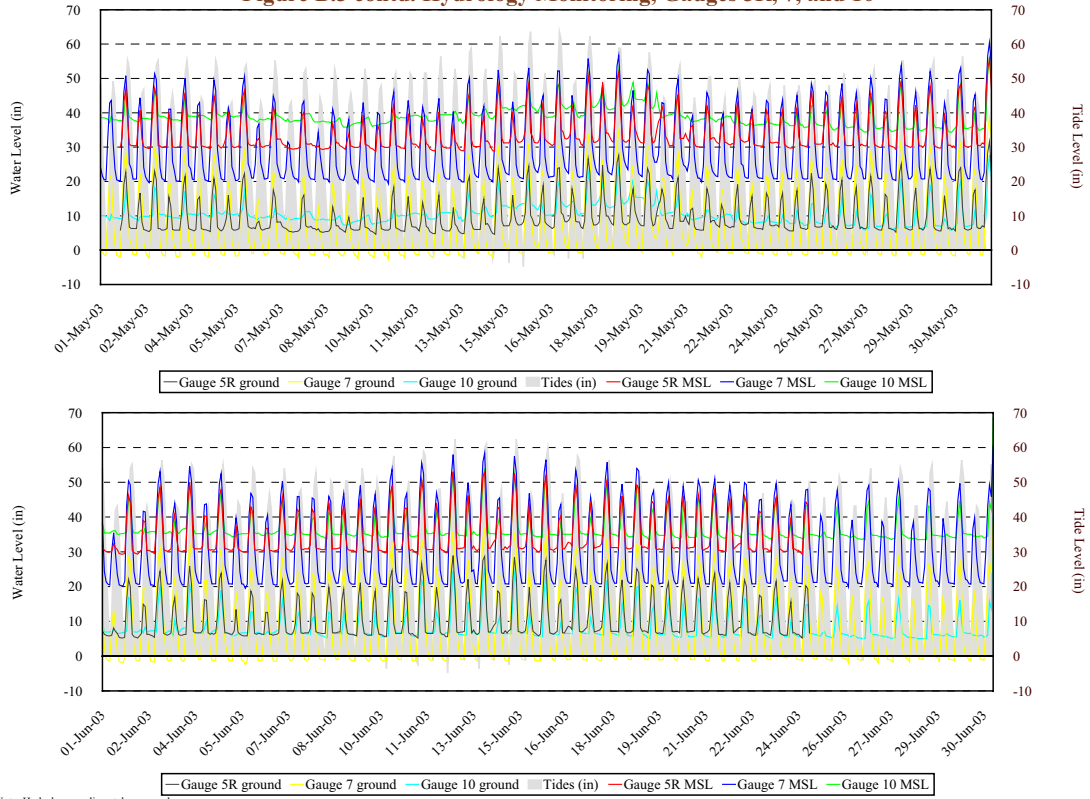
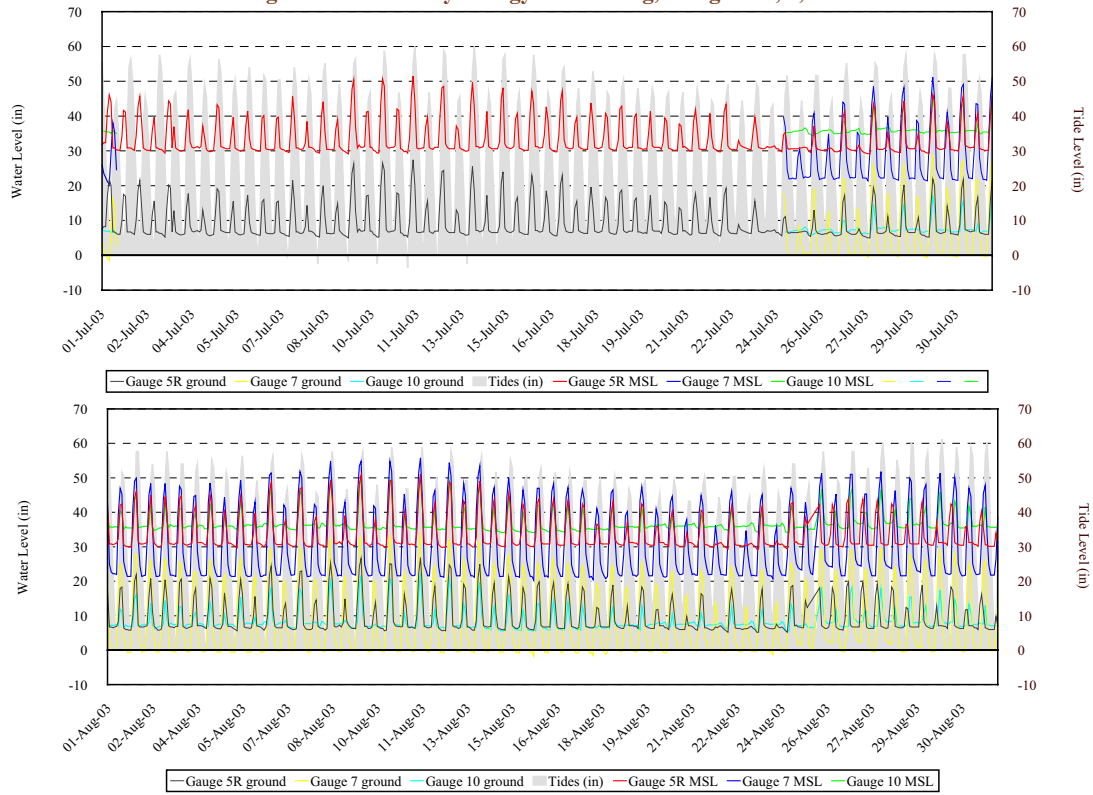
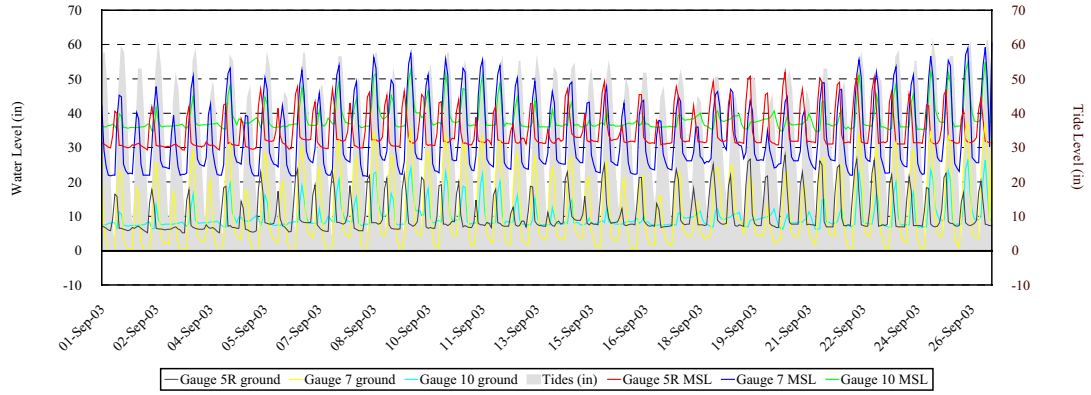
Figure B.5. Hydrology Monitoring, Gauges 5R, 7, and 10

Note: Hydrology readings taken every hour.
Tide data are from the Cape Fear River at Wilmington.

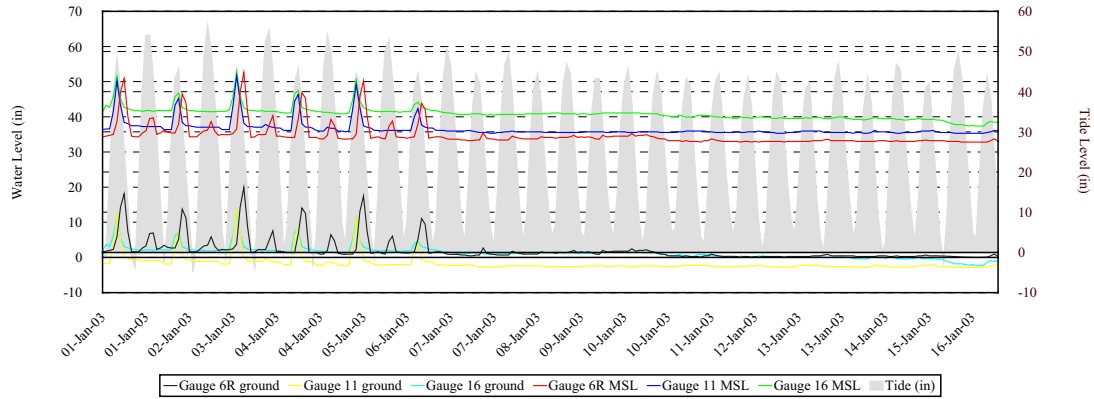
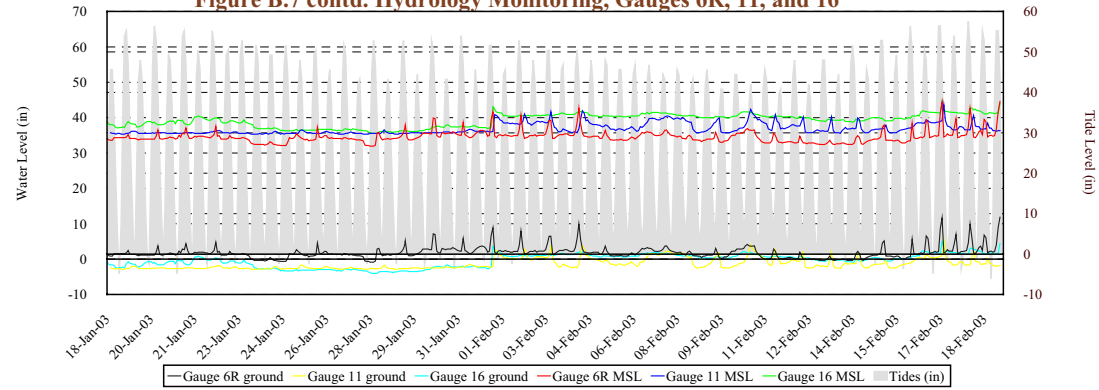
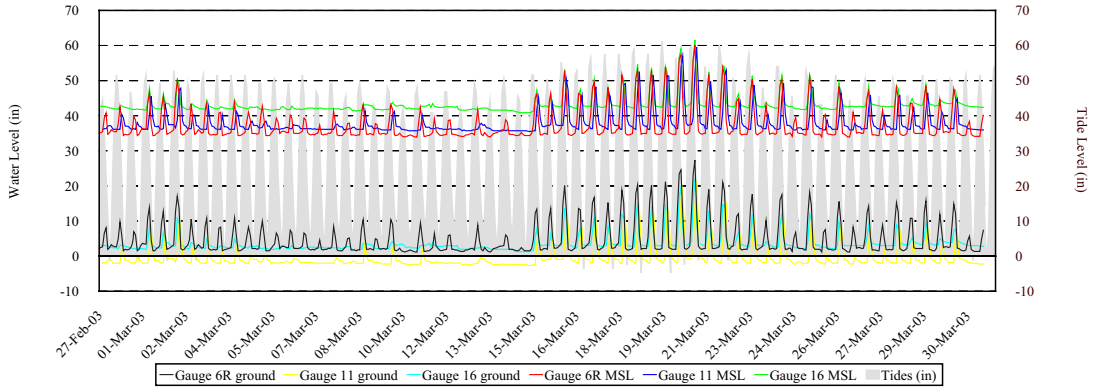
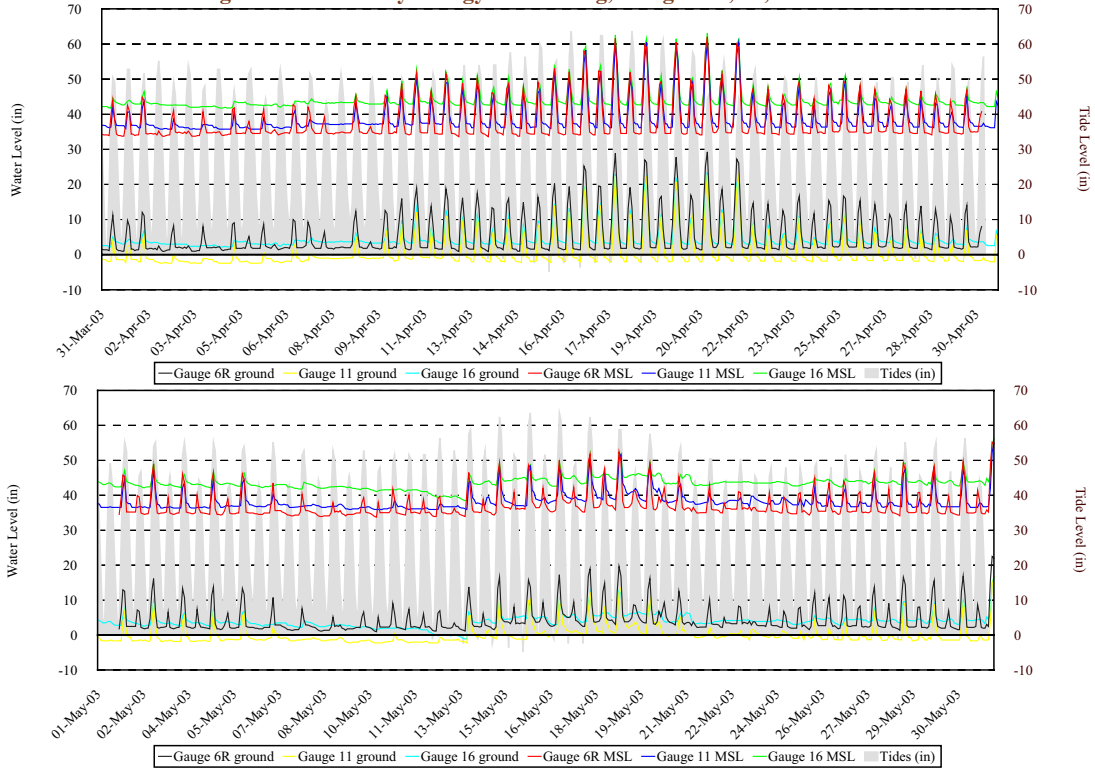
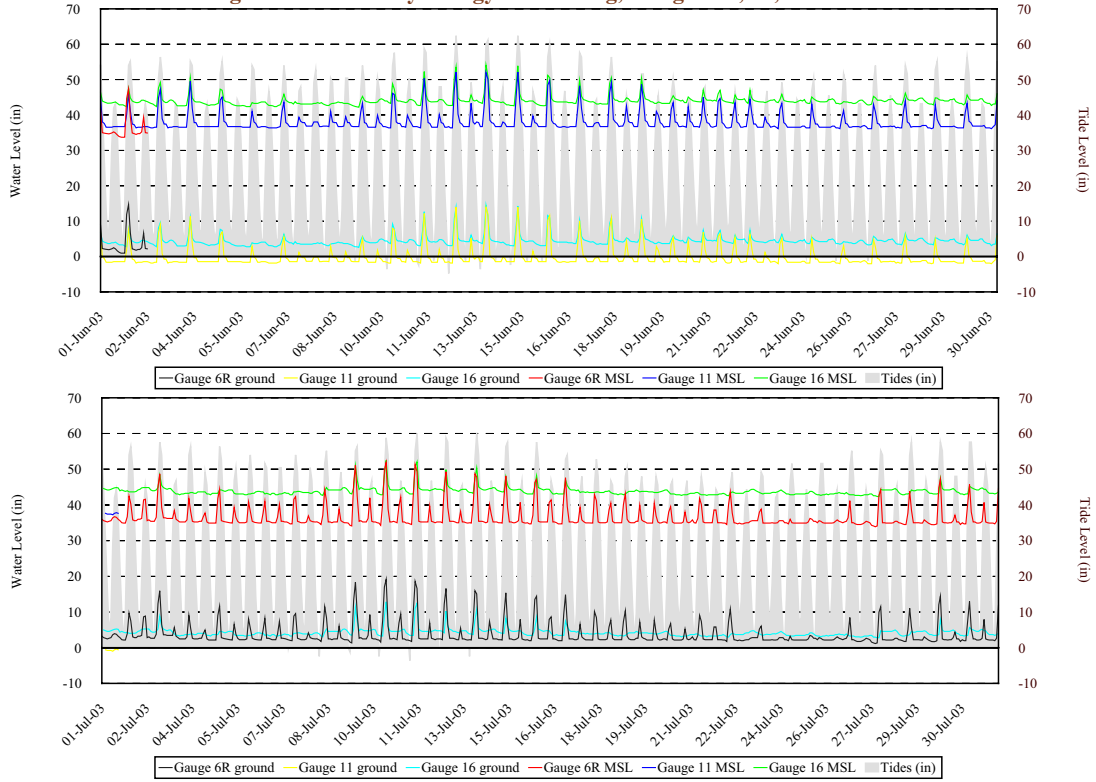
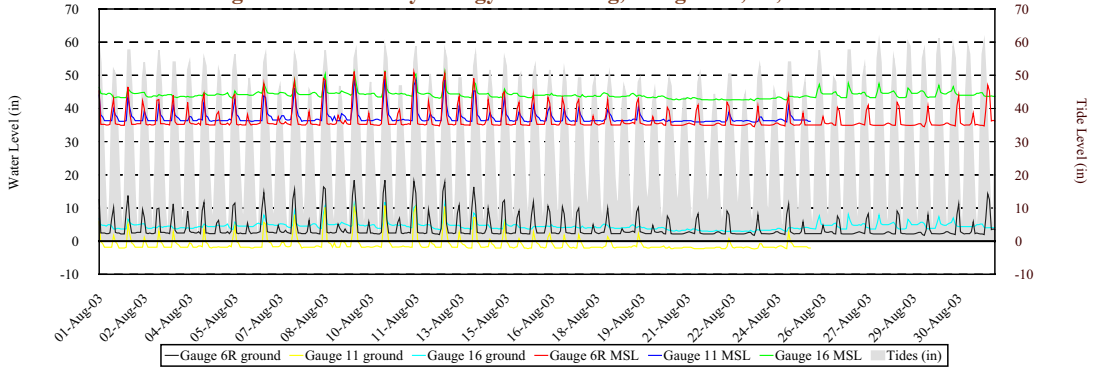
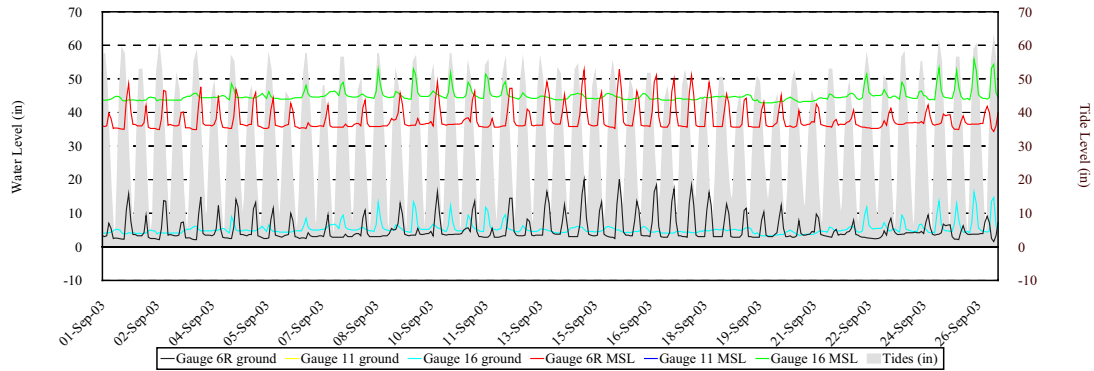
Figure B.7. Hydrology Monitoring, Gauges 6R, 11, and 16

Note: Hydrology readings taken every hour.
Tide data are from the Cape Fear River at Wilmington.
