**McIntyre Tract:
Year Five Monitoring Report**

Brunswick County, NC

Prepared by:
Land Management Group, Inc.
Wilmington, NC

January 2006

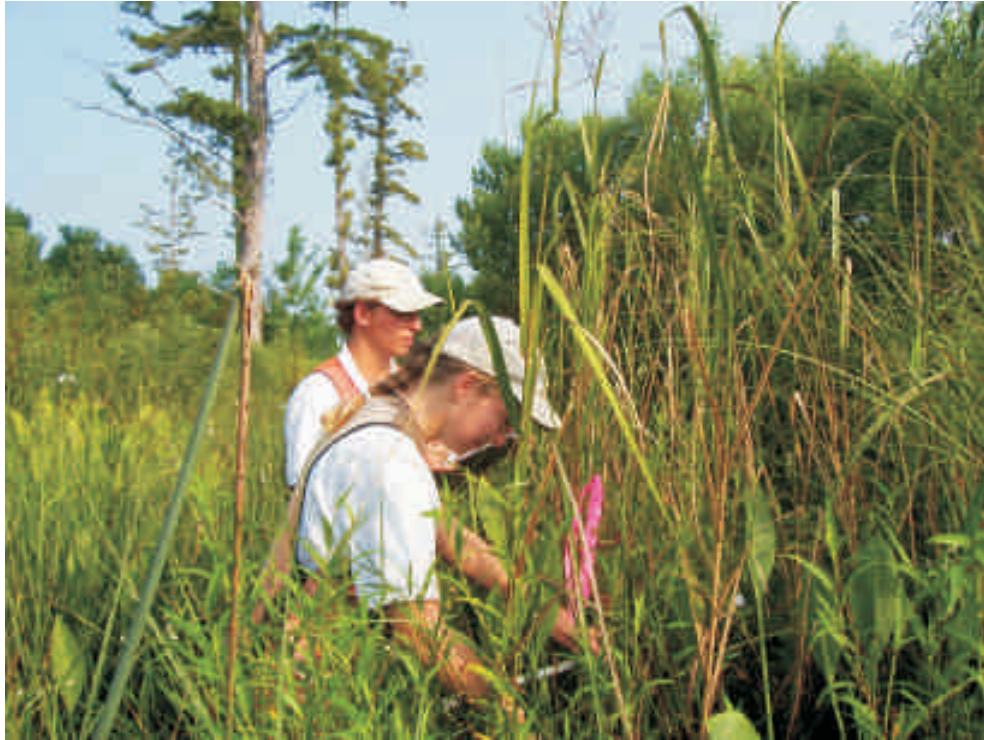
↓ Counting vegetation within the scrub shrub habitat.

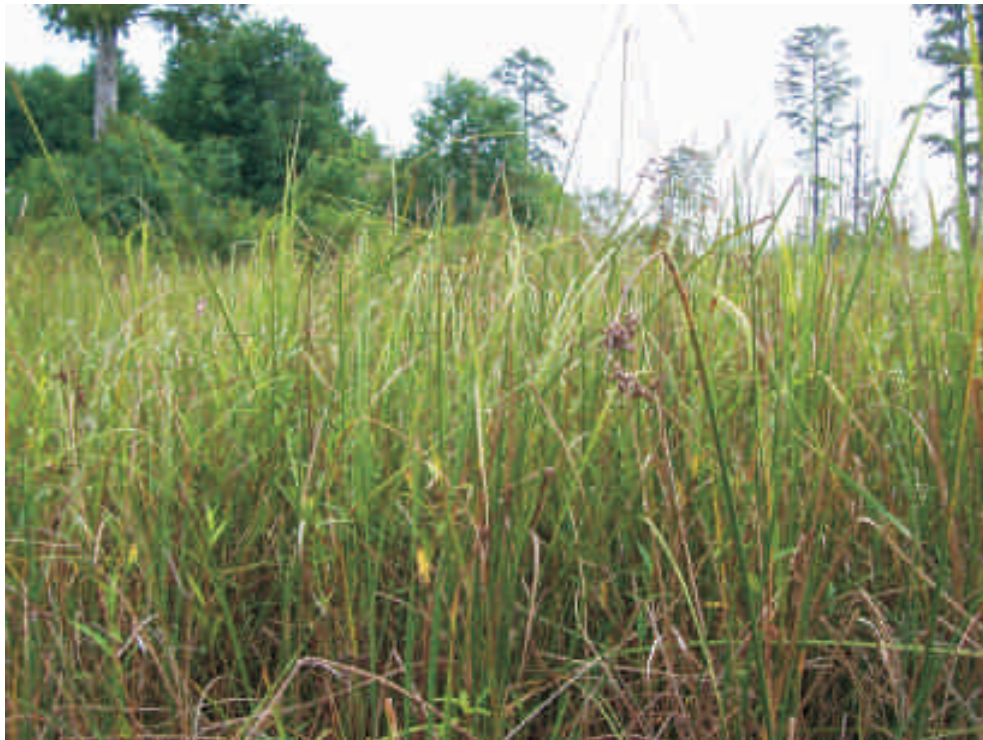
↓ *Scirpus robustus* within the scrub shrub habitat.

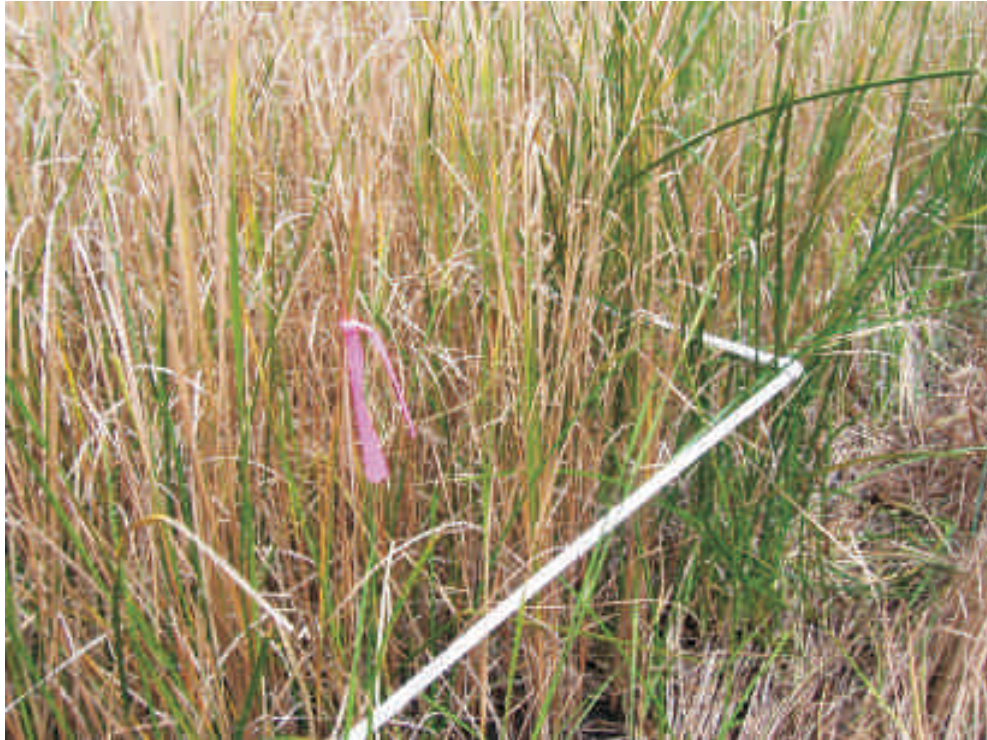
↓ Sawgrass and *Scirpus spp.* within the freshwater marsh habitat.

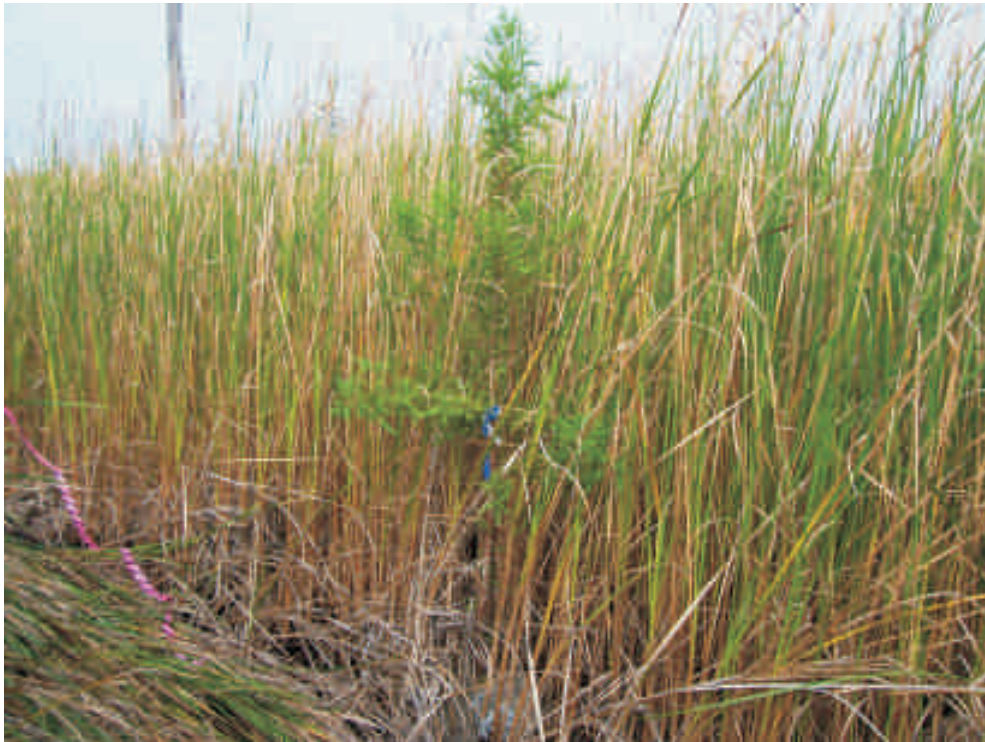
↓ Bald cypress within the cypress gum habitat.

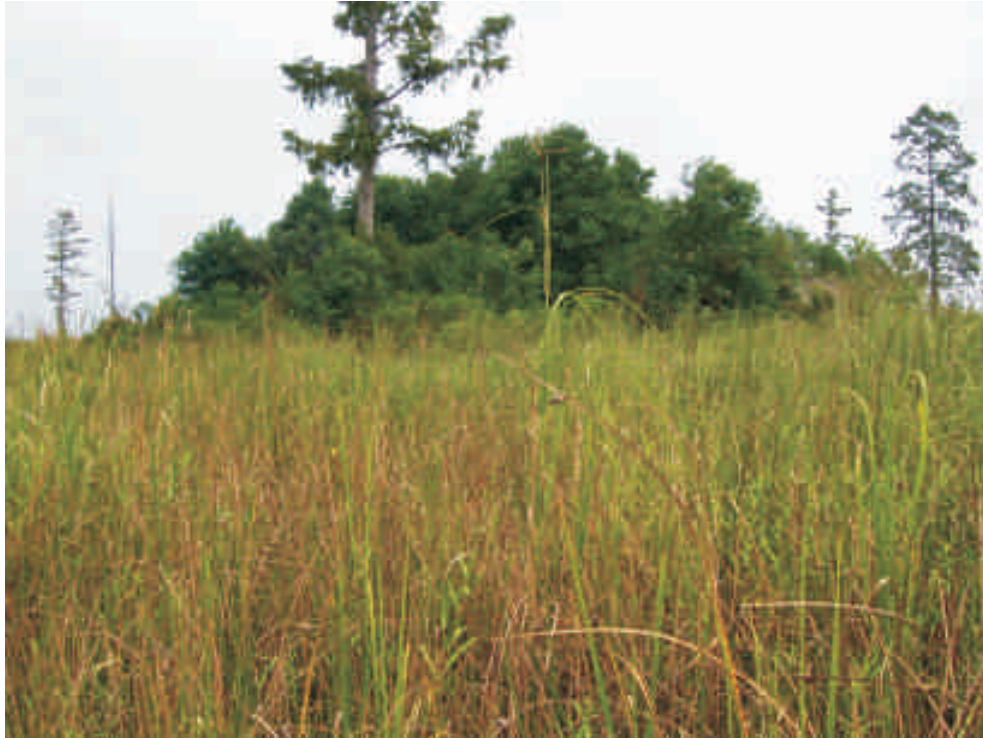
↓ Vegetation within the scrub shrub habitat.

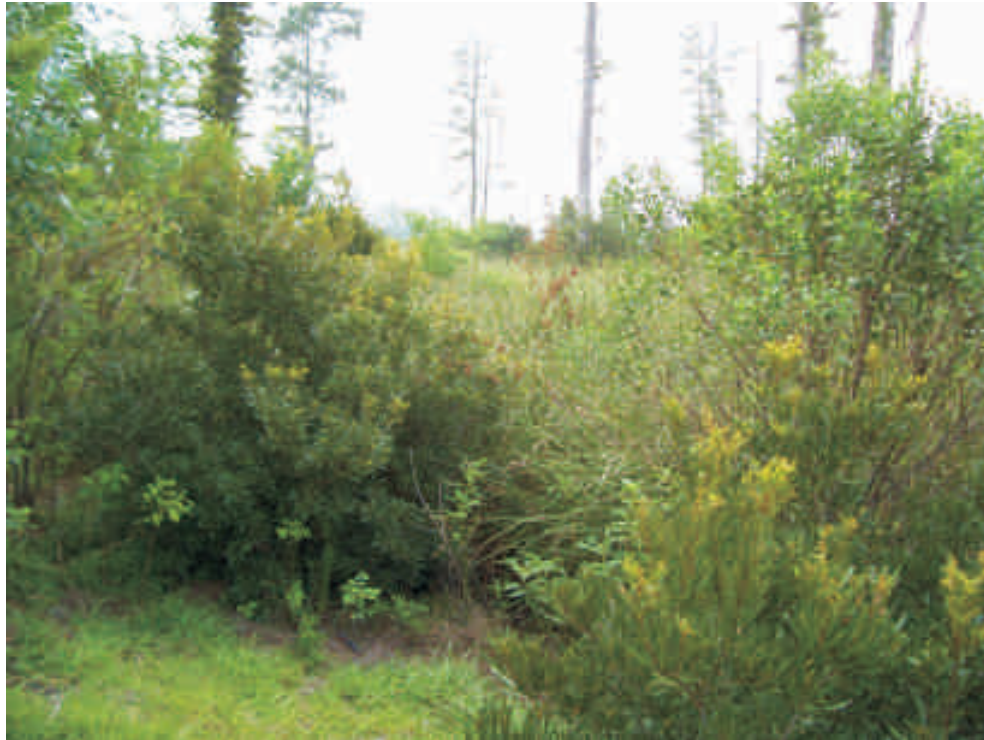
↓ Wax myrtle and marsh elder within the scrub shrub habitat.
