# Mill Creek Restoration Plan

## Randolph County, North Carolina

**FINAL REPORT**

**Baker Project Number 109664**

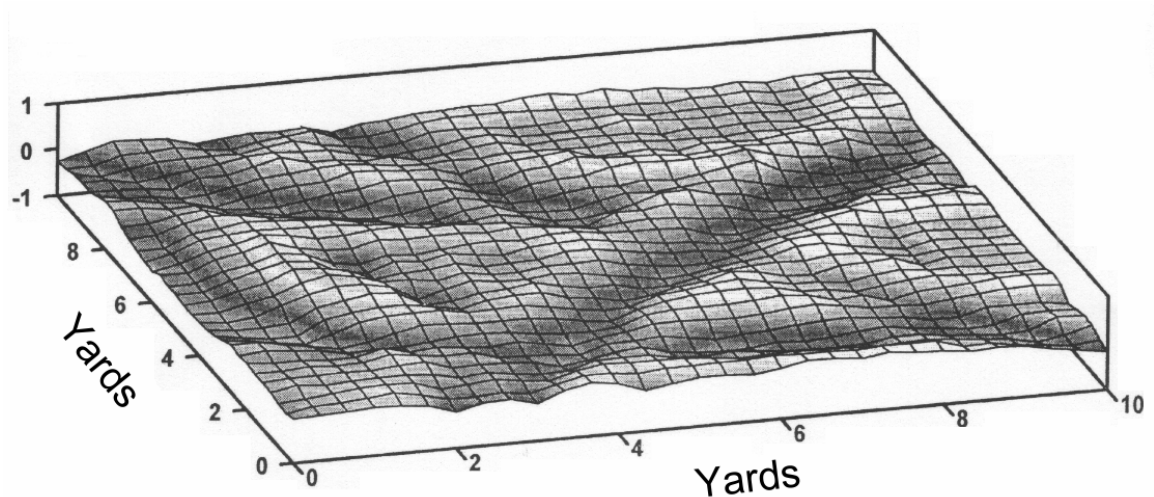
Typical Pattern of Restored Wetland Microtopography (Scherrer, 2000)
