**MITIGATION PLAN  
FINAL**

**Mill Dam Creek Restoration Site  
Yadkin County, North Carolina  
DMS Project Number 97136  
DEQ Contract 6898  
SAW-2016-01335**

**FULL-DELIVERY PROJECT**

**Yadkin River Basin  
Cataloging Unit 03040101**

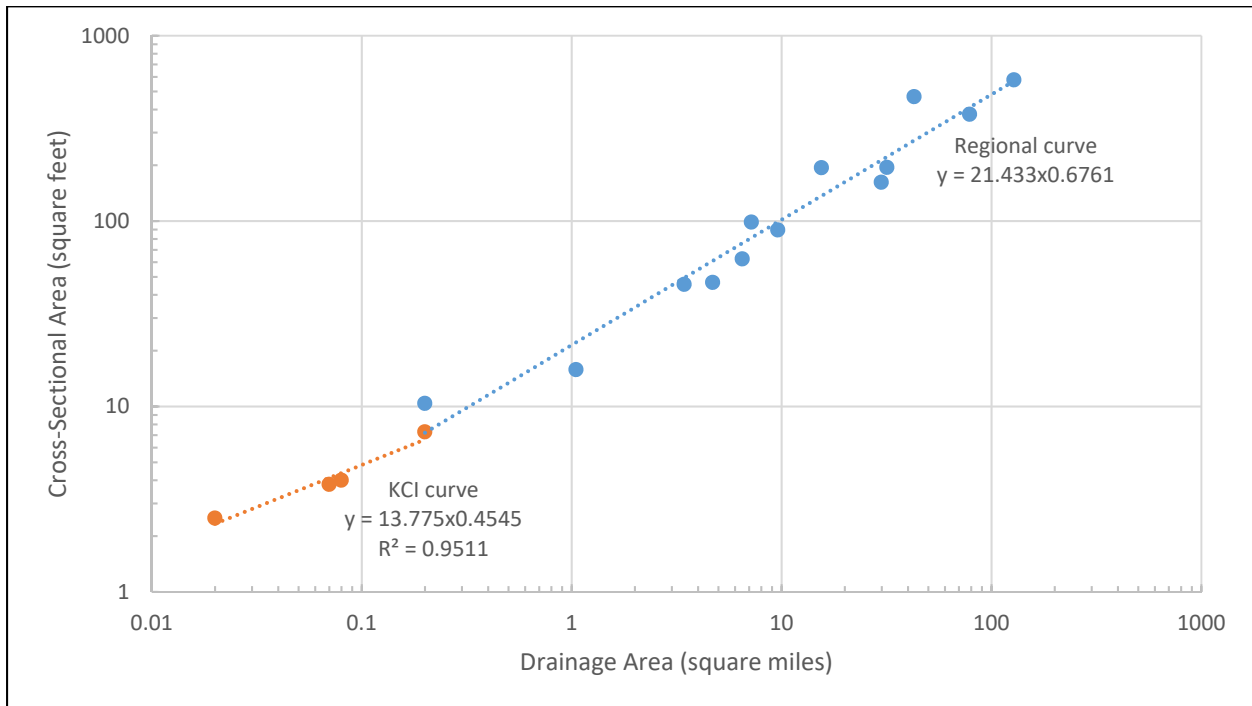
**Figure 9. Local Curve for Bankfull Area Determination**

Cross-Section Location	Acres	Drainage Area (Sq. Miles)	Field XS Area (sf)	XS Area Estimate (sf) from Local Regional Curve	Q (cfs)
T8 XS1	13.1	0.020	2.5	2.4	13.8
T1 XS2	42.9	0.067	3.8	4.0	13.6
UTHC XS2	52.6	0.082	4.0	4.4	15.6
UTHC XS4	127.8	0.200	7.3	6.6	37.4
