SUBJECT: Millstone Creek Mitigation Site - NCIRT Comments during 30-day Mitigation Plan Review

NCDMS Project Name: Millstone Creek Mitigation Site, Randolph County, NC

FINAL MITIGATION PLAN - MAY 1, 2020

MILLSTONE CREEK
NC DMS MITIGATION SITE
RANDOLPH COUNTY
FINAL MITIGATION PLAN

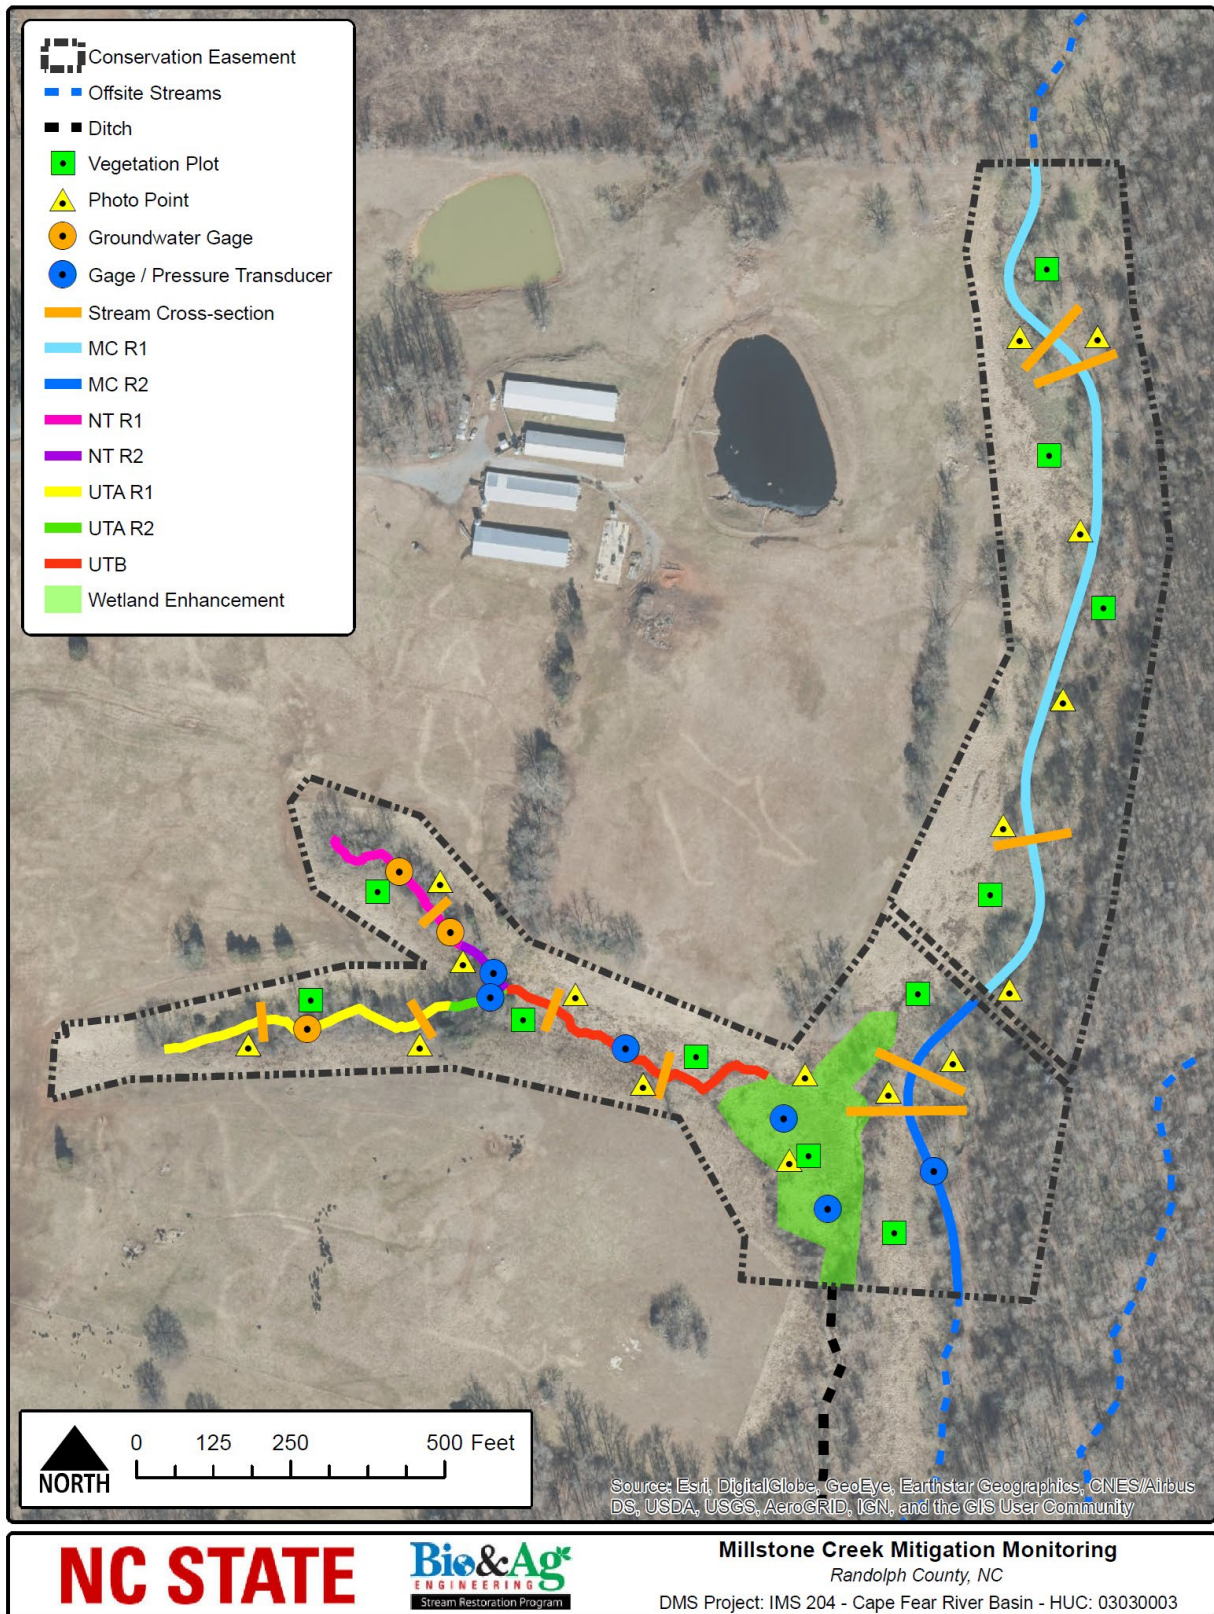
Figure 10.1: Millstone Creek Site Mitigation Monitoring Plan

8. Photo point stations include monitoring cross-sections.

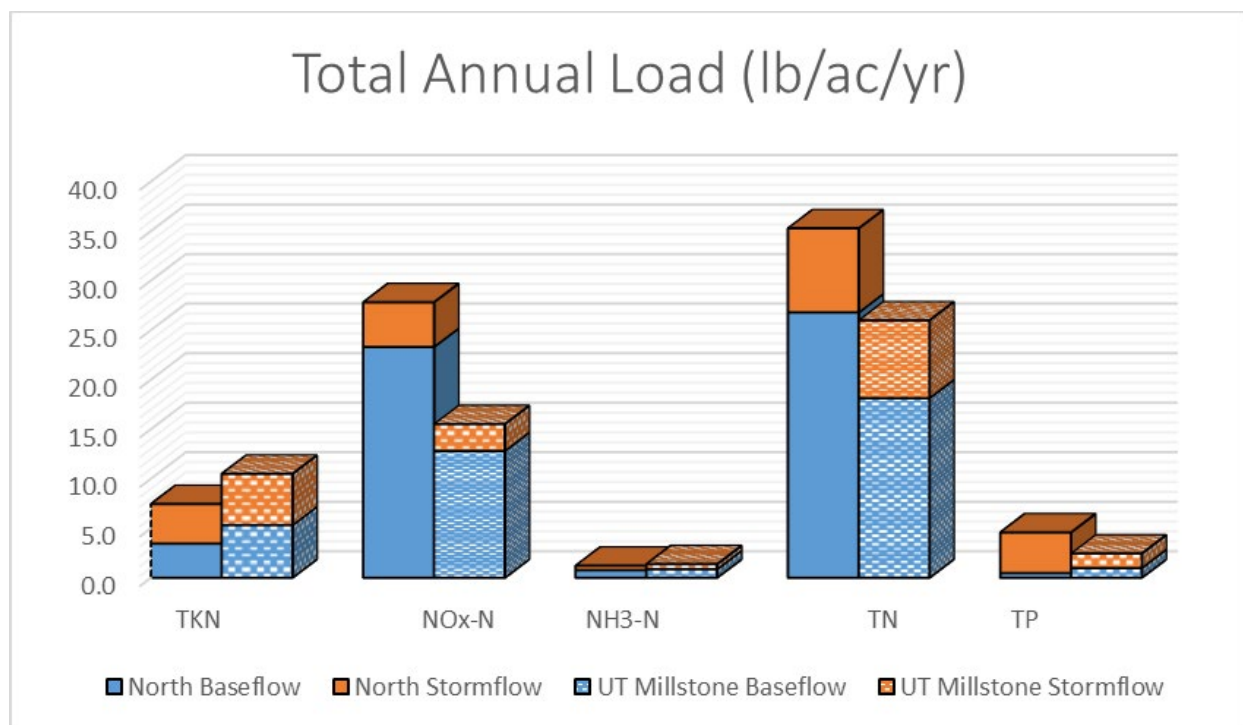
Figure 13.2: Total Nutrient Loads From Baseflow and Stormflow for UT to Millstone Reach A and North Tributary

The base flow discharge on both streams was much greater than the storm discharge, which was unexpected considering the slope of the pasture and the soils. The low storm discharge may be attributed to the relatively dense pasture grass, roughness and contouring of the ground surface. The pasture has many 8-10 ft. diameter and 1-2 ft. deep depressions and several terraces. These depressions create a macro-roughness that likely enhances infiltration and reduces surface runoff. Figure 13.2 shows that base flow export for NOx, NH3-N and TN are much greater in base flow than in stormflow. In contrast, stormflow export of TP exceed those from base flow as phosphorus attaches to sediment. TKN is near equal in stormflow and base flow. This figure also indicates that total export is greater for NT compared to UTA. Large reductions in sediment export occurred as a result of the fencing, especially in the UTA.

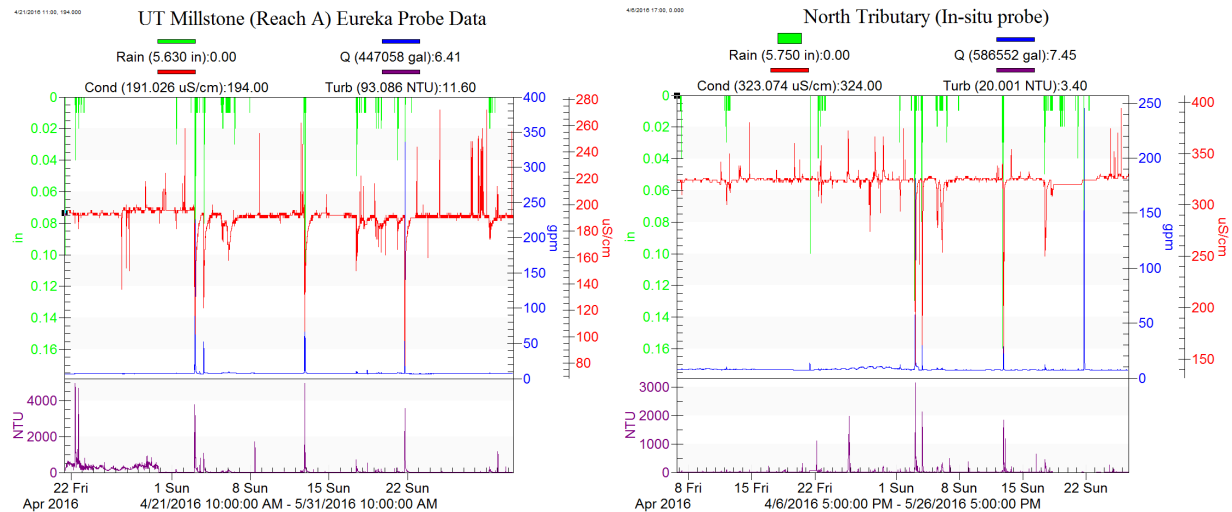
Figure 13.3: In-Situ Probe Conductivity Measurements at NT and UTA.

Stream conductivity is an important indicator of suitable water chemistry conditions for fish and macroinvertebrates. In-situ conductivity measurements for UTA are shown in Figure 13.3. As shown, while there are many anomalous measurements, which are typical of in-situ probes, the vast majority of the conductivity measurements were about 190 $\mu\text{S}/\text{cm}$. During periods of surface discharge (4 large events), the conductivity decreased considerably. For NT, the majority of the conductivity measurements were about 325 $\mu\text{S}/\text{cm}$, which was considerably greater than those at UTA. One possible reason for the higher conductivity at the NT was that it had higher NOx-N concentrations, which means it had more anions in the water to increase the conductivity. This may also help explain why during periods of surface discharge the conductivity decreased given that NOx-N concentrations were much less in storm flow samples. The conductivity of most rivers in the US is generally between 50 to 1500 $\mu\text{S}/\text{cm}$. Studies of inland fresh waters indicates that streams supporting good mixed fisheries have a range between 150 and 500 $\mu\text{S}/\text{cm}$. This suggests that tributary conductivity measurements are already within the suitable range for macroinvertebrate communities. Furthermore, clay soils tend to have higher conductivity due to the presence of materials that ionize when mixed with runoff or stream flow. There is additional opportunity to decrease conductivity by preventing bank erosion and creating shallow groundwater flows within U/S BMPs to enhance water chemistry for macroinvertebrates.

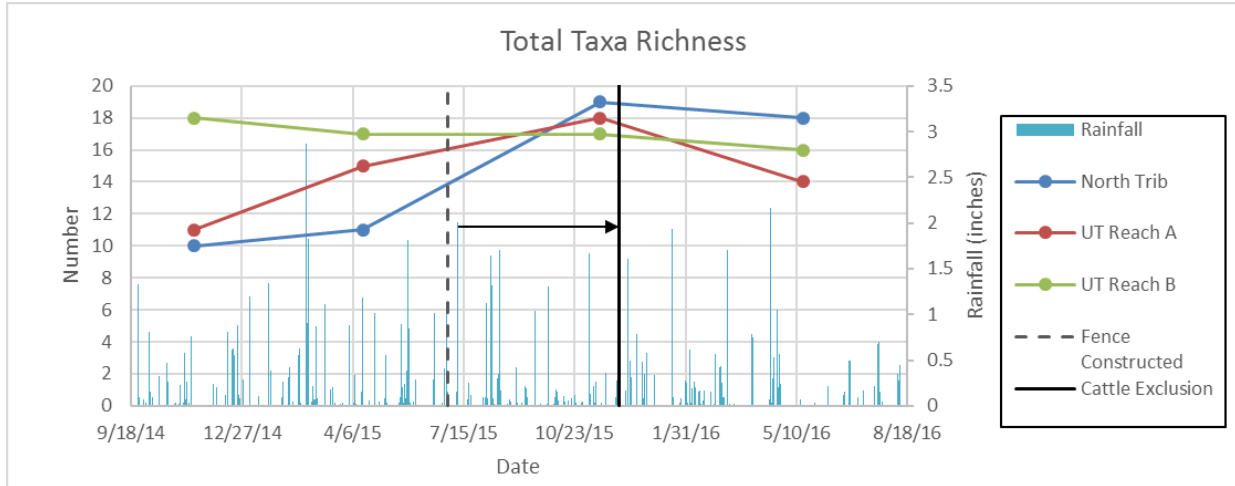
Figure 13.6: Total taxa richness for Millstone Creek tributaries

The sample location of UTB is approximately 160 ft. below the confluence of NT and UTA. The instream habitat at this location becomes slightly more heterogeneous and the presence of bank habitat was noted. For the first sampling in Fall 2014, the total number of taxa was 18 at this location and 3 EPT taxa were collected (two mayflies; *Paraleptophlebia* spp, which was common, and *Centroptilum* spp: and one caddisfly *Ptilostomis* spp). The benthic fauna at this location is also dominated by tolerant taxa including midges and *Physidae* snails. Three taxa that have a NC Biotic Index of ≤ 2.5 were collected, which lowered the total biotic index for the site to 6.12 and a Fair bioclassification using these criteria. The improvement in biological conditions noted at the NT and UTA during the third sampling, however, was not seen at the UTB station below the confluence. Comparison of Nov. 2014 and 2015 samples at this location noted a slight decline in the fauna; slightly lower taxa richness values and a lower number of intolerant taxa. During the spring 2016 visit, the bioclassification increased only slightly in UTB. Extremely high numbers of blackfly larvae were collected during this survey, but interestingly the relatively intolerant baetid mayfly *Baetis pluto* became abundant during this survey. This mayfly has only been collected from these stations only during the last two surveys and only abundantly from this site. These data resulted in a Fair bioclassification for all four surveys at this reach. Comparisons of total taxa richness and EPT taxa richness and abundance for the three tributary sampling stations are provided in figures 13.6, 13.7 and 13.8 below.
