# Moccasin Creek Riparian Buffer Restoration Johnston County, North Carolina

## MITIGATION PLAN

Greene Environmental Services, LLC  
90 Ham Produce Rd.  
Snow Hill, NC 28580

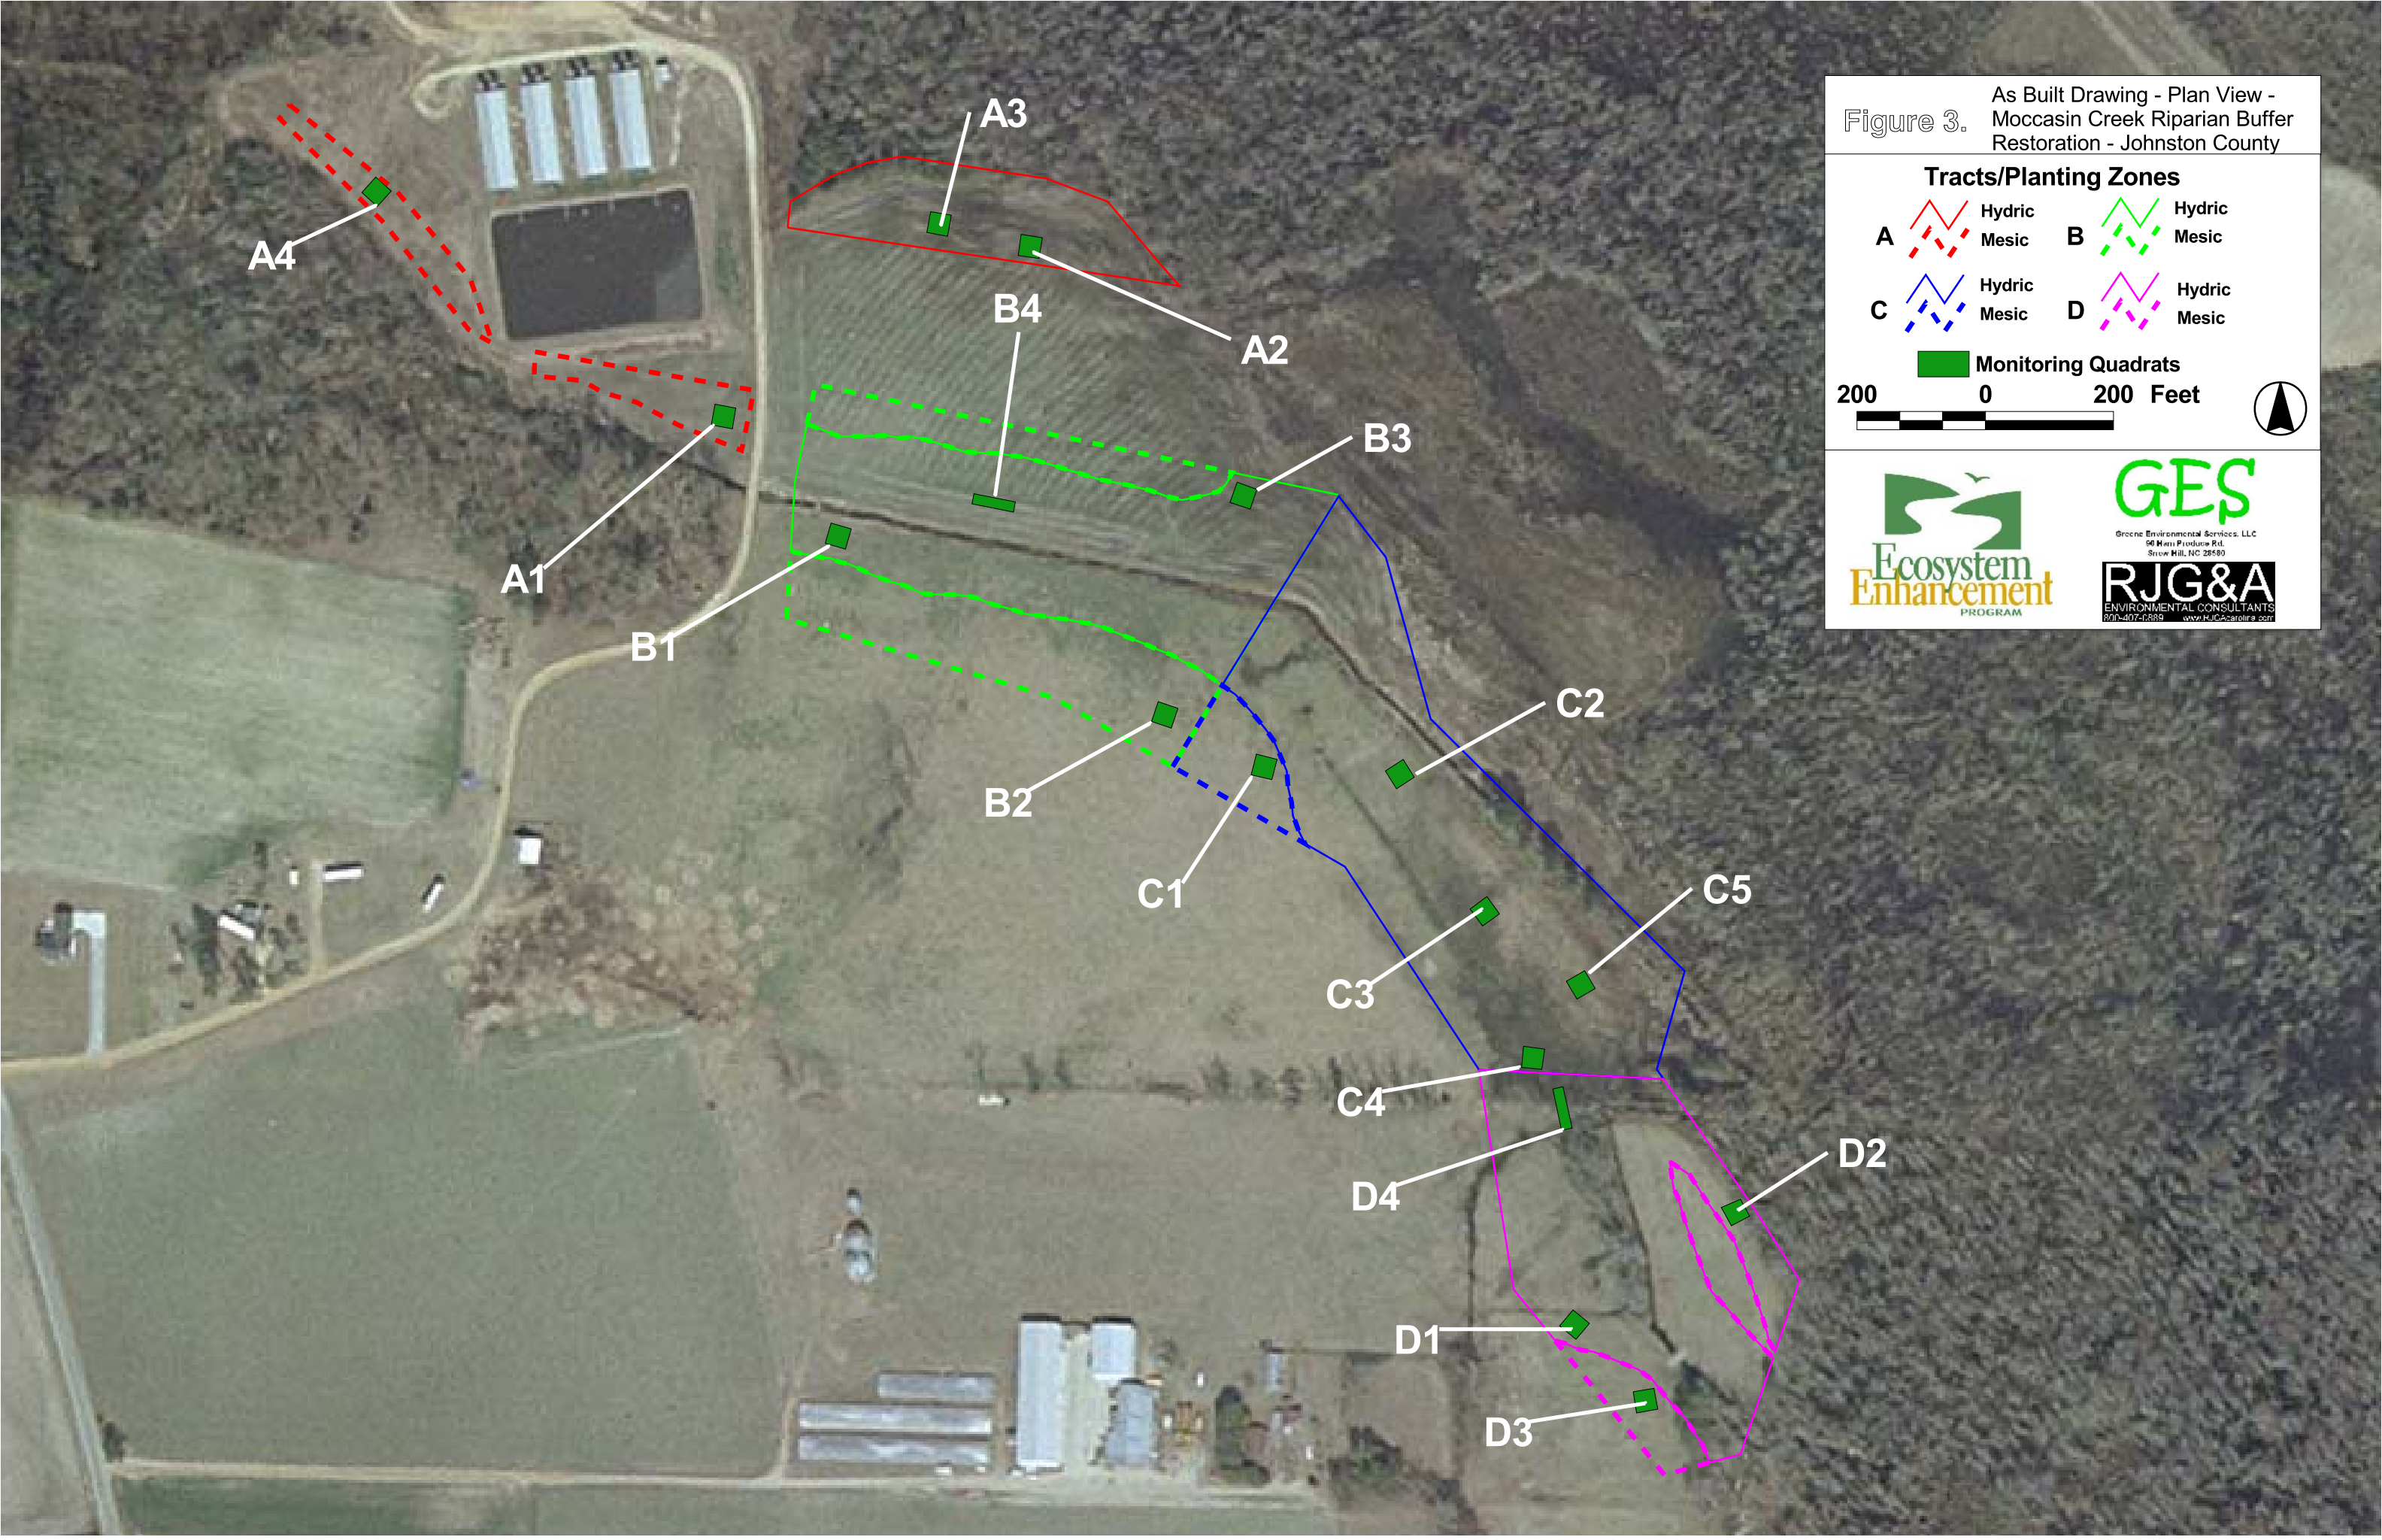
As Built Drawing - Plan View -  
 Figure 3. Moccasin Creek Riparian Buffer  
 Restoration - Johnston County

**Tracts/Planting Zones**

**Monitoring Quadrats**

The Moccasin Creek project has restored 20.2 acres of riparian buffer along approximately 4,550 feet of unnamed first order tributaries to Moccasin Creek. The project area is in southeastern Johnston County, approximately 2.75 miles south of Princeton along Moccasin Creek’s western bank. The unnamed tributary that the buffer surrounds conflues Moccasin Creek immediately to the southeast of the restoration site, approximately 7.5 stream miles north of its confluence with the Neuse River (Figure 1). The entire project lies on the Danny Kornegay Farm in USGS Hydrologic Unit 03020201160010 (Figure 2). Hay fields and cattle pastures adjacent to the buffers receive liquid hog waste from the farm and typically have 65 cow/calf pairs rotating between fields (Figure 3).

The hydric zone was significantly expanded where soil moisture warranted (Figure 3). Similarly, where a drier soil moisture regime prevailed, species suitable for more well drained conditions were planted in the mesic zone, which extended to the interior buffer boundary in the upper portions of Tract A.

Pursuant to the *Protocol*, each quadrat was placed to accurately represent a given stand's physical, biological, and hydrologic characteristics. Every effort was made to select sites that were not overly influenced by the heterogeneity of adjacent areas. All sample quadrats measure 100 square meters and are either ten by ten meter squares (15 of 17) or five by 20 meter rectangles (two of 17 (B4 and D4)). Quadrat dimension and orientation were determined at each randomly located point based on species composition, diversity, range of hydroperiod and other locally important factors (e.g., presence of erosion control devices or disturbance) (Figure 3).
