FIRST ANNUAL MONITORING REPORT – 2006 GROWING SEASON

Moccasin Creek Riparian Buffer Restoration (EEP Contract: 005015)

December 2006

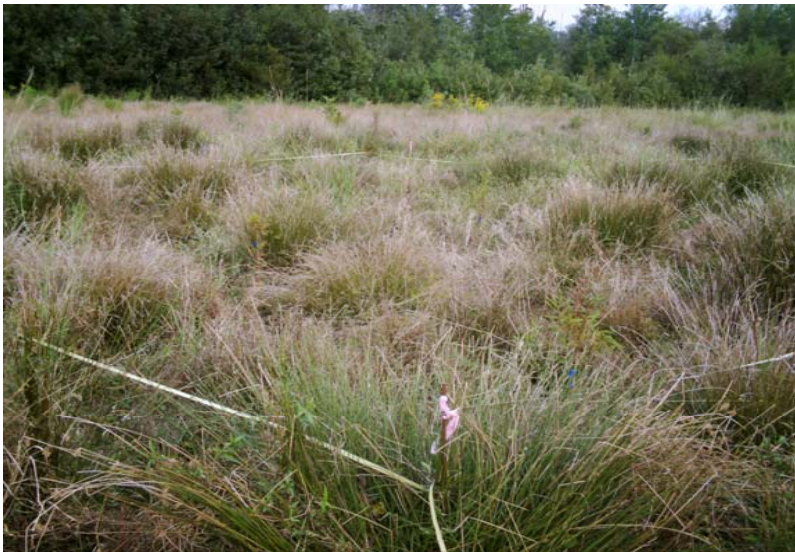
Planted woody stem mortality was observed in a few locations, but the quantitative data accurately reflect that overall planted woody stem success was high after the first growing season. Almost all planted woody stem mortality resulted from having *L. tulipifera* planted in the very wet portions of tracts

B and C (Photo PA1). Limited mortality, and less vigor was also observed in portions of tracts A, B, and C where rhizomatous grass density was extremely high (Photo PA 2) (Figure 2). While not a problem causing any observed mortality during the first growing season, invasive annuals, biennials, and short lived perennials (e.g. *Conyza Canadensis*, *Eupatorium capillofolium*, *Ambrosia trifida*, and *Phytolacca americana*) have colonized several locations throughout the site.

PA 1 Soil too wet for mesic species

To address the observed mortality in the wet areas, approximately 1000 bare root water tolerant seedlings (*T. distichum*, *Nyssa sylvantica*, *N. aquatica*, and *N. biflora*) will be planted during January and/or February 2006. Approximately 500 woody stems of species less tolerant of hydric soil (*L. tulipifera* and *F. pensylvanica*) will be planted in the mesic areas with significant mortality. The site will be reevaluated in the early 2006 growing season to identify areas with serious weed encroachment. Weedy areas will be evaluated individually for the appropriate treatment.

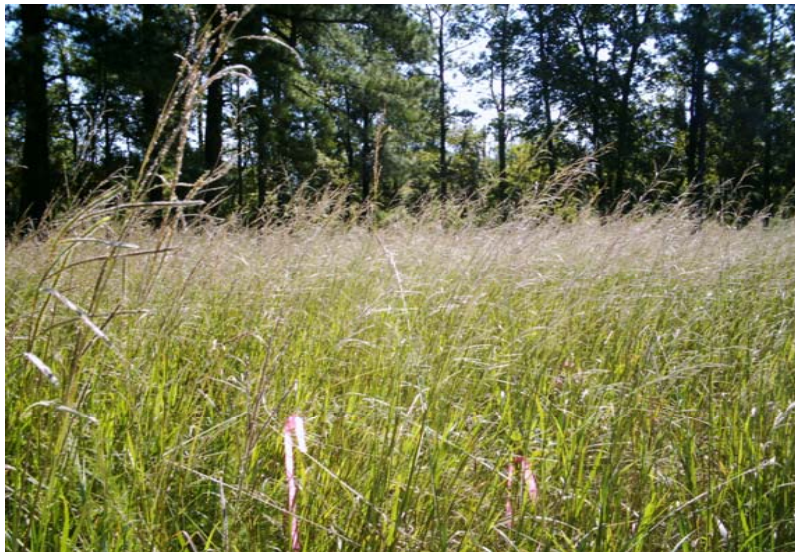
PA 2 Dense rhizomatous grass

Because the dense rhizomatous grasses appear to be reducing planted stem vigor, maintenance teams will manually trim (using machetes and string trimmers) rings around the planted stems during June and July. If any areas are determined to need herbicide application, the application crews will be closely observed and managed by the designer, to avoid overspray that could cause additional mortality.
