Wetland Restoration Plan for the Moore Property

Johnston County, North Carolina

Project ID No. 060673501

March 2008

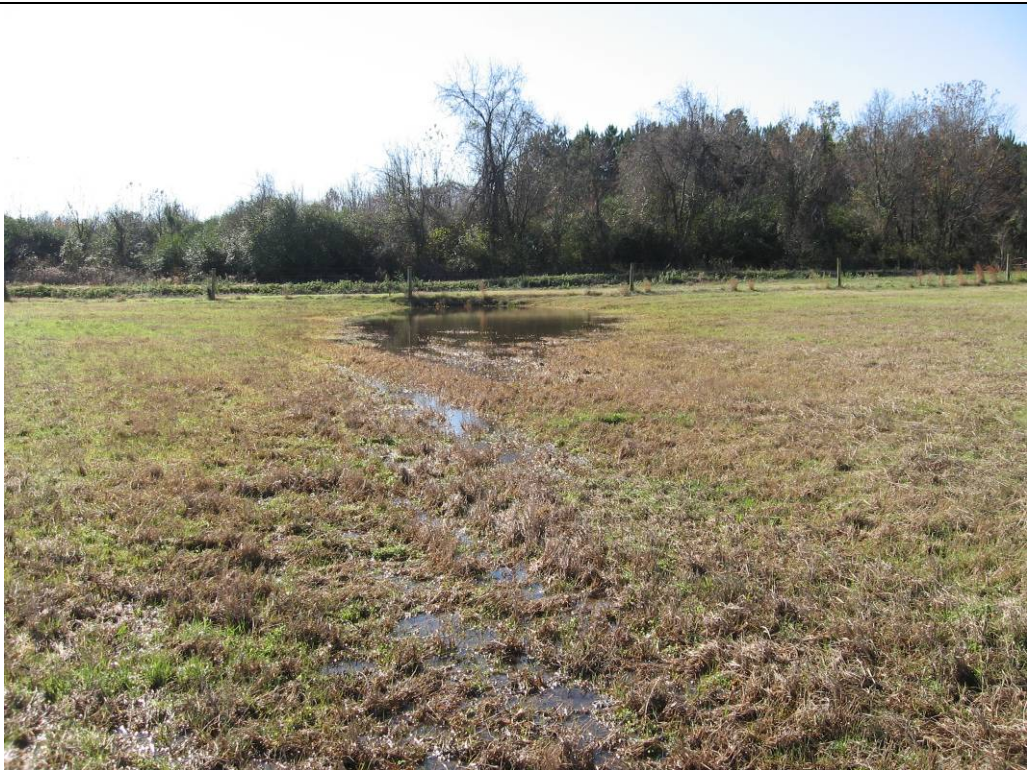
Photo 4: Standing water at southern end of WED tract (11/17/06 – Typical)

When viewing in the field, the Wehadkee tract appears as a very shallow swale that has standing water or saturated soils during most of the year. The swale may be a relic portion of Swift Creek. The entire Wehadkee tract serves as active pasture. Between the Wehadkee tract and Swift Creek lies a levee forest, RPN. Portions of the levee forest have been cleared, reshaped, or created by the landowner. The landowner has created a berm within the levee forest along the strip of land farthest away from the creek. The grading plan in the design sheets shows the berm. He noted that flood waters periodically breach the berm and he has attempted to repair the breaches and maintain the berm.

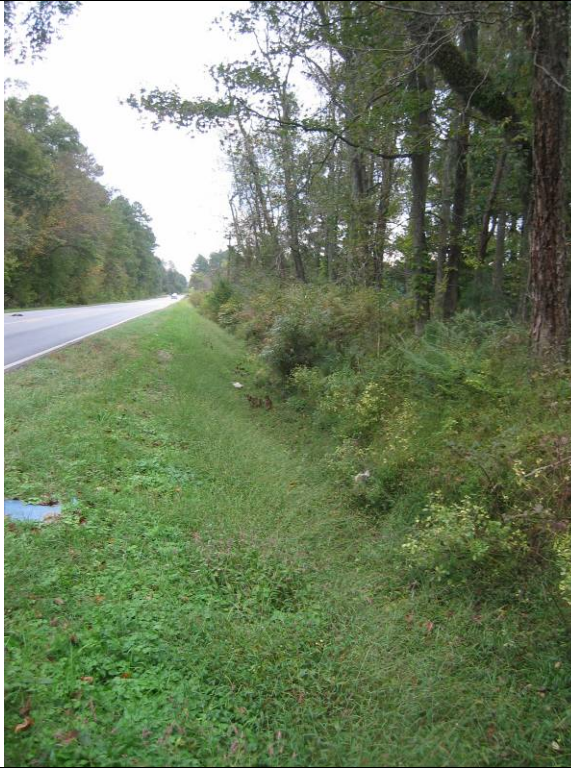
Photo 7: Road side ditch flowing to north section of TOM-A tract (10/18/04 – Typical)

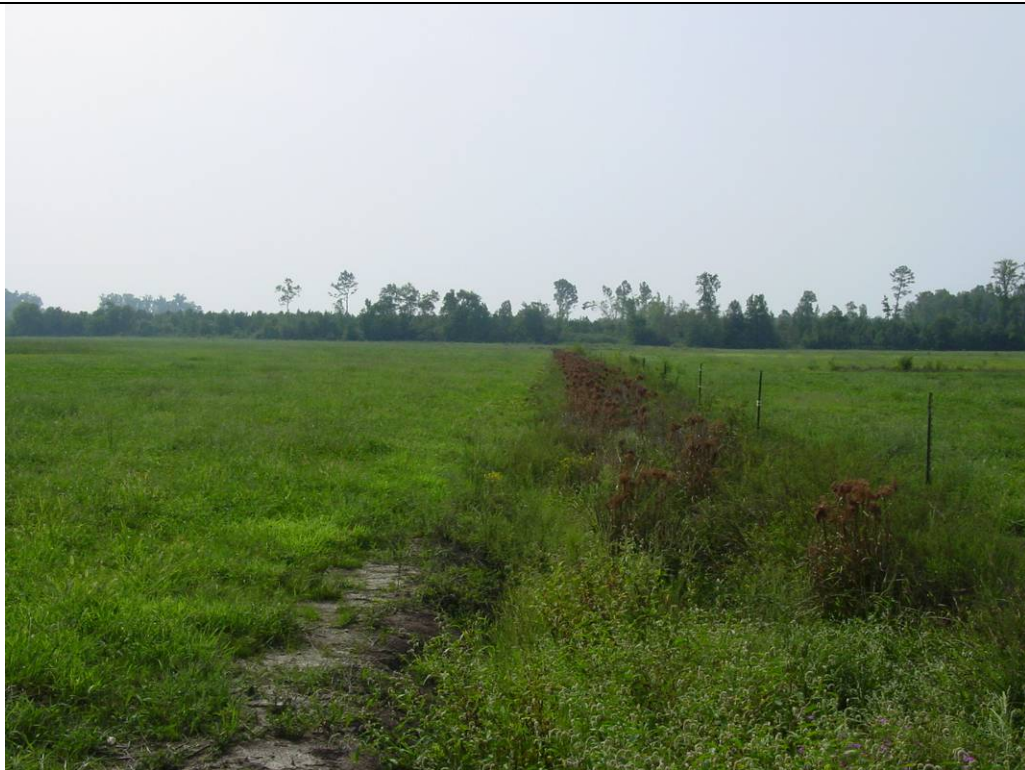
Photo 8: Site ditch flowing from middle section to southern section of TOM-A tract (9/17/2002 – Typical)

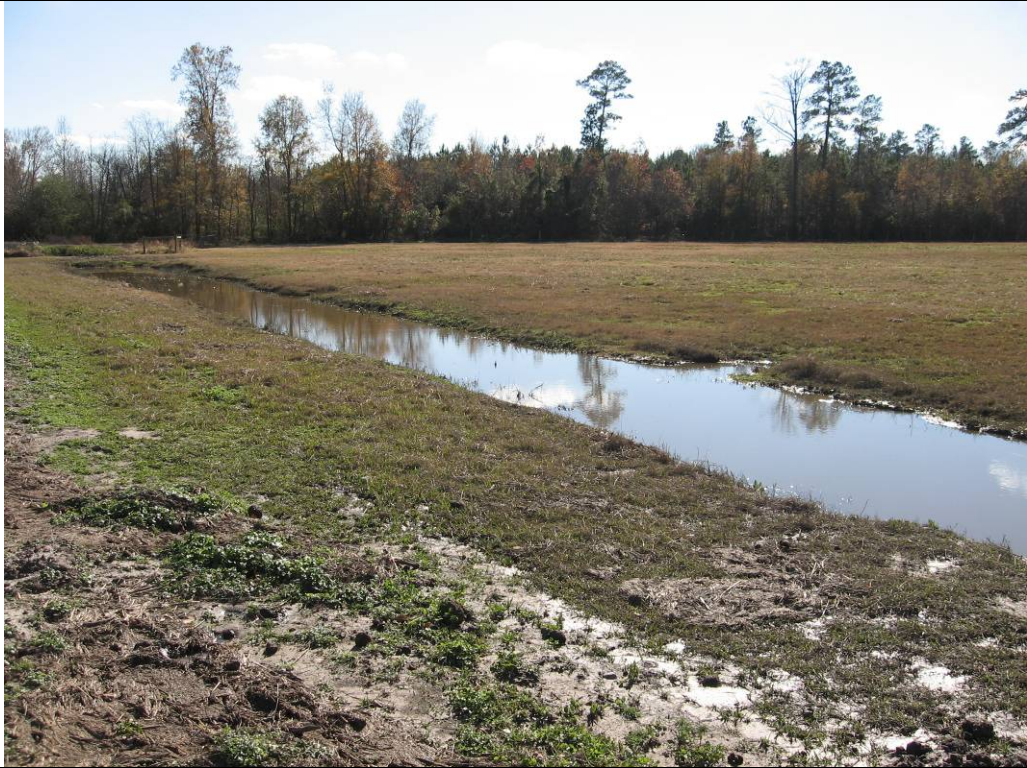
Photo 9: Site ditch flowing from section of TOM-A tract to lateral ditch (11/17/06 – Typical)

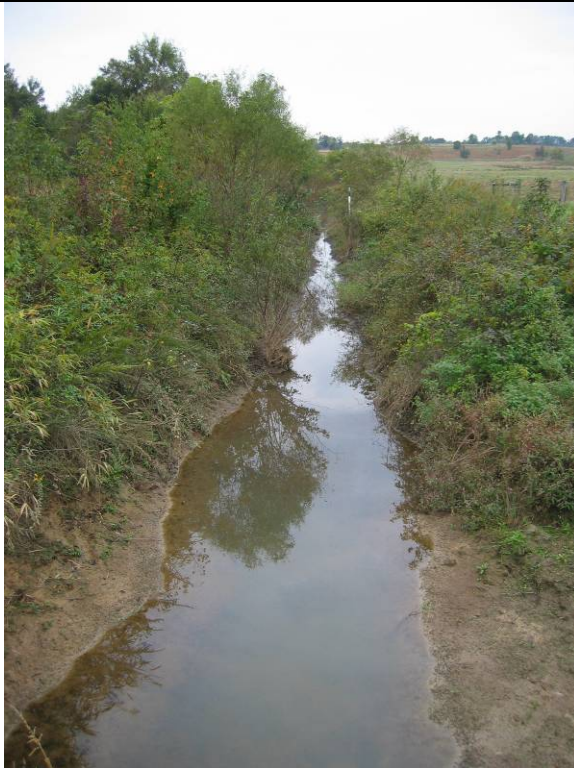
Photo 10: Lateral ditch at southern end of site flowing to Swift Creek (10/18/04 – Typical)

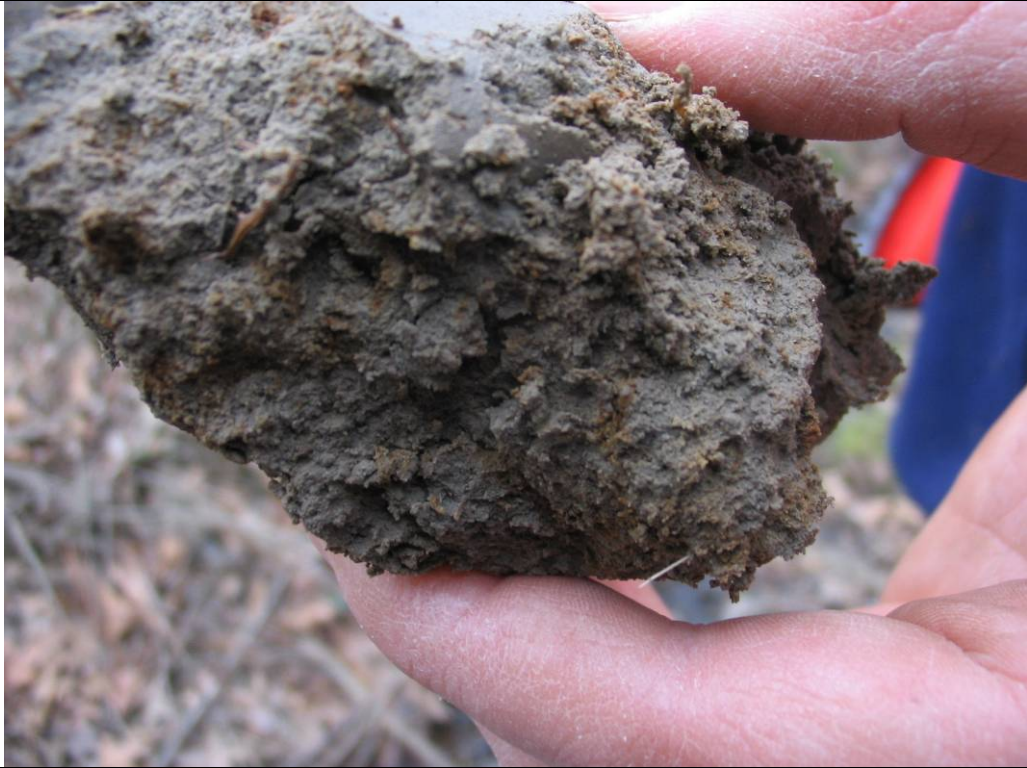
Photo 1: Soil sample of TOM-REF tract (2/7/07 – Typical)

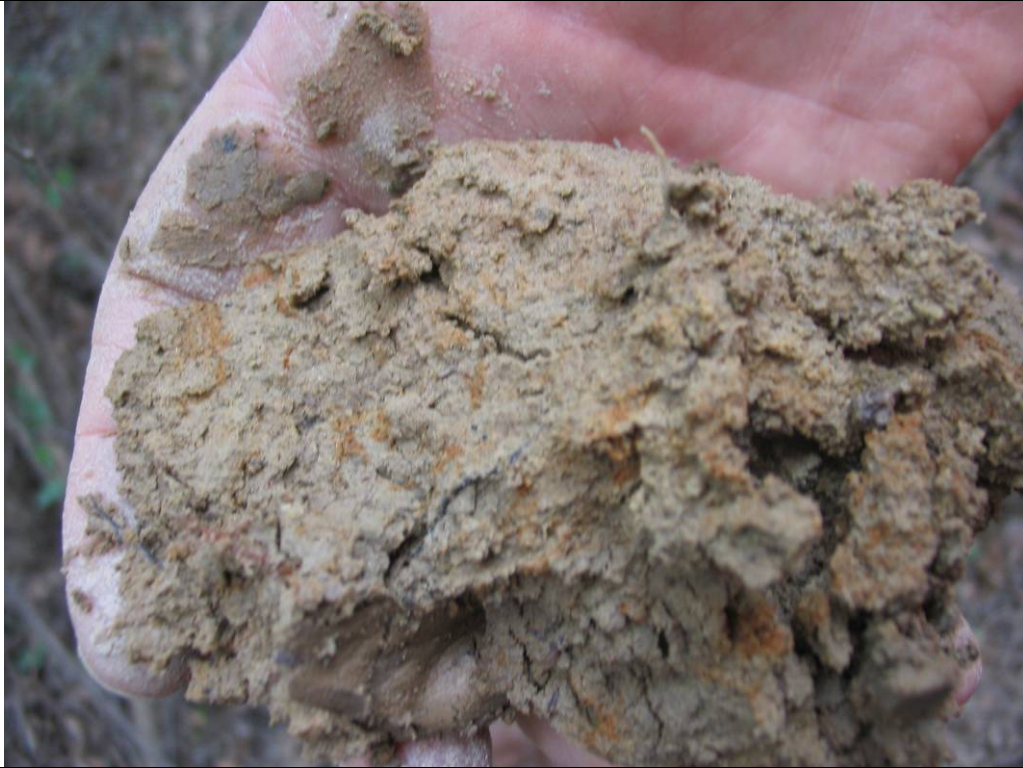
Photo 3: Soil sample of WED-REF tract (2/7/07 – Typical)
