# Moore Property Monitoring Report FINAL Year 1 (2011)

Johnston County, North Carolina

EEP Project ID #725

KHA performed wetland monitoring in the fall of 2011 for this Year 1 Monitoring Report with the site visit occurring on November 21<sup>st</sup>, 22<sup>nd</sup>, and 30<sup>th</sup>, 2011. Site monitoring field work included Carolina Vegetation Survey (CVS) level 2 assessment, groundwater well data collection, and visual assessment of the vegetation and wetland restoration components of the project. The following table details the rainfall by month for the site for the 2011 monitoring year.

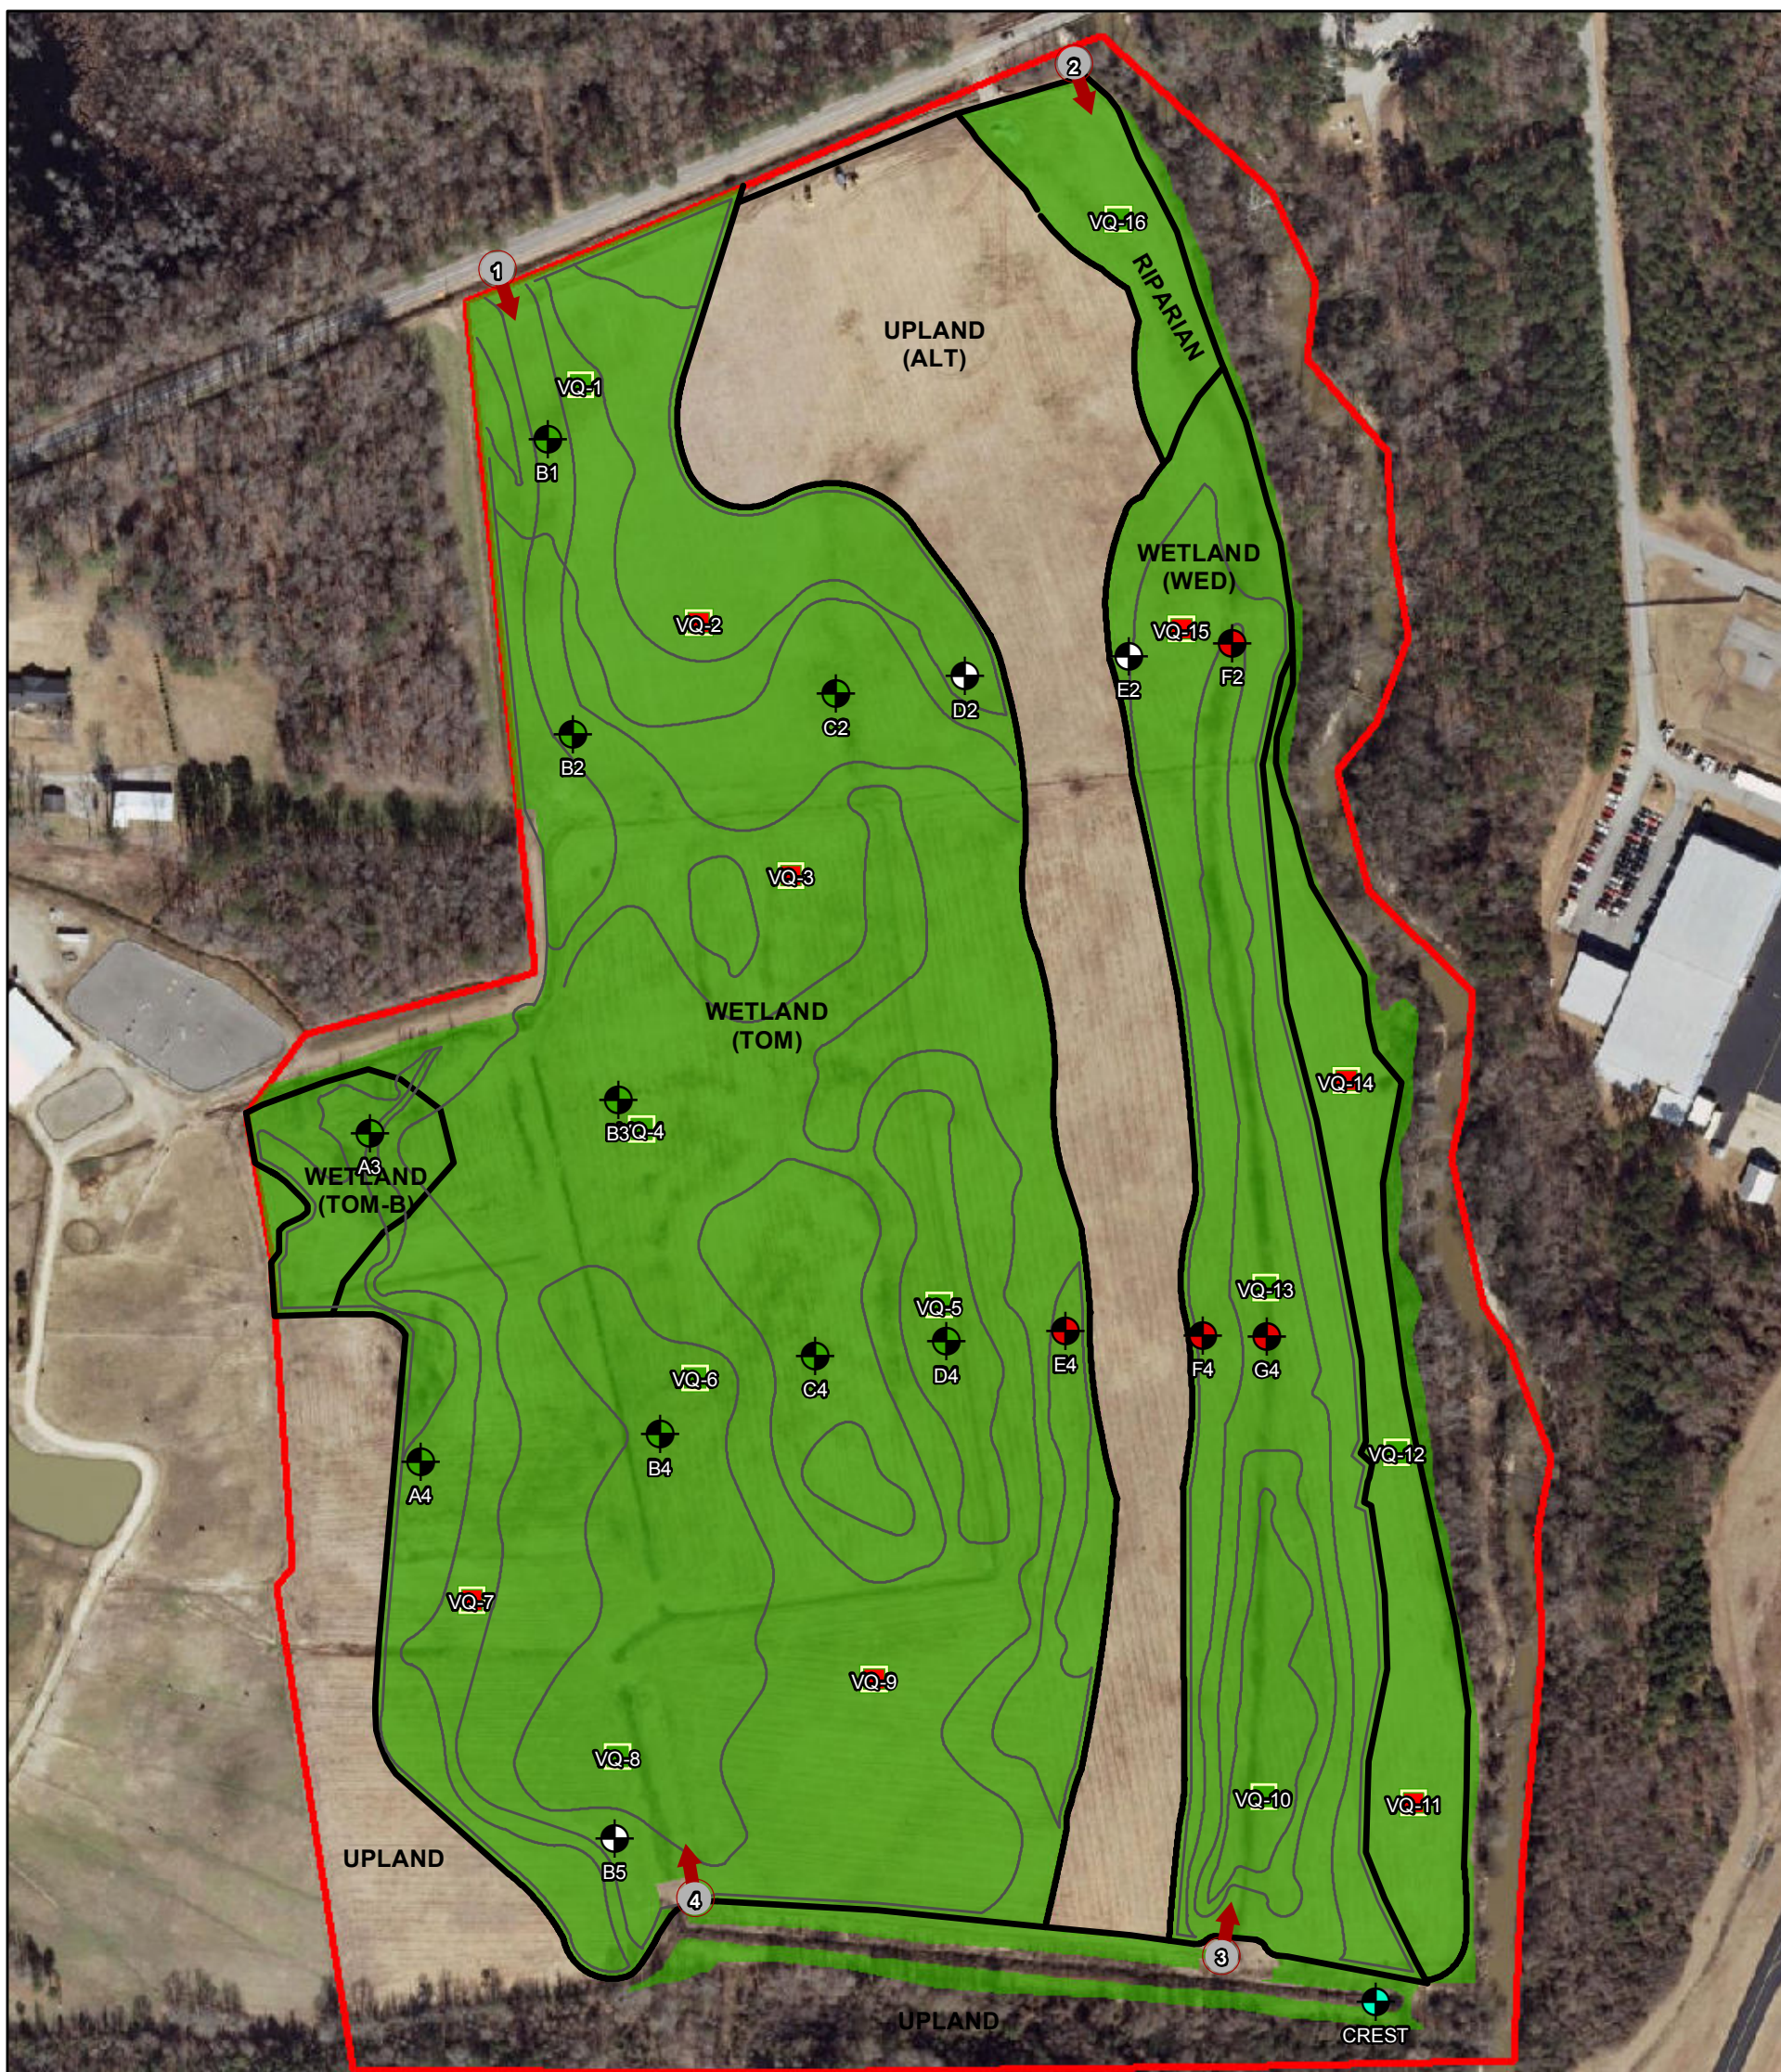
<b>Title</b>	<b>Current Conditions Plan View (2010 Aerial)</b>		
<b>Prepared For:</b>	<b>Project</b>	Moore Property Monitoring (725) 2011 - Year 1 Johnston County, NC	
		<b>Date</b> 01/24/2012	<b>KHA Project Number</b> 011795033

- Cattails (*Typha latifolia*) have begun to establish in the wetland swale, however the size of the invasive population was below the EEP mapping threshold (1,000 square feet) for the Current Conditions Plan View.

- There were no bare areas identified during the site visit that were equal to or greater than the EEP mapping threshold for bare areas (0.1 acres). There were small isolated areas of weak herbaceous growth (Appendix B, Photo SP2). These areas were also below the EEP mapping threshold.

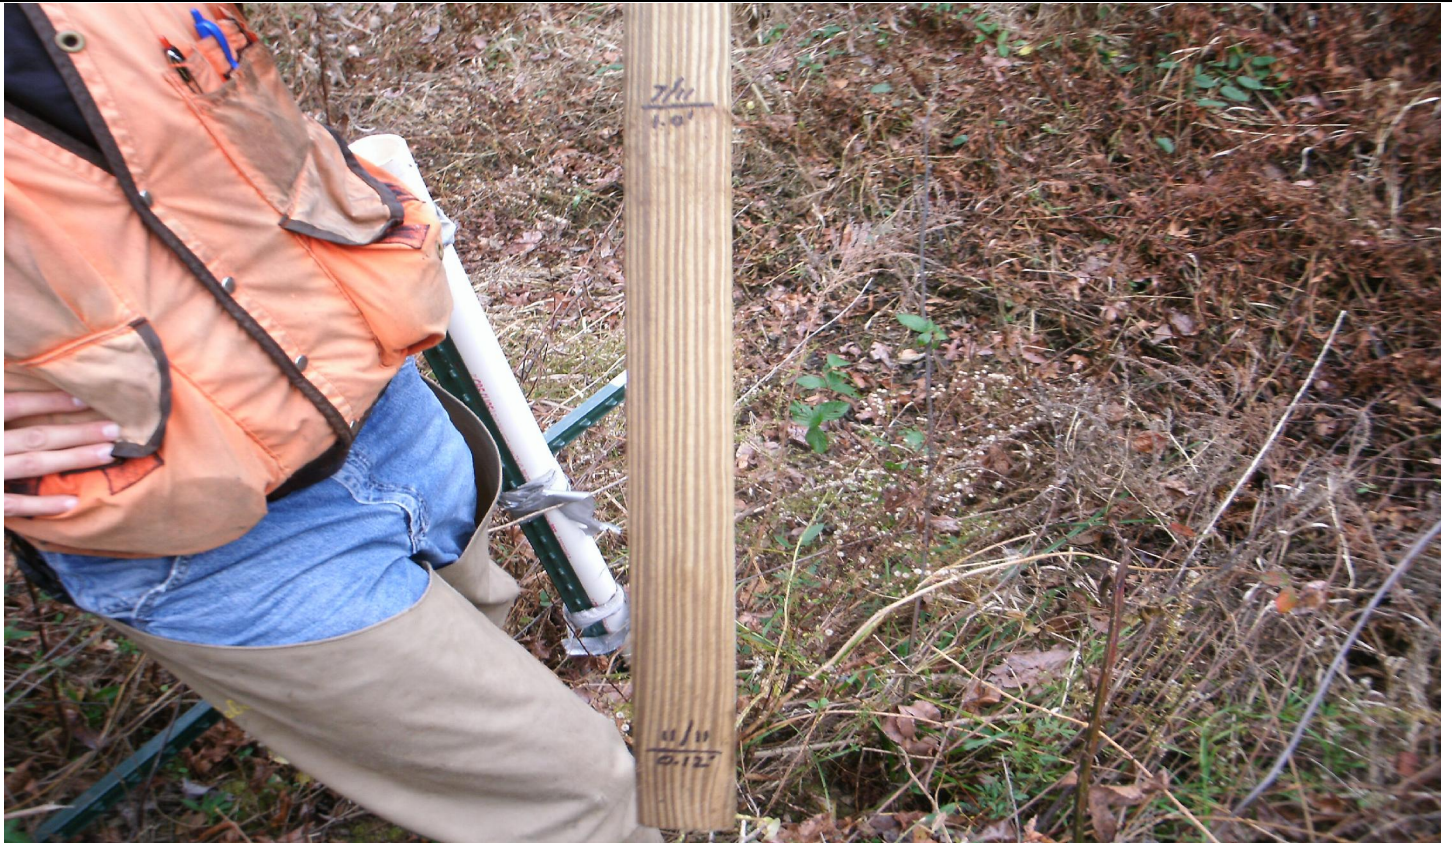
SP1 (2011)

- The crest gauge located in the outlet ditch for the wetland recorded two bankfull events in the monitoring year. It should be noted that the crest gauge was installed so that the bottom of the gauge was at the same elevation as the bankfull indicators located along the outlet ditch. The crest gauge indicating a bankfull event does not necessarily mean that the floodplain and wetland were accessed by floodwaters from Swift Creek.

Bankfull events recorded by crest gauge

Date of Data Collection	Date of Occurrence	Method	Photo # (if available)
7/1/2011	N/A	Crest gauge indicated flow stage 1.0' over bankfull	SP1
11/1/2011	N/A	Crest gauge indicated flow stage 0.12' over bankfull	SP1

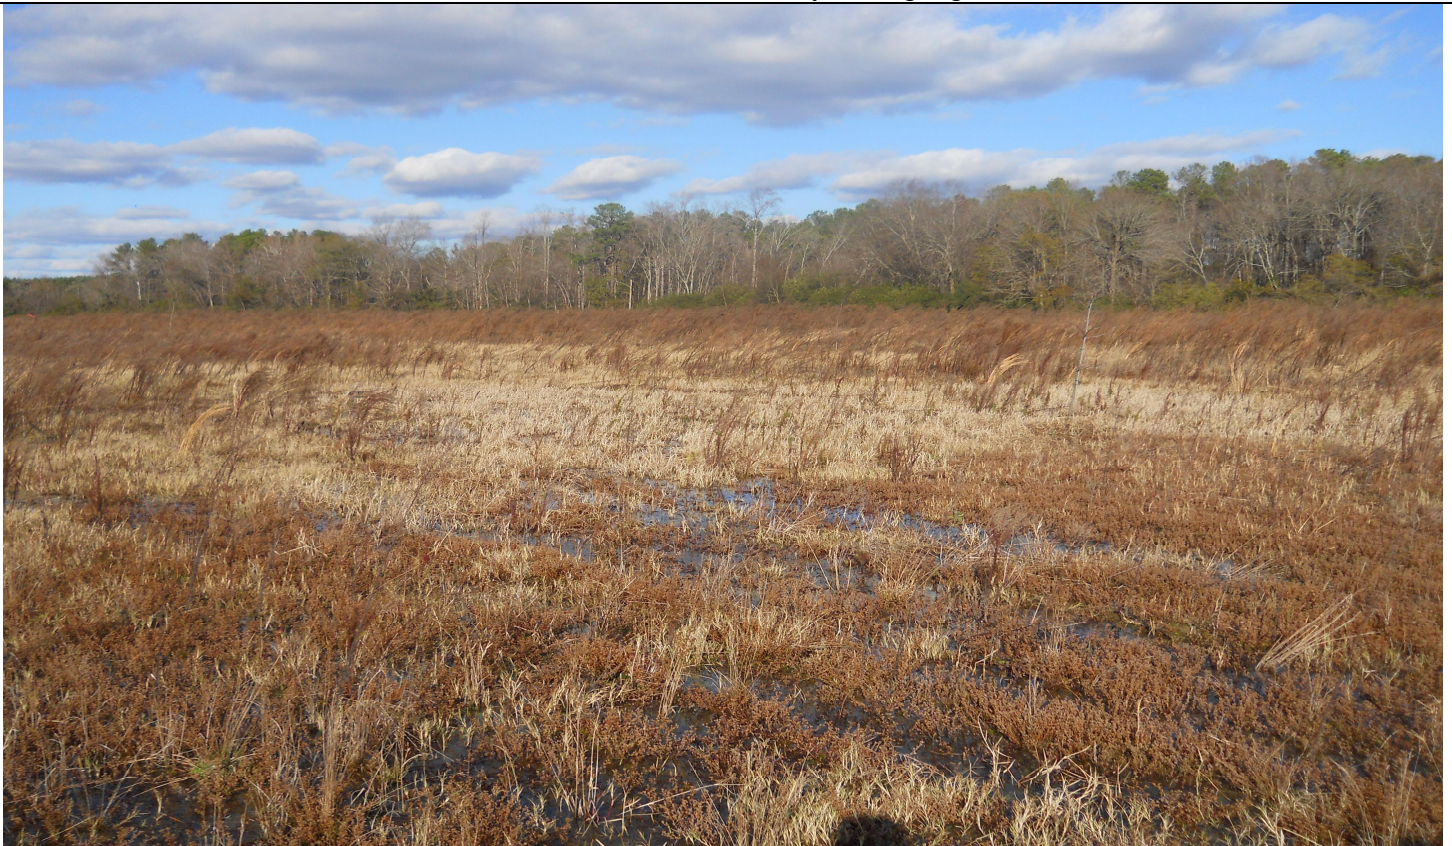
SP2 (2011)

Low herbaceous growth due to inundation

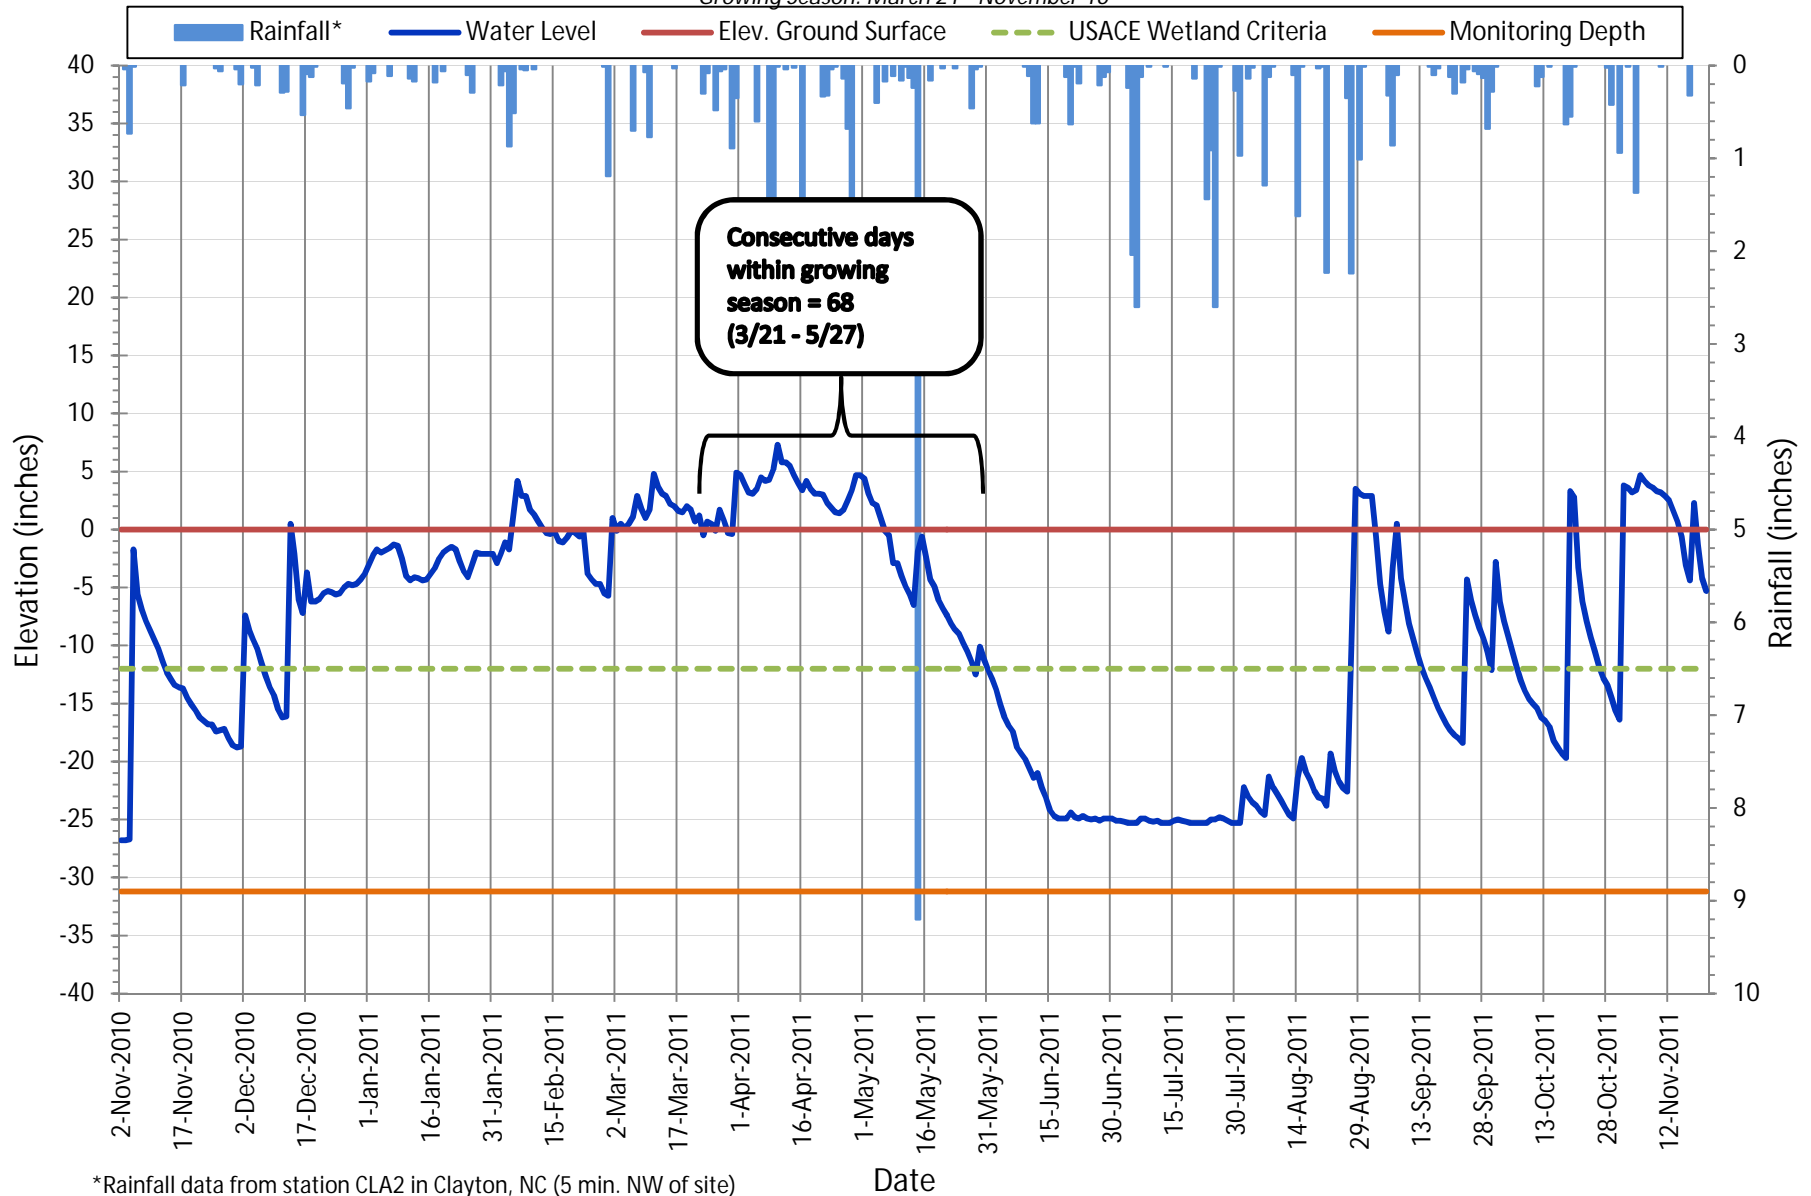
# Shallow Water Table Gauge B1

Ground Elevation*	MY1 - 2011	MY2 - 2012	MY3 - 2013	MY4 - 2014	MY5 - 2015	Notes
Percentage of monitoring gauges with criteria met	---	56.25%					
<b>Groundwater Gauge B1</b>							
Consecutive days within range <sup>1</sup>	124.1'	68					
% of growing season <sup>2</sup>		28.22%					
Criteria met <sup>3</sup> ?		Y					
<b>Groundwater Gauge B2</b>							
Consecutive days within range	124.0'	50					
% of growing season		20.75%					
Criteria met?		Y					
<b>Groundwater Gauge C2</b>							
Consecutive days within range	124.5'	47					No data from 7/6/2011 - 11/30/2011 (dead batteries). Replaced unit on 11/30/2011.
% of growing season		19.50%					
Criteria met?		Y					
<b>Groundwater Gauge D2</b>							
Consecutive days within range	125.7'	0					To be replaced - data does not reflect field observations, possible gauge malfunction.
% of growing season		0.00%					
Criteria met?		N/A					
<b>Groundwater Gauge E2</b>

November 2, 2010 - November 21, 2011

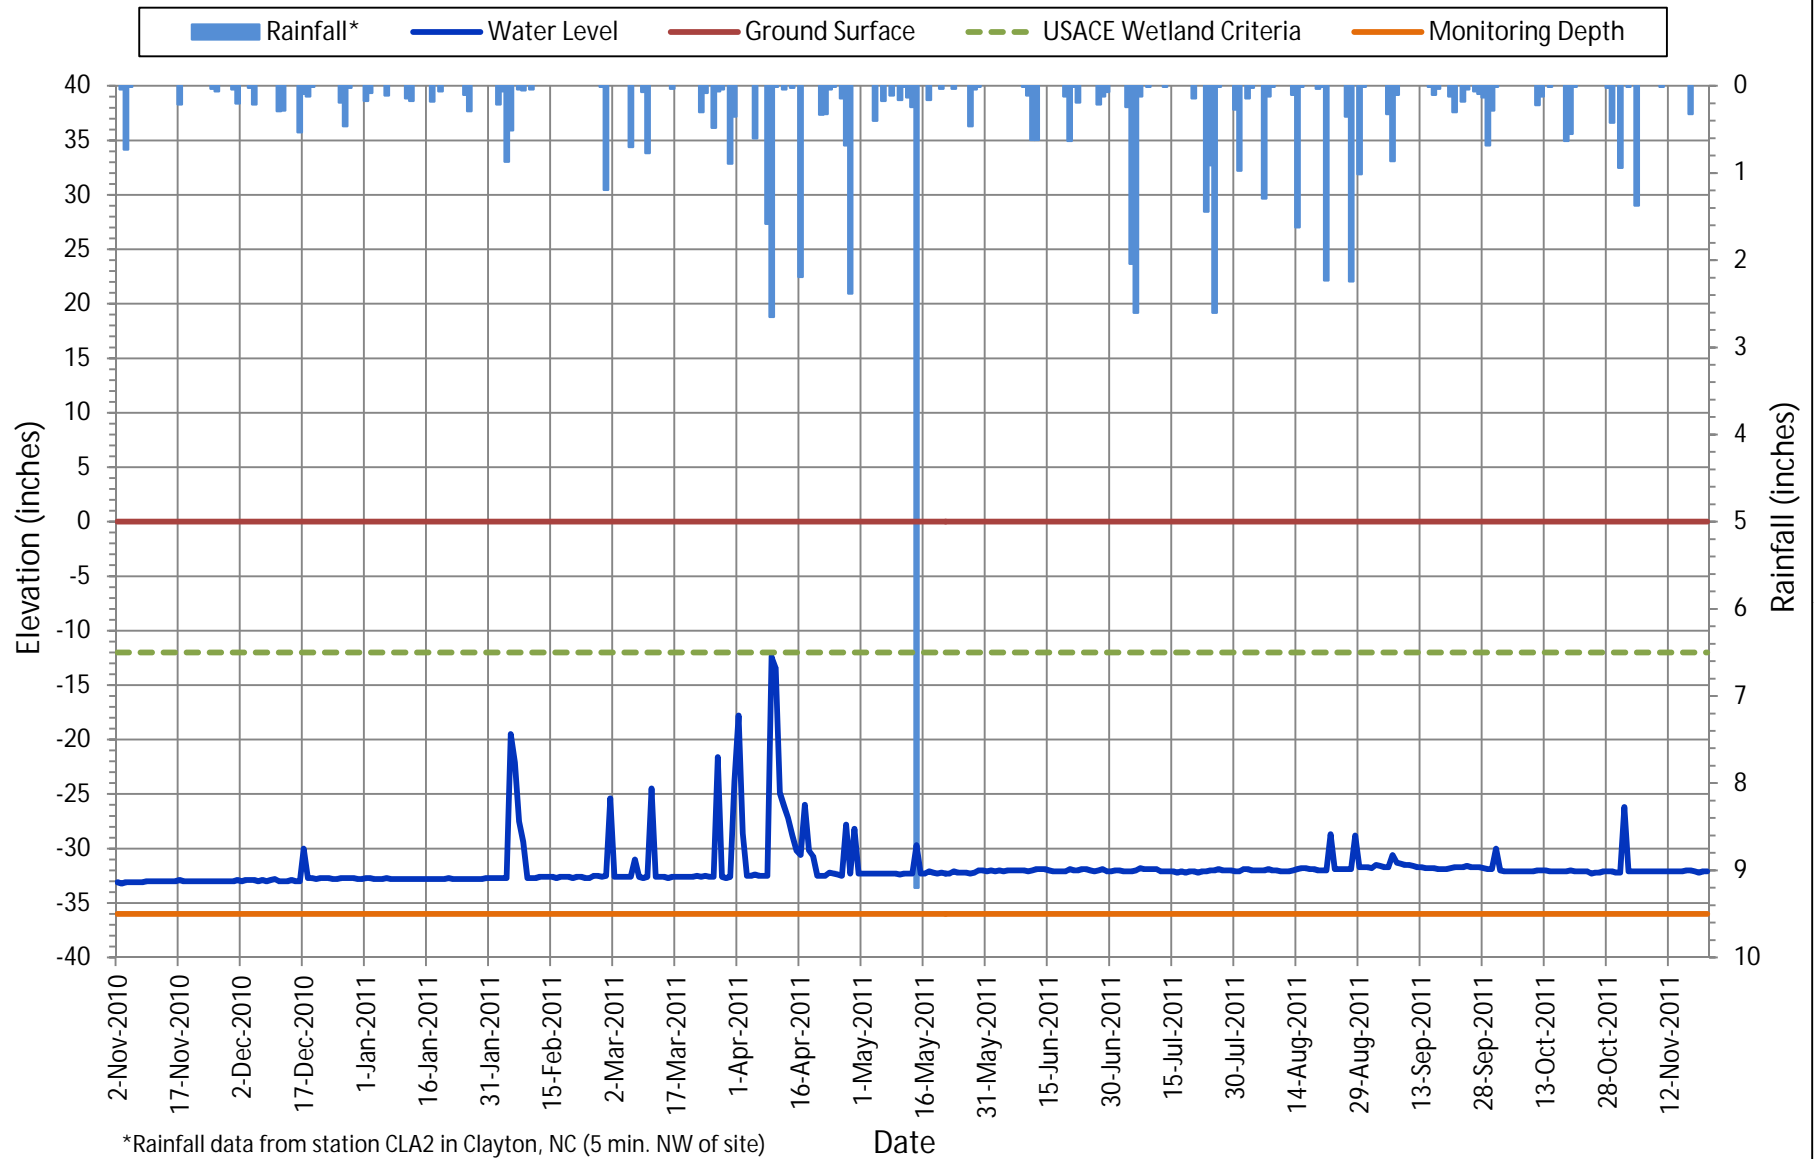
## Shallow Water Table Gauge E2

Consecutive days within range	124.8'	0					To be replaced - data does not reflect field observations, possible gauge malfunction.
% of growing season		0.00%					
Criteria met?		N/A					
<b>Groundwater Gauge F2</b>							
Consecutive days within range	124.2'	4					
% of growing season		1.66%					
Criteria met?		N					
<b>Groundwater Gauge A3</b>							
Consecutive days within range	123.8'	103					
% of growing season		42.74%					
Criteria met?		Y					
<b>Groundwater Gauge B3</b>							
Consecutive days within range	123.7'	45					
% of growing season		18.67%					
Criteria met?		Y					
<b>Groundwater Gauge A4</b>							
Consecutive days within range	124.6'	20					
% of growing season		8.30%					
Criteria met?		N					
<b>Groundwater Gauge B4</b>							
Consecutive days within range	123.0'	75					
% of growing season		31.12%					
Criteria met?		Y					
<b>Groundwater Gauge C4</b>							
Consecutive days within range	124.3'	20

November 2, 2010 - November 21, 2011  
Growing Season: March 21 - November 16

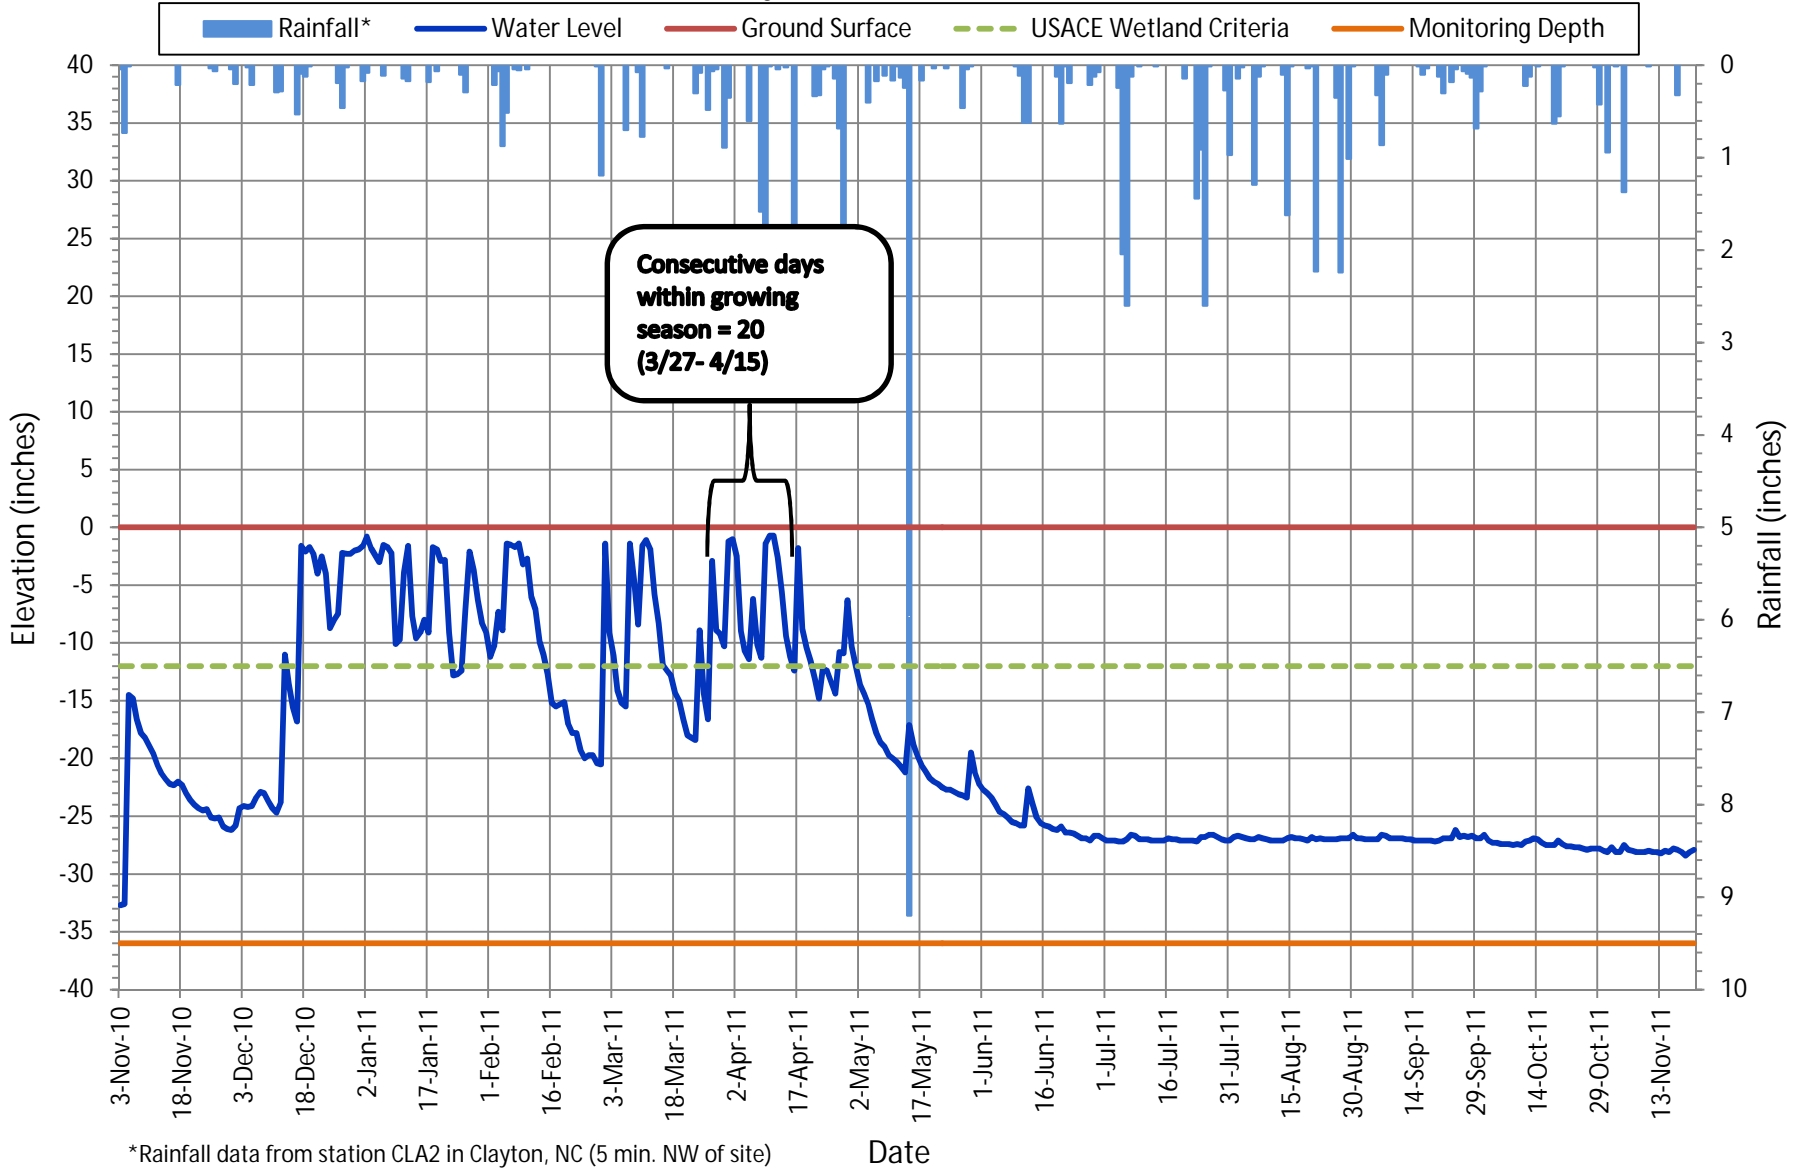
# Shallow Water Table Gauge C4

% of growing season		8.30%					
Criteria met?		N					
<b>Groundwater Gauge D4</b>							
Consecutive days within range	123.3'	75					
% of growing season		31.12%					
Criteria met?		Y					
<b>Groundwater Gauge E4</b>							
Consecutive days within range	124.8'	4					
% of growing season		1.66%					
Criteria met?		N					
<b>Groundwater Gauge F4</b>							
Consecutive days within range	124.8'	4					
% of growing season		1.66%					
Criteria met?		N					
<b>Groundwater Gauge G4</b>							
Consecutive days within range	123.5'	11					
% of growing season		4.56%					
Criteria met?		N					
<b>Groundwater Gauge B5</b>							
Consecutive days within range	123.4'	6					No data from 2/8/2011 - 8/22/2011 (configuration error). Re-configured unit on 8/22/2011
% of growing season		2.49%					
Criteria met?		N/A

November 3, 2010 - November 21, 2011  
Growing Season: March 21 - November 16

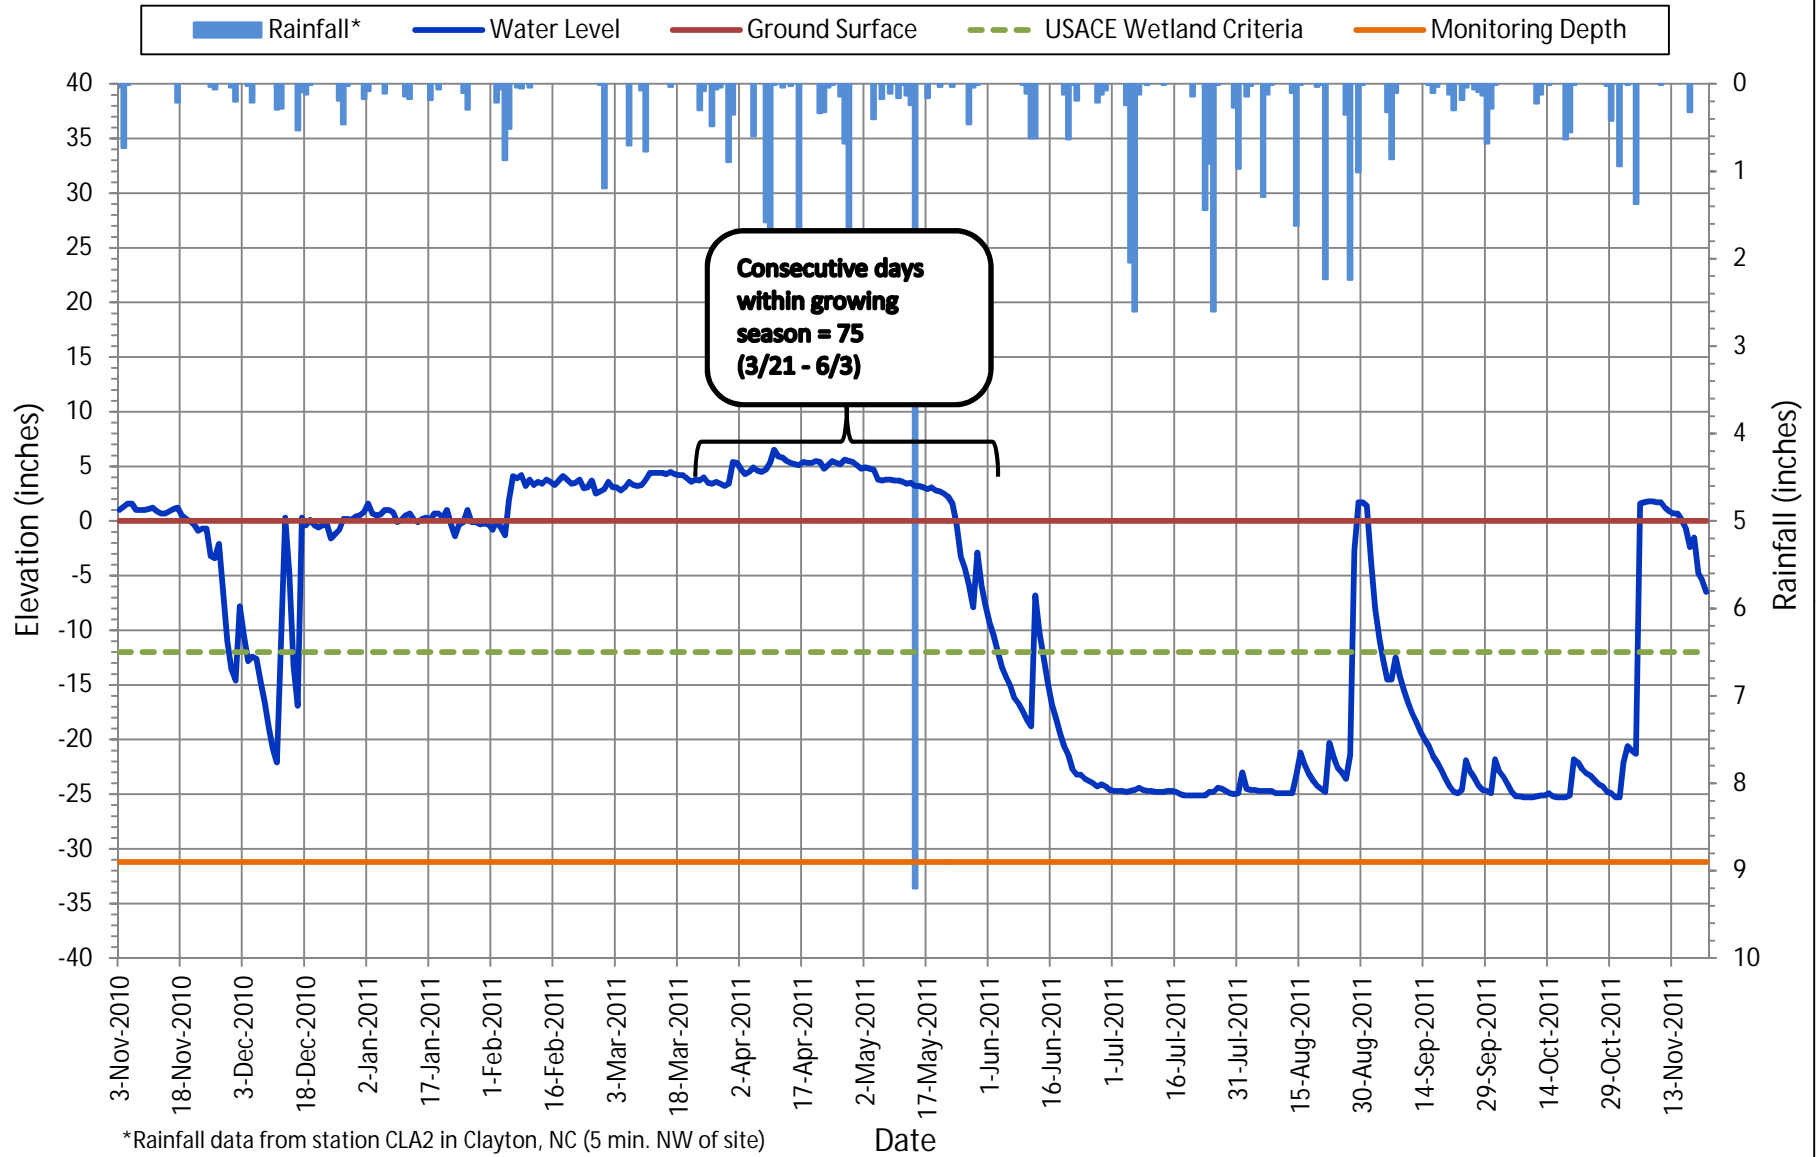
# Shallow Water Table Gauge D4

November 3, 2010 - November 21, 2011  
Growing Season: March 21 - November 16

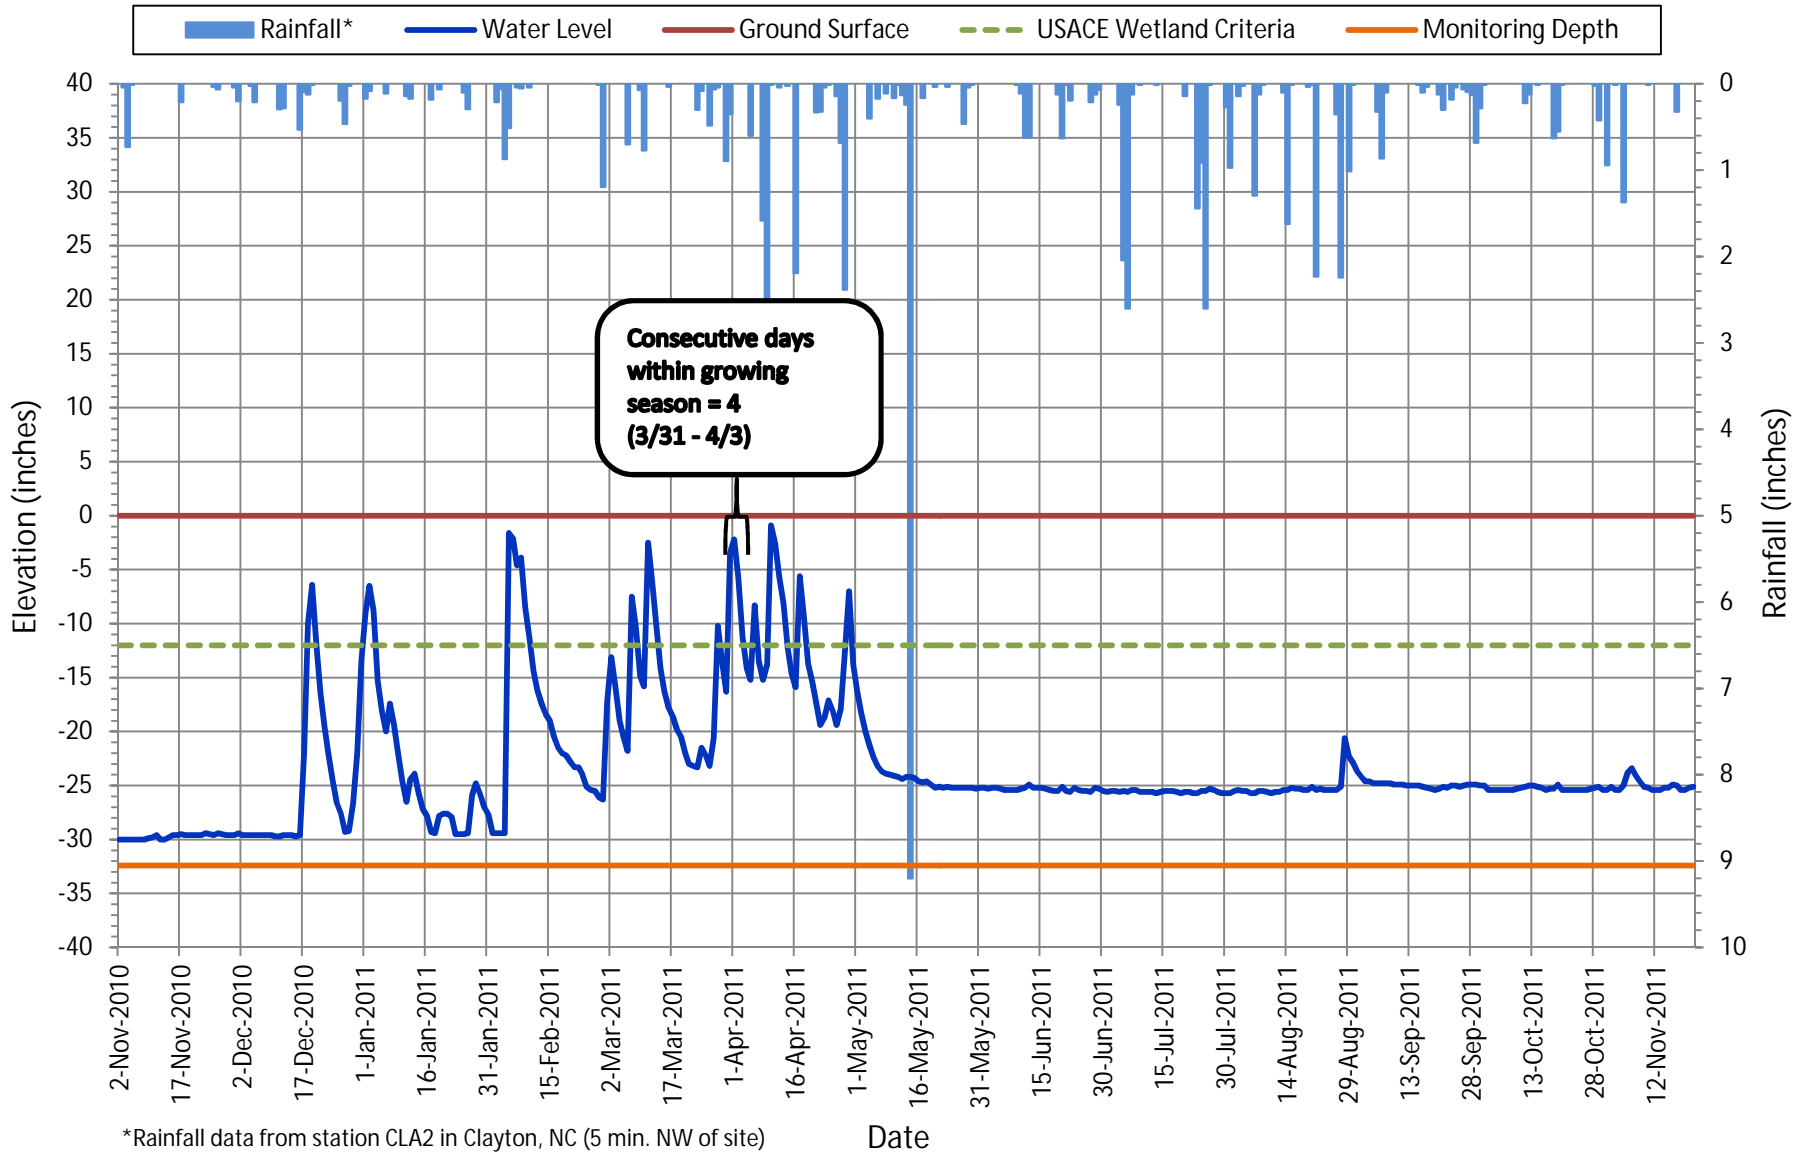
# Shallow Water Table Gauge E4

November 2, 2010 - November 21, 2011  
 Growing Season: March 21 - November 16

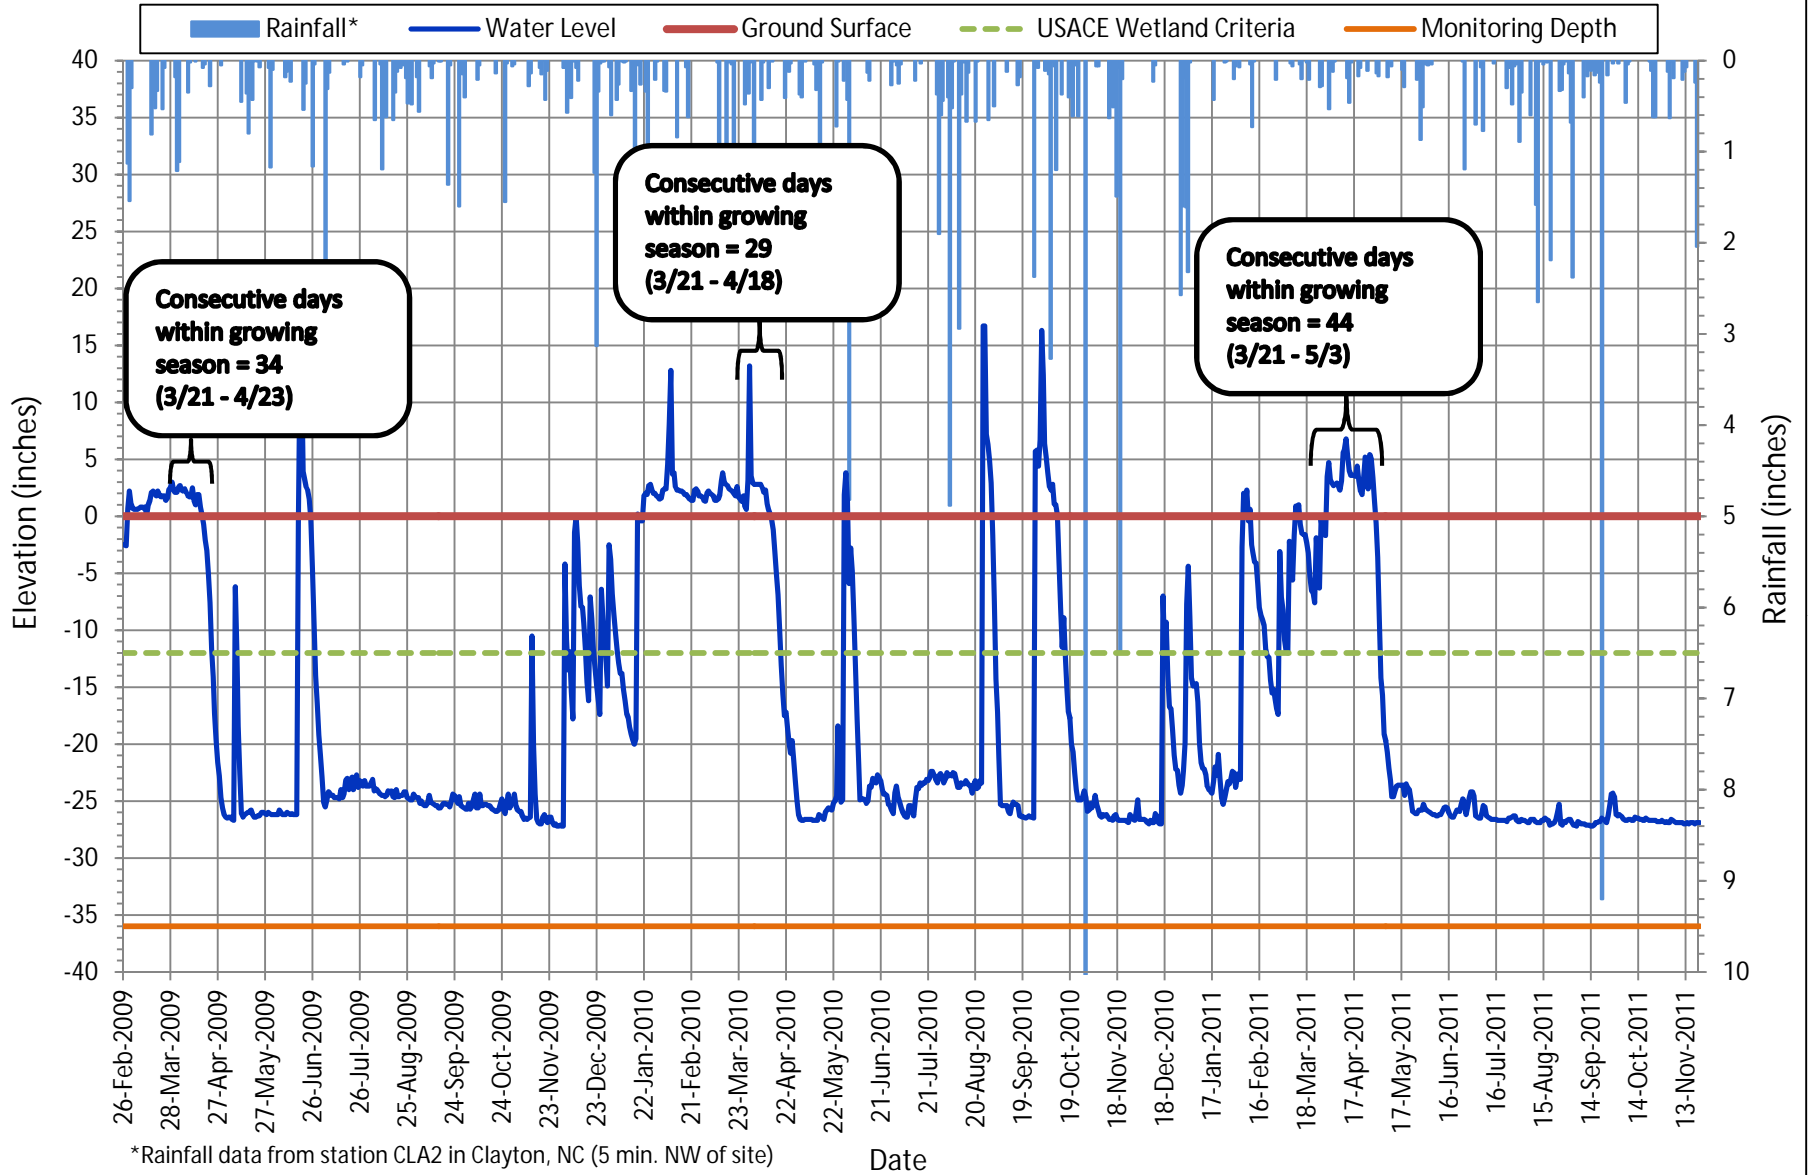
## Shallow Water Table Gauge REF-B February 26, 2009 - November 22, 2011 Growing Season: March 21 - November 16

Ground Elevation*	2009	2010	MY1 - 2011	MY2 - 2012	MY3 - 2013	MY4 - 2014	MY5 - 2015	Notes
<b>Groundwater Gauge REF-B</b>									
Consecutive days within range	124'	34	29	44					
% of growing season		14.11%	12.03%	18.26%					
Criteria met?		Y	Y	Y					
<b>Groundwater Gauge REF-C</b>									
Consecutive days within range	124'	35	30	45					
% of growing season		14.52%	12.45%	18.67%					
Criteria met?		Y	Y	Y					
<b>Groundwater Gauge REF-D</b>									
Consecutive days within range	124'	43	--	--					No data from 9/2/2009 - 8/18/2011 (dead batteries). Replaced unit on 8/18/2011.
% of growing season		17.84%	--	--					
Criteria met?		Y	--	--					
<b>Groundwater Gauge REF-E</b>									
Consecutive days within range	123'	33	--	--					No data from 9/2/2009 - 8/18/2011 (dead batteries). Replaced unit on 8/18/2011.
% of growing season		13.69%	--	--					
Criteria met?		Y	--	--					
<b>Groundwater Gauge REF-F</b>

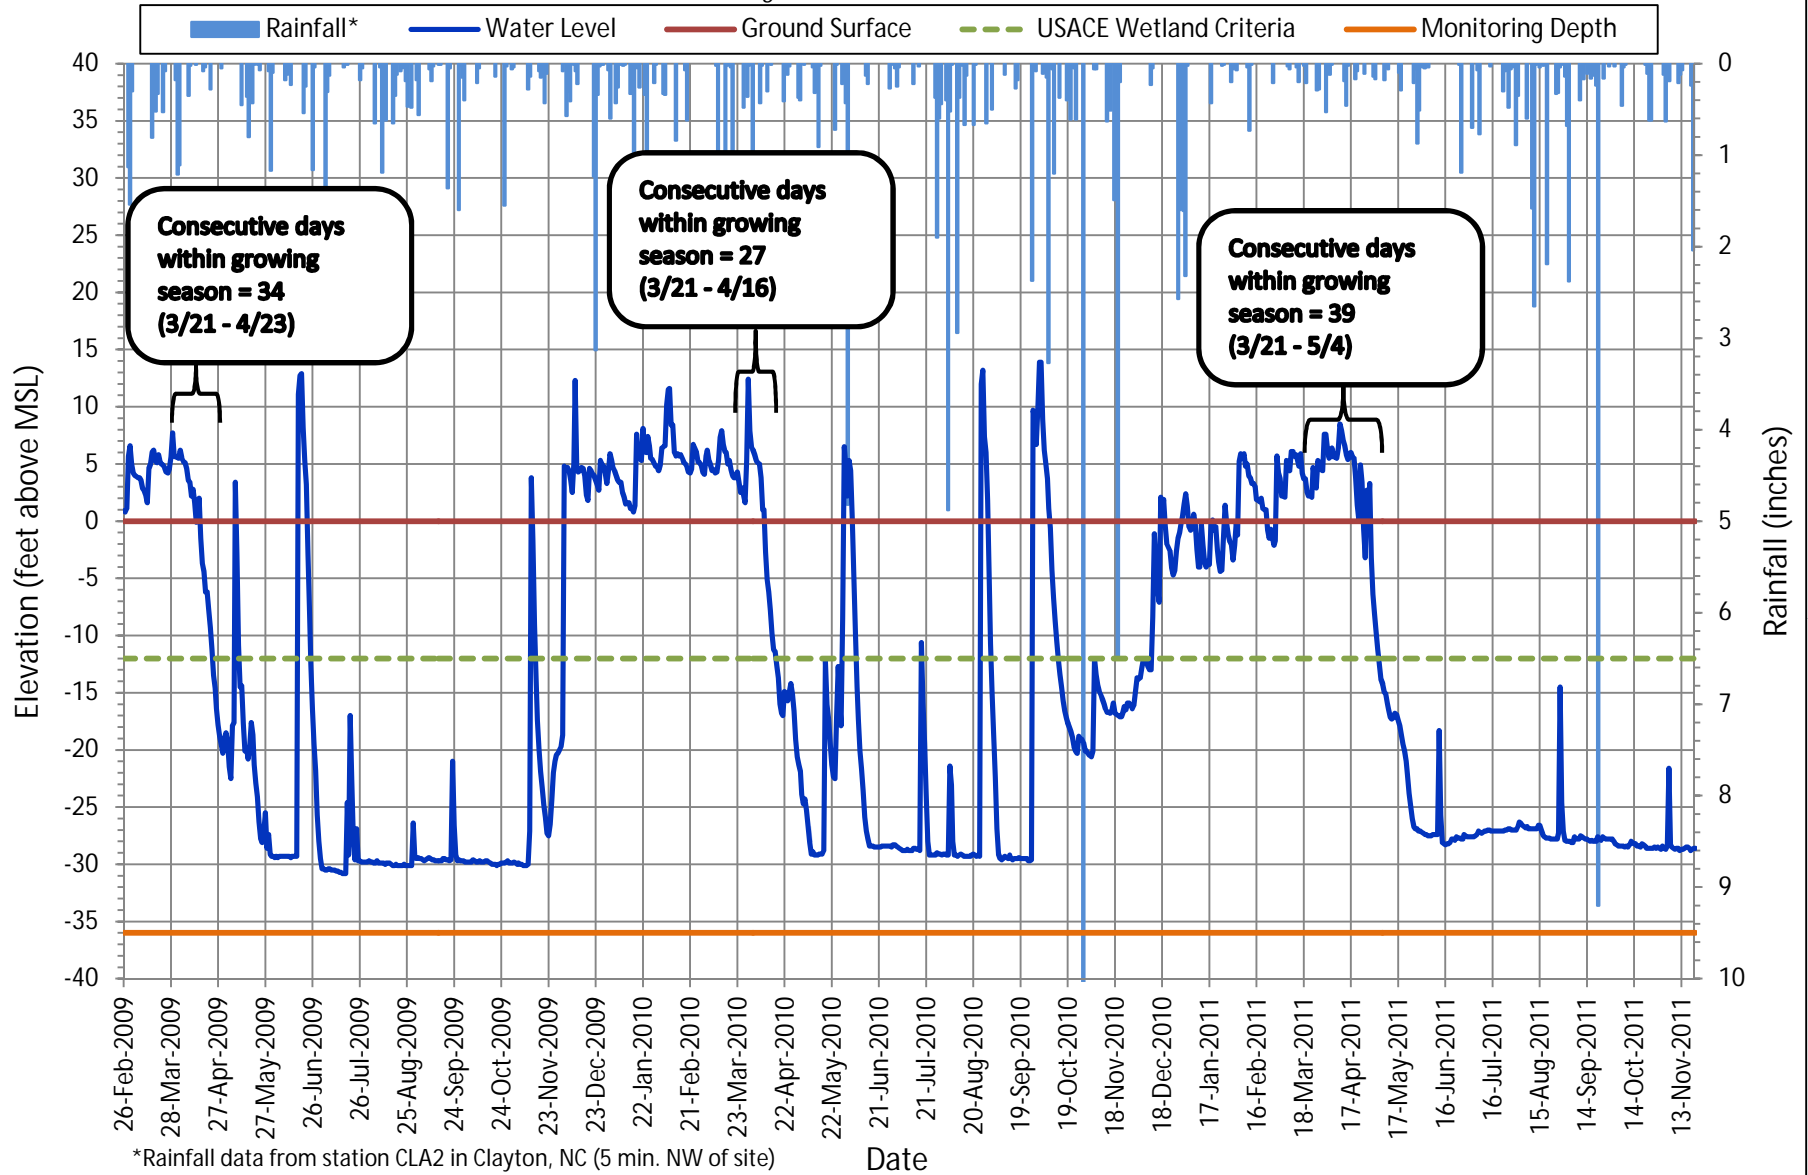
# Shallow Water Table Gauge REF-F

Consecutive days within range	123'	34	27	39					
% of growing season		14.11%	11.20%	16.18%					
Criteria met?		Y	Y	Y					
<b>Average reference hydroperiod</b>	---	<b>36</b>	<b>29</b>	<b>43</b>					
<b>Consecutive number of days needed to meet the 50% deviation success criteria</b>	---	<b>18</b>	<b>15</b>	<b>22</b>

February 26, 2009 - November 22, 2011  
Growing Season: March 21 - November 16
