# Moore Property Monitoring Report FINAL Year 3 (2013)

Johnston County, North Carolina

EEP Project ID #725

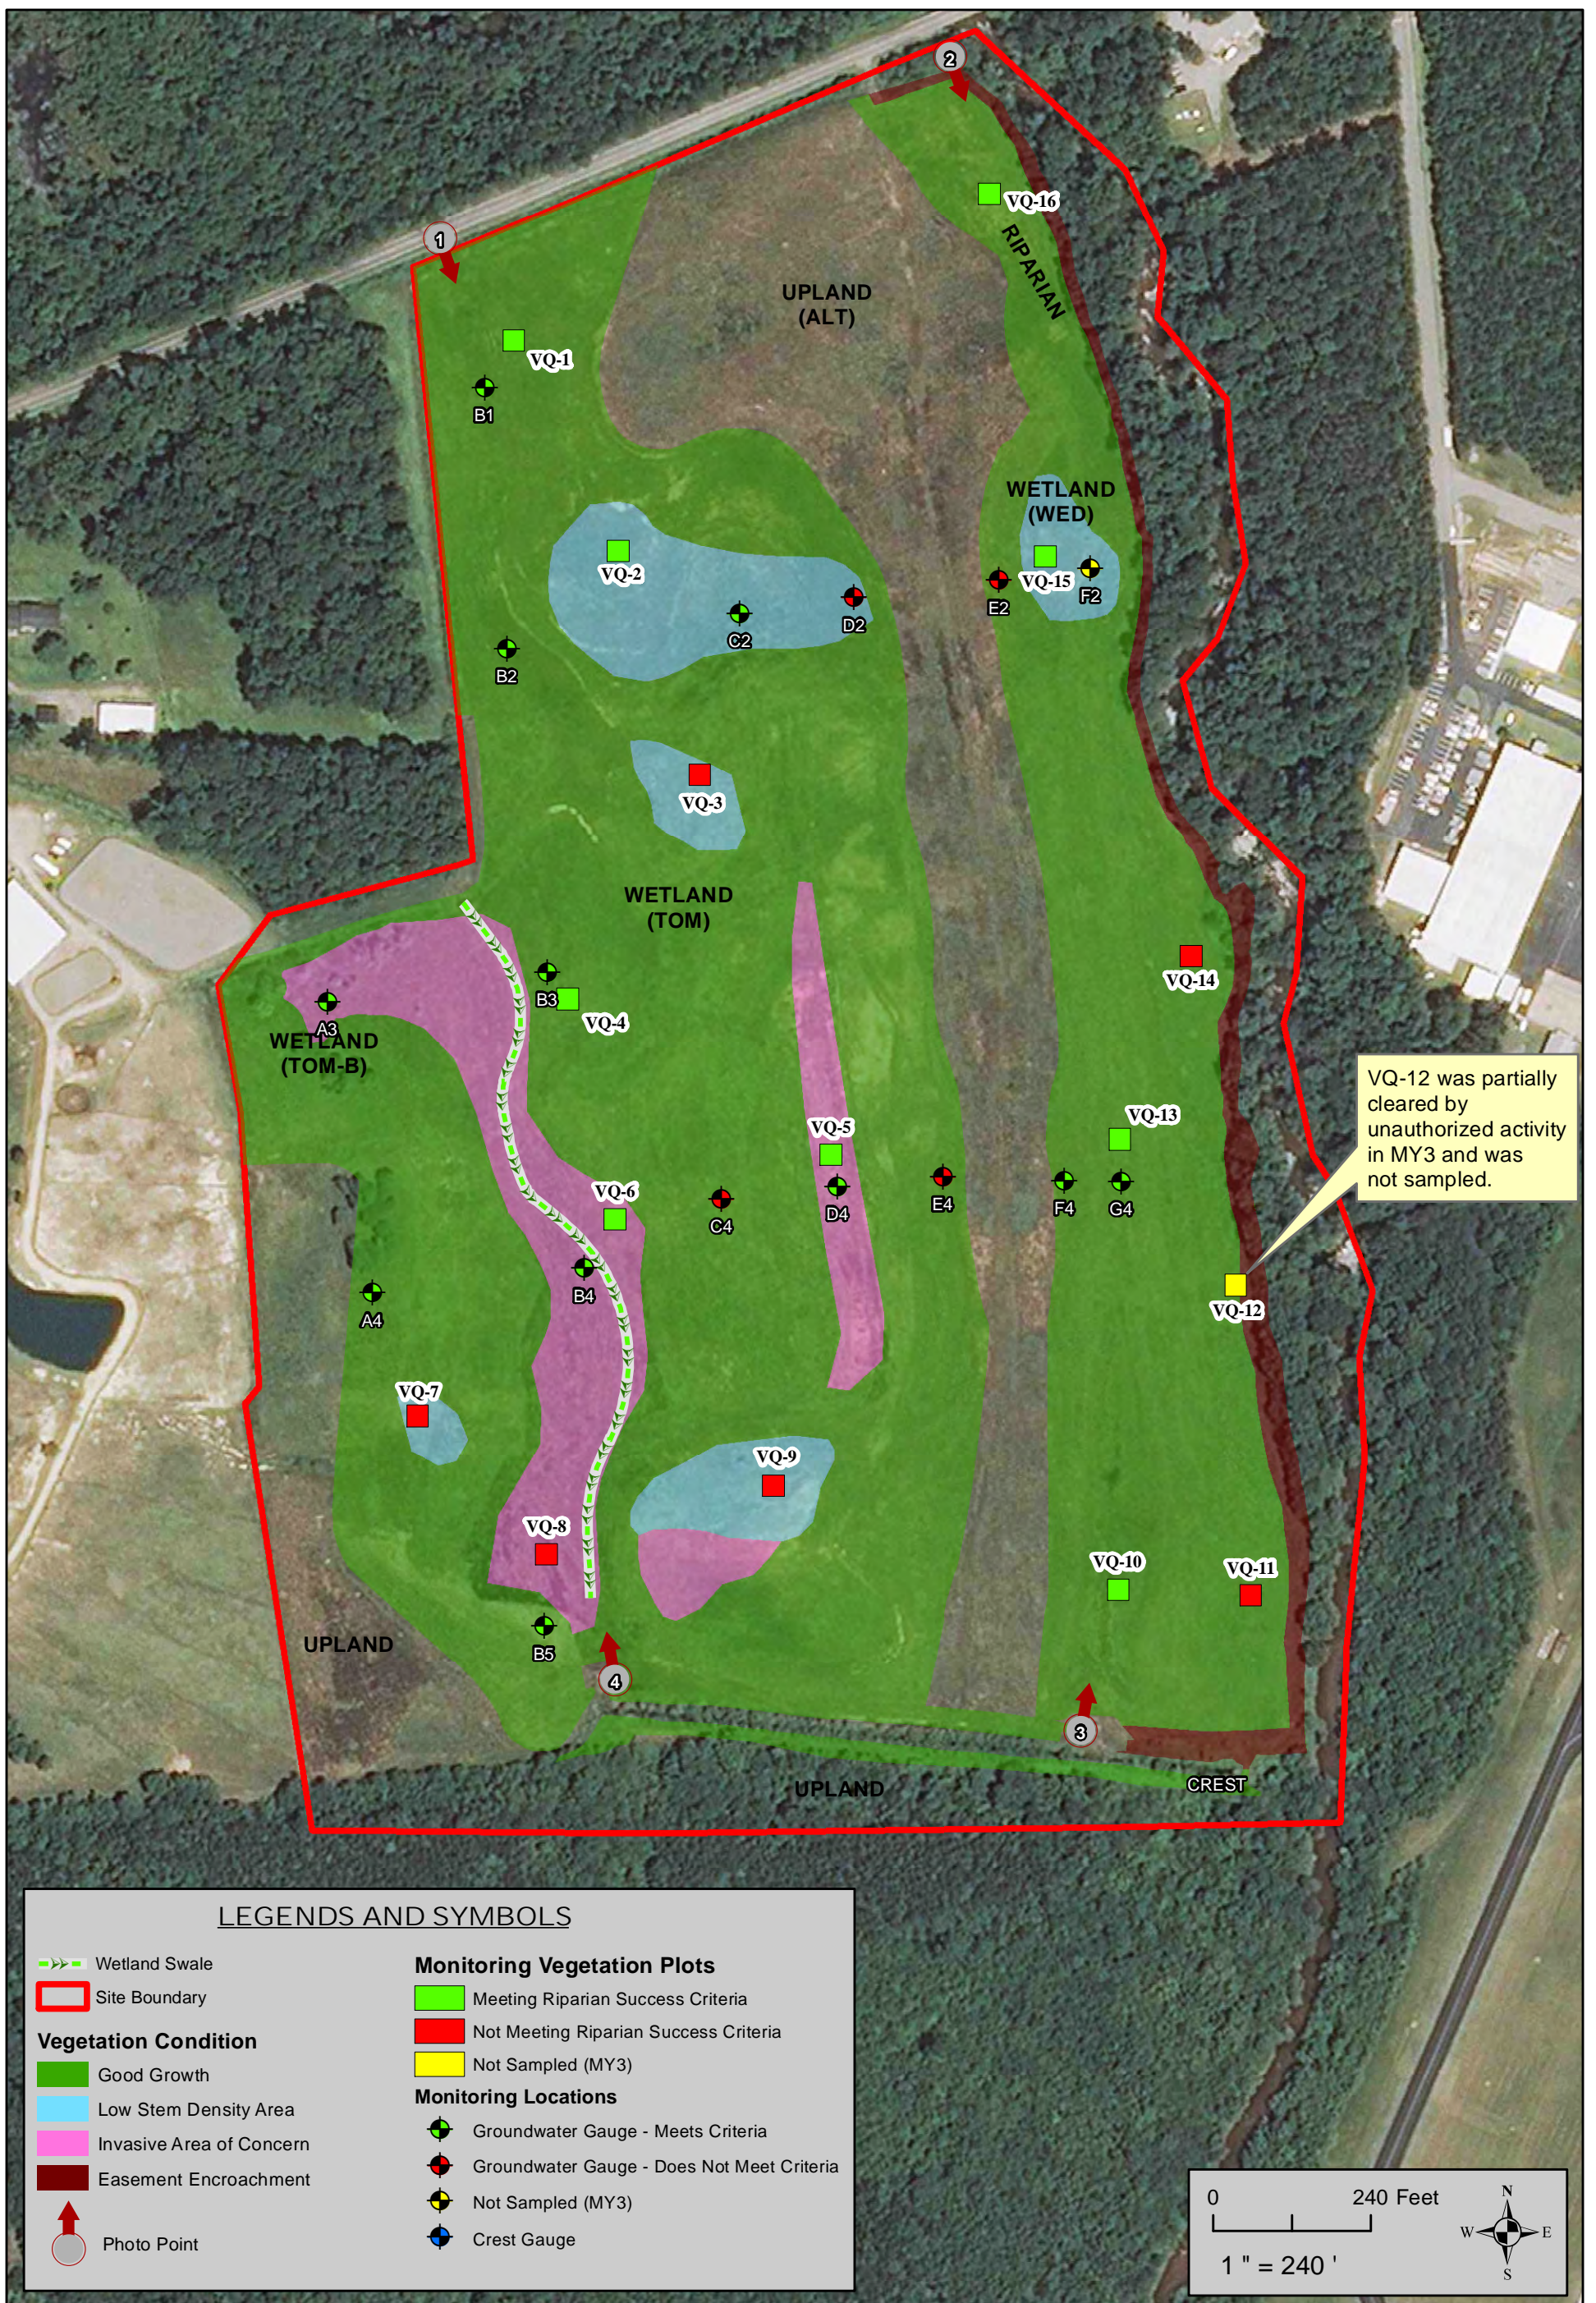
<b>Title</b>	<b>Current Conditions Plan View (2012 NAIP Aerial)</b>		
<b>Prepared For:</b>	<b>Project</b>	Moore Property Monitoring (725) 2013 - Year 3 Johnston County, NC

- As shown on the Current Conditions Plan View, cattails (*Typha latifolia*) have continued to establish in the vicinity of the wetland seep, the constructed wetland swale, and in the historic agricultural ditch location. Since MY2, the cattail populations have begun to merge into one large population.

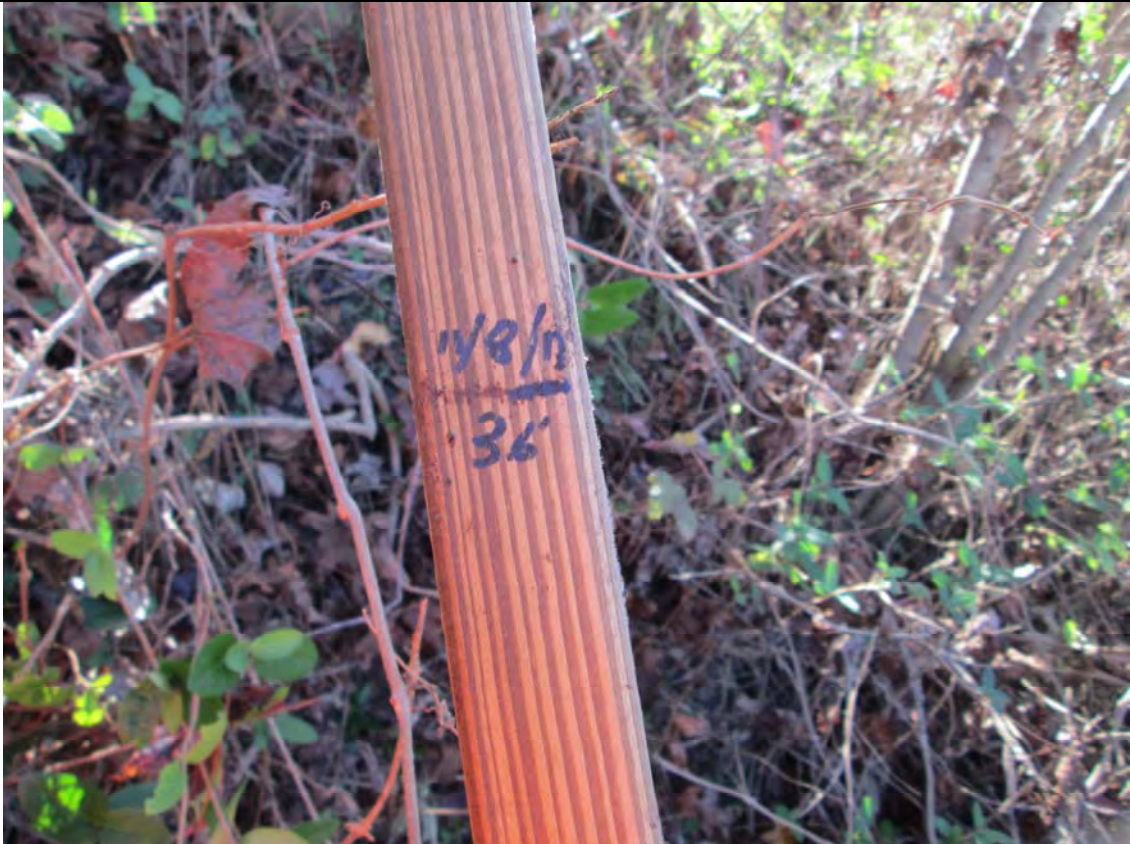
WP1 (November 8, 2013)

- The crest gauge located in the outlet ditch for the wetland recorded at least two bankfull events in Swift Creek in the monitoring year (Appendix B, Photo WP1). It should be noted that the crest gauge was installed so that the bottom of the gauge was at the same elevation as the bankfull indicators located along the outlet ditch. The bankfull event occurring in June overtopped the crest gauge as evidenced by sediment staining on the banks (Appendix B, Photo WP2), so the exact height of the crest is not known.

Bankfull event recorded by crest gauge in wetland outlet ditch on November 8, 2013.

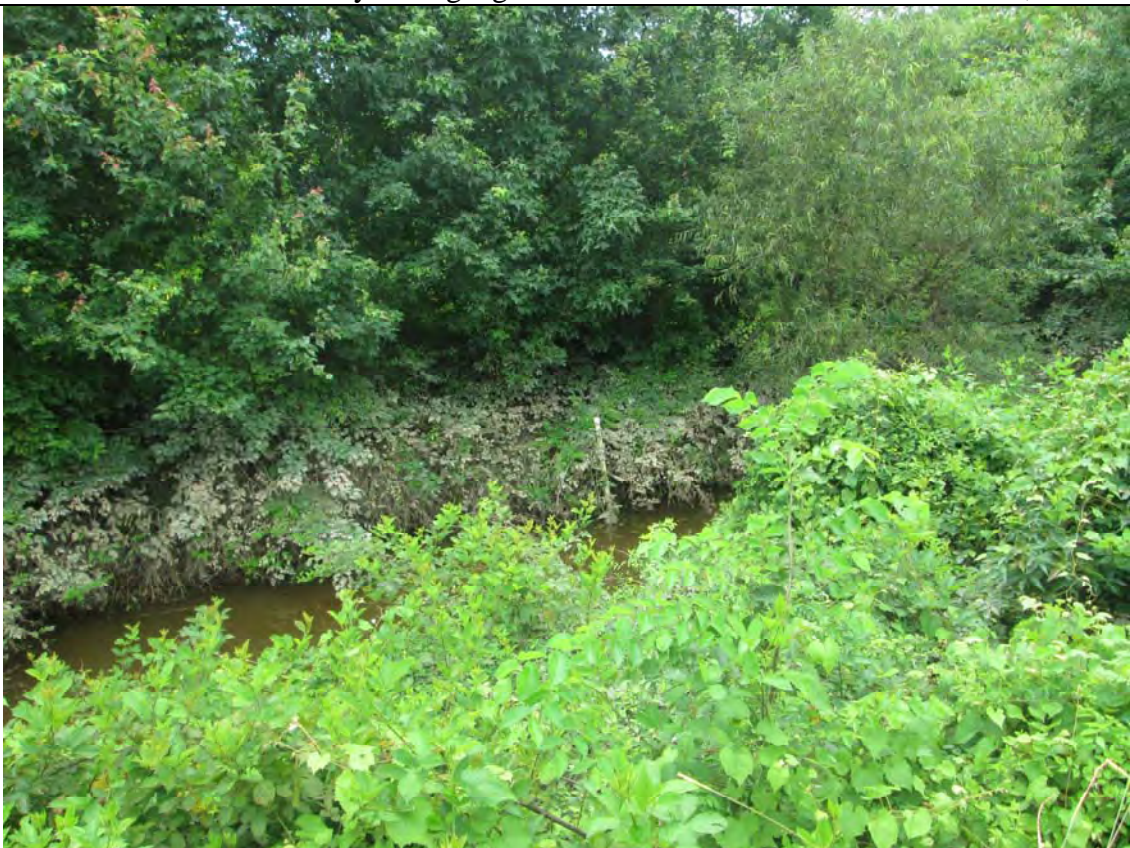
WP2 (July 31, 2013)

Sediment deposits indicating bankfull event surpassing the height of the crest gauge.

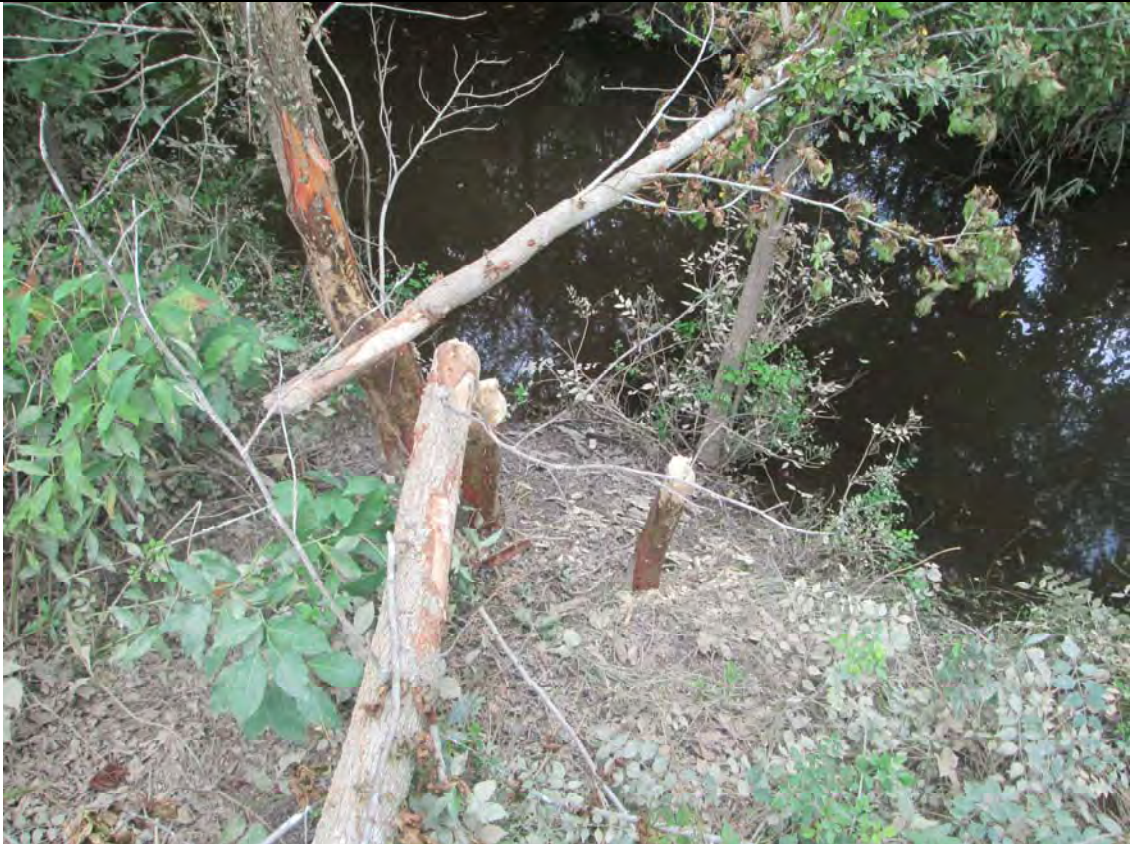
WP3 (July 31, 2013)

- Significant beaver activity was observed both within the site and the adjacent area of the outlet ditch at the southern end of the site. The primary culvert outlet from the site was completely impounded by a beaver dam, holding water within the ditch. This may have contributed to the high crest gauge reading previously discussed (Appendix B, Photos WP3 and WP4).

Beaver activity observed within site around the outlet ditch to Swift Creek.

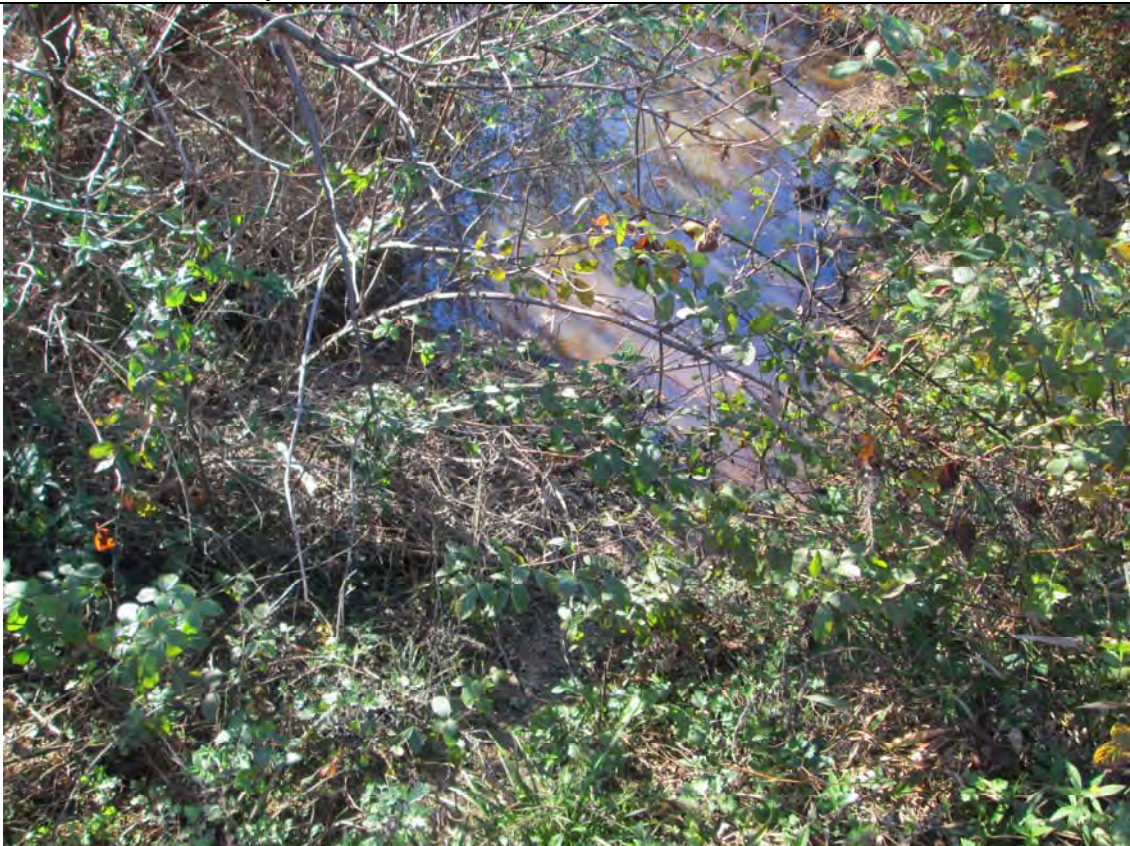
WP4 (November 8, 2013)

Beaver impoundment constructed around site outlet connection near Swift Creek.

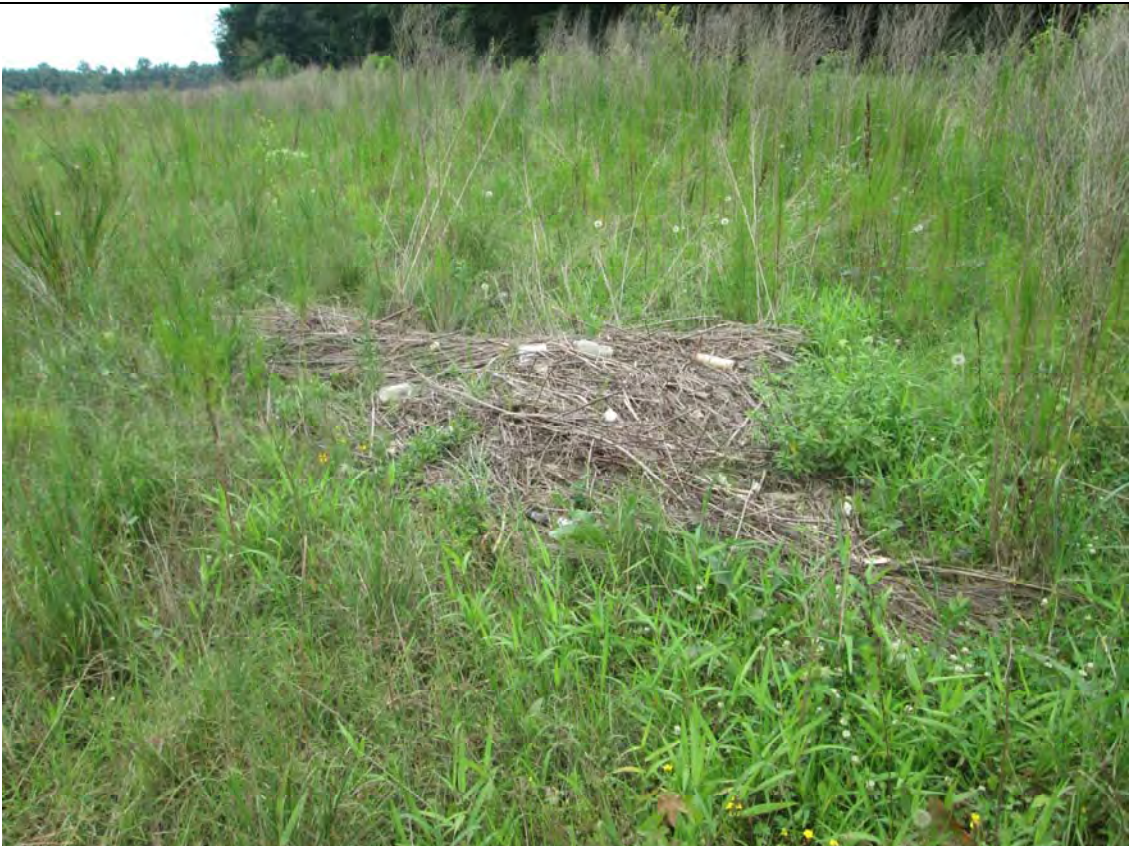
- While 2013 received above average rainfall (57” recorded against an annual average of 46”), the site did not experience any overbank floodwaters from Swift Creek this monitoring year. A significant tropical storm event in June, followed by higher than normal rainfall in July (286% of normal), provided multiple high flow events within Swift Creek which likely provided some flow from both the adjacent roadside ditch, and the outfall ditch as (Appendix B, Photo WP6).

WP6 (July 31, 2013)  
Drift deposits observed throughout the drainage swale flowing into the site near Swift Creek Road.

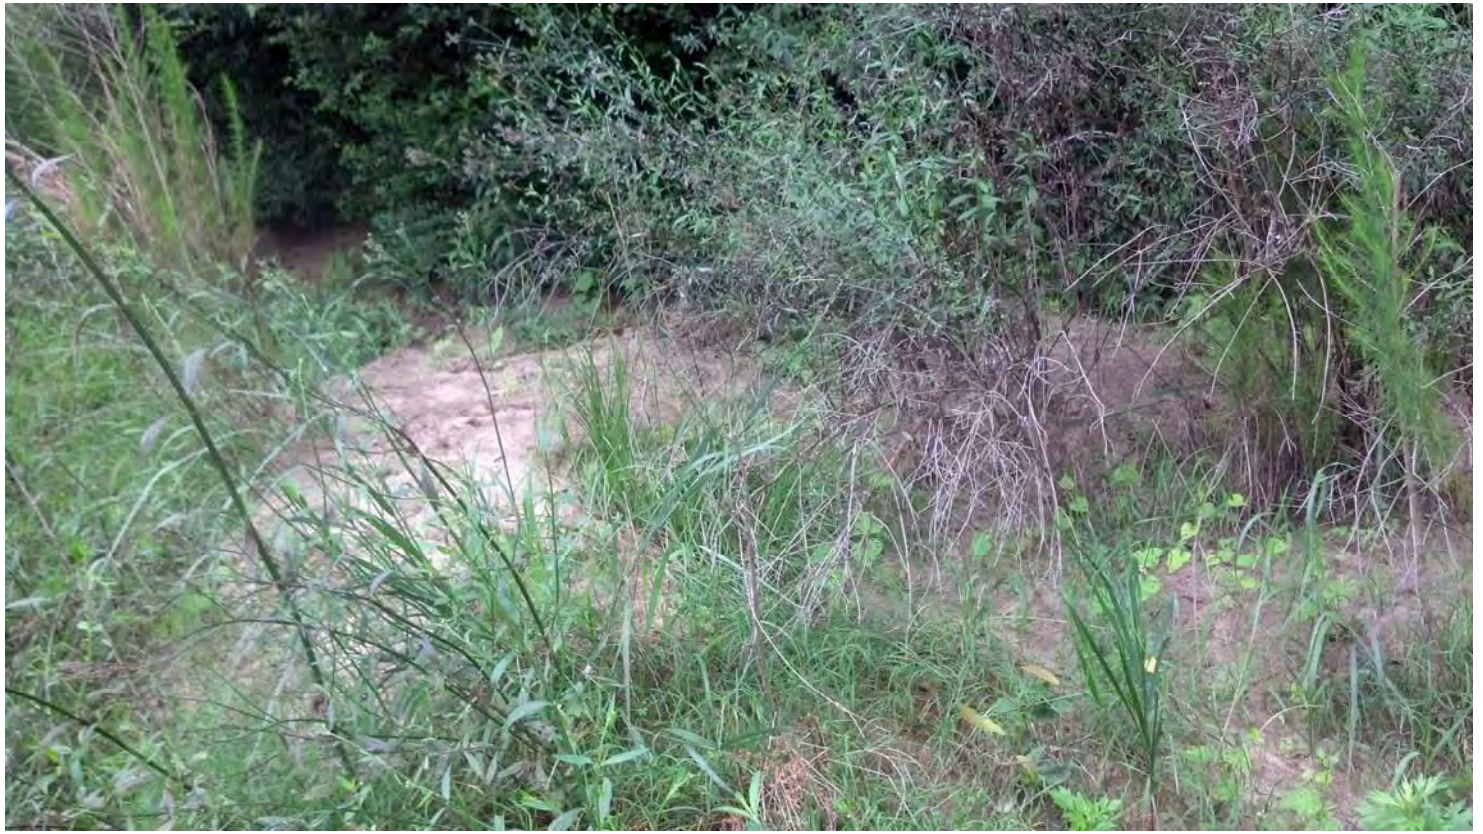
WP7 (July 10, 2013)

- During a site visit conducted on July 10, 2013, NC EEP staff observed a breach in the sand berm adjacent to Swift Creek (WP7 and WP8). Sand was deposited within the site

indicating overwash from Swift Creek, likely a result of the high-flow event recorded by the USGS gauge on June 7, 2013. Subsequent site visits were not able to locate similar breaches in this area, indicating no further overbank flow into the site at this location during the monitoring year.

Sand deposition from overbank flow from Swift Creek into the site.

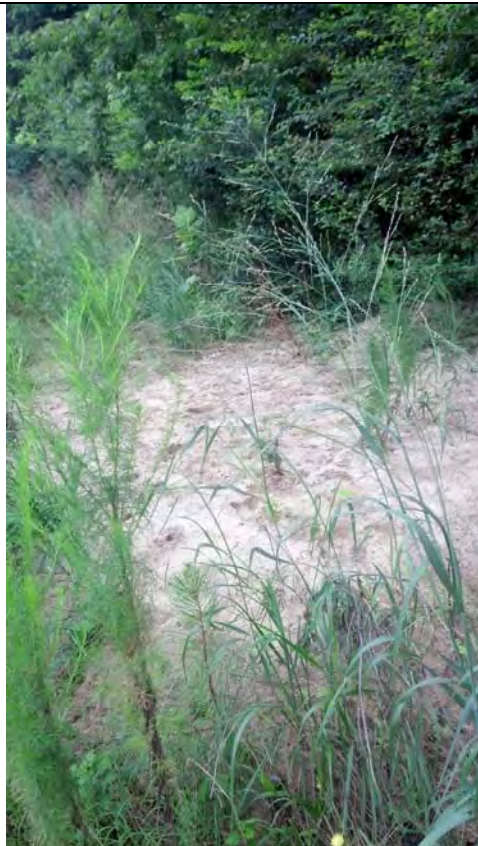
WP8 (July 10, 2013)

Sand deposition from overbank flow from Swift Creek into the site.

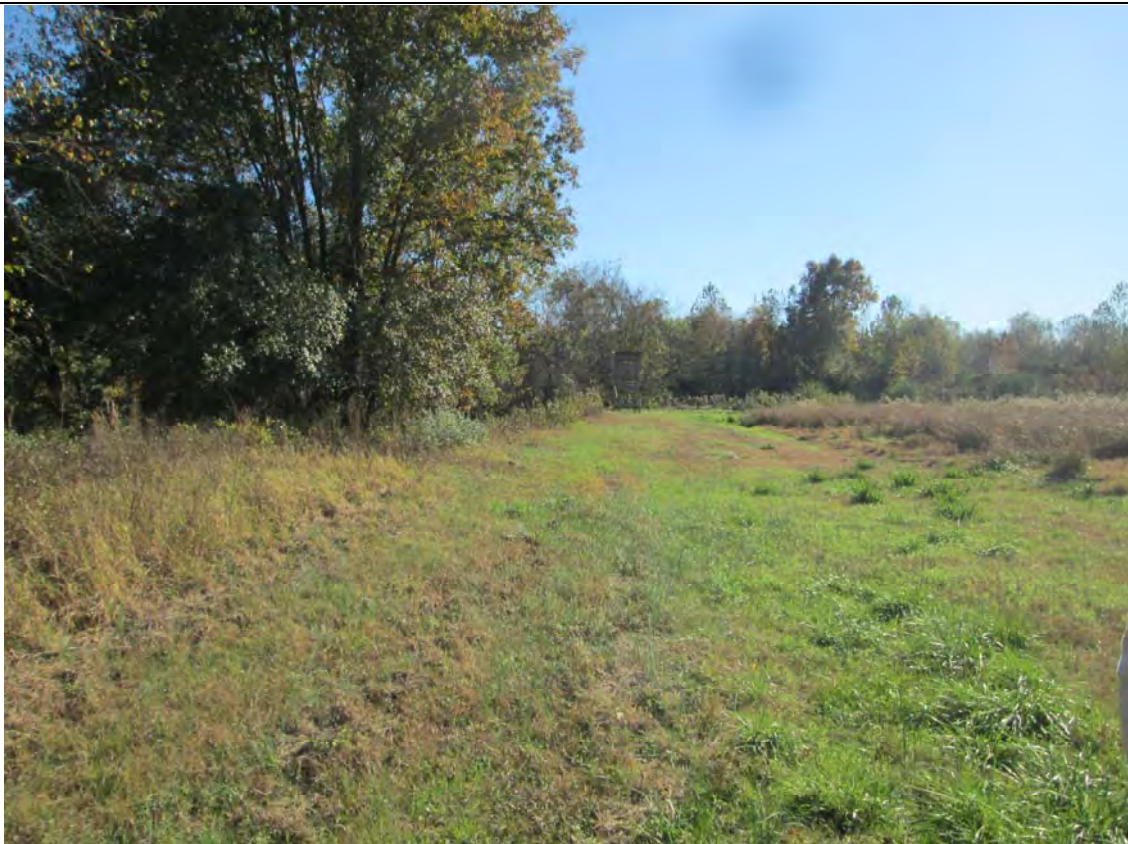
- Recent unauthorized activity on the site has resulted in the mechanized clearing (bush hogging) of a wildlife corridor from the access driveway on Swift Creek Road, along the perimeter of the site to the east, down to the southeastern corner of the site where a deer stand was erected. The clearing activities impacted vegetation plot 12 (VQ-12), of which

approximately half of the plot has been mowed, cleared, and seeded, destroying both the planted and naturally occurring vegetation within the plot. The rebar pins at both the origin (0,0) and the southeastern corner (0,10) have been removed or destroyed. These pins will be reset at the beginning of monitoring year 4. Due to the clearing and lack of locatable rebar pins, VQ-12 was not surveyed this year. NC EEP has been in coordination with the land manager to remove the hunting structures and prevent further clearing activities within the site. This area will be observed throughout the spring of MY4 to determine if the woody stems will re-sprout or if supplemental planting will be required to restore this riparian area. Any supplemental planting would be conducted during the dormant season of MY4.

VQ12 (November 8, 2013) – Plot was destroyed by unauthorized bush hogging, and boundary pins were destroyed or removed. Plot was not sampled this year, but pins will be re-set and sampling completed for MY4.
