Moore Property Monitoring Report FINAL Year 4 (2014)

Johnston County, North Carolina

EEP Project ID #725

Submitted December 2014

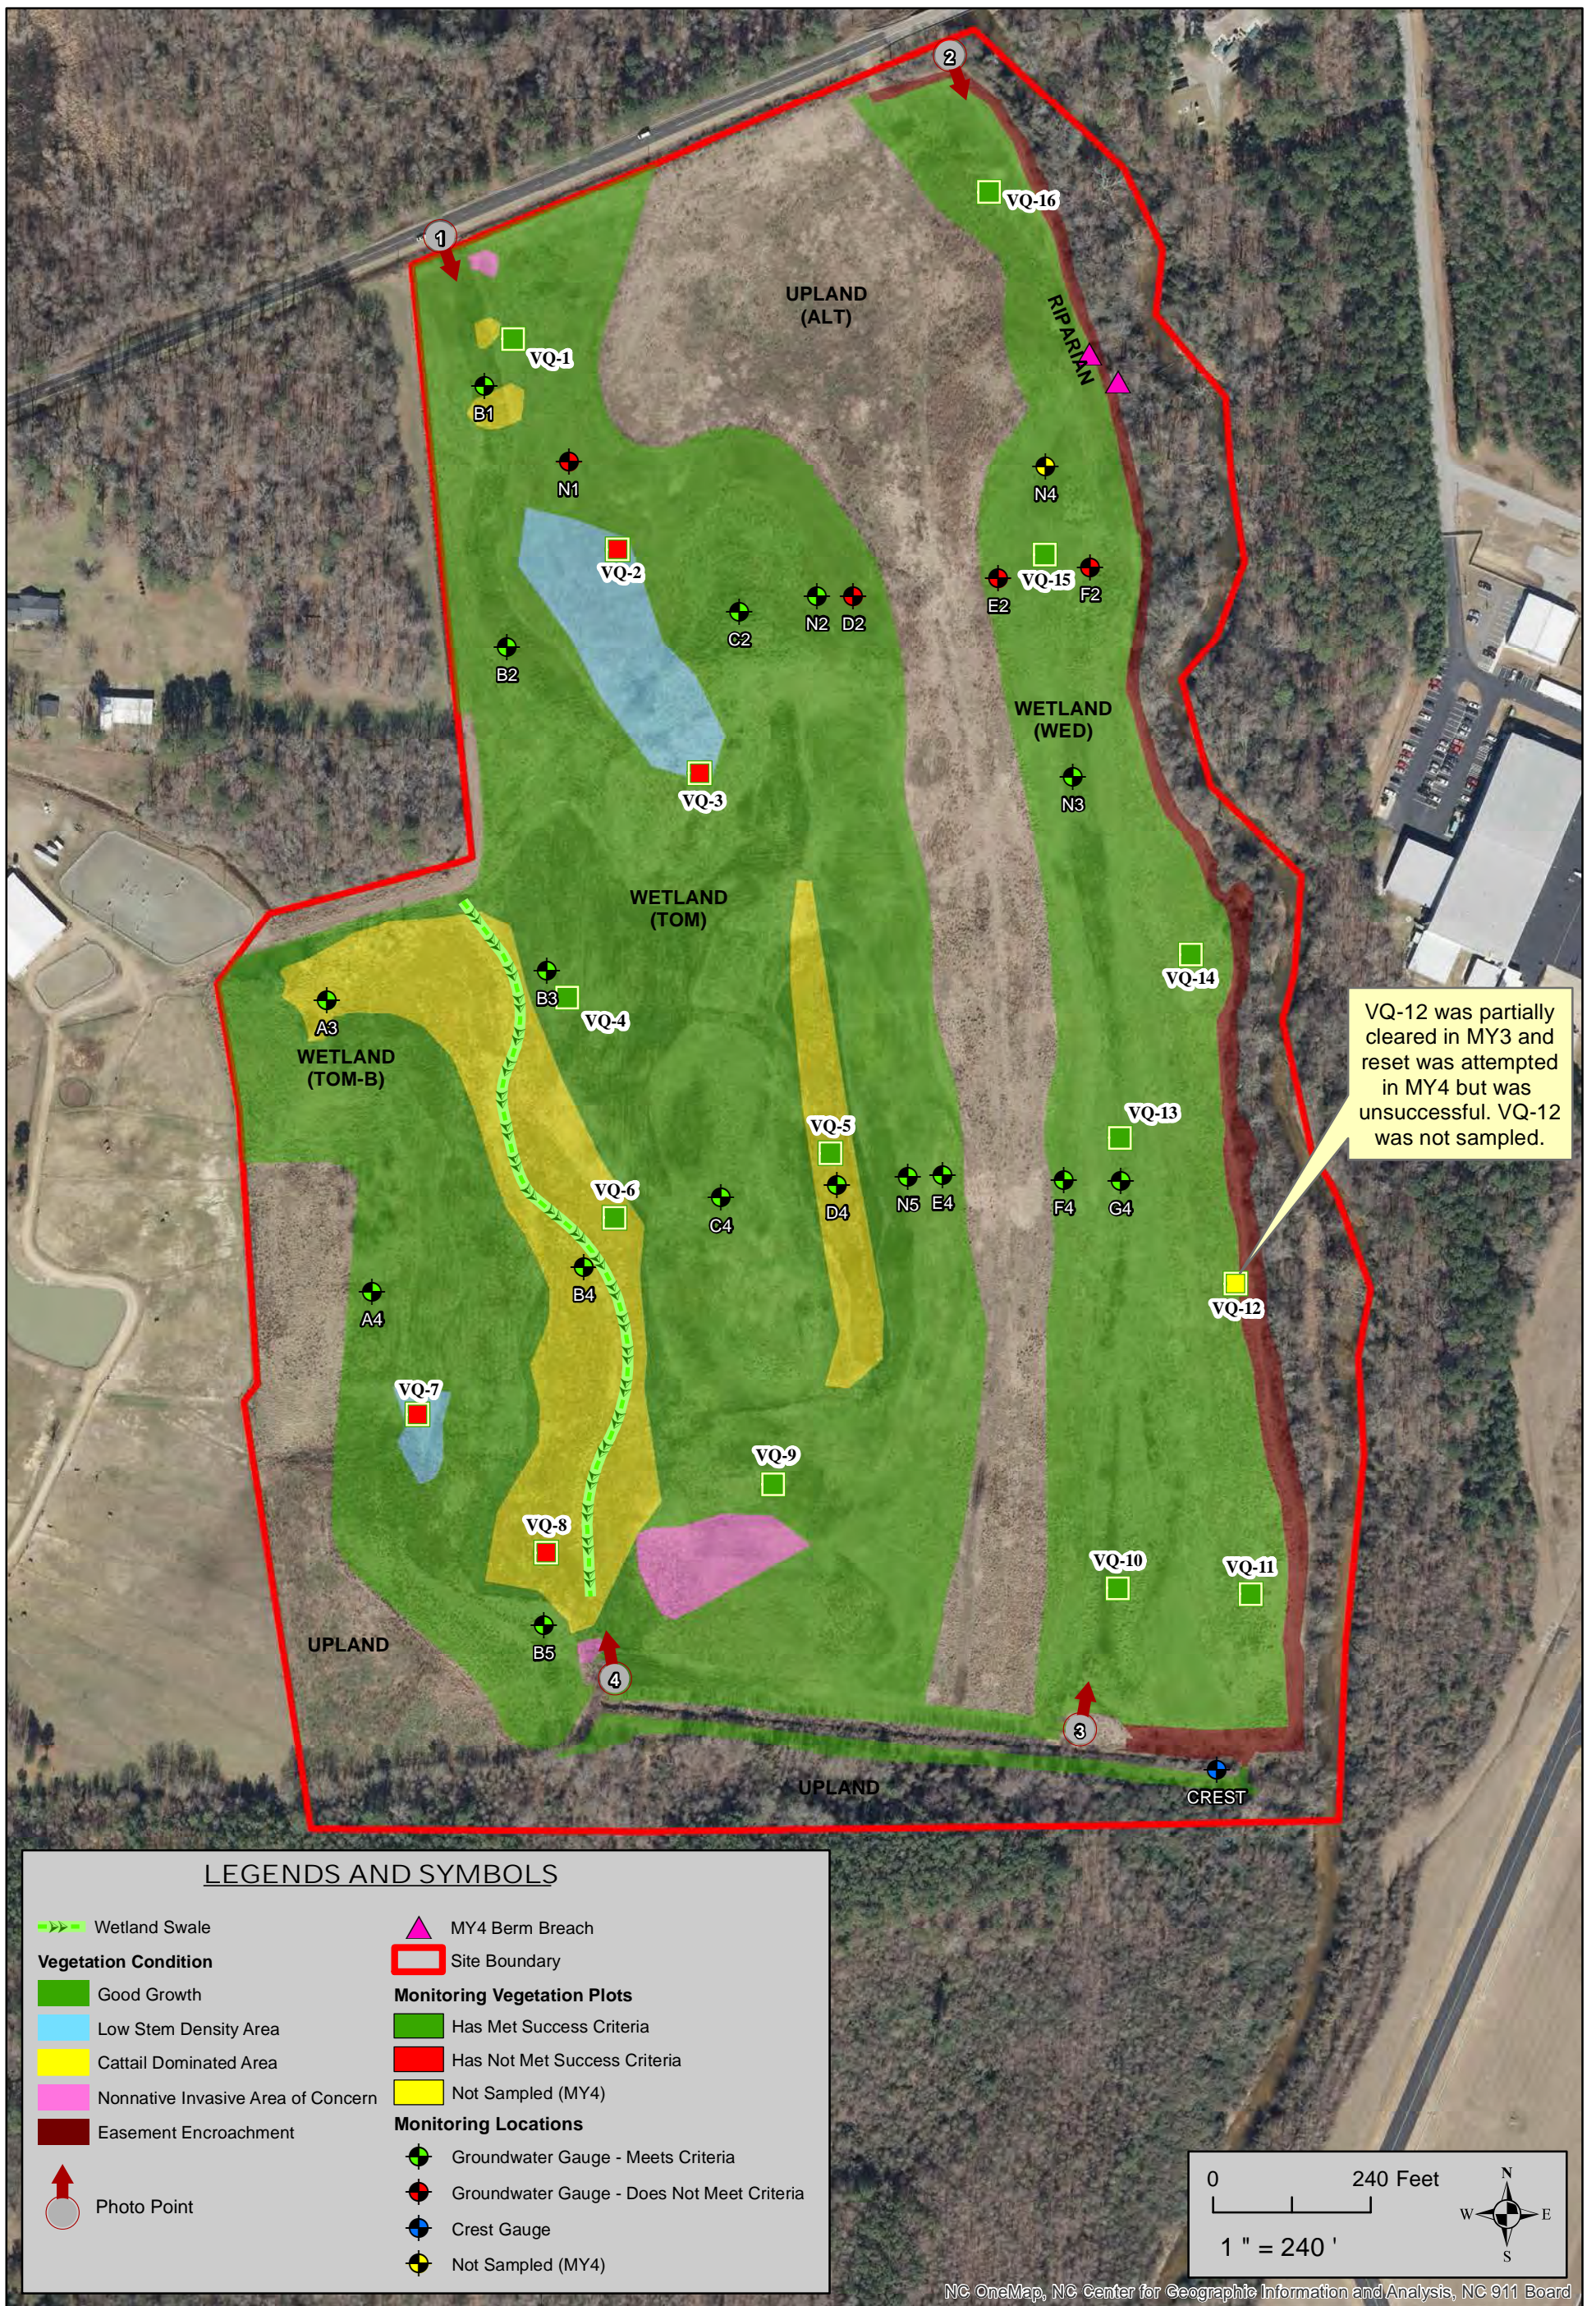
Title Current Conditions Plan View (2013 Aerial)				
Prepared For: 	Project	Moore Property Monitoring (725) 2014 - Year 4 Johnston County, NC		
		Date	KHA Project Number	Figure
		12/18/2014	011795033	2

VQ-12 was partially cleared in MY3 and reset was attempted in MY4 but was unsuccessful. VQ-12 was not sampled.

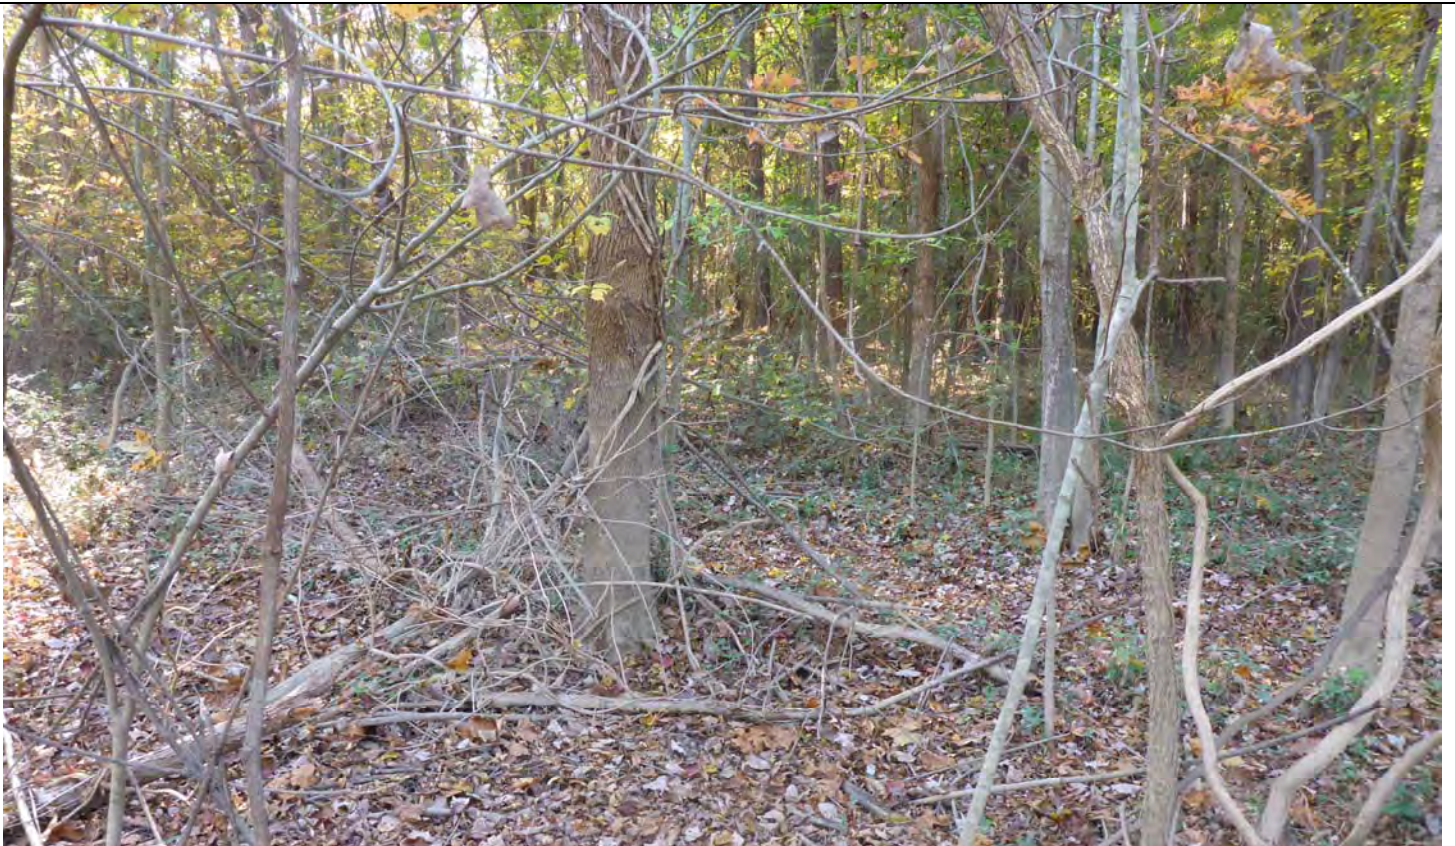
WP2 (November 11, 2014)
Sediment staining on trees near reference well C indicating inundation to depths of 4'.

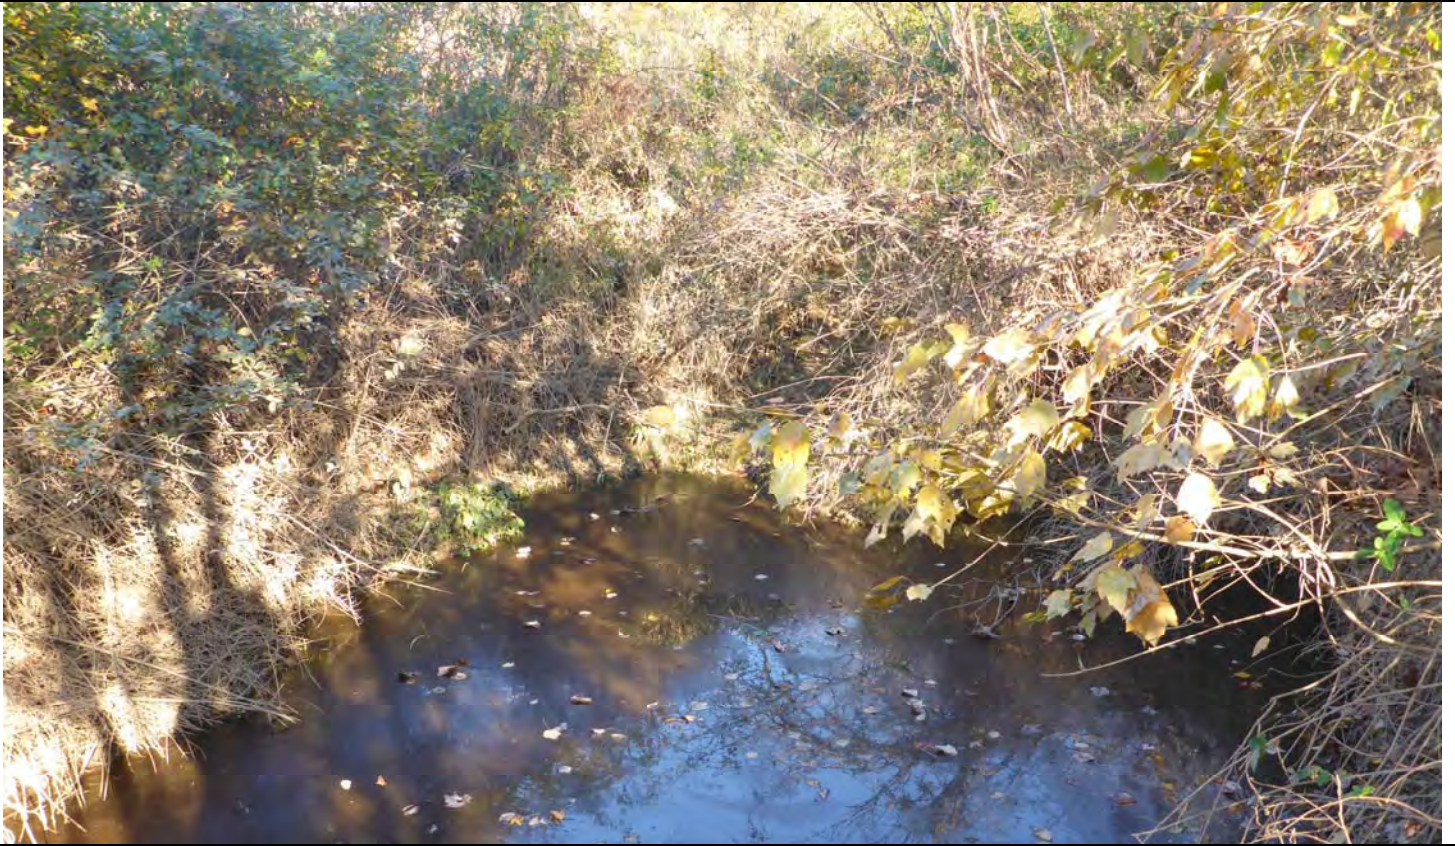
- Beaver activity was again observed along the outlet ditch, but no beaver damage was found within the site itself. The primary culvert outlet from the site remains completely impounded by a beaver dam, holding water within the ditch (WP3).

WP3 (November 11, 2014)
Beaver impoundment blocking outlet culvert in outlet ditch to Swift Creek (top of photo).

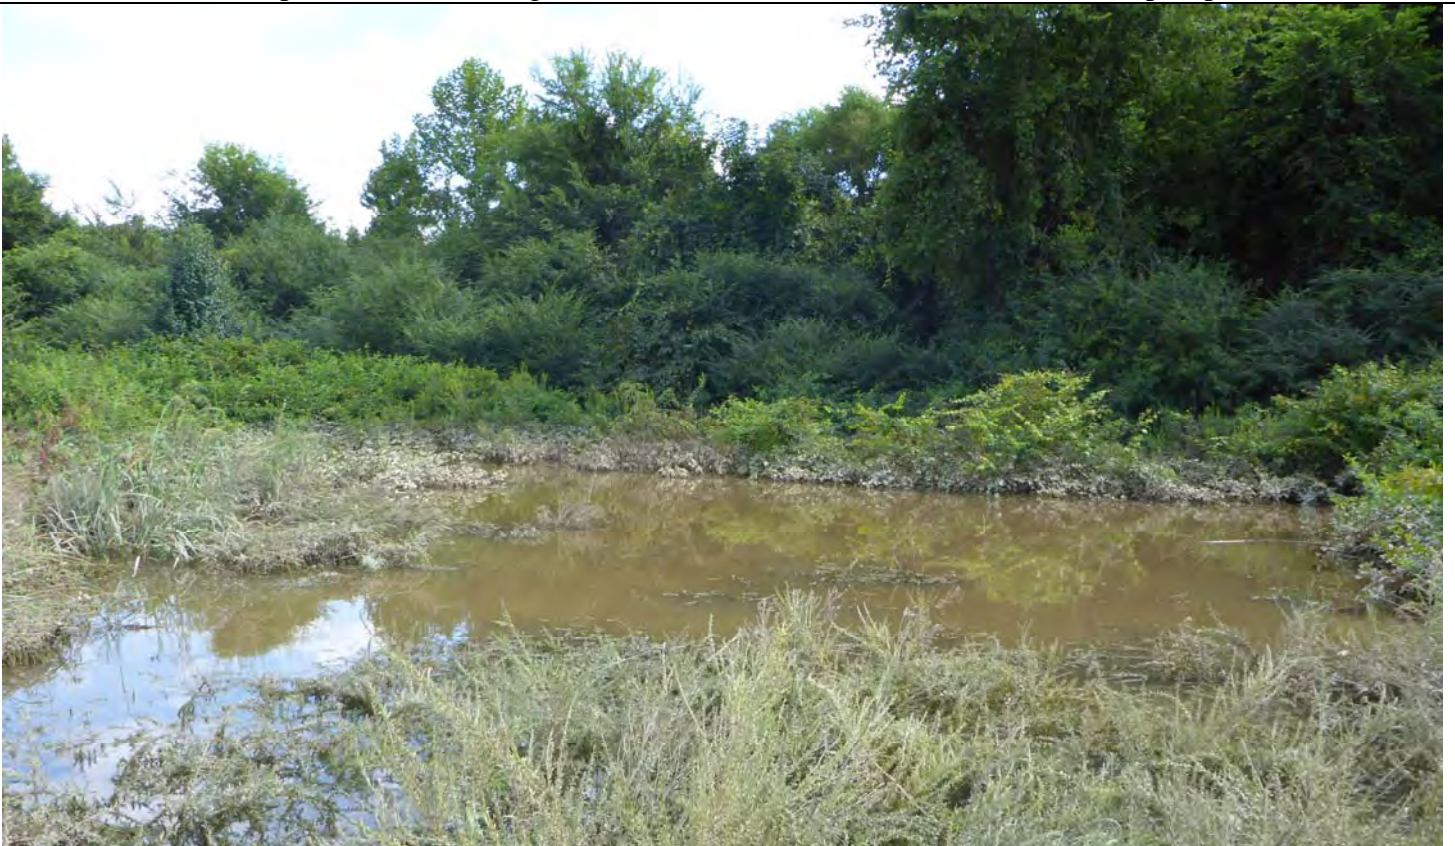
- The crest gauge located in the outlet ditch for the wetland recorded at least two bankfull events in Swift Creek in the monitoring year. Once based on sediment deposits observed in the outlet ditch and noted in the Site Assessment Report submitted in June 2014, and at least once more as observed by Kimley-Horn staff in September (WP4) when the crest gauge was fully submerged by standing water. Due to the crest gauge's installation close to the bottom of the outlet ditch, the flow events evidenced through the site in MY3 and MY4 seem to be regularly overtopping the gauge, so the exact height of the crest is unknown.

WP4 (September 10, 2014)
Inundation in outlet ditch from Swift Creek flooding. Crest gauge is completely inundated.

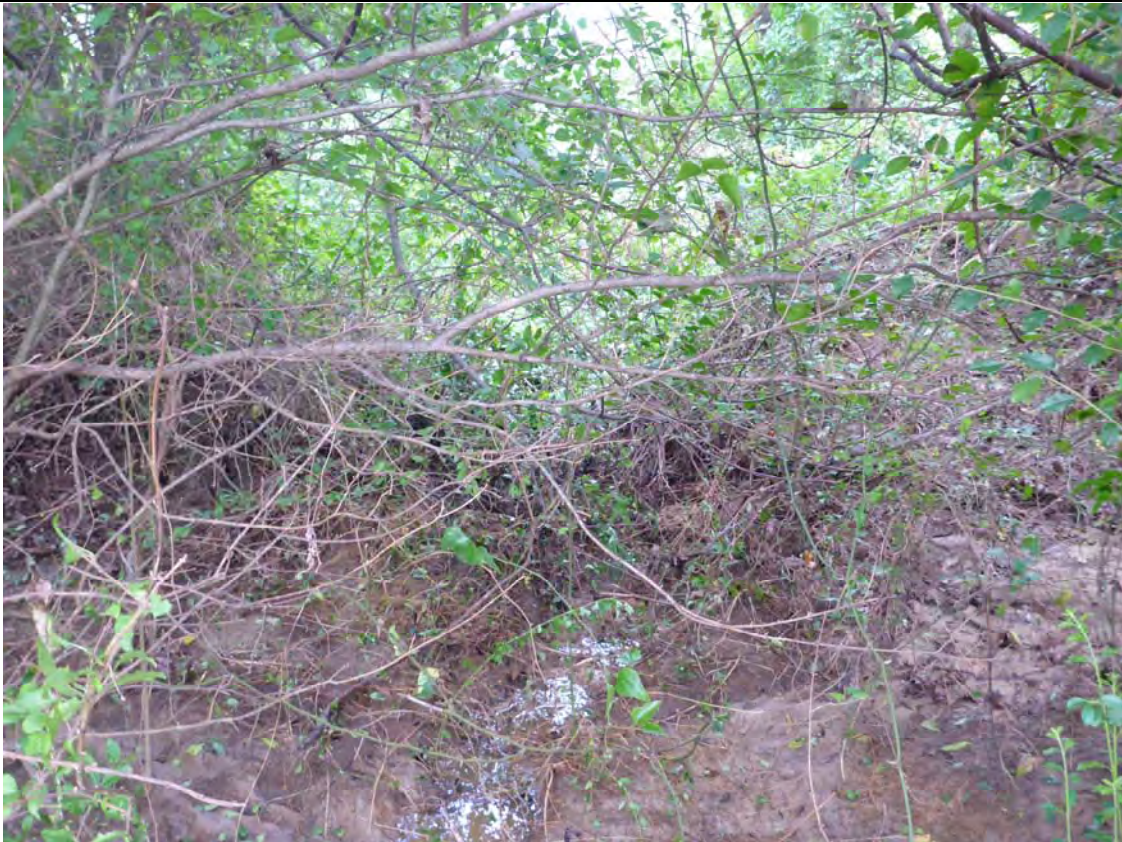
- High flow events occurring within Swift Creek during MY4 created multiple breaches in the berm adjacent to the site. The original breach noted by NCEEP staff in July 2013 was again utilized by Swift Creek, further depositing sediment into the site, but two new breaches were observed by Kimley-Horn staff and are shown on the CCPV figure. A photo of the breach is included as WP5, WP6, and WP7.

WP5 (September 10, 2014)
Southern breach in berm from Swift Creek flooding. Photo is facing east towards Swift Creek.

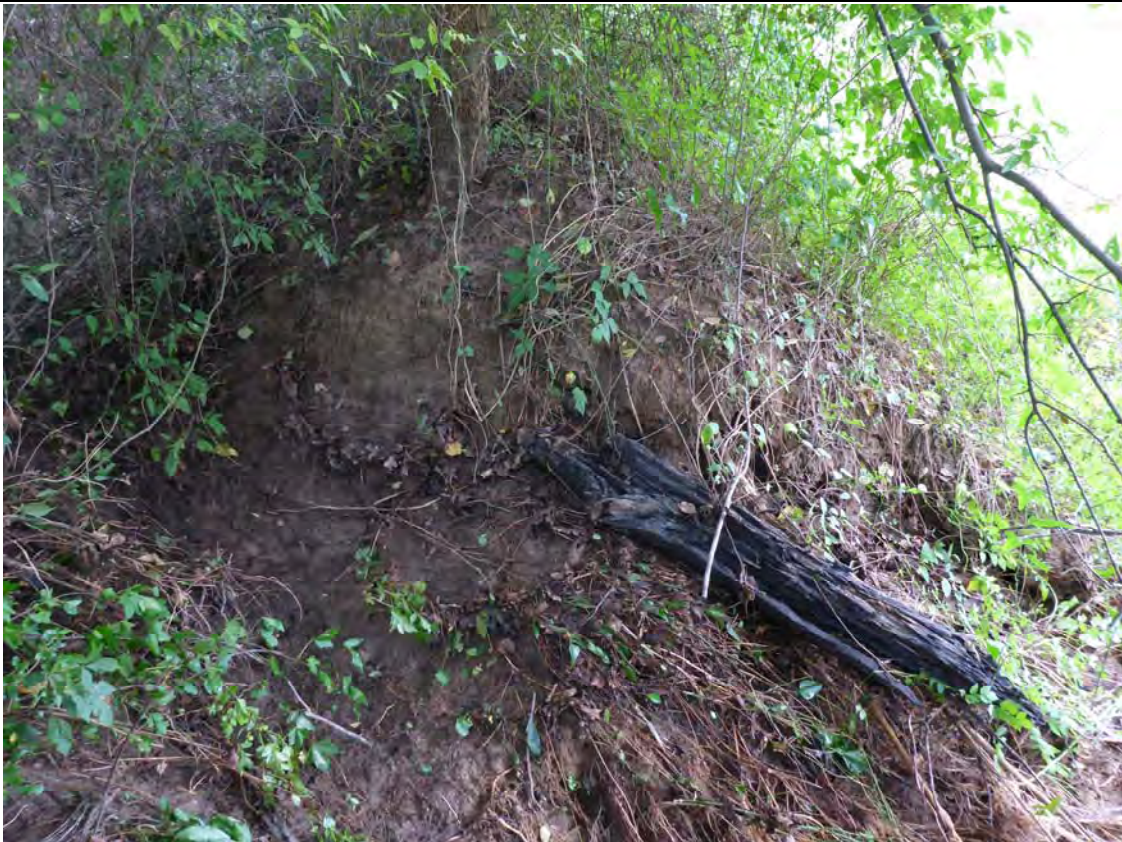
WP6 (September 10, 2014)
Cross-sectional view of southern breach in berm from Swift Creek.. Photo is facing south.

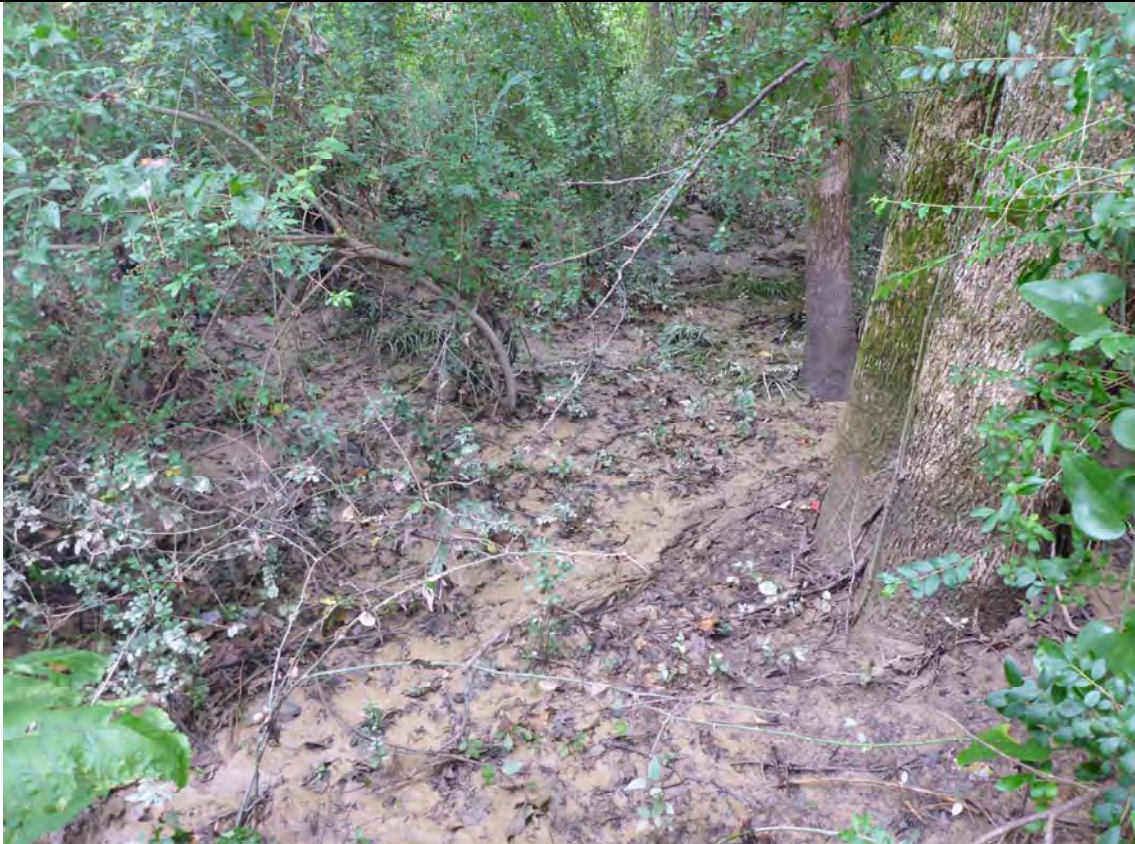
WP7 (September 10, 2014)
Northern breach in berm from Swift Creek

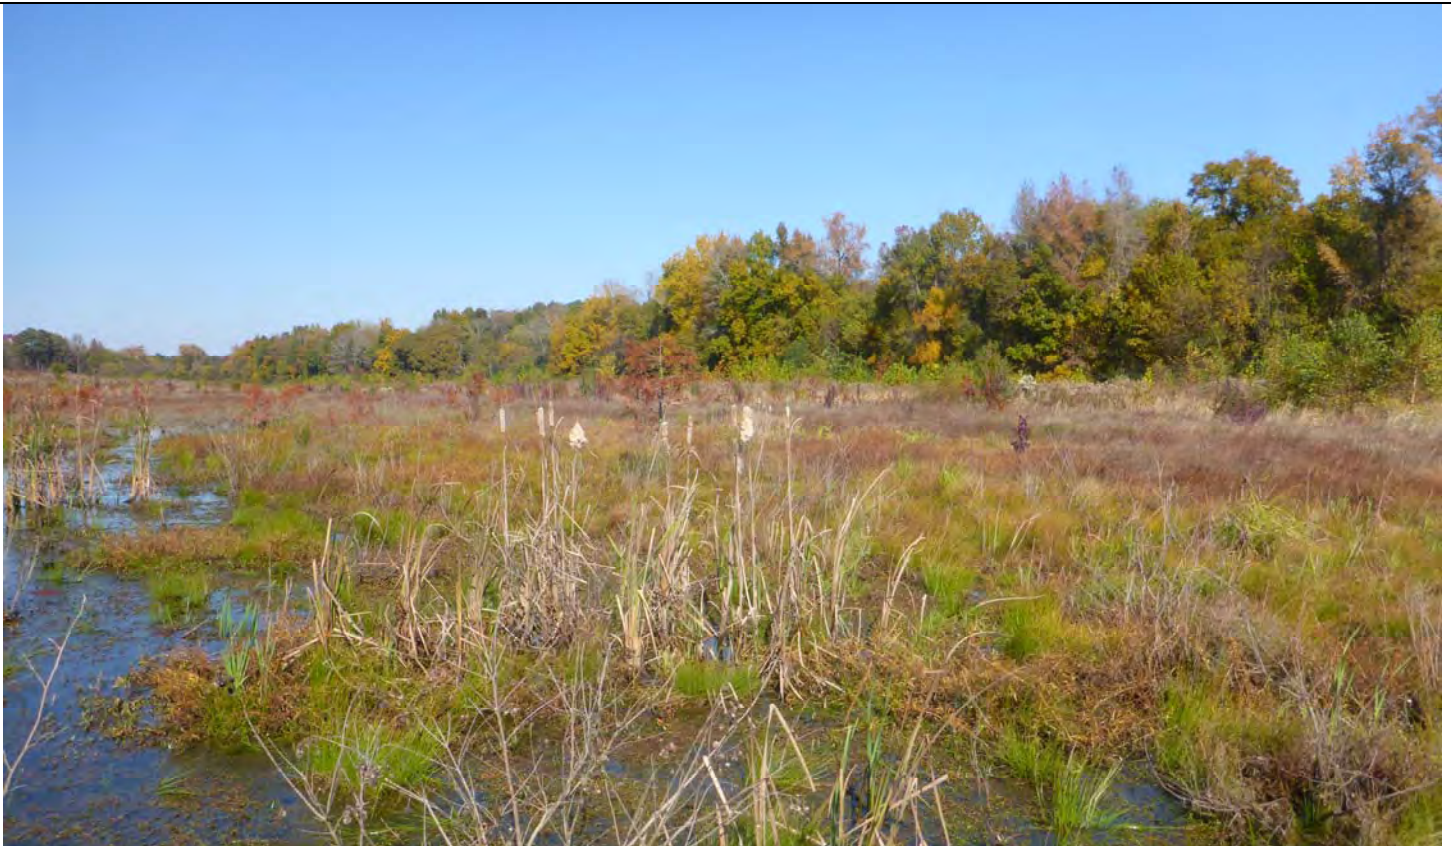
WP8 (November 12, 2014)
Cypress establishing well in wetland swale in southeastern quadrant of site.

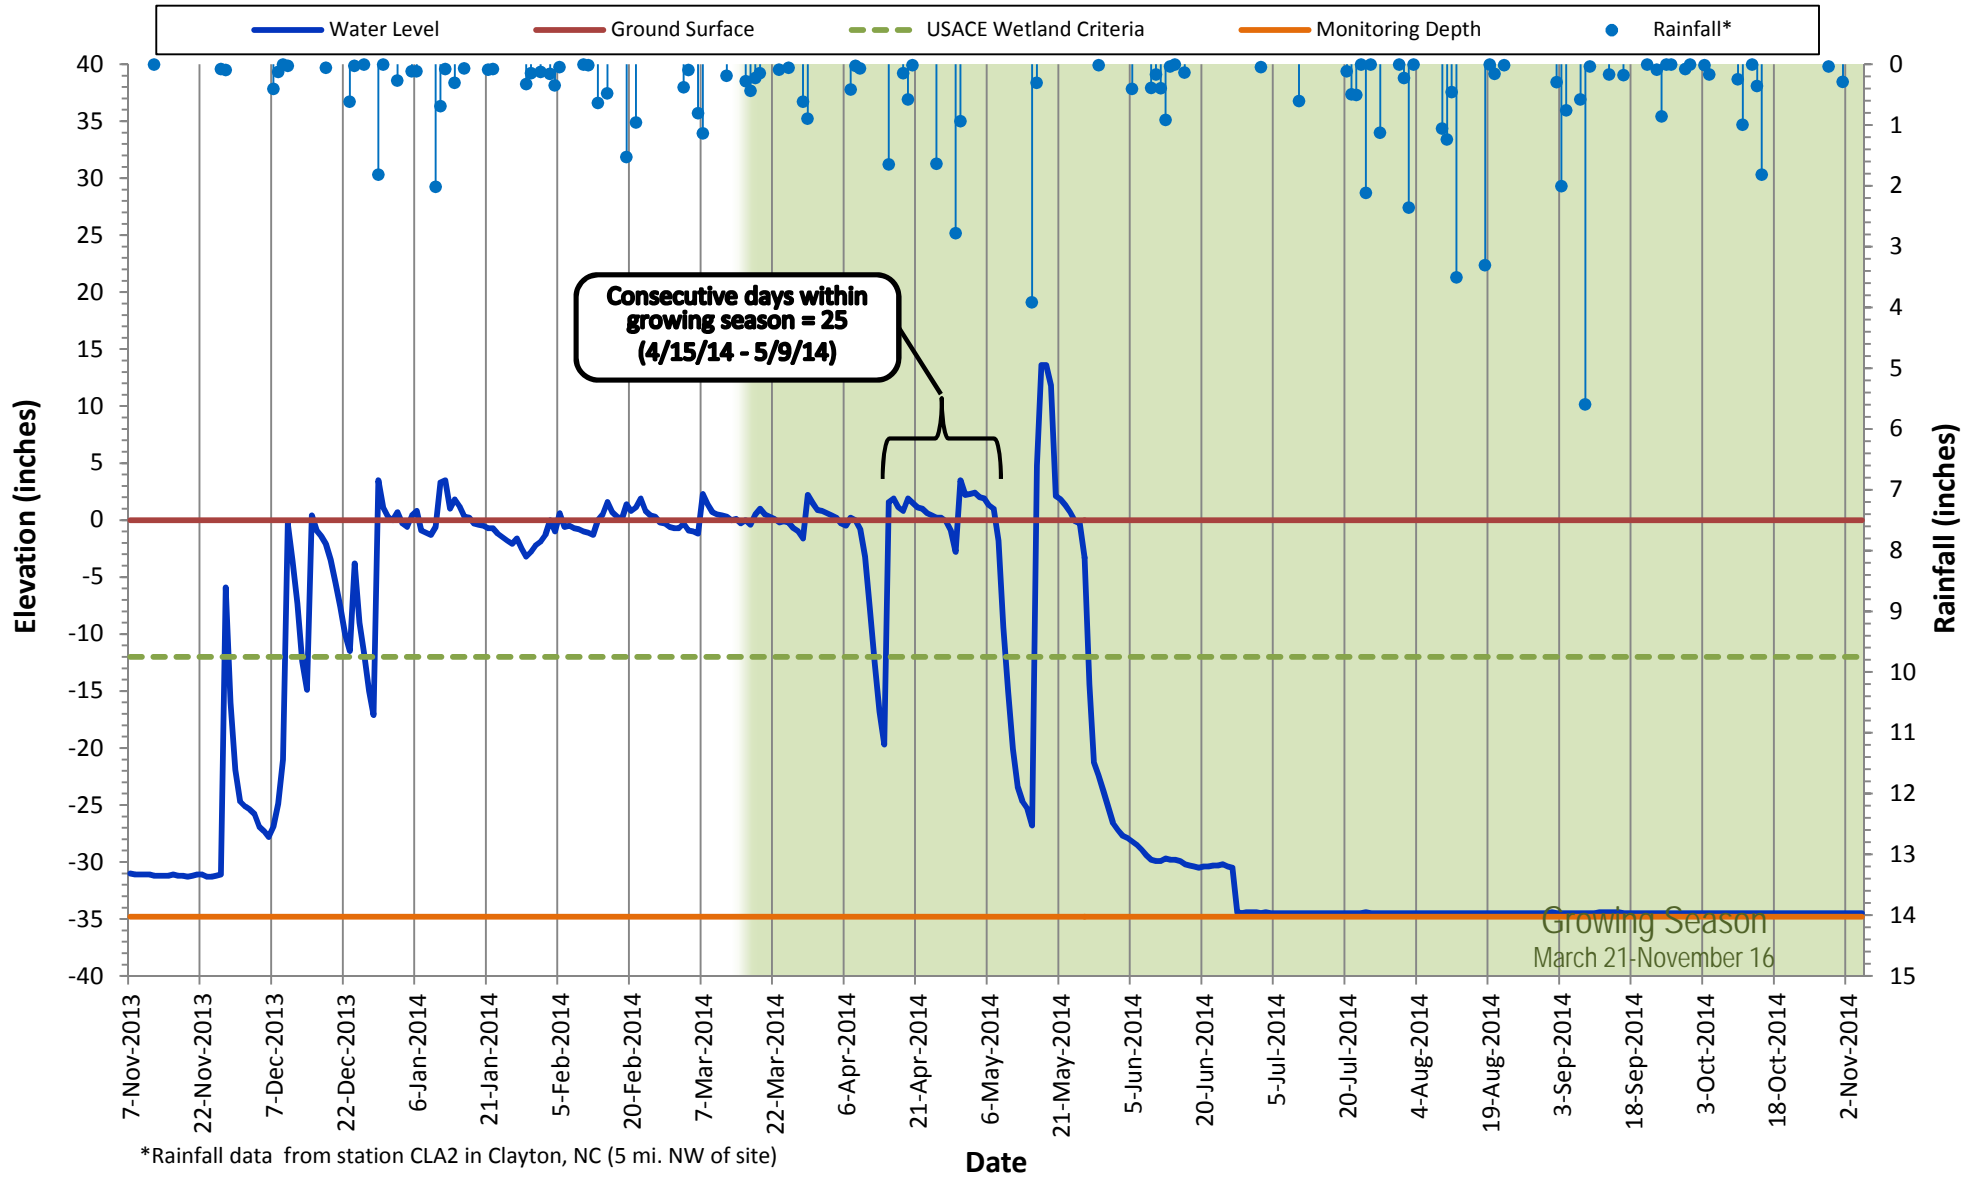
Shallow Water Table Gauge G4

% of growing season		1.66%	0.41%	7.5%	6.6%		
Criteria met?		N	N	Y	Y		
Groundwater Gauge G4							
Consecutive days within range	123.5'	11	8	25	25		Gauge G4 is heavily influenced by rainfall, and a significant water table drawn down was noted in late-May. Water levels did not return later in the growing season with a wet September, but water was at or above the ground surface through the spring.
% of growing season		4.56%	3.32%	10.4%	10.4%		
Criteria met?		N	Y	Y	Y		
Groundwater Gauge B5							
Consecutive days within range	123.4'	6	26	66	52		Water levels sustained near the ground surface for most of the year except for low rainfall periods in June. Peaks were noted during May and September with high rainfall events. Many smaller events kept water above the ground surface during the growing season.
% of growing season		2.49%	10.79%	27.4%	21.6%		
Criteria met?		N	Y	Y	Y		
Groundwater Gauge N1							
Consecutive days within range	126'	N1 installed spring MY4				4	Gauge N1 was installed in March 2014. Water levels were low throughout the year, with two peaks of surface water recorded after significant rainfall events. In addition to the two peaks, groundwater peaked into the upper 12" 5 other times during the growing season.

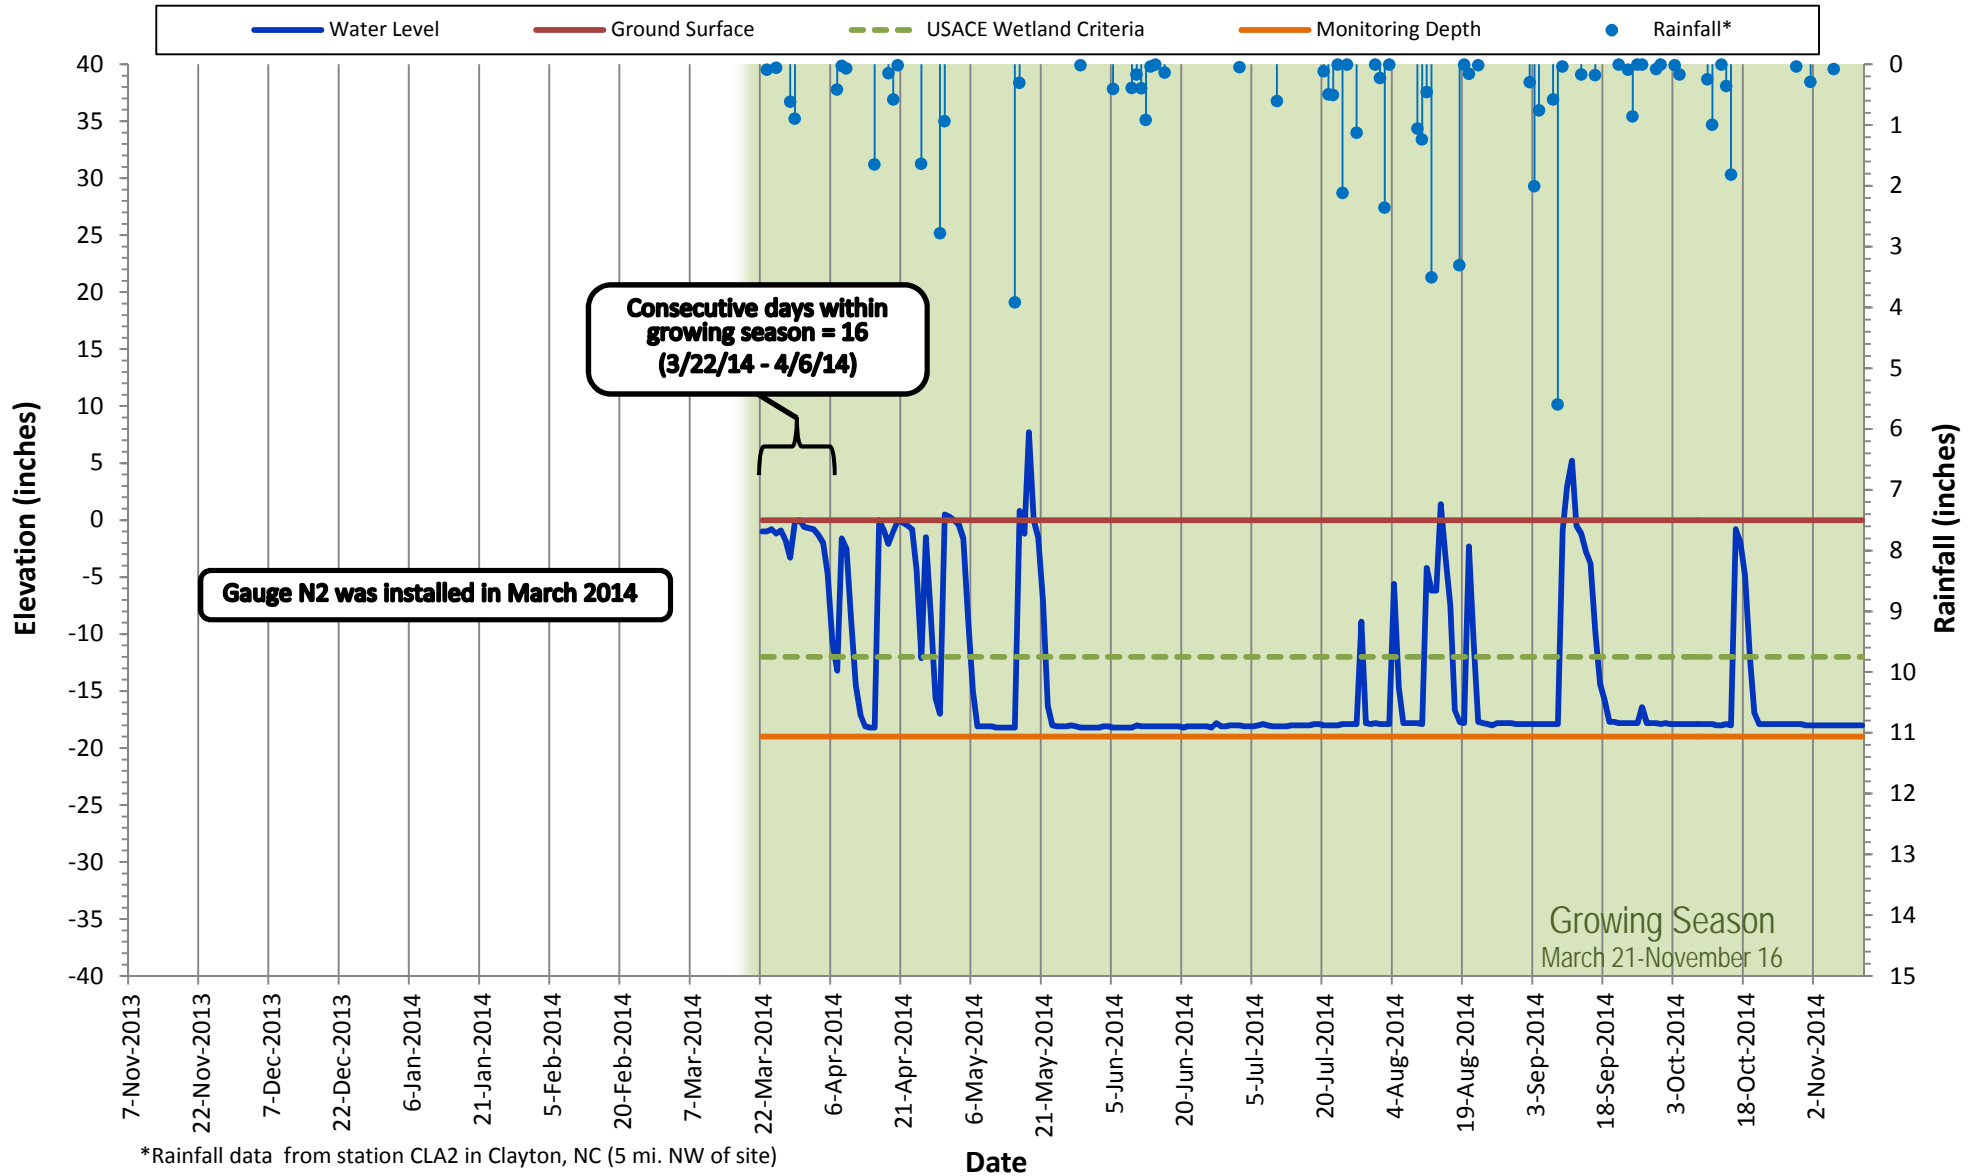
Shallow Water Table Gauge N2

% of growing season						1.7%	
Criteria met?						N	
Groundwater Gauge N2							
Consecutive days within range	126.3'	N2 installed spring MY4				16	Gauge N2 was installed in March 2014. Water levels were highly variable with rainfall events, and rapid draw downs were noted after rainfall events.
% of growing season						6.6%	
Criteria met?						Y	
Groundwater Gauge N3							
Consecutive days within range	124'	N3 installed spring MY4				22	Gauge N3 was installed in March 2014. Water levels were sustained within 12" for much of the year, with a noticeable drawdown during the growing season due to low rainfall. N3 appears to fluctuate rapidly with rainfall events.
% of growing season						9.1%	
Criteria met?						Y	
Groundwater Gauge N4							
Consecutive days within range	124.8'	N4 installed spring MY4				N/A	Gauge N4 was installed in March 2014, but due to a GPS malfunction, the datapoint was unreadable. Attempts to locate N4 in the field were unsuccessful due to herbaceous growth. N4 will be located during winter 2014/2015 once herbaceous vegetation has died back.

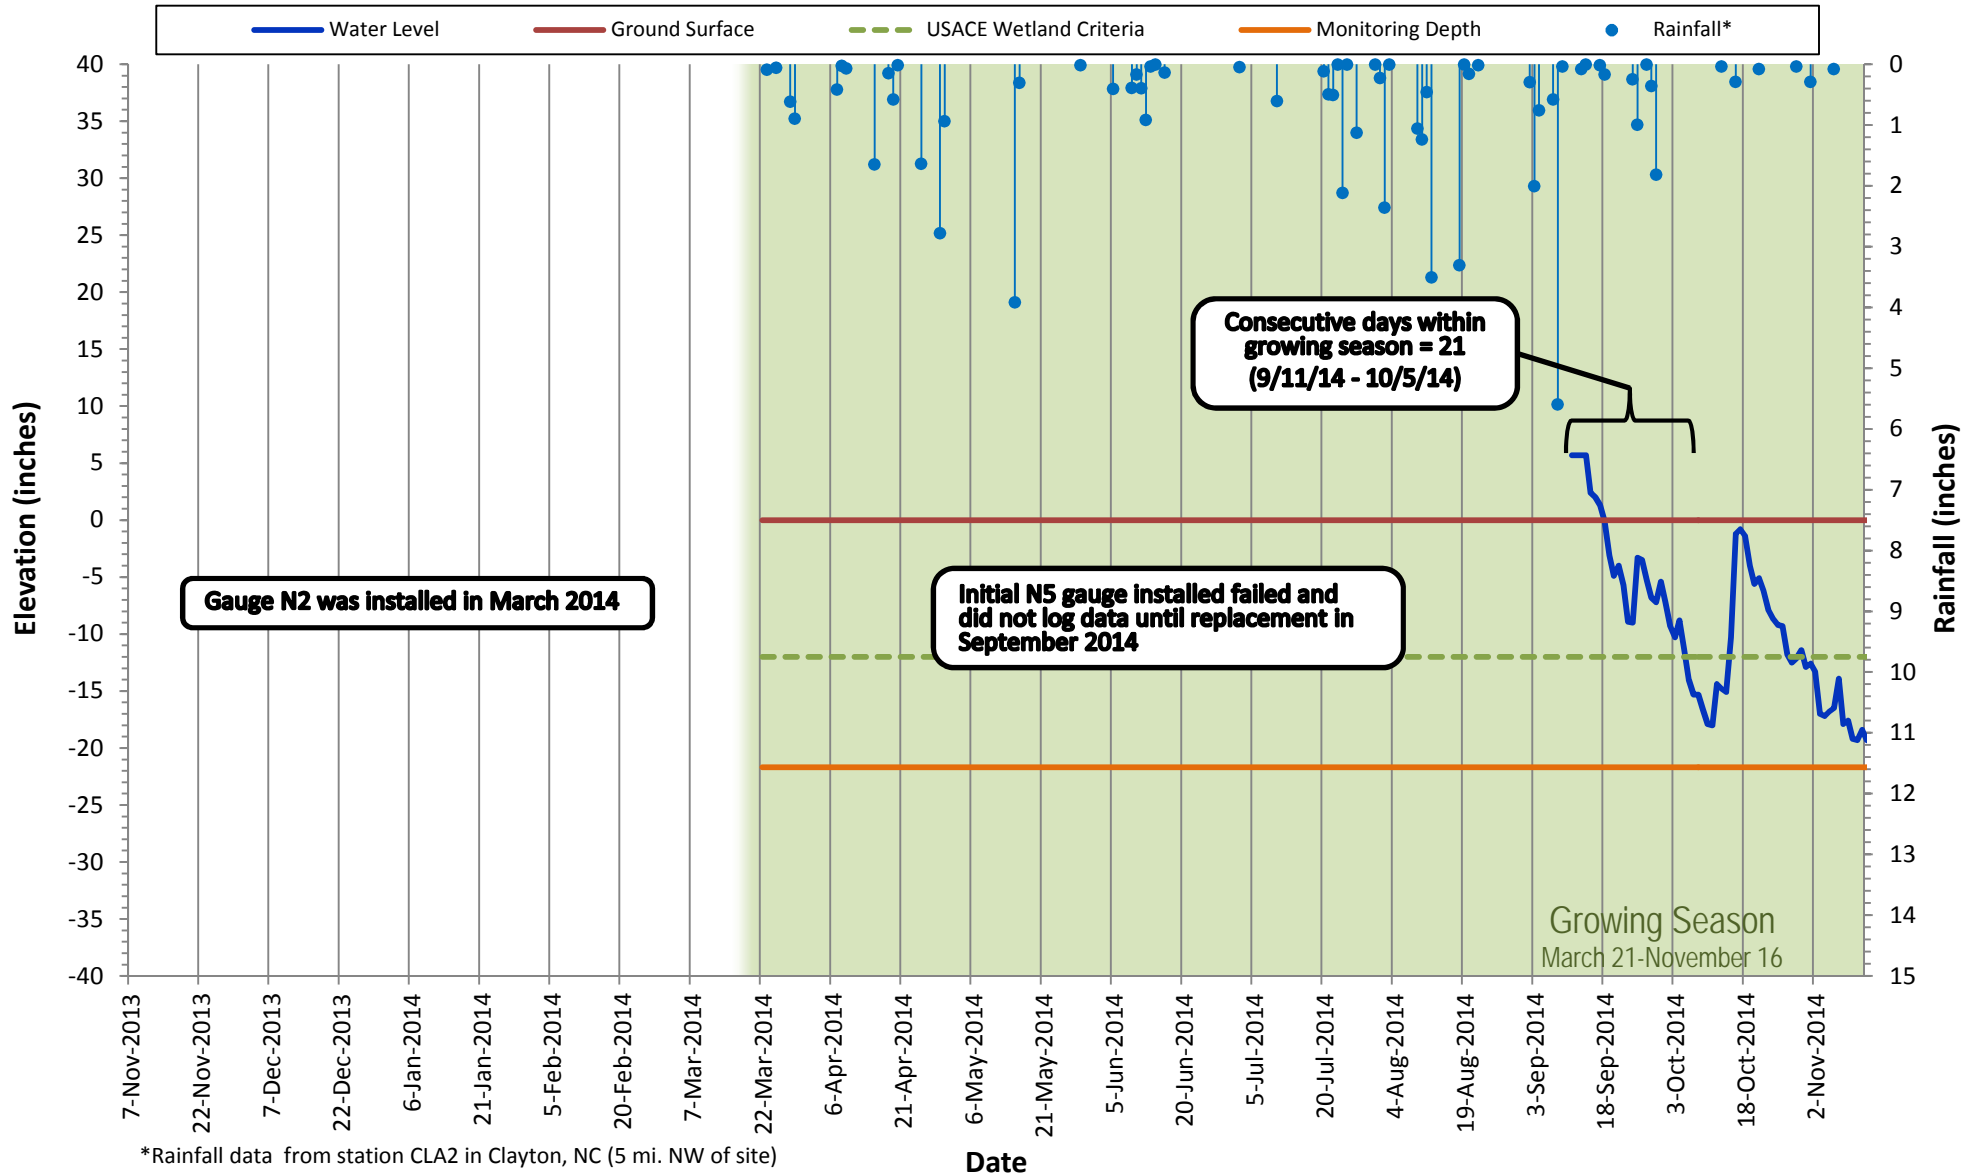
Shallow Water Table Gauge N5

% of growing season						N/A	
Criteria met?						N/A	
Groundwater Gauge N5							
Consecutive days within range	124'	N5 installed spring MY4				25	Gauge N5 was installed in March 2014 but appears to have malfunctioned after installation and data was not able to be downloaded. Well was replaced in September 2014, and still met success criteria prior to end of growing season.
% of growing season						10.4%	
Criteria met?						Y
