**Moore Property  
Monitoring Report  
FINAL  
Year 5 (2015)**

**Johnston County, North Carolina**

**NCDMS Project ID #725**

Submitted February 2016

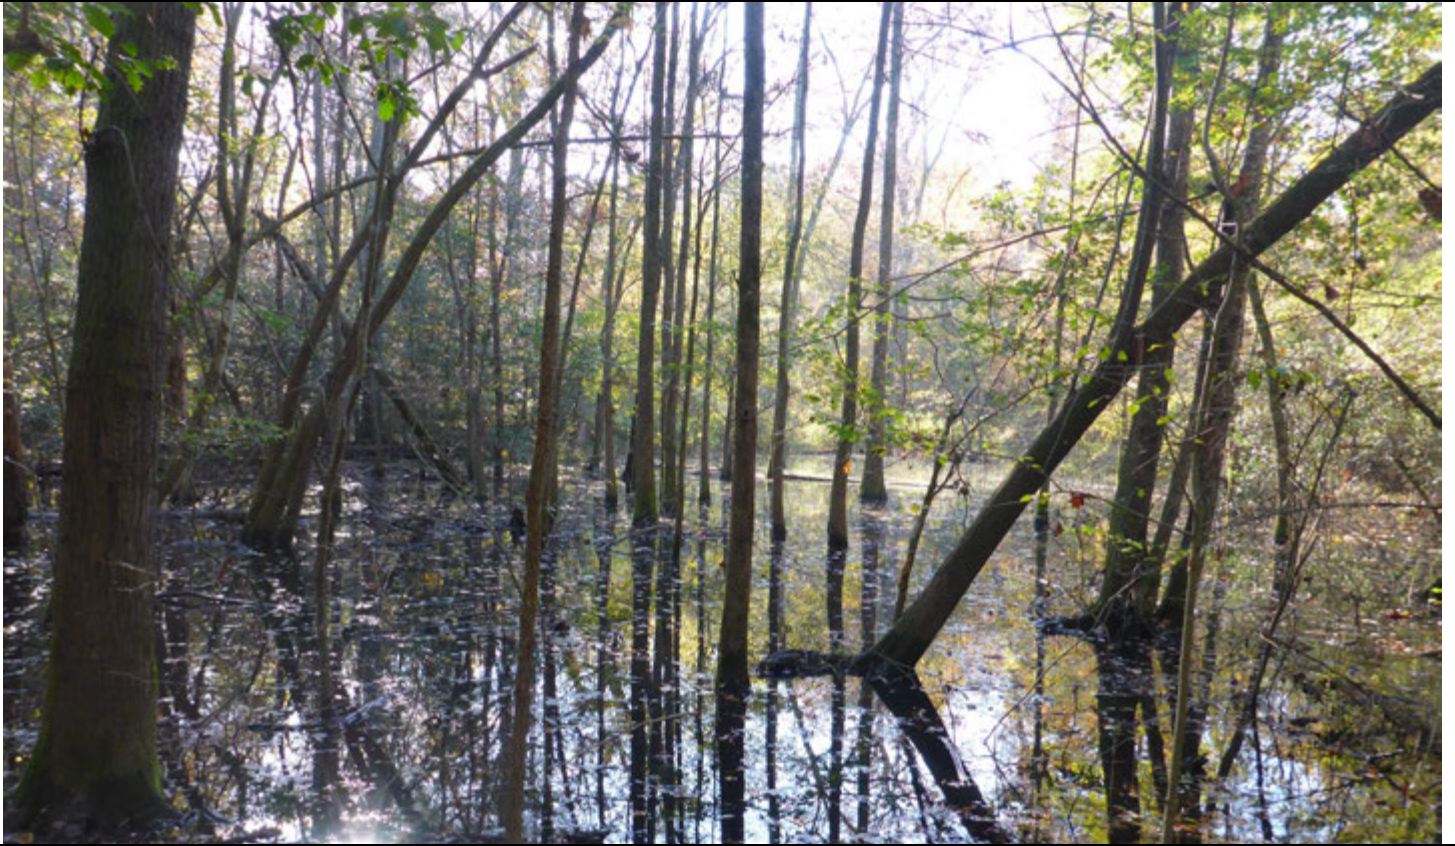
WP1 (November 12, 2015)  
Reference wetland well Ref-B

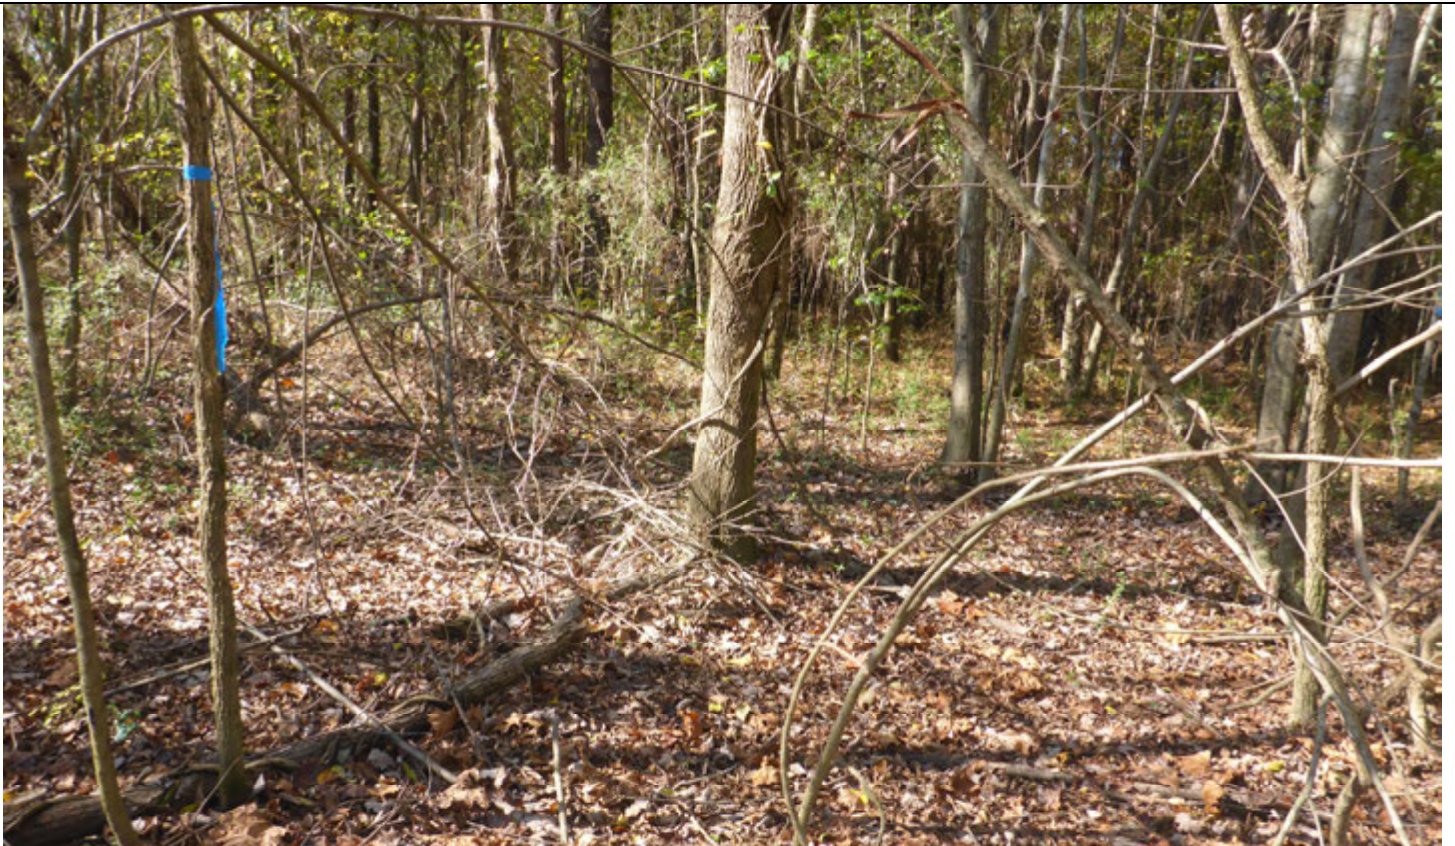
WP2 (November 12, 2015)  
Reference wetland wells Ref-C and Ref-D were inundated earlier in the year, but not in November 2015.

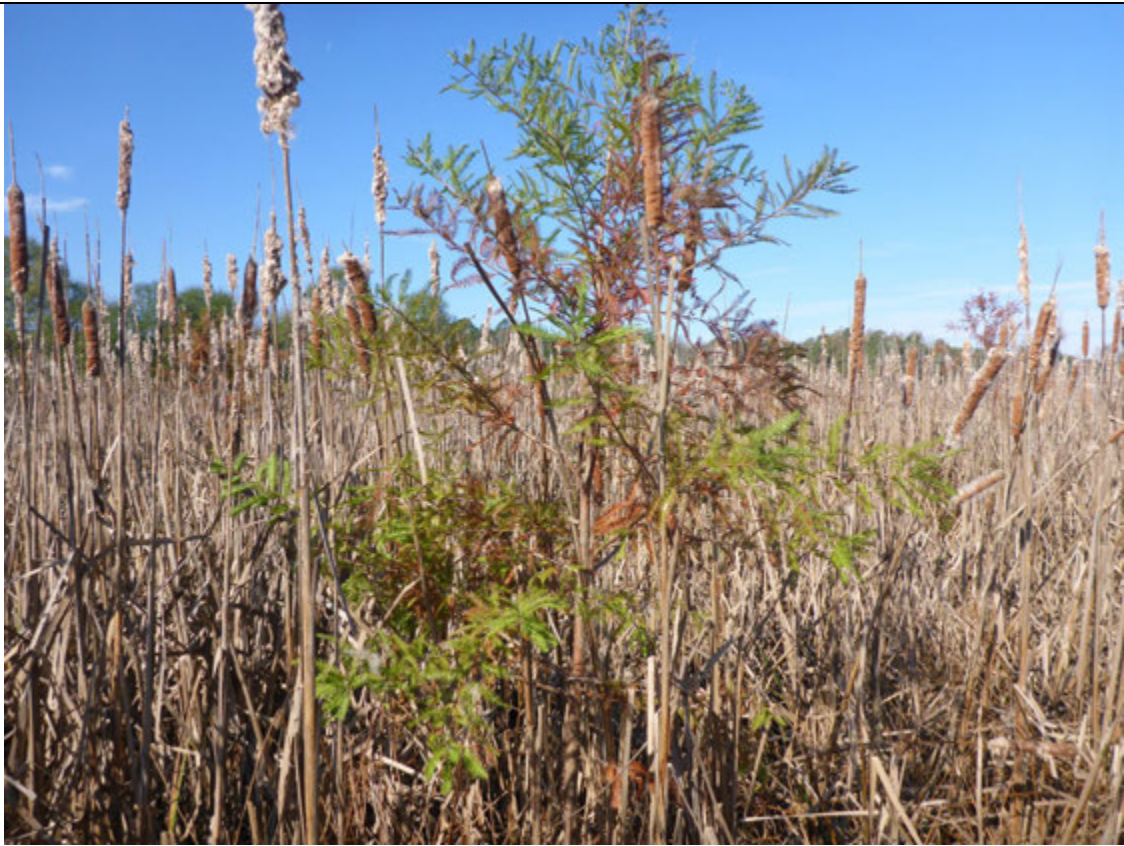
WP3 (November 12, 2015)

Bald cypress trees are beginning to overtop cattail colonies in the wetter areas of the Site-

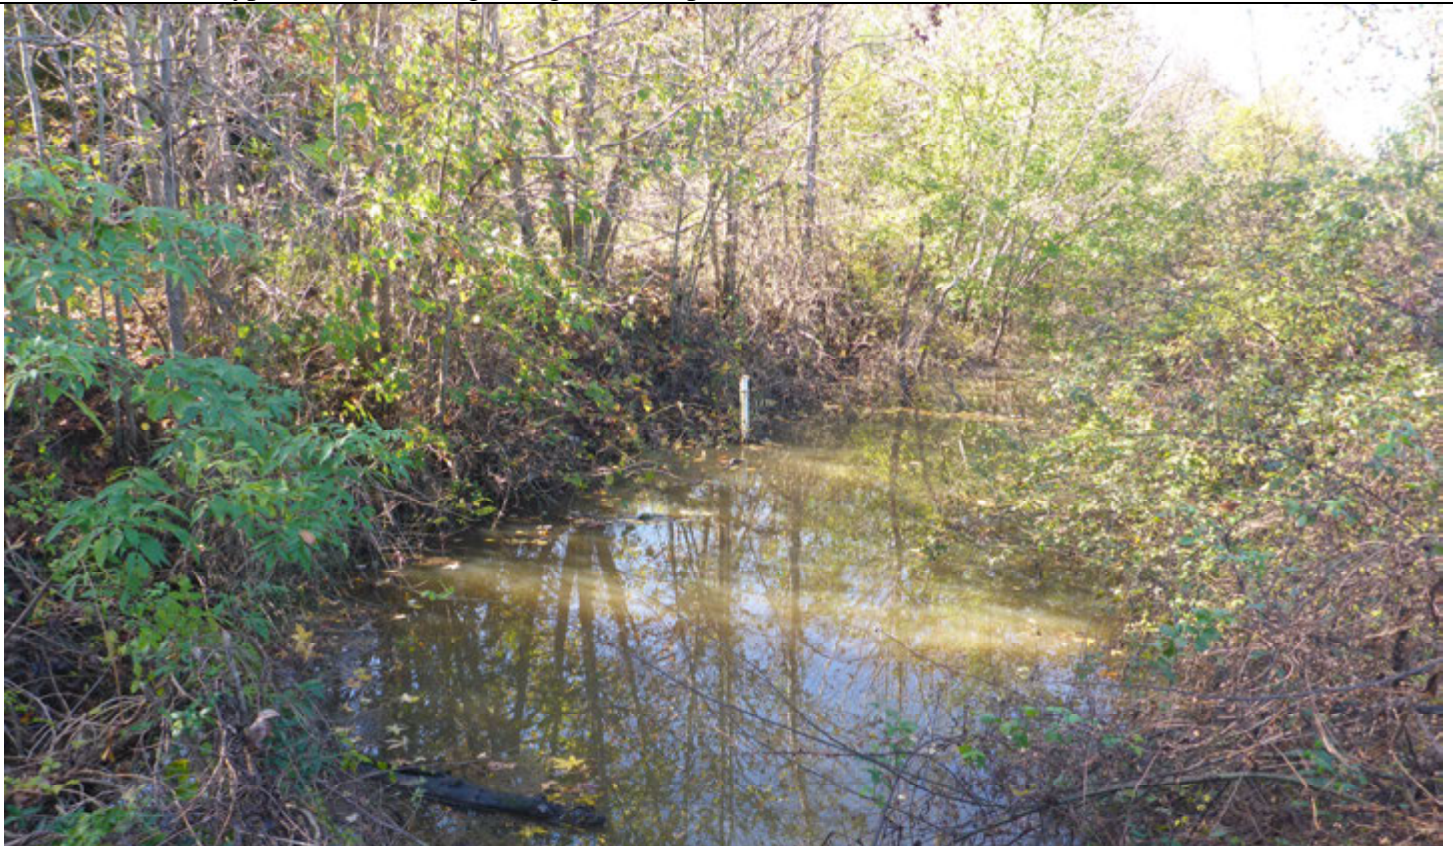
WP4 (November 12, 2015)

High water in outlet ditch due to Swift Creek flooding. Crest gauge has been inundated multiple times in MY5.

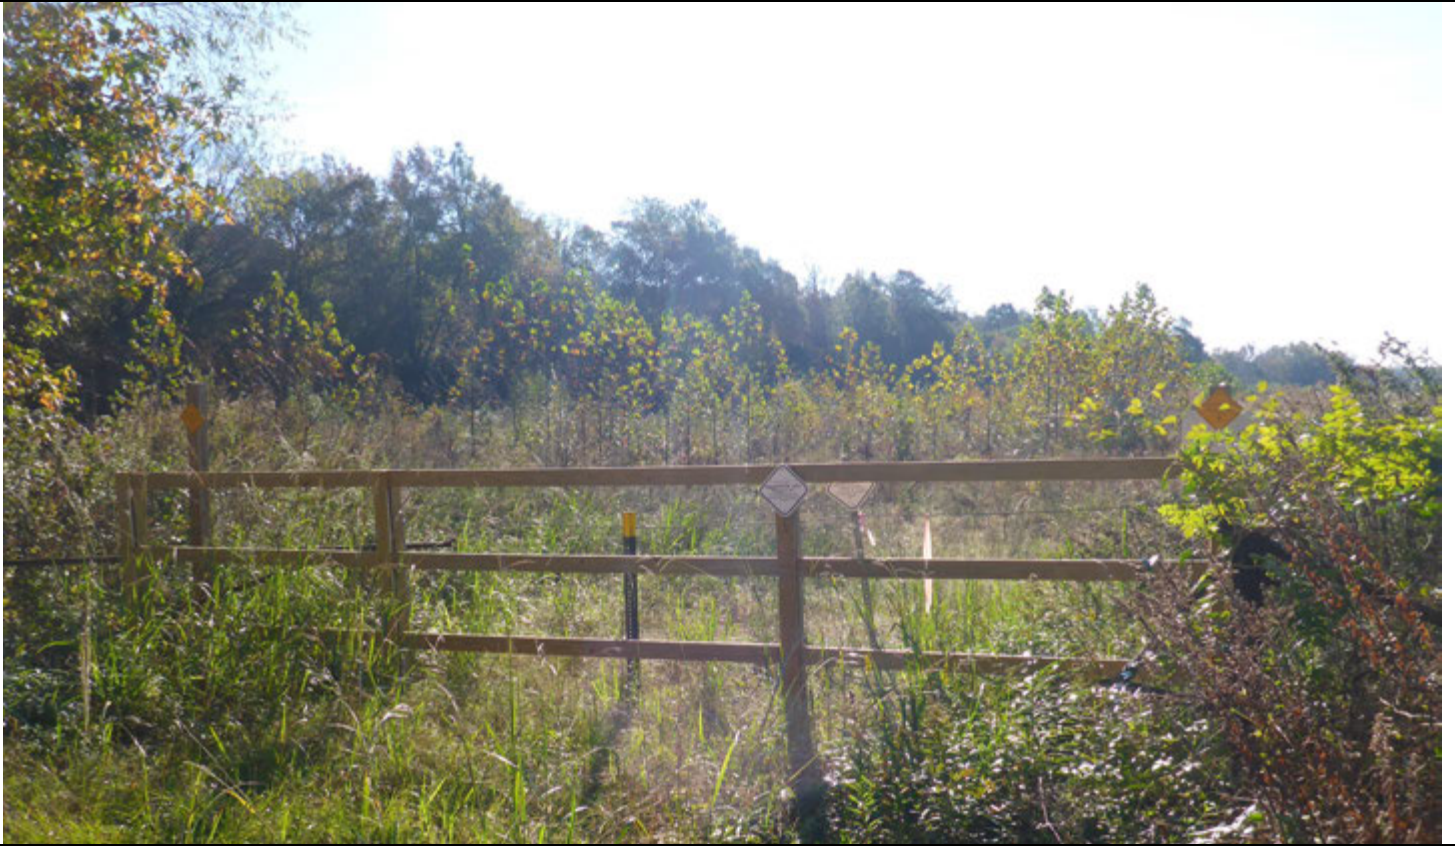
WP5 (November 12, 2015)  
Site access barrier constructed in MY5 by NCDMS.

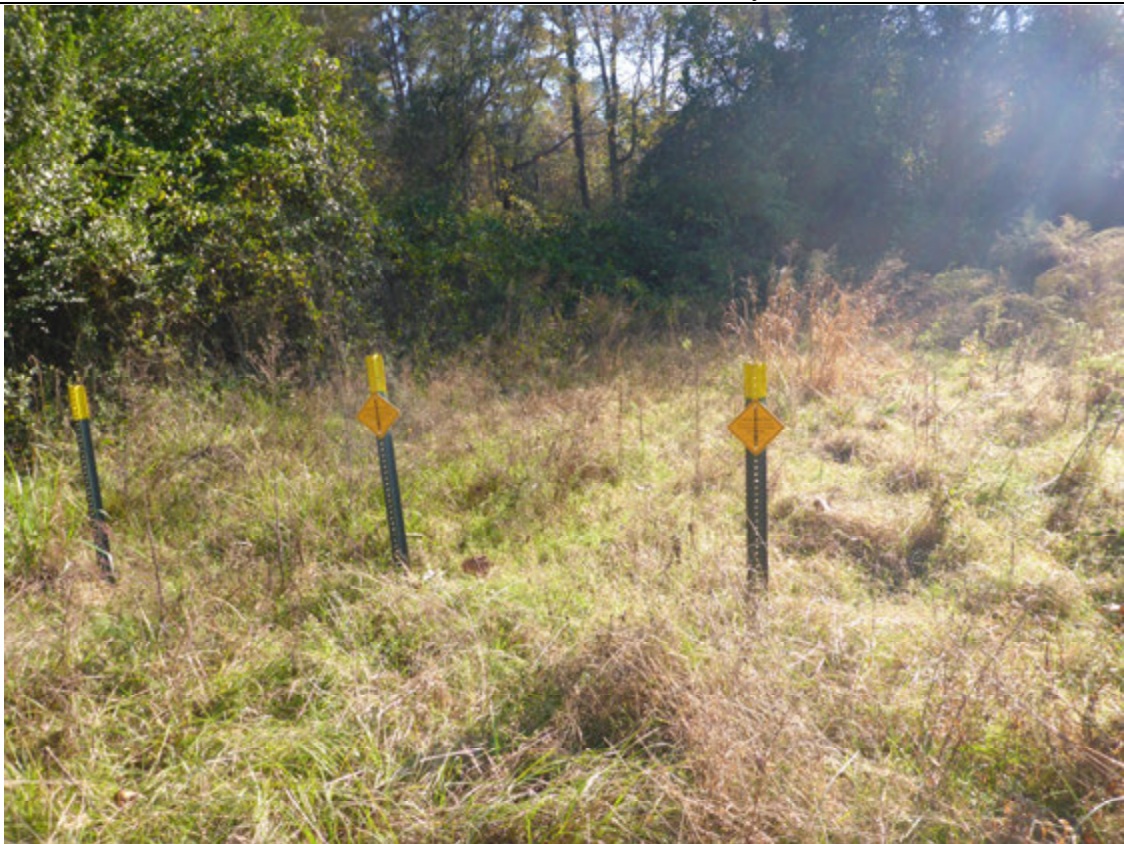
WP6 (November 12, 2015)  
Secondary barrier constructed in easement encroachment

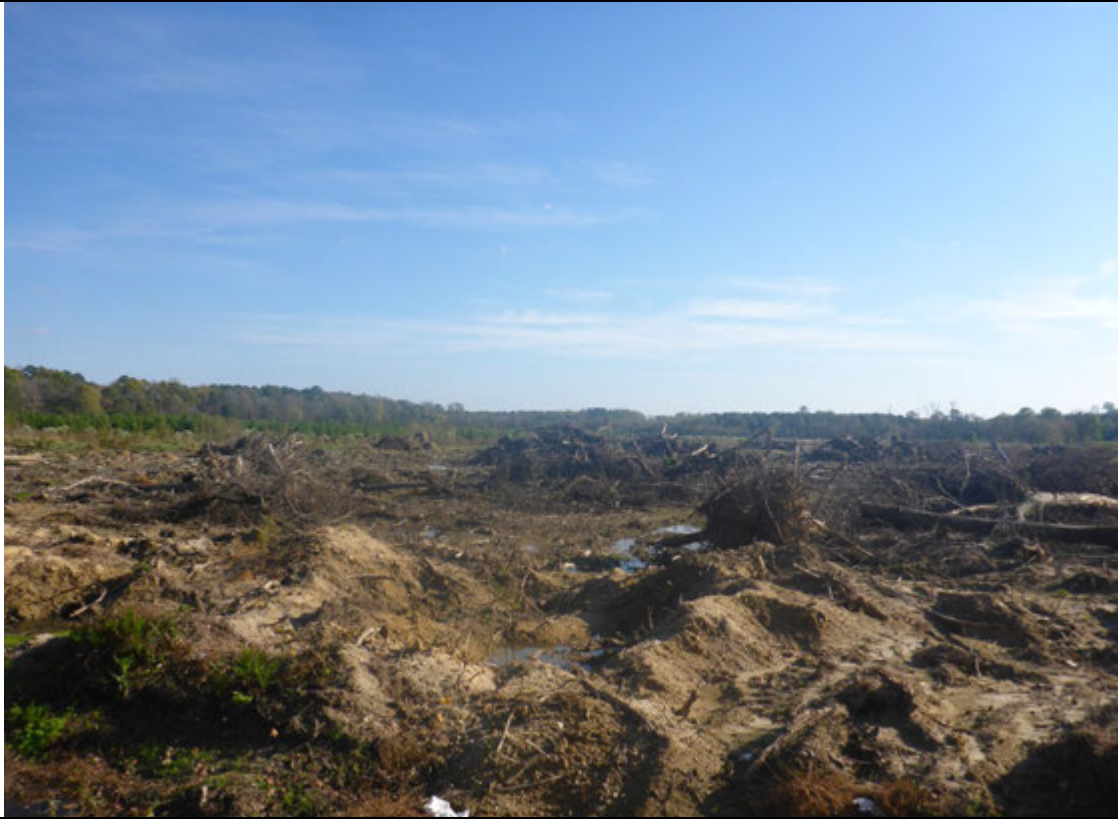
WP7 (November 12, 2015)

The adjacent tract has historically been a remnant mature floodplain forest, however the tract was timbered in MY5. Site 725 is located along the tree line visible at the back of the photo.

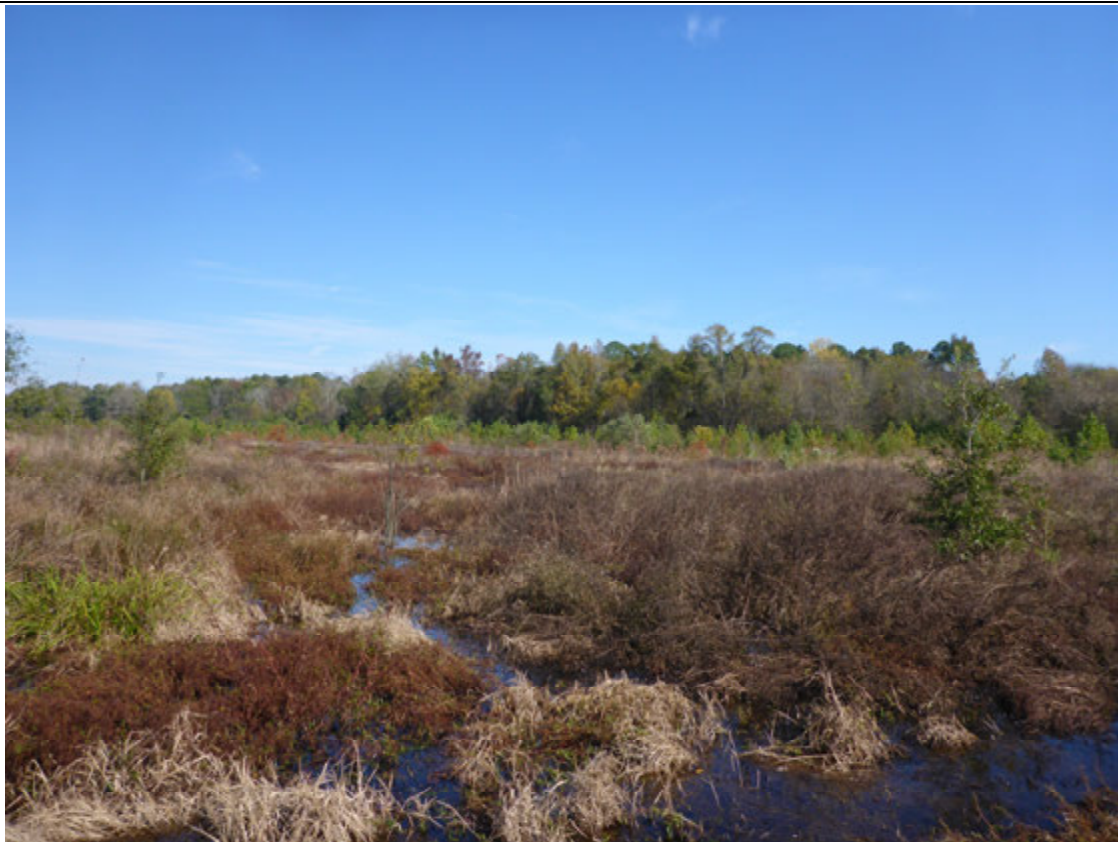
WP8 (November 12, 2015)

Woody vegetation is establishing well in the wetland swale in the southeastern quadrant of site.

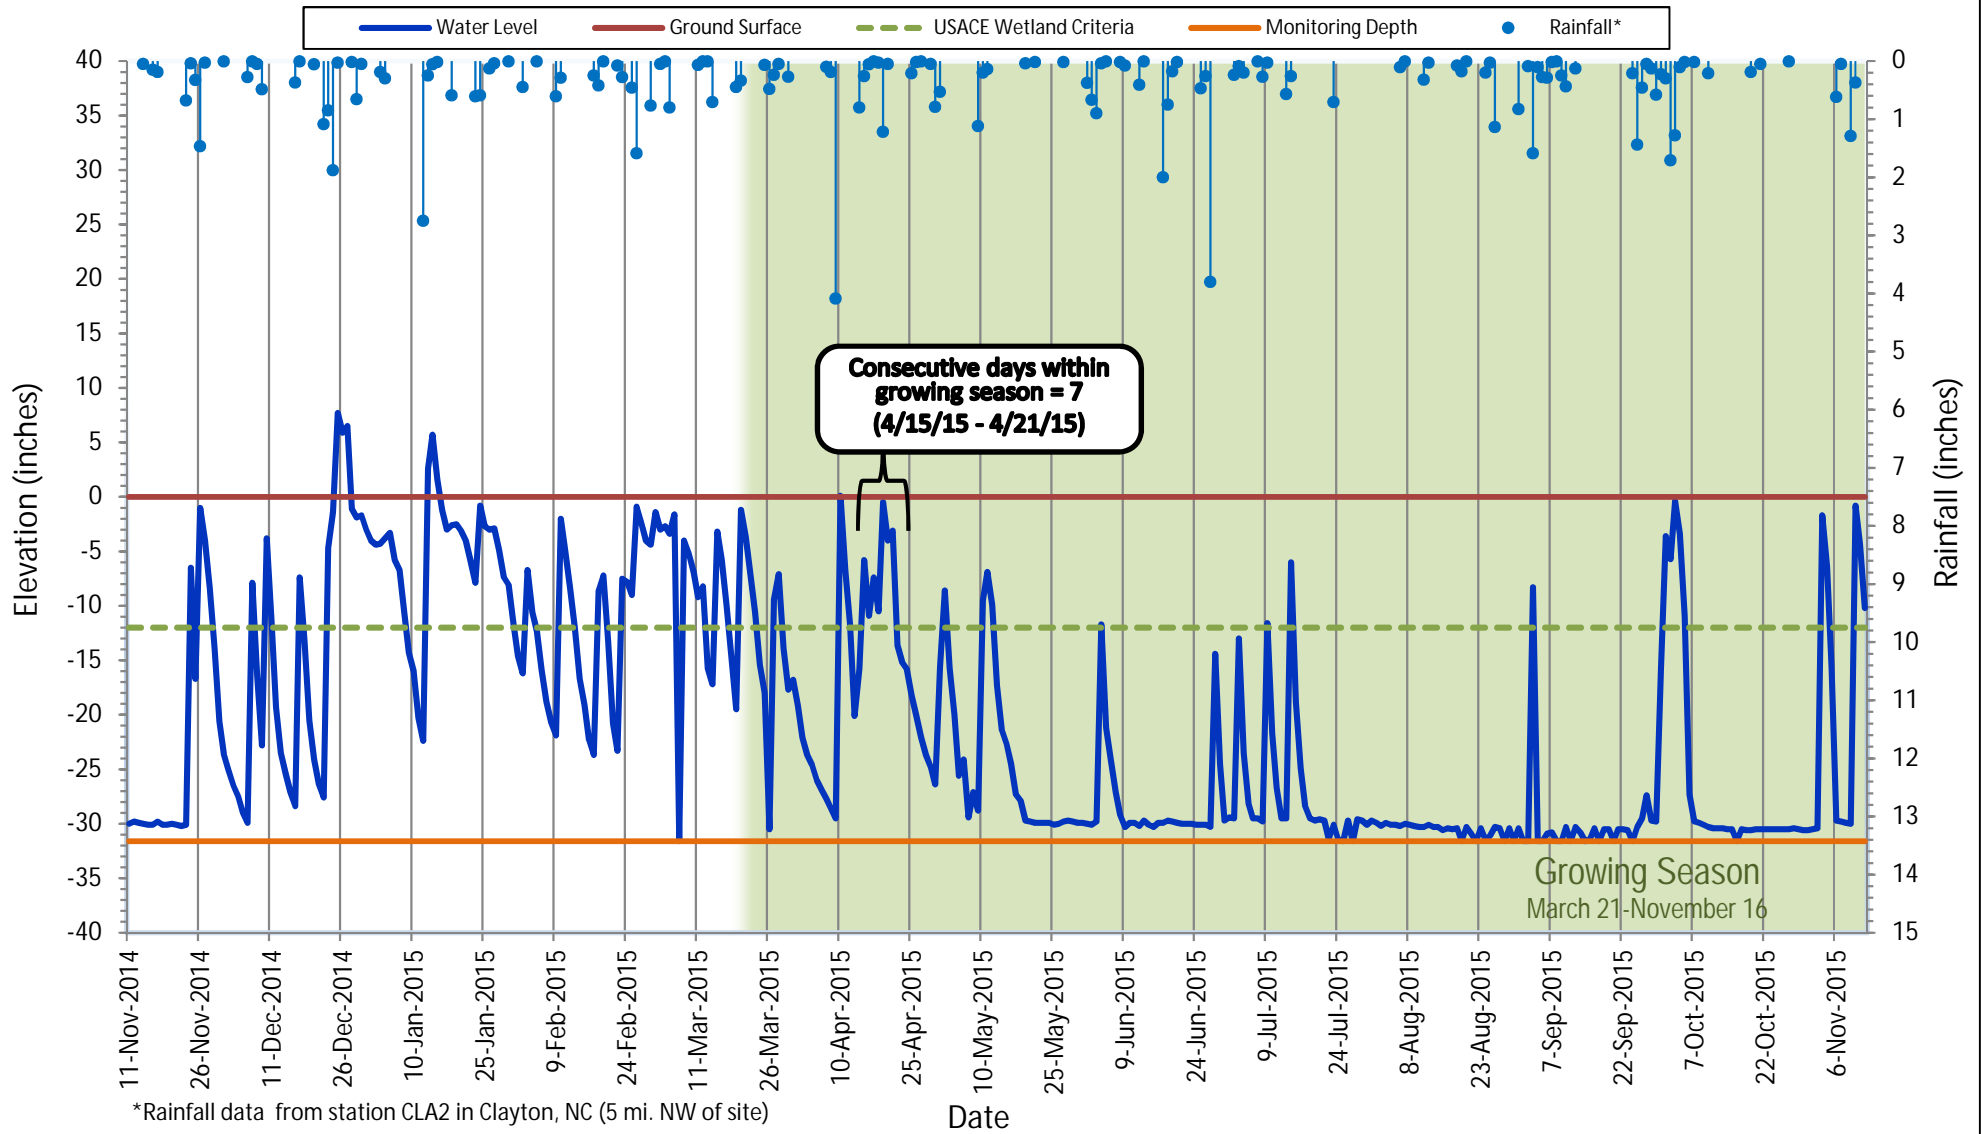
# Shallow Water Table Gauge F2

The remaining gauges that did not meet minimum criteria are F2 and C4. Gauge F2 is located at the upper end of the drainage swale carrying flood flows from Swift Creek. This gauge was not inundated by flooding during the growing season in MY5 as had occurred during MY4. However, it is anticipated that through future flooding events within Swift Creek and continued natural expansion of the berm breaches, Gauge F2 will see more regular and sustained wetland hydrology. Gauge C4 failed from the beginning of the growing season until being and did not collect any groundwater data for that period, but was successfully replaced early in July. Water levels at gauge C4 were near the ground surface towards the end of the growing season, but not for a long enough period to meet the minimum success criteria.

% of growing season		0.00%	0.41%	2.9%	3.3%	5.0%	
Criteria met?		N/A	N	N	N	N	
<b>Groundwater Gauge F2</b>							
Consecutive days within range	124.2'	4	6	2	8	7	Gauge F2 indicates frequent and rapid variation in response to rainfall events, with ten peaks recorded above the 12" USACE wetland criteria throughout the growing season.
% of growing season		1.66%	2.49%	0.8%	3.3%	2.9%	
Criteria met?		N	N	N	N	N	
<b>Groundwater Gauge A3</b>							
Consecutive days within range	123.8'	103	93	231	237	148	Gauge A3 failed at some point towards the end of May. The water levels were sustained above the ground surface until the gauge failed. Surface water was observed to depths of 2'-4" at this gauge during every site visit during monitoring year 2015.
% of growing season		42.74%	38.59%	95.9%	98.3%	61.4%	
Criteria met?		Y	Y	Y	Y	Y	
<b>Groundwater Gauge B3</b>							
Consecutive days within range	123.7'	45	21	25	48	46	Water level at gauge B3 was sustained at or above the ground surface through early May, but was drawn down below 12" USACE wetland criteria depth by early May. Water level peaked above the 12" mark six times through the remainder of the growing season.

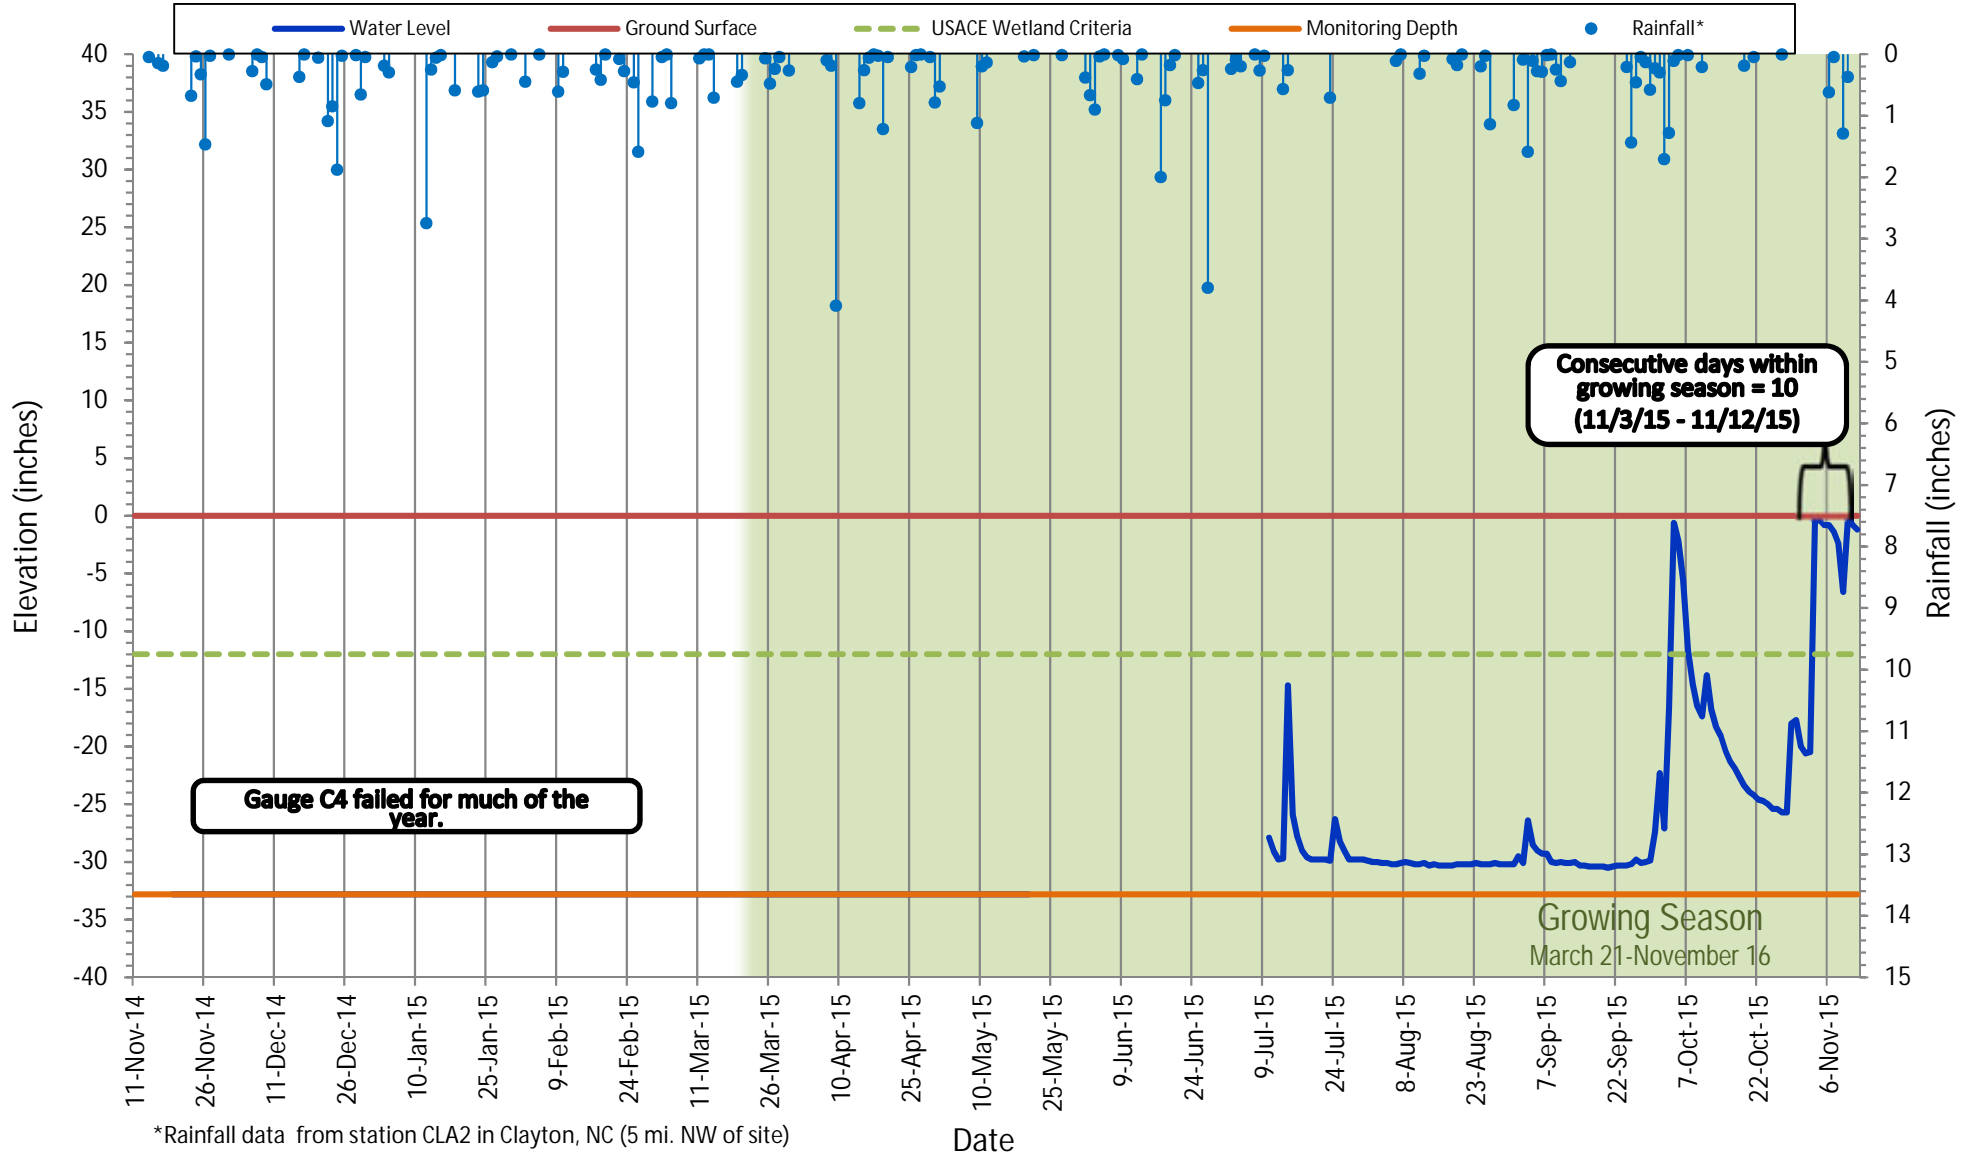
# Shallow Water Table Gauge C4

In MY5, six gauges (A3, C4, B5, REF-B, REF-C, and REF-D) experienced failures resulting in data loss. Gauges A3 and B5 experienced failures in the later months of the growing season, but still met success criteria March 21 and late June. Gauge C4 failed from the beginning of the growing season until July, and did show water levels near the ground surface towards the end of the growing season but did not meet the minimum success criteria.

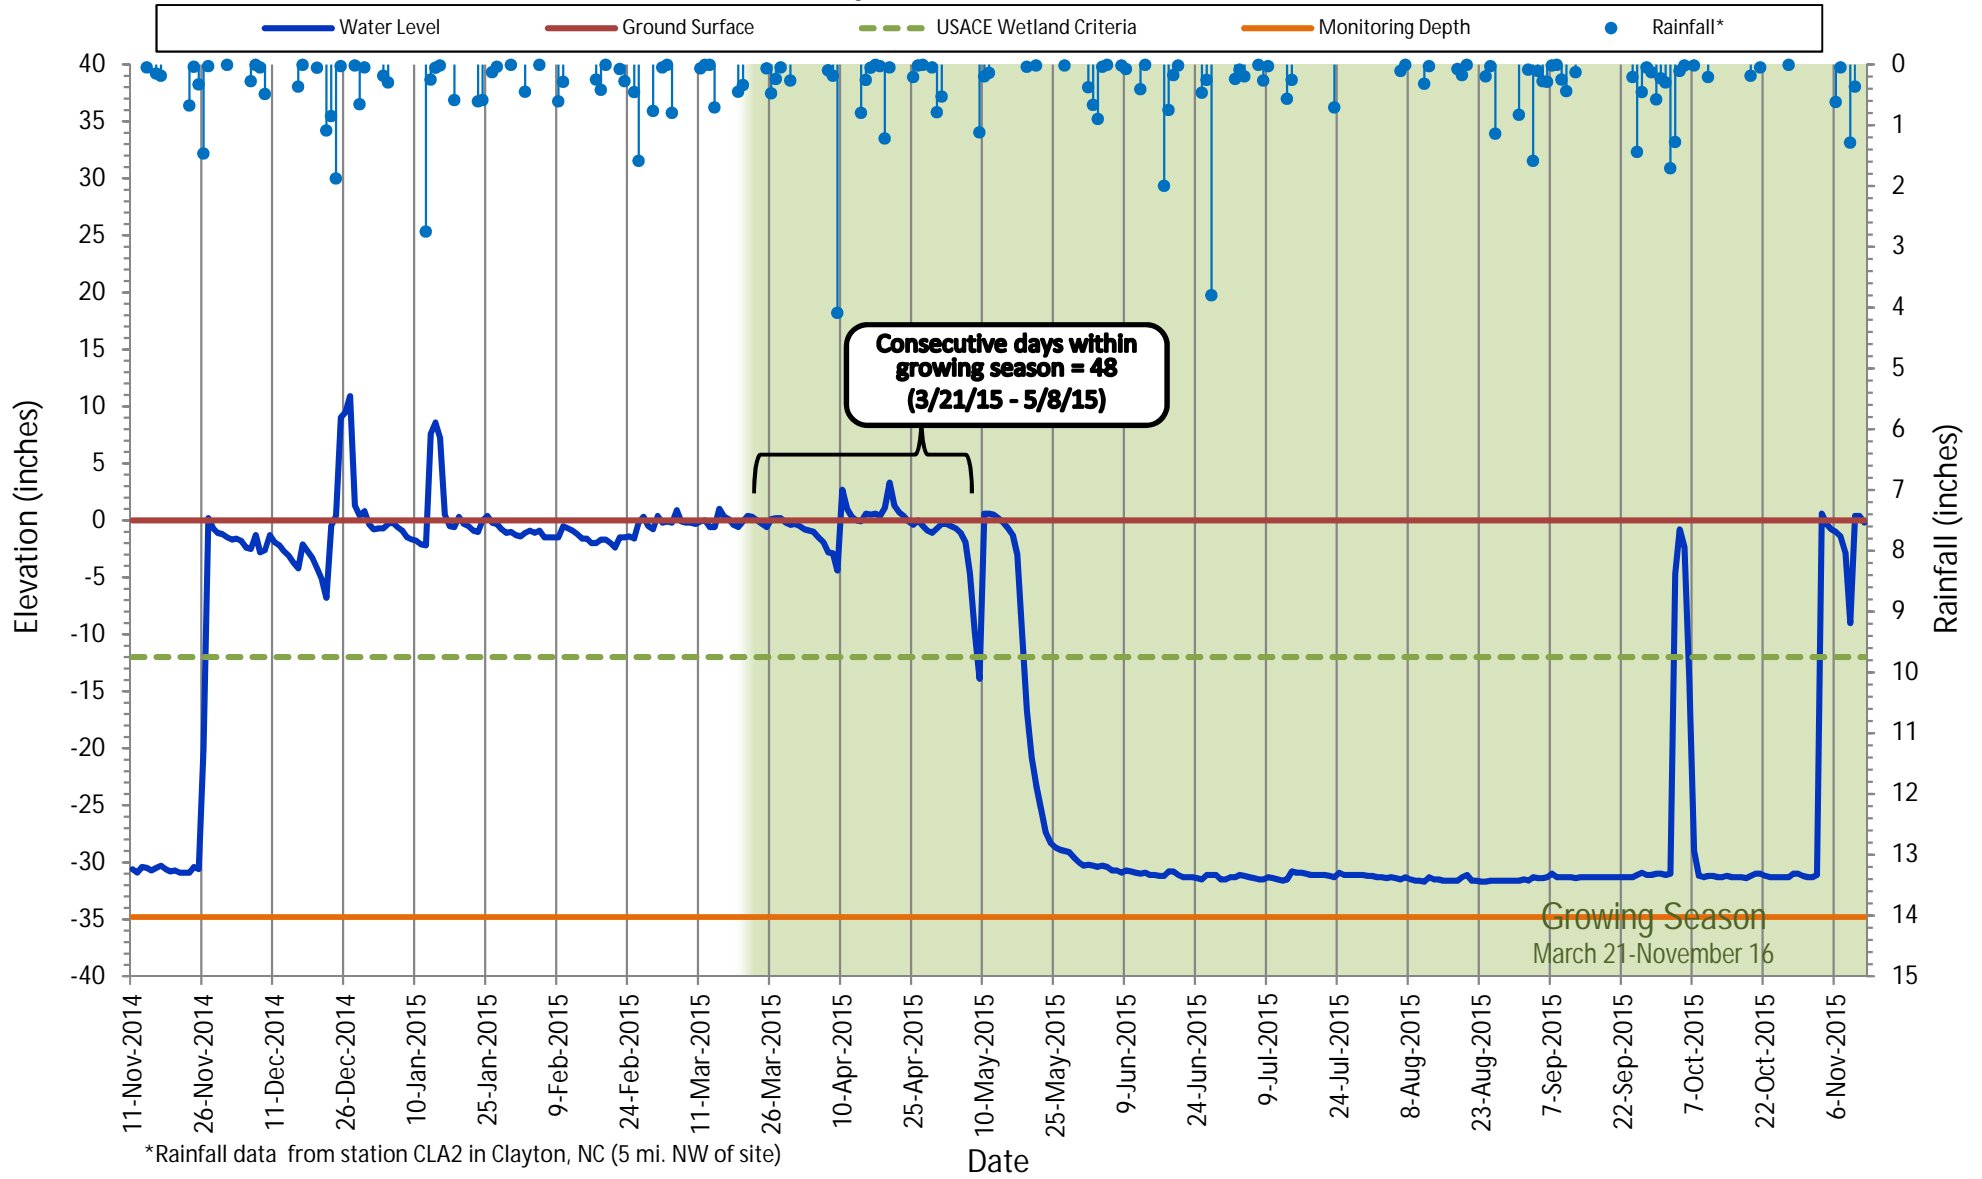
# Shallow Water Table Gauge G4

% of growing season		1.66%	0.41%	7.5%	6.6%	7.9%	
Criteria met?		N	N	Y	N	N	
<b>Groundwater Gauge G4</b>							
Consecutive days within range	123.5'	11	8	25	25	48	The water table at gage G4 was at or above the ground surface for much of the first few months in the growing season. Water level dipped below the 12" mark in mid-May and stayed below until peaking above 12" two times late in the growing season.
% of growing season		4.56%	3.32%	10.4%	10.4%	19.9%	
Criteria met?		N	Y	Y	N	Y	
<b>Groundwater Gauge B5</b>							
Consecutive days within range	123.4'	6	26	66	52	62	Gauge B5 failed and no data was recorded after July 9. However, water level was mostly above ground level until mid-May.
% of growing season		2.49%	10.79%	27.4%	21.6%	25.7%	
Criteria met?		N	Y	Y	Y	Y	
<b>Groundwater Gauge N1</b>							
Consecutive days within range	126'	N1 installed spring MY4			4	3	Water levels were low throughout the year, with water levels peaking briefly above the 12" USACE wetland criteria only three times during the growing season.

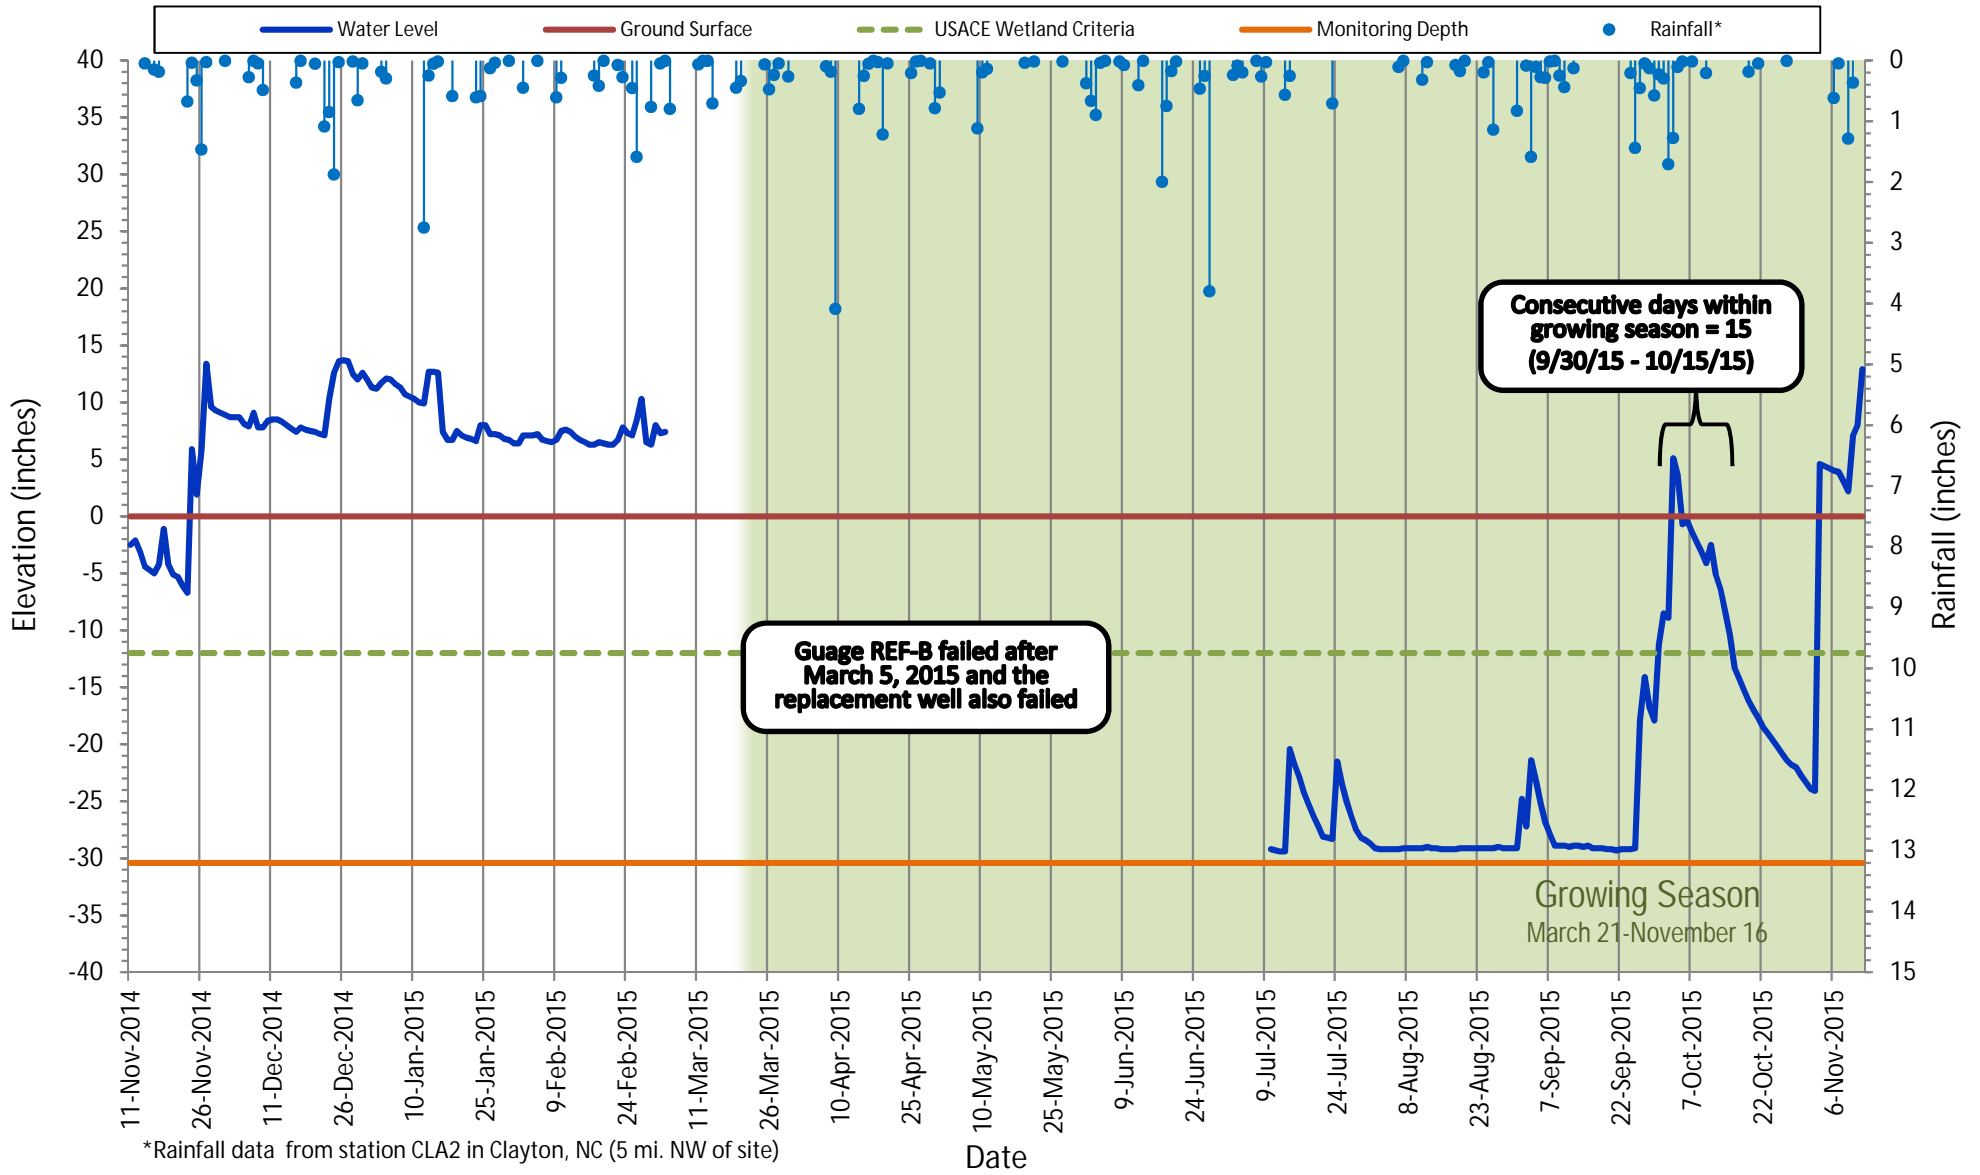
# Shallow Water Table Gauge REF-B

Ground Elevation*	2009	2010	MY1 2011	MY2 2012	MY3 2013	MY4 2014	MY5 2015	Notes
<b>Groundwater Gauge REF-B</b>	124'	34	29	44	2	35	53	15	Floodplain depression, depends on flood events from Swift Creek, which appears to have occurred multiple times during 2015. Sediment deposits on trees adjacent to the reference wells indicate inundation of 2-3' in the wetland interior. Gauge REF-B failed from March 5-July 10.
<b>Consecutive days within range<sup>1</sup></b>		14.11%	12.03%	18.26%	0.83%	14.52%	21.99%	6.22%	
<b>% of growing season<sup>2</sup></b>		Y	Y	Y	N	Y	Y	Y	
<b>Criteria met<sup>3</sup>?</b>									
<b>Groundwater Gauge REF-C</b>	124'	35	30	45	2	33	53	56	Gauge REF-C was inundated through the end of 2014 until early late April 2015. The gauge failed after July 9, 2015 and no data was collected for the remainder of the year.
<b>Consecutive days within range</b>		14.52%	12.45%	18.67%	0.83%	13.69%	21.99%	23.24%

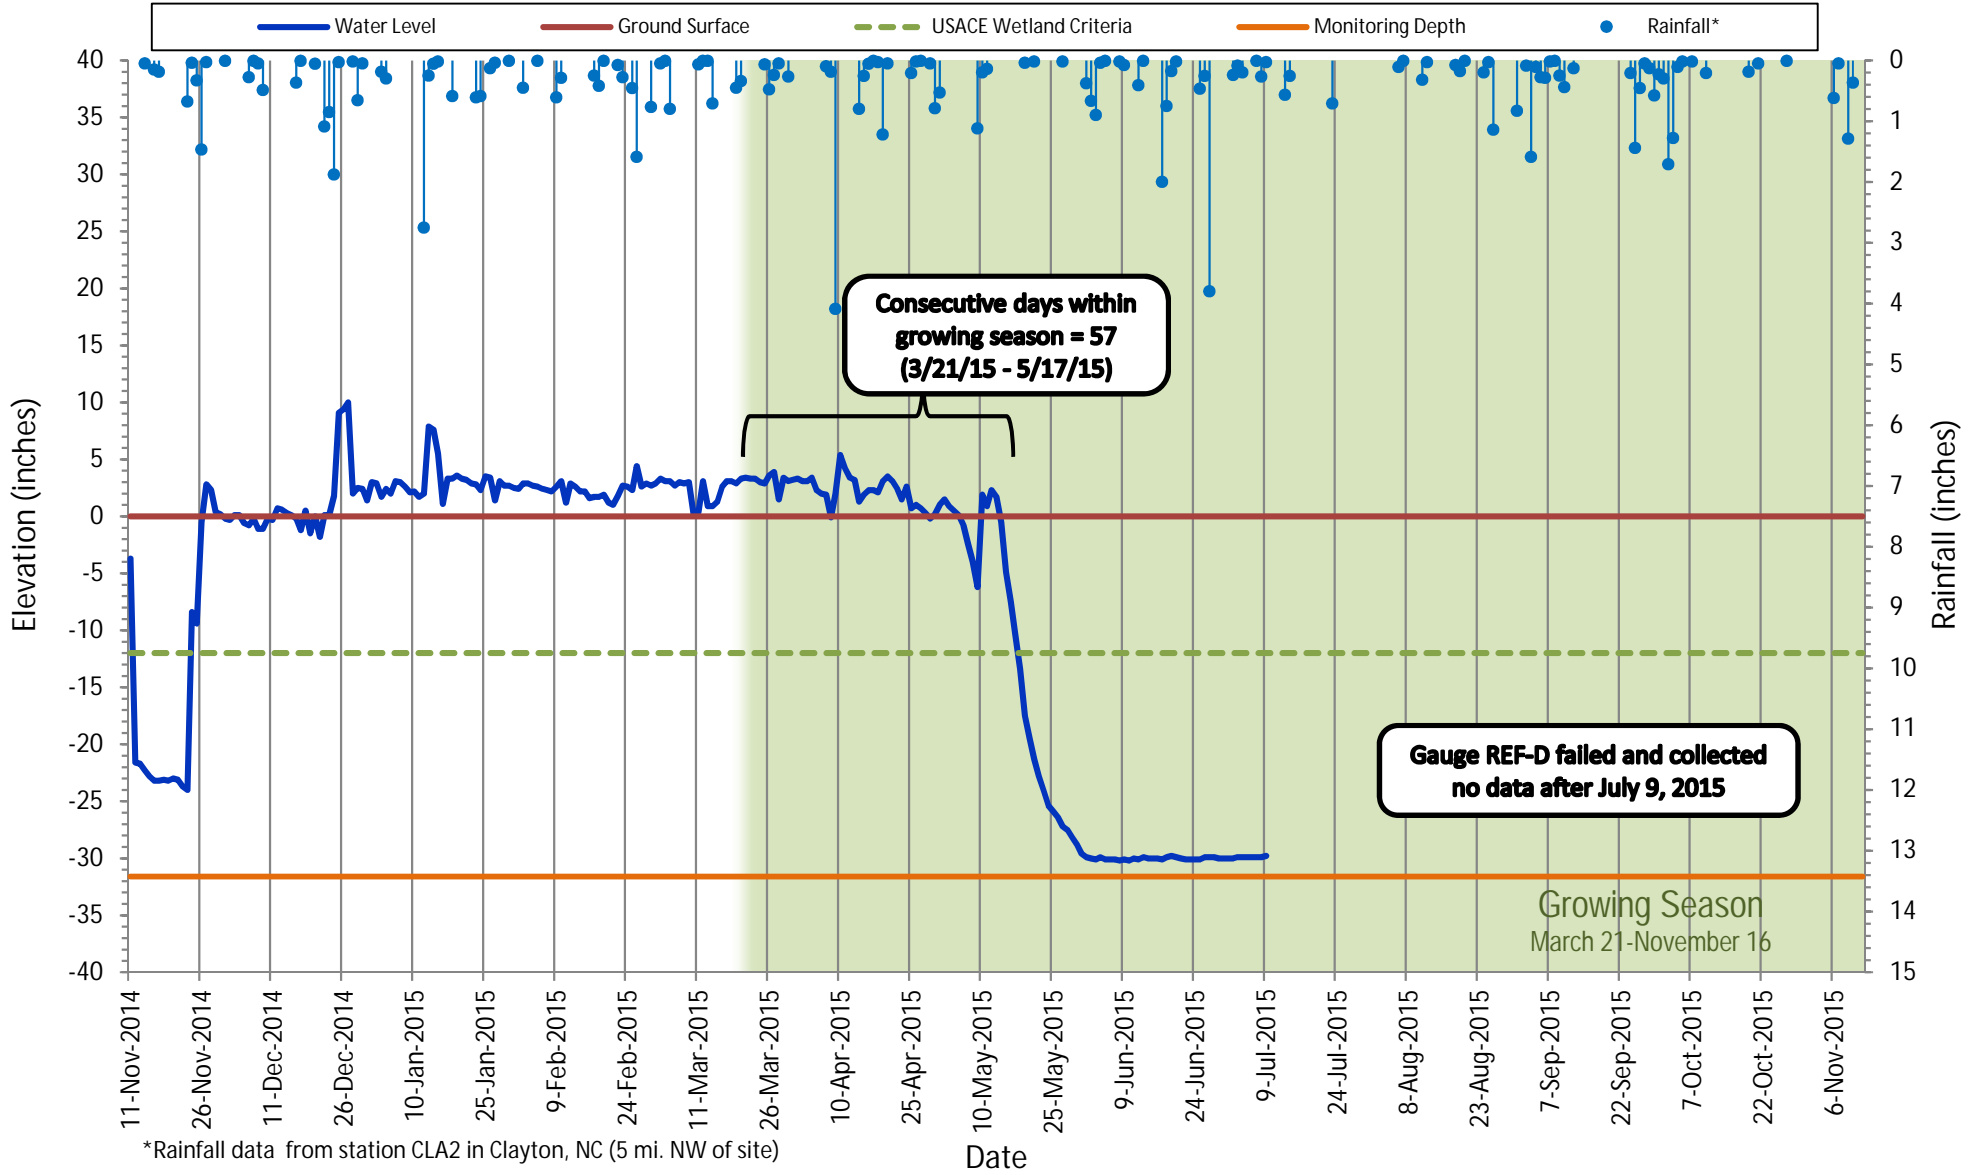
# Shallow Water Table Gauge REF-D

<b>% of growing season</b>		Y	Y	Y	N	Y	Y	Y	
<b>Criteria met?</b>									
<b>Groundwater Gauge REF-D</b>	124'	43	--	--	22	62	91	57	Gauge REF-C was inundated through the end of 2014 until early late April 2015. The gauge failed after July 9, 2015 and no data was collected for the remainder of the year.
<b>Consecutive days within range</b>		17.84%	--	--	9.13%	25.73%	37.76%	23.65%	
<b>% of growing season</b>		Y	--	--	Y	Y	Y	Y	
<b>Criteria met?</b>									
<b>Groundwater Gauge REF-E</b>	123'	33	--	--	22	19	49	47	Water table was at or above the surface from November 2014 through mid-May 2015. Water levels dipped below the 12" USACE wetland criteria in mid-May and did not rise above again until November.
<b>Consecutive days within range</b>		13.69%	--	--	9.13%	7.88%	20.33%	19.50%	
<b>% of growing season</b>		Y	--	--	Y	Y	Y	Y	
<b>Criteria met?</b>									
<b>Groundwater Gauge REF-F</b>	123'	34	27	39	23	28	49	47	Water table was at or above the surface from November 2014 through early May 2015. Water levels dipped below the 12" USACE wetland criteria in early May and did not rise above again until October.
