**MITIGATION PLAN – FINAL**

**Moore's Fork Stream Restoration Project  
Surry County, North Carolina  
EEP Project No. 94709**

Upper Yadkin River Basin  
Cataloging Unit 03040101

**Confluence Engineering, PC  
16 Broad Street  
Asheville, NC 28801  
828.255.5530**

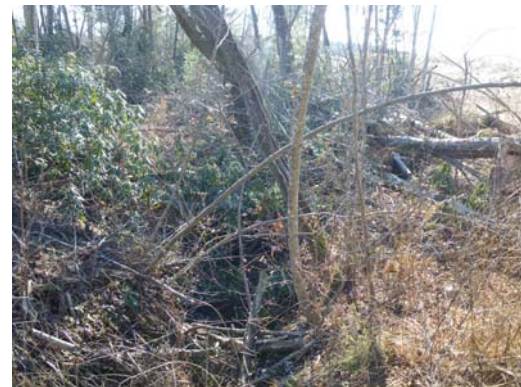
Corn Tributary, looking downstream from upstream end; logging damage;  
February 8, 2011

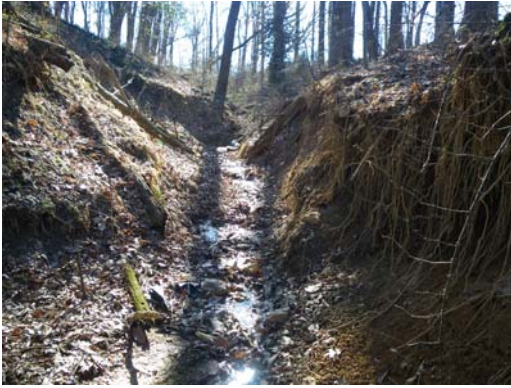
Silage Tributary, looking upstream at headwaters; channel incision and bank erosion; February 8, 2011

Landowners indicated that an on-line pond was once present in the Silage Tributary channel, but the precise location of the former pond is not known. Removal of the dam and rapid drawdown of the impoundment may have also initiated some headcut erosion. Given the relatively small size of the watersheds, it is likely that these streams were once shorter and the bank heights much lower than they are now, with hydrology governed by groundwater rather than runoff. It appears that the changing flow regime began the incision and degradation, and buffer deforestation and cattle trampling exacerbated the problems. The upstream end of UT1 exhibits characteristics similar to the Cow tributaries, but the degradation over its downstream reach is less severe.

The downstream 850 LF of the Silage Tributary flows through a flatter and slightly wider valley; here the evolutionary sequence (C to F) is similar to that observed in Moores Fork, with bank erosion and lateral migration ongoing. As with Moores Fork, this lateral migration will likely continue without intervention.

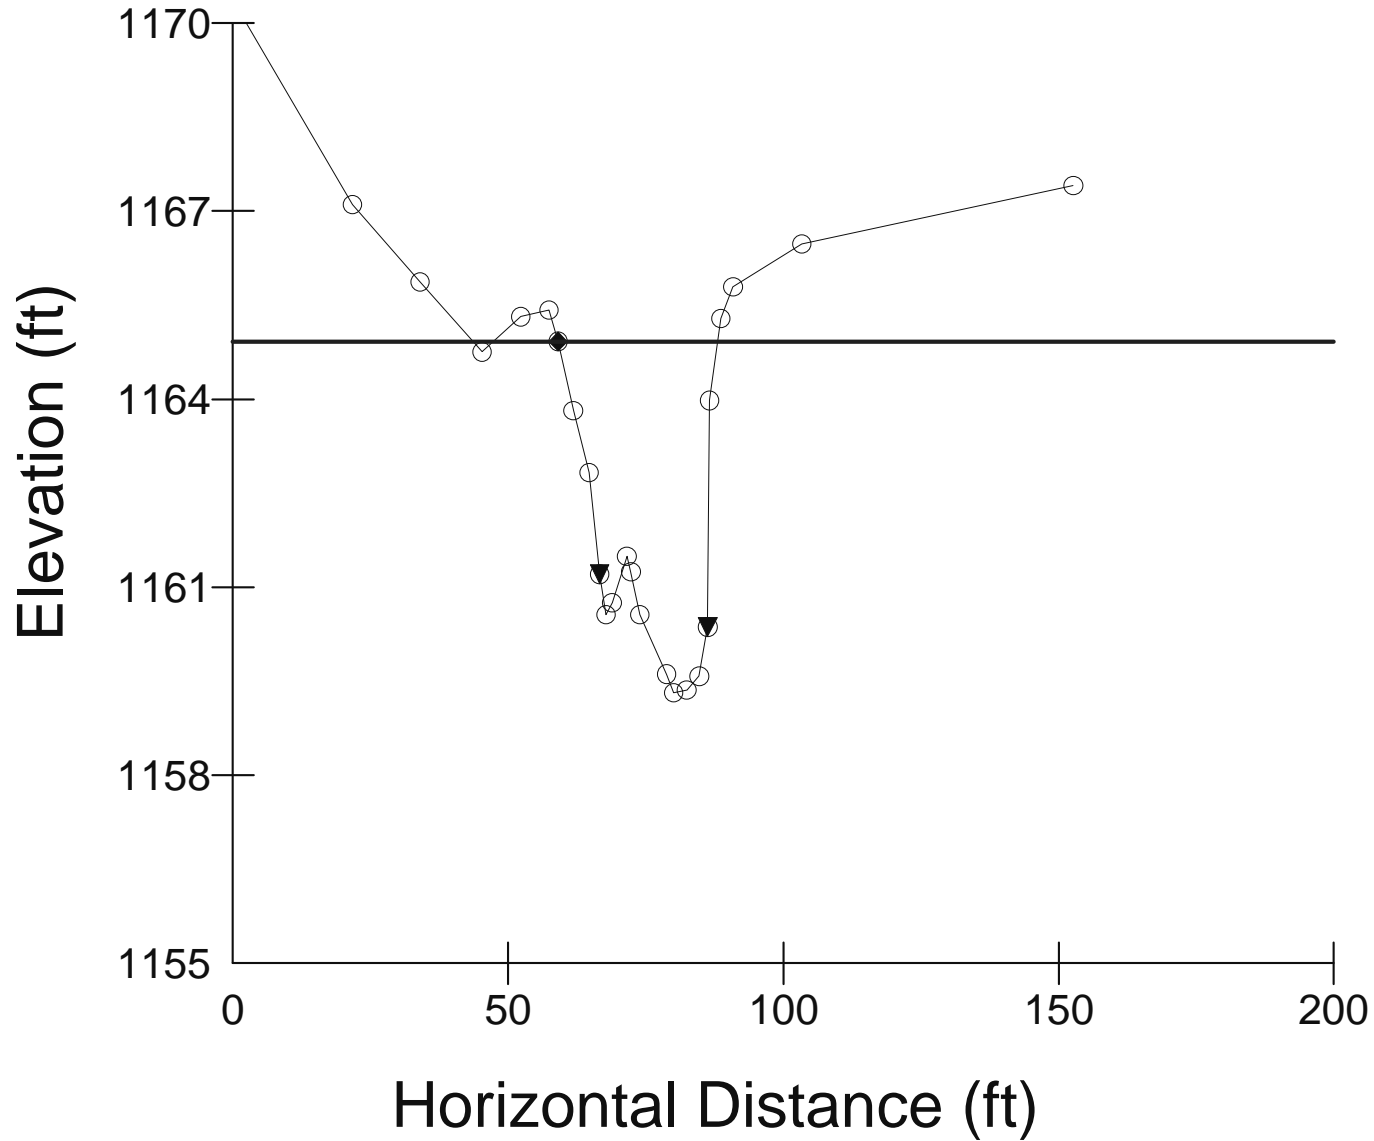
# XS-M1.3

Wbkf = 27.3    Dbkf = 1.72    Abkf = 46.9
