MITIGATION PLAN

**Morgan Branch Restoration Site
Buncombe County, North Carolina
RFP# 16-007724 (Issued: 3/1/19)
DMS Project Number 100127
DMS Contract 7909
USACE Action ID: SAW-2018-01163
DWR #: 20181030**

**French Broad River Basin
Cataloging Unit 06010105**

Prepared for:
NC Department of Environmental Quality
Division of Mitigation Services
1652 Mail Service Center
Raleigh, NC 27699
May 2024

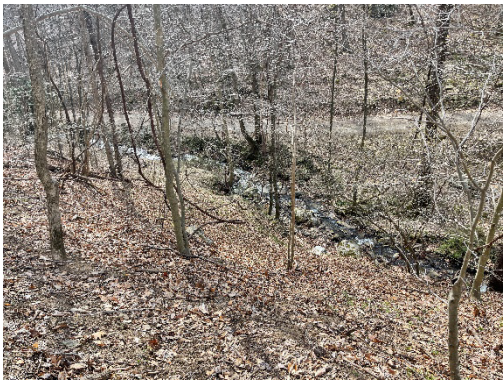
MB-2 looking downstream. There is an access road along the right bank.

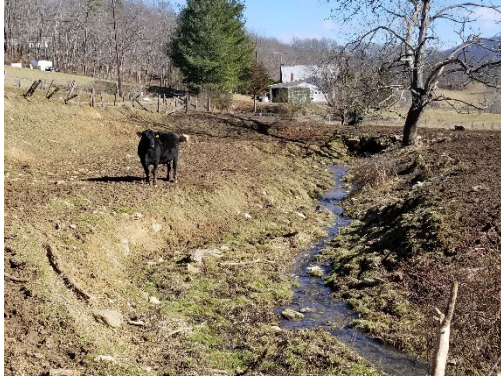
MB-3 looking downstream as it flows through an active cattle field.

After MB exits the forested area, MB Reach 3 begins and continues east and shortly after flows through a 4' CMP as it crosses under a road again. The right bank contains a thin canopy consisting of mature trees. The landowners have constructed a small timber deck pad immediately adjacent to the stream along this reach. MB Reach 3 continues to flow east for another 775 feet, where it reaches the open area of the valley. This reach is severely impacted by cattle, resulting in inconsistent bed and channel form, signs of instability, and fine sediment from bank erosion compromising stream function. There is no forested riparian buffer located along this section of the reach. This area also contains a small emergent wetland, W4 (0.07 acre), which has been impacted by cattle trampling and a reduced hydroperiod by the disconnected stream.

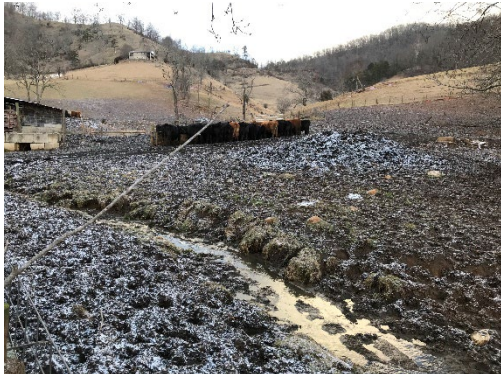
T4 looking upstream as it flows through an active cattle field.

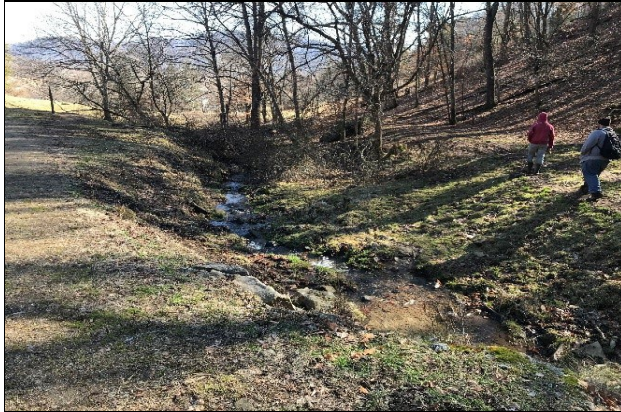
Photo 1: Cattle-impacted channel. Morgan Branch – enhancement reach. 1/24/2018

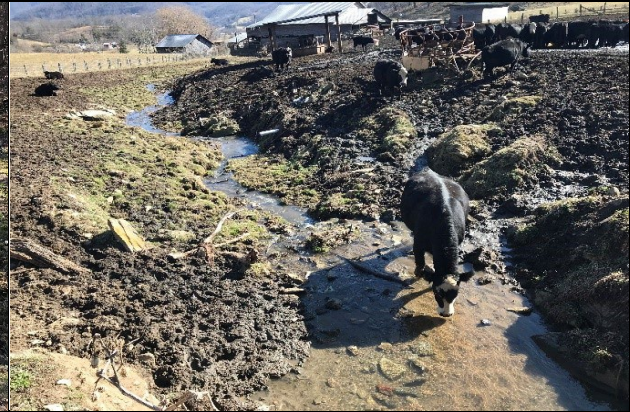
Photo 2: Cattle-impacted channel. Morgan Branch – restoration reach. 1/24/2018

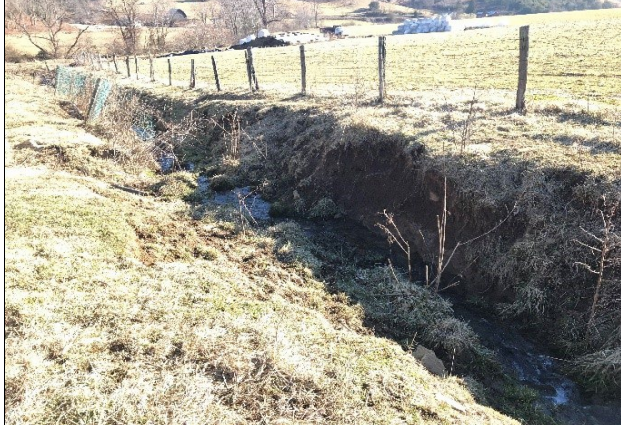
Photo 3: Channelized portion of T1. 1/24/2018

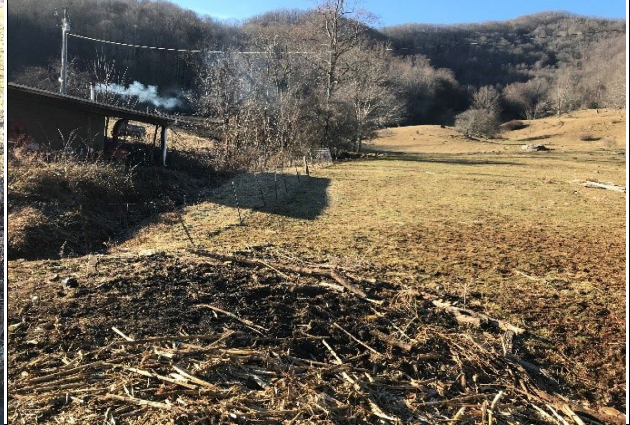
Photo 4: Channelized portion of T2. 1/24/2018

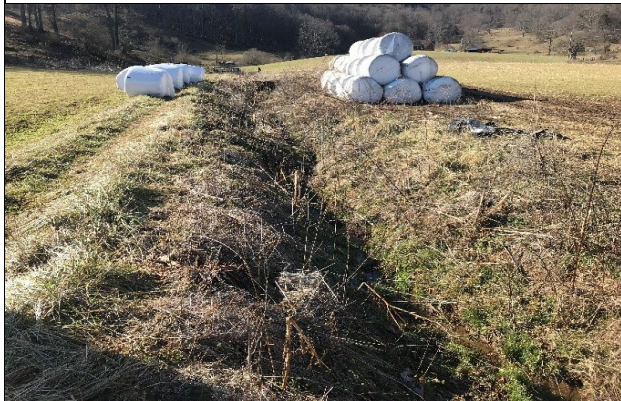
Photo 5: Channelized portion of T3. 1/24/2018

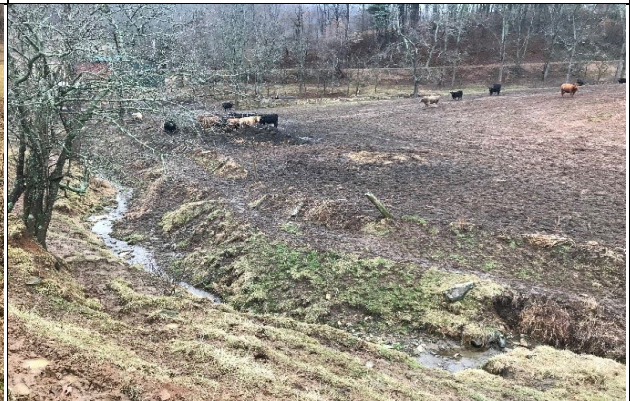
Photo 6: Highly incised and cattle impacted channel along T4. 1/24/2018

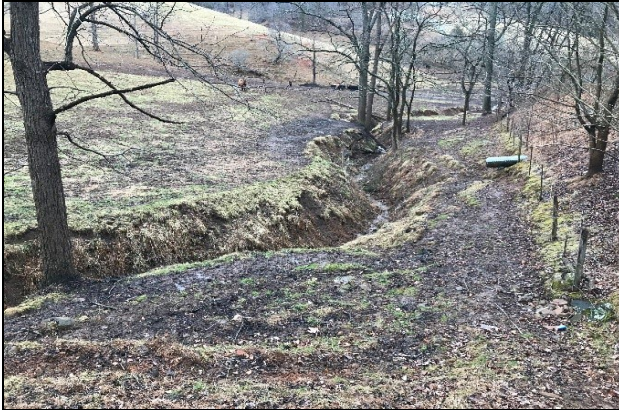
Photo 7: Highly incised and cattle impacted channel along T4-2. 1/24/2018

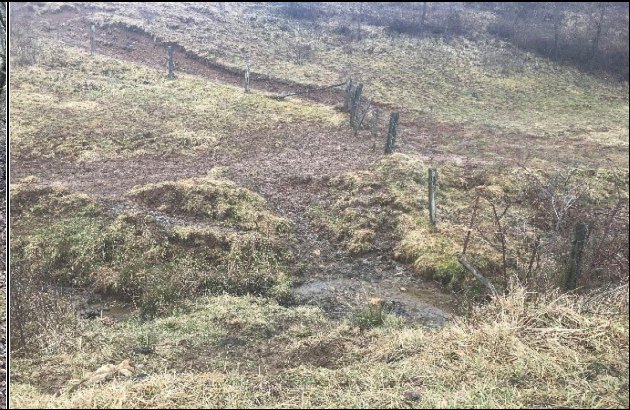
Photo 8: Cattle crossing/wallow along T5. 1/24/2018

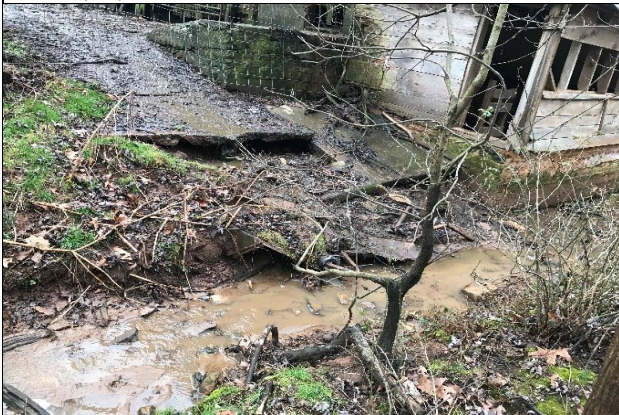
Photo 9: Cattle feed lot runoff spilling into T7. 1/24/2018

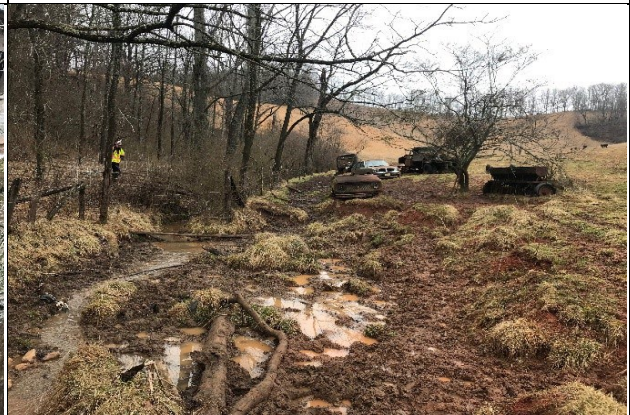
Photo 10: Cattle crossing/wallow along T7. 1/24/2018

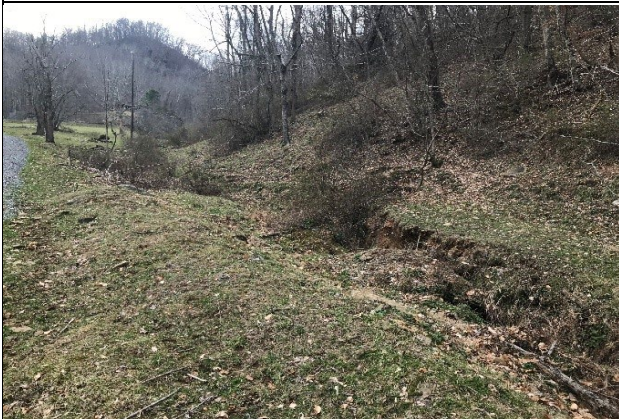
Photo 11: Erosion and instability along T9. 1/24/2018

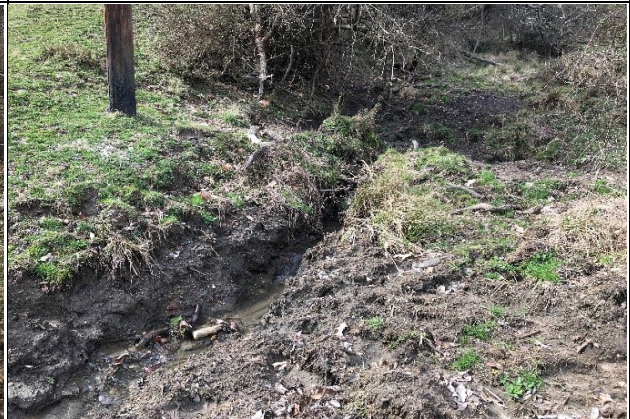
Photo 12: Headcut and erosion along T8. 1/24/2018

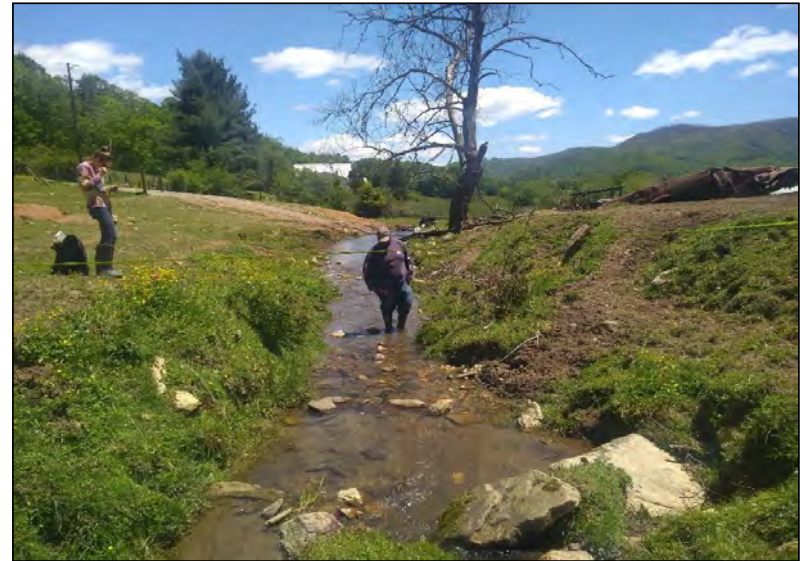
River Basin:	French Broad
Site	Morgan Branch
XS ID	XSA
Drainage Area (sq mi):	0.54
Date:	5/11/2020
Field Crew:	T. Seelinger, A. Gutierrez

Station	Elevation
0.0	2303.64
6.6	2300.81
13.2	2299.98
20.4	2299.72
28.5	2299.24
32.1	2298.66
33.8	2298.30
36.0	2296.35
36.2	2294.65
38.1	2294.43
39.3	2294.35
41.1	2294.51
42.7	2294.43
43.9	2294.70
44.7	2295.24
46.6	2296.30
48.1	2296.47
50.1	2297.07
51.8	2298.07
52.0	2298.08
55.4	2300.11
58.3	2300.32
66.1	2300.75
93.9	2301.95

SUMMARY DATA	
Bankfull Elevation (ft):	2295.7
Bankfull Cross-Sectional Area (ft²):	10.2
Bankfull Width (ft):	9.4
Flood Prone Area Elevation (ft):	2297.0
Flood Prone Width (ft):	14.8
Max Depth at Bankfull (ft):	1.3
Mean Depth at Bankfull (ft):	1.1
W / D Ratio:	8.7
Entrenchment Ratio:	1.6
Bank Height Ratio:	2.9

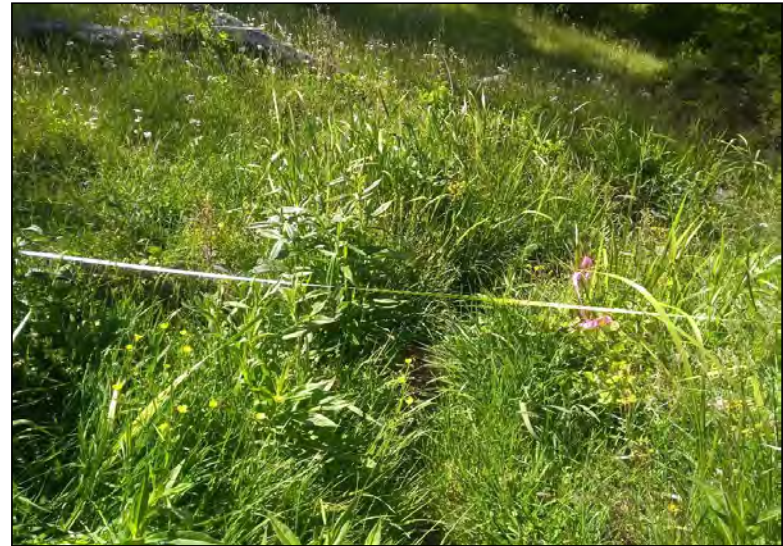
French Broad River Basin, Morgan Branch, T1 XSA

River Basin:	French Broad
Site	Morgan Branch
XS ID	T1 XSA
Drainage Area (sq mi):	0.13
Date:	5/11/2020
Field Crew:	T. Seelinger, A. Gutierrez

Station	Elevation
0.0	2594.89
5.2	2593.38
10.1	2593.14
13.4	2591.69
14.9	2591.75
16.0	2591.74
16.8	2590.57
17.9	2590.33
18.5	2589.92
19.0	2589.64
19.7	2589.48
20.1	2589.50
20.8	2589.59
21.4	2590.60
22.4	2590.70
24.6	2590.67
30.4	2590.46
37.2	2590.38
40.5	2590.07

SUMMARY DATA	
Bankfull Elevation (ft):	2590.37
Bankfull Cross-Sectional Area (ft²):	2.1
Bankfull Width (ft):	3.5
Flood Prone Area Elevation (ft):	2591.3
Flood Prone Width (ft):	24.1
Max Depth at Bankfull (ft):	0.9
Mean Depth at Bankfull (ft):	0.6
W / D Ratio:	5.9
Entrenchment Ratio:	6.9
Bank Height Ratio:	1.3

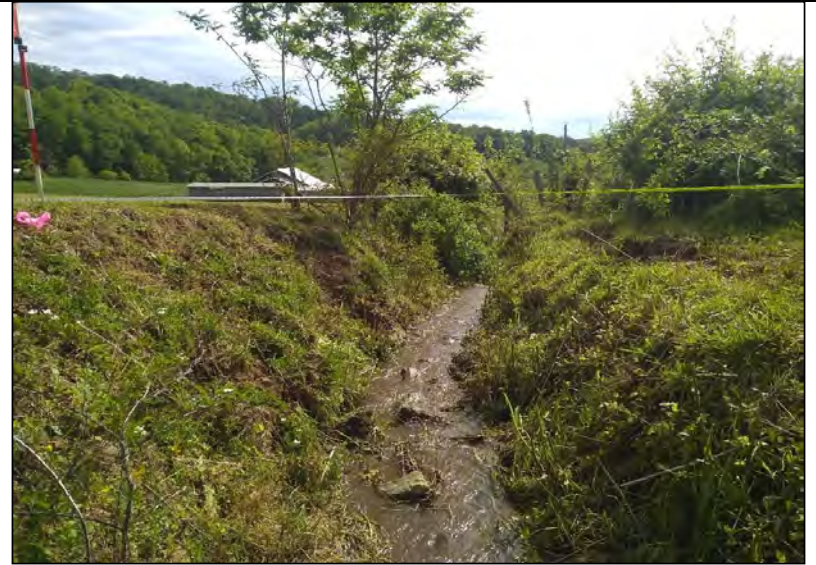
River Basin:	French Broad
Site	Morgan Branch
XS ID	T1 XSB
Drainage Area (sq mi):	0.16
Date:	5/12/2020
Field Crew:	T. Seelinger, A. Gutierrez

Station	Elevation
0.0	2329.94
20.5	2328.78
27.4	2329.06
33.9	2329.17
36.9	2328.98
39.1	2328.07
40.4	2326.02
41.5	2325.29
42.0	2324.70
42.7	2324.59
44.0	2324.62
44.8	2324.51
45.2	2324.58
45.5	2324.86
46.3	2325.95
47.7	2327.50
49.0	2328.11
50.9	2328.68
52.9	2329.10
54.5	2329.33
58.9	2329.37
67.0	2329.79
80.2	2330.03

SUMMARY DATA	
Bankfull Elevation (ft):	2325.4
Bankfull Cross-Sectional Area (ft²):	3.2
Bankfull Width (ft):	4.7
Flood Prone Area Elevation (ft):	2326.3
Flood Prone Width (ft):	6.4
Max Depth at Bankfull (ft):	0.9
Mean Depth at Bankfull (ft):	0.7
W / D Ratio:	6.7
Entrenchment Ratio:	1.4
Bank Height Ratio:	3.3

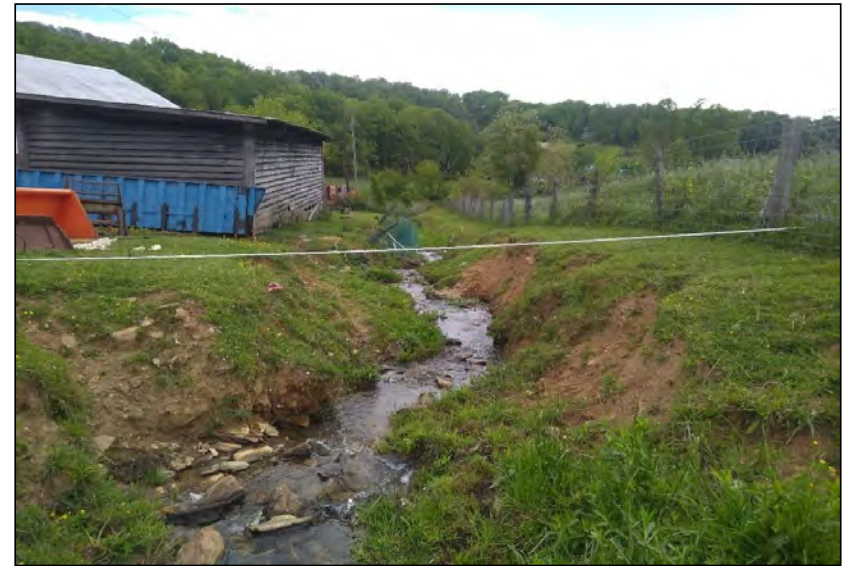
River Basin:	French Broad
Site	Morgan Branch
XS ID	T1 XSC
Drainage Area (sq mi):	0.16
Date:	5/12/2020
Field Crew:	T. Seelinger, A. Gutierrez

Station	Elevation
0.0	2289.43
12.8	2288.84
20.2	2288.70
25.7	2288.35
27.7	2287.98
29.2	2286.54
29.9	2285.13
30.3	2285.00
31.2	2285.00
31.3	2284.94
31.9	2284.69
32.8	2284.87
33.7	2284.93
34.1	2285.09
34.6	2286.07
36.8	2288.45
38.4	2288.92
41.7	2289.18
42.7	2289.22
47.9	2289.29
57.2	2289.53
69.0	2290.18

SUMMARY DATA	
Bankfull Elevation (ft):	2285.7
Bankfull Cross-Sectional Area (ft²):	3.6
Bankfull Width (ft):	4.8
Flood Prone Area Elevation (ft):	2286.7
Flood Prone Width (ft):	6.2
Max Depth at Bankfull (ft):	1.0
Mean Depth at Bankfull (ft):	0.7
W / D Ratio:	6.5
Entrenchment Ratio:	1.3
Bank Height Ratio:	3.2

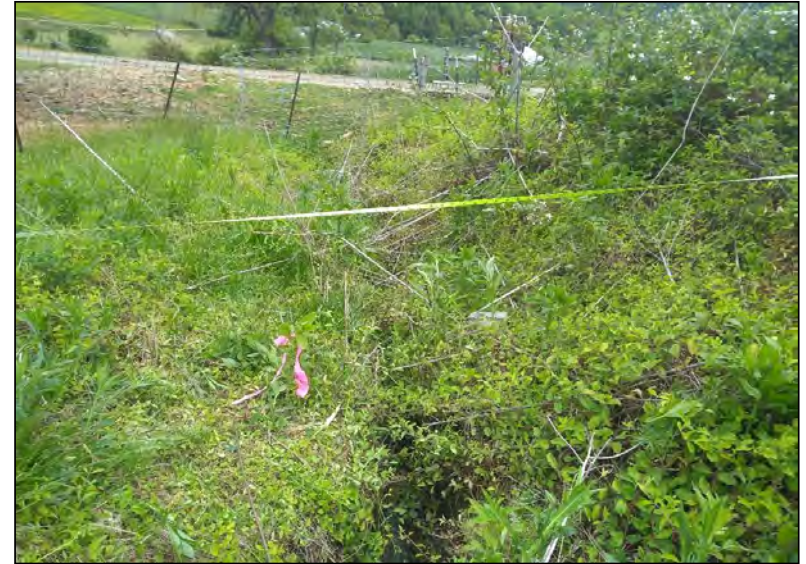
River Basin:	French Broad
Site	Morgan Branch
XS ID	T2 XSB
Drainage Area (sq mi):	0.05
Date:	5/12/2020
Field Crew:	T. Seelinger, A. Gutierrez

Station	Elevation
0.0	2361.58
12.3	2361.43
12.3	2361.45
23.0	2360.81
27.9	2360.90
30.2	2360.87
31.8	2360.81
36.0	2360.93
37.8	2360.81
39.5	2359.94
41.4	2359.60
42.0	2357.64
42.2	2357.55
42.6	2357.49
43.0	2357.81
44.0	2359.53
45.0	2359.84
47.3	2360.85
51.4	2362.89
53.1	2362.97
59.5	2362.92
69.3	2363.48

SUMMARY DATA	
Bankfull Elevation (ft):	2359.4
Bankfull Cross-Sectional Area (ft²):	3.0
Bankfull Width (ft):	2.4
Flood Prone Area Elevation (ft):	2361.3
Flood Prone Width (ft):	33.6
Max Depth at Bankfull (ft):	1.9
Mean Depth at Bankfull (ft):	1.2
W / D Ratio:	2.0
Entrenchment Ratio:	13.9
Bank Height Ratio:	1.1

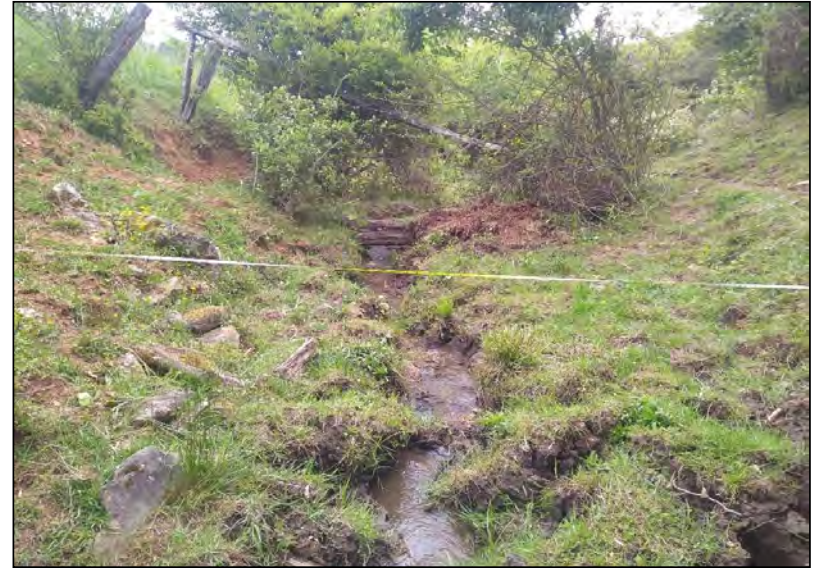
River Basin:	French Broad
Site	Morgan Branch
XS ID	T3 XSA
Drainage Area (sq mi):	0.05
Date:	5/12/2020
Field Crew:	T. Seelinger, A. Gutierrez

Station	Elevation
0.0	2341.67
7.0	2340.20
10.3	2339.67
12.4	2339.24
13.7	2338.81
16.1	2337.46
18.9	2335.59
20.3	2335.11
21.0	2334.23
22.6	2333.65
23.5	2333.72
24.3	2333.87
25.0	2332.49
25.1	2332.31
25.6	2332.28
26.0	2332.44
26.3	2332.47
26.5	2333.58
26.9	2333.77
29.1	2333.79
30.8	2333.88
32.2	2334.71
34.2	2334.87
35.7	2336.46
37.7	2336.47
47.2	2341.45

SUMMARY DATA	
Bankfull Elevation (ft):	2333.8
Bankfull Cross-Sectional Area (ft²):	2.5
Bankfull Width (ft):	4.1
Flood Prone Area Elevation (ft):	2335.3
Flood Prone Width (ft):	14.7
Max Depth at Bankfull (ft):	1.5
Mean Depth at Bankfull (ft):	0.6
W / D Ratio:	6.6
Entrenchment Ratio:	3.6
Bank Height Ratio:	1.0

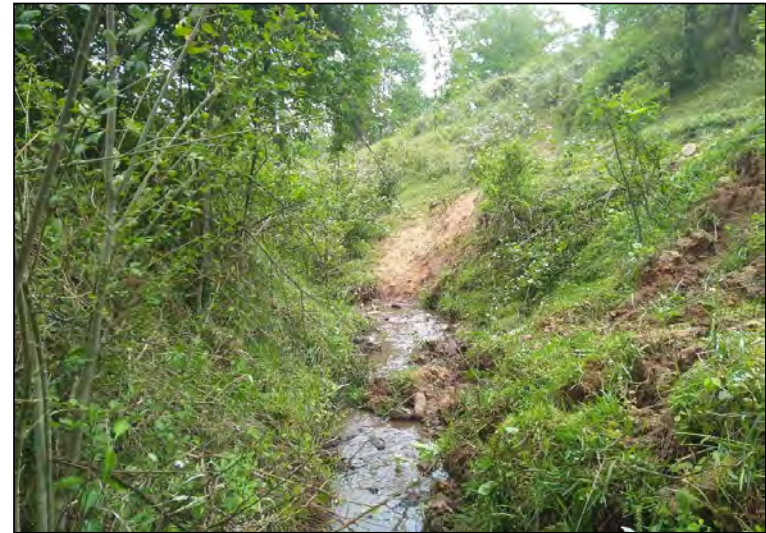
River Basin:	French Broad
Site	Morgan Branch
XS ID	T3 XSB
Drainage Area (sq mi):	0.06
Date:	5/12/2020
Field Crew:	T. Seelinger, A. Gutierrez

Station	Elevation
0.0	2313.66
14.3	2313.57
18.8	2313.31
22.0	2313.47
24.5	2314.26
26.6	2314.80
27.7	2314.83
29.2	2314.40
30.1	2314.03
31.1	2313.42
33.9	2309.28
34.5	2309.22
35.1	2309.37
35.8	2309.29
36.0	2309.16
36.1	2311.02
37.5	2311.56
37.7	2312.23
38.5	2312.40
40.1	2312.85
41.5	2313.97
43.5	2315.29
44.1	2315.73
46.4	2316.54
48.0	2316.87
53.0	2317.19
57.0	2317.30
60.3	2318.55
61.5	2319.36

SUMMARY DATA	
Bankfull Elevation (ft):	2310.4
Bankfull Cross-Sectional Area (ft²):	2.8
Bankfull Width (ft):	2.9
Flood Prone Area Elevation (ft):	2311.6
Flood Prone Width (ft):	5.2
Max Depth at Bankfull (ft):	1.2
Mean Depth at Bankfull (ft):	1.0
W / D Ratio:	3.1
Entrenchment Ratio:	1.8
Bank Height Ratio:	1.5

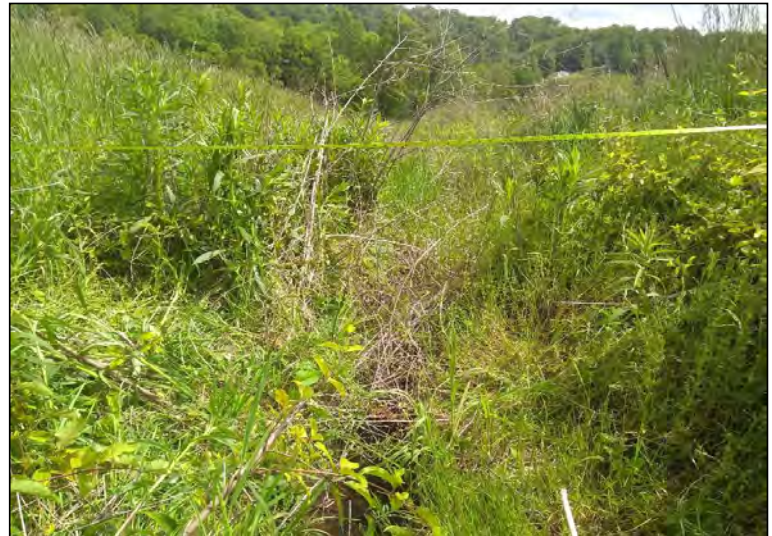
River Basin:	French Broad
Site	Morgan Branch
XS ID	T3 XSC
Drainage Area (sq mi):	0.07
Date:	5/12/2020
Field Crew:	T. Seelinger, A. Gutierrez

Station	Elevation
0.0	2288.51
10.2	2287.71
18.4	2287.17
21.2	2286.94
23.5	2286.12
24.8	2285.55
26.2	2285.39
26.6	2284.73
26.8	2283.66
27.4	2283.67
27.6	2283.56
28.1	2283.59
28.5	2285.15
29.0	2285.20
29.7	2285.35
30.9	2285.72
32.0	2287.10
32.9	2287.29
35.5	2287.30
38.2	2287.41
39.7	2287.60
46.0	2287.73
52.9	2288.03
63.6	2288.26
75.8	2288.55

SUMMARY DATA	
Bankfull Elevation (ft):	2285.3
Bankfull Cross-Sectional Area (ft²):	3.1
Bankfull Width (ft):	3.5
Flood Prone Area Elevation (ft):	2287.1
Flood Prone Width (ft):	13.2
Max Depth at Bankfull (ft):	1.8
Mean Depth at Bankfull (ft):	0.9
W / D Ratio:	3.9
Entrenchment Ratio:	3.8
Bank Height Ratio:	1.0

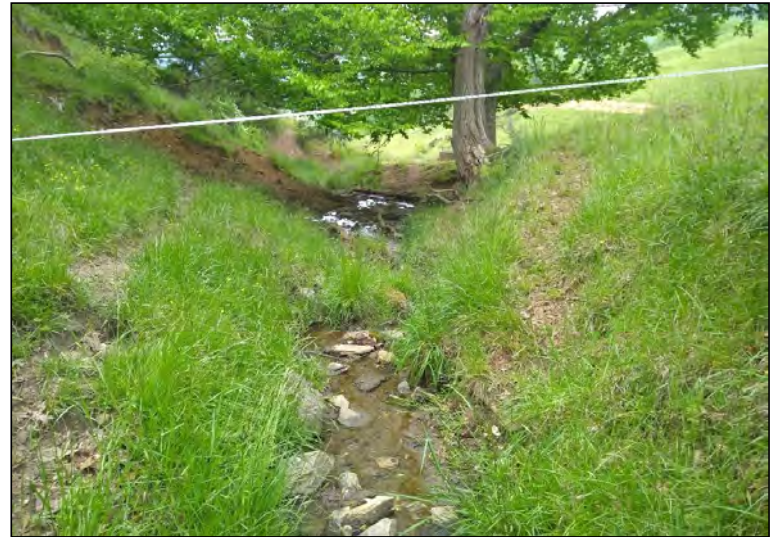
River Basin:	French Broad
Site	Morgan Branch
XS ID	T4 XSA
Drainage Area (sq mi):	0.03
Date:	5/14/2020
Field Crew:	T. Seelinger, A. Gutierrez

Station	Elevation
0.0	2344.39
1.3	2343.88
3.1	2343.24
4.5	2342.82
5.3	2343.15
7.4	2341.98
7.7	2341.70
9.7	2341.55
10.6	2340.58
11.8	2340.38
12.3	2338.96
13.6	2338.08
14.0	2338.23
14.6	2338.21
15.4	2338.27
15.8	2338.43
17.1	2338.46
17.5	2339.44
19.0	2340.09
20.7	2342.83
21.4	2343.20
23.5	2344.20
28.5	2346.33
33.1	2347.47
39.4	2347.98

SUMMARY DATA	
Bankfull Elevation (ft):	2338.9
Bankfull Cross-Sectional Area (ft²):	2.6
Bankfull Width (ft):	4.9
Flood Prone Area Elevation (ft):	2339.7
Flood Prone Width (ft):	6.1
Max Depth at Bankfull (ft):	0.8
Mean Depth at Bankfull (ft):	0.5
W / D Ratio:	9.2
Entrenchment Ratio:	1.3
Bank Height Ratio:	1.7

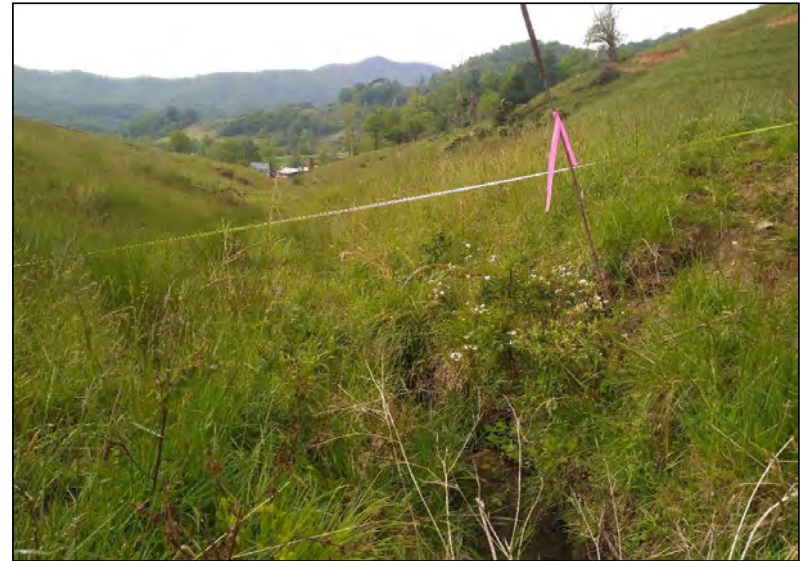
River Basin:	French Broad
Site	Morgan Branch
XS ID	T4 XSB
Drainage Area (sq mi):	0.04
Date:	5/14/2020
Field Crew:	T. Seelinger, A. Gutierrez

Station	Elevation
0.0	2324.38
8.1	2323.48
13.6	2320.63
17.8	2318.63
20.0	2317.83
21.4	2317.51
23.1	2316.54
23.9	2316.41
25.0	2316.54
25.9	2315.72
26.4	2314.91
27.0	2314.68
27.1	2314.18
27.2	2314.09
27.6	2314.14
28.0	2314.33
28.6	2314.80
29.4	2315.55
31.3	2318.45
32.0	2318.98
34.1	2319.86
35.7	2320.79
36.9	2321.20
38.3	2320.46
40.1	2321.31
45.1	2321.21
48.6	2321.16

SUMMARY DATA	
Bankfull Elevation (ft):	2315.5
Bankfull Cross-Sectional Area (ft²):	2.6
Bankfull Width (ft):	3.3
Flood Prone Area Elevation (ft):	2316.9
Flood Prone Width (ft):	7.8
Max Depth at Bankfull (ft):	1.4
Mean Depth at Bankfull (ft):	0.8
W / D Ratio:	4.3
Entrenchment Ratio:	2.3
Bank Height Ratio:	1.8

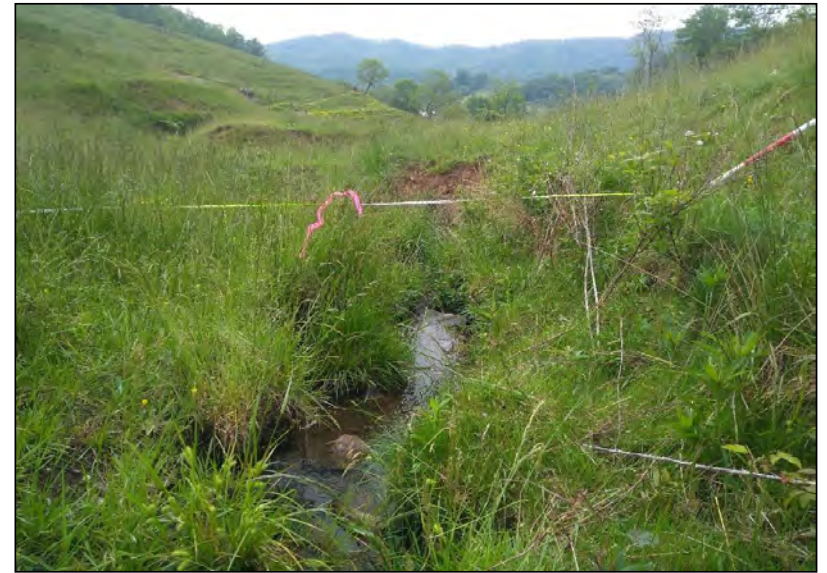
Station	Elevation
0.0	2298.49
6.1	2297.77
14.8	2296.04
18.2	2294.23
21.8	2293.48
24.2	2293.07
27.1	2293.07
30.0	2293.14
32.0	2292.89
32.9	2293.06
33.6	2291.63
34.4	2291.40
34.9	2291.34
35.1	2291.39
35.6	2291.62
36.0	2291.57
36.9	2292.90
37.9	2293.29
38.5	2294.48
39.2	2294.92
40.2	2294.90
43.0	2297.59
45.1	2298.08
48.6	2301.36
51.8	2302.76

SUMMARY DATA	
Bankfull Elevation (ft):	2292.5
Bankfull Cross-Sectional Area (ft²):	2.9
Bankfull Width (ft):	3.4
Flood Prone Area Elevation (ft):	2293.7
Flood Prone Width (ft):	17.1
Max Depth at Bankfull (ft):	1.2
Mean Depth at Bankfull (ft):	0.9
W / D Ratio:	4.0
Entrenchment Ratio:	5.0
Bank Height Ratio:	1.5

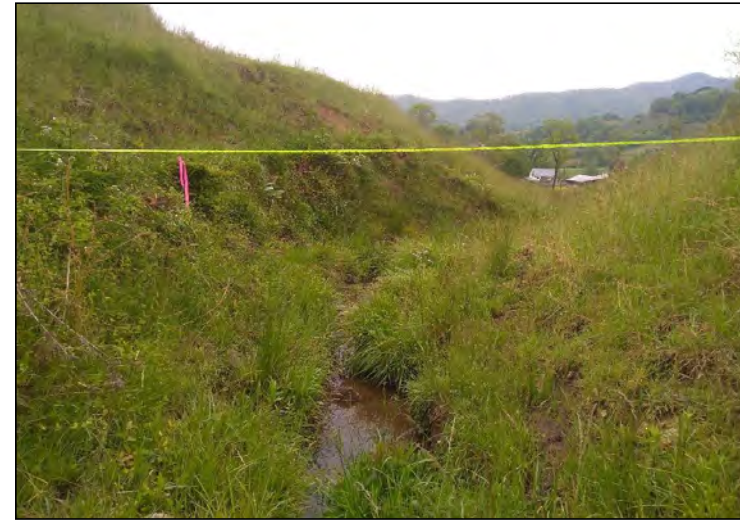
River Basin:	French Broad
Site	Morgan Branch
XS ID	T4 XSD
Drainage Area (sq mi):	0.06
Date:	5/14/2020
Field Crew:	T. Seelinger, A. Gutierrez

Station	Elevation
0.0	2297.53
2.8	2294.05
4.9	2293.93
6.6	2294.42
7.1	2294.35
11.0	2291.26
12.5	2290.74
15.3	2287.03
16.3	2286.61
16.8	2285.15
18.1	2284.64
18.9	2284.56
19.7	2284.57
20.8	2285.19
21.3	2286.48
23.1	2286.90
25.5	2289.97
28.9	2291.71
32.4	2292.67
35.9	2292.49
42.6	2292.29
50.8	2292.54
59.8	2292.75
72.0	2292.93
77.8	2294.79

SUMMARY DATA	
Bankfull Elevation (ft):	2285.50
Bankfull Cross-Sectional Area (ft²):	3.0
Bankfull Width (ft):	4.2
Flood Prone Area Elevation (ft):	2286.4
Flood Prone Width (ft):	5.0
Max Depth at Bankfull (ft):	0.9
Mean Depth at Bankfull (ft):	0.7
W / D Ratio:	6.0
Entrenchment Ratio:	1.2
Bank Height Ratio:	2.0

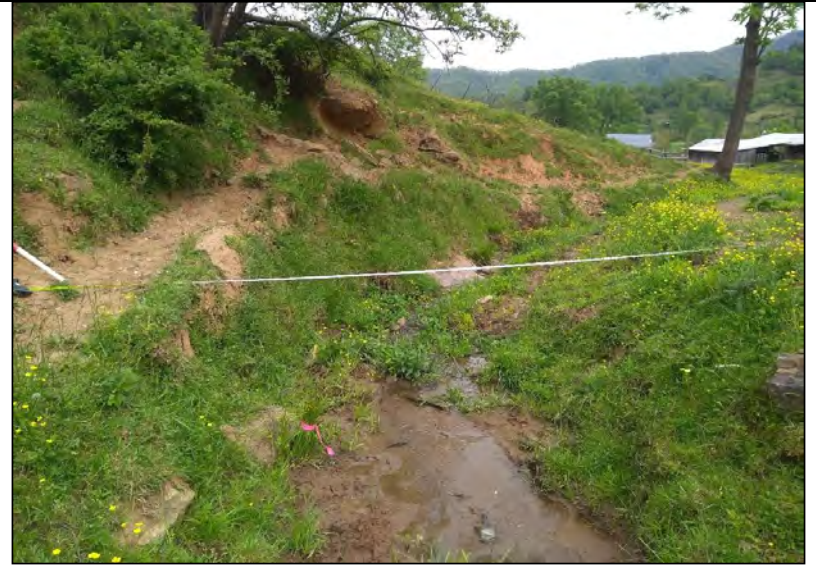
River Basin:	French Broad
Site	Morgan Branch
XS ID	T4 XSE
Drainage Area (sq mi):	0.08
Date:	5/13/2020
Field Crew:	T. Seelinger, A. Gutierrez

Station	Elevation
0.0	2271.42
2.6	2271.30
3.2	2269.77
5.5	2269.71
7.9	2266.79
10.2	2266.20
11.8	2266.08
12.0	2266.48
13.1	2263.74
14.2	2263.36
15.2	2263.06
16.3	2262.90
17.1	2263.02
18.1	2262.96
18.5	2263.12
20.2	2263.39
21.6	2265.45
23.3	2265.93
24.7	2266.67
26.9	2266.99
29.6	2267.46
32.9	2268.62
38.9	2268.94
44.5	2269.24

SUMMARY DATA	
Bankfull Elevation (ft):	2263.8
Bankfull Cross-Sectional Area (ft²):	4.3
Bankfull Width (ft):	7.4
Flood Prone Area Elevation (ft):	2264.6
Flood Prone Width (ft):	8.3
Max Depth at Bankfull (ft):	0.9
Mean Depth at Bankfull (ft):	0.6
W / D Ratio:	12.5
Entrenchment Ratio:	1.1
Bank Height Ratio:	4.1

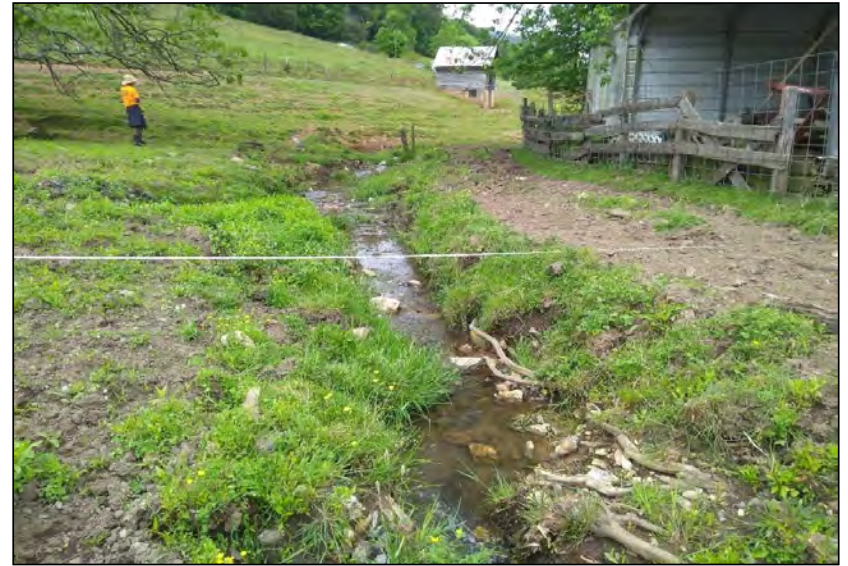
River Basin:	French Broad
Site	Morgan Branch
XS ID	T4 XSF
Drainage Area (sq mi):	0.12
Date:	5/13/2020
Field Crew:	T. Seelinger, A. Gutierrez

Station	Elevation
0.0	2251.38
10.6	2249.57
16.1	2249.33
20.7	2248.95
22.3	2248.73
23.3	2247.85
24.4	2248.02
25.1	2247.97
25.3	2246.87
26.1	2246.76
26.4	2246.58
27.4	2246.59
27.8	2246.79
28.1	2248.18
29.3	2248.88
30.2	2249.00
32.0	2248.96
36.1	2249.08
36.5	2249.47
42.7	2250.13

SUMMARY DATA	
Bankfull Elevation (ft):	2248.2
Bankfull Cross-Sectional Area (ft²):	4.6
Bankfull Width (ft):	5.2
Flood Prone Area Elevation (ft):	2249.8
Flood Prone Width (ft):	30.1
Max Depth at Bankfull (ft):	1.6
Mean Depth at Bankfull (ft):	0.9
W / D Ratio:	5.9
Entrenchment Ratio:	5.8
Bank Height Ratio:	1.3

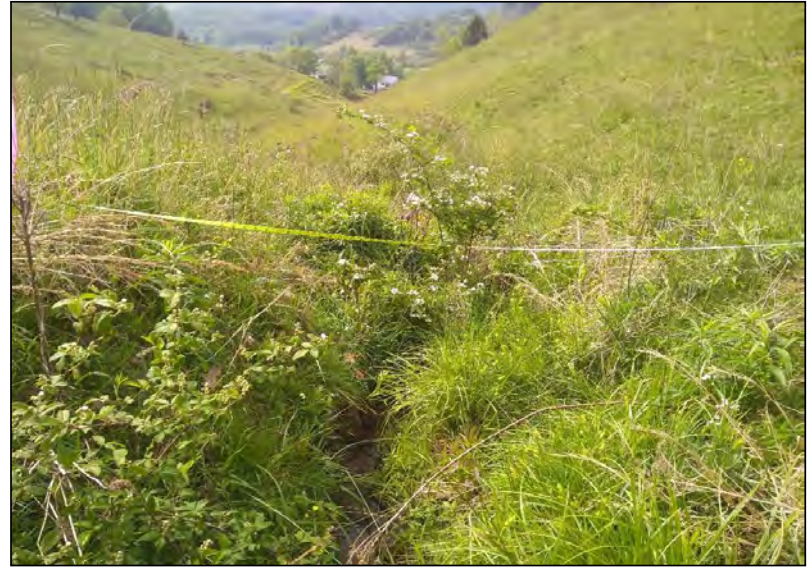
River Basin:	French Broad
Site	Morgan Branch
XS ID	T4-1 XSA
Drainage Area (sq mi):	0.02
Date:	5/14/2020
Field Crew:	T. Seelinger, A. Gutierrez

Station	Elevation
0.0	2338.05
7.1	2337.05
12.8	2337.18
17.0	2337.09
21.0	2336.51
24.4	2335.57
27.0	2334.49
28.3	2332.90
30.1	2330.33
30.5	2330.28
30.7	2330.32
31.2	2330.35
31.5	2330.46
32.2	2331.24
34.1	2331.52
35.0	2332.29
36.0	2333.58
37.7	2334.02
40.1	2334.23
42.5	2334.37
45.1	2335.24
51.6	2338.48

SUMMARY DATA	
Bankfull Elevation (ft):	2330.69
Bankfull Cross-Sectional Area (ft²):	0.5
Bankfull Width (ft):	1.8
Flood Prone Area Elevation (ft):	2331.1
Flood Prone Width (ft):	2.5
Max Depth at Bankfull (ft):	0.4
Mean Depth at Bankfull (ft):	0.3
W / D Ratio:	6.2
Entrenchment Ratio:	1.4
Bank Height Ratio:	8.1

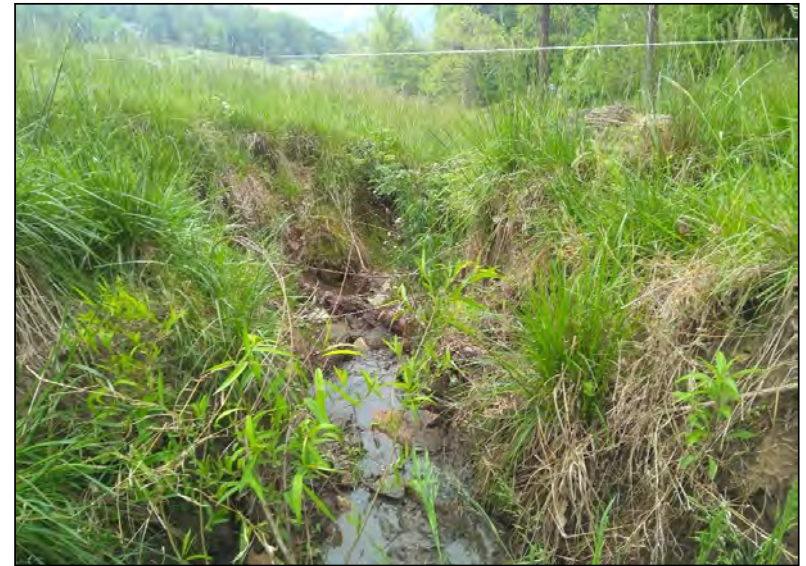
Station	Elevation
0.0	2360.18
4.1	2359.86
7.3	2359.05
10.5	2357.53
12.4	2357.07
14.2	2356.72
15.5	2356.49
16.0	2355.72
17.1	2353.07
17.7	2352.87
18.6	2352.59
18.9	2352.61
19.1	2352.95
19.9	2353.05
21.5	2355.07
22.1	2355.87
23.2	2356.53
24.1	2356.74
25.8	2357.29
28.7	2357.85
33.1	2358.90
41.0	2360.70
49.3	2361.87

SUMMARY DATA	
Bankfull Elevation (ft):	2353.3
Bankfull Cross-Sectional Area (ft²):	1.3
Bankfull Width (ft):	3.0
Flood Prone Area Elevation (ft):	2354.0
Flood Prone Width (ft):	3.9
Max Depth at Bankfull (ft):	0.7
Mean Depth at Bankfull (ft):	0.4
W / D Ratio:	7.1
Entrenchment Ratio:	1.3
Bank Height Ratio:	4.4

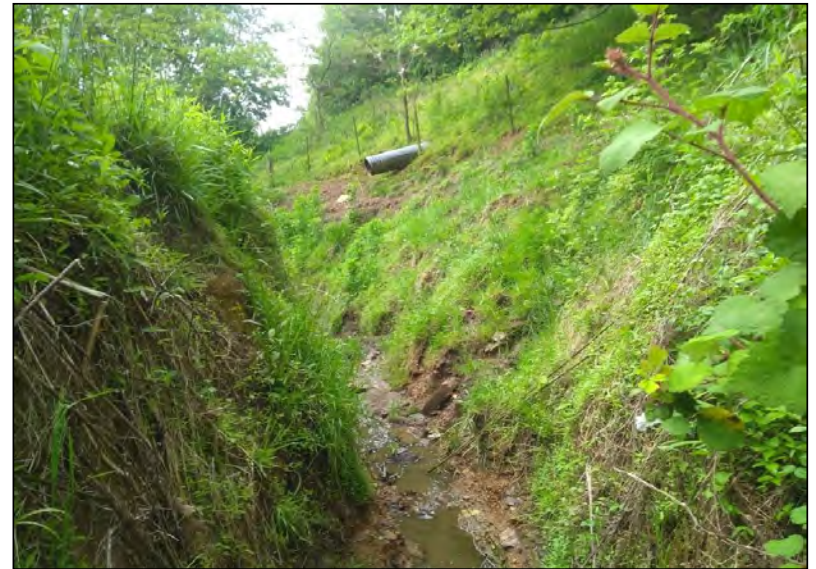
River Basin:	French Broad
Site	Morgan Branch
XS ID	T4-2 XSB
Drainage Area (sq mi):	0.03
Date:	5/14/2020
Field Crew:	T. Seelinger, A. Gutierrez

Station	Elevation
0.0	2302.35
12.0	2301.25
25.6	2300.92
32.5	2301.37
39.1	2301.54
41.9	2301.52
43.2	2300.39
43.8	2300.39
47.9	2292.99
48.3	2292.89
48.8	2293.03
50.0	2293.51
54.0	2299.56
54.7	2301.75
56.7	2302.13
58.5	2302.11
60.5	2302.54
63.8	2302.55
67.7	2302.81
72.4	2303.88
77.1	2304.67
79.0	2306.19

SUMMARY DATA	
Bankfull Elevation (ft):	2294.0
Bankfull Cross-Sectional Area (ft²):	2.2
Bankfull Width (ft):	3.0
Flood Prone Area Elevation (ft):	2295.1
Flood Prone Width (ft):	4.3
Max Depth at Bankfull (ft):	1.1
Mean Depth at Bankfull (ft):	0.7
W / D Ratio:	4.1
Entrenchment Ratio:	1.5
Bank Height Ratio:	7.7

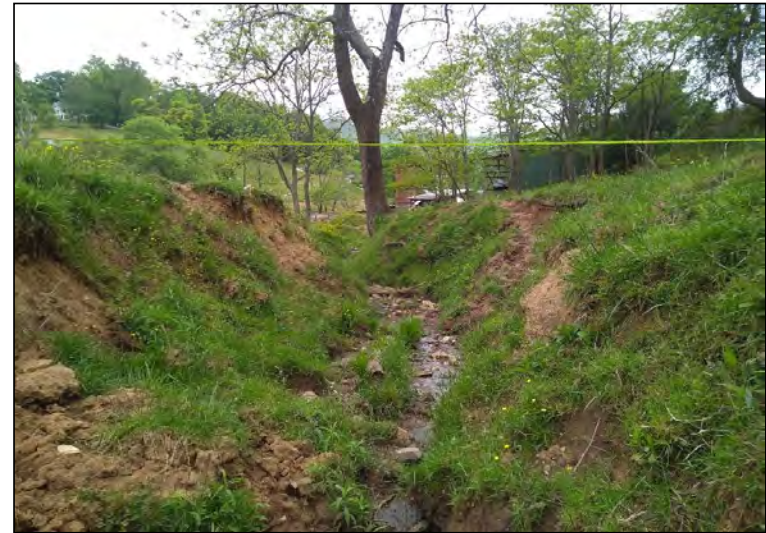
Station	Elevation
0.0	2282.70
9.6	2282.09
16.3	2281.36
21.6	2280.62
24.4	2280.59
26.9	2277.06
28.2	2275.98
29.2	2274.52
29.6	2274.11
31.3	2274.00
32.3	2273.77
32.9	2273.62
33.6	2273.69
37.2	2278.30
39.9	2280.44
44.8	2280.68
52.4	2281.32
56.8	2281.64
64.2	2283.14

SUMMARY DATA	
Bankfull Elevation (ft):	2274.4
Bankfull Cross-Sectional Area (ft²):	2.3
Bankfull Width (ft):	4.9
Flood Prone Area Elevation (ft):	2275.2
Flood Prone Width (ft):	6.0
Max Depth at Bankfull (ft):	0.8
Mean Depth at Bankfull (ft):	0.5
W / D Ratio:	10.3
Entrenchment Ratio:	1.2
Bank Height Ratio:	8.7

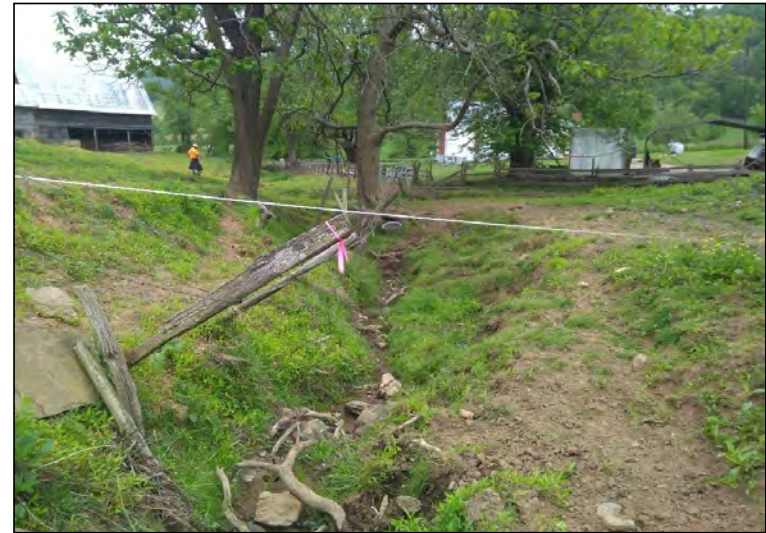
River Basin:	French Broad
Site	Morgan Branch
XS ID	T4-3 XSA
Drainage Area (sq mi):	0.03
Date:	5/13/2020
Field Crew:	T. Seelinger, A. Gutierrez

Station	Elevation
0.0	2256.21
7.5	2254.78
15.0	2253.75
17.1	2253.55
19.7	2251.79
22.1	2250.94
25.3	2250.05
26.8	2248.59
27.1	2248.65
27.4	2247.62
29.1	2247.22
29.6	2247.22
30.1	2247.01
30.8	2247.03
31.3	2248.59
33.5	2249.74
36.0	2250.42
39.9	2251.89
41.5	2252.23
45.7	2252.46
54.0	2253.03
60.5	2253.37

SUMMARY DATA	
Bankfull Elevation (ft):	2247.9
Bankfull Cross-Sectional Area (ft²):	2.3
Bankfull Width (ft):	3.7
Flood Prone Area Elevation (ft):	2248.8
Flood Prone Width (ft):	5.1
Max Depth at Bankfull (ft):	0.9
Mean Depth at Bankfull (ft):	0.6
W / D Ratio:	6.1
Entrenchment Ratio:	1.4
Bank Height Ratio:	3.0

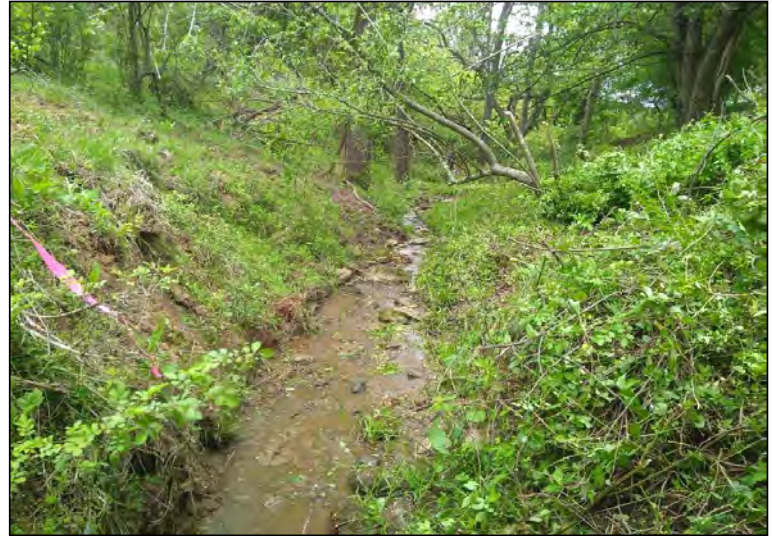
River Basin:	French Broad
Site	Morgan Branch
XS ID	T5 XSA
Drainage Area (sq mi):	0.03
Date:	5/12/2020
Field Crew:	T. Seelinger, A. Gutierrez

Station	Elevation
0.0	2323.57
1.7	2323.17
5.4	2322.01
5.9	2321.21
8.1	2320.54
9.1	2319.86
10.8	2316.57
11.5	2316.54
12.4	2316.57
12.9	2316.60
14.0	2316.64
14.9	2317.18
16.3	2319.38
17.8	2319.86
20.9	2321.84
23.1	2322.87
26.9	2323.73
30.2	2325.77

SUMMARY DATA	
Bankfull Elevation (ft):	2317.2
Bankfull Cross-Sectional Area (ft²):	2.3
Bankfull Width (ft):	4.4
Flood Prone Area Elevation (ft):	2317.8
Flood Prone Width (ft):	5.1
Max Depth at Bankfull (ft):	0.6
Mean Depth at Bankfull (ft):	0.5
W / D Ratio:	8.6
Entrenchment Ratio:	1.2
Bank Height Ratio:	4.5

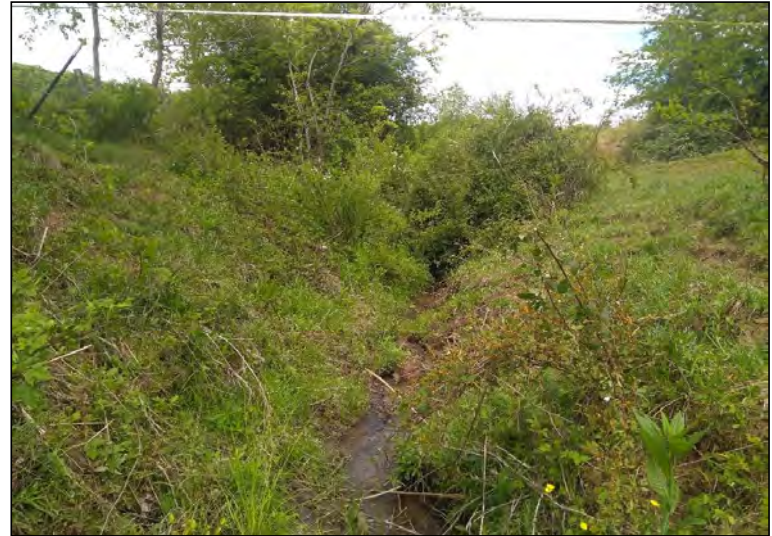
River Basin:	French Broad
Site	Morgan Branch
XS ID	T5 XSB
Drainage Area (sq mi):	0.05
Date:	5/12/2020
Field Crew:	T. Seelinger, A. Gutierrez

Station	Elevation
0.0	2267.90
8.6	2266.48
17.9	2265.90
20.8	2265.73
21.4	2265.72
22.6	2265.07
26.0	2264.61
30.0	2263.22
31.6	2261.52
32.4	2261.35
33.8	2259.37
35.9	2258.58
36.0	2258.08
36.4	2257.99
36.7	2257.96
37.4	2258.09
37.9	2258.05
40.0	2261.11
41.0	2261.19
41.5	2261.85
43.0	2262.14
43.0	2262.99
45.6	2263.89
49.3	2264.30
55.6	2264.88
60.3	2265.77
70.2	2266.81
75.0	2269.08

SUMMARY DATA	
Bankfull Elevation (ft):	2259.1
Bankfull Cross-Sectional Area (ft²):	2.9
Bankfull Width (ft):	4.1
Flood Prone Area Elevation (ft):	2260.2
Flood Prone Width (ft):	6.2
Max Depth at Bankfull (ft):	1.1
Mean Depth at Bankfull (ft):	0.7
W / D Ratio:	5.9
Entrenchment Ratio:	1.5
Bank Height Ratio:	2.9

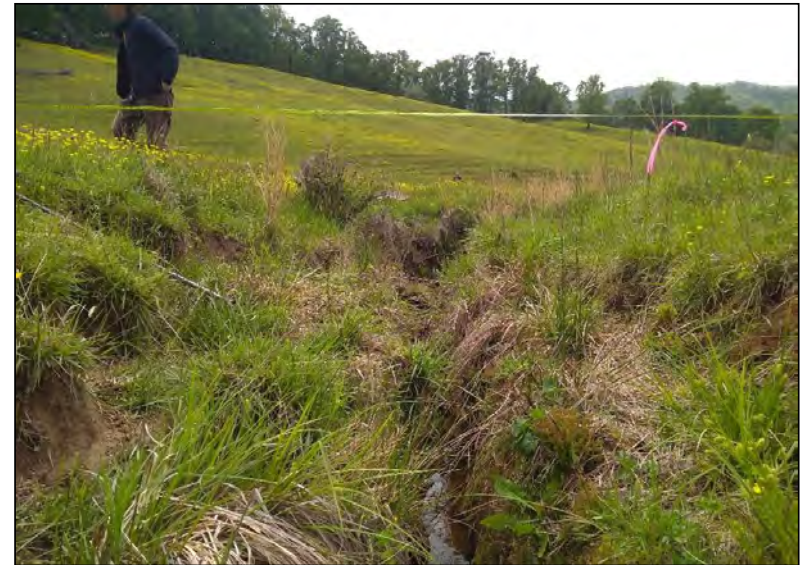
Station	Elevation
0.0	2280.42
9.7	2279.44
14.7	2278.87
21.8	2278.99
23.5	2278.79
24.6	2278.38
25.6	2277.25
26.5	2276.75
27.3	2276.50
28.7	2276.27
29.0	2276.38
29.8	2273.73
30.0	2273.80
30.2	2273.80
30.3	2273.90
31.4	2276.38
32.0	2276.36
32.7	2276.25
33.9	2277.70
37.5	2279.18
40.0	2279.29
44.9	2279.39

SUMMARY DATA	
Bankfull Elevation (ft):	2275.0
Bankfull Cross-Sectional Area (ft²):	1.1
Bankfull Width (ft):	1.3
Flood Prone Area Elevation (ft):	2276.3
Flood Prone Width (ft):	2.4
Max Depth at Bankfull (ft):	1.3
Mean Depth at Bankfull (ft):	0.8
W / D Ratio:	1.7
Entrenchment Ratio:	1.8
Bank Height Ratio:	2.1

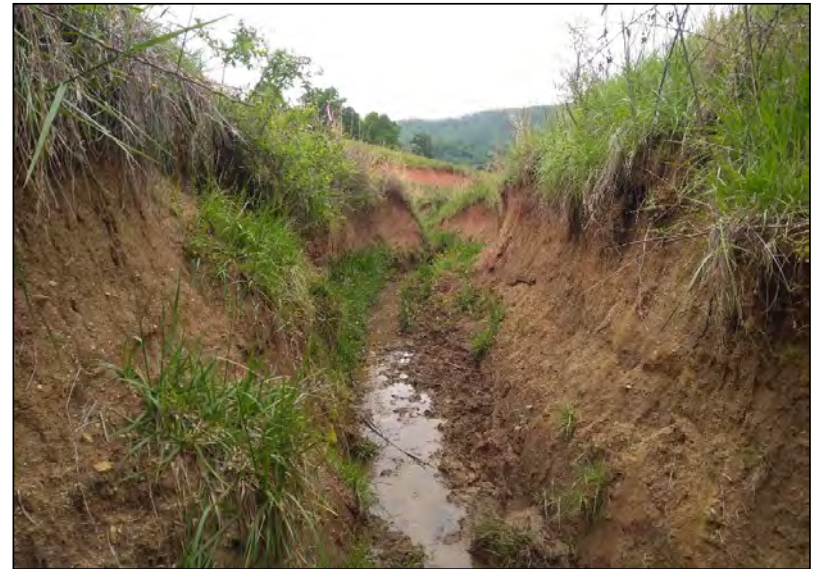
River Basin:	French Broad
Site	Morgan Branch
XS ID	T7 XSB
Drainage Area (sq mi):	0.02
Date:	5/13/2020
Field Crew:	T. Seelinger, A. Gutierrez

Station	Elevation
0.0	2262.93
8.0	2262.83
14.2	2262.72
17.8	2262.32
21.1	2260.88
23.7	2253.84
24.3	2253.84
24.8	2253.73
25.1	2253.73
25.6	2253.95
26.2	2254.17
28.0	2259.53
29.5	2261.19
31.9	2262.25
35.8	2262.66
44.8	2263.15
60.6	2264.48

SUMMARY DATA	
Bankfull Elevation (ft):	2254.7
Bankfull Cross-Sectional Area (ft²):	2.3
Bankfull Width (ft):	3.0
Flood Prone Area Elevation (ft):	2255.7
Flood Prone Width (ft):	3.7
Max Depth at Bankfull (ft):	1.0
Mean Depth at Bankfull (ft):	0.8
W / D Ratio:	4.0
Entrenchment Ratio:	1.2
Bank Height Ratio:	7.4

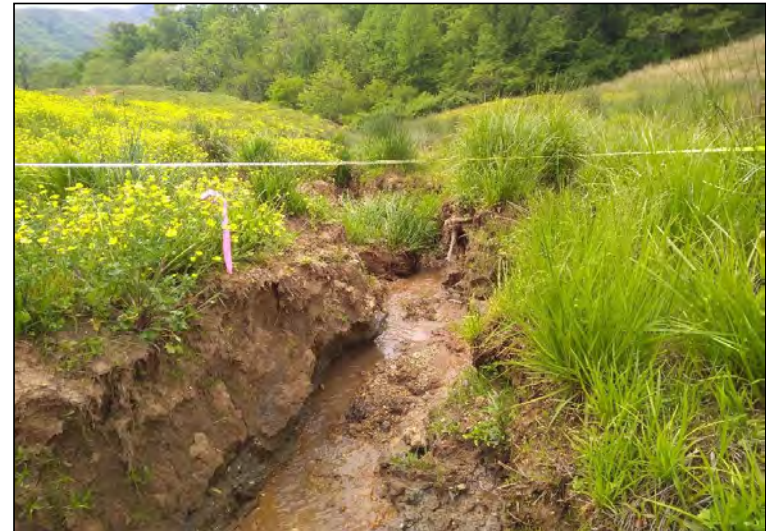
Station	Elevation
0.0	2238.04
9.8	2237.20
15.1	2236.61
16.4	2235.32
17.6	2235.79
19.9	2236.02
21.2	2235.40
22.9	2235.43
25.8	2235.25
27.0	2235.36
28.0	2235.31
28.6	2232.71
29.0	2232.74
29.1	2232.91
30.2	2233.22
31.0	2235.11
31.7	2235.22
33.1	2235.61
36.6	2235.52
41.9	2236.20
47.9	2237.61
57.0	2239.21
64.0	2240.06
72.2	2240.67

SUMMARY DATA	
Bankfull Elevation (ft):	2234.1
Bankfull Cross-Sectional Area (ft²):	2.3
Bankfull Width (ft):	2.3
Flood Prone Area Elevation (ft):	2235.5
Flood Prone Width (ft):	12.3
Max Depth at Bankfull (ft):	1.4
Mean Depth at Bankfull (ft):	1.0
W / D Ratio:	2.4
Entrenchment Ratio:	5.3
Bank Height Ratio:	1.7

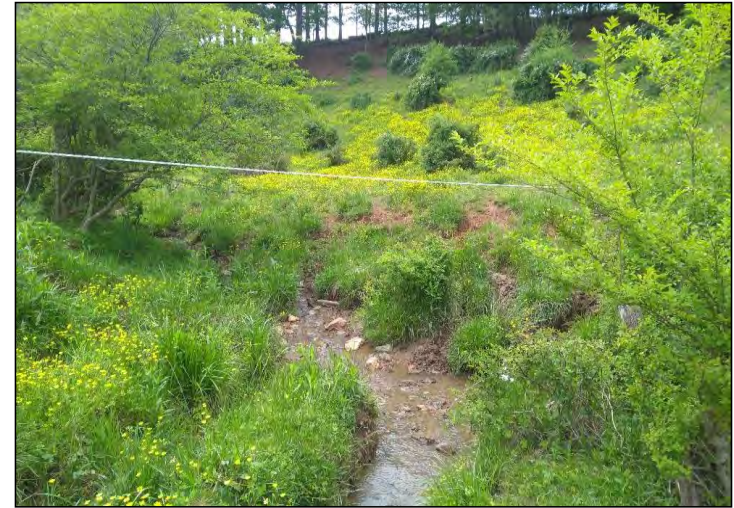
River Basin:	French Broad
Site	Morgan Branch
XS ID	T7 XSD
Drainage Area (sq mi):	0.05
Date:	5/13/2020
Field Crew:	T. Seelinger, A. Gutierrez

Station	Elevation		
0.0	2222.55		
7.8	2221.37		
15.8	2220.79		
23.1	2220.66		
29.9	2220.36		
34.7	2219.99		
37.3	2219.32		
39.4	2218.41		
39.9	2217.17		
43.0	2216.27		
44.1	2216.23		
44.8	2215.43		
45.6	2215.13		
46.2	2214.10		
47.4	2214.19		
48.5	2213.98		
49.3	2214.39		
50.7	2213.95		
51.6	2212.87		
52.0	2212.79		
52.8	2212.77		
54.0	2212.67		
54.6	2212.76	67.6	2213.61
55.2	2212.87	68.4	2215.08
55.8	2213.74	68.8	2213.97
57.3	2213.94	70.6	2213.97
57.9	2214.00	71.2	2215.25
58.4	2213.23	72.6	2215.26
59.3	2213.18	73.2	2214.41
59.8	2214.19	75.5	2214.74
60.5	2214.09	76.4	2215.45
60.9	2213.23	80.0	2216.70
63.1	2213.11	81.9	2217.77
63.5	2214.05	85.9	2218.95
64.9	2214.13	96.8	2221.00
66.0	2213.88	103.5	2222.84

Bankfull Elevation (ft):	2213.6
Bankfull Cross-Sectional Area (ft²):	4.9
Bankfull Width (ft):	8.7
Flood Prone Area Elevation (ft):	2214.4
Flood Prone Width (ft):	24.4
Max Depth at Bankfull (ft):	0.8
Mean Depth at Bankfull (ft):	0.6
W / D Ratio:	15.2
Entrenchment Ratio:	2.8
Bank Height Ratio:	3.8

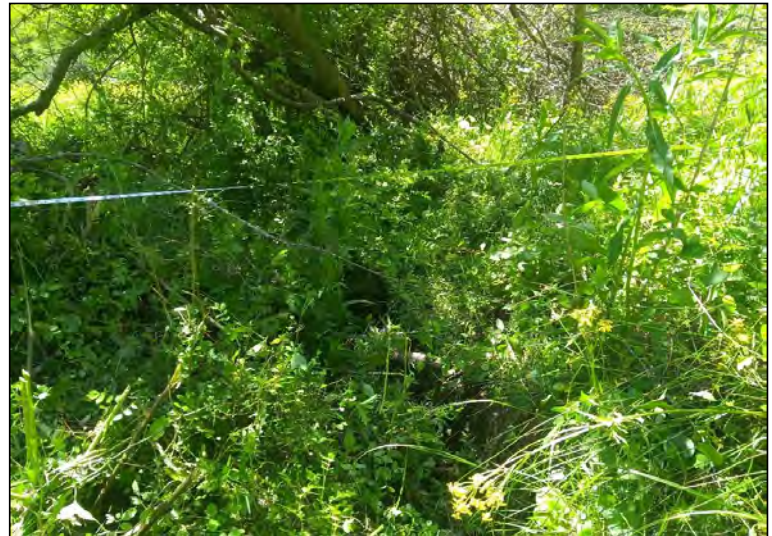
River Basin:	French Broad
Site	Morgan Branch
XS ID	T8 XSA
Drainage Area (sq mi):	0.01
Date:	5/11/2020
Field Crew:	T. Seelinger, A. Gutierrez

Station	Elevation
0.0	2643.26
8.2	2643.34
9.7	2643.41
12.4	2642.55
14.9	2641.93
16.6	2642.00
17.4	2641.73
18.6	2641.10
19.5	2639.98
20.8	2640.01
21.4	2638.70
21.9	2638.37
22.3	2638.55
22.5	2640.52
23.3	2640.39
24.1	2641.59
25.3	2641.72
26.7	2642.20
29.3	2642.66
31.5	2642.52
33.6	2641.67
37.5	2642.32

SUMMARY DATA	
Bankfull Elevation (ft):	2638.7
Bankfull Cross-Sectional Area (ft²):	0.2
Bankfull Width (ft):	0.9
Flood Prone Area Elevation (ft):	2639.1
Flood Prone Width (ft):	1.1
Max Depth at Bankfull (ft):	0.4
Mean Depth at Bankfull (ft):	0.2
W / D Ratio:	4.3
Entrenchment Ratio:	1.2
Bank Height Ratio:	7.9

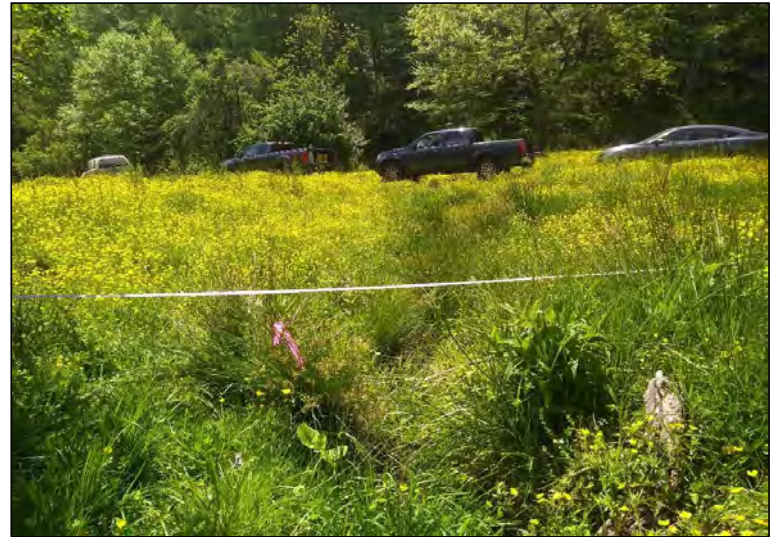
River Basin:	French Broad
Site	Morgan Branch
XS ID	T8 XSB
Drainage Area (sq mi):	0.01
Date:	5/11/2020
Field Crew:	T. Seelinger, A. Gutierrez

Station	Elevation
0.0	2627.65
15.7	2628.15
22.8	2627.93
25.3	2627.59
28.4	2626.78
31.1	2626.09
32.9	2625.97
34.6	2625.72
36.0	2625.62
36.2	2624.58
36.3	2624.38
36.7	2624.34
36.8	2624.51
37.0	2625.22
37.7	2625.78
38.5	2625.81
39.2	2625.86
40.1	2626.45
41.0	2626.78
42.8	2627.25
44.4	2627.49
46.6	2627.70
49.5	2628.39
52.4	2628.39

SUMMARY DATA	
Bankfull Elevation (ft):	2625.0
Bankfull Cross-Sectional Area (ft²):	0.4
Bankfull Width (ft):	0.8
Flood Prone Area Elevation (ft):	2625.6
Flood Prone Width (ft):	1.5
Max Depth at Bankfull (ft):	0.6
Mean Depth at Bankfull (ft):	0.5
W / D Ratio:	1.8
Entrenchment Ratio:	1.8
Bank Height Ratio:	2.2

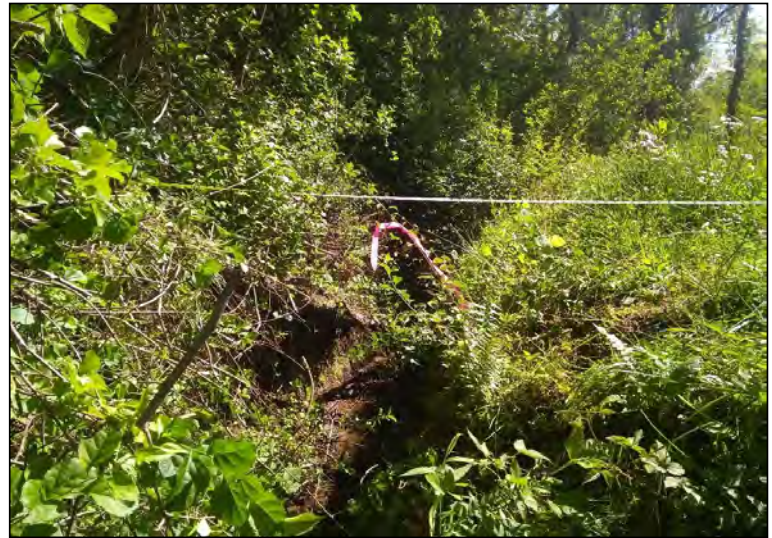
River Basin:	French Broad
Site	Morgan Branch
XS ID	T9 XSA
Drainage Area (sq mi):	0.03
Date:	5/11/2020
Field Crew:	T. Seelinger, A. Gutierrez

Station	Elevation
0.0	2762.22
3.9	2760.06
5.5	2758.86
6.4	2758.33
6.7	2755.13
7.6	2754.63
7.6	2754.05
8.1	2754.00
8.6	2754.02
8.9	2754.11
10.8	2757.61
11.7	2758.23
13.2	2758.31
16.9	2758.62
24.3	2758.61
33.5	2758.54

SUMMARY DATA	
Bankfull Elevation (ft):	2755.1
Bankfull Cross-Sectional Area (ft²):	2.0
Bankfull Width (ft):	2.7
Flood Prone Area Elevation (ft):	2756.3
Flood Prone Width (ft):	3.5
Max Depth at Bankfull (ft):	1.1
Mean Depth at Bankfull (ft):	0.7
W / D Ratio:	3.9
Entrenchment Ratio:	1.3
Bank Height Ratio:	3.4
