MITIGATION PLAN

**Morgan Branch Restoration Site
Buncombe County, North Carolina
RFP# 16-007724 (Issued: 3/1/19)
DMS Project Number 100127
DMS Contract 7909
USACE Action ID: SAW-2018-01163
DWR #: 20181030**

**French Broad River Basin
Cataloging Unit 06010105**

Prepared for:
NC Department of Environmental Quality
Division of Mitigation Services
1652 Mail Service Center
Raleigh, NC 27699
May 2024

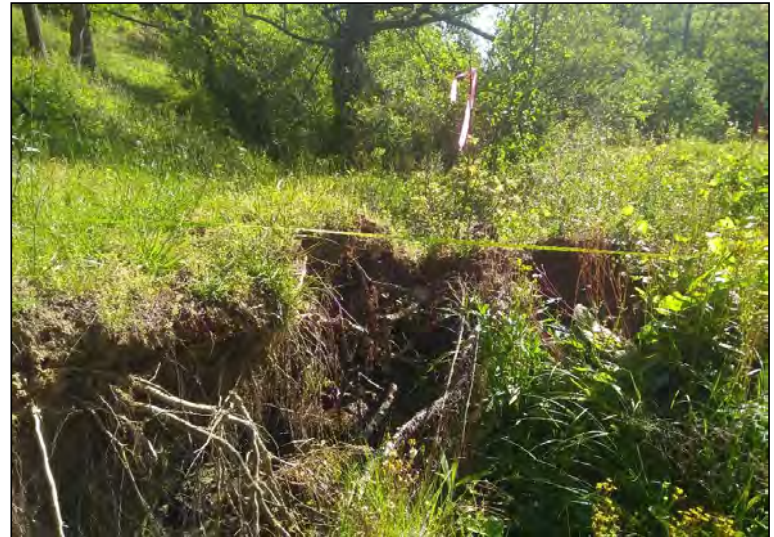
River Basin:	French Broad
Site	Morgan Branch
XS ID	T9 XSB
Drainage Area (sq mi):	0.04
Date:	5/11/2020
Field Crew:	T. Seelinger, A. Gutierrez

Station	Elevation
0.0	2727.28
3.4	2725.21
4.4	2724.86
8.3	2724.63
11.5	2724.29
12.6	2723.96
10.5	2720.30
13.0	2720.31
13.1	2720.67
13.7	2720.64
14.3	2720.18
14.6	2720.20
14.9	2720.48
15.9	2721.20
17.5	2723.27
18.9	2723.24
20.9	2722.91
22.6	2723.02
24.5	2723.63
27.1	2725.07
28.4	2725.71
30.6	2725.44
33.5	2724.51

SUMMARY DATA	
Bankfull Elevation:	2721.20
Bankfull Cross-Sectional Area:	3.8
Bankfull Width:	4.9
Flood Prone Area Elevation:	2722.2
Flood Prone Width:	5.1
Max Depth at Bankfull:	1.0
Mean Depth at Bankfull:	0.8
W / D Ratio:	6.3
Entrenchment Ratio:	1.0
Bank Height Ratio:	3.0

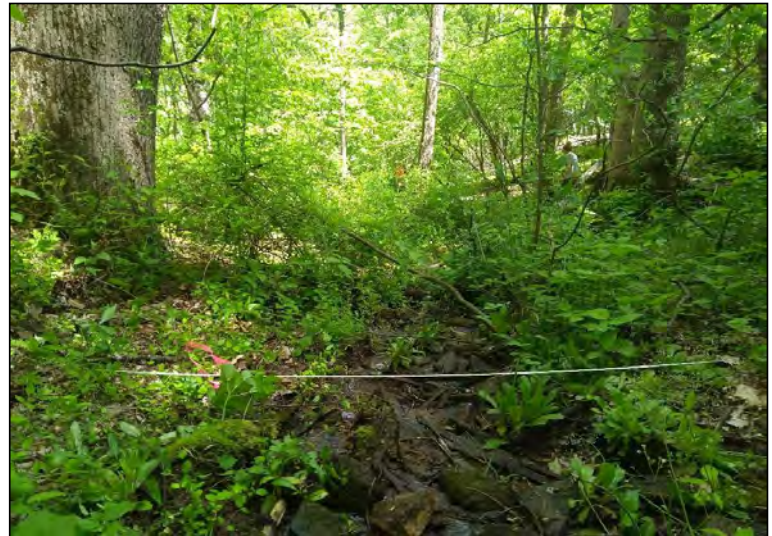
River Basin:	French Broad
Site	Morgan Branch
XS ID	Reference A XS1
Drainage Area (sq mi):	0.10
Date:	5/13/2020
Field Crew:	T. Seelinger, A. Gutierrez

Station	Elevation
0.0	3013.71
3.6	3011.92
7.5	3010.41
9.5	3009.94
10.9	3009.81
11.6	3009.63
12.1	3009.65
13.1	3009.56
14.0	3009.49
14.8	3009.66
15.2	3010.13
16.0	3010.15
16.0	3010.33
19.8	3011.38
24.5	3012.51
26.6	3012.89

SUMMARY DATA	
Bankfull Elevation (ft):	3010.1
Bankfull Cross-Sectional Area (ft²):	2.4
Bankfull Width (ft):	6.4
Flood Prone Area Elevation (ft):	3010.7
Flood Prone Width (ft):	10.7
Max Depth at Bankfull (ft):	0.6
Mean Depth at Bankfull (ft):	0.4
W / D Ratio:	16.8
Entrenchment Ratio:	1.7
Bank Height Ratio:	1.0

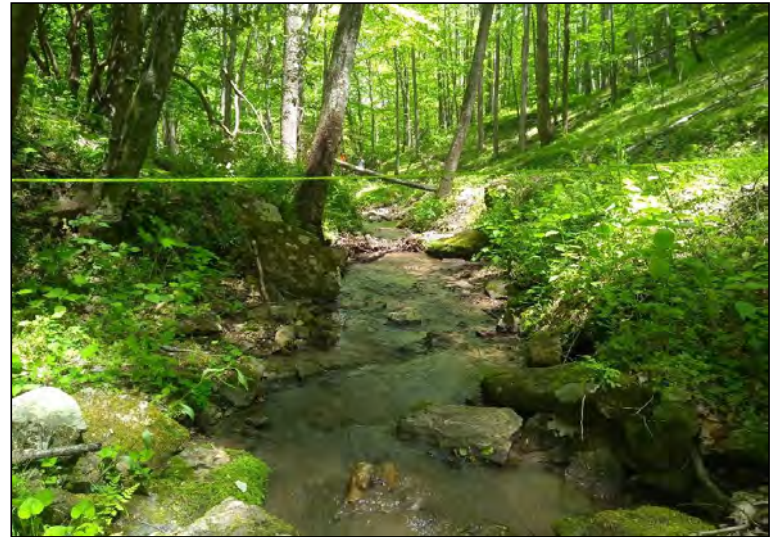
River Basin:	French Broad
Site	Morgan Branch
XS ID	Reference B XS1
Drainage Area (sq mi):	0.40
Date:	5/13/2020
Field Crew:	T. Seelinger, A. Gutierrez

Station	Elevation
0.0	2534.32
1.7	2532.70
4.2	2529.90
6.1	2528.90
7.4	2528.75
8.3	2528.64
9.4	2528.33
9.6	2527.87
10.7	2527.67
12.1	2527.51
12.7	2527.44
13.9	2527.79
14.6	2527.92
15.8	2529.05
17.6	2530.44
20.5	2532.08
23.4	2532.60

SUMMARY DATA	
Bankfull Elevation (ft):	2528.6
Bankfull Cross-Sectional Area (ft²):	5.2
Bankfull Width (ft):	6.9
Flood Prone Area Elevation (ft):	2529.8
Flood Prone Width (ft):	12.2
Max Depth at Bankfull (ft):	1.2
Mean Depth at Bankfull (ft):	0.8
W / D Ratio:	9.1
Entrenchment Ratio:	1.8
Bank Height Ratio:	1.0

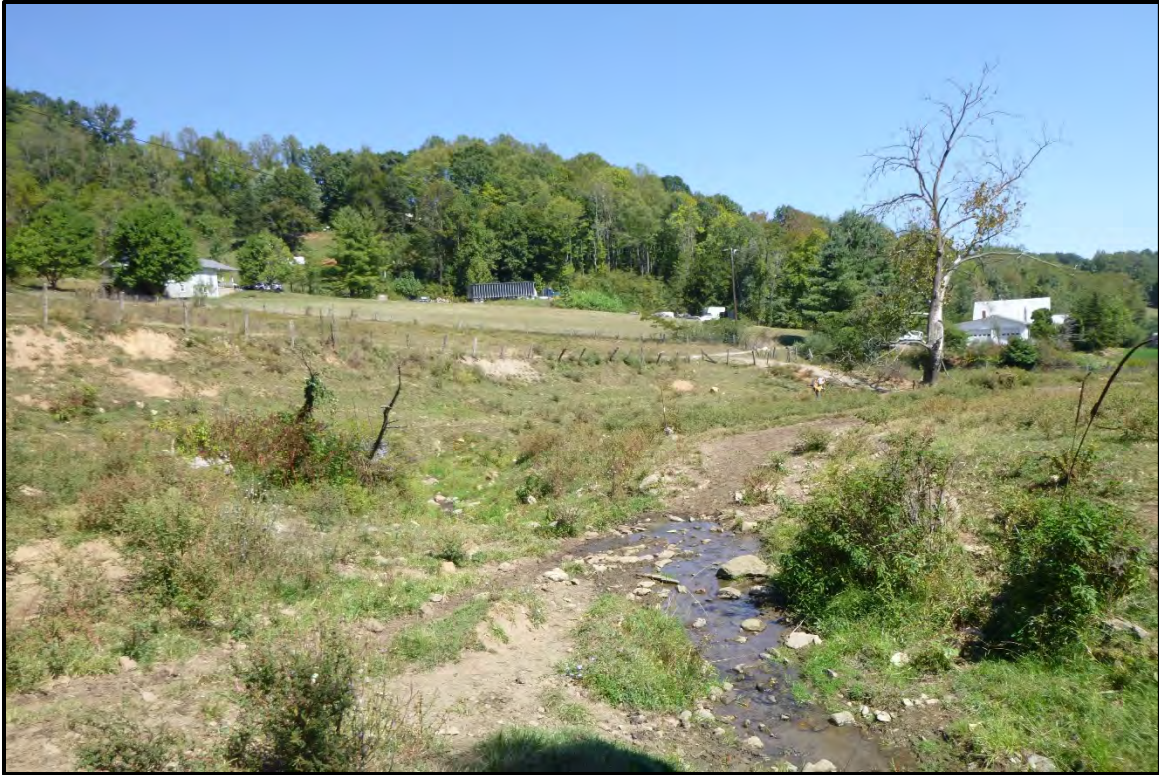
Figure 2.1. Tributary 2, severely eroded area in pasture, facing southeast.

The Morgan Branch Stream Restoration Project is located along nine tributaries of Morgan Branch on the east and west sides of Morgan Branch Road (SR 1220) north of its intersection with Newfound Road (SR 1004) in Leicester, Buncombe County, North Carolina. The Project corridor includes both agricultural and livestock fields and/or pastures as well as wooded and overgrown areas along the stream courses (Figures 2.1–2.4).

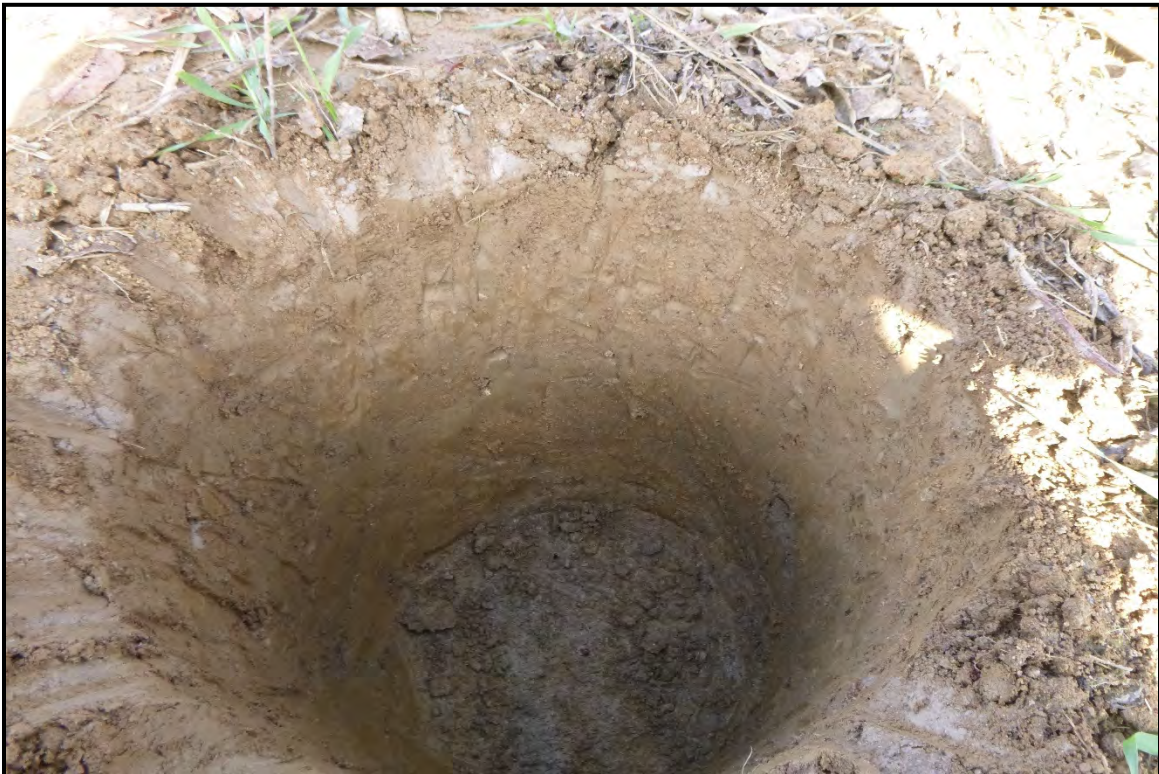
Figure 5.10. Shovel test 223 profile at 31BN265.

The soil type at 31BN265 is Unison loam, 8–15% slopes (UnC), which is a well-drained loam derived from old alluvium found on stream terraces and slope bases (USDA NRCS 2019). Soils observed in the shovel tests across the site were relatively consistent, consisting of a 31–49 cm thick plowzone (Ap horizon) of dark yellowish brown (10YR 4/4) sandy loam overlying dark yellowish brown (10YR 3/6) sandy loam to depths of 41 to 63 cmbs at which point the soils became coarser sand and more hydric in nature (Figure 5.10).

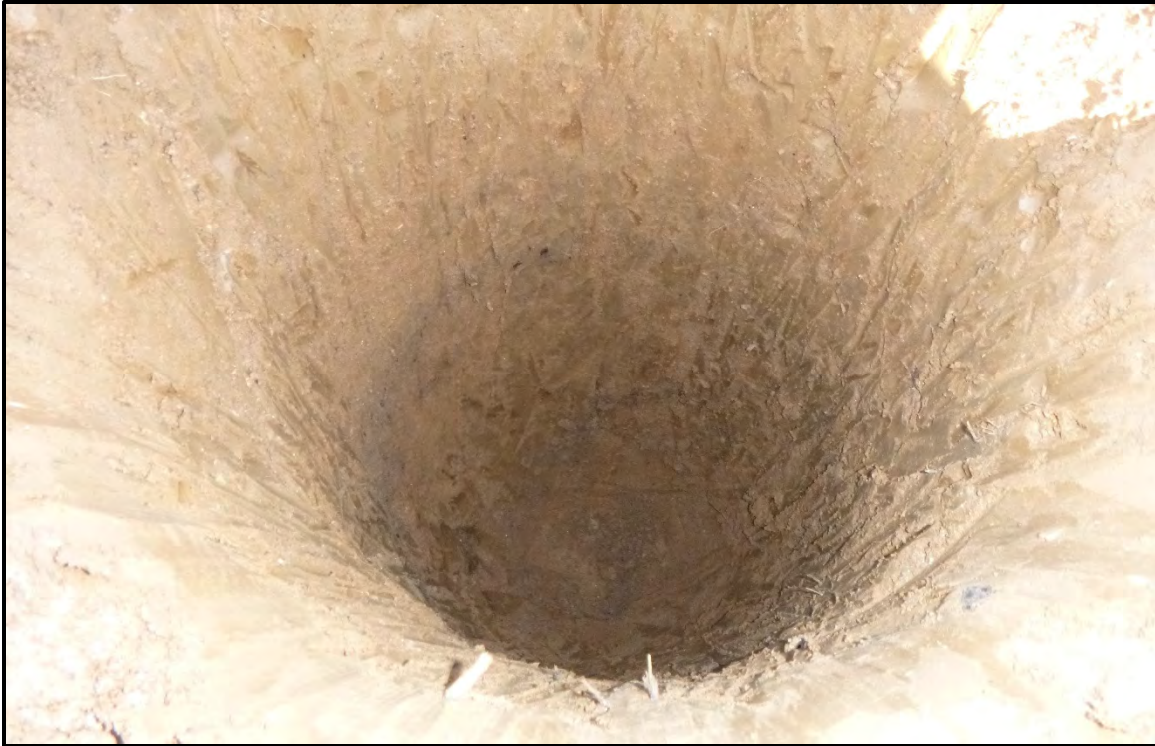
Figure 5.14. Shovel test 211 profile at 31BN266.

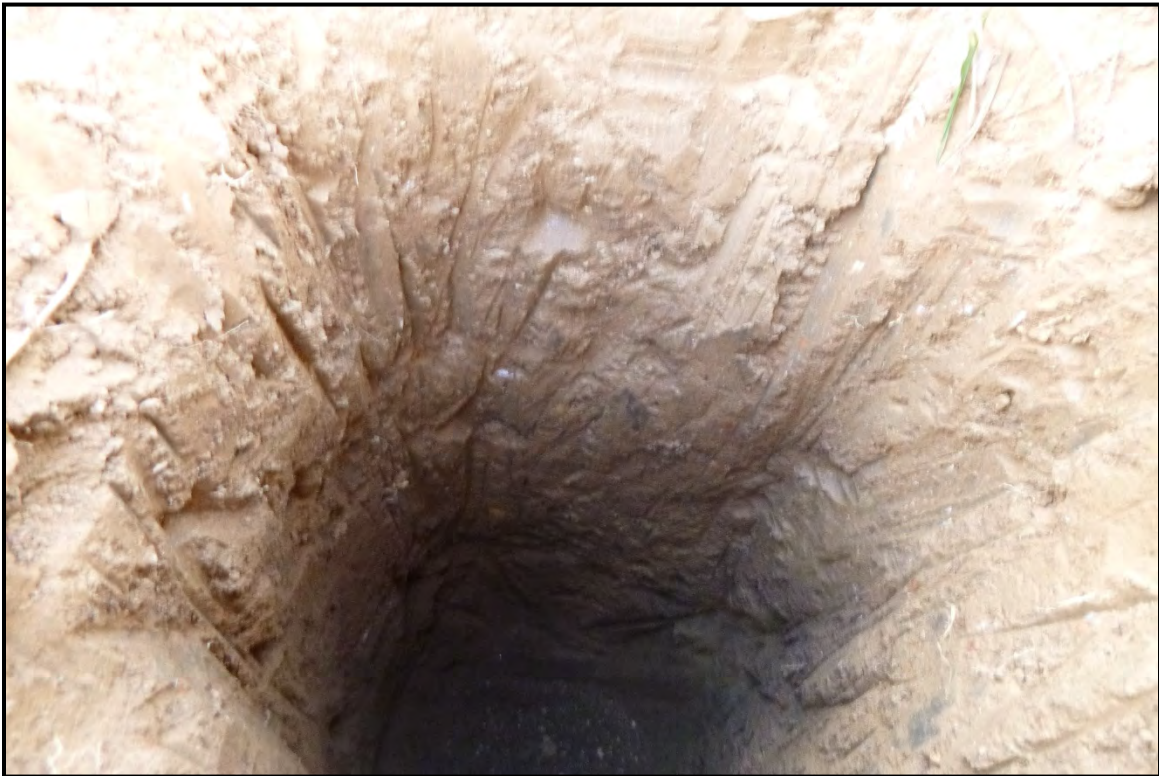
Figure 5.18. Shovel test 75 profile at 31BN411, showing buried Ap horizon.

Two soil types are mapped within site 31BN411, including Unison loam (8–15% slopes) along the northern and western edges of the site and French loam (0–3% slopes) in the southeastern corner. Unison loam is a well-drained loam derived from old alluvium found on stream terraces and slope bases, while French loam is somewhat poorly drained loamy alluvium atop sandy and gravelly alluvium (USDA NRCS 2019). Soils observed in the shovel tests across the site varied slightly, most shovel tests contained an approximately 30 cm thick plowzone (Ap horizon) of dark yellowish brown (10YR 3/6) silt loam overlying a strong brown (7.5YR 5/8) sandy clay B horizon. Five shovel tests, including two shovel tests (STs 75 and 81) that contained artifacts, encountered a buried plowzone or alluvial deposit of dark yellowish brown (10YR 3/4) coarse sandy loam at various depths (starting at 25–50 cmbs and ending at 32–75 cmbs) (Figure 5.18).

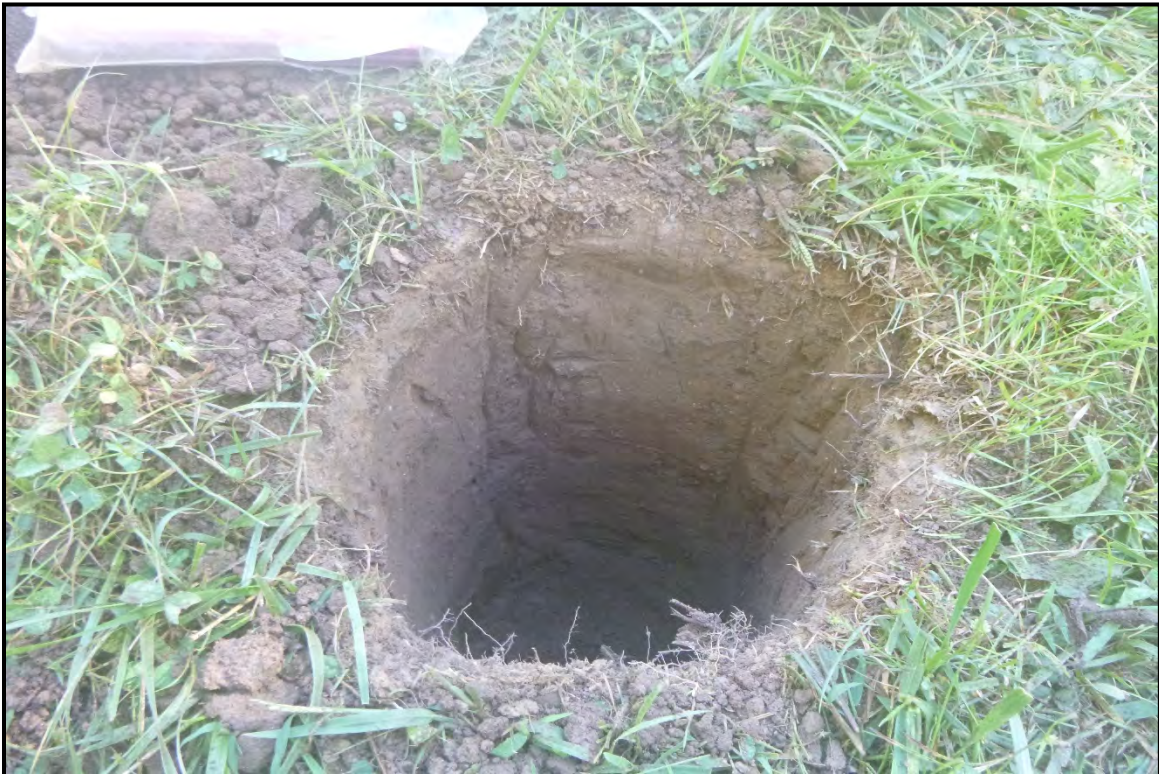
Figure 5.29. Shovel test 102 profile at 31BN1088.

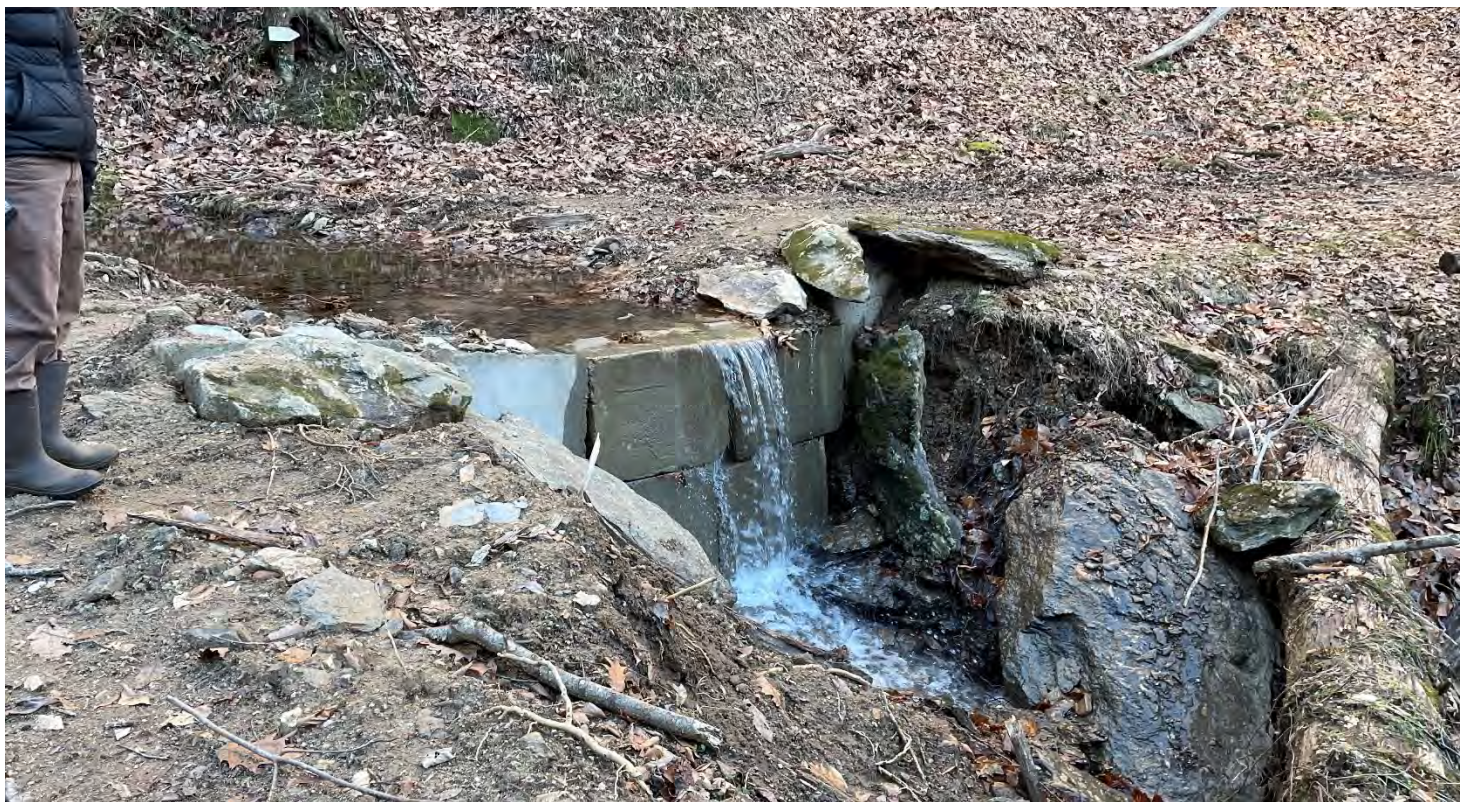
Washed-out culvert was temporary repaired by the landowner with a ford secured with concrete blocks (Area D).

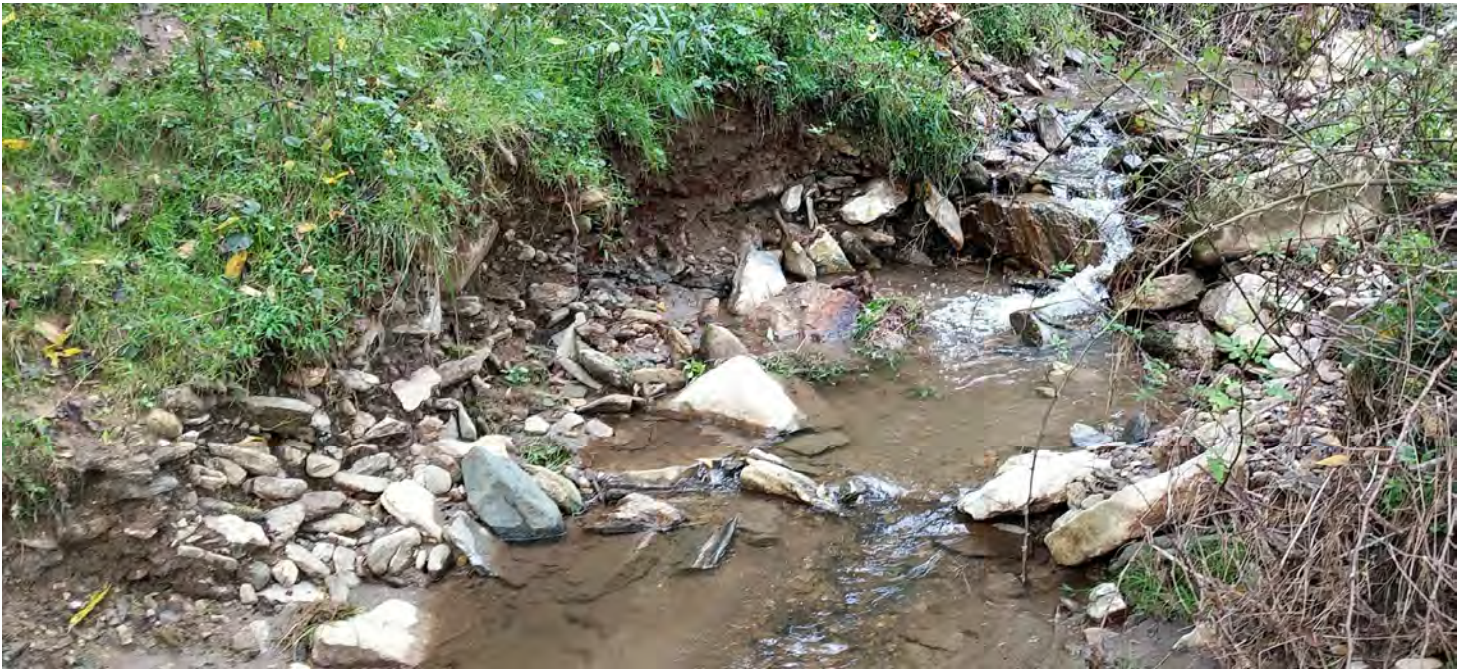
Formerly stable bank on Morgan Branch, now actively eroding after storm event, will require bank grading, stabilization, and bench grading (Area F).

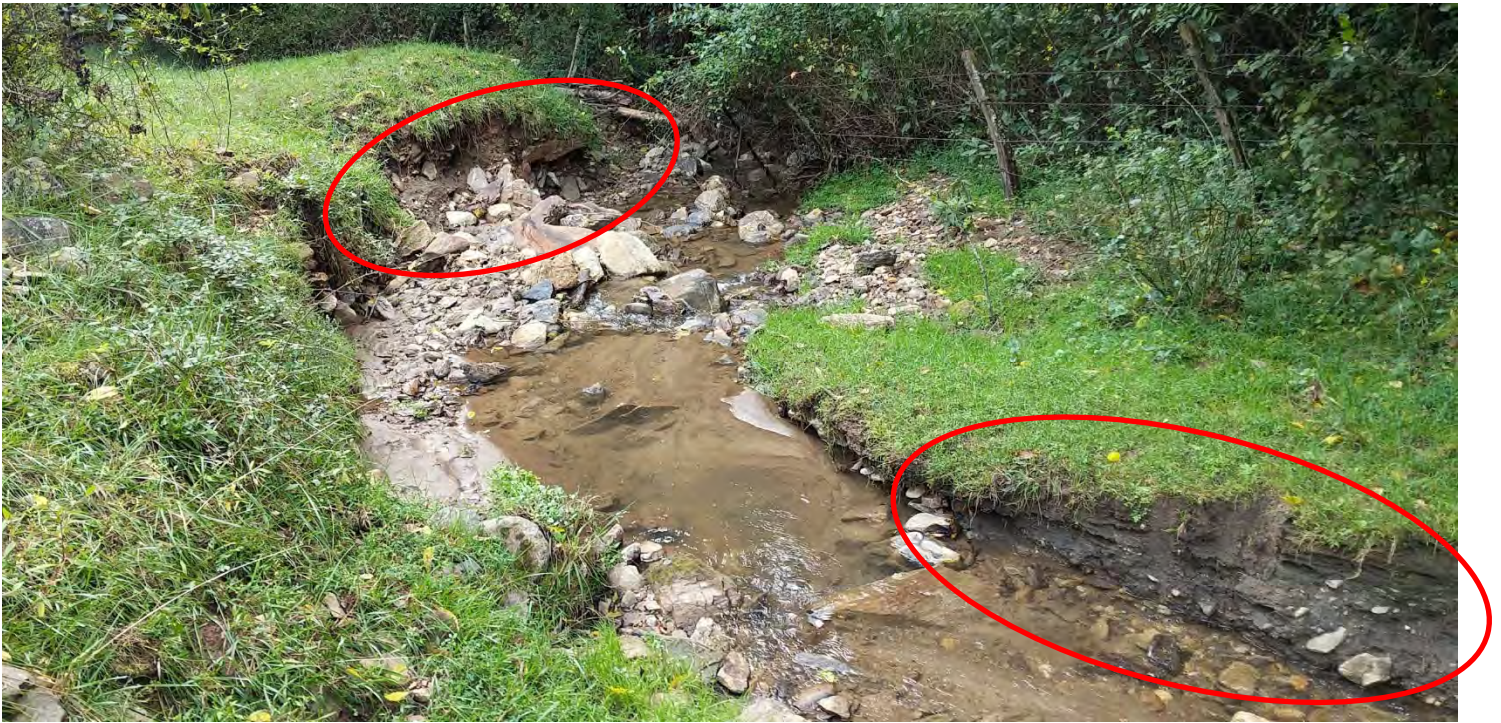
Another view on Morgan Branch of a formerly stable bank, now actively eroding after storm event requiring bank grading, stabilization, and bench grading (Area F).

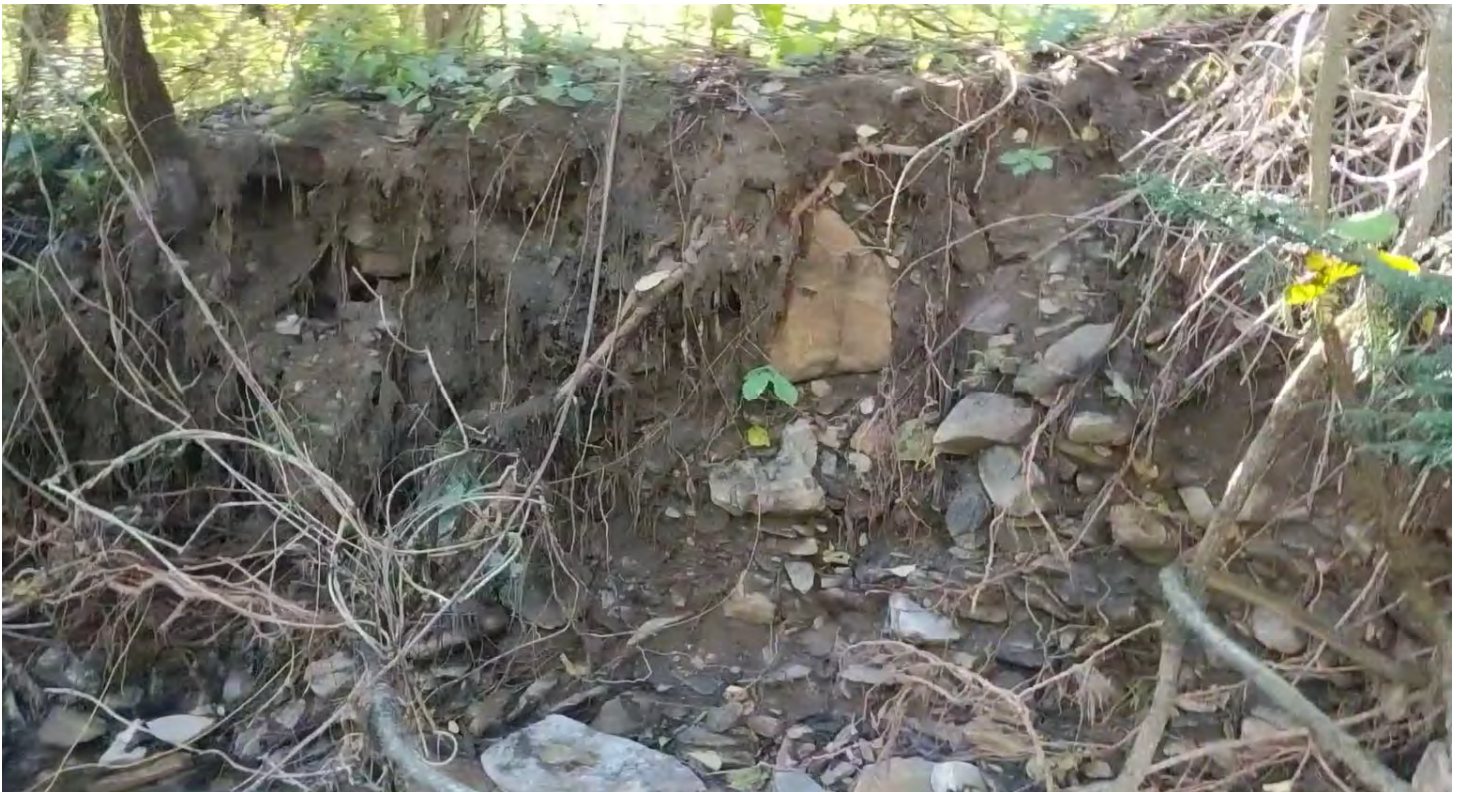
Formerly stable banks, now both are actively eroding after storm event requiring bank grading, stabilization, and bench grading (Area F).

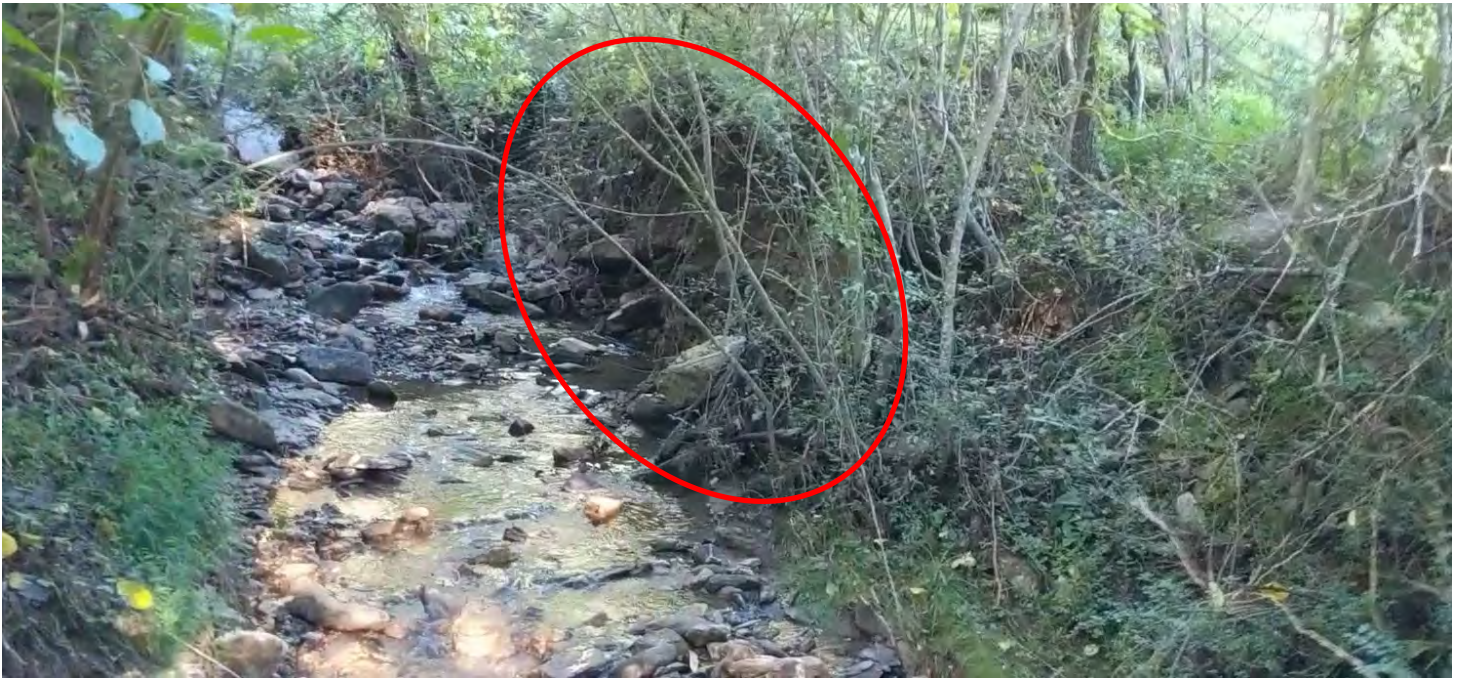
Formerly stable banks throughout this section are now unconsolidated and actively eroding after storm event requiring bank grading, stabilization, and bench grading (Area H).

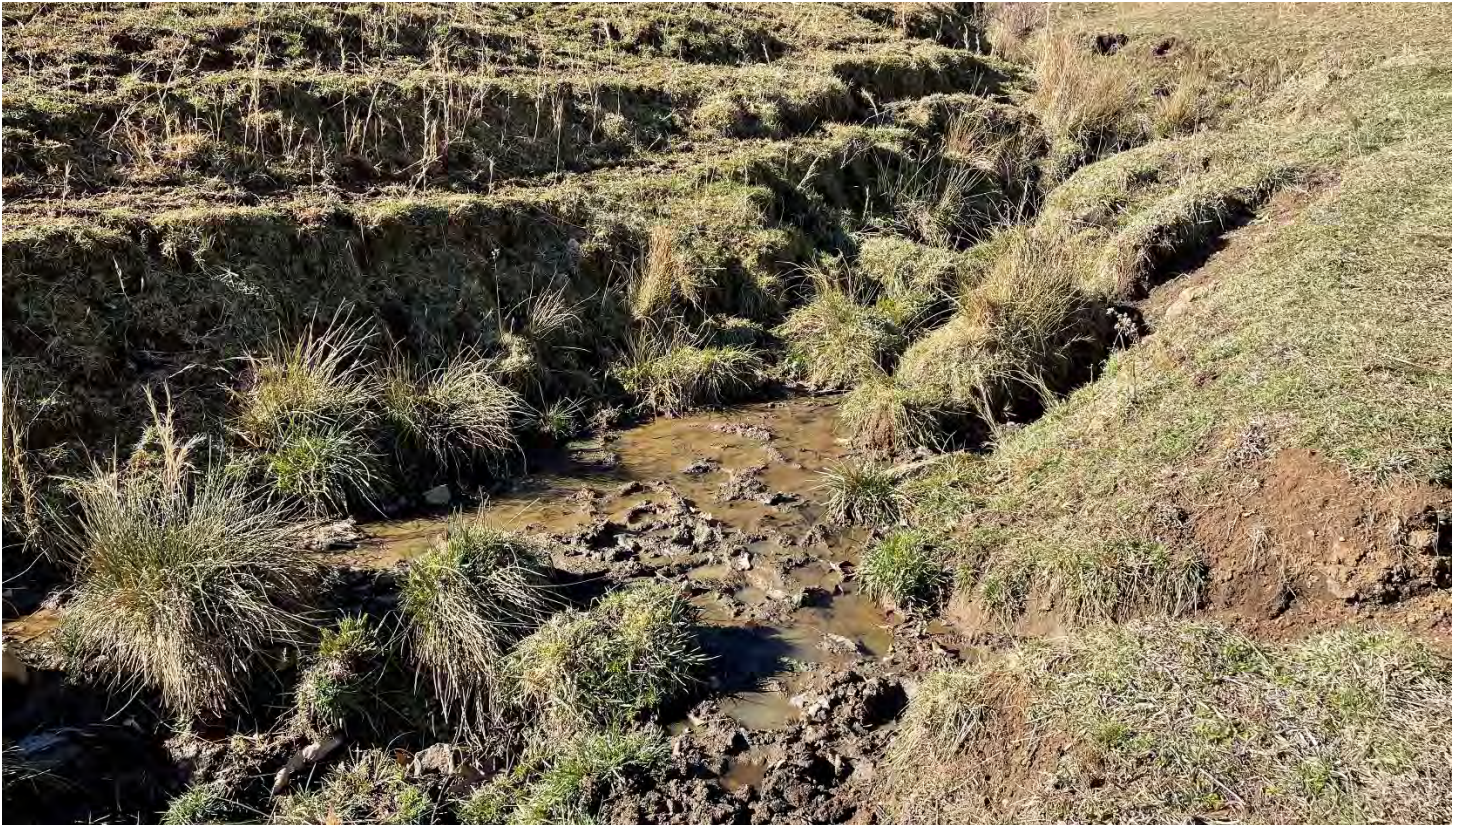
Bed lowering and incision has occurred in this section. The banks are unconsolidated and eroding and the minimal buffer is almost all invasive vegetation (Area H). This area will benefit from bank grading and stabilization and bed work to create more stable bed features.

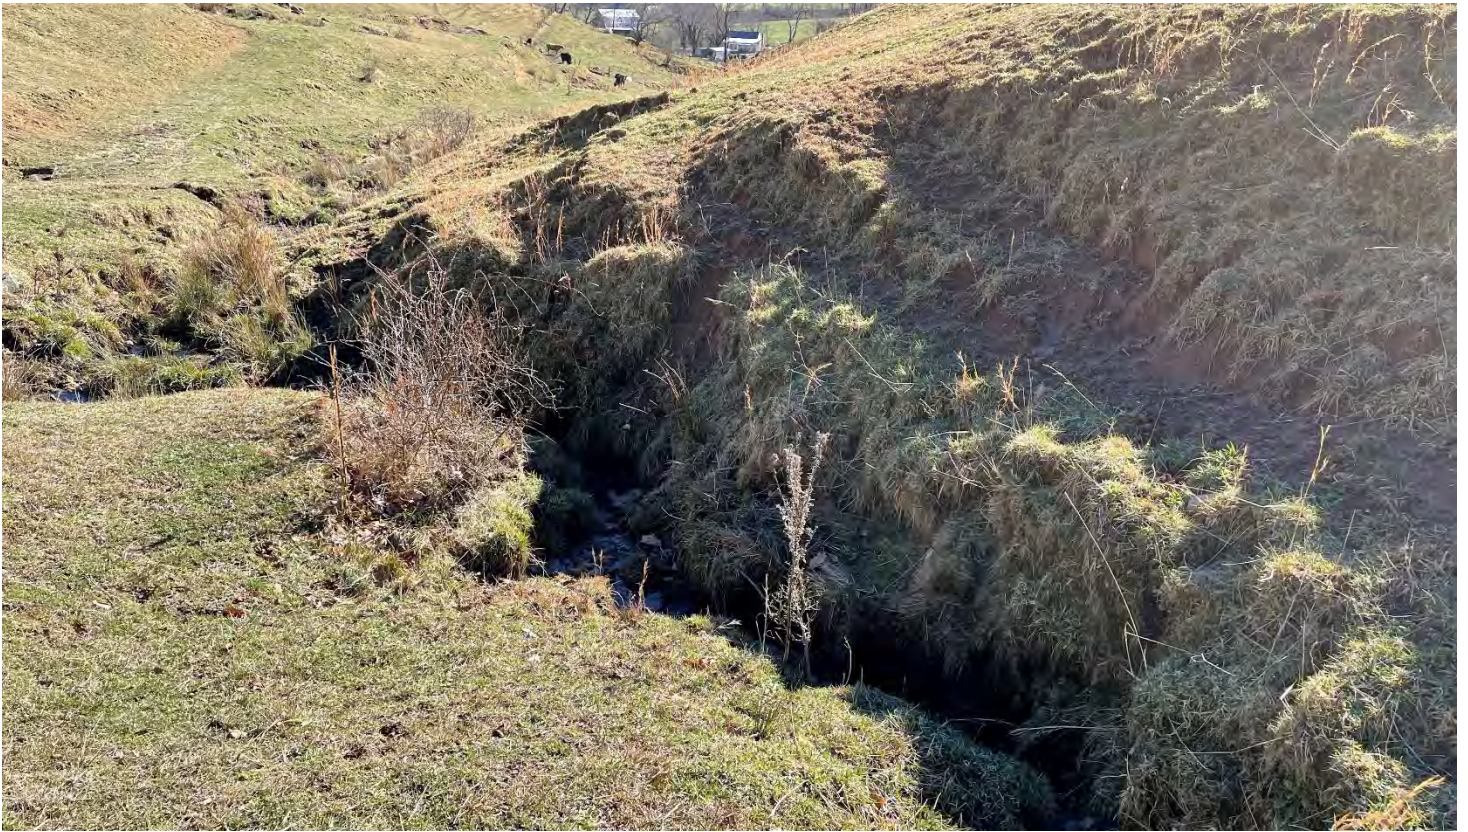
A portion of T4-1 has continued to erode, and the bed and banks are poorly formed from cattle impacts. This reach would benefit from a Restoration approach, matching the approach proposed for T4 and T4-2.

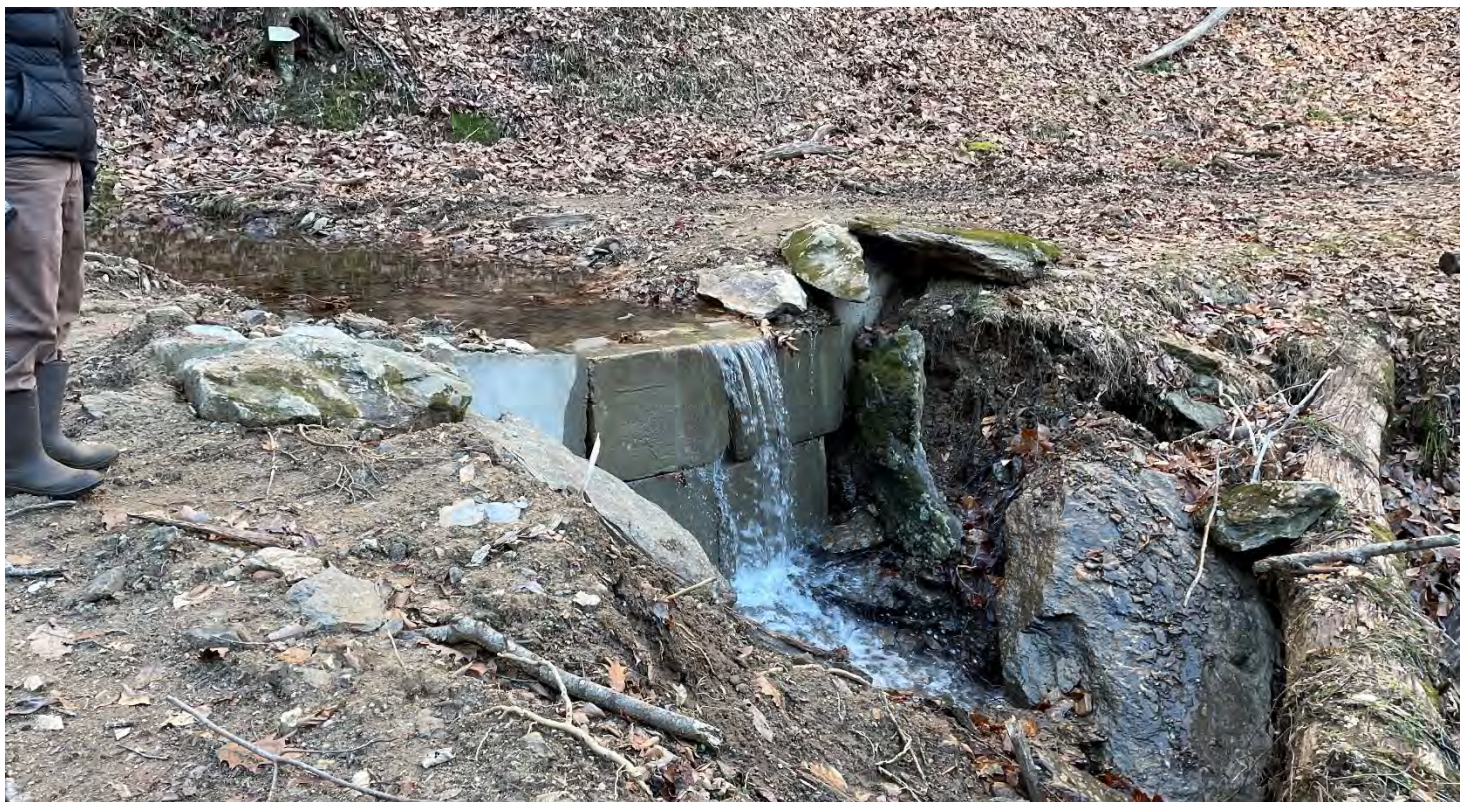
Washed-out culvert was temporary repaired by the landowner with a ford secured with concrete blocks (Area D).

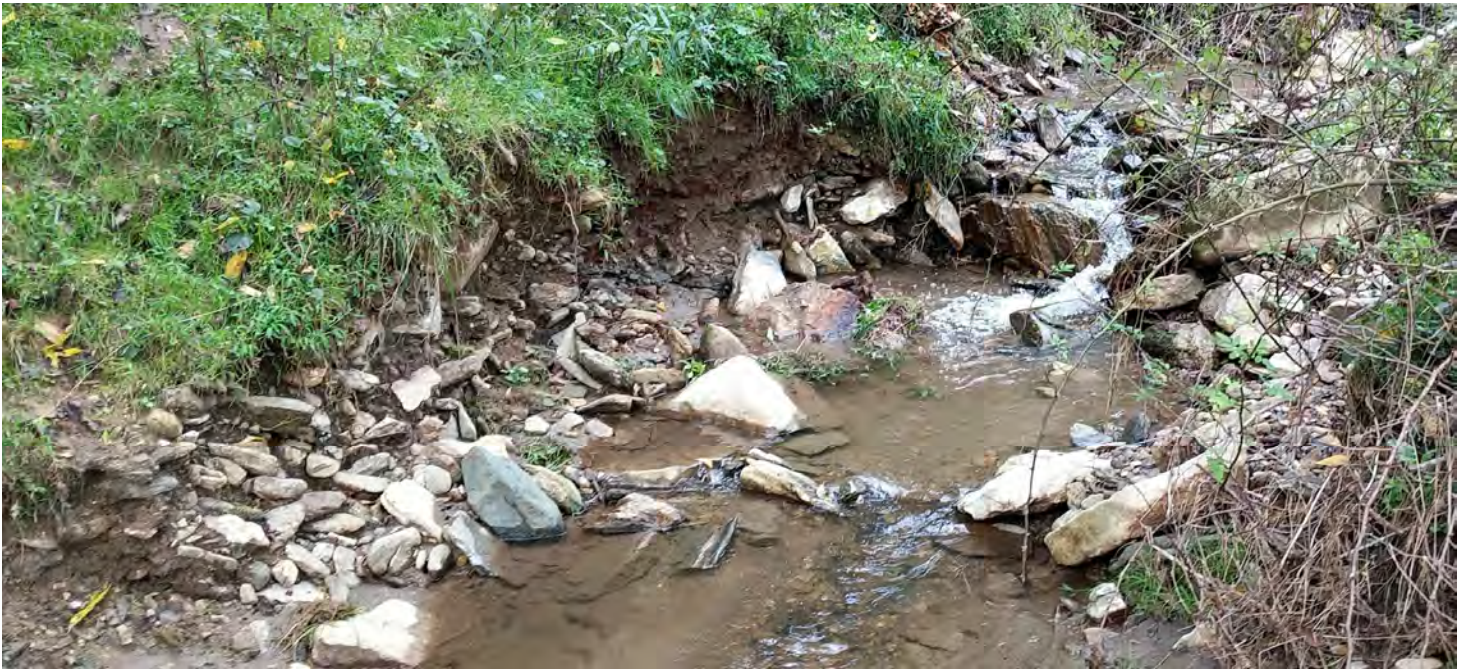
Formerly stable bank on Morgan Branch, now actively eroding after storm event, will require bank grading, stabilization, and bench grading (Area F).
