# **Mason Farm Wetland/Floodplain Restoration & Stream/buffer Enhancement Chapel Hill, Orange & Durham Counties, North Carolina**

## **Restoration Plan**

**July 3, 2008**

# Mason Farm Wetland/Floodplain Restoration & Stream/Buffer Enhancement Chapel Hill, Orange, and Durham Counties, North Carolina

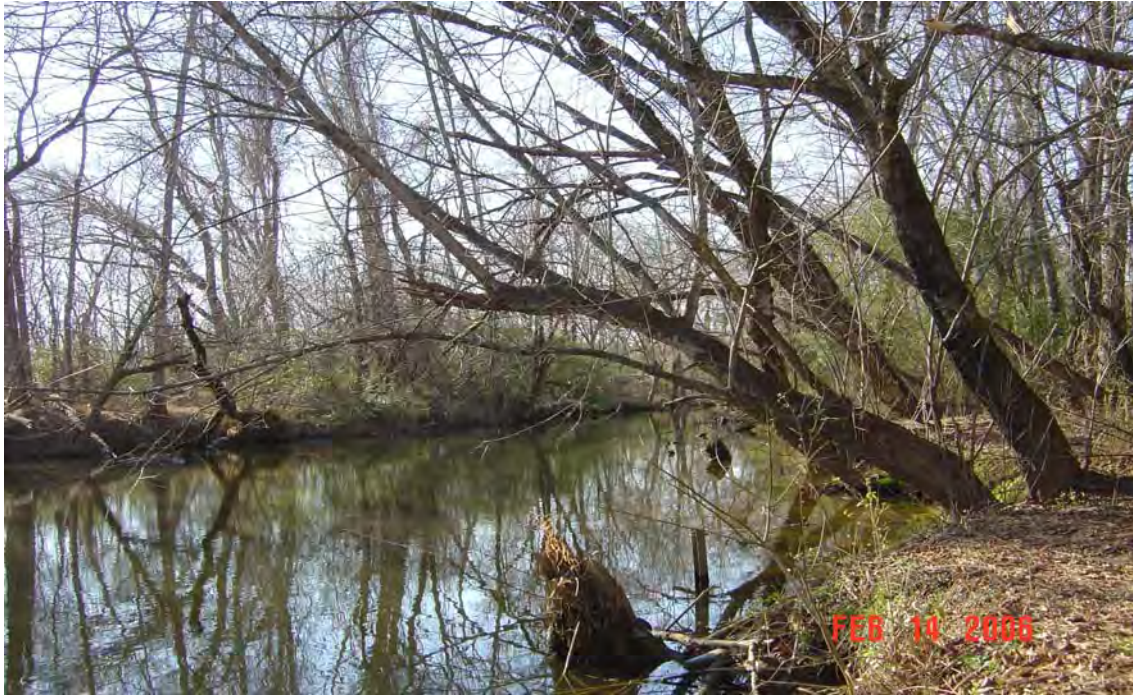
**Photo 7: Morgan Creek Looking Downstream**

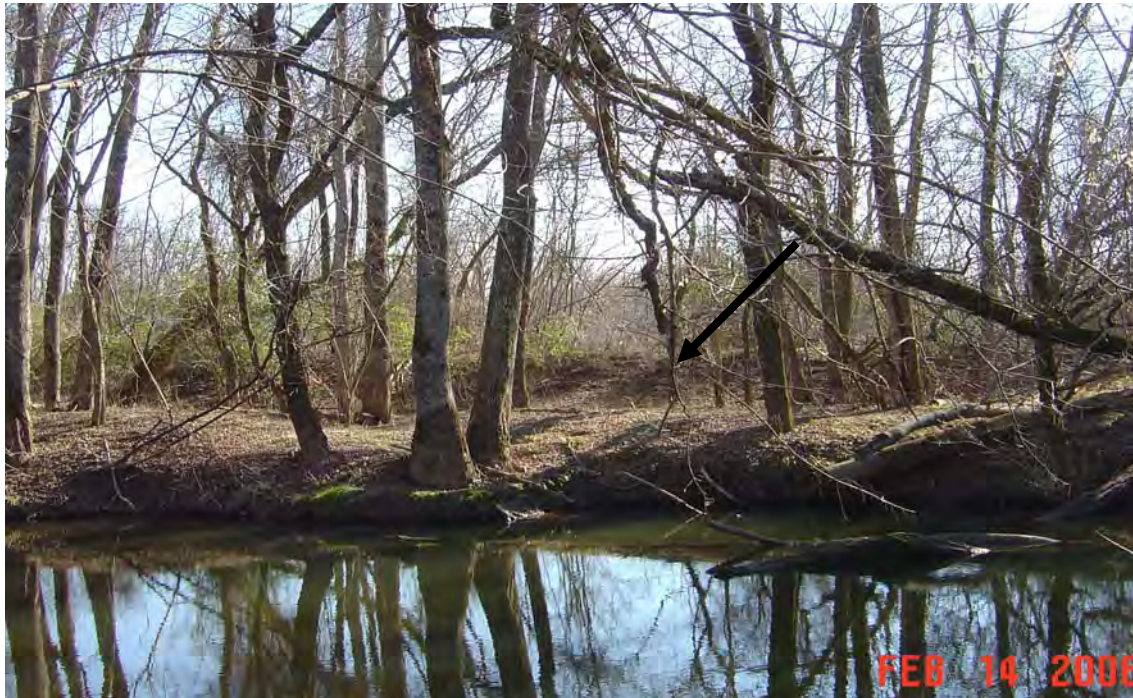
**Photo 8: Existing Southern Berm as viewed from the Northern bank of Morgan Creek**

The project site is within the floodplain of Morgan Creek. An approximately 3,800-foot long berm was constructed in the 1940’s and runs along the south bank of the creek to control flooding. While the berm, in conjunction with several drainage ditches, created conditions suitable for agriculture, it resulted in loss of the ecological functions of the floodplain and wetlands, as floodwaters now reach the project site only once a decade. There are approximately 17.5-acres of soil within the study area that show evidence of historically supporting wetland hydrology. There is also an 8-acre remnant of the previous functioning wetland at the eastern most extent of the project site. This area receives backwater flooding from Morgan Creek, which is the result of beaver colonizing the creek just downstream of the project site.

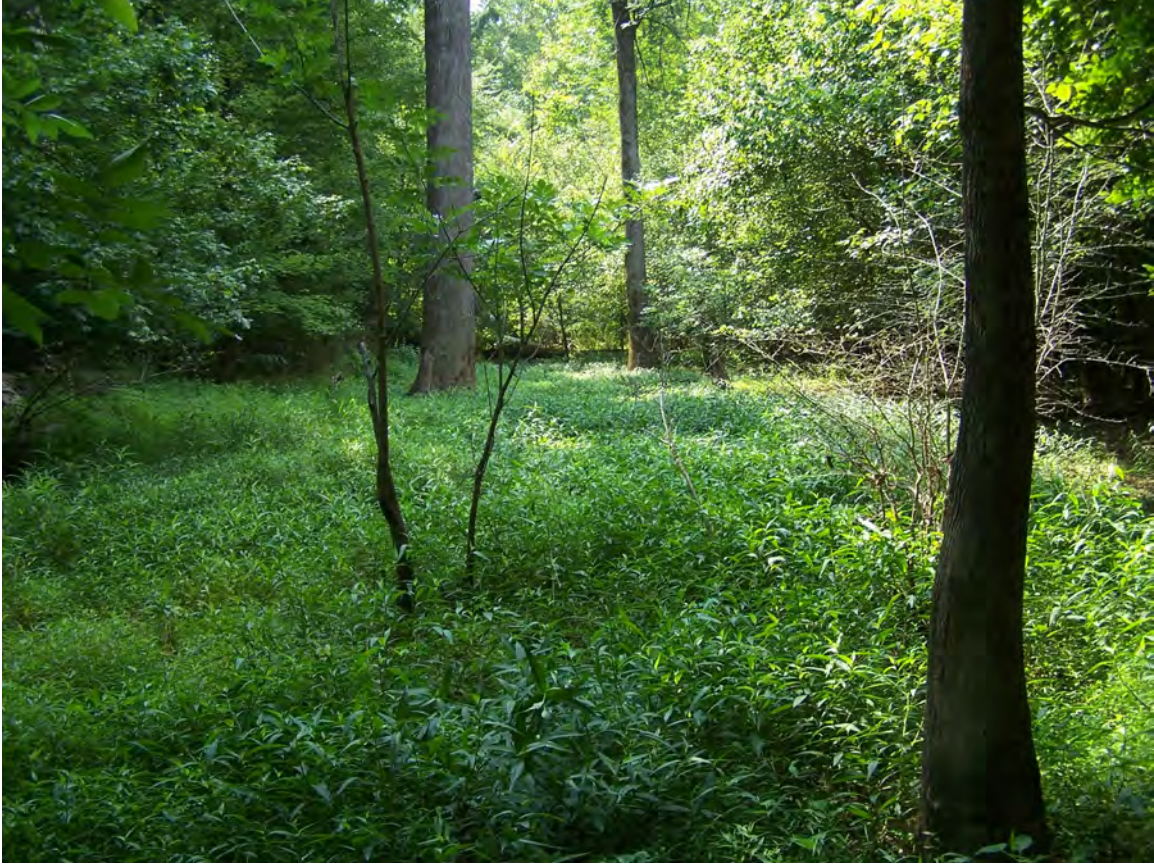
**Photo 3.** View facing southeast with Morgan Creek to the right. Pennsylvania smartweed (*Polygonum pennsylvanicum*) is the dominant herbaceous species in this wetland.

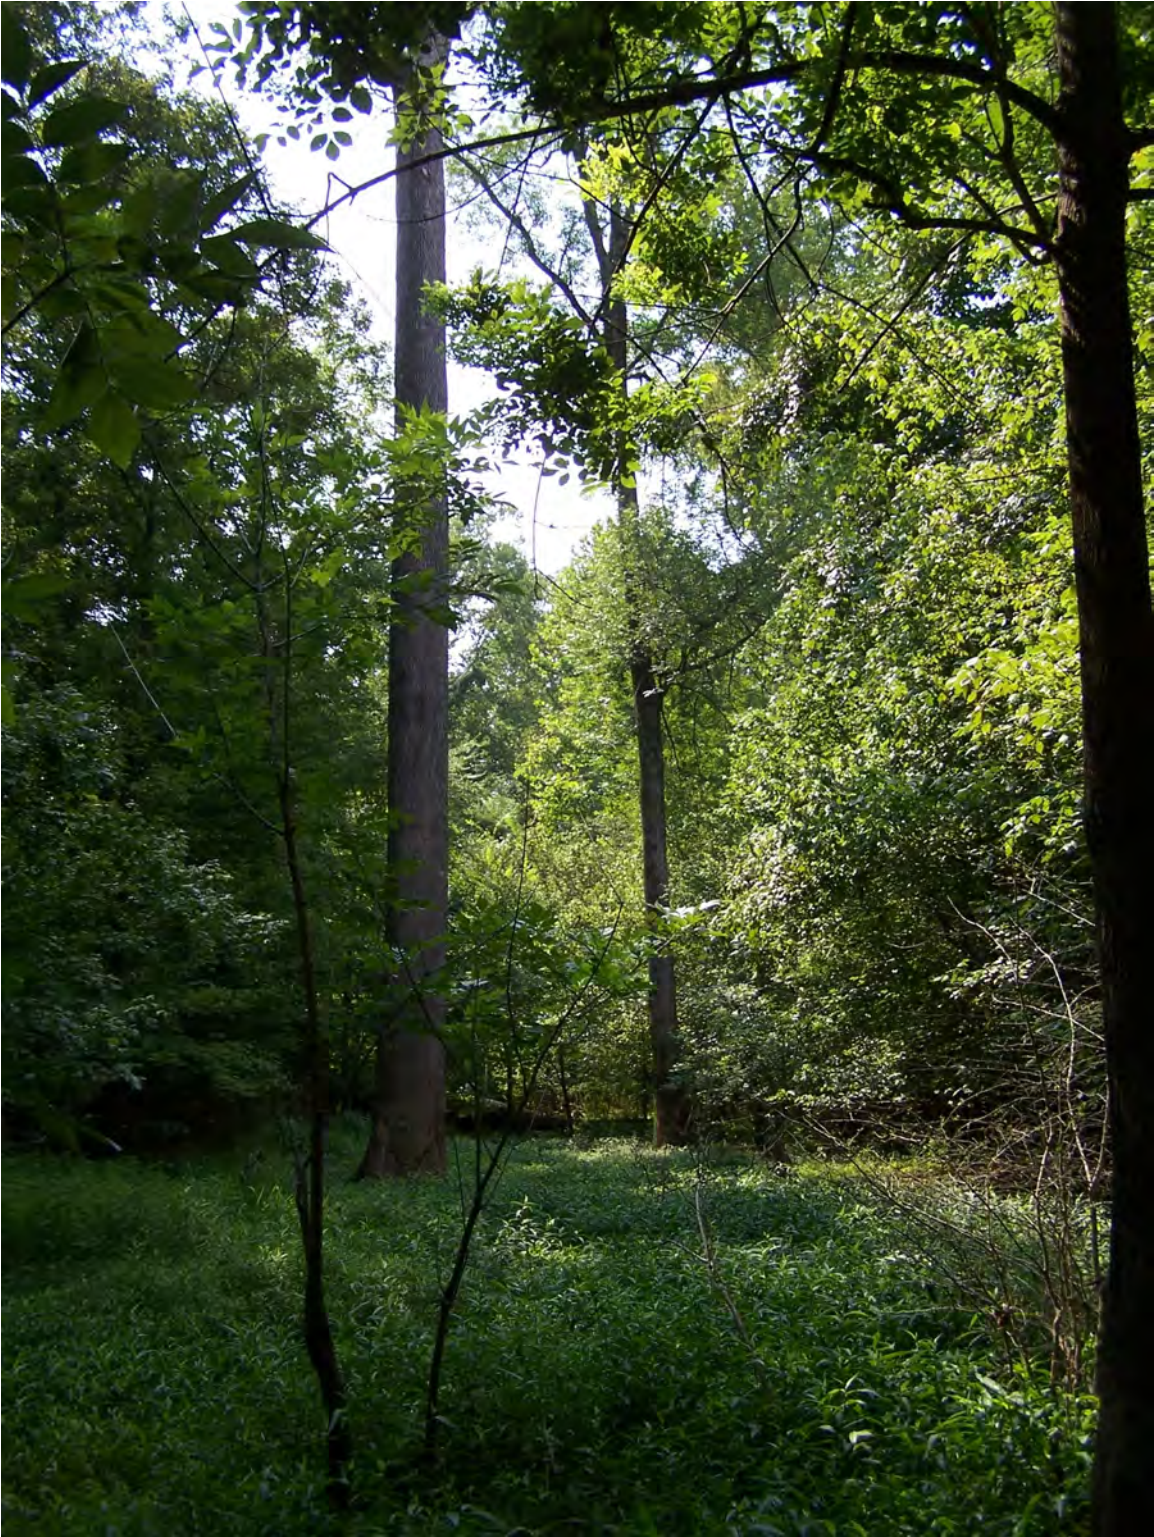
**Photo 4.** The large tulip poplar tree (*Liriodendron tulipifera*) in the center of the picture is actually a dead snag allowing for more sunlight creating optimal conditions for a thriving herbaceous wetland community.

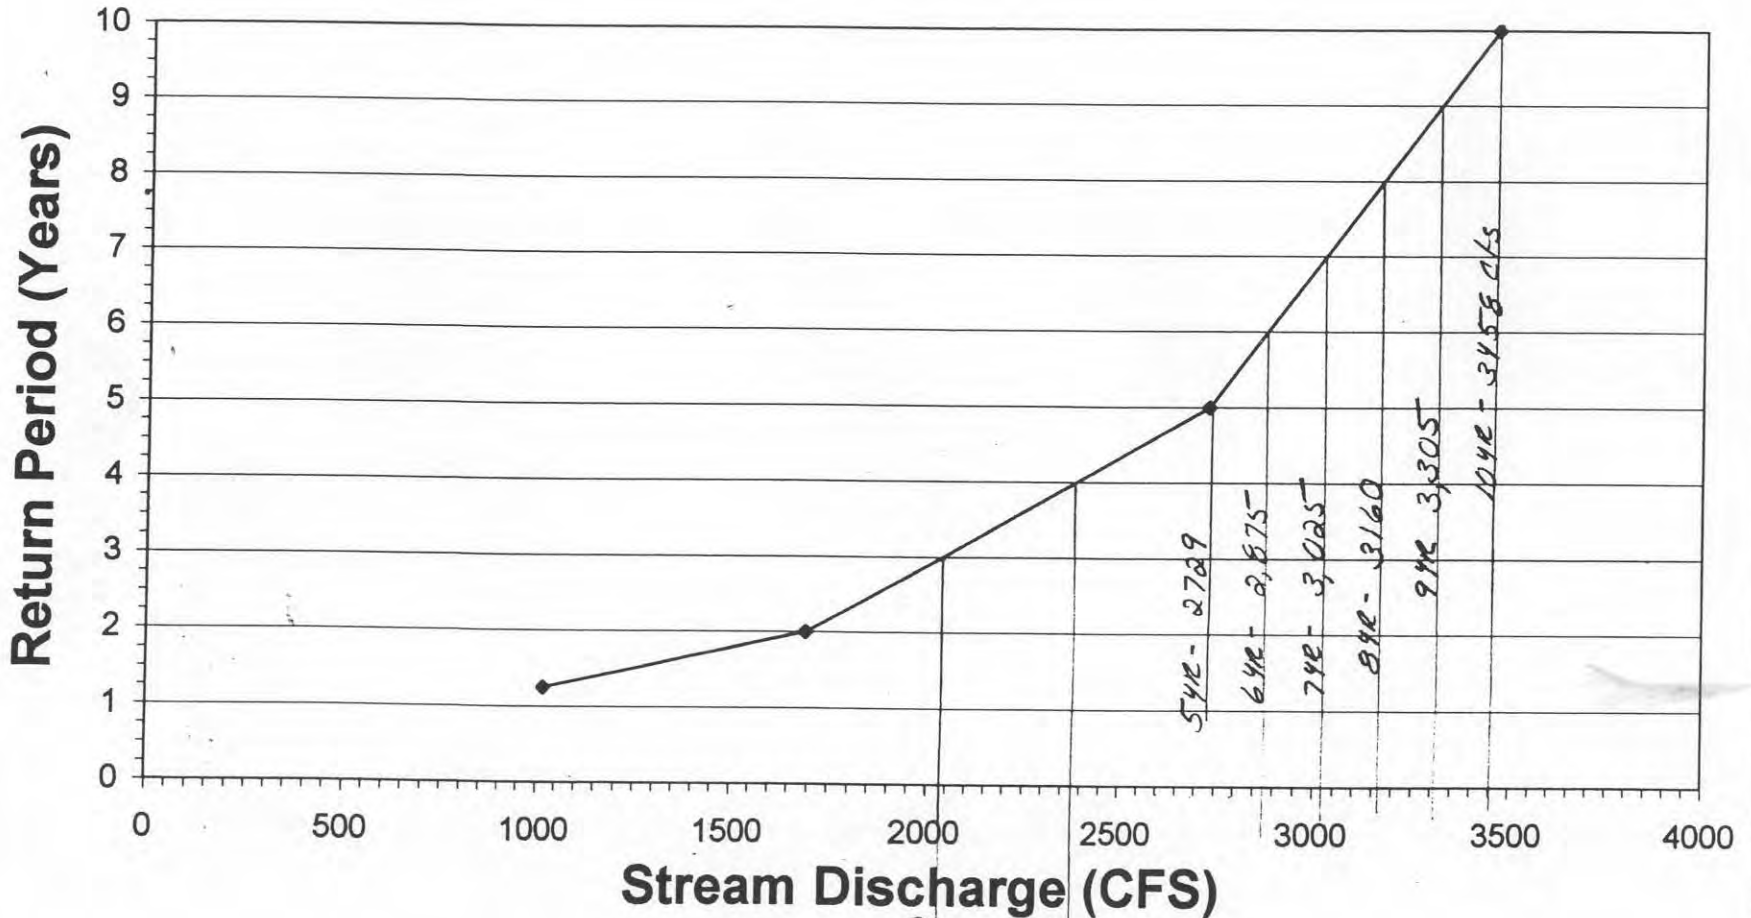
# Storm Return Period Vs. Morgan Creek Discharge

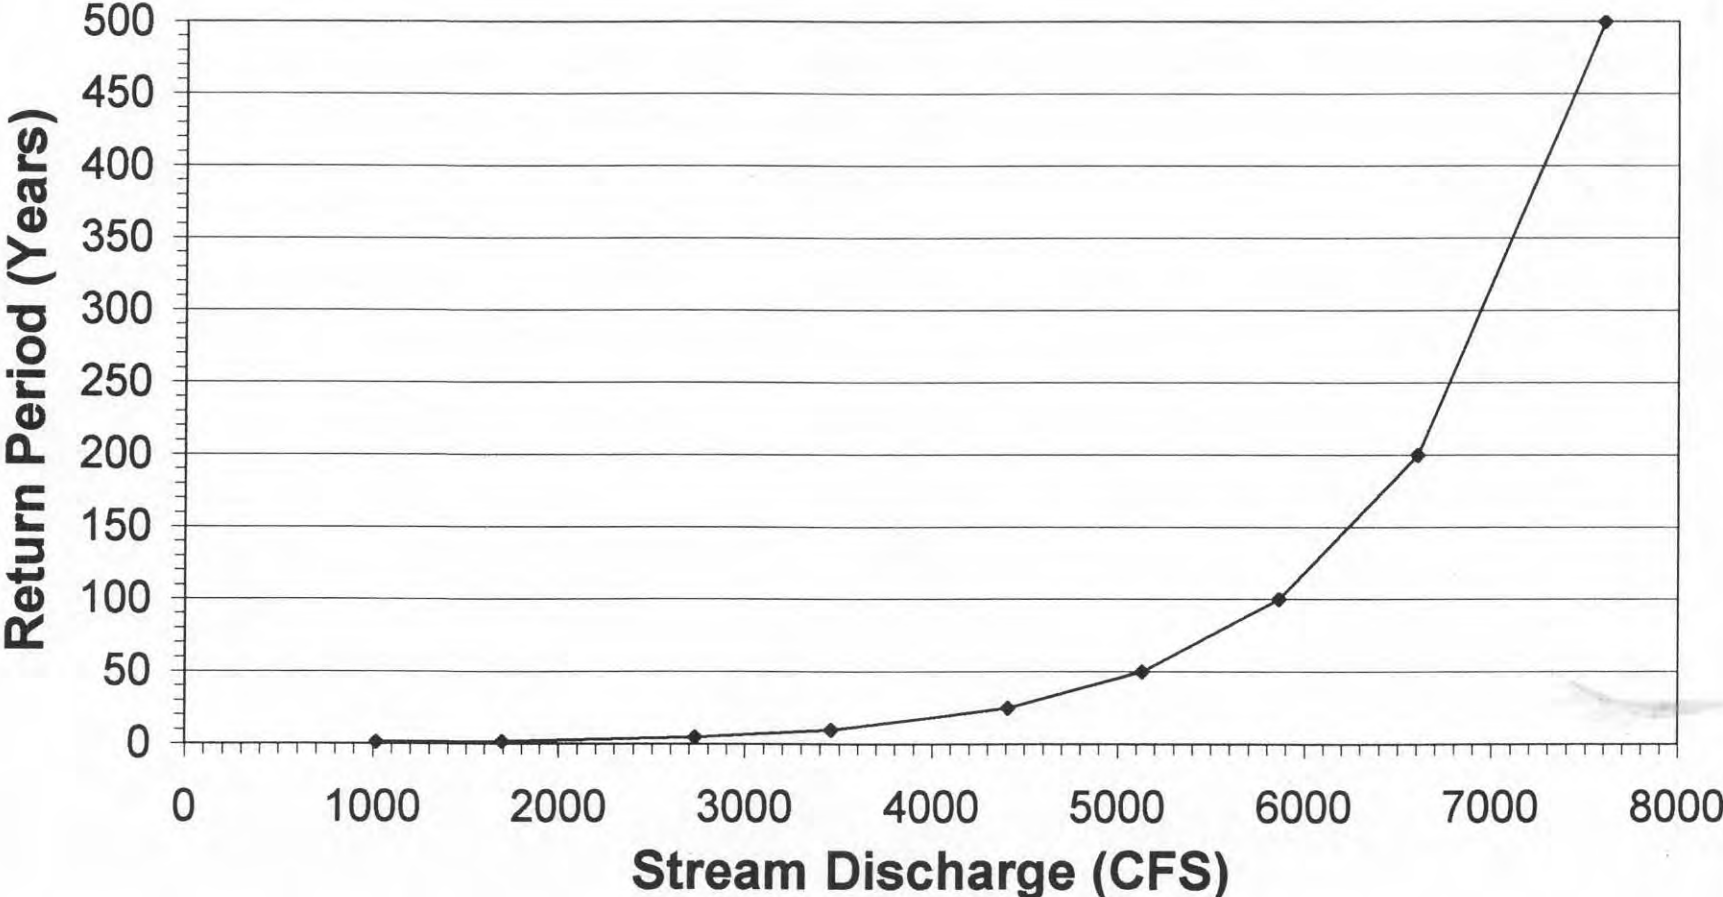
# Storm Return Period Vs. Morgan Creek Discharge

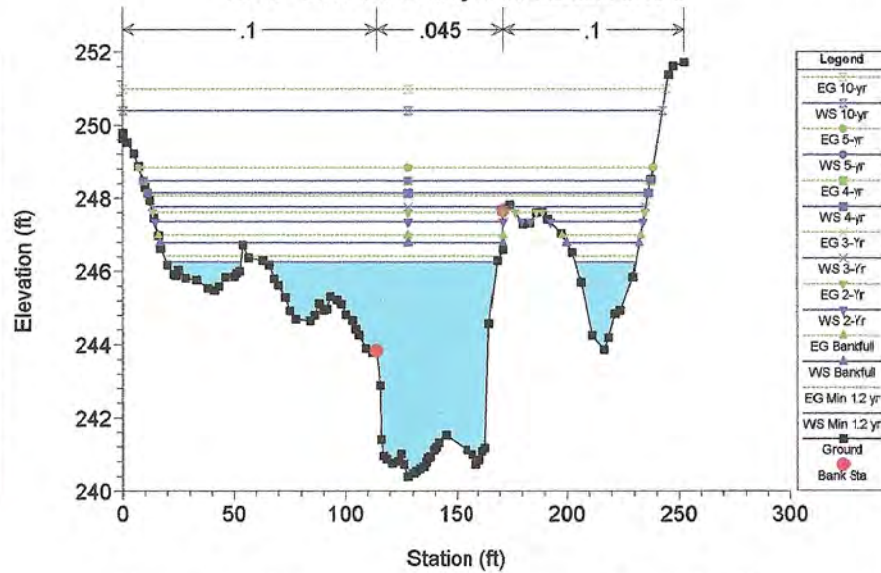
Mason Farms Morgan Creek Plan: 5-weirs rev 1-31 5/21/2007  
40250 - Riffle section #4 just downstream of ford

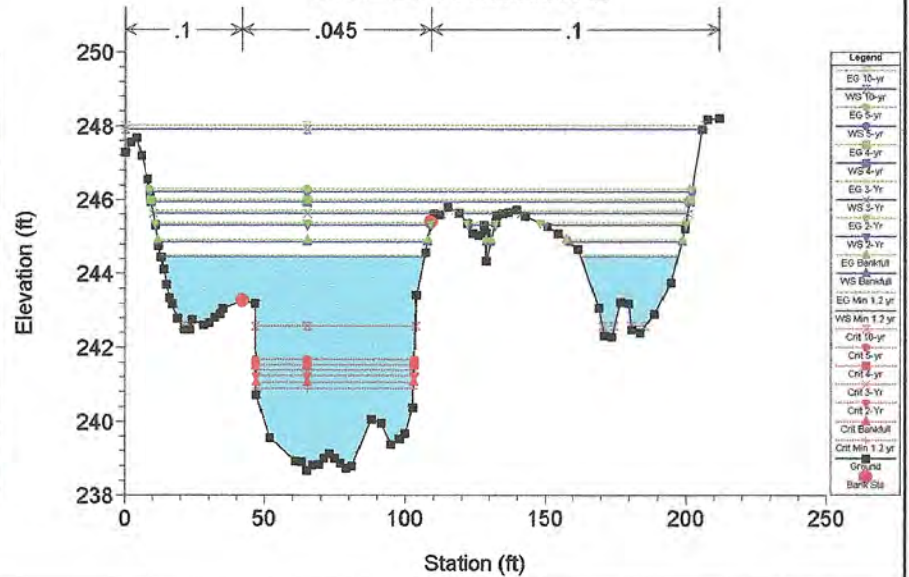
Mason Farms Morgan Creek Plan: 5-weirs rev 1-31 5/21/2007  
38400 - Cross Section #2 Riffle

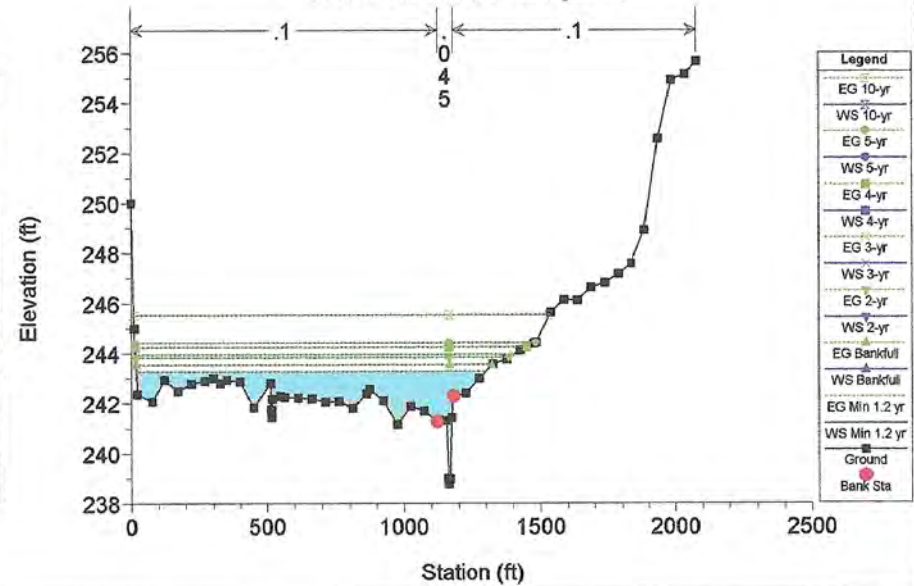
Section 39340 Field surveyed #3

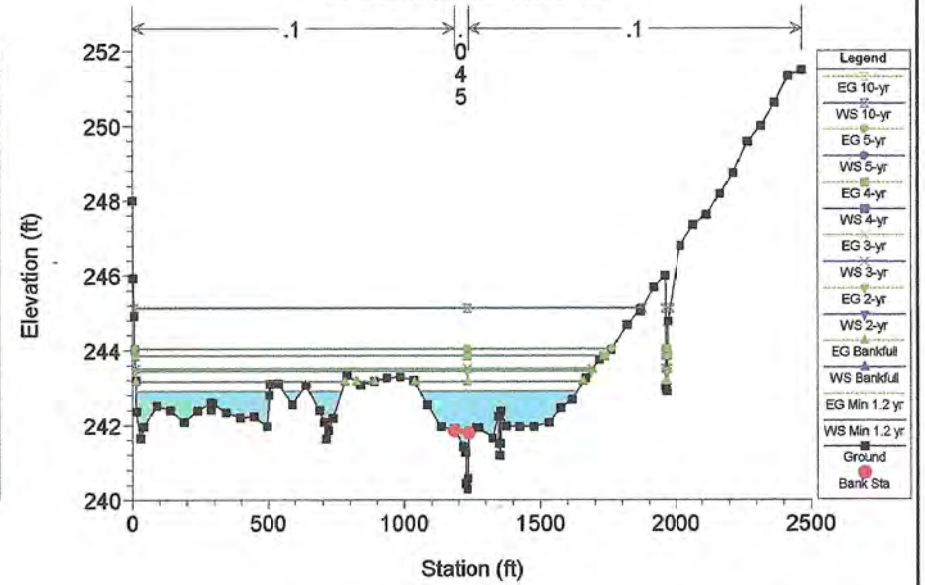
38750- field cross section #4
