**Morgan Creek Floodplain
Orange/Durham Counties, North Carolina
EEP Project# 258**

MY-01 Monitoring Report

Data Collected: November 2011
Submitted: March, 2012

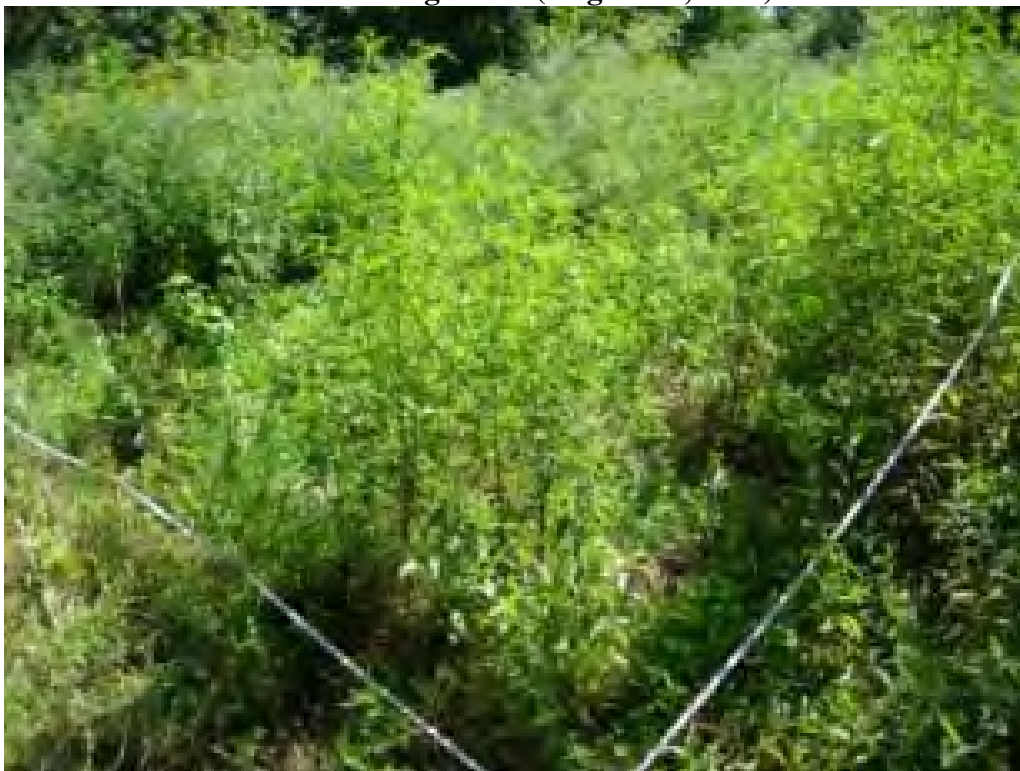
Photo 2. Veg Plot 2 (August 23, 2011)

Table 6. Vegetation Plot Criteria Attainment		
Vegetation Plot ID	Vegetation Survival Threshold Met?	Tract Mean
VP 1	Yes	100%
VP 2	No	
VP 3	Yes	
VP 4	Yes	
VP 5	Yes

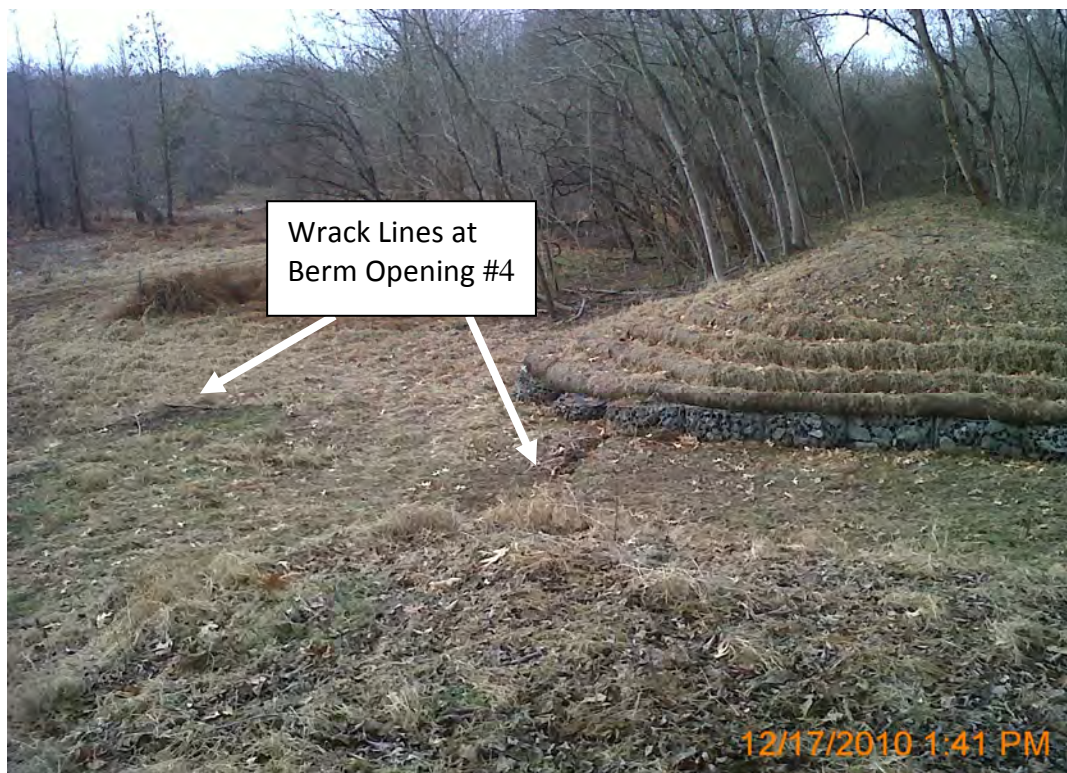
The USGS stream gauge (02097517 Morgan Creek near Chapel Hill, NC) located on the adjacent Morgan Creek provides real time gauge height updates to monitoring performers. On September 30, 2010, the gauge height reached a maximum height of 7.8 feet in which flow was observed through berm opening #4. An alert has been established through USGS to notify monitoring performers of any gauge height of 8.0 feet or greater, where flow will access the floodplain through the berm openings. Monitoring performers are documenting each berm activation event, and correlating gauge height, in order to better quantify the volume of flow through the openings during a given rain event for future monitoring purposes.

Photo 6. Wrack lines at berm opening #4

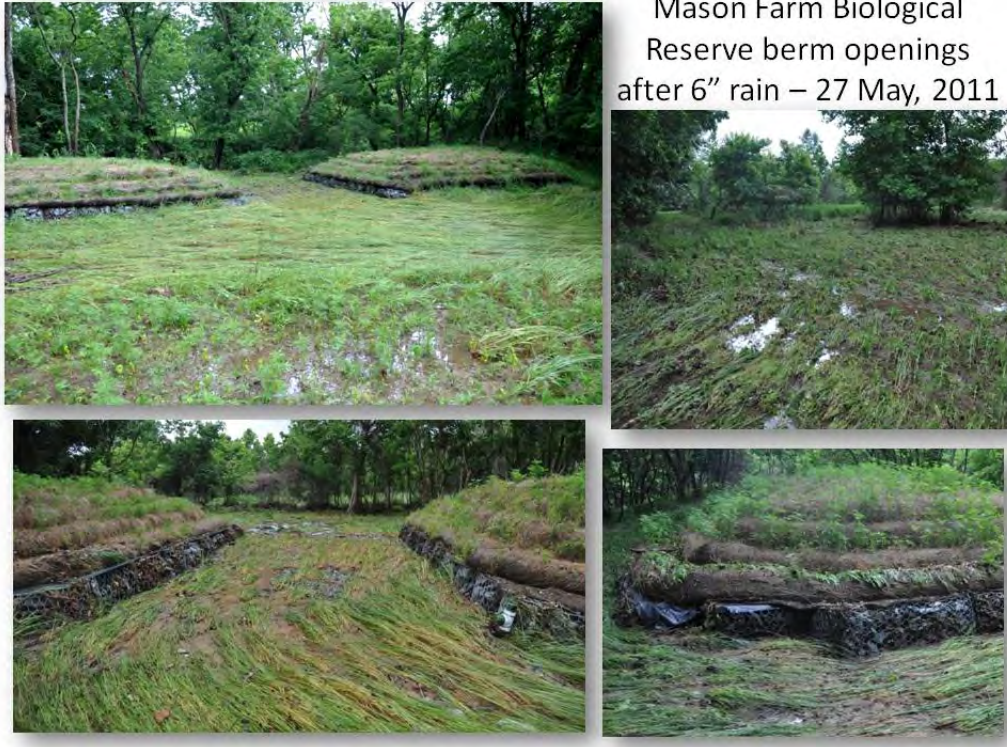
Mason Farm Biological Reserve berm openings after 6" rain – 27 May, 2011

Photo 7. Overland flow

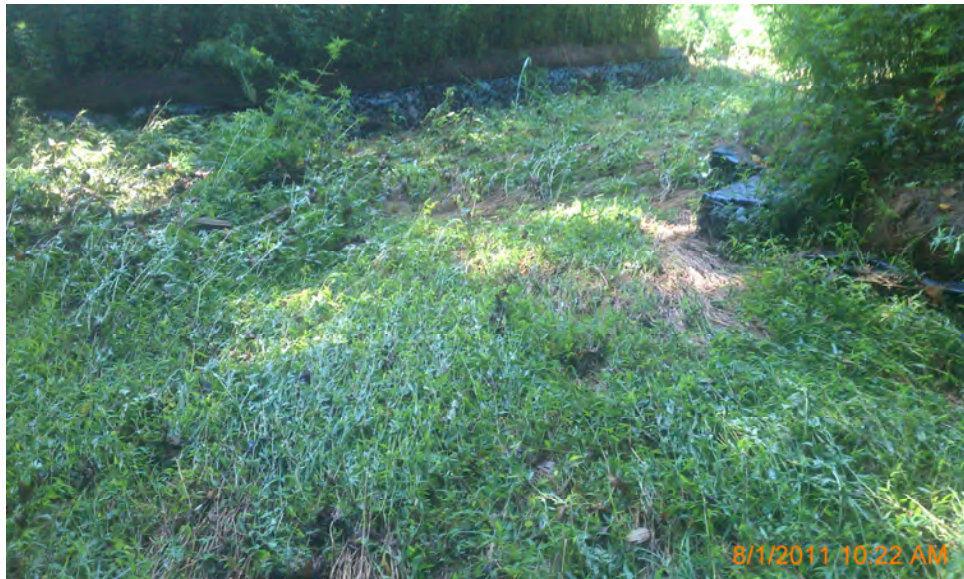
Photo 8. Overland flow indicators at Berm #1

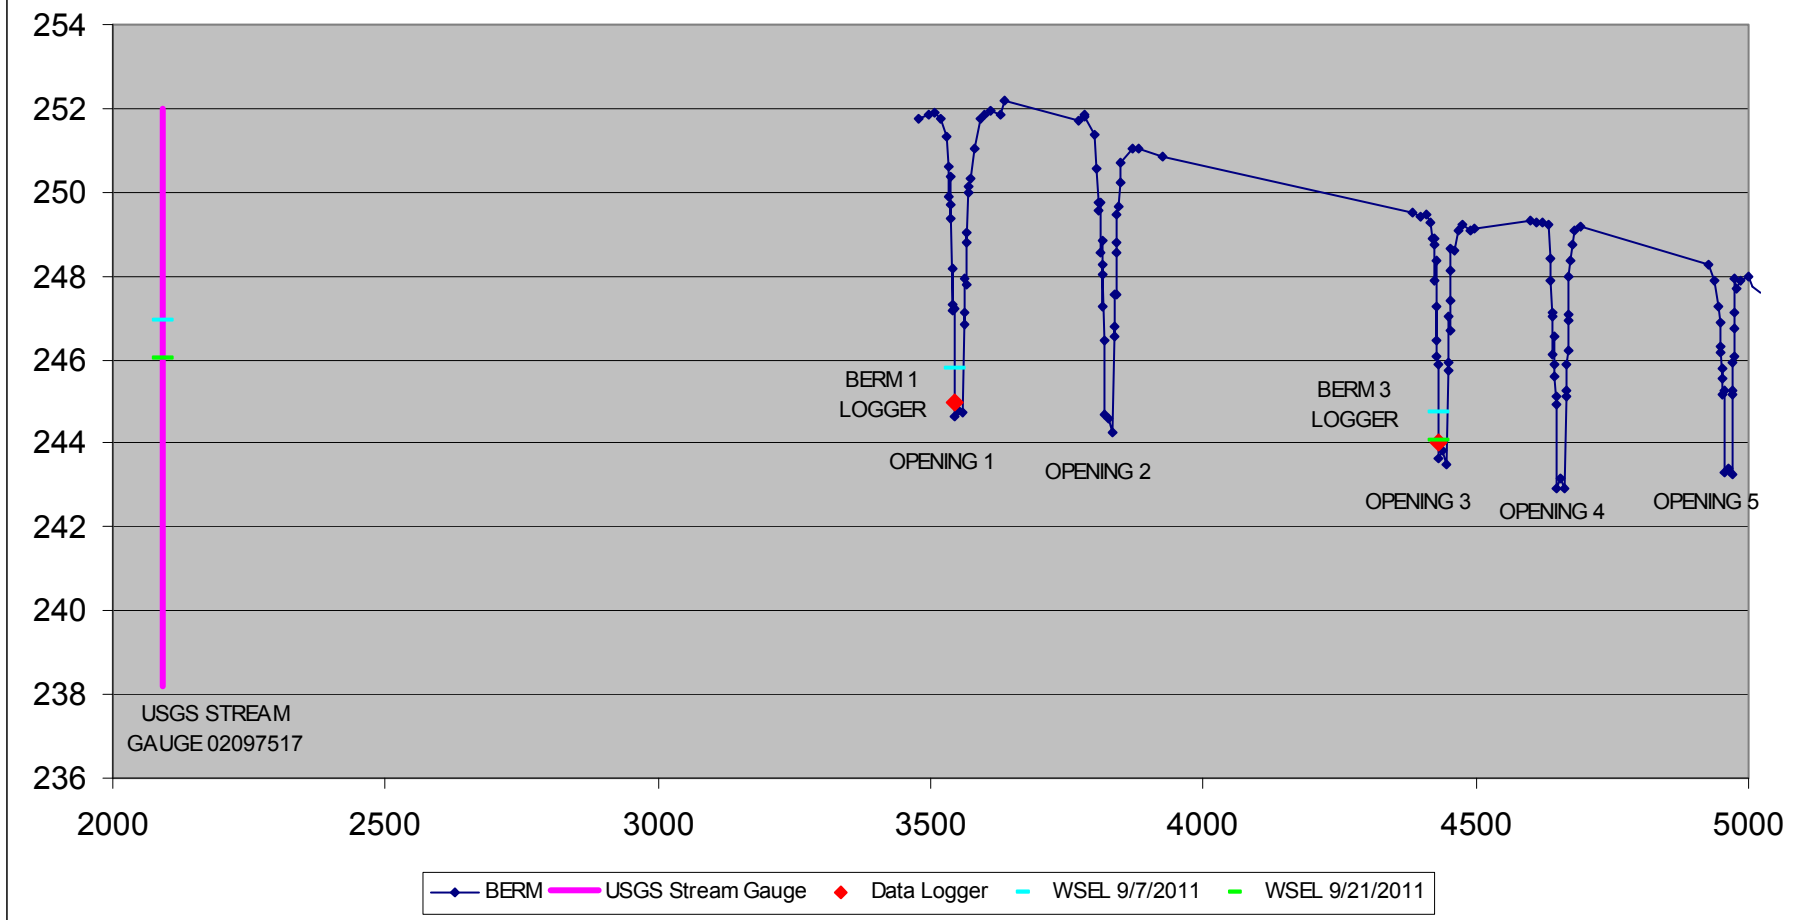
FIGURE 3 - BERM FLOW EXHIBIT

Gauge 9 did meet the anticipated hydrological requirement for Soil Unit 2 obtaining wetland hydrology for 14% of the growing season (Appendix E). Gauge 8 within Big Woods obtained wetland hydrology for 12% of the growing season. The wetland reference gauge obtained wetland hydrology for 28% of the growing season. Flooding through the berm openings was observed after rain events on May 27, 2011, and November 3, 2011. Several onsite data collection methods are being used to correlate the USGS stream gauge height reading and streambank overflow conditions. According to the USGS surface water level gauge located approximately 1500 ft upstream of the site, similar flood events occurred on September 7th and 21st of 2011 (See Figure 3).

Observed Water Elevation				
Date	Gauge	Gauge Station	Gauge Reading	Flow Elevation
9/7/2011	USGS	2091.19	8.71	246.92
	Berm 1	3544.71	0.81	245.78
	Berm 3	4431.37	0.74	244.74
9/21/2011	USGS	2091.19	7.82	246.03
	Berm 1	3544.71	-	-
	Berm 3	4431.37	0.08	244.08

Data loggers installed at berm openings 1 and 3 only

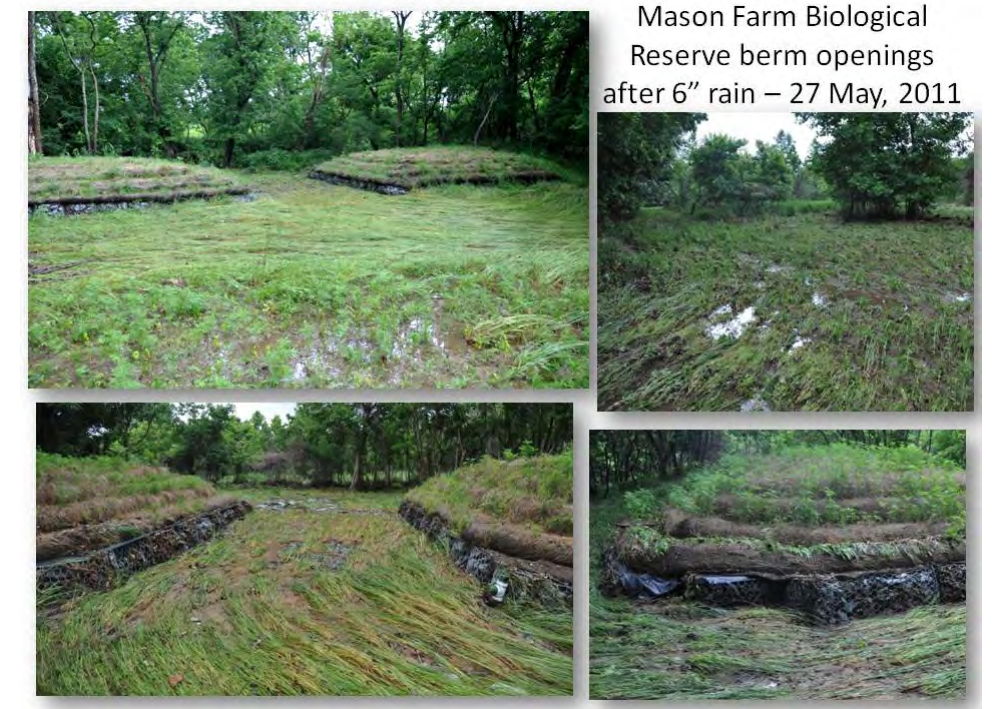
As predicted – this 6" rain and subsequent floodwaters were released through the berm openings and did not (as usual) cause berm overtopping and flooding above and within the parking lot. There was also minimal wash-over across the loop road and with no erosion.

Mason Farm Biological Reserve berm openings after 6" rain – 27 May, 2011
