# South Muddy Creek Stream Restoration McDowell County, North Carolina

NCDENR Contract D07032S

FINAL Restoration Plan  
Submission Date: January 2008

Baker Engineering NY, Inc.

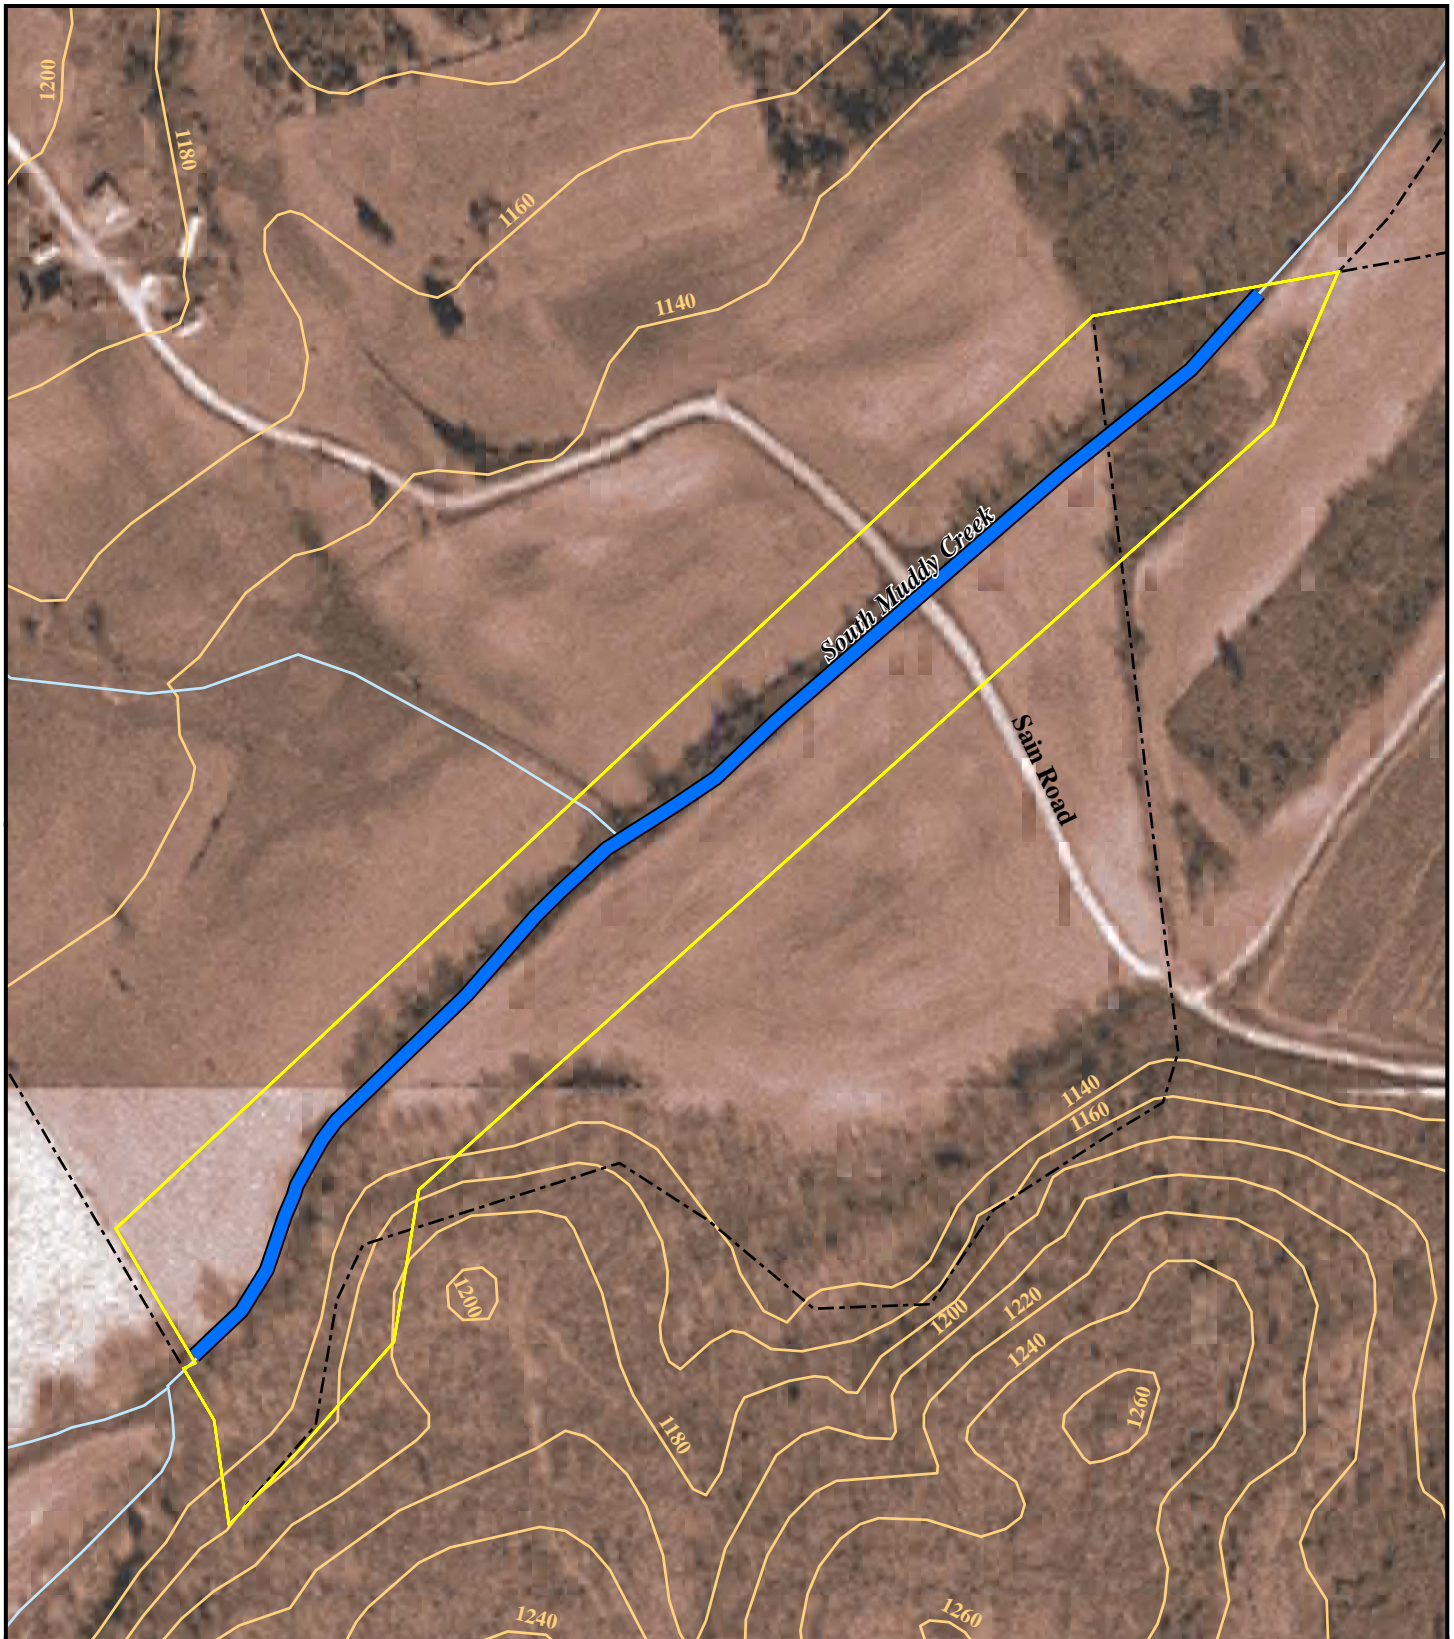
**Figure 1.2: South Muddy Creek  
Reach Location Map  
South Muddy Creek  
Stream Restoration Project  
EEP Project D07032S  
McDowell County, NC**

Within the project boundary, the land surrounding the South Muddy Creek site has been used predominantly for crop cultivation. A small percentage of land near the upstream and downstream extents of the project boundary is forested. Figure 1.2 depicts the agricultural area surrounding the project.

The South Muddy Creek site is depicted in Figure 1.2 and is comprised of one reach. South Muddy Creek flows through a broad, alluvial floodplain characteristic of a Rosgen Valley Type VIII. Alluvial terraces typically present in a Valley Type VIII were not observed along South Muddy Creek; however historic agricultural manipulation of the floodplain in the form of filling, grading, and plowing has likely altered the topography of the area. The overall valley slope is 0.0017 feet per foot (ft/ft).

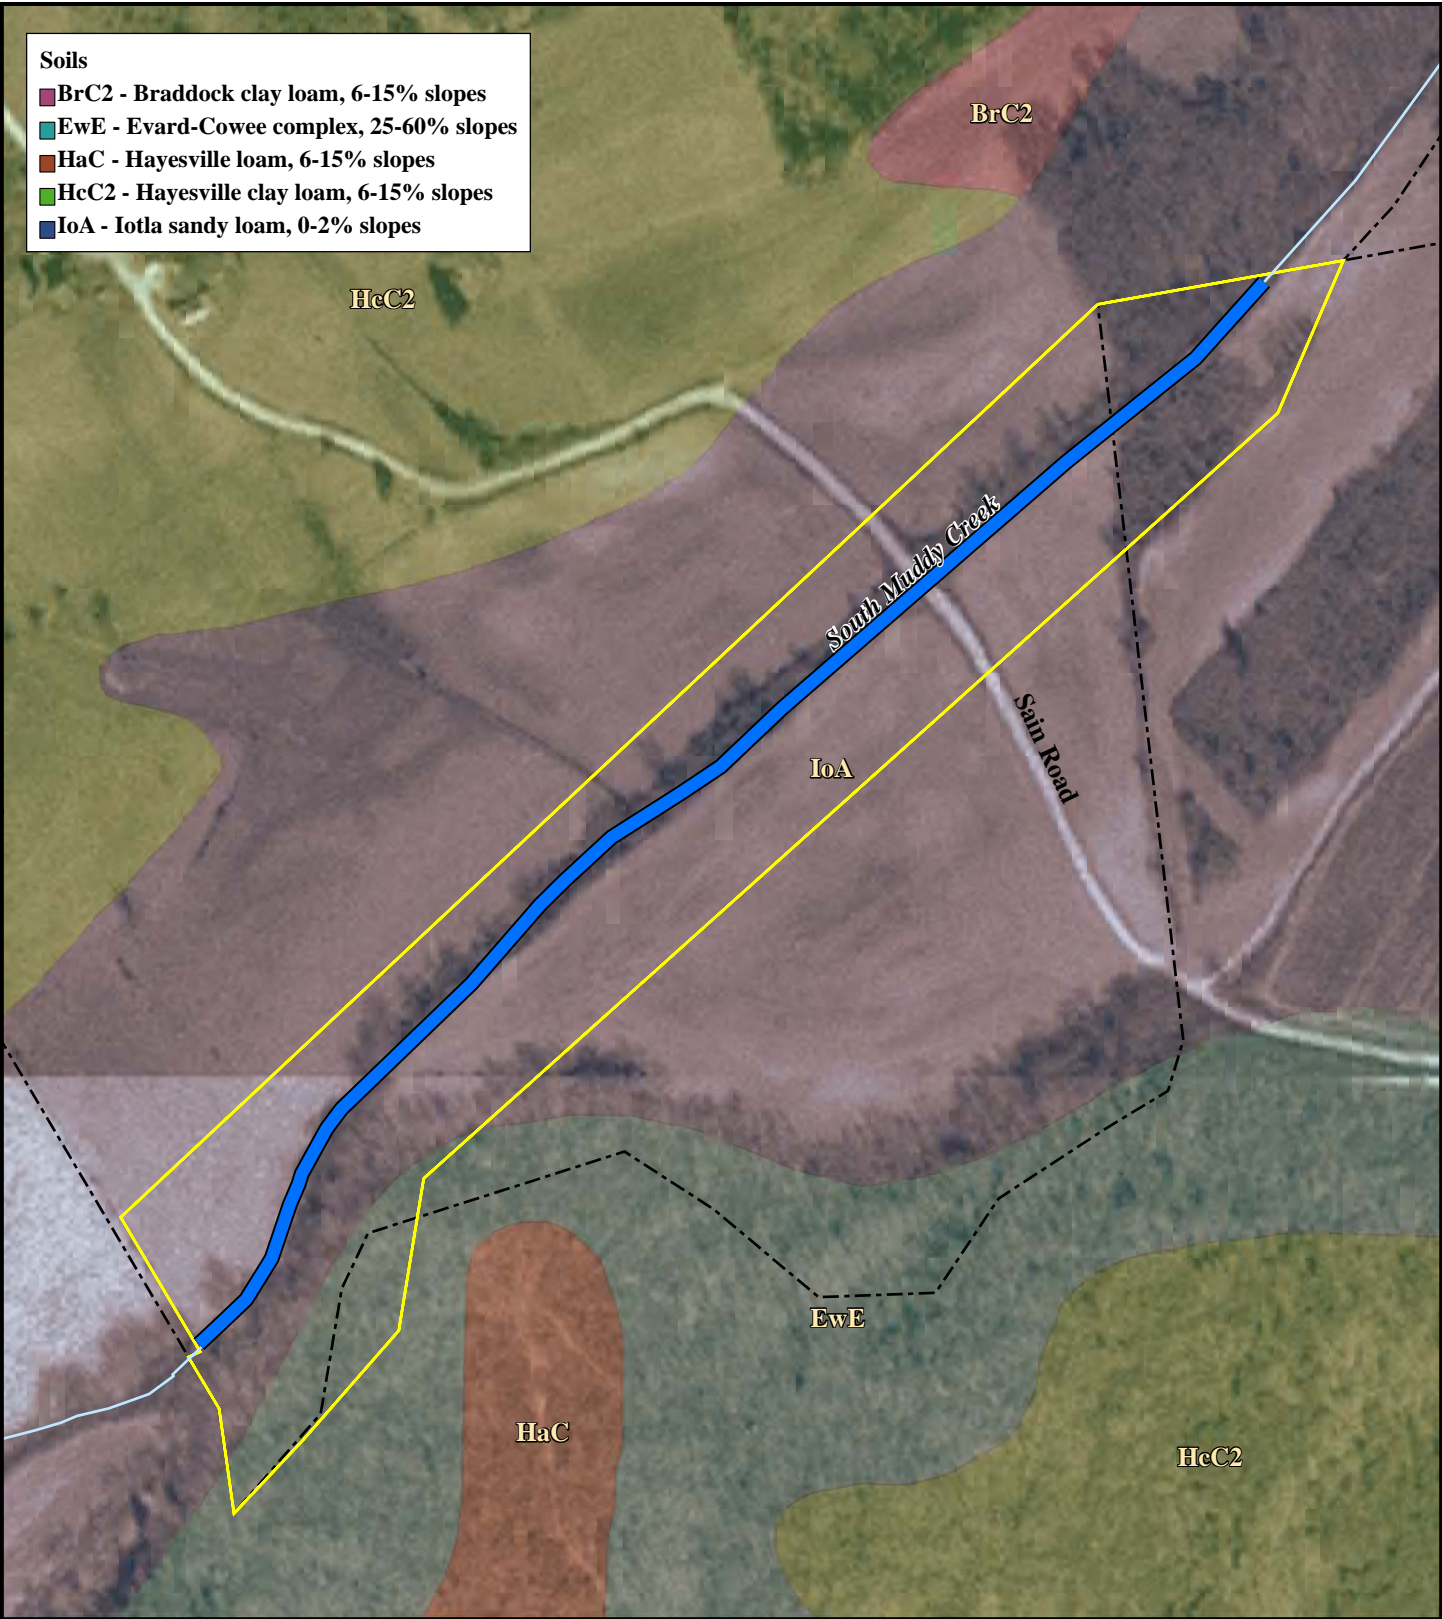
Figure 2.3: South Muddy Creek Site Soils Map  
 South Muddy Creek Stream Restoration Project  
 EEP Project D07032S  
 McDowell County, NC

The soils surrounding the South Muddy and South Fork Hoppers sites are primarily Hayesville clay loam, Hayesville-Evard Complex, and Iotla sandy loam. Within the South Muddy Creek project boundary, Iotla sandy loam dominates with a small portion of the site consisting of Evard-Cowee complex (Figure 2.3). Iotla sandy loams are very deep, somewhat poorly drained soils. Permeability is moderately rapid and shrink-swell potential is low with the potential for occasional flooding. Evard-Cowee complex soils form in residuum from granite, schist, and gneiss. Evard soils are very deep and well drained. Permeability is moderate and shrink-swell potential is low. Cowee soils are moderately deep and well drained. Soft bedrock is within a depth of 20 to 40 inches. Permeability is moderate and shrink-swell potential is low.

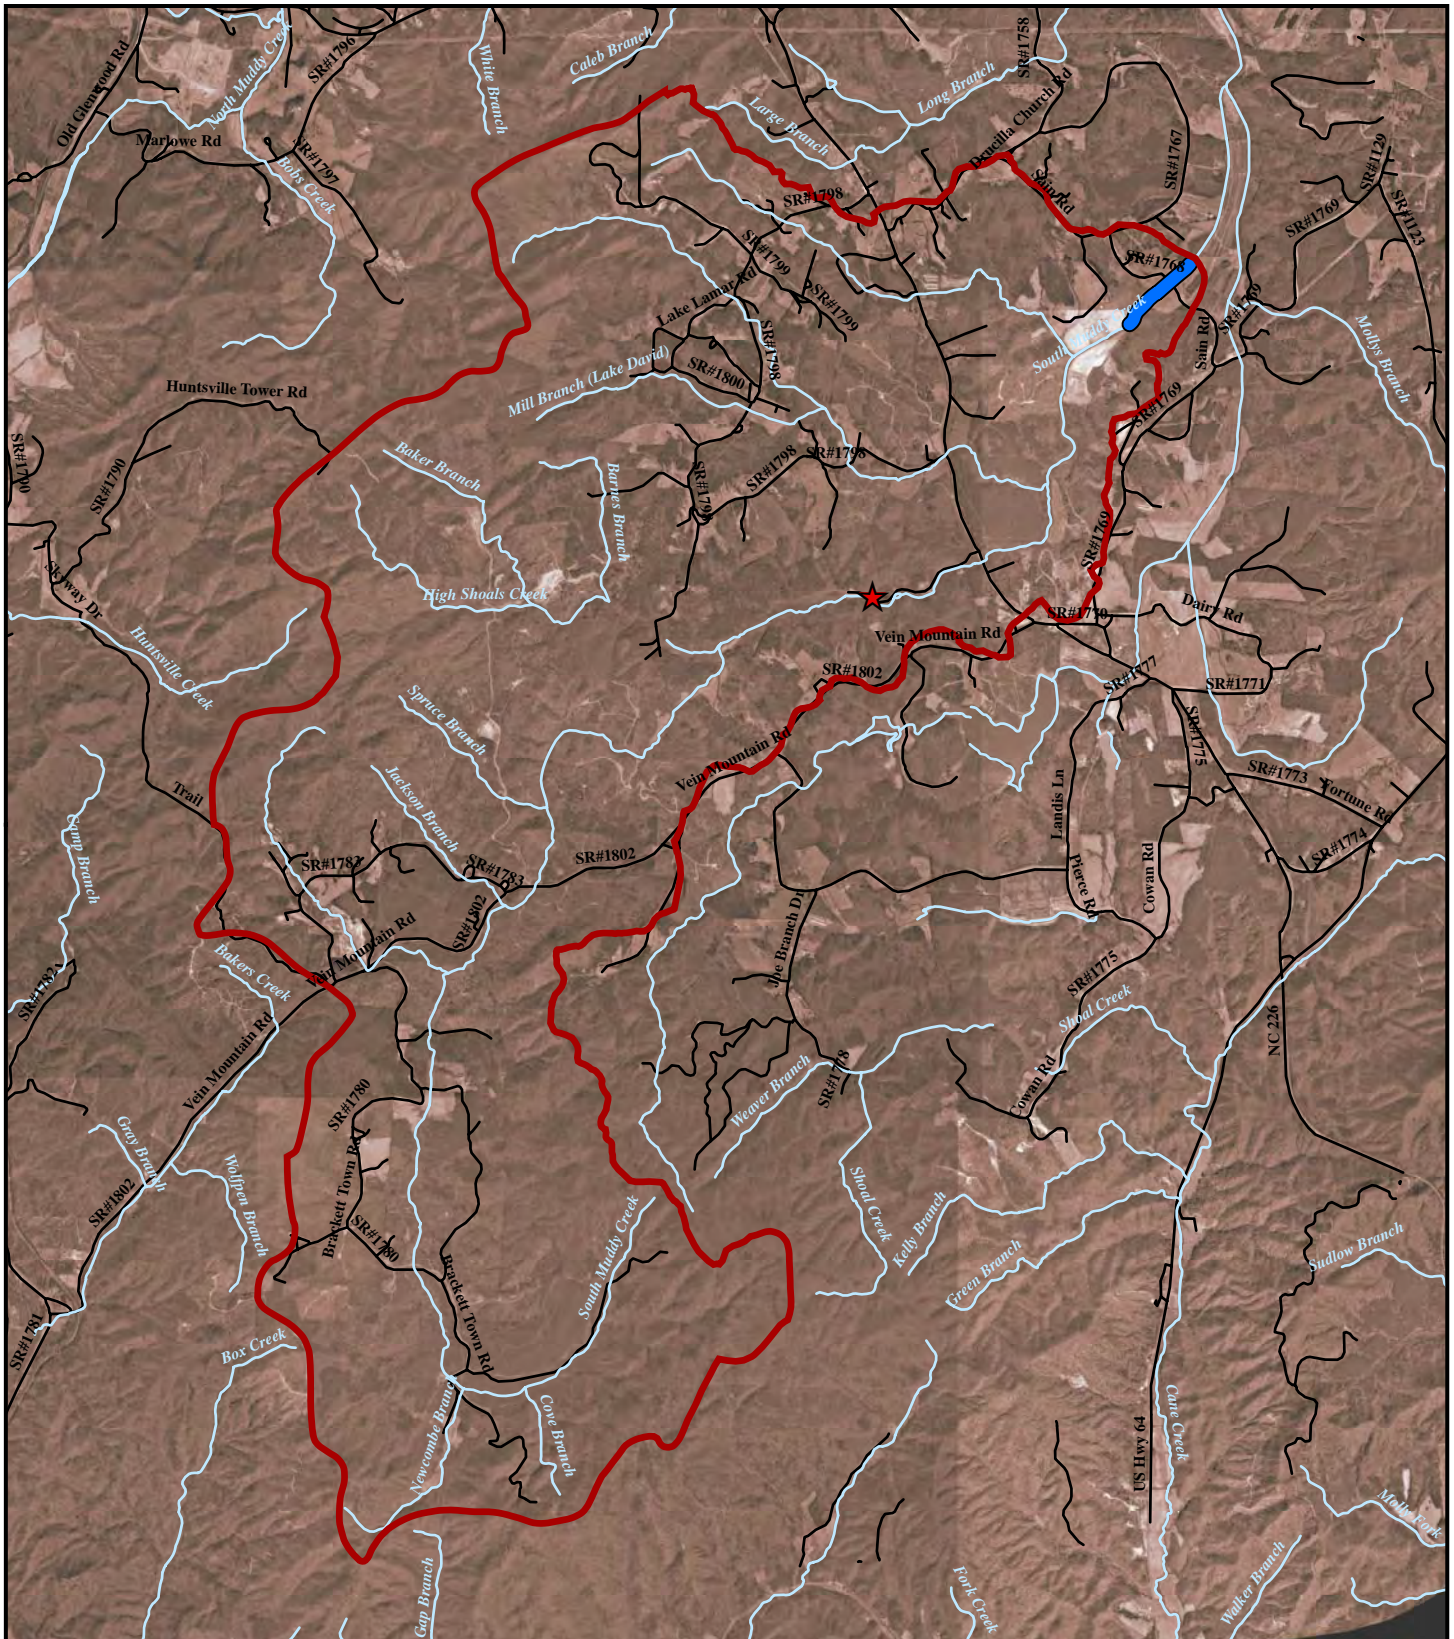
**Figure 2.1: South Muddy Creek Watershed Map & Impoundment Location**  
 South Muddy Creek  
 Stream Restoration Project  
 EEP Project D07032S  
 McDowell County, NC

Table 2.1 displays the drainage areas for the stream reaches within the project boundaries. Figures 2.1 and 2.2 depict the drainage areas for each project reach.

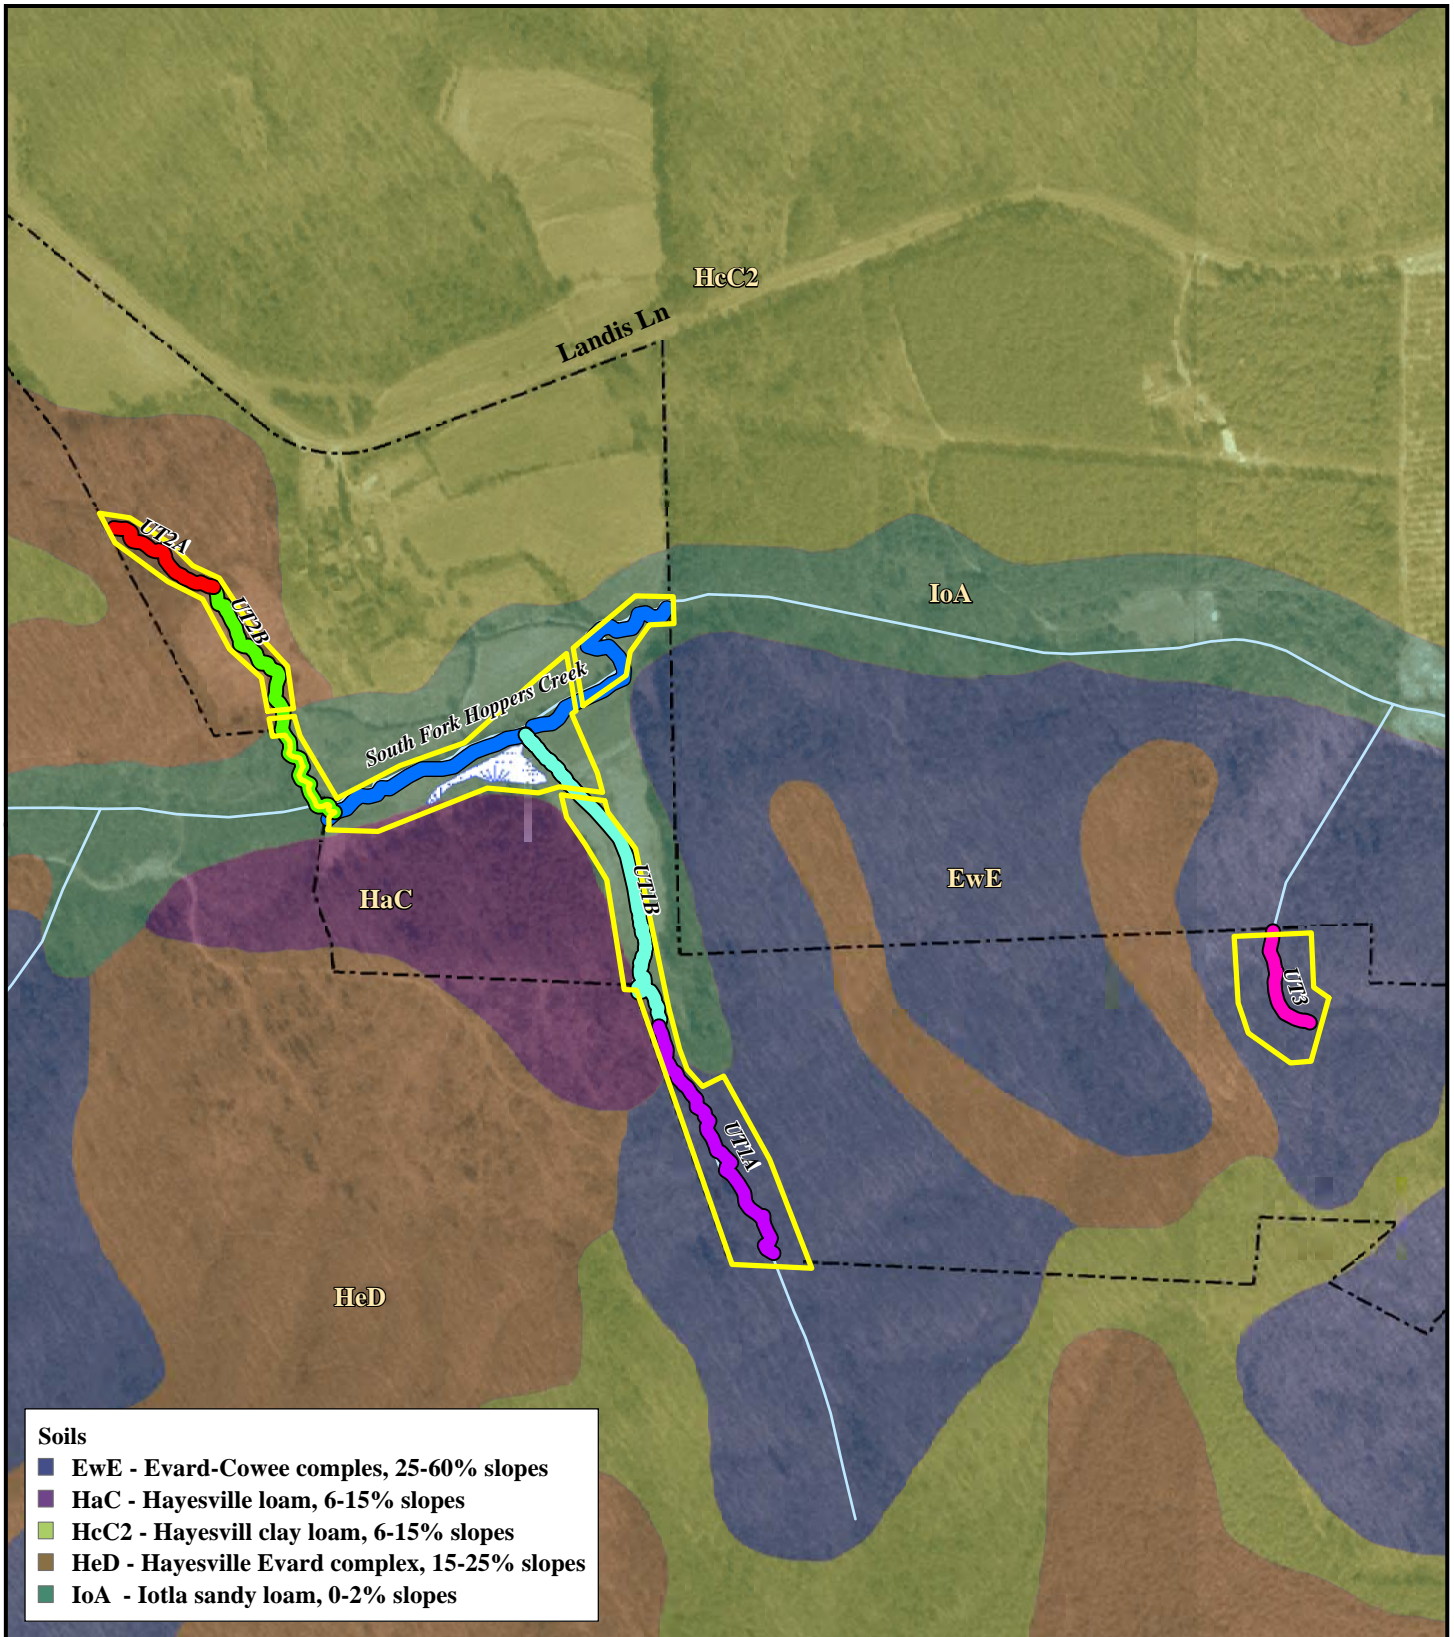
Figure 2.4: South Fork Hoppers Creek Site Soils Map  
 South Muddy Creek Stream Restoration Project  
 EEP Project D07032S  
 McDowell County, NC

The soils within the South Fork Hoppers Creek site boundaries are dominated by Iotla sandy loams with small portions of Evard-Cowee, Hayesville loam, and Hayesville clay loam (Figure 2.4). Hayesville loams are strongly sloping, very deep, and well drained soils on uplands. They formed in residuum from granite, gneiss, and schist. Permeability is moderate and shrink-swell potential is low. Hayesville clay loams are strongly sloping, very deep, well drained, eroded soils on uplands. They also form the in residuum from granite, gneiss, and schist. Permeability is moderate and shrink-swell potential is low.

- Soils**
- EwE - Evard-Cowee complexes, 25-60% slopes
  - HaC - Hayesville loam, 6-15% slopes
  - HcC2 - Hayesville clay loam, 6-15% slopes
  - HeD - Hayesville Evard complex, 15-25% slopes
  - IoA - Iotla sandy loam, 0-2% slopes

The project soils are mapped as Iotla sandy loam according to the McDowell County Soil Survey. The Iotla soil series is on the hydric B list for McDowell County. The soil survey indicates that these areas contain hydric inclusions. The Iotla series is described as a nearly level, somewhat poorly-drained soil on flood plains adjacent to streams. Permeability is moderately rapid, and surface runoff is slow. The seasonal high water table is at a depth of 1.5 to 3.5 feet from November through April. The Iotla series is mapped for the entire wetland restoration project area. A description of other, non-hydric soils on the upland areas of the project site is provided in Section 2.3, and a soils map for the site is provided as Figure 2.4.

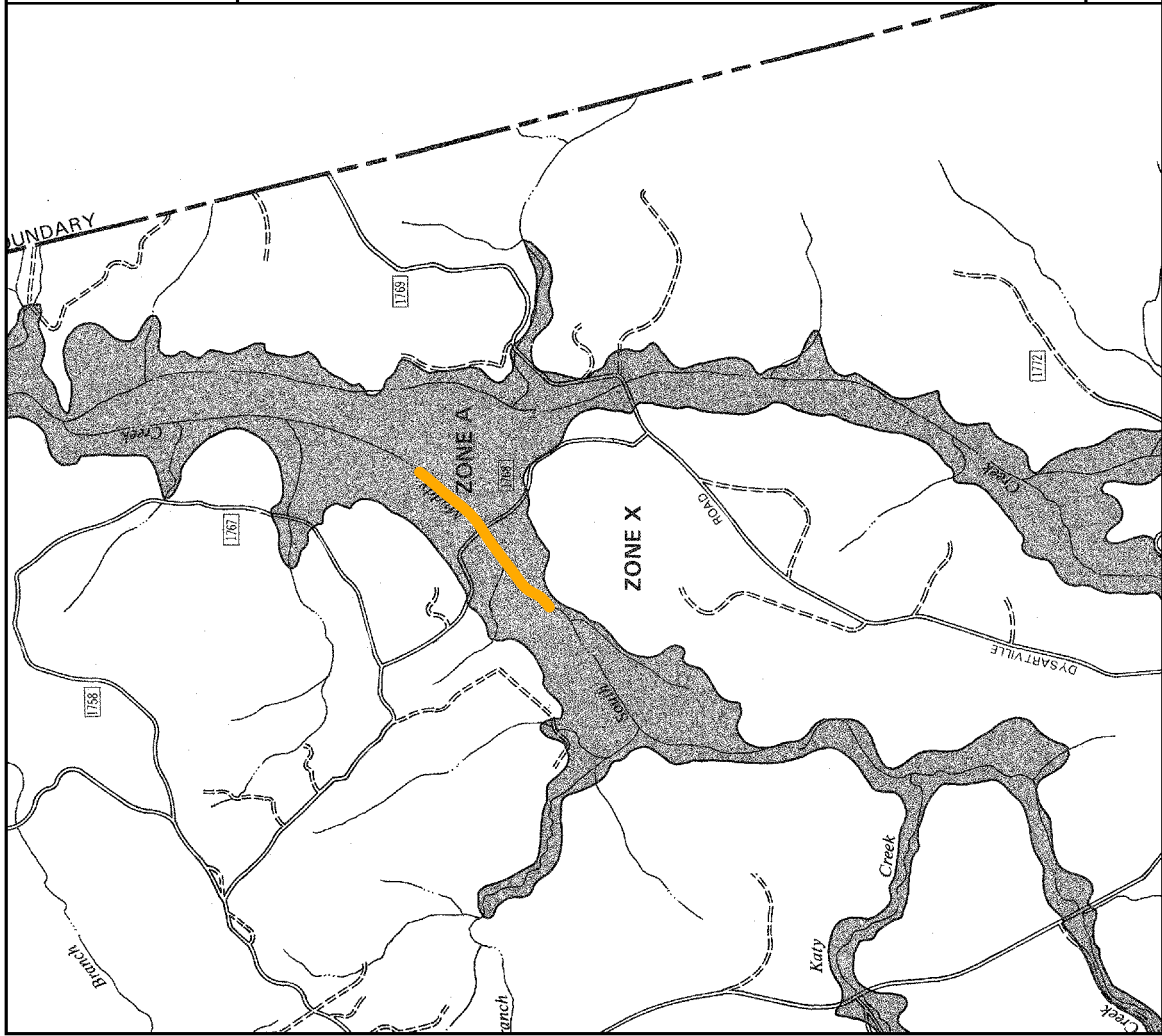
Figure 2.5 South Muddy Creek  
FEMA Map  
South Muddy Creek  
Stream Restoration Project  
EEP Project D07032S  
McDowell County, NC

Panel 200 of the FEMA Flood Insurance Rate Map (FIRM) for McDowell County, NC (Community Number 37111) indicates that the South Muddy Creek site is located in Zone A of the regulatory floodplain. Figure 2.5 illustrates the FEMA mapping at the South Muddy Creek site.

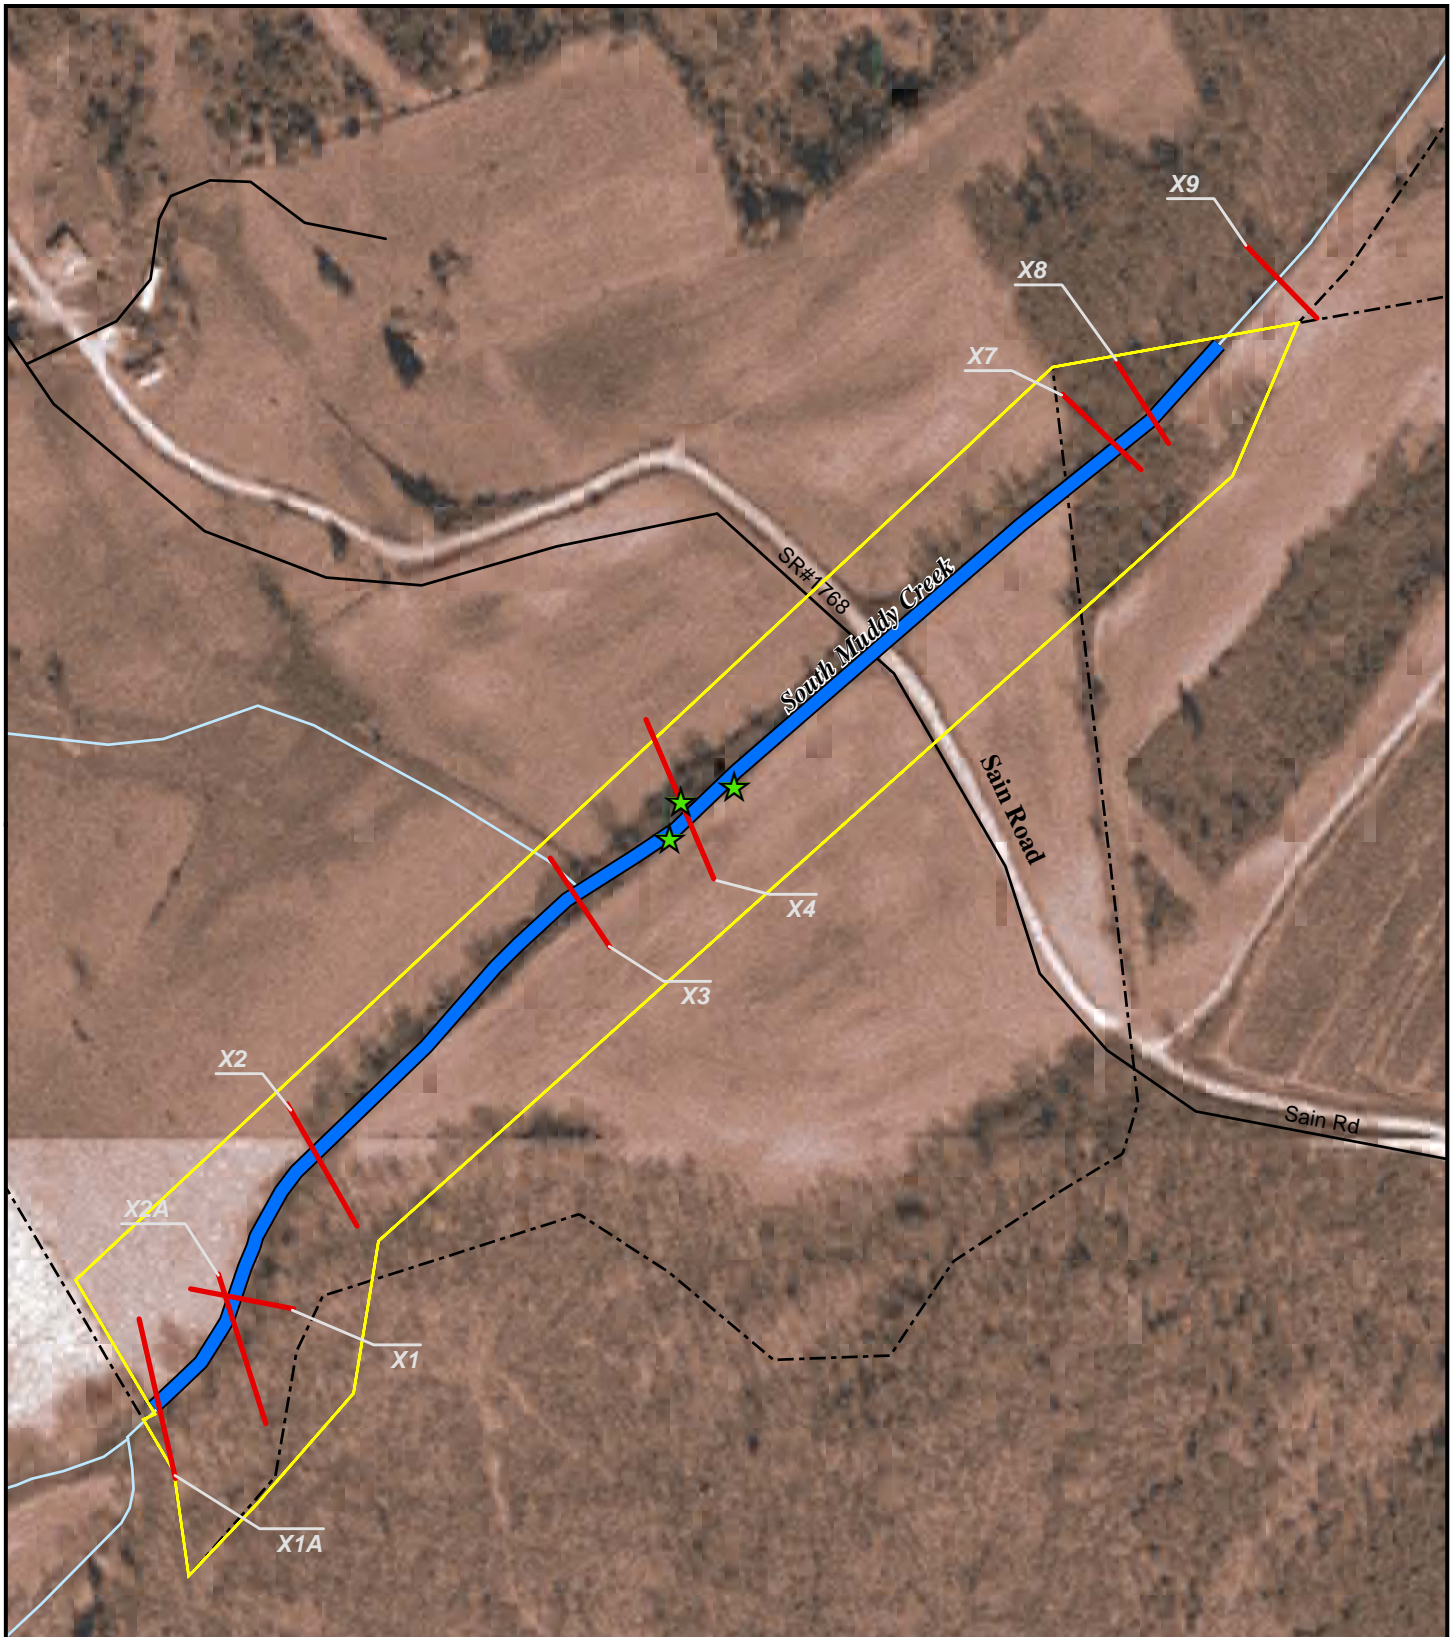
Figure 3.1: South Muddy Creek Existing Conditions Cross-Sections Map  
 South Muddy Creek Stream Restoration Project  
 EEP Project D07032S  
 McDowell County, NC

- Project Reach
- Streams
- Proposed Conservation Easement
- Cross-Section
- Property Boundaries
- Bank Pins-By Others

Baker Engineering performed representative longitudinal and cross-section surveys of the stream reaches to assess the current condition and overall stability of the channels. Baker Engineering also performed pebble counts and collected substrate samples to characterize stream sediments. Figures 3.1 and 3.2 illustrate the locations of cross-section surveys on the South Muddy Creek site and the South Fork Hoppers Creek site, respectively. The following sections of this report summarize the survey results for the stream reaches proposed for work. A photo log of the sites is included in Appendix 1.

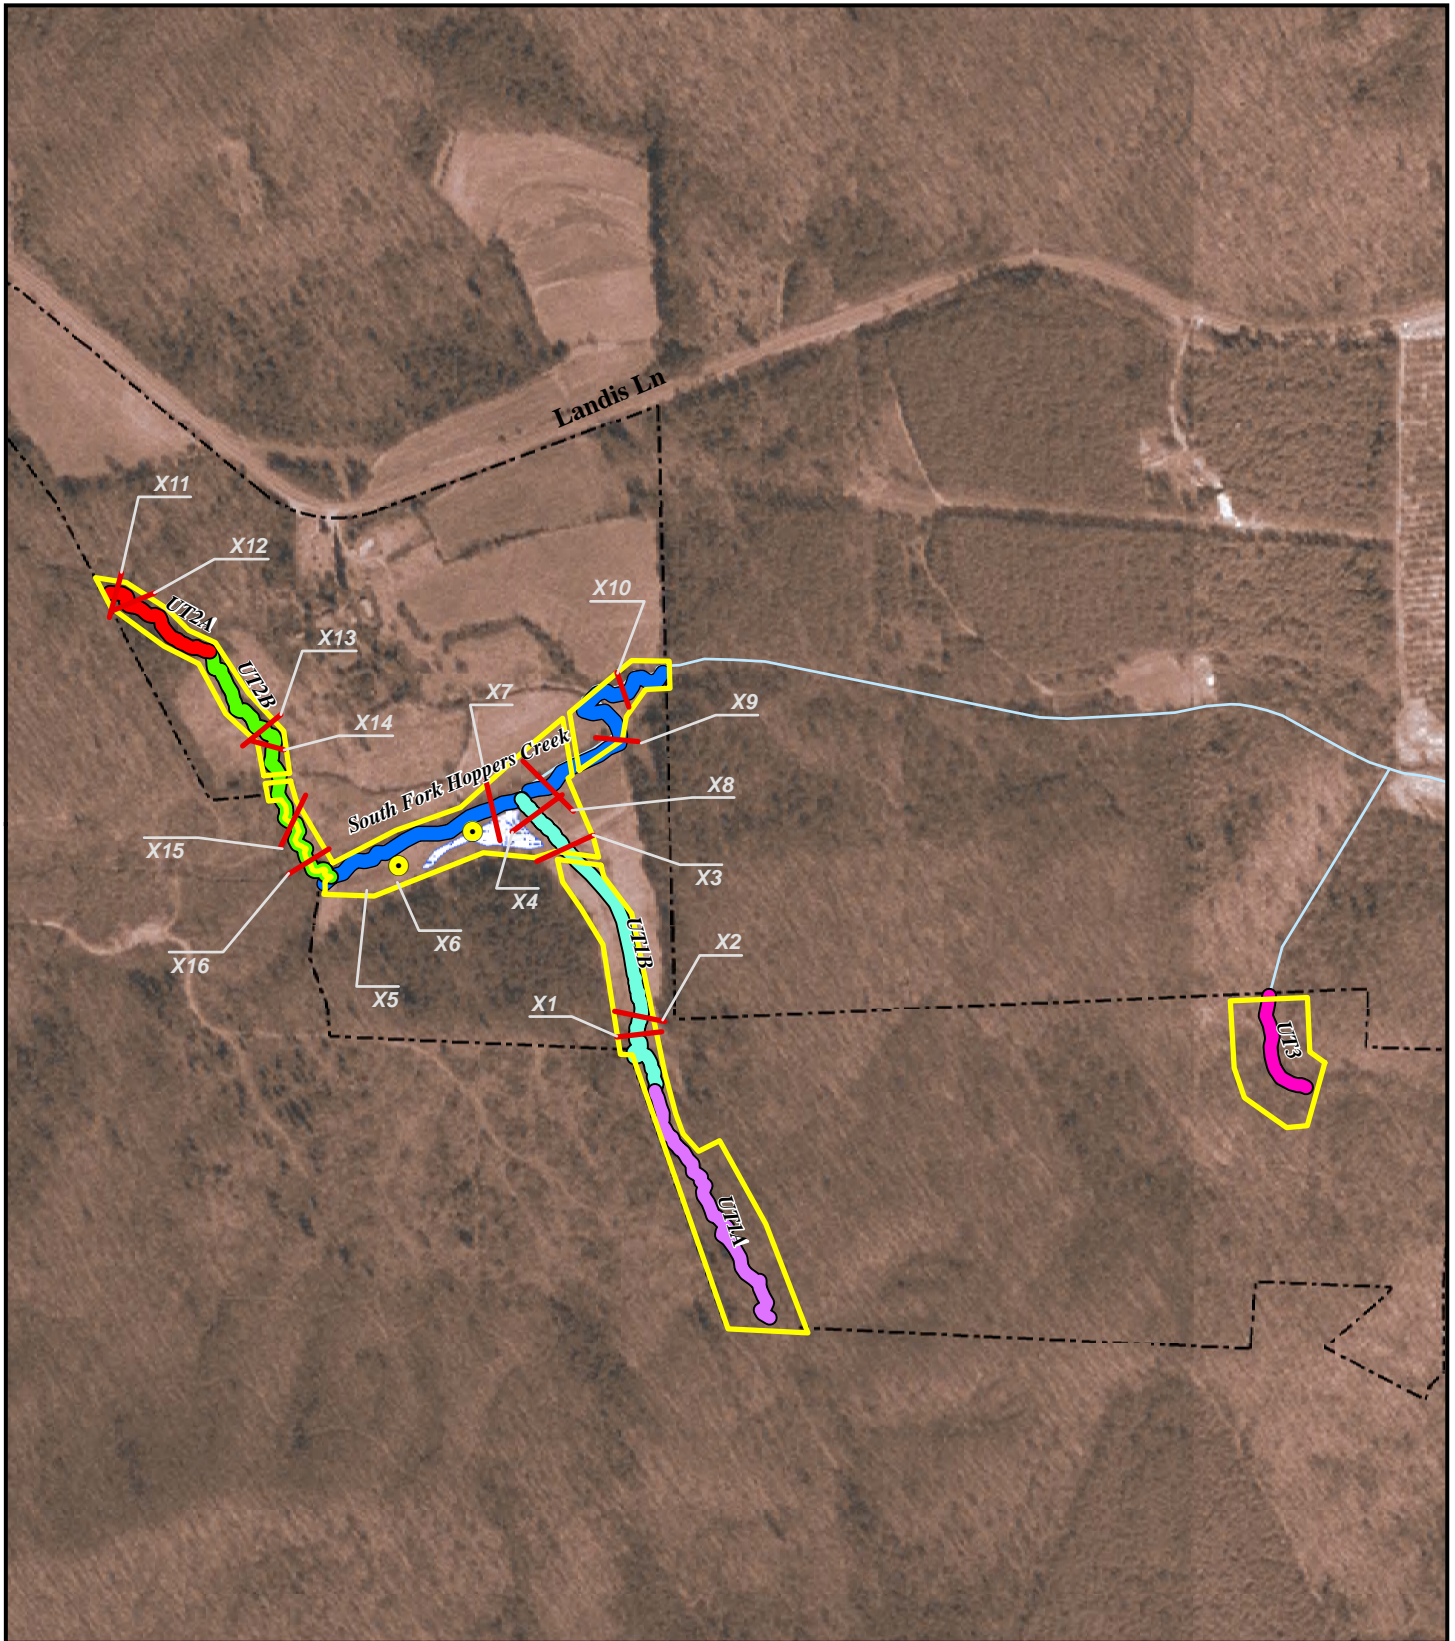
Figure 3.2: South Fork Hoppers Creek Existing Conditions Cross-Sections Map  
 South Muddy Creek Stream Restoration Project  
 EEP Project D07032S  
 McDowell County, NC

- Streams
- █ South Fork Hoppers Creek
- Approximate Property Boundary
- UT1A
- Cross-Section
- UT1B
- Final Conservation Easement
- UT2A
- Wetland Gages
- UT2B
- Existing Wetland
- UT3

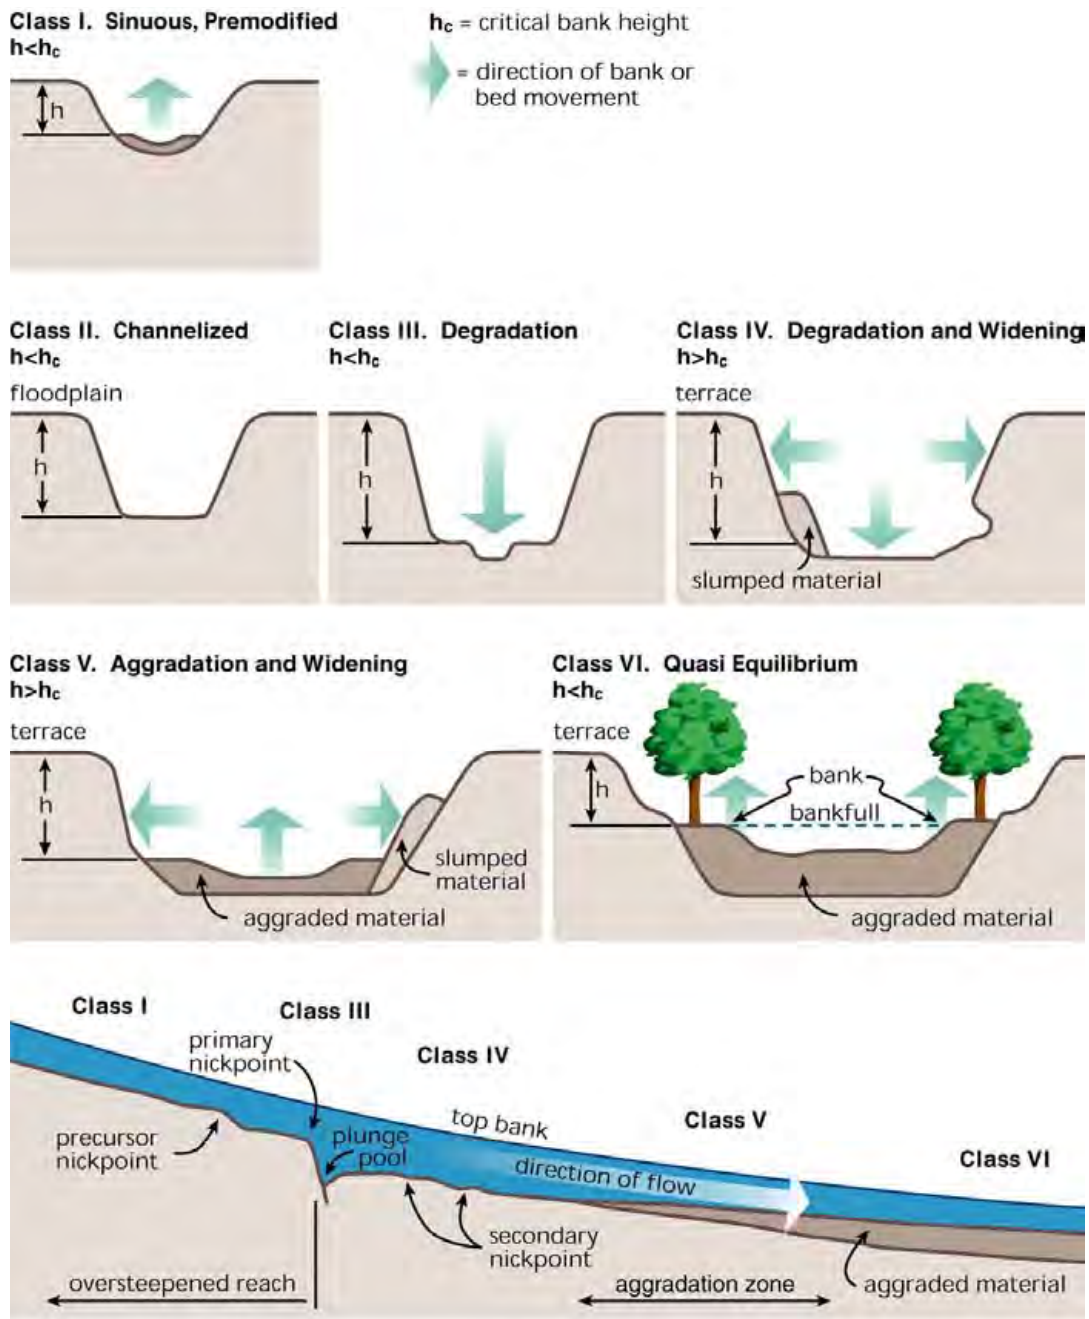
**Figure 3.3**  
 Simon Channel Evolution Model  
 South Muddy Creek Stream Restoration Plan  
 EEP Project D07032S  
 McDowell County, NC

Source: Simon, 1989; US Army Corps of Engineers, 1990.  
 Fig. 7.14 -- Channel evolution model.  
 In Stream Corridor Restoration: Principles, Processes, and Practices, 10/98.  
 Interagency Stream Restoration Working Group (FISRWG)(15 Federal agencies of the US).

A common sequence of physical adjustments has been observed in many streams following disturbance. This adjustment process is often referred to as channel evolution. Disturbance can result from channelization, increase in runoff due to build-out in the watershed, removal of streamside vegetation, and other changes that negatively affect stream stability. All of these disturbances occur in both urban and rural environments. Several models have been used to describe this process of physical adjustment for a stream. The Simon Channel Evolution Model (1989) characterizes evolution in six steps, including:

1. Sinuous, pre-modified
2. Channelized
3. Degradation
4. Degradation and widening
5. Aggradation and widening
6. Quasi-equilibrium.

The channel evolution process is initiated once a stable, well-vegetated stream that interacts frequently with its floodplain is disturbed. Disturbance commonly results in an increase in stream power that causes degradation, often referred to as channel incision (Lane, 1955). Incision eventually leads to over-steepening of the banks and, when critical bank heights are exceeded, the banks begin to fail and mass wasting of soil and rock leads to channel widening. Incision and widening continue moving upstream in the form of a head-cut. Eventually the mass wasting slows, and the stream begins to aggrade. A new, low-flow channel begins to form in the sediment deposits. By the end of the evolutionary process, a stable stream with dimension, pattern, and profile similar to those of undisturbed channels forms in the deposited alluvium. The new channel is at a lower elevation than its original form, with a new floodplain constructed of alluvial material (FISRWG, 1998).

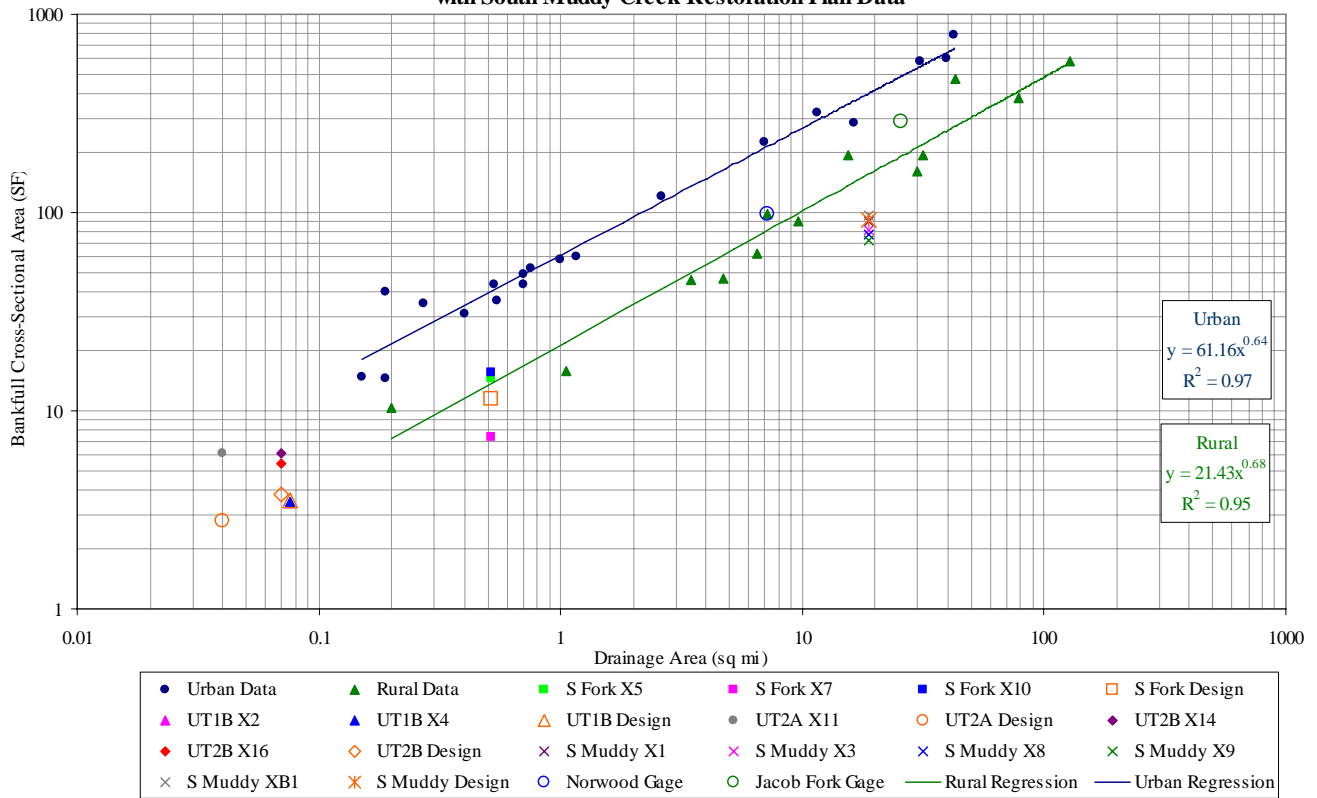
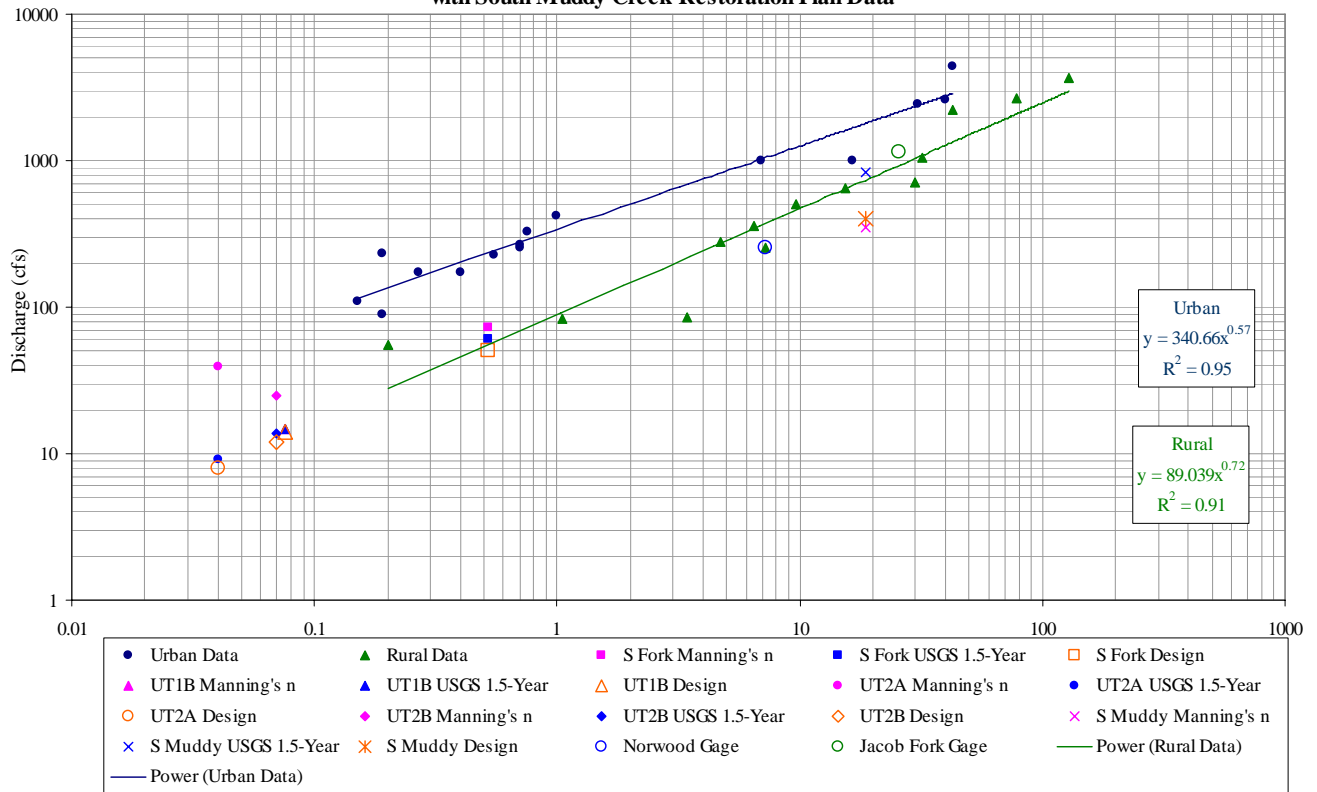
**Figure 3.4**  
 NC Piedmont Regional Curves with Project Reach Data  
 South Muddy Creek Stream Restoration Plan  
 EEP Project D07032S  
 McDowell County, NC

**North Carolina Piedmont Regional Curve: Cross-Sectional Area  
with South Muddy Creek Restoration Plan Data**

**North Carolina Piedmont Regional Curve: Discharge  
with South Muddy Creek Restoration Plan Data**

Note: Project data were not considered in regional curve development.
