# South Muddy Creek Stream Restoration McDowell County, North Carolina

NCDENR Contract D07032S

FINAL Restoration Plan  
Submission Date: January 2008

Baker Engineering NY, Inc.

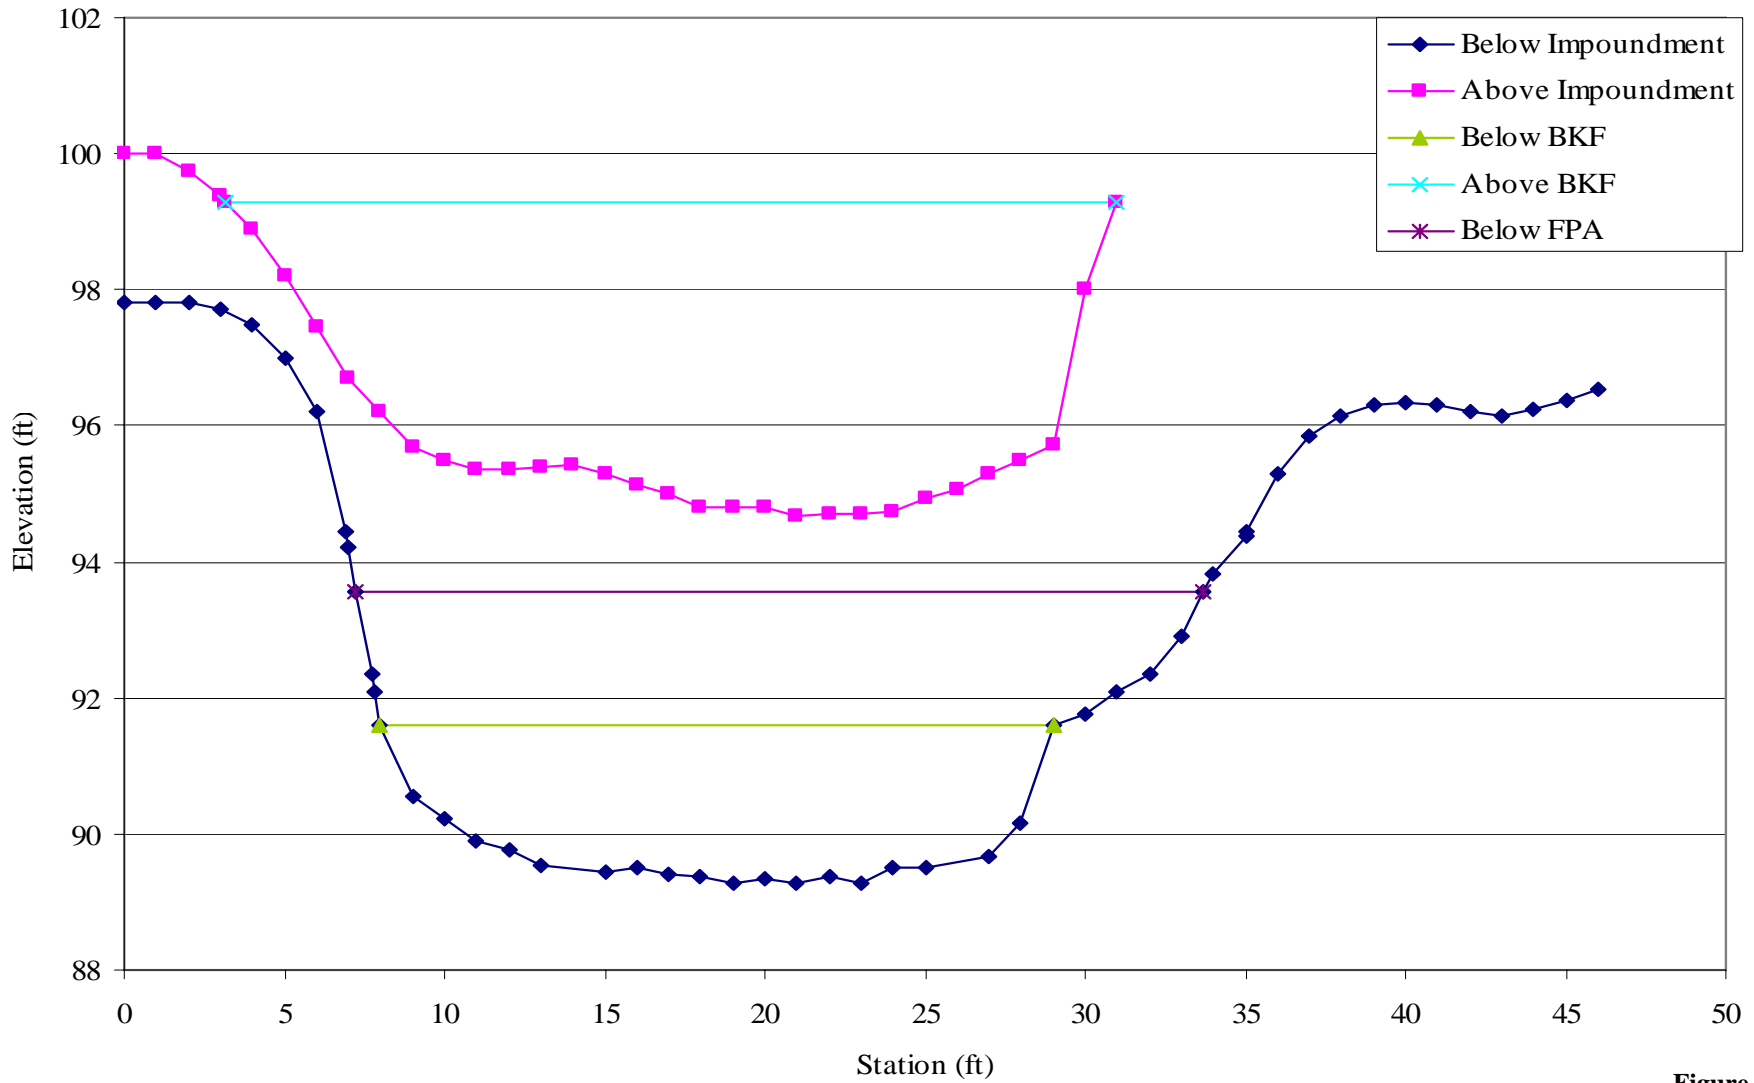
**Figure 3.5**  
South Muddy Creek Impoundment Study  
South Muddy Creek Stream Restoration Plan  
EEP Project D07032S  
McDowell County, NC

South Muddy Creek Impoundment Study  
Cross Sections Above and Below the Impoundment

The South Muddy Creek reach is located approximately 2.6 miles downstream from an in-line flood control structure. This structure (referred to hereafter as the impoundment) is located on private land in McDowell County and is operated by the NRCS. The impoundment was built in the early 1960's in response to downstream flooding and is well maintained and functional today. The riser structure is designed to pass the base flow from the 12.4 square mile watershed, retaining water during flows higher than baseflow conditions. Because of the size of the impoundment, Baker Engineering studied the impoundment's effect on bankfull geometry and discharge. Please refer to Section 3.3.1 for detailed information.

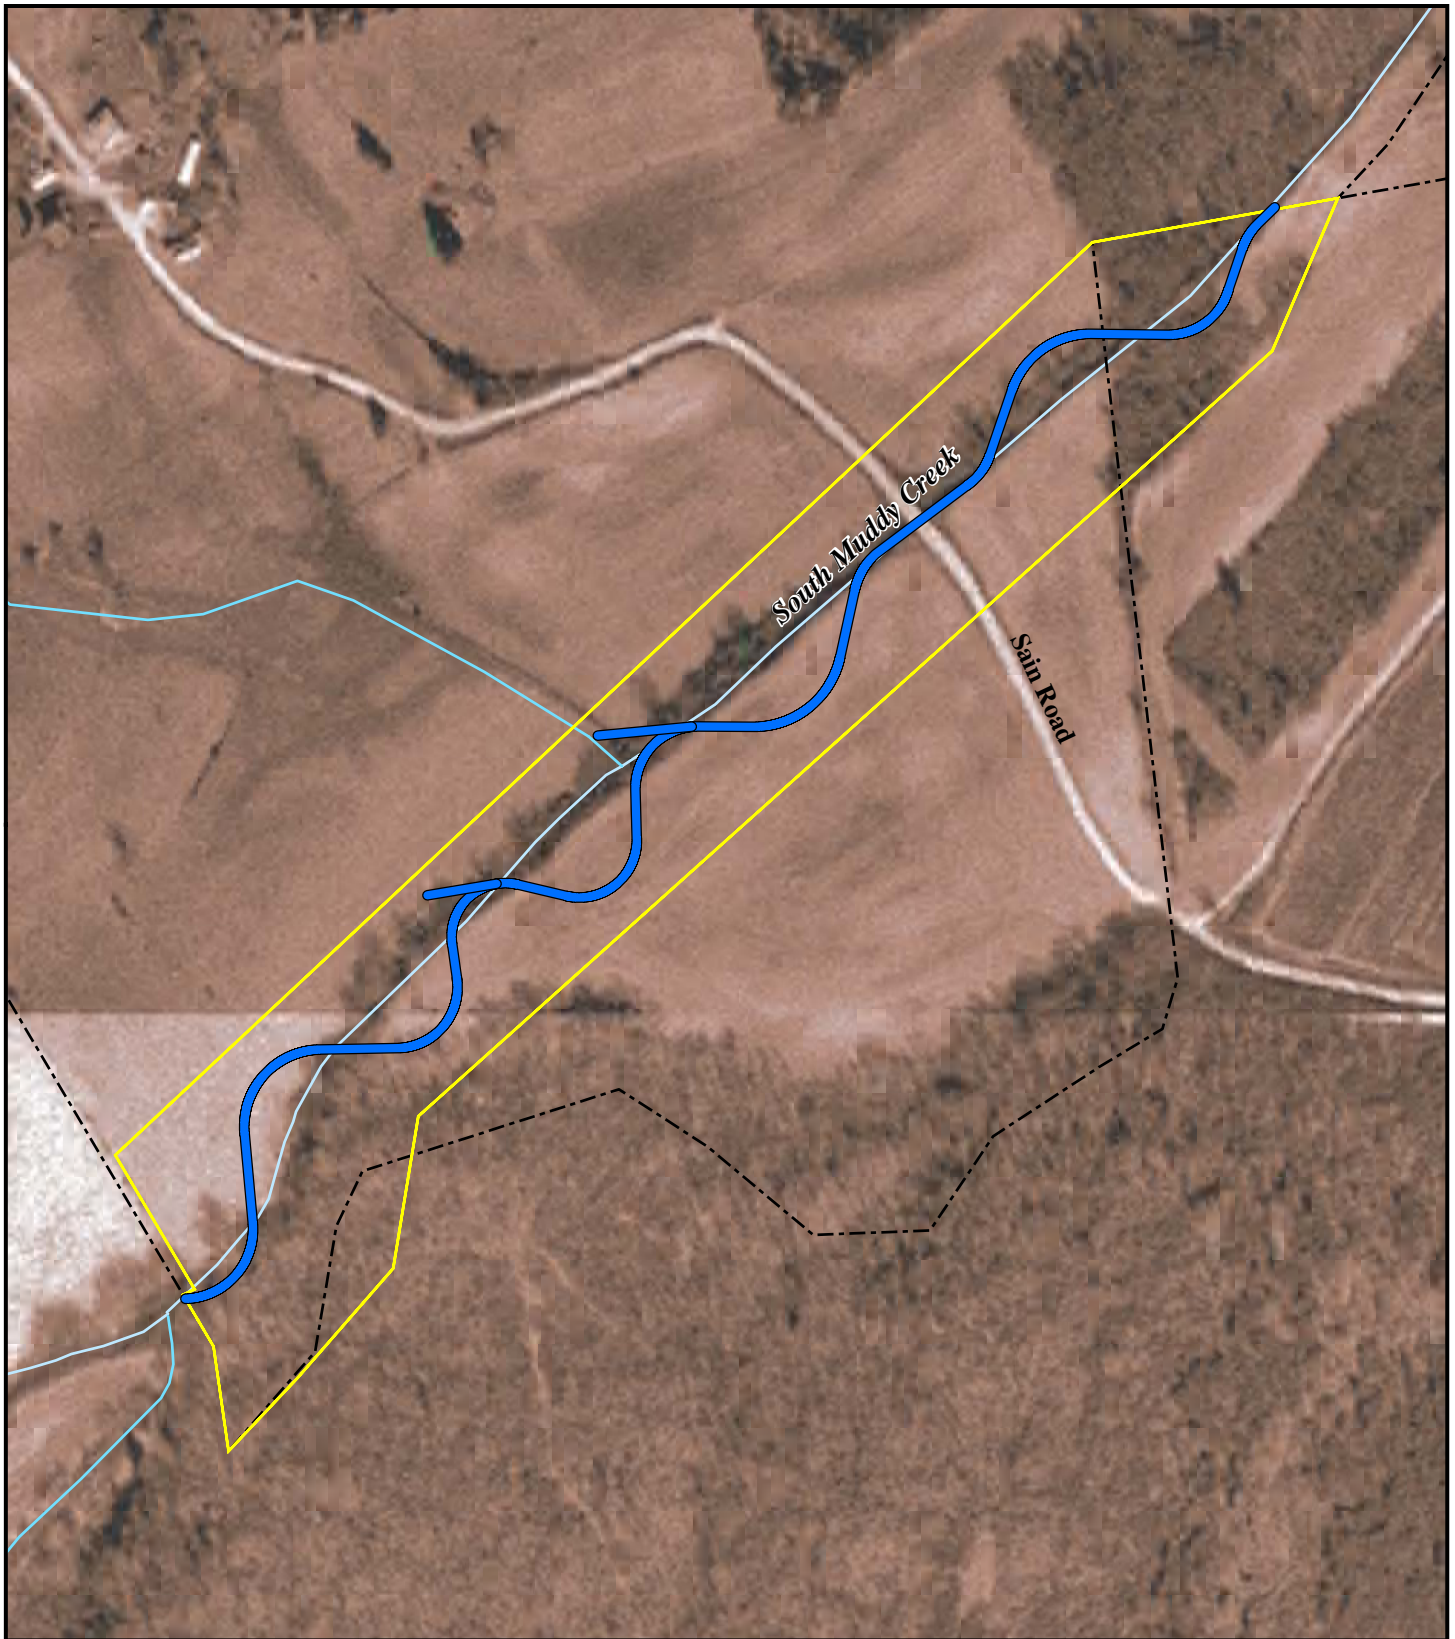
Figure 7.1: South Muddy Creek  
 Proposed Restoration Design  
 South Muddy Creek  
 Stream Restoration Project  
 EEP Project D07032S  
 McDowell County, NC

- Proposed Restoration Design
- Proposed Conservation Easement
- Property Boundaries
- Streams

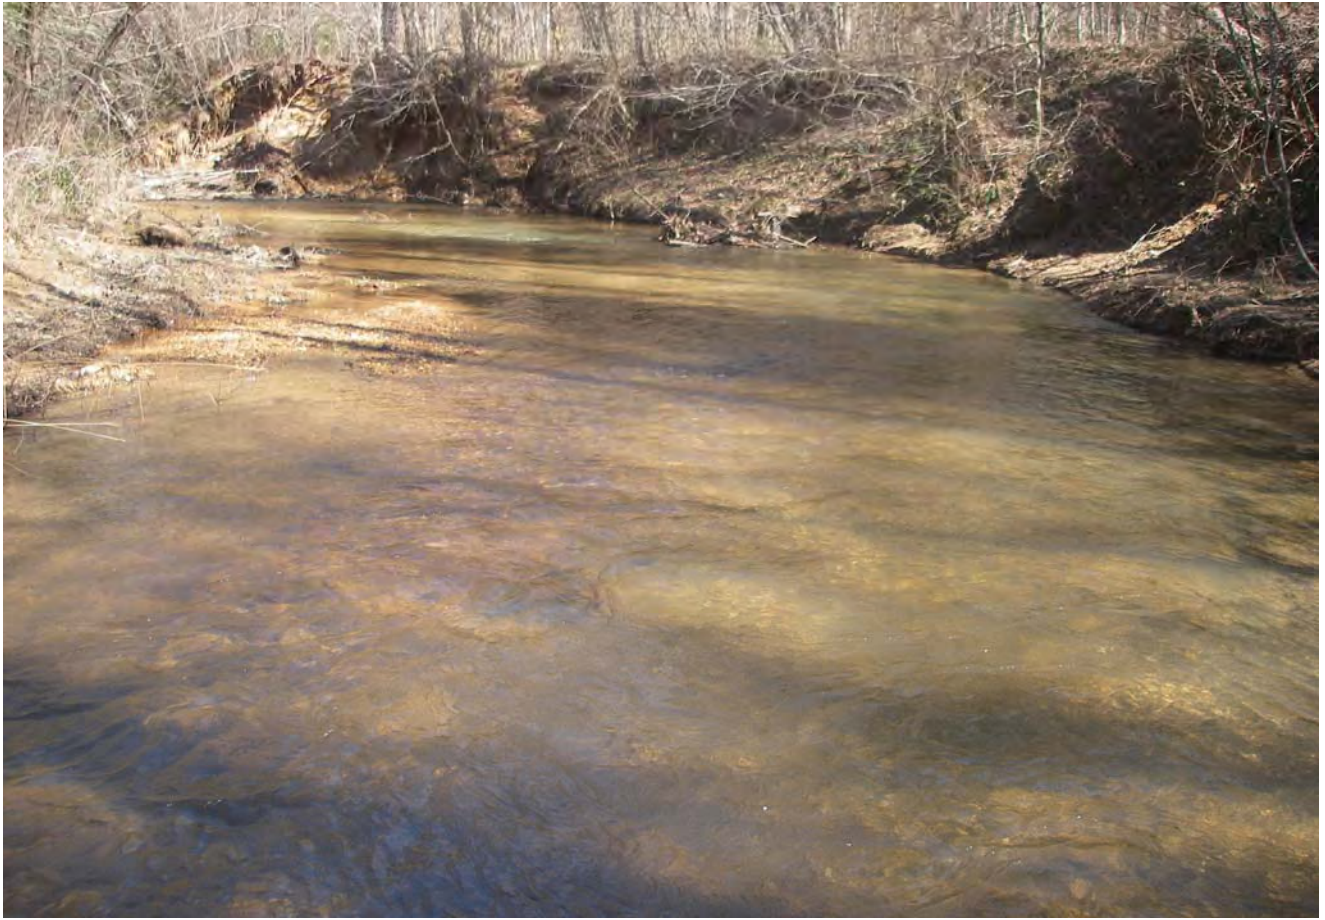
**South Muddy Creek Site - South Muddy Creek**  
**Cross-section Data: X1A Riffle**

Feature	Stream Type	BKF Area	BKF Width	BKF Depth	Max BKF Depth	W/D	BH Ratio	ER	BKF Elev	TOB Elev
Riffle	G4c ->F4	97.2	51.2	1.9	3.3	26.9	3.2	1.4	1123.3	1130.7

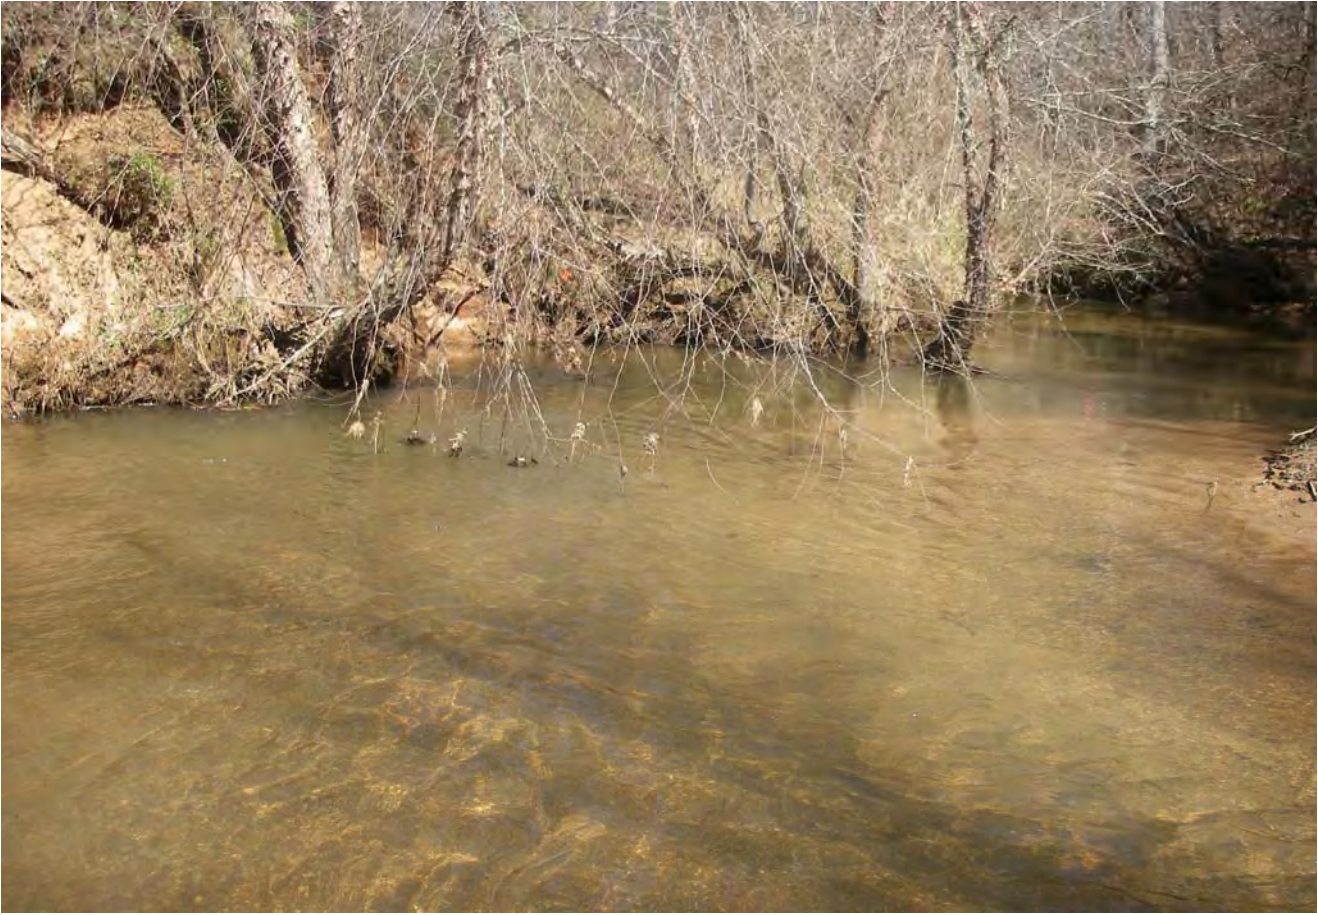
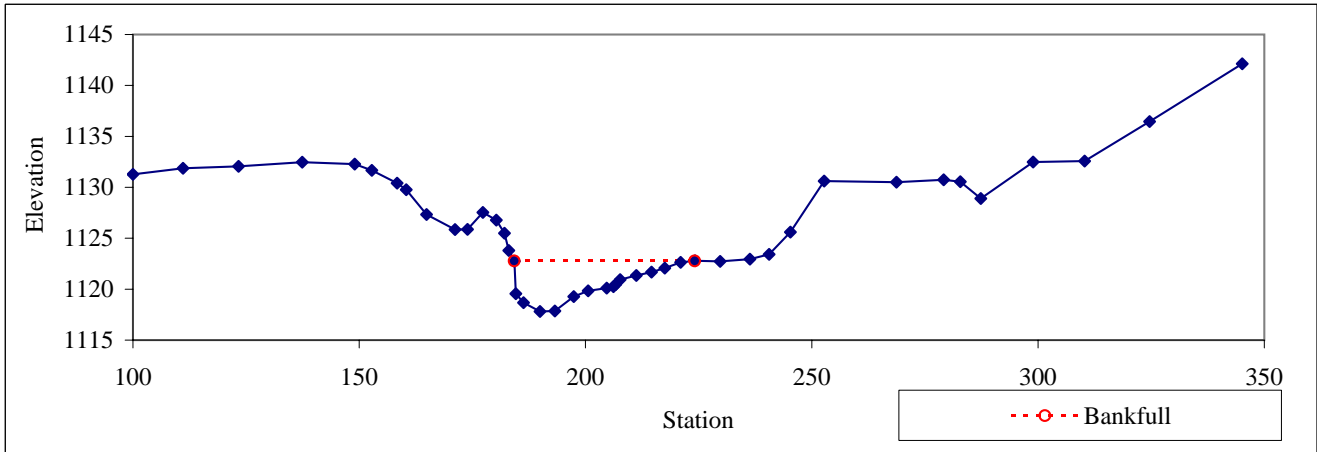
**South Muddy Creek Site - South Muddy Creek**  
**Cross-section Data: X1B Pool**

Feature	Stream Type	BKF Area	BKF Width	BKF Depth	Max BKF Depth	W/D	BH Ratio	ER	BKF Elev	TOB Elev
Pool		100.5	39.9	2.5	5.0	16.0	2.6		1122.8	1130.6

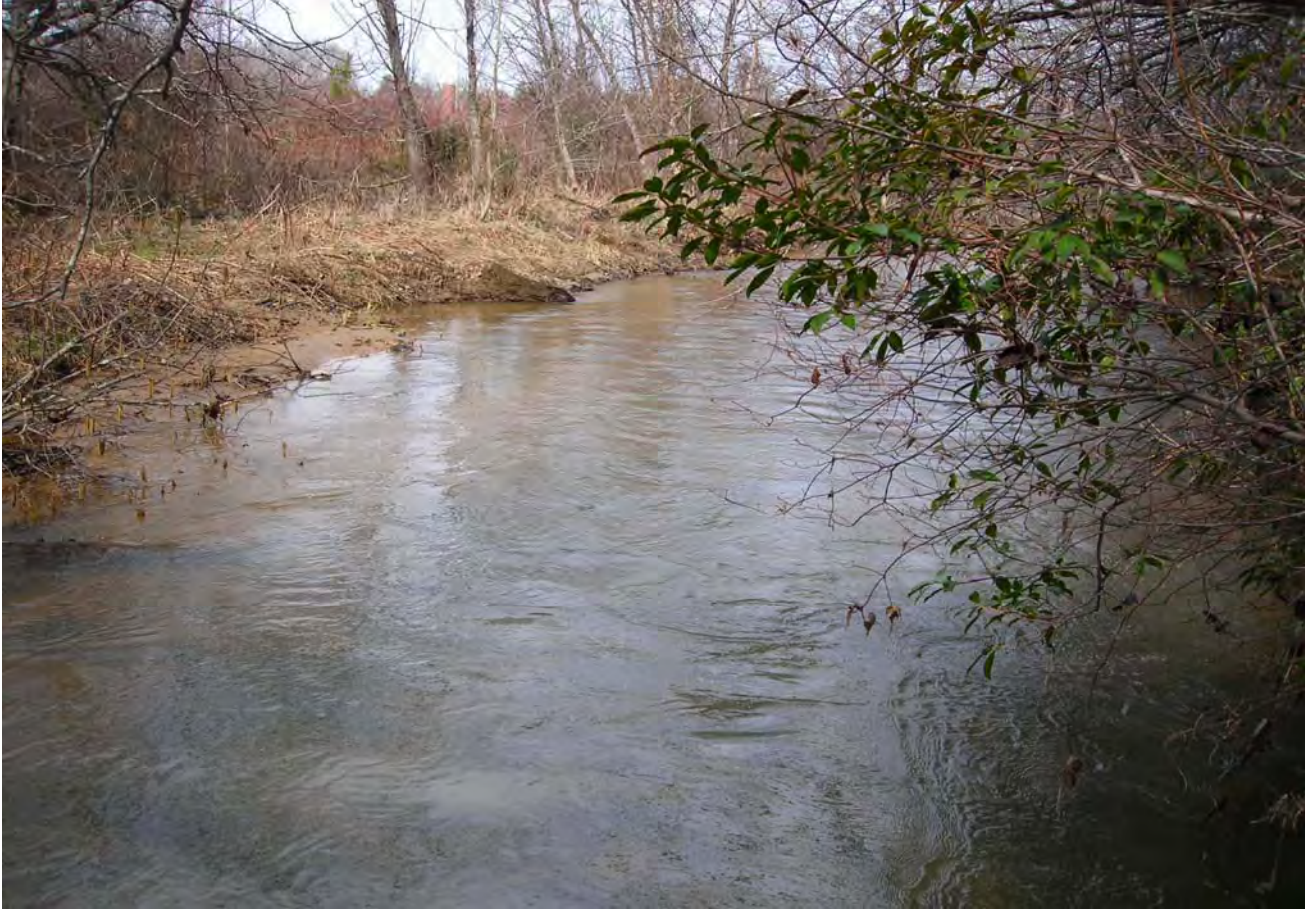
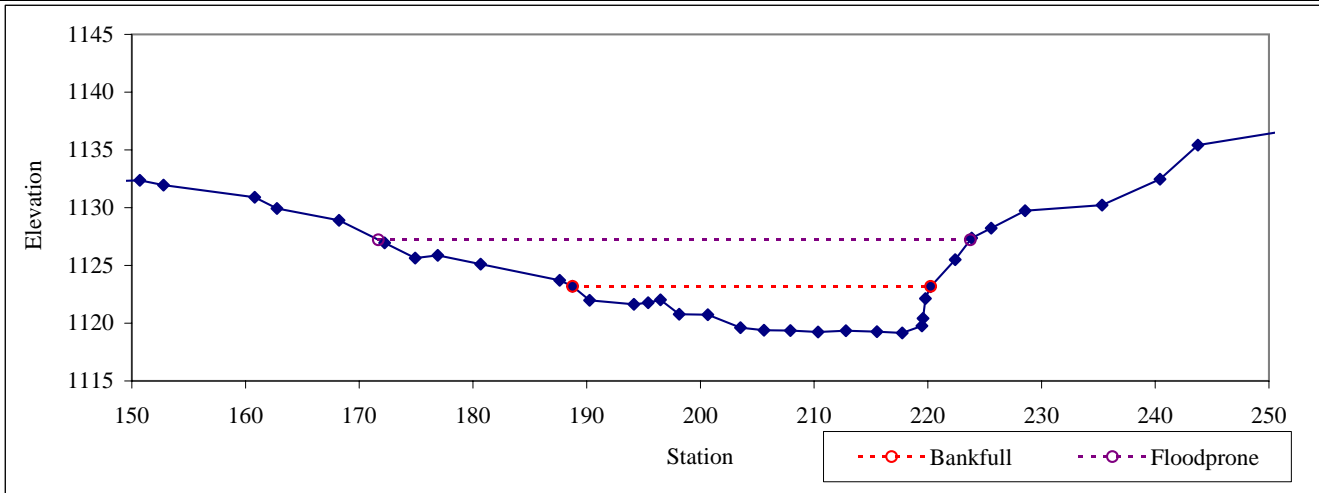
**South Muddy Creek Site - South Muddy Creek**  
**Cross-section Data: X1 Riffle**

Feature	Stream Type	BKF Area	BKF Width	BKF Depth	Max BKF Depth	W/D	BH Ratio	ER	BKF Elev	TOB Elev
Riffle	G4c	89.6	31.5	2.9	4.0	10.9	2.6	1.7	1123.2	1129.7

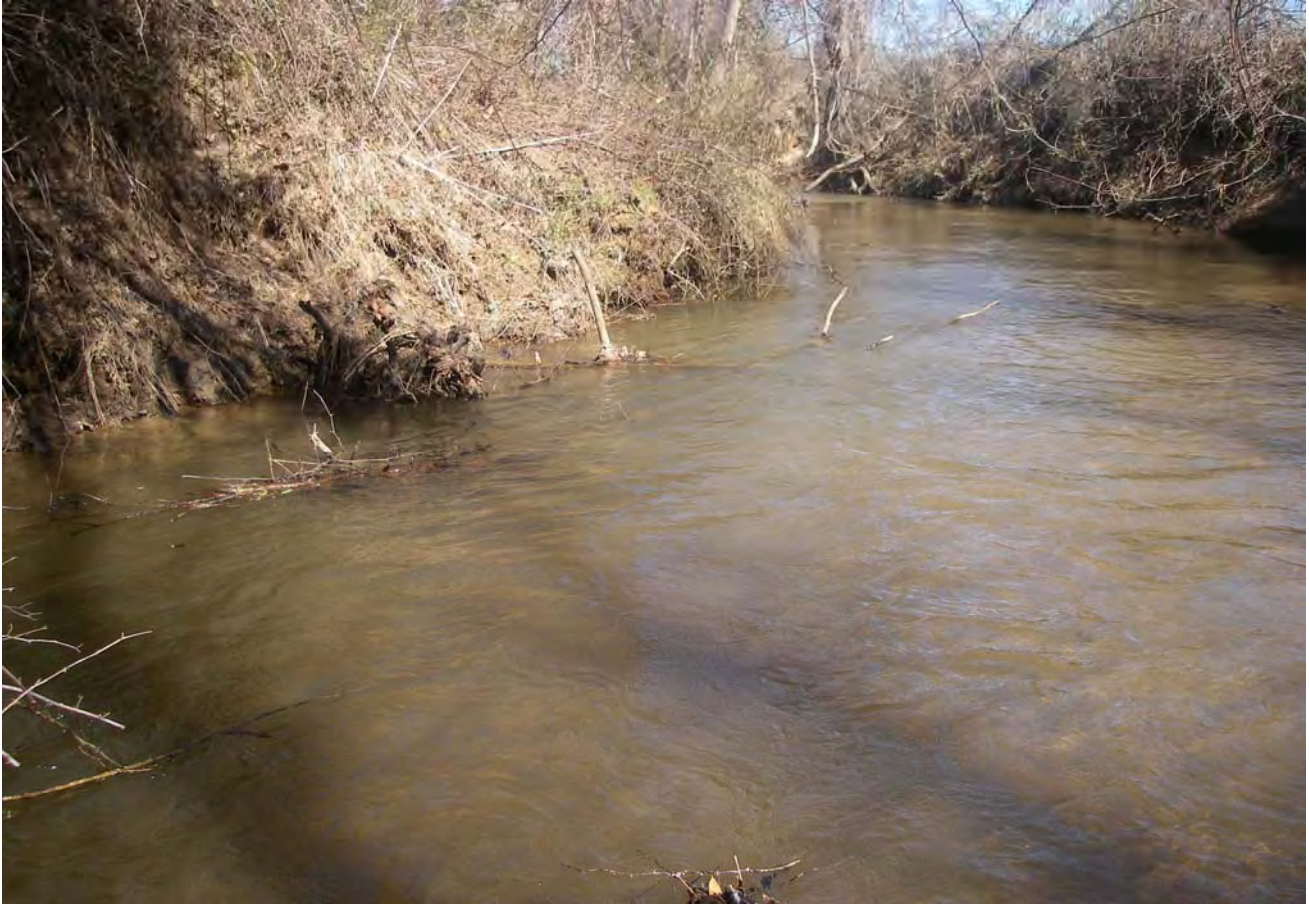
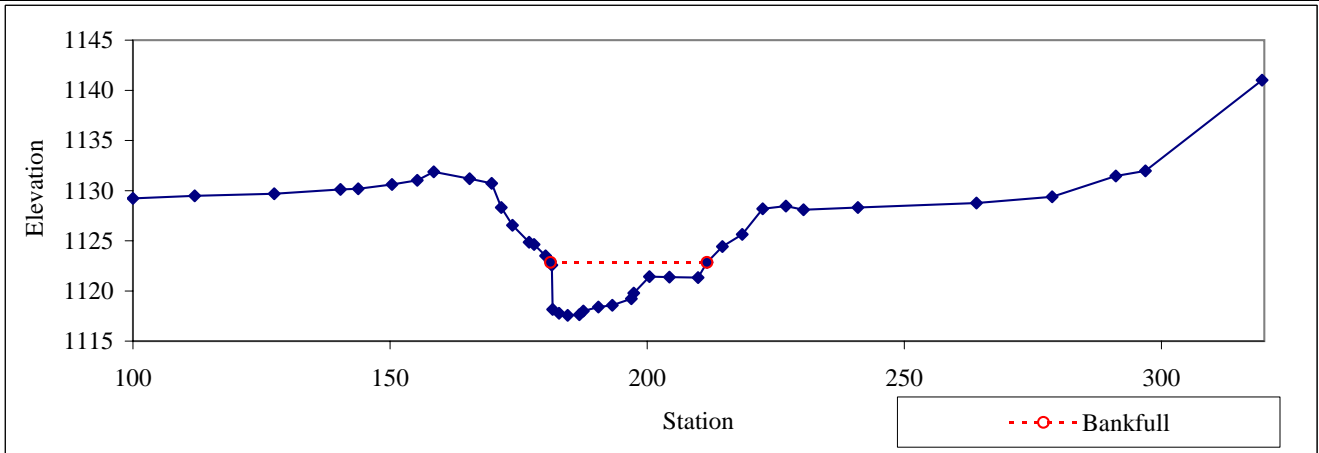
**South Muddy Creek Site - South Muddy Creek  
Cross-section Data: X2 Pool**

Feature	Stream Type	BKF Area	BKF Width	BKF Depth	Max BKF Depth	W/D	BH Ratio	ER	BKF Elev	TOB Elev
Pool		94.5	30.4	3.1	5.3	9.8	2.0		1122.8	1128.2

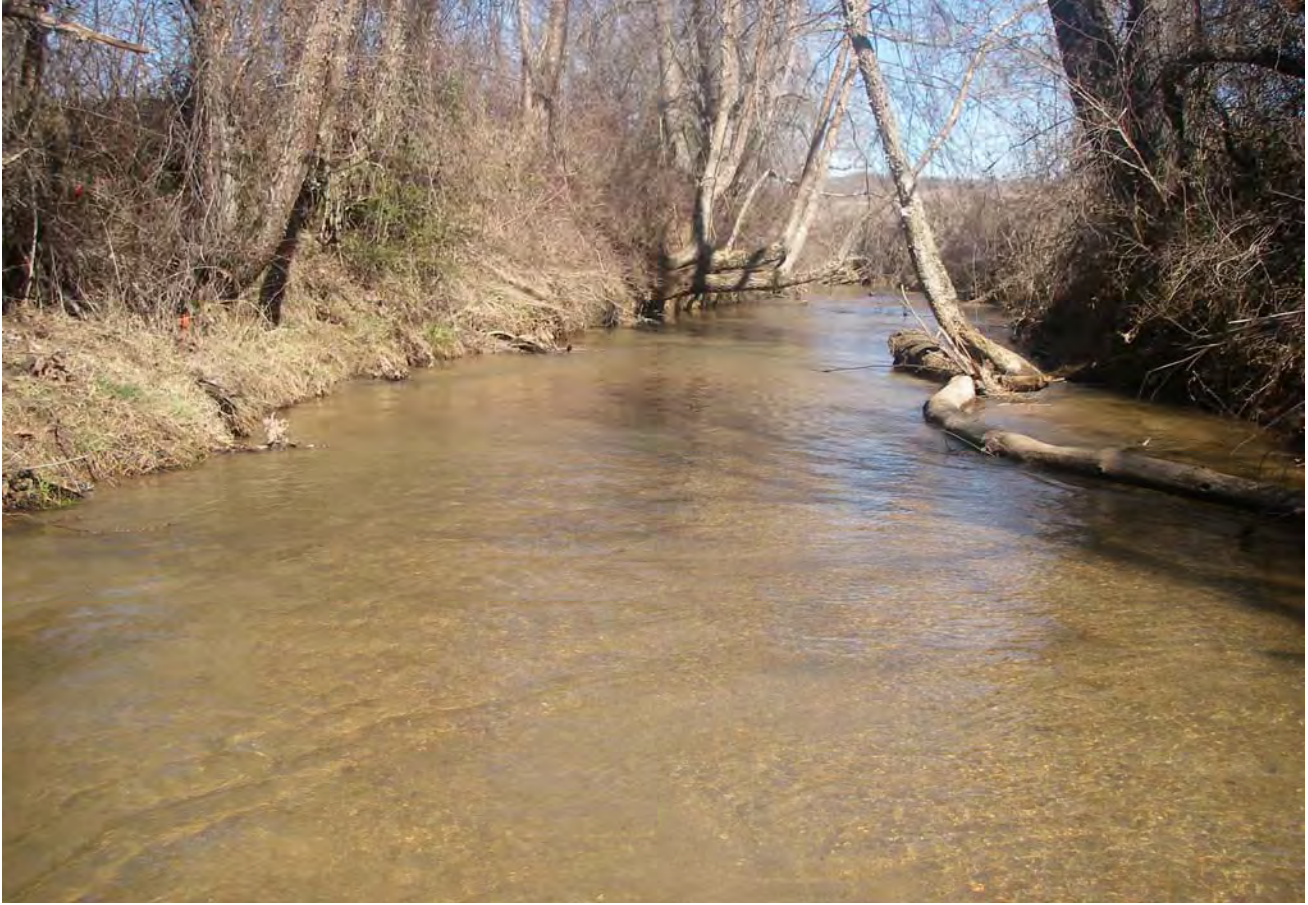
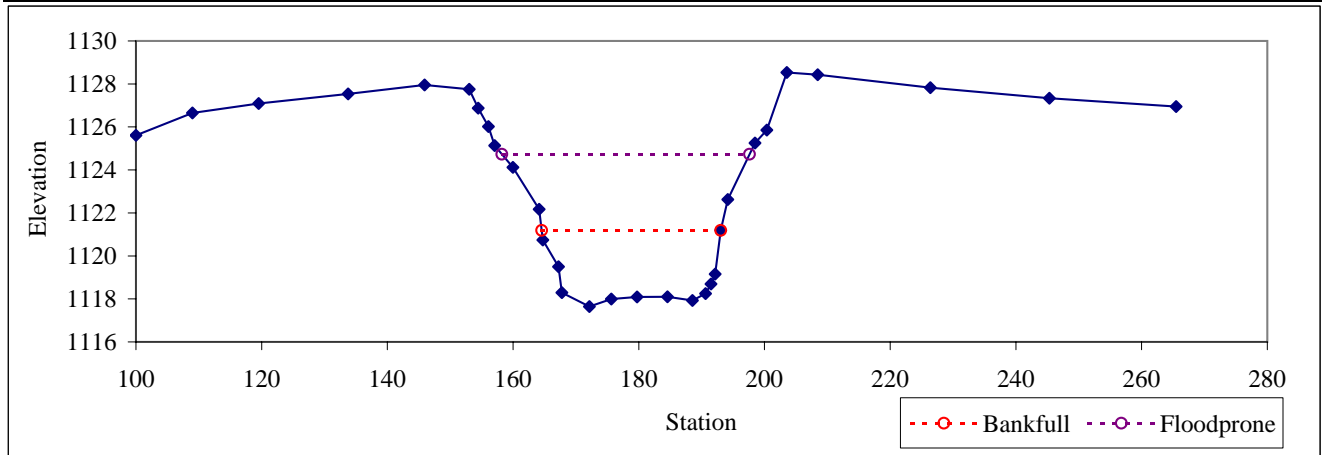
**South Muddy Creek Site - South Muddy Creek  
Cross-section Data: X3 Riffle**

Feature	Stream Type	BKF Area	BKF Width	BKF Depth	Max BKF Depth	W/D	BH Ratio	ER	BKF Elev	TOB Elev
Riffle	G4c	81.5	28.5	2.9	3.5	9.8	2.9	1.4	1121.2	1127.8

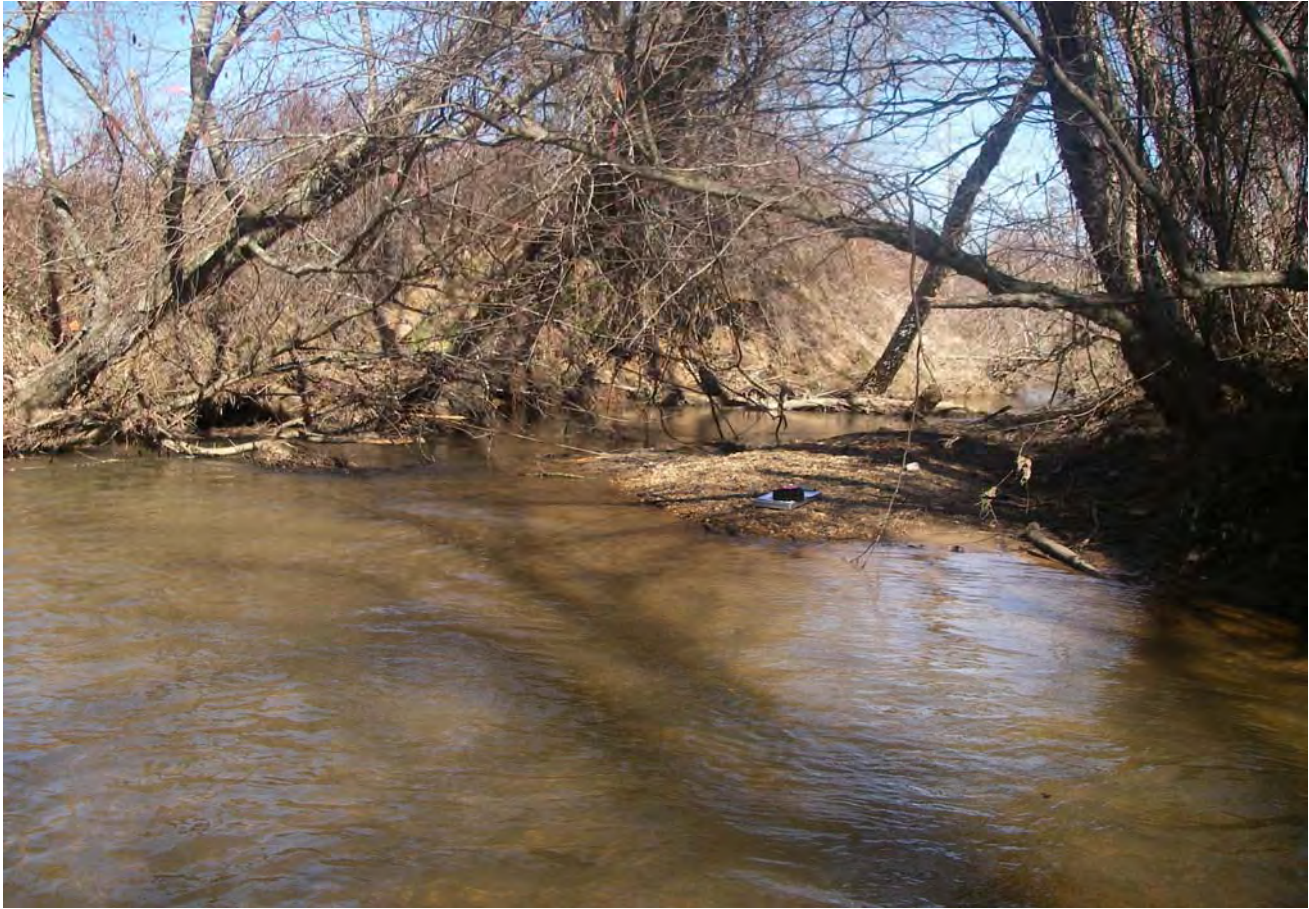
**South Muddy Creek Site - South Muddy Creek  
Cross-section Data: X4 Pool**

Feature	Stream Type	BKF Area	BKF Width	BKF Depth	Max BKF Depth	W/D	BH Ratio	ER	BKF Elev	TOB Elev
Pool		85.9	28.1	3.1	5.7	9.1	2.0		1121.1	1126.6

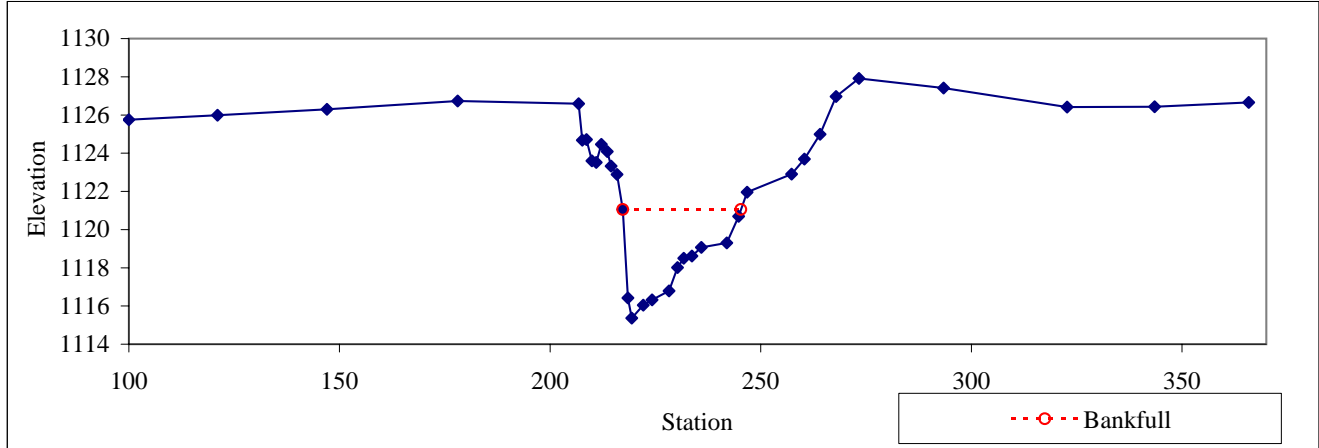
**South Muddy Creek Site - South Muddy Creek**  
**Cross-section Data: X7 Pool**

Feature	Stream Type	BKF Area	BKF Width	BKF Depth	Max BKF Depth	W/D	BH Ratio	ER	BKF Elev	TOB Elev
Pool		103.7	30.6	3.4	5.8	9.0	2.0		1119.6	1125.4

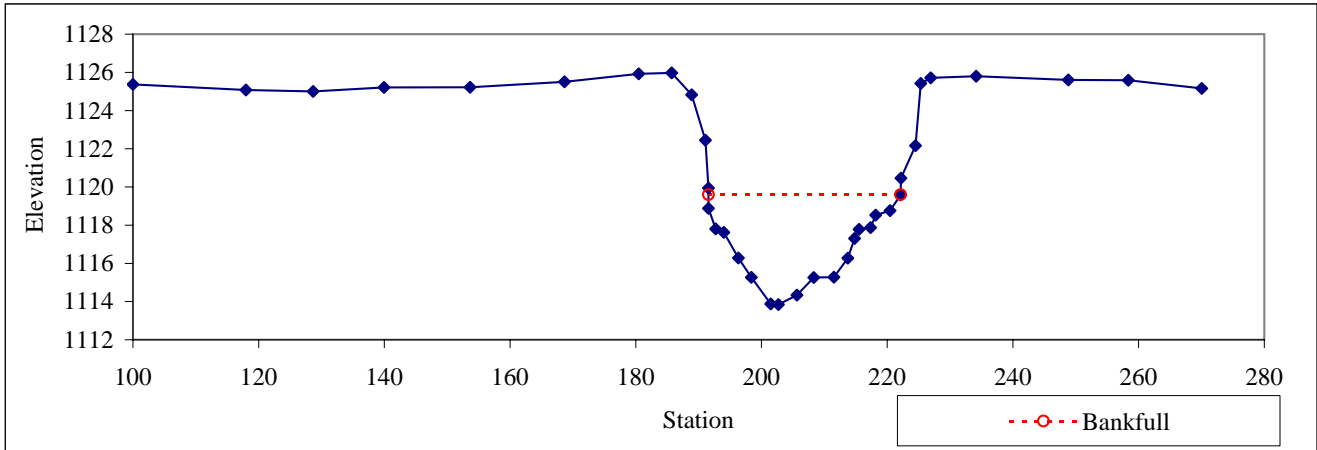
**South Muddy Creek Site - South Muddy Creek  
Cross-section Data: X8 Riffle**

Feature	Stream Type	BKF Area	BKF Width	BKF Depth	Max BKF Depth	W/D	BH Ratio	ER	BKF Elev	TOB Elev
Riffle	G4c	77.7	25.8	3.0	3.7	8.6	2.4	1.1	1119.9	11125.0

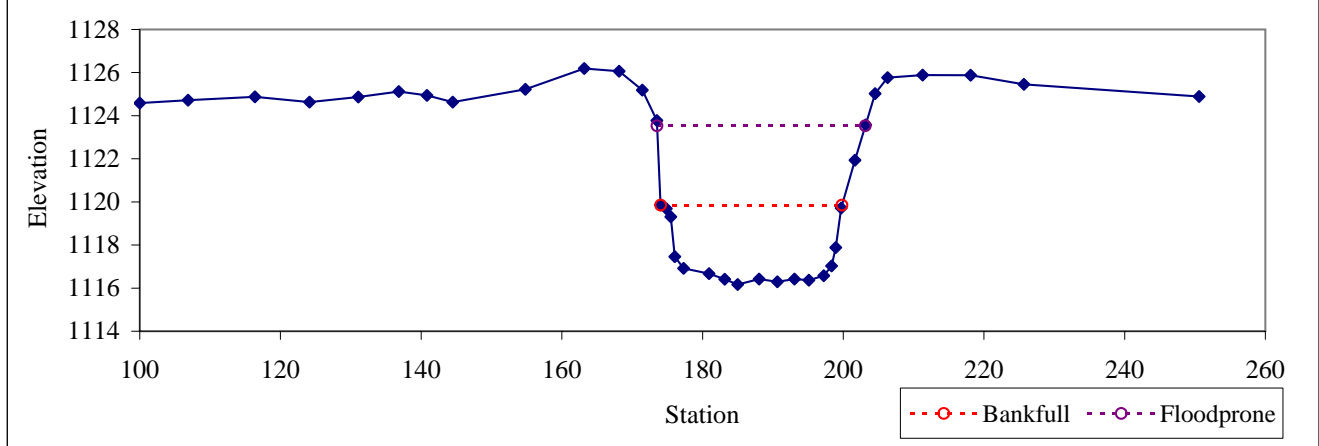
**South Muddy Creek Site - South Muddy Creek  
Cross-section Data: X9 Riffle**

Feature	Stream Type	BKF Area	BKF Width	BKF Depth	Max BKF Depth	W/D	BH Ratio	ER	BKF Elev	TOB Elev
Riffle	G4c	72.8	24.3	3.0	3.5	8.1	2.8	1.2	118.7	1125.0

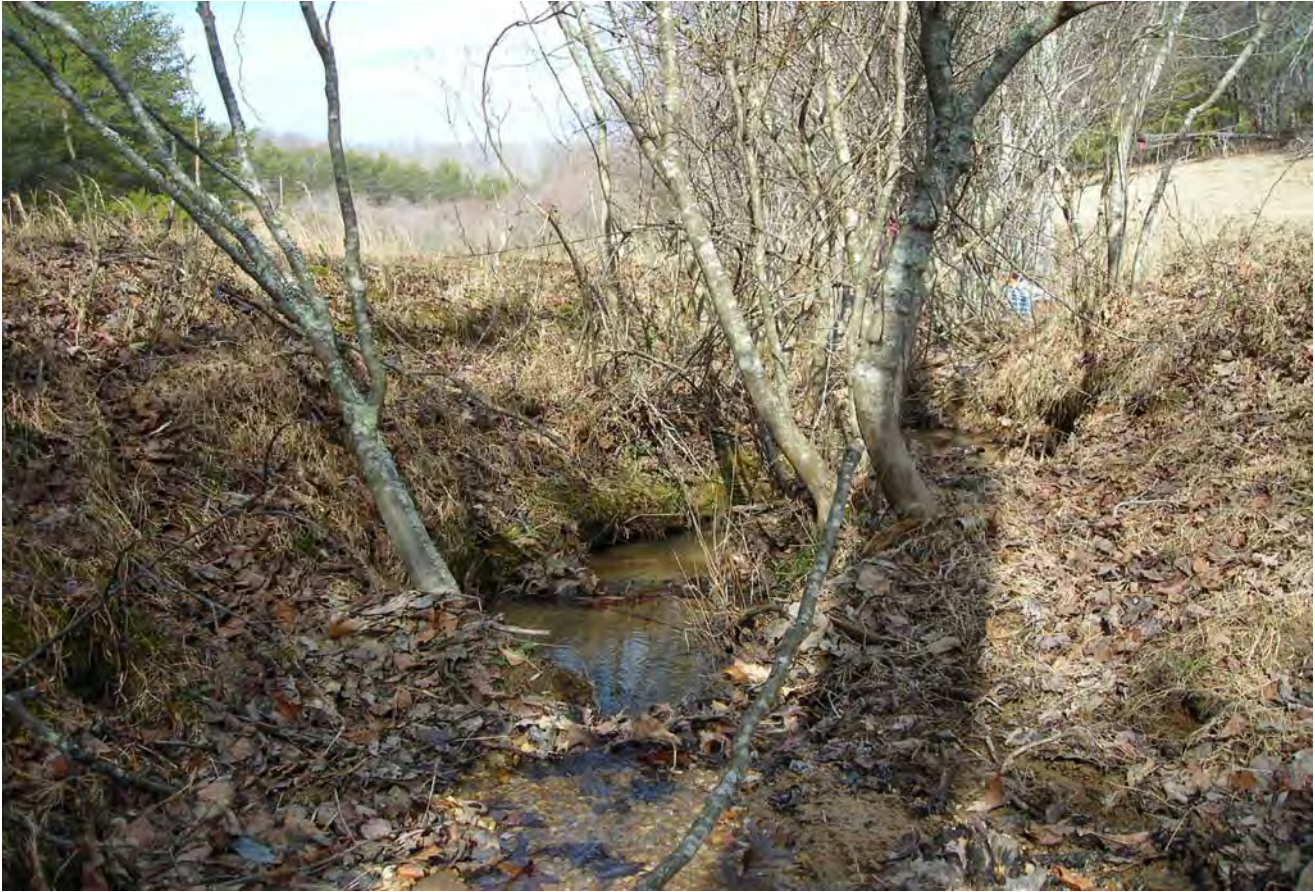
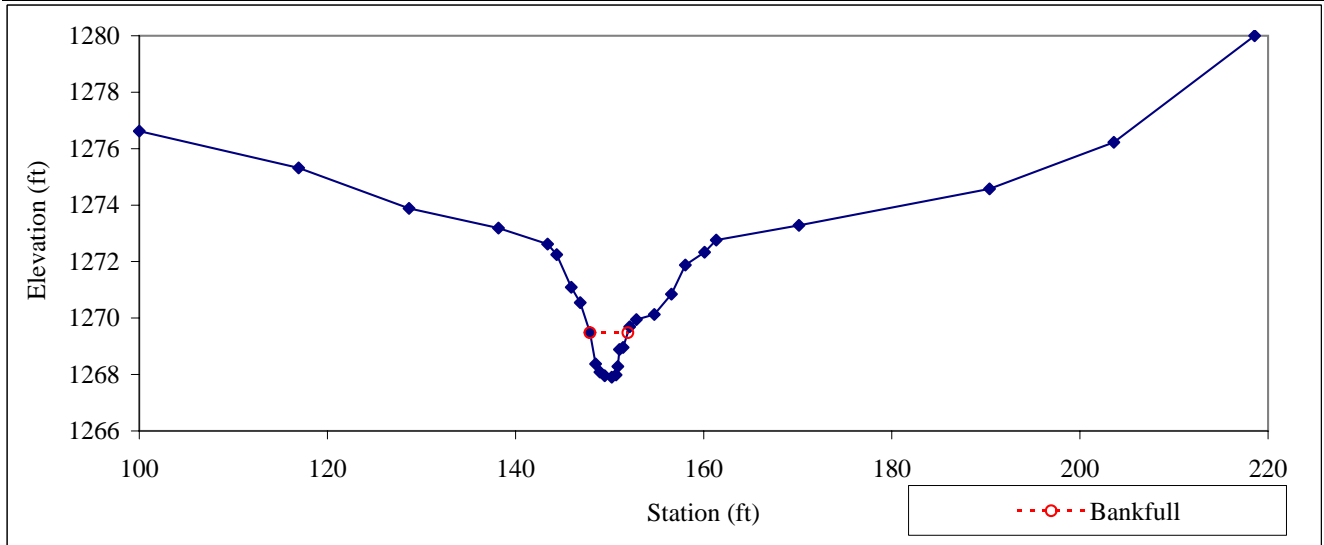
**South Fork Hoppers Site - UT1B**  
**Cross-section Data: X1 Pool**

Feature	Stream Type	BKF Area	BKF Width	BKF Depth	Max BKF Depth	W/D	BH Ratio	ER	BKF Elev	TOB Elev
Pool		4.3	4	1.1	1.6	3.6	2.8		1269.5	1272.3

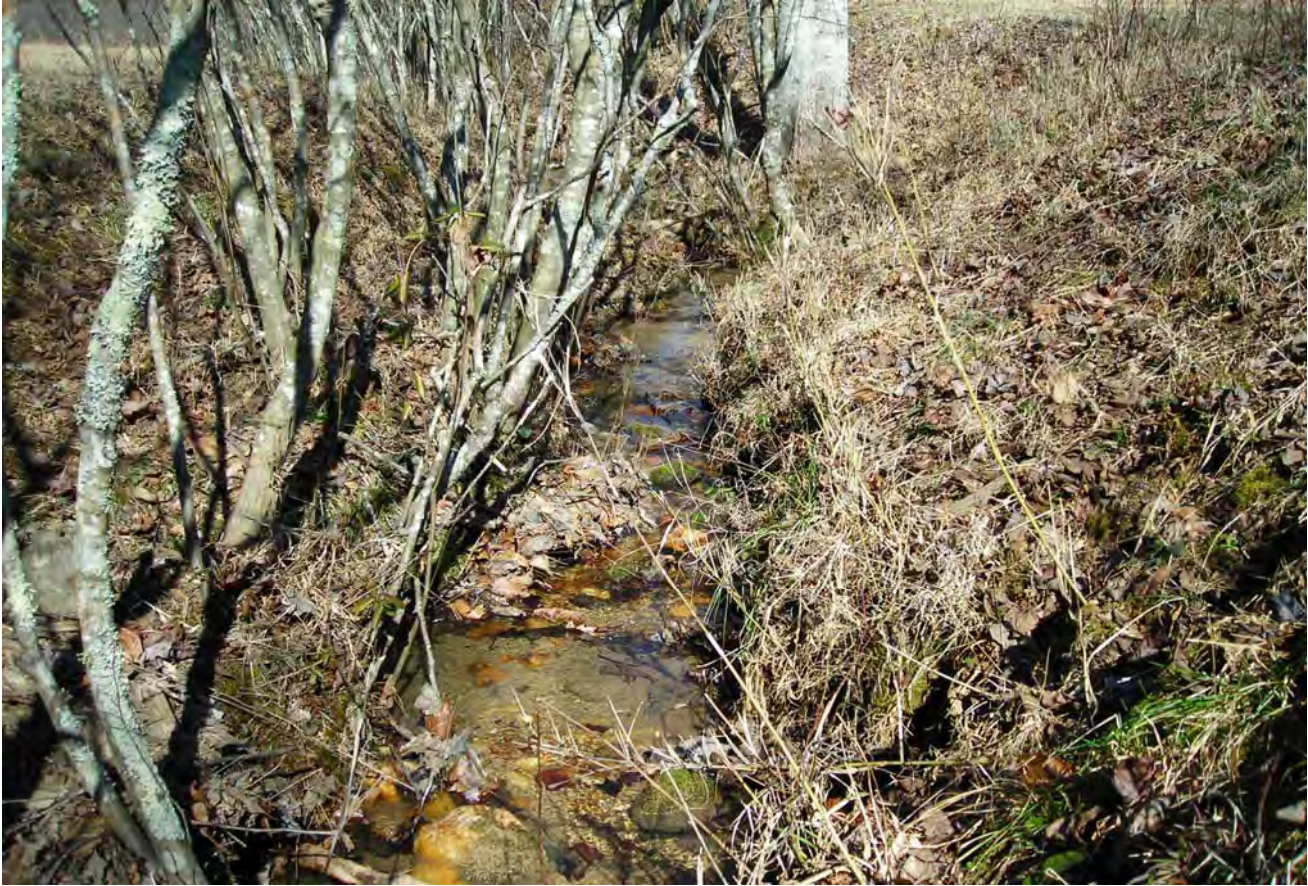
**South Fork Hoppers Site - UT1B**  
**Cross-section Data: X2 Riffle**

Feature	Stream Type	BKF Area	BKF Width	BKF Depth	Max BKF Depth	W/D	BH Ratio	ER	BKF Elev	TOB Elev
Riffle	E5	3.4	3.4	1	1.4	3.4	2.5	2.9	1268.7	1270.9

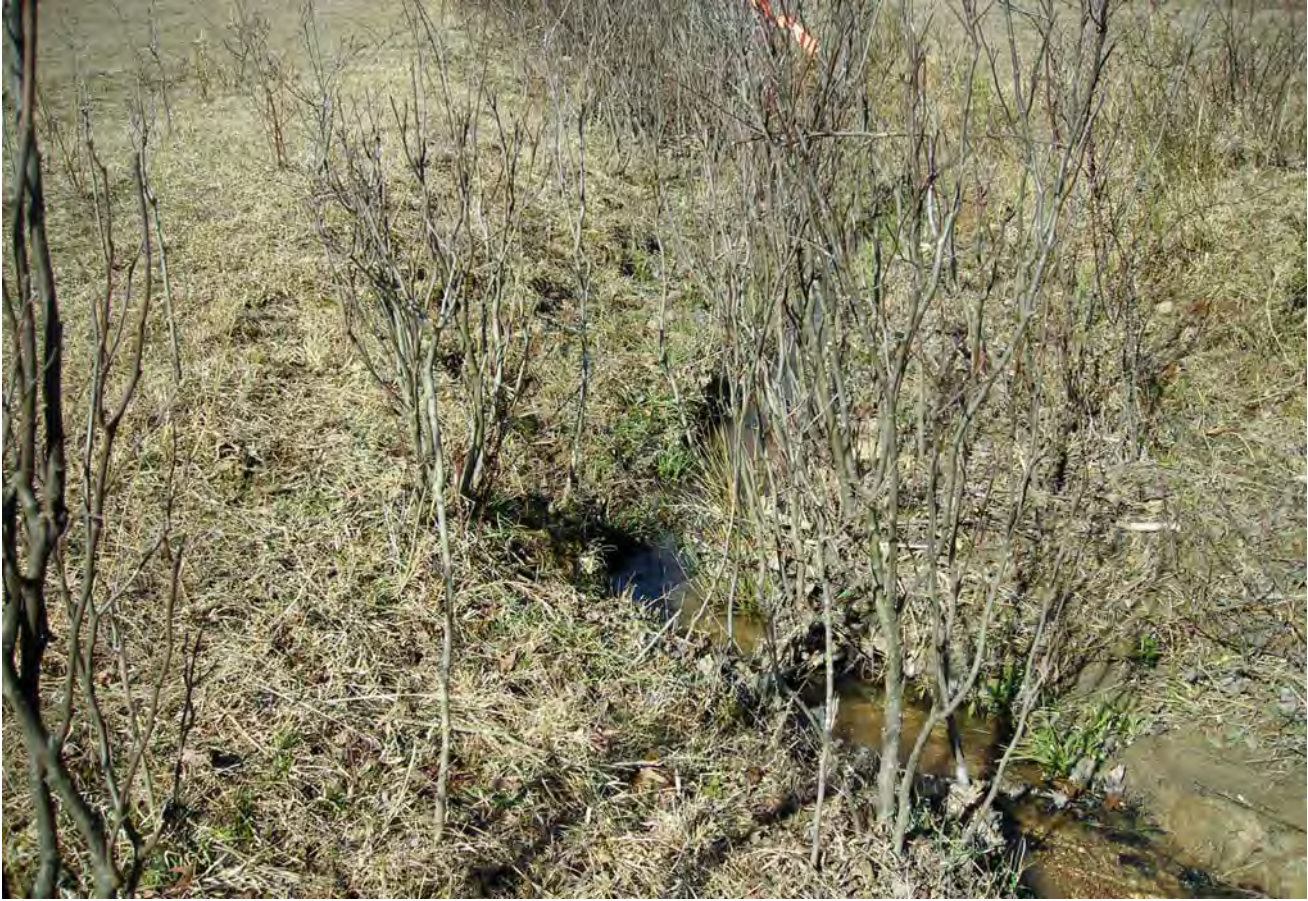
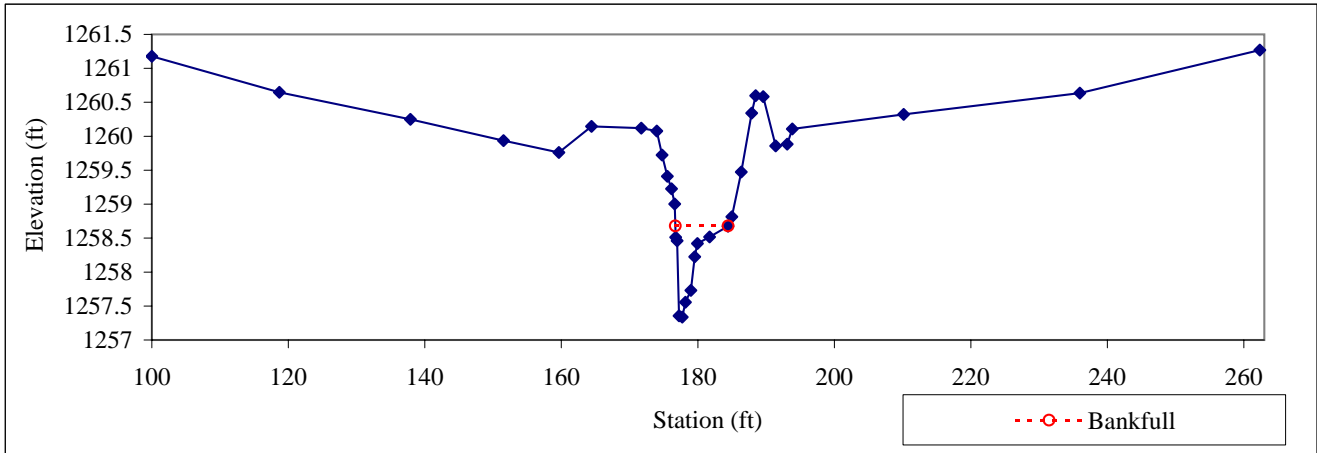
**South Fork Hoppers Site - UT1B**  
**Cross-section Data: X3 Pool**

Feature	Stream Type	BKF Area	BKF Width	BKF Depth	Max BKF Depth	W/D	BH Ratio	ER	BKF Elev	TOB Elev
Pool		3.4	7.7	0.4	1.3	19.3	2.0		1258.7	1260.1

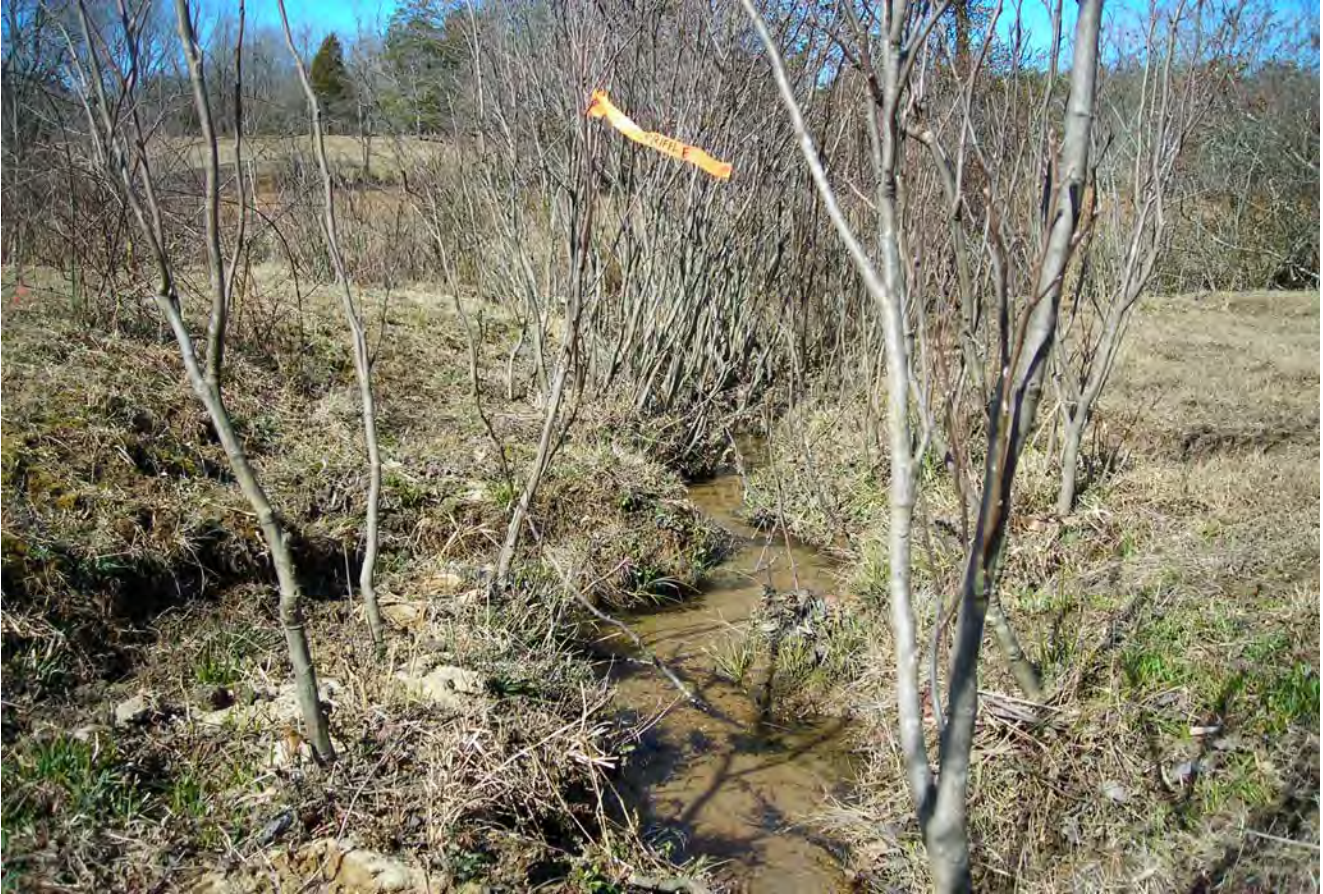
**South Fork Hoppers Site - UT1B**  
**Cross-section Data: X4 Riffle**

Feature	Stream Type	BKF Area	BKF Width	BKF Depth	Max BKF Depth	W/D	BH Ratio	ER	BKF Elev	TOB Elev
Riffle	E5	3.5	5.7	0.6	1.3	9.5	1.4	16.2	1256.2	1256.8
