# South Muddy Creek Stream Restoration McDowell County, North Carolina

NCDENR Contract D07032S

FINAL Restoration Plan  
Submission Date: January 2008

Baker Engineering NY, Inc.

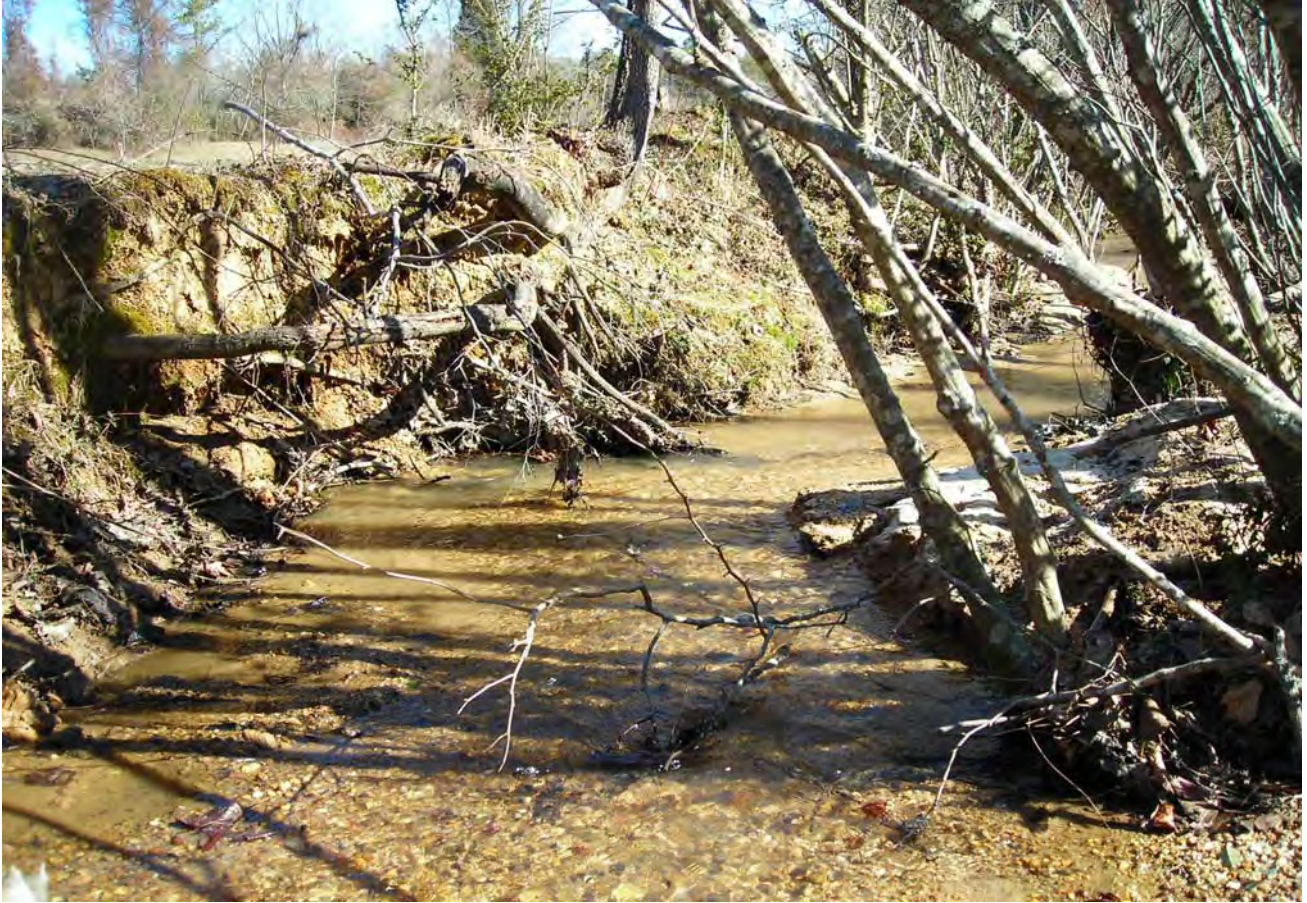
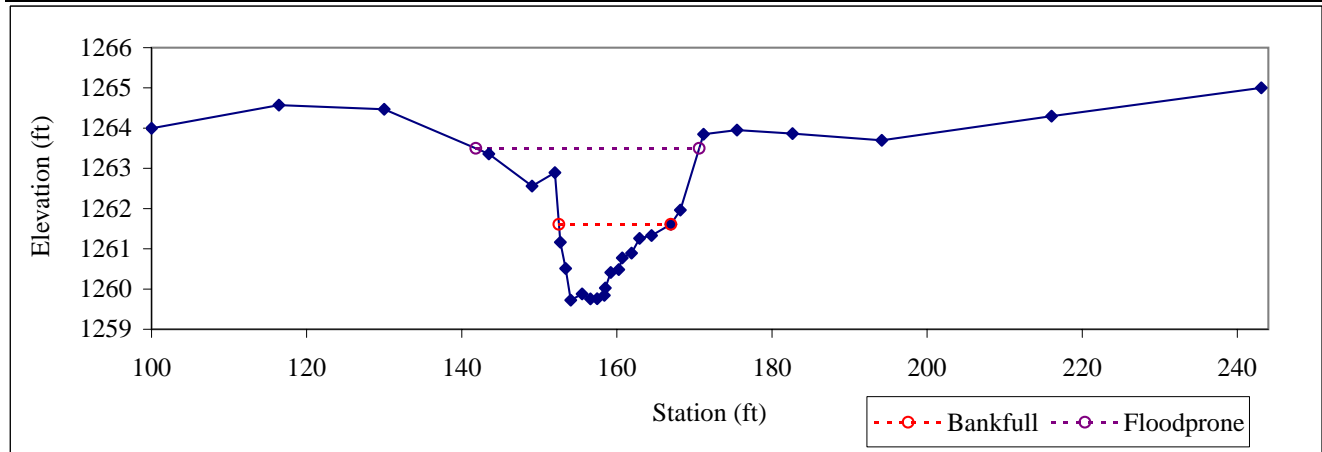
**Sork Fork Hoppers Site - South Fork Hoppers**  
**Cross-section Data: X5 Riffle**

Feature	Stream Type	BKF Area	BKF Width	BKF Depth	Max BKF Depth	W/D	BH Ratio	ER	BKF Elev	TOB Elev
Riffle	G5c	14.5	14.4	1	1.9	14.4	1.7	2.0	1261.6	1262.9

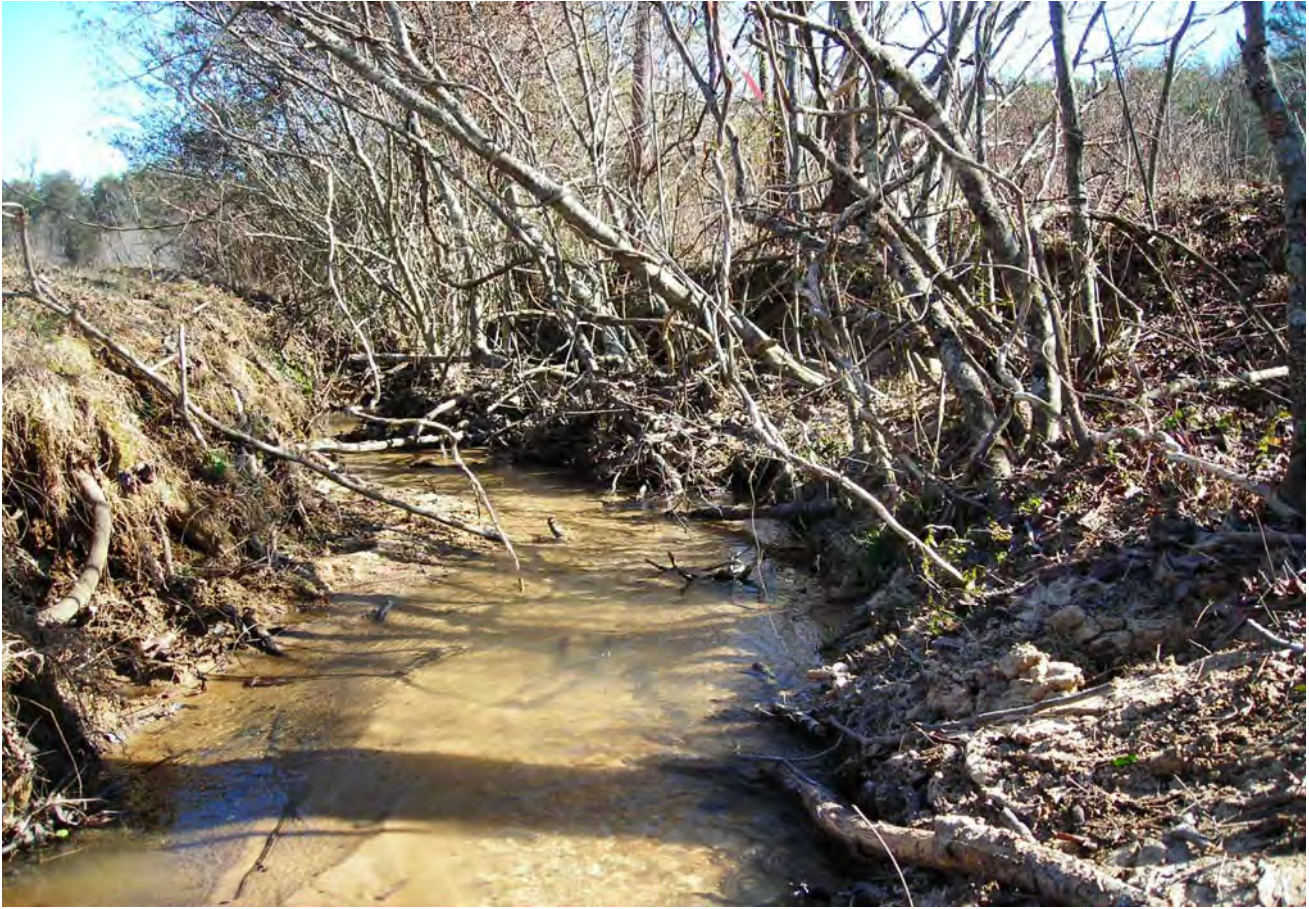
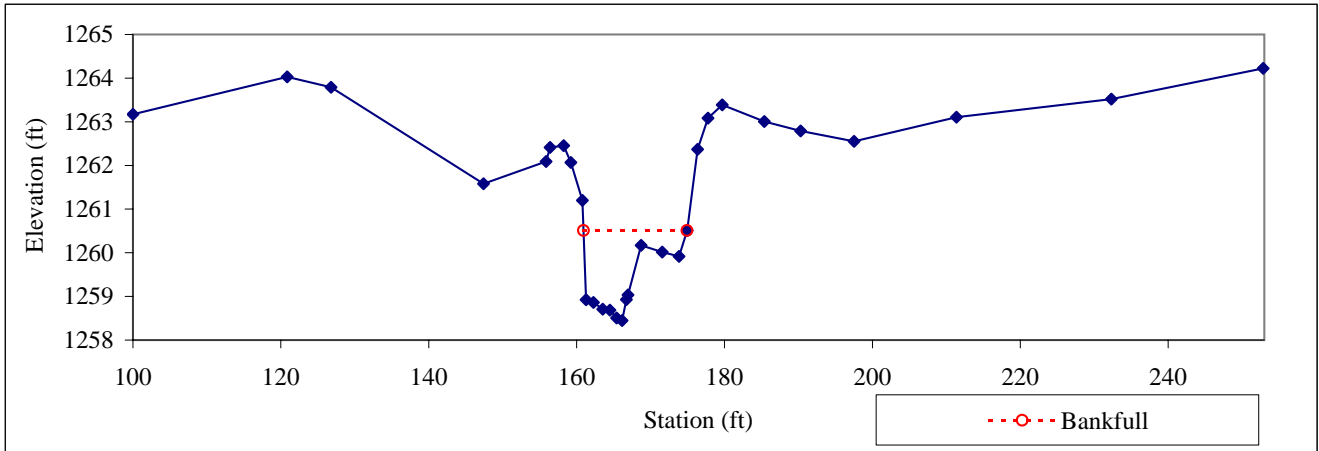
**Sork Fork Hoppers Site - South Fork Hoppers**  
**Cross-section Data: X6 Pool**

Feature	Stream Type	BKF Area	BKF Width	BKF Depth	Max BKF Depth	W/D	BH Ratio	ER	BKF Elev	TOB Elev
Pool		14.8	14	1.1	2.1	12.7	1.9		1260.5	1262.5

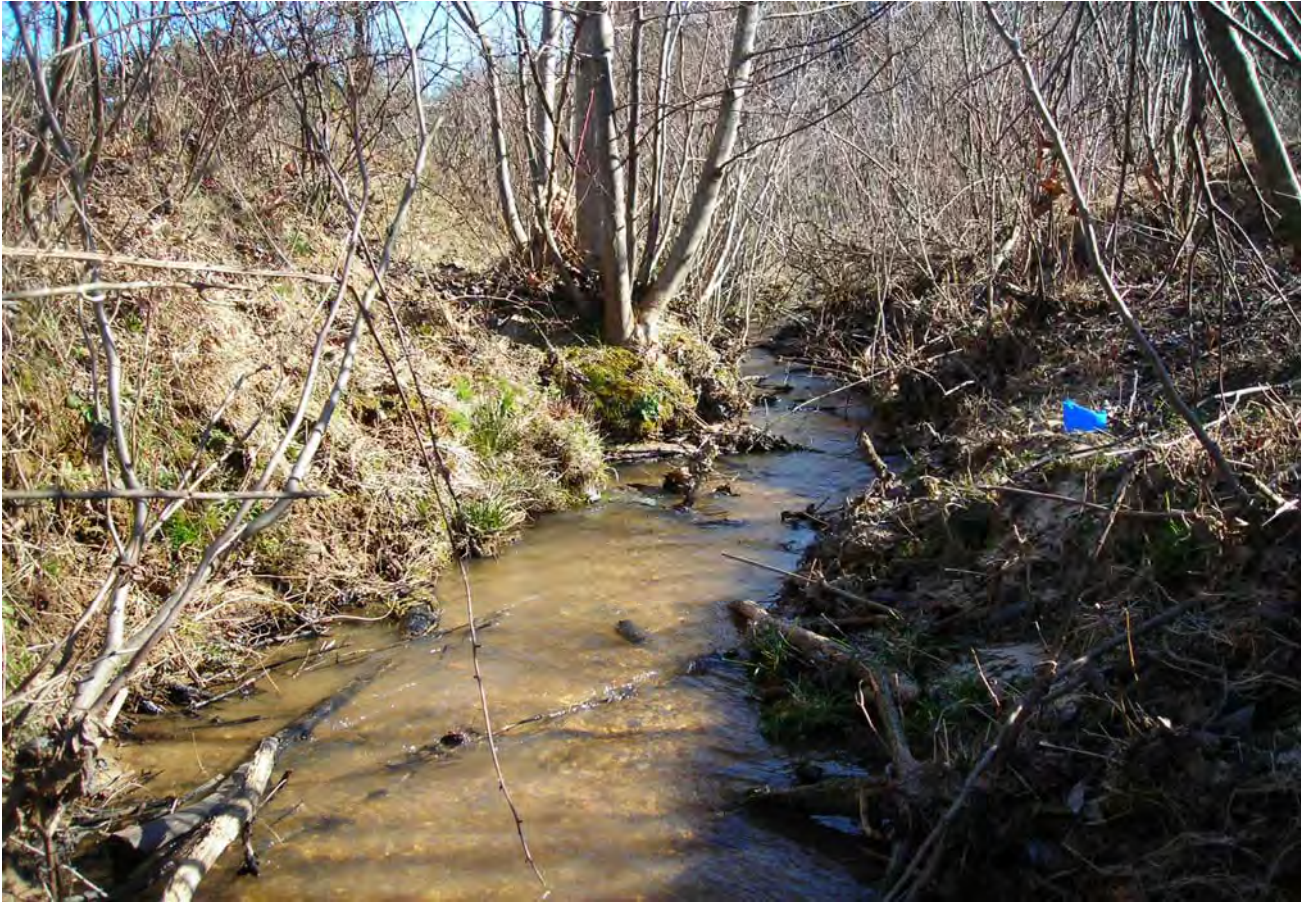
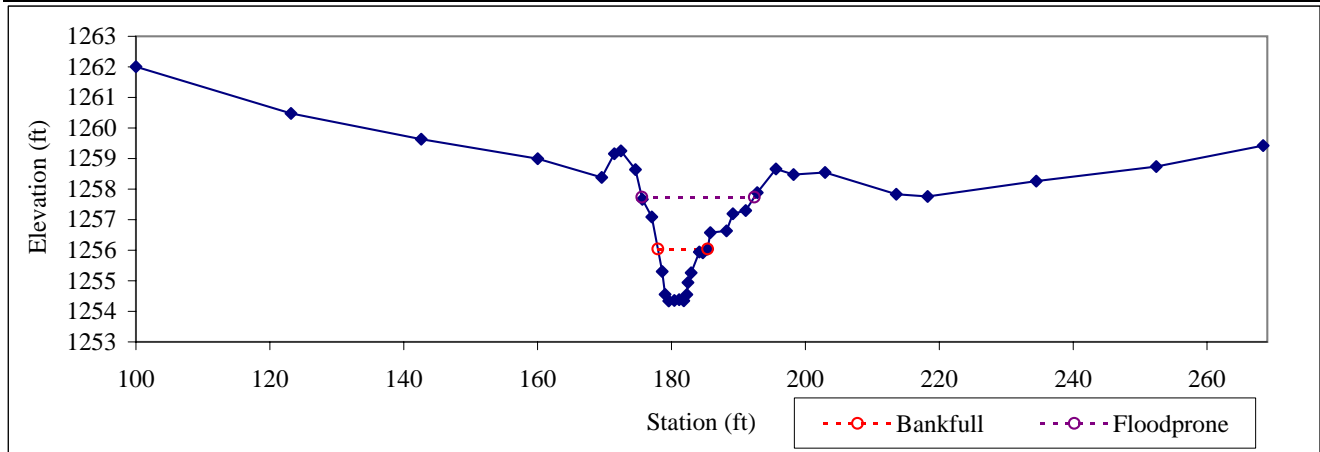
**Sork Fork Hoppers Site - South Fork Hoppers**  
**Cross-section Data: X7 Riffle**

Feature	Stream Type	BKF Area	BKF Width	BKF Depth	Max BKF Depth	W/D	BH Ratio	ER	BKF Elev	TOB Elev
Riffle	G5c	7.4	7.4	1.0	1.7	7.4	2.5	2.3	1256.0	1258.7

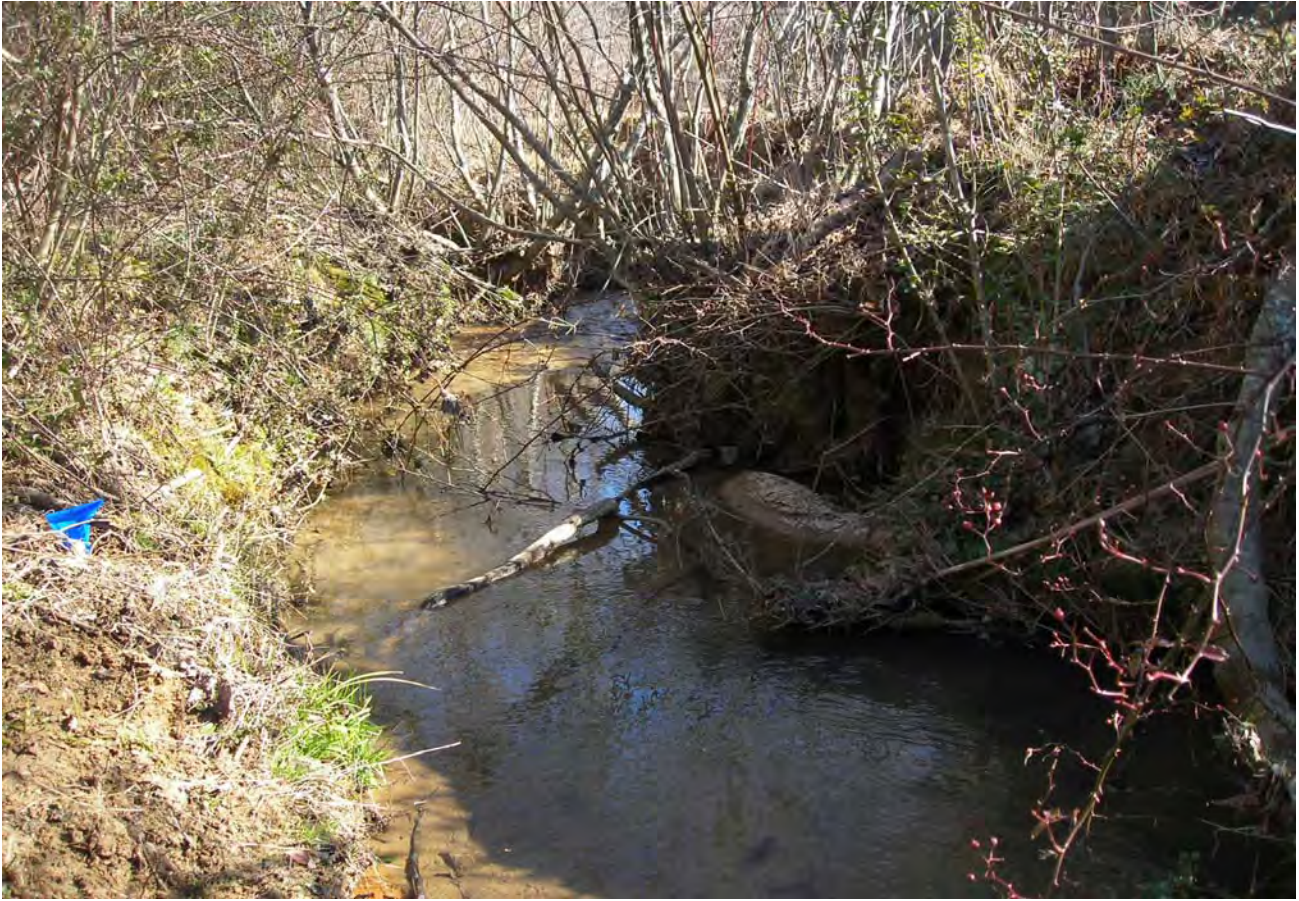
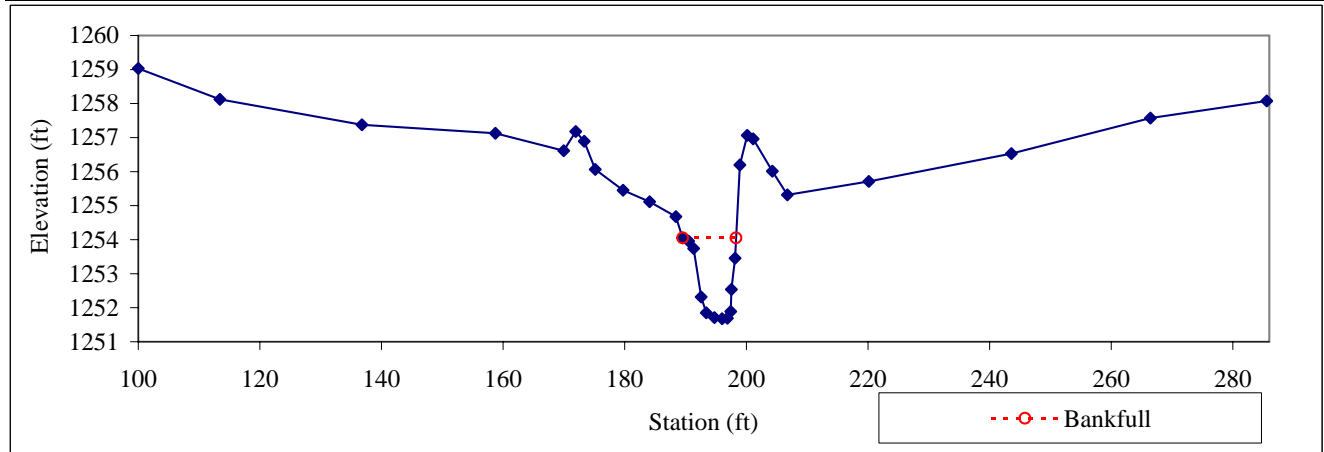
**Sork Fork Hoppers Site - South Fork Hoppers**  
**Cross-section Data: X8 Pool**

Feature	Stream Type	BKF Area	BKF Width	BKF Depth	Max BKF Depth	W/D	BH Ratio	ER	BKF Elev	TOB Elev
Pool		13.3	8.8	1.5	2.4	5.9	2.3		1254.1	1257.1

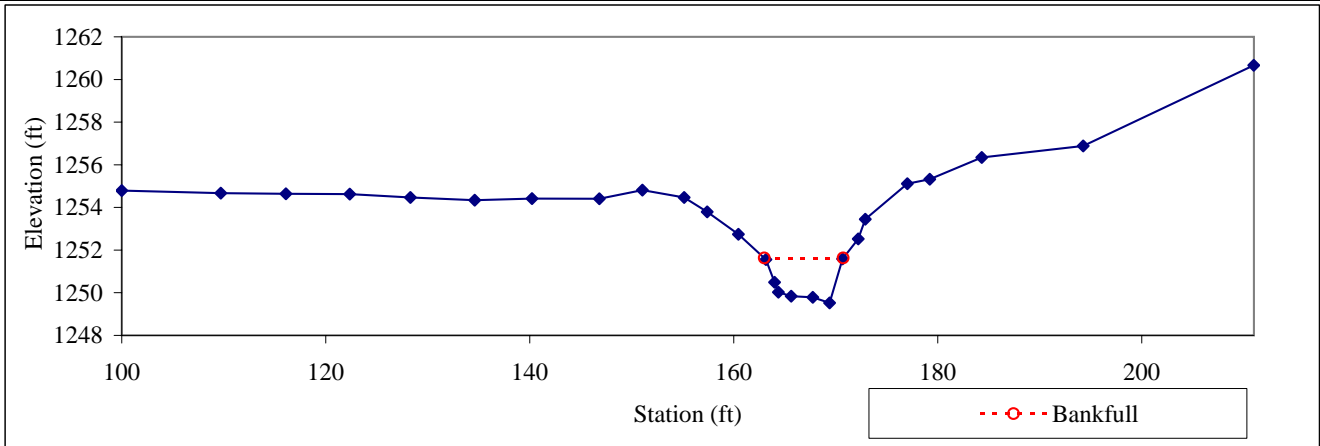
**Sork Fork Hoppers Site - South Fork Hoppers**  
**Cross-section Data: X10 Riffle**

Feature	Stream Type	BKF Area	BKF Width	BKF Depth	Max BKF Depth	W/D	BH Ratio	ER	BKF Elev	TOB Elev
Riffle	G5c	15.6	9.7	1.6	2.0	6.1	1.5	3.4	1250.0	1251.1

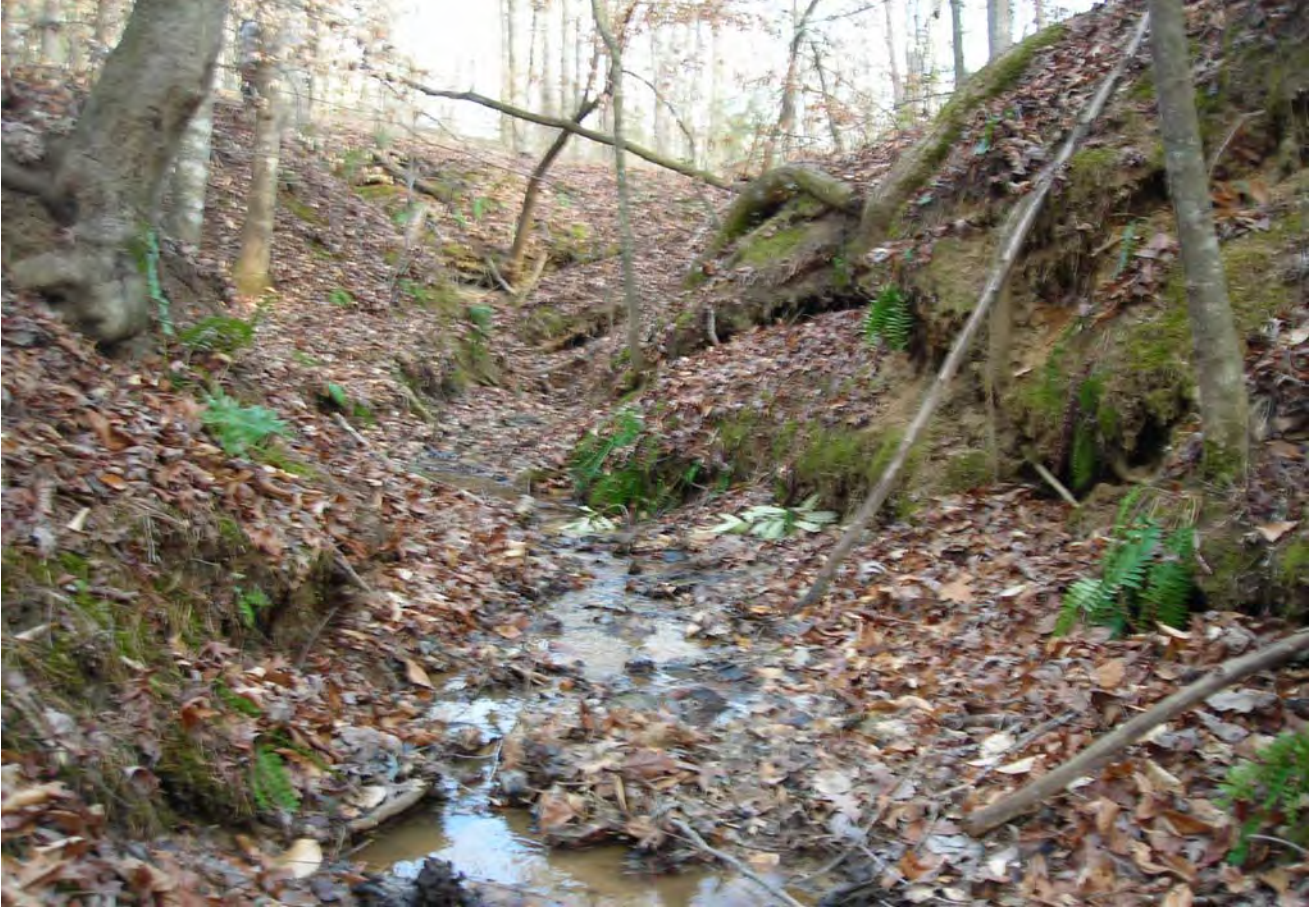
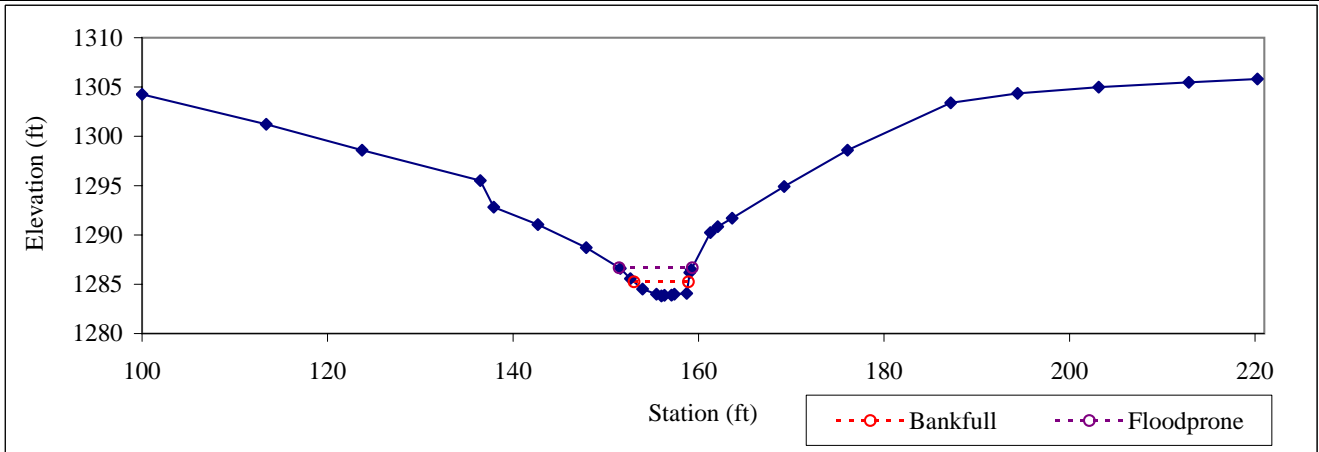
**South Fork Hoppers Creek Site - UT2A**  
**Cross-section Data: X11 Riffle**

Feature	Stream Type	BKF Area	BKF Width	BKF Depth	Max BKF Depth	W/D	BH Ratio	ER	BKF Elev	TOB Elev
Riffle	G5	6.1	5.9	1.1	1.4	5.4	5.5	1.3	1285.2	1291.7

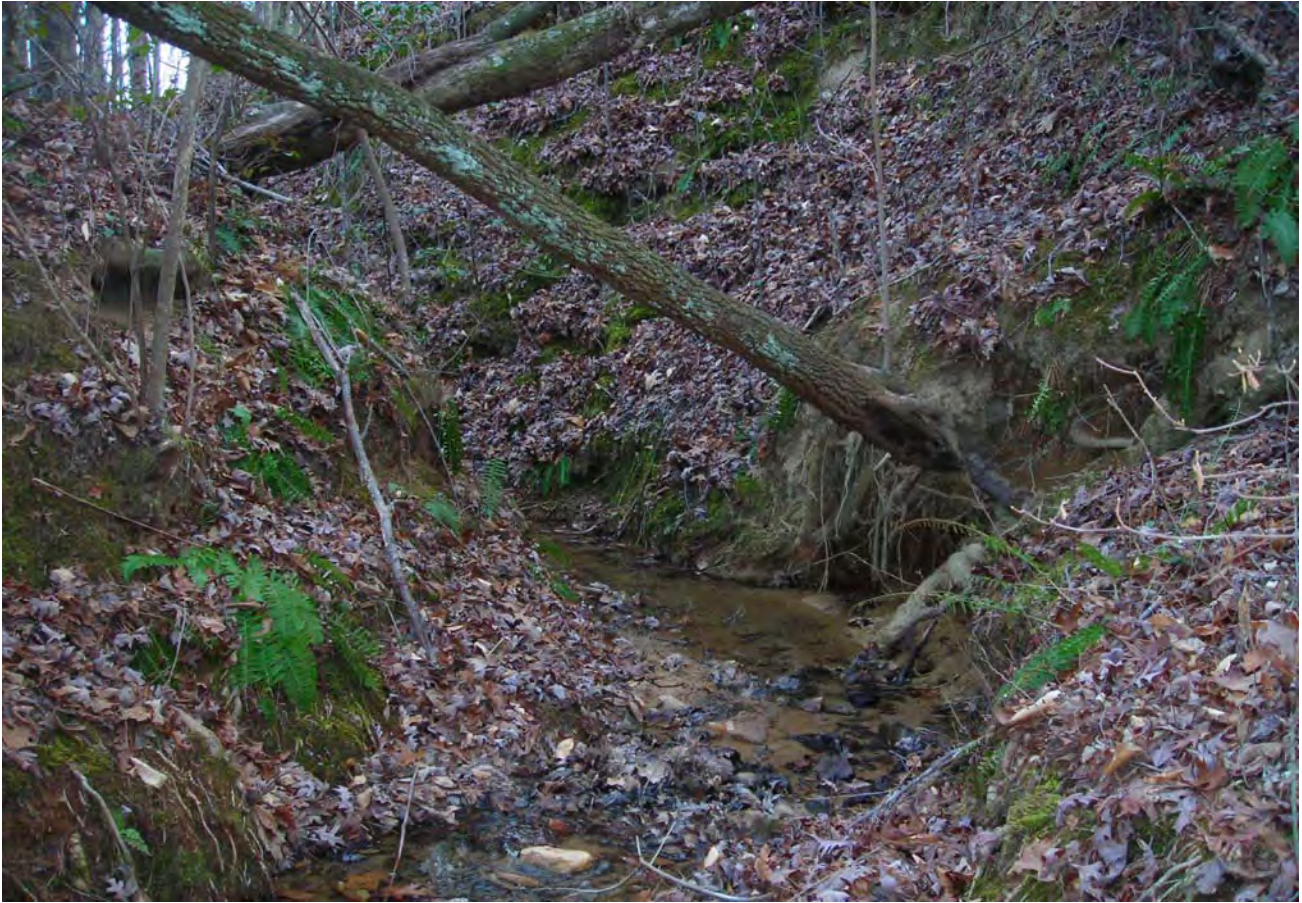
**South Fork Hoppers Creek Site - UT2A**  
**Cross-section Data: X12 Pool**

Feature	Stream Type	BKF Area	BKF Width	BKF Depth	Max BKF Depth	W/D	BH Ratio	ER	BKF Elev	TOB Elev
Pool		9.4	5	1.9	2.6	2.6	2.7		1284.7	1289.1

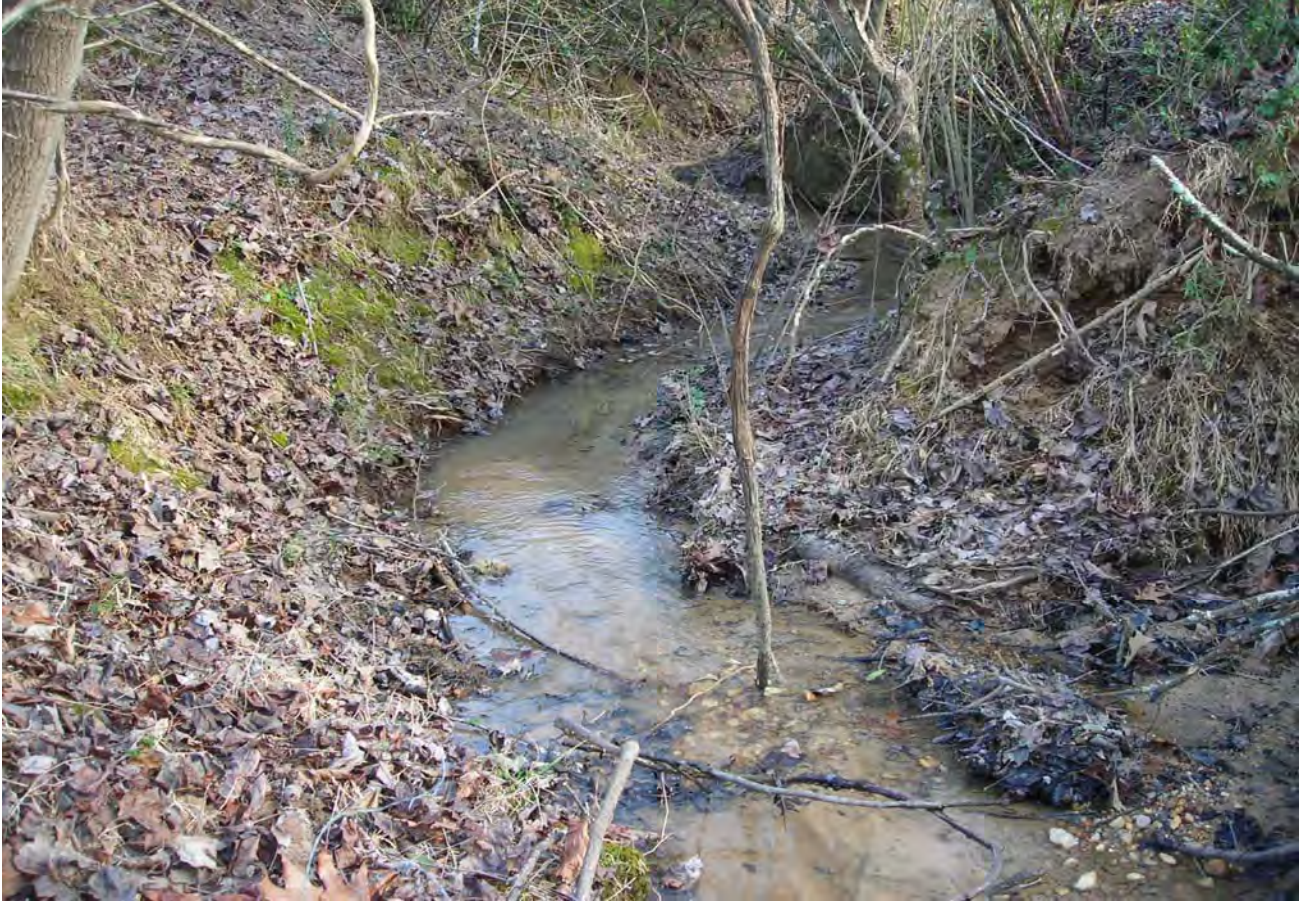
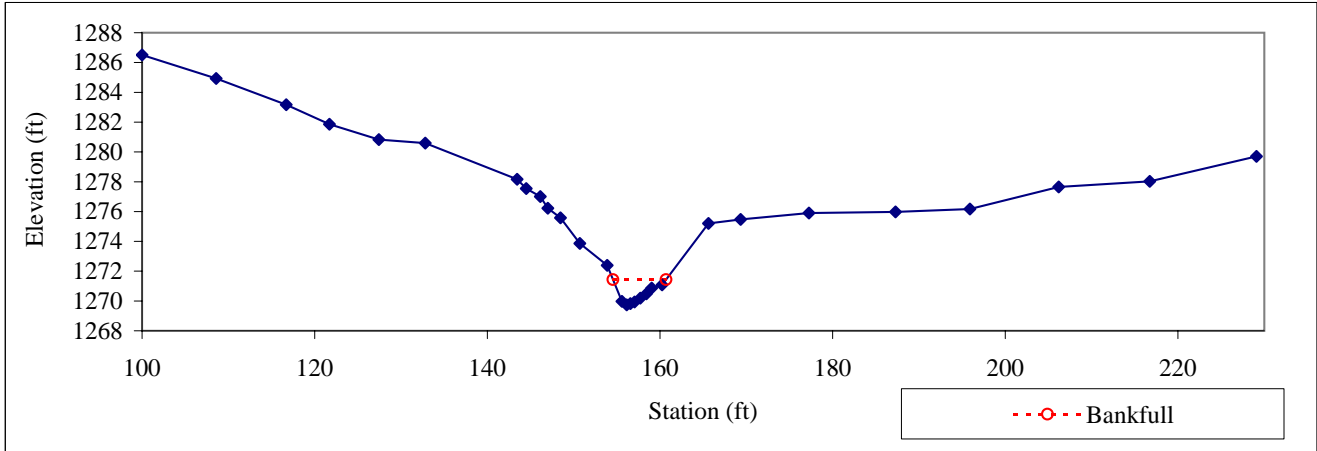
**South Fork Hoppers Creek Site - UT2B**  
**Cross-section Data: X13 Pool**

Feature	Stream Type	BKF Area	BKF Width	BKF Depth	Max BKF Depth	W/D	BH Ratio	ER	BKF Elev	TOB Elev
Pool		5.9	6.2	1.0	1.7	6.2	3.2		1271.4	1275.2

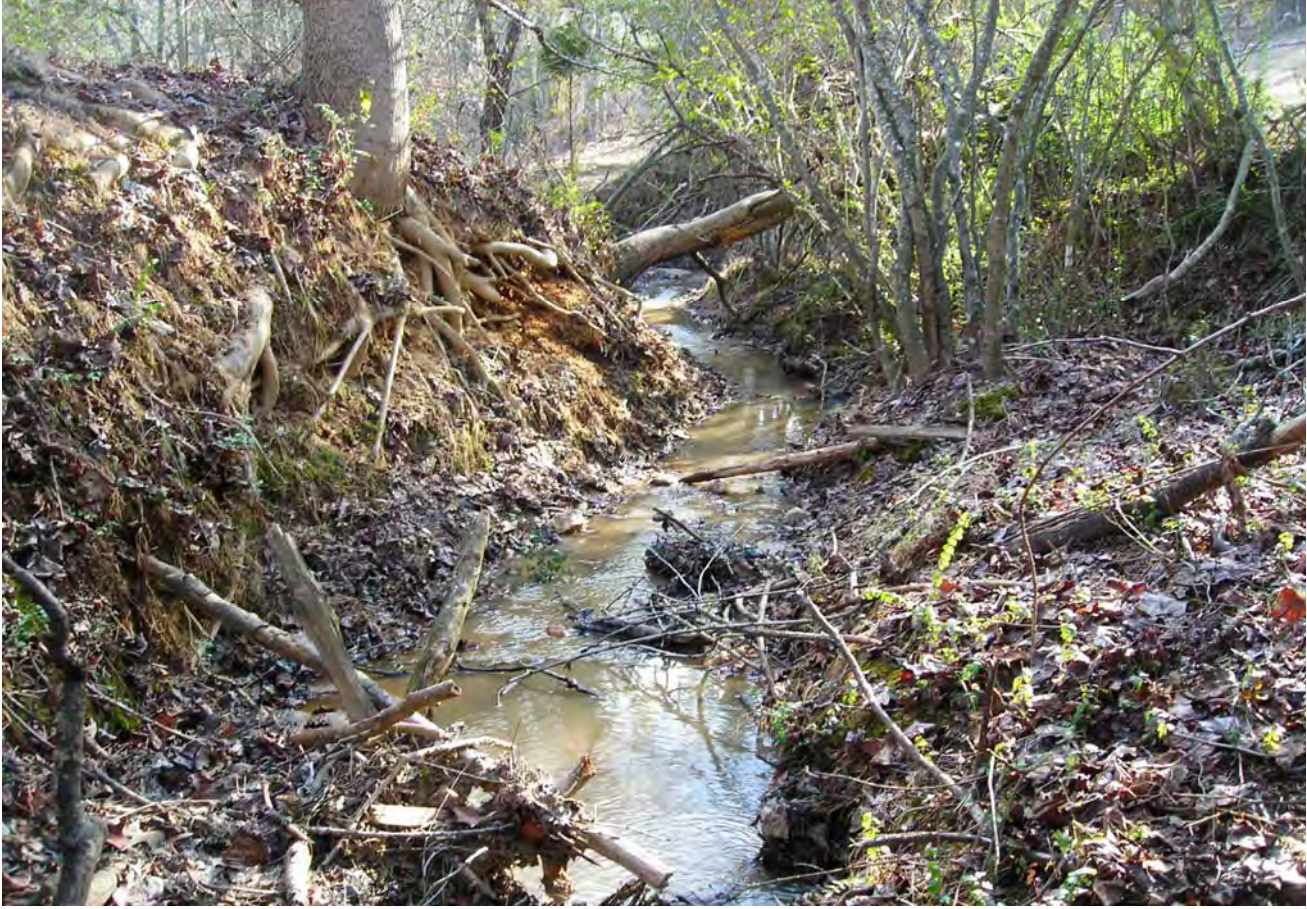
**South Fork Hoppers Creek Site - UT2B**  
**Cross-section Data: X14 Riffle**

Feature	Stream Type	BKF Area	BKF Width	BKF Depth	Max BKF Depth	W/D	BH Ratio	ER	BKF Elev	TOB Elev
Riffle	G5c	6.1	5.5	1.1	1.5	5.0	3.9	2.7	1270.7	1275.1

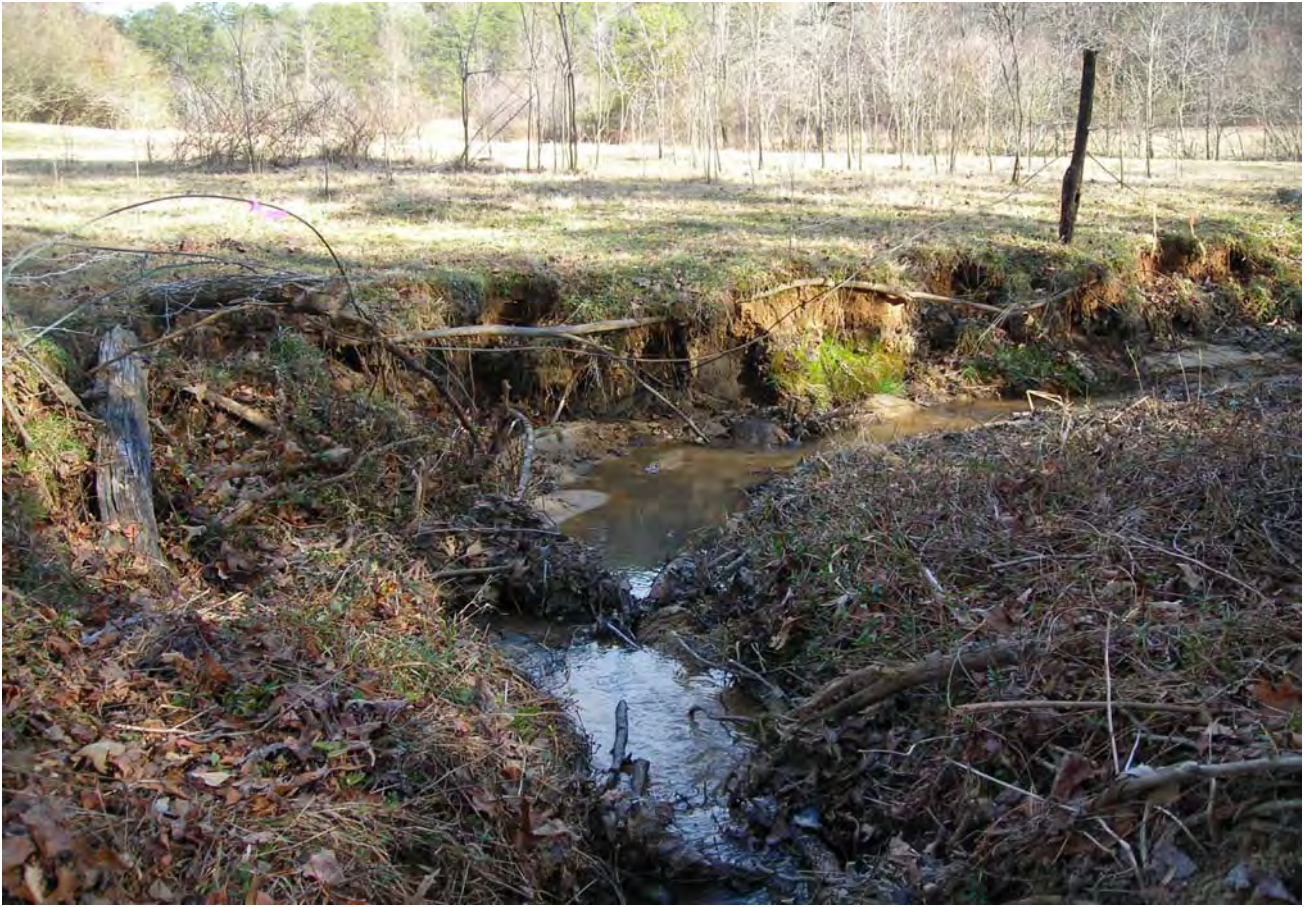
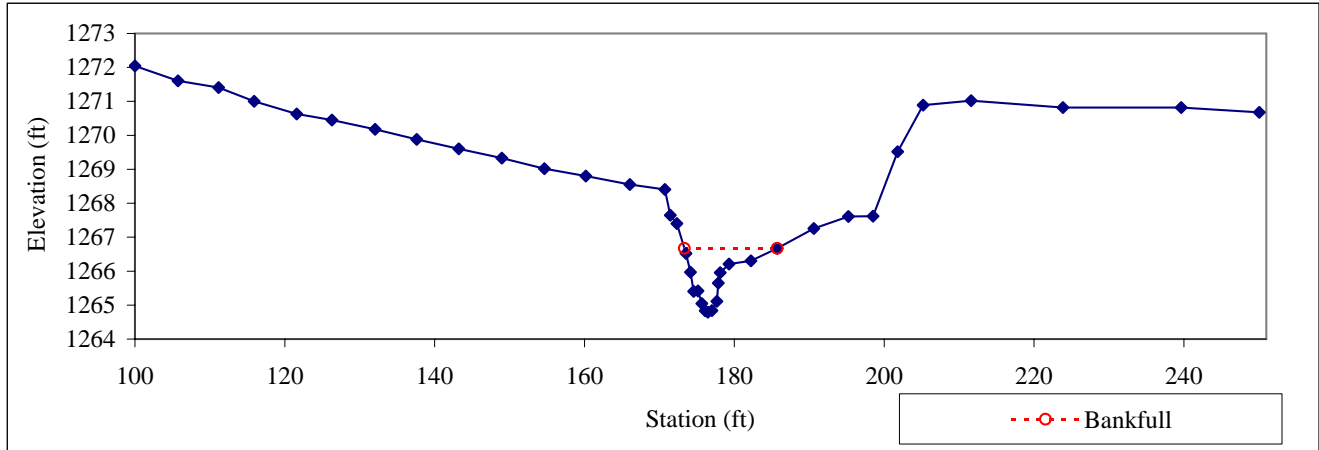
**South Fork Hoppers Creek Site - UT2B**  
**Cross-section Data: X15 Pool**

Feature	Stream Type	BKF Area	BKF Width	BKF Depth	Max BKF Depth	W/D	BH Ratio	ER	BKF Elev	TOB Elev
Pool		8.7	12.4	0.7	1.9	17.7	1.9		1266.7	1268.4

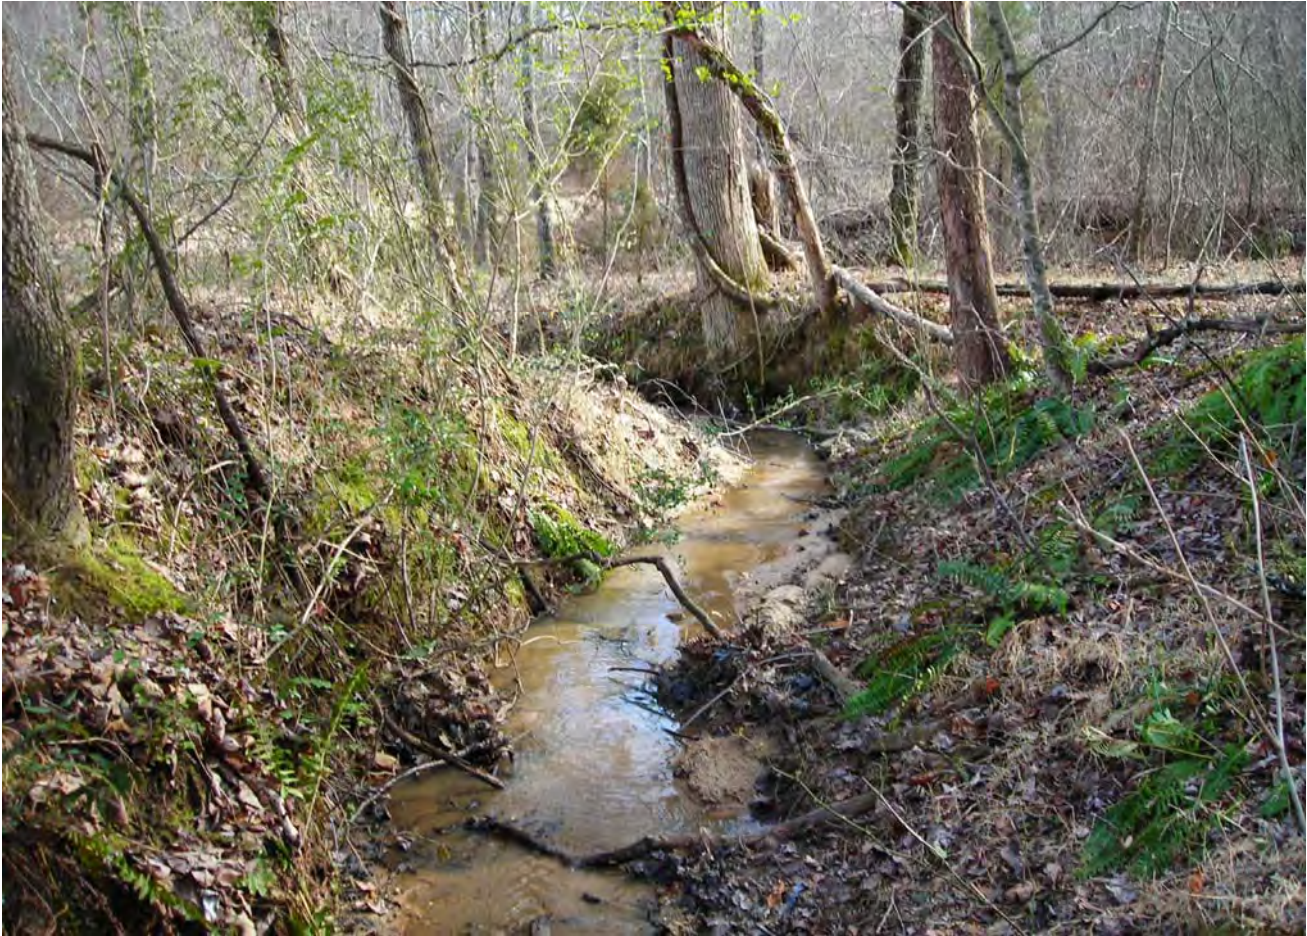
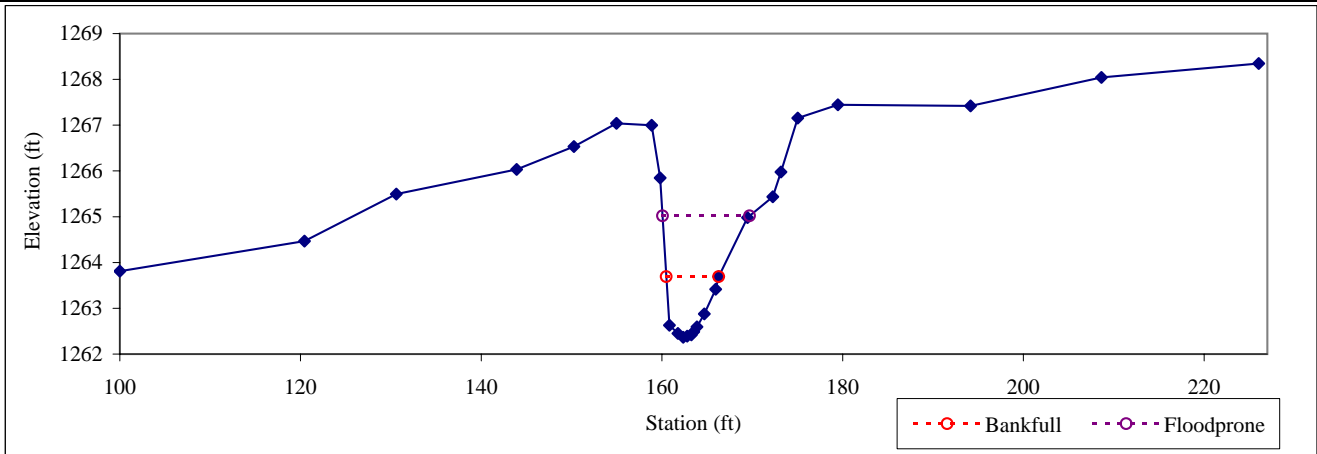
**South Fork Hoppers Creek Site - UT2B**  
**Cross-section Data: X16 Riffle**

Feature	Stream Type	BKF Area	BKF Width	BKF Depth	Max BKF Depth	W/D	BH Ratio	ER	BKF Elev	TOB Elev
Riffle	G5c	5.4	5.8	0.9	1.3	6.4	3.5	1.7	1263.7	1267.0

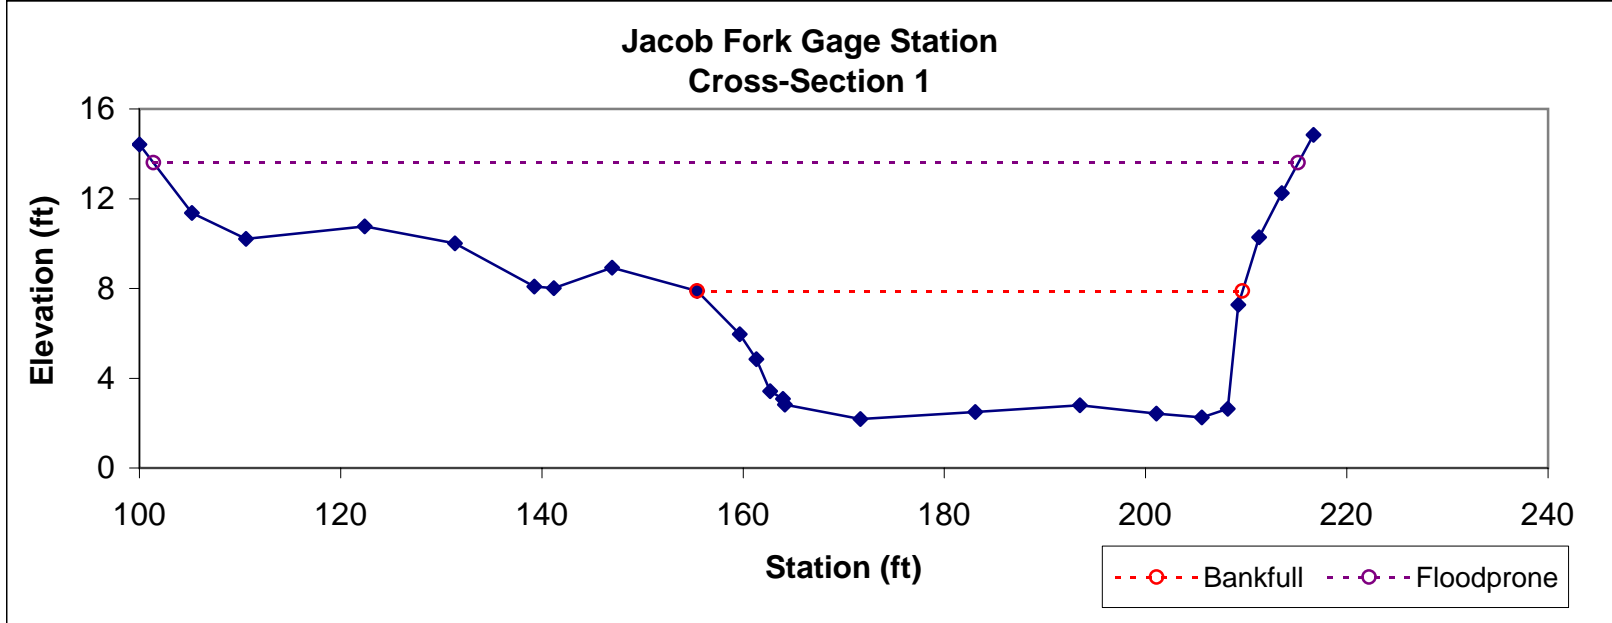
### Jacob Fork Gage Station Cross-Section 1

Feature	Stream Type	BKF Area	BKF Width	BKF Depth	Max BKF Depth	W/D	BH Ratio	ER	BKF Elev	TOB Elev
Riffle	E4	261.1	54.2	4.8	5.7	11.3	1.0	2.1	7.9	7.9

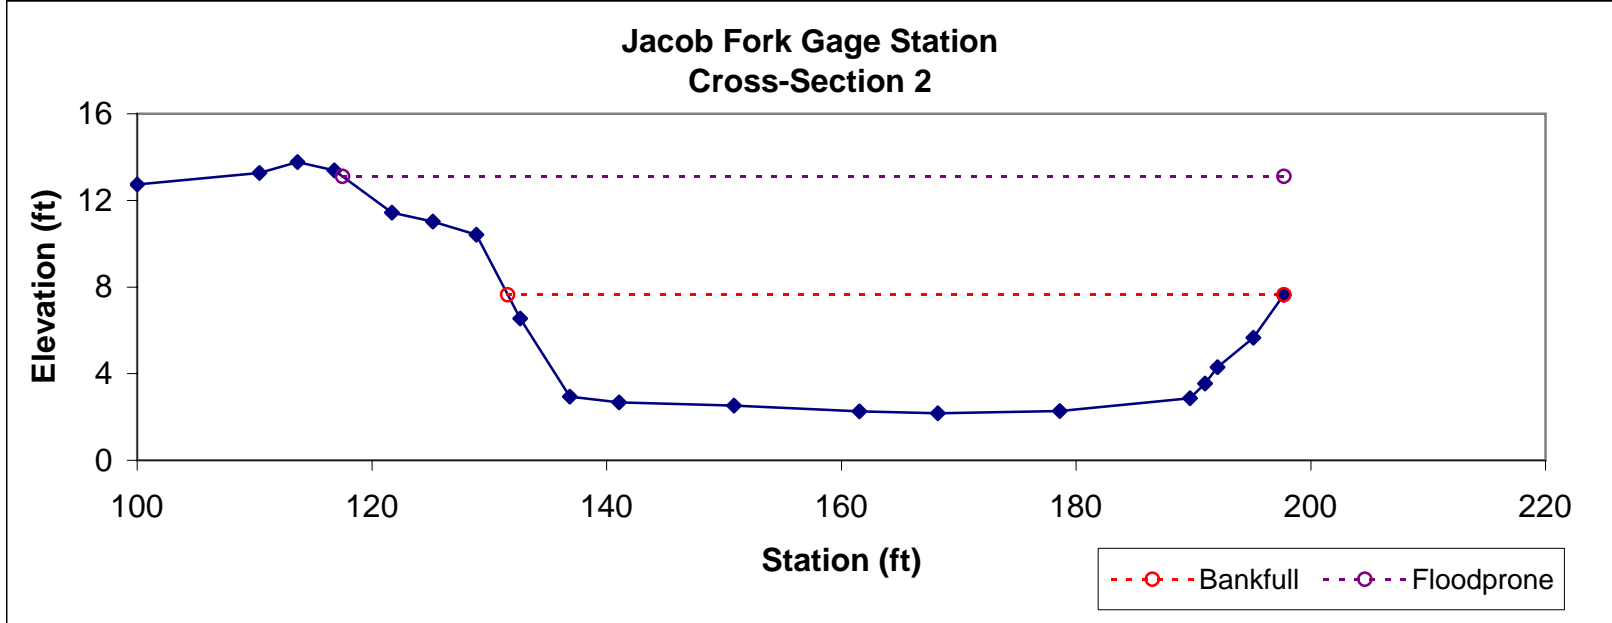
### Jacob Fork Gage Station Cross-Section 2

Feature	Stream Type	BKF Area	BKF Width	BKF Depth	Max BKF Depth	W/D	BH Ratio	ER	BKF Elev	TOB Elev
Riffle	C4	307.8	66.1	4.7	5.5	14.2	1.0	>1.2	7.6	7.6

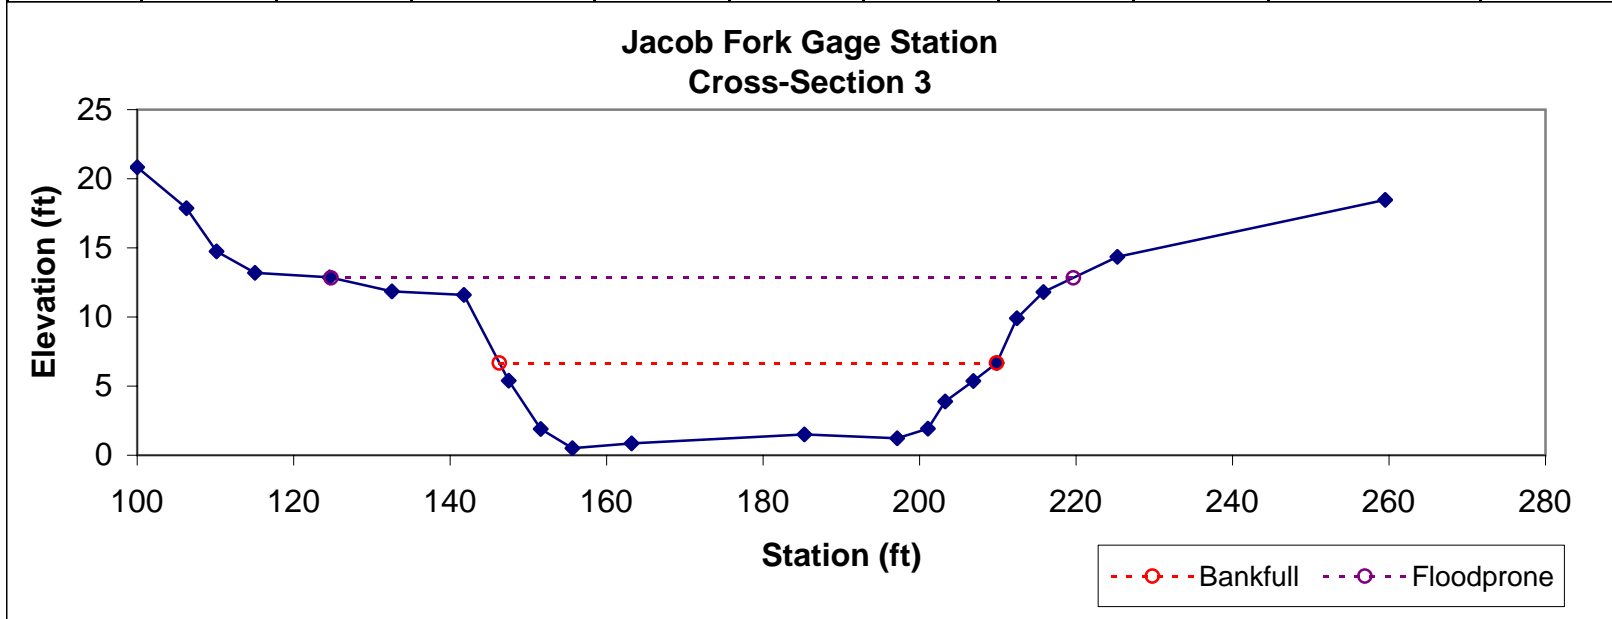
### Jacob Fork Gage Station Cross-Section 3

Feature	Stream Type	BKF Area	BKF Width	BKF Depth	Max BKF Depth	W/D	BH Ratio	ER	BKF Elev	TOB Elev
Riffle	C4	302.0	63.6	4.8	6.2	13.4	1.8	1.5	6.7	11.6

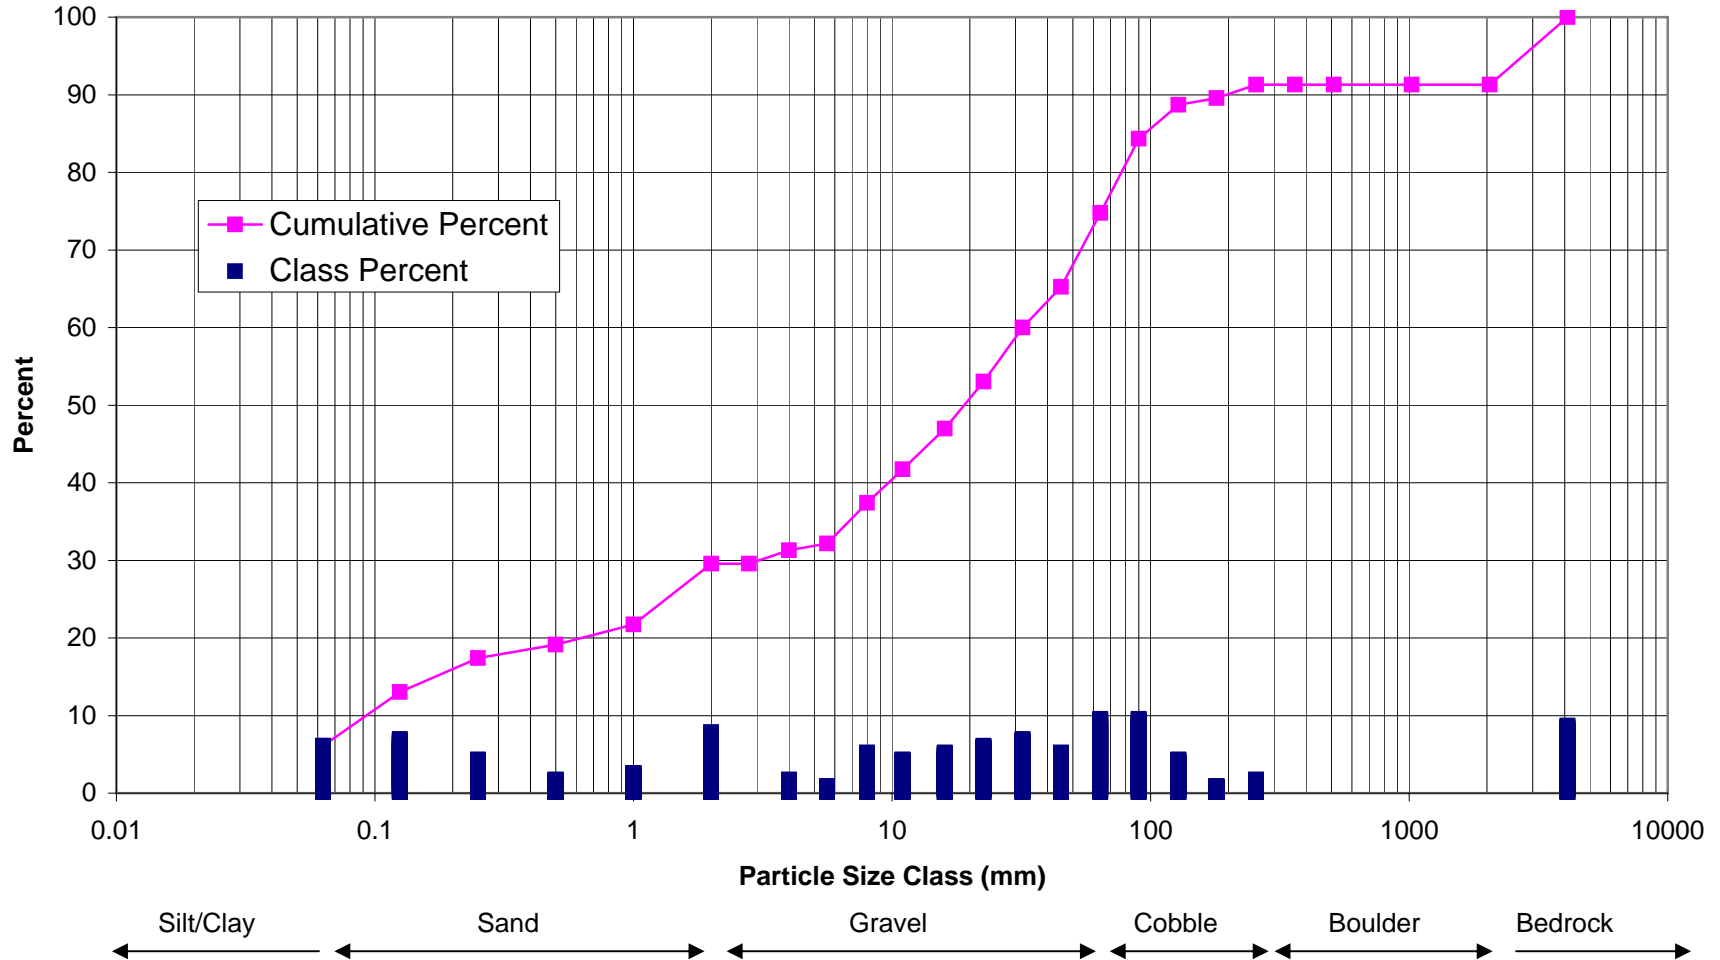
# Jacob Fork Sediment Distribution

Size Distribution	mm
D16	0.2
D35	6.8
D50	19.0
D84	88.9
D95	>2048
