# South Muddy Creek Stream Restoration McDowell County, North Carolina

NCDENR Contract D07032S

FINAL Restoration Plan  
Submission Date: January 2008

Baker Engineering NY, Inc.

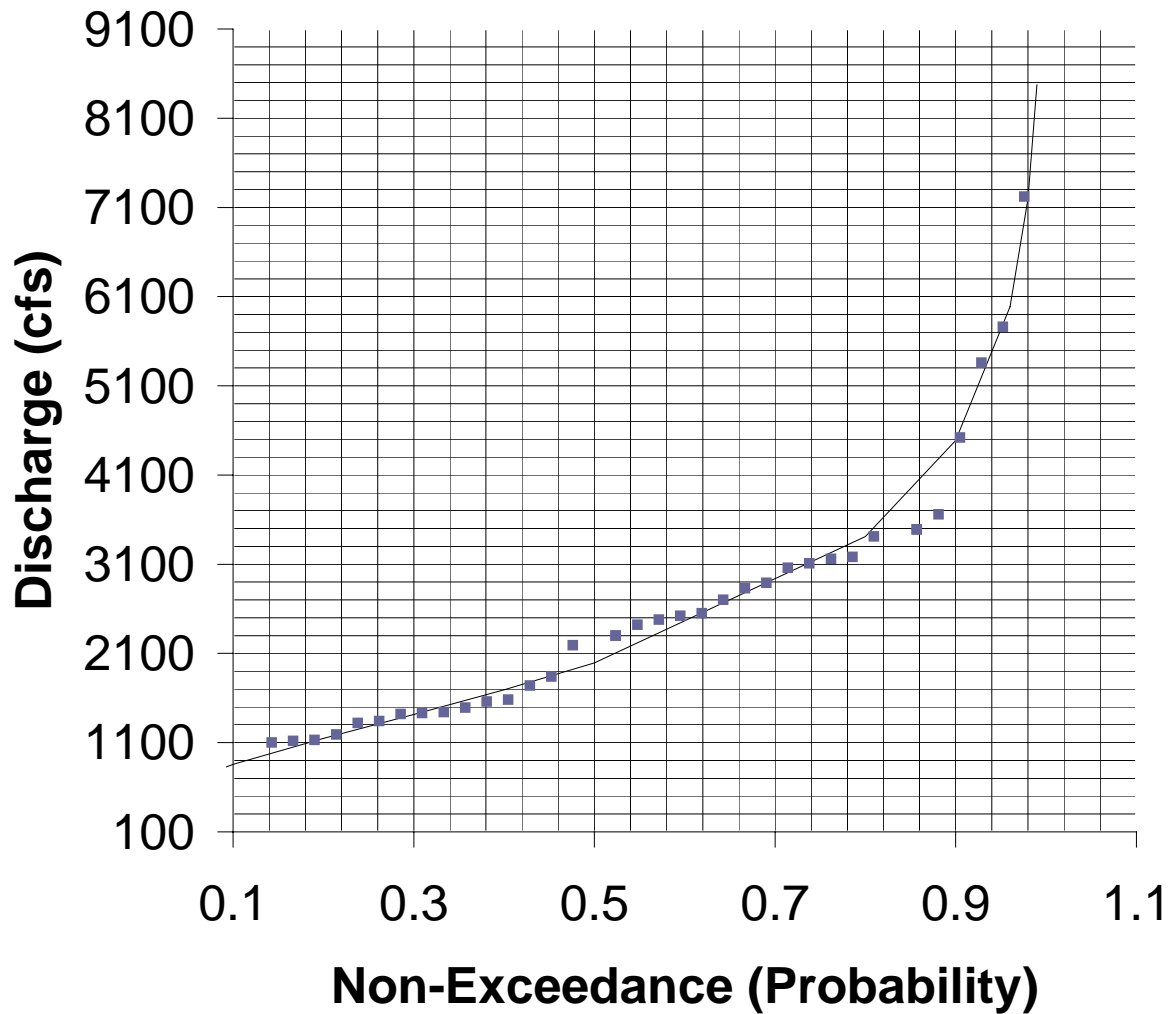
Log Pearson Analysis  
Jacob Creek

- Observed Peak
- Log Pearson Frequency
- ▲ USGS 1993 Unweighted Estimate
- ◆ USGS 1993 Estimate
- Unweighted G Estimates

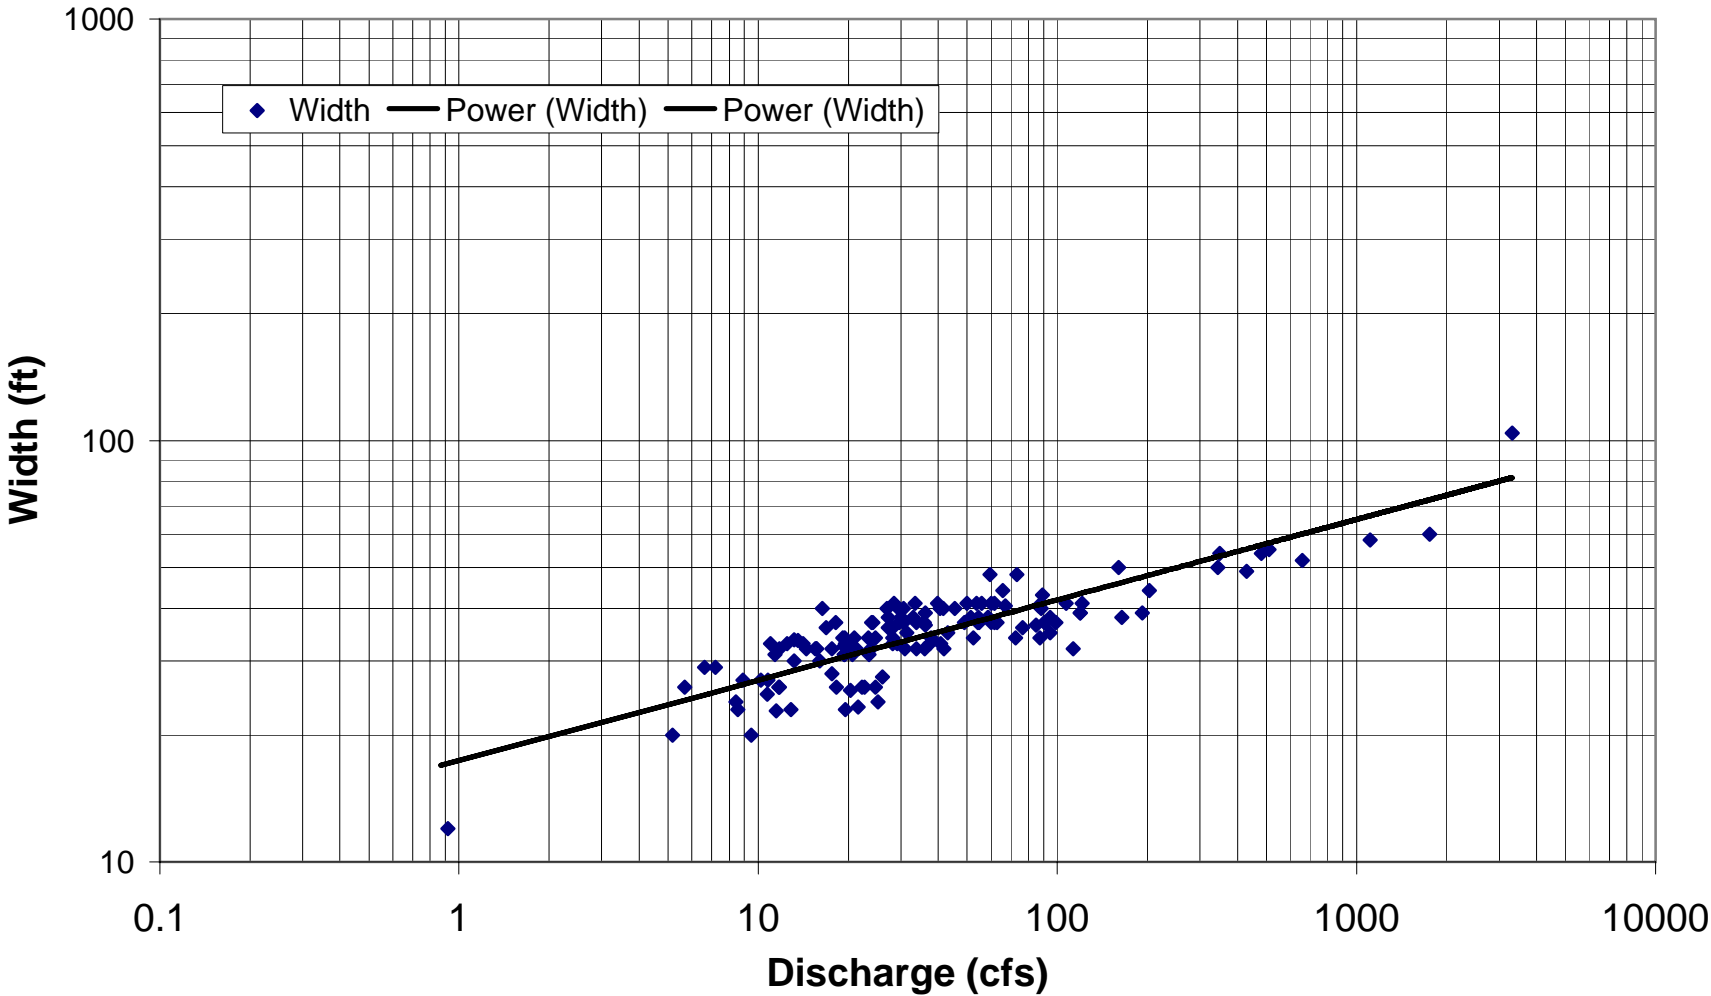
# Jacob Fork 9-207 Data Discharge vs Width

$y = 17.38x^{0.19}$   
 $R^2 = 0.72$

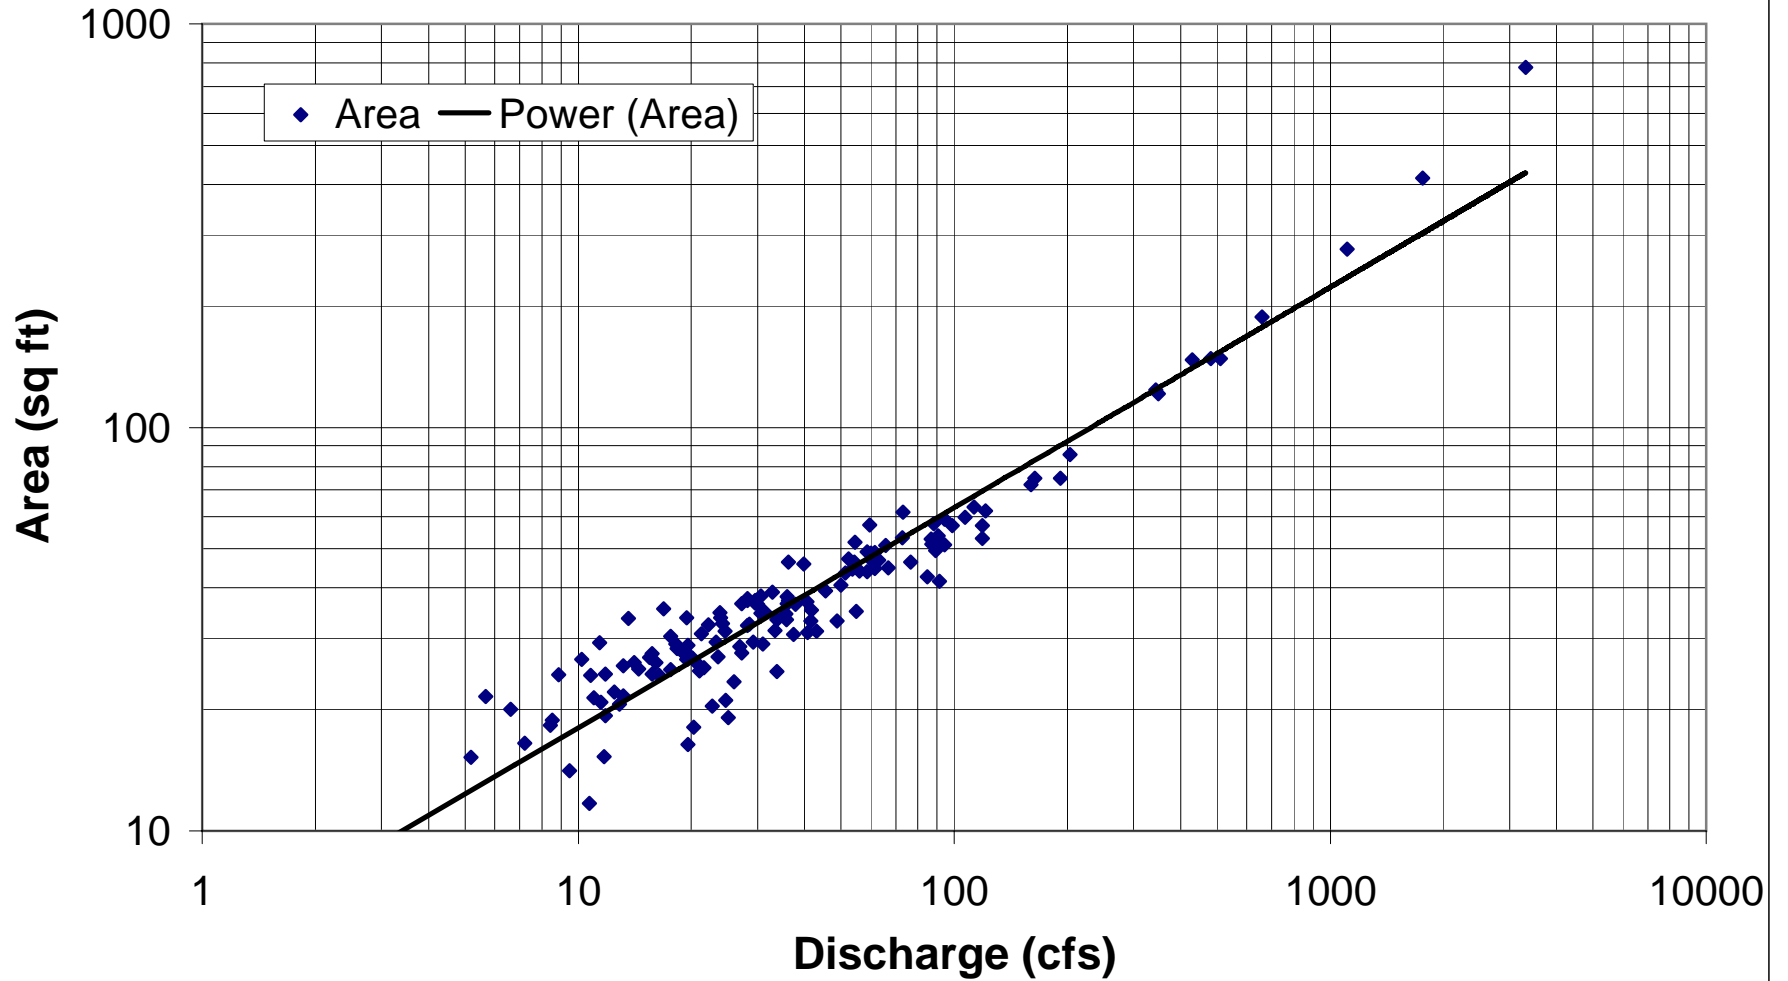
# Jacob Fork 9-207 Data Discharge vs Area

$$y = 5.12x^{0.55}$$
$$R^2 = 0.91$$
