FINAL MITIGATION PLAN

Mud Lick Creek Mitigation Site
Chatham County, North Carolina
DEQ Contract No. D14001i
SCO No. 1209857-01
DMS ID No. 93482

Cape Fear River Basin
HUC 03030003

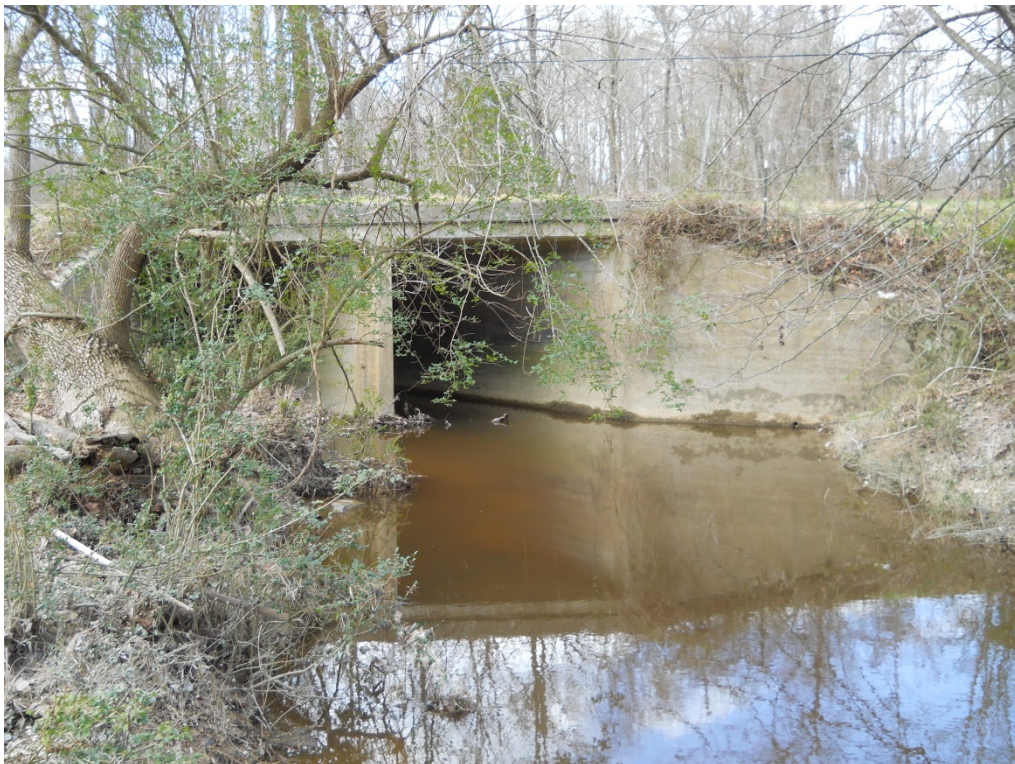
Photo 4. Double box culvert at downstream end of project

The channel slopes and valley slopes for Mud Lick Creek are typical for Piedmont streams in similar valley types (Table 4). The bed of Mud Lick Creek is characterized by short riffles, long pools, mid-channel bars, large debris dams, and macrophyte communities at certain locations in the channel bed. In many areas, the density of macrophytes has caused accretion of the channel bed and the development of a bench feature. The substrate coarsens somewhat in the downstream direction, from sand in Reach 1 to fine gravel in Reaches 2 and 3. While the dominant substrate size is small gravel, bedrock outcrops and some larger gravel and small cobble were observed throughout the site. There is a double box culvert at the downstream end that sets base level.

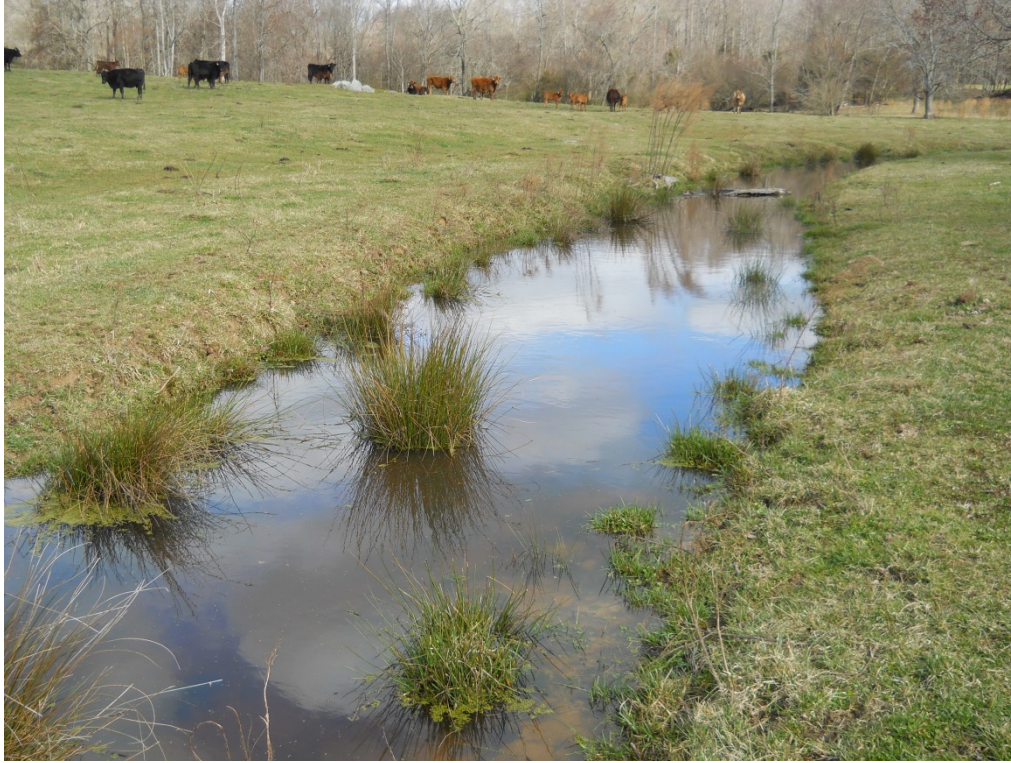
Photo 5. Existing wetland feature adjacent to Mud Lick Creek

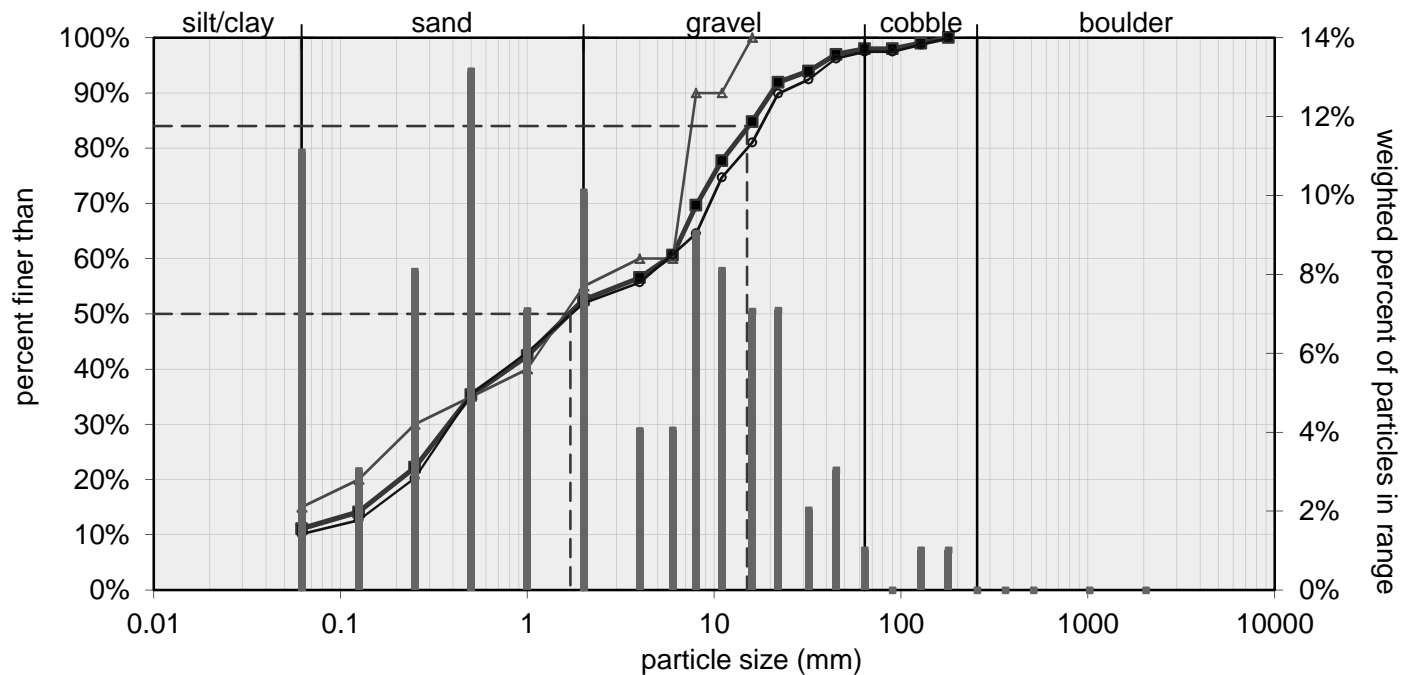
Weighted pebble count by bed features Mud Lick Creek R1

20% riffle 80% pool

Size (mm)		Size Distribution		Type			
D16	0.15	mean	1.5	silt/clay	11%	bedrock	1%
D35	0.49	dispersion	10.1	sand	41%		
D50	1.7	skewness	-0.04	gravel	45%		
D65	6.9			cobble	2%		
D84	15			boulder	0%		
D95	36

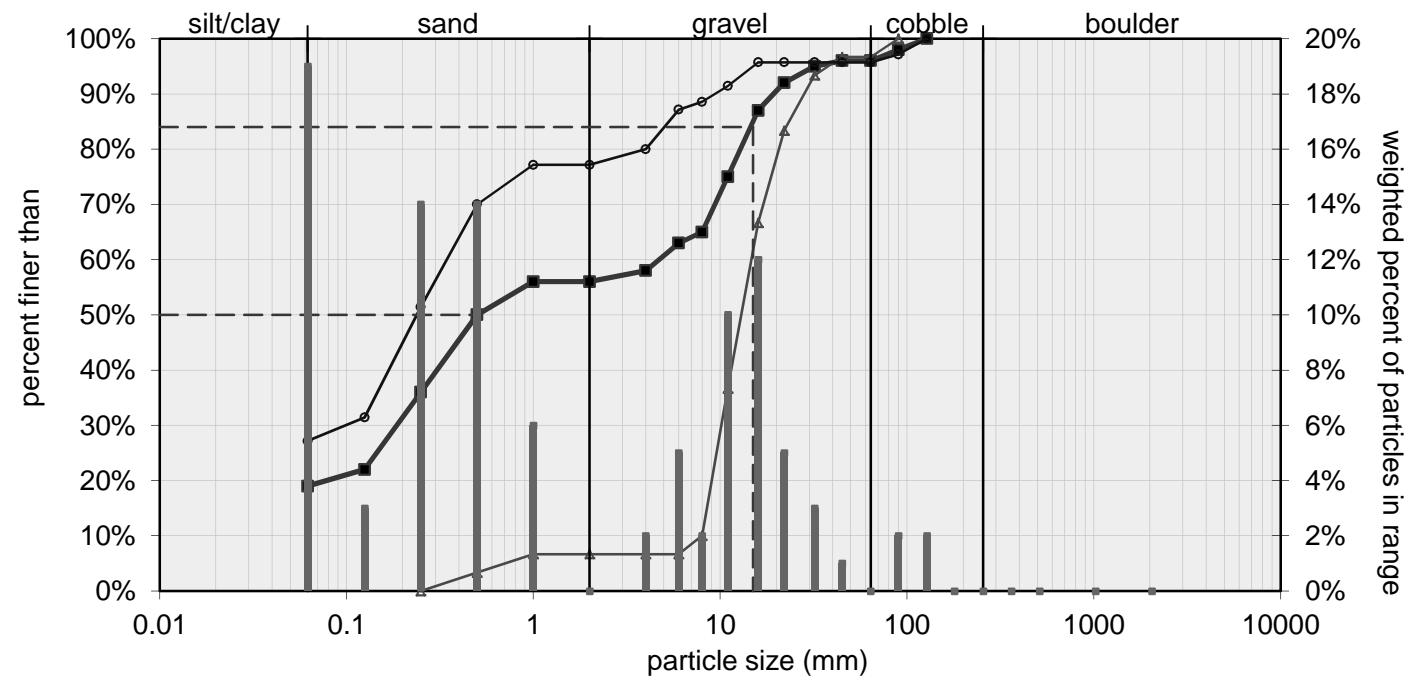
Weighted pebble count by bed features North Branch

30% riffle 70% pool

Size (mm)		Size Distribution		Type			
D16	0.062	mean	1.0	silt/clay	19%	bedrock	1%
D35	0.24	dispersion	19.0	sand	37%		
D50	0.5	skewness	0.18	gravel	40%		
D65	8			cobble	4%		
D84	15			boulder	0%		
D95	32
