Mitigation Plan

Mushroom Meadow Mitigation Site

Caswell County, North Carolina
Roanoke River Basin HUC 03010104
DMS Project ID No. 100192
Full Delivery Contract No. 200204-01
USACE Action ID No. SAW-2021-00348
NCDWR No. 20210400, V1

Prepared For: North Carolina Division of Mitigation Services
Raleigh, North Carolina
January 2023

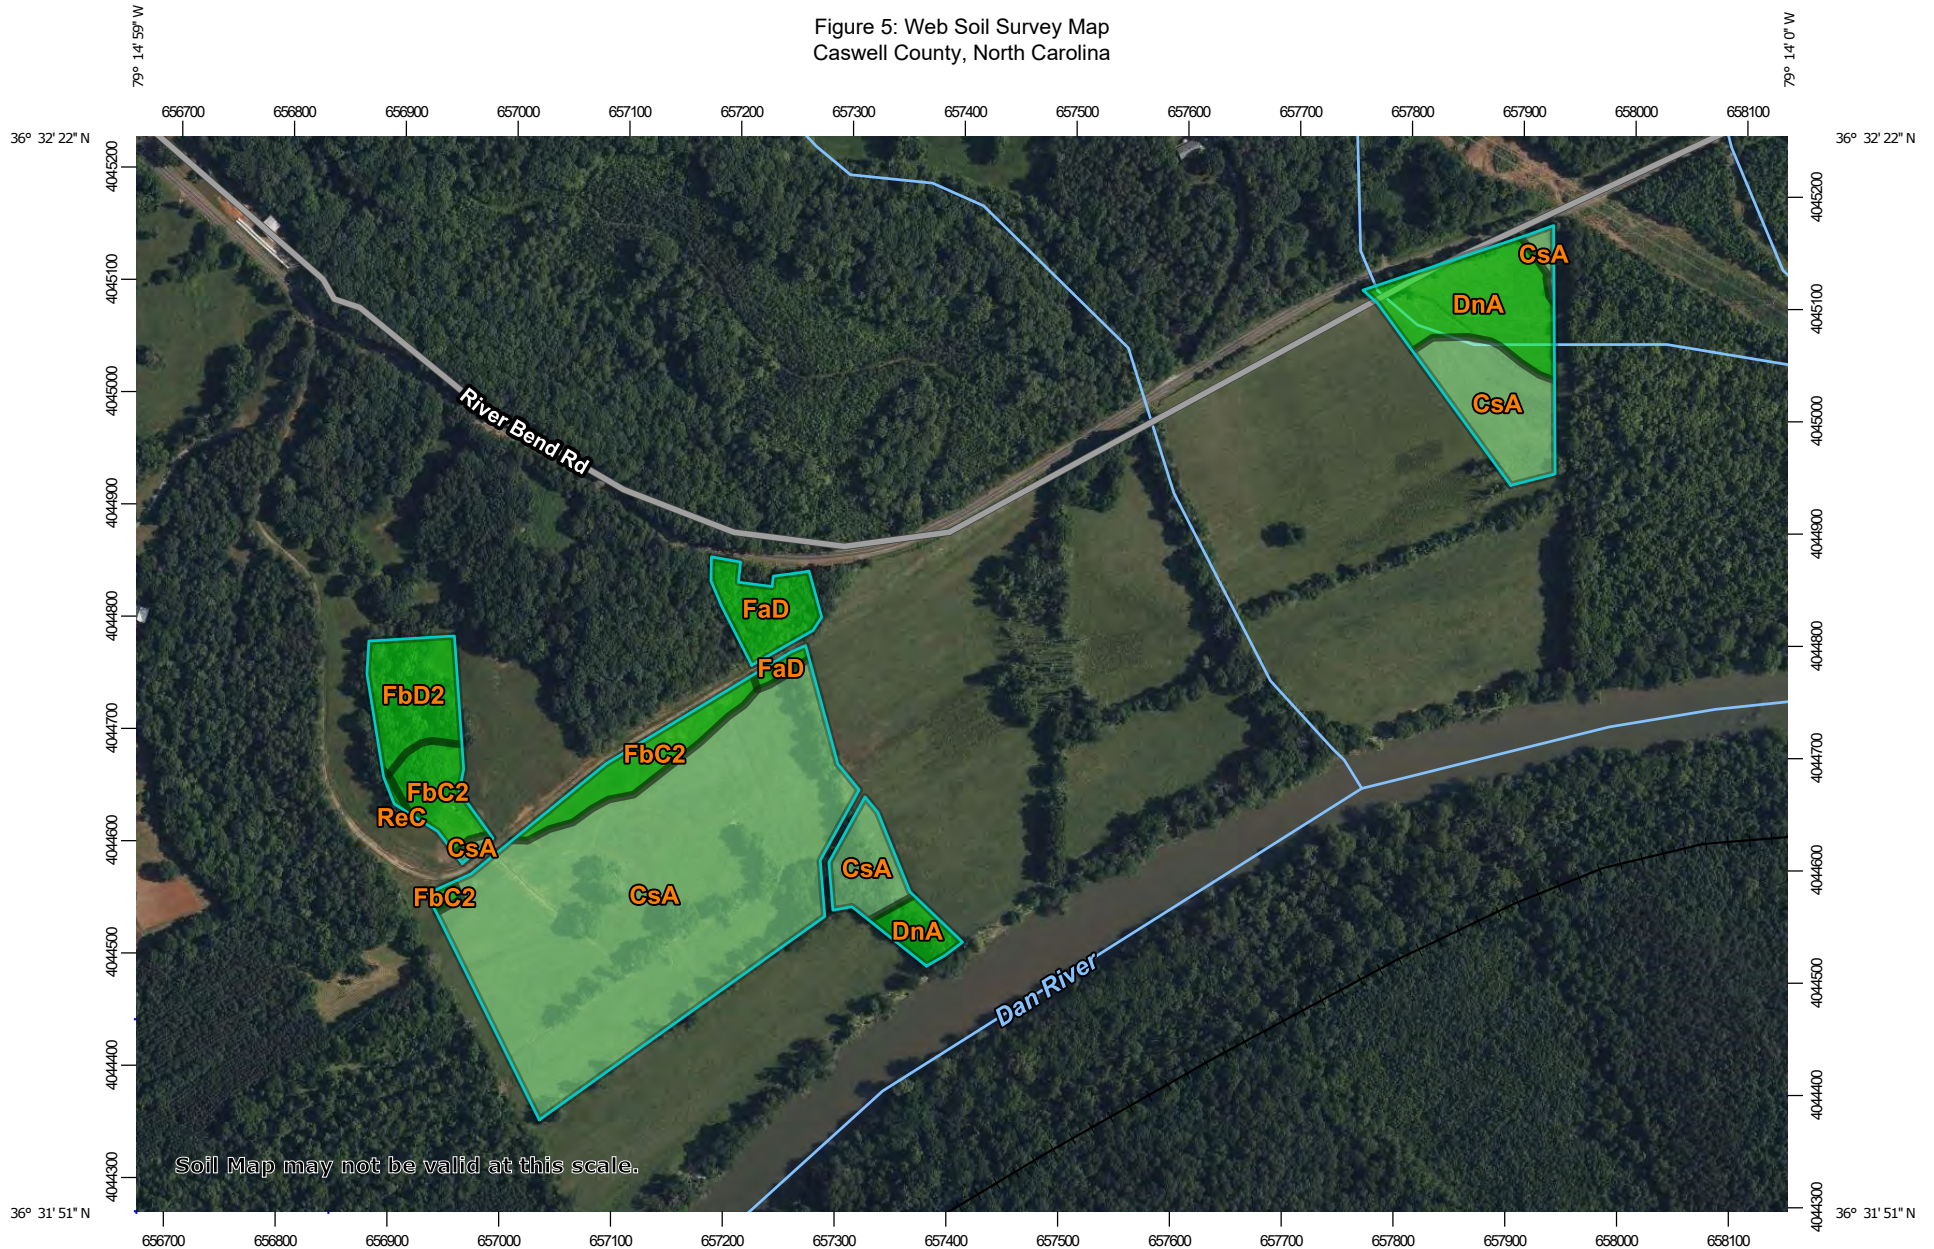
Figure 5: Web Soil Survey Map
Caswell County, North Carolina

Codorus and Dan River loams are the dominant soils underlying the Project Area (Figure 5). These floodplain soils undergo conditions of frequent to occasional flooding, with the primary difference being landscape position. Dan River loam is topographically higher, reflecting more mesic habitat conditions. Only the Codorus series exhibits hydric characteristics (primarily from its minor soil, Hatboro silt loam).

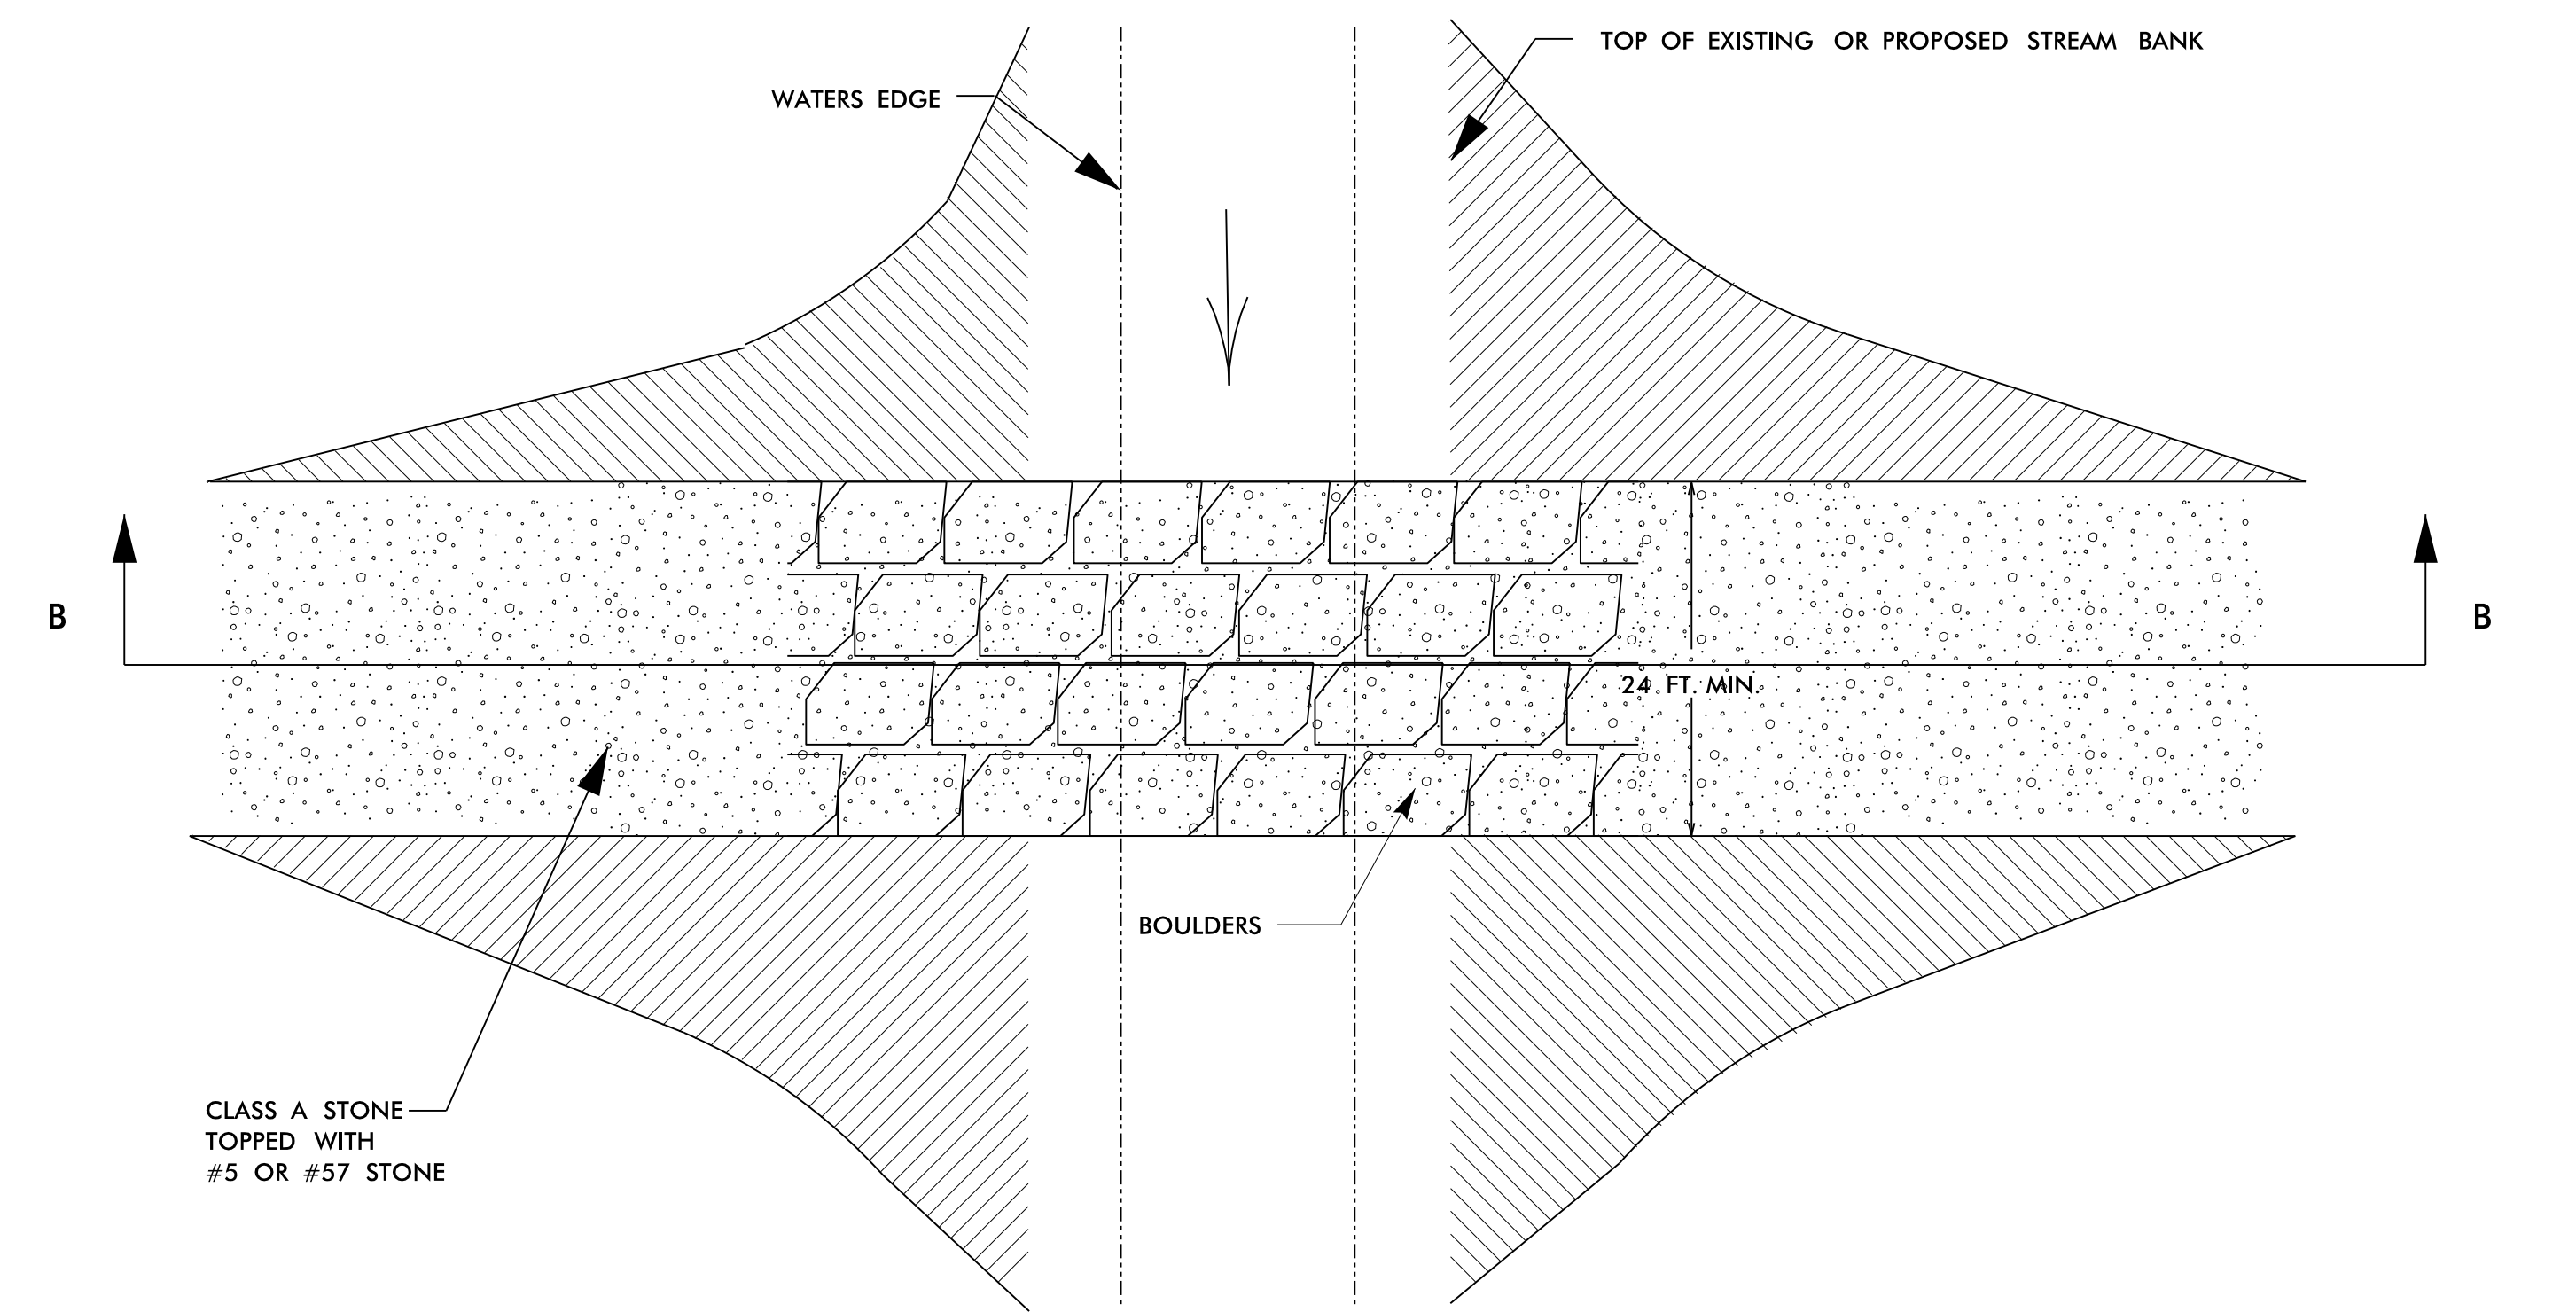
PERMANENT AT GRADE STREAM CROSSING

- NOTES:**
- STONE APPROACH SECTION 10:1, SLOPE ON ROAD.
 - KEEP CLEARING AND EXCAVATION OF STREAM BANKS, BED, AND APPROACH SECTIONS TO A MINIMUM.
 - DIVERT ALL SURFACE RUNOFF FROM THE CONSTRUCTION SITE ONTO UNDISTURBED AREAS ADJOINING THE STREAM.
 - KEEP STREAM CROSSINGS AT RIGHT ANGLES TO THE STREAM FLOW.
 - ALIGN ROAD APPROACHES WITH THE CENTER LINE OF THE CROSSING FOR A MINIMUM DISTANCE OF 30 FEET.
 - STABILIZE ALL DISTURBED AREAS SUBJECT TO FLOWING WATER, INCLUDING PLANNED OVERFLOW AREAS.
 - SIDE SLOPES WHERE CROSSING CONNECTS TO EXISTING STREAMBANKS SHOULD BE A MAXIMUM OF 2:1.
 - INSPECT STREAM CROSSINGS AFTER RUNOFF-PRODUCING RAINS TO CHECK FOR BLOCKAGE IN CHANNEL, EROSION OF BANKS, CHANNEL SCOUR, STONE DISPLACEMENT, OR PIPING. MAKE ALL REPAIRS IMMEDIATELY TO PREVENT FURTHER DAMAGE TO THE INSTALLATION.

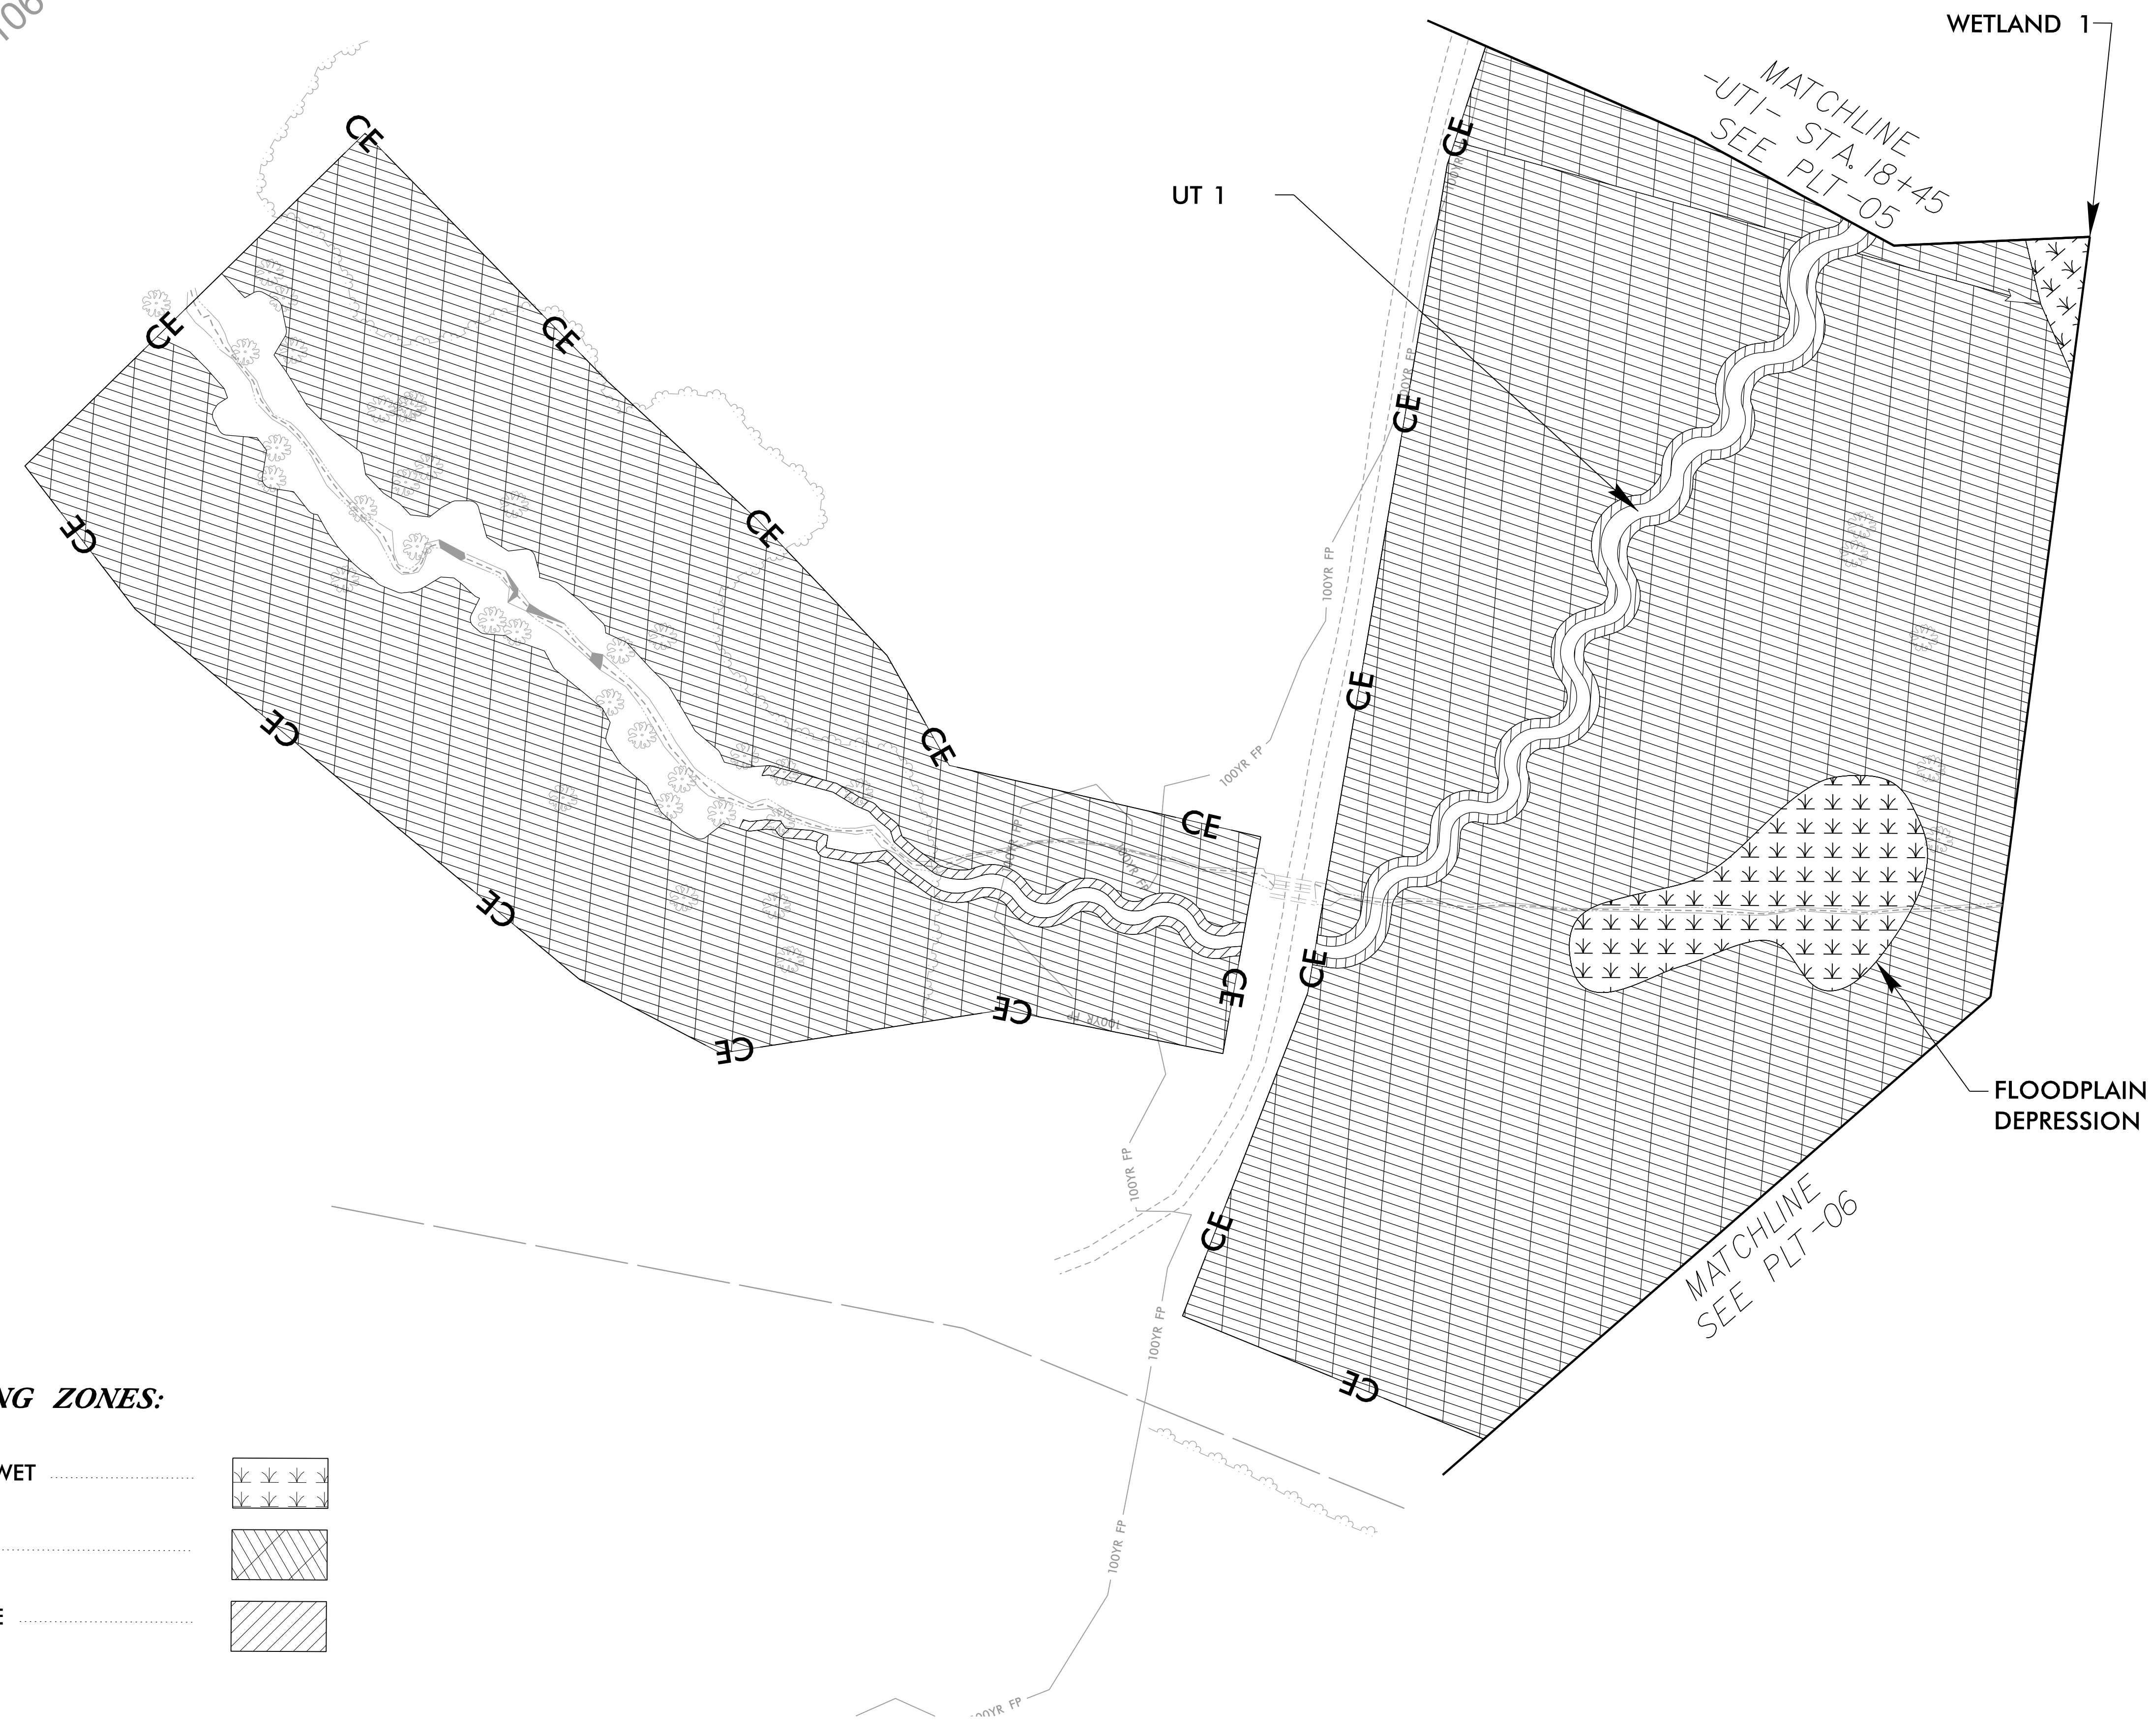
PLANTING ZONES:

- RIPARIAN WET
- UPLANDS
- STREAMSIDE

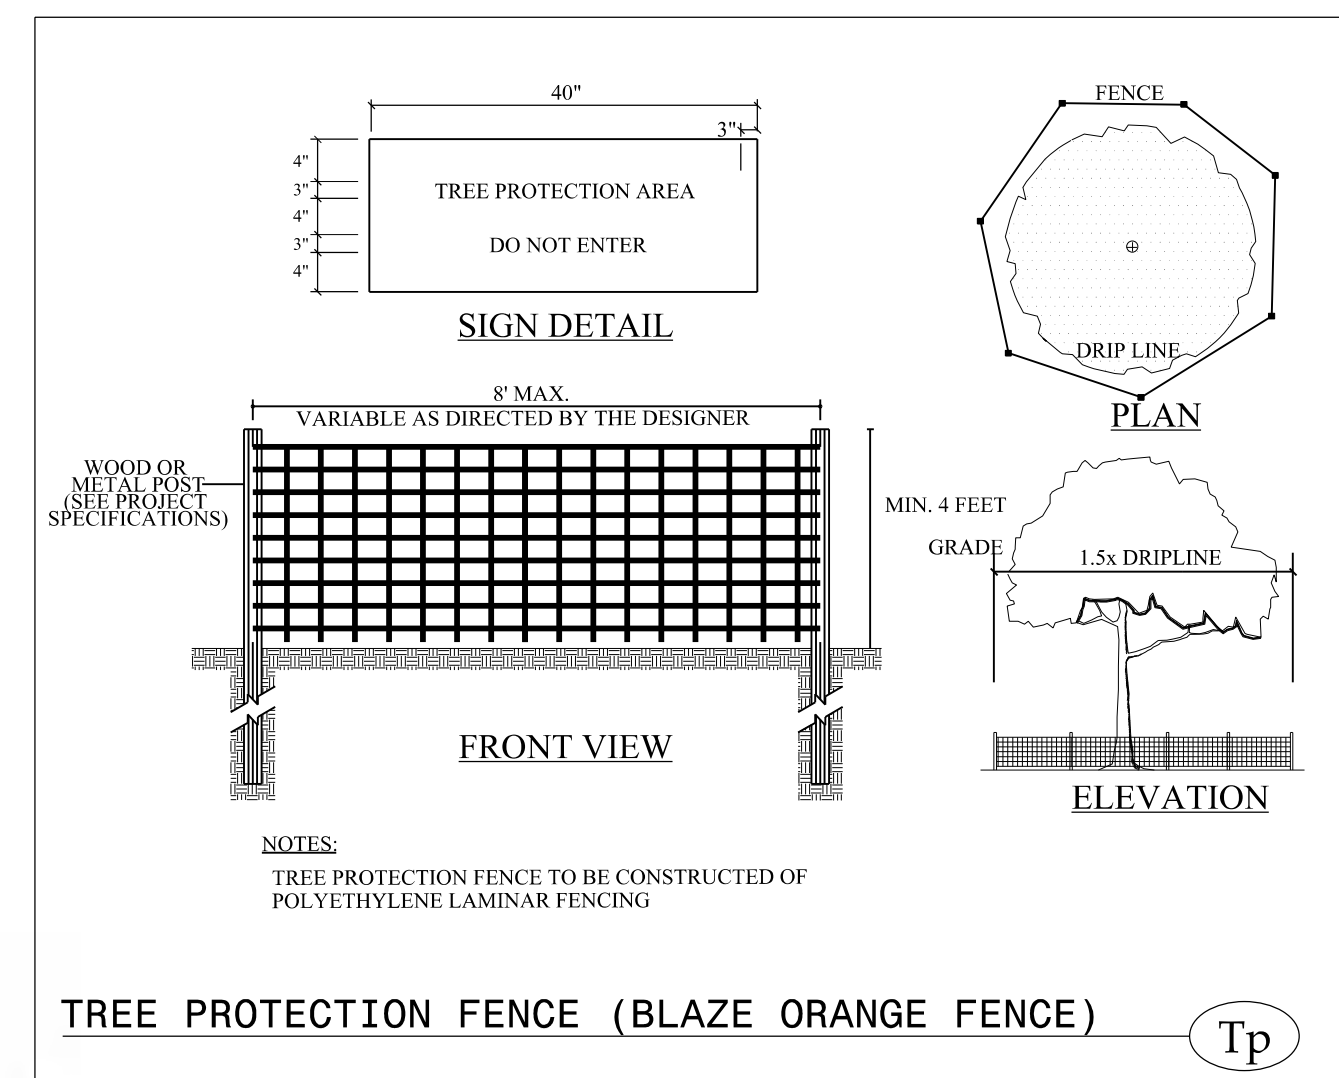
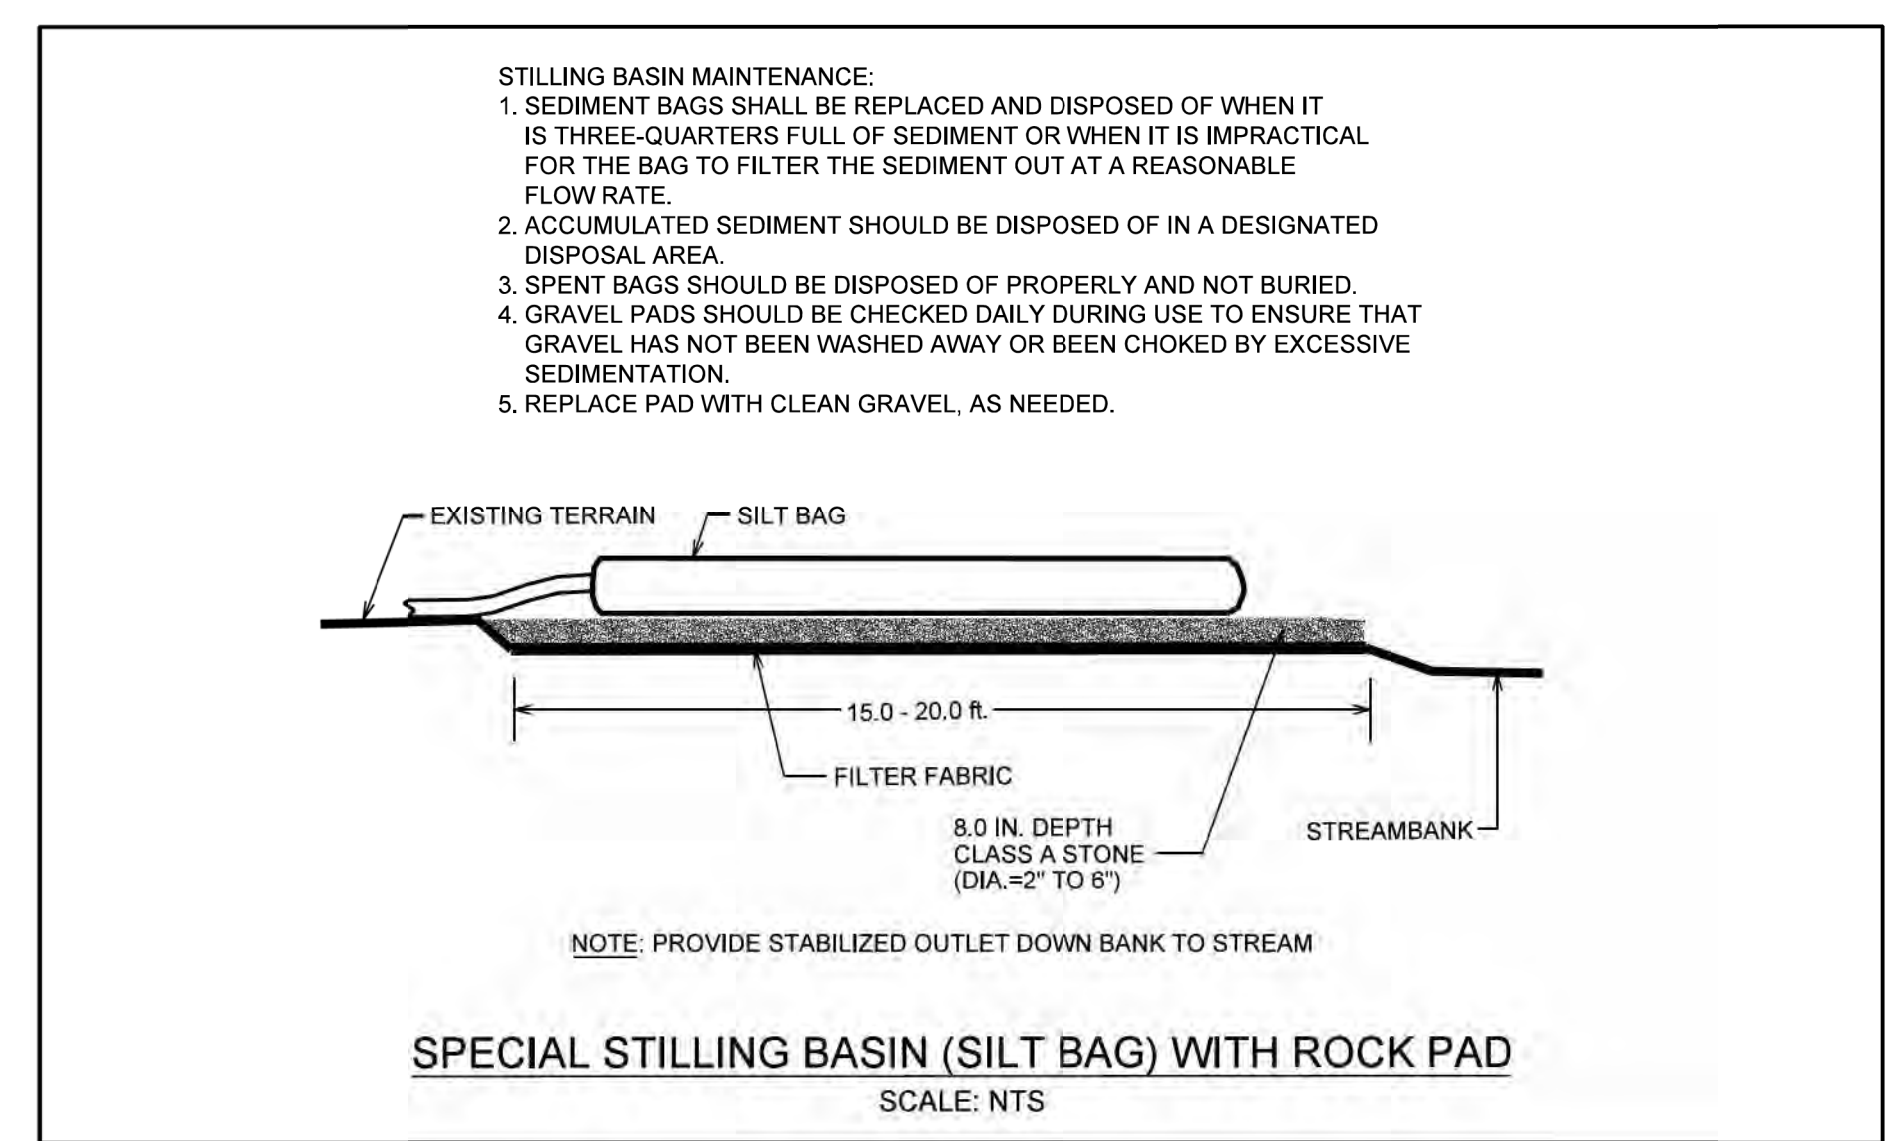
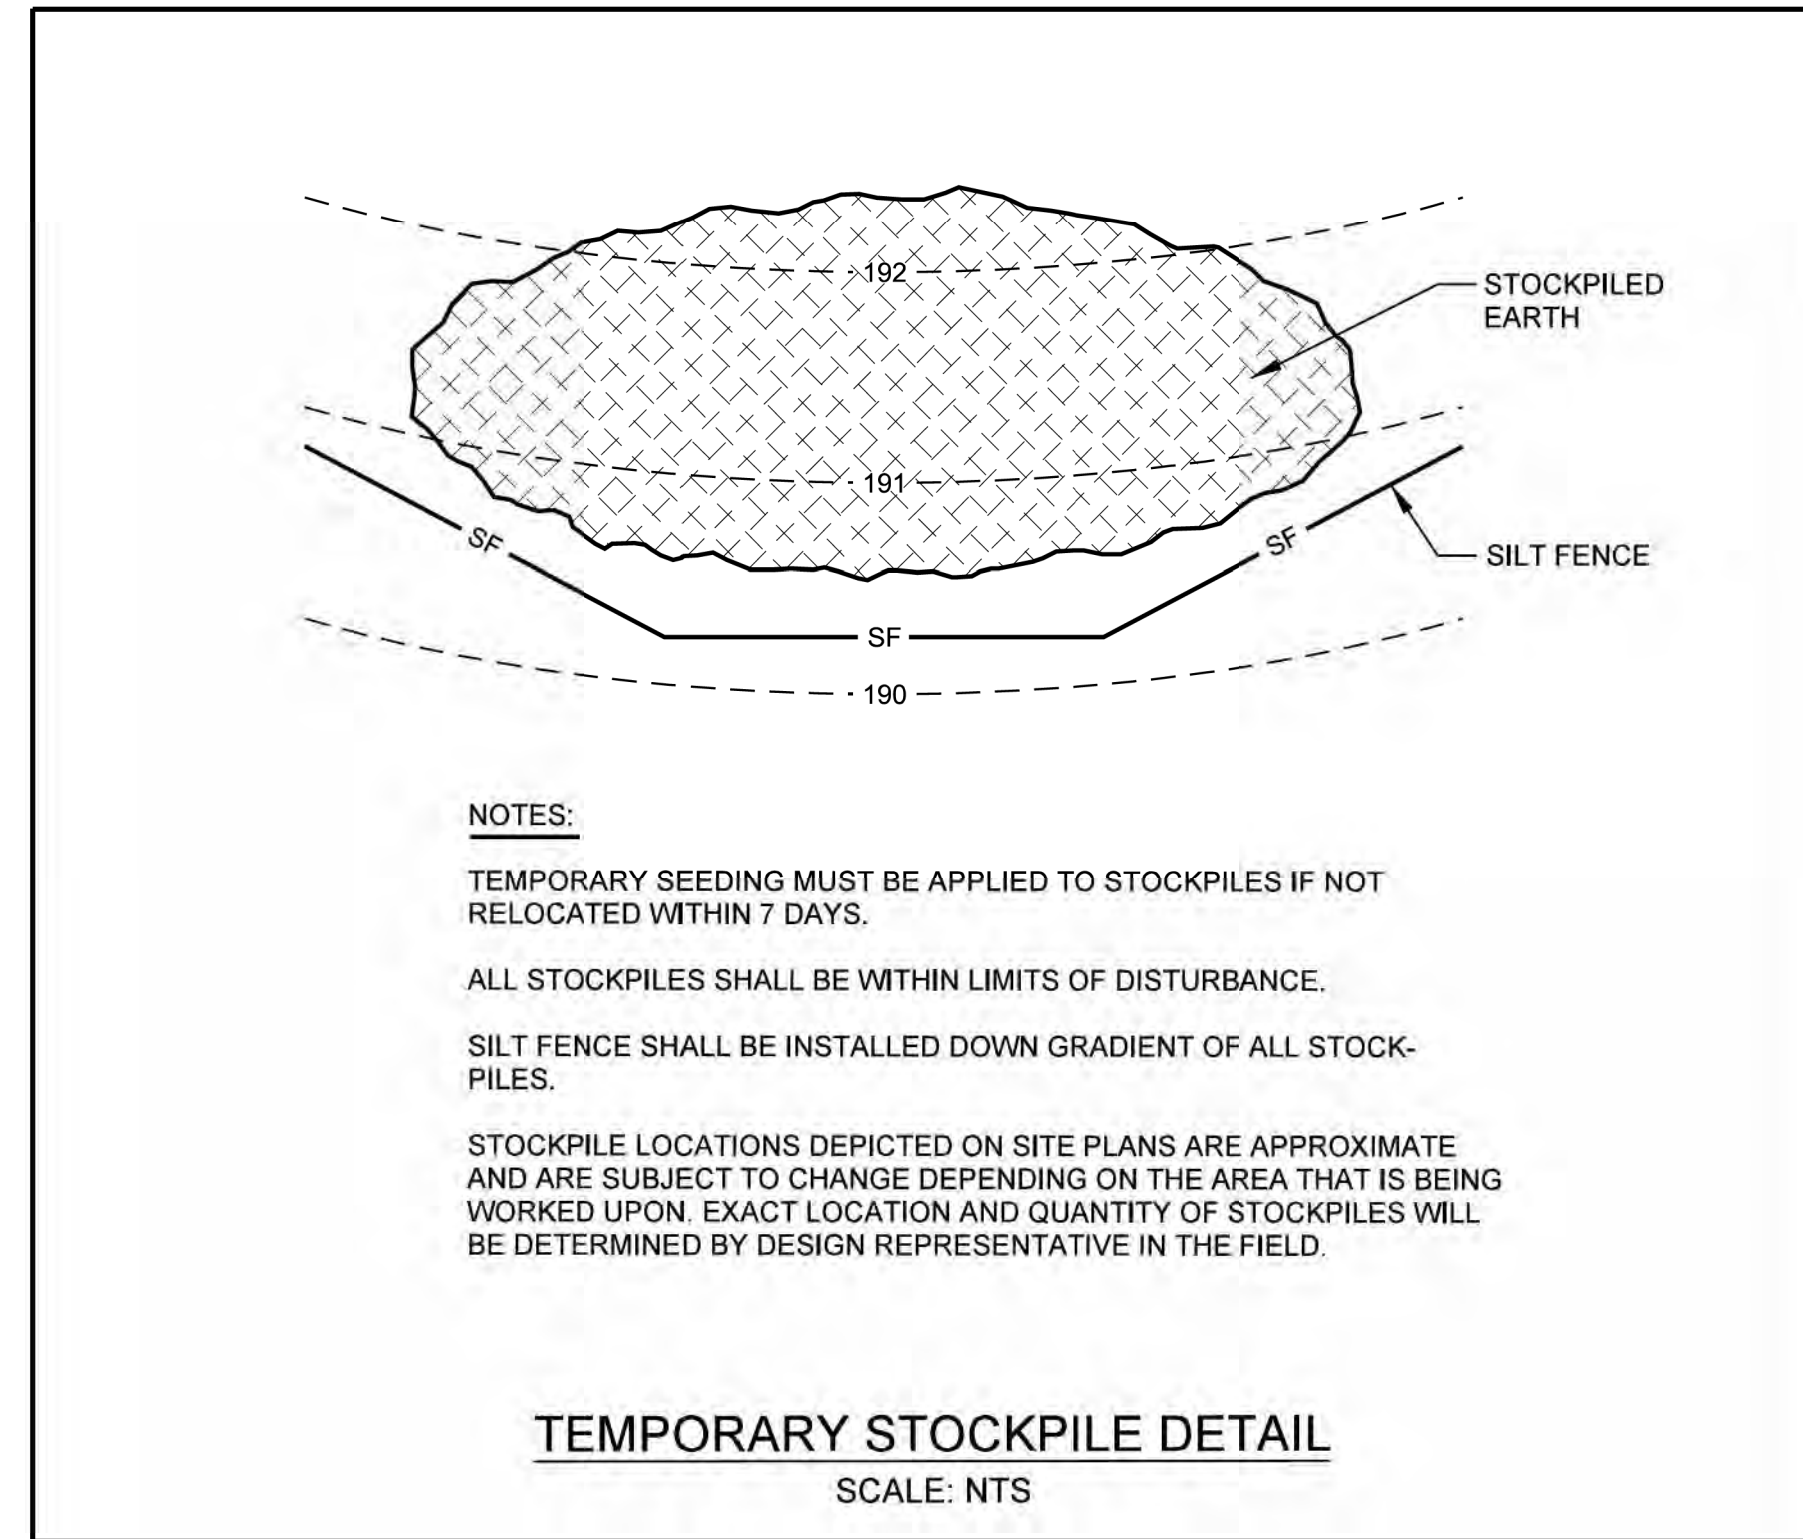
EROSION CONTROL DETAILS
FOR THE
MUSHROOM MEADOW MITIGATION BANK
PREPARED FOR
ECO TERRA PARTNERS, LLC

- STILLING BASIN MAINTENANCE:**
1. SEDIMENT BAGS SHALL BE REPLACED AND DISPOSED OF WHEN IT IS THREE-QUARTERS FULL OF SEDIMENT OR WHEN IT IS IMPRACTICAL FOR THE BAG TO FILTER THE SEDIMENT OUT AT A REASONABLE FLOW RATE.
 2. ACCUMULATED SEDIMENT SHOULD BE DISPOSED OF IN A DESIGNATED DISPOSAL AREA.
 3. SPENT BAGS SHOULD BE DISPOSED OF PROPERLY AND NOT BURIED.
 4. GRAVEL PADS SHOULD BE CHECKED DAILY DURING USE TO ENSURE THAT GRAVEL HAS NOT BEEN WASHED AWAY OR BEEN CHOKED BY EXCESSIVE SEDIMENTATION.
 5. REPLACE PAD WITH CLEAN GRAVEL, AS NEEDED.

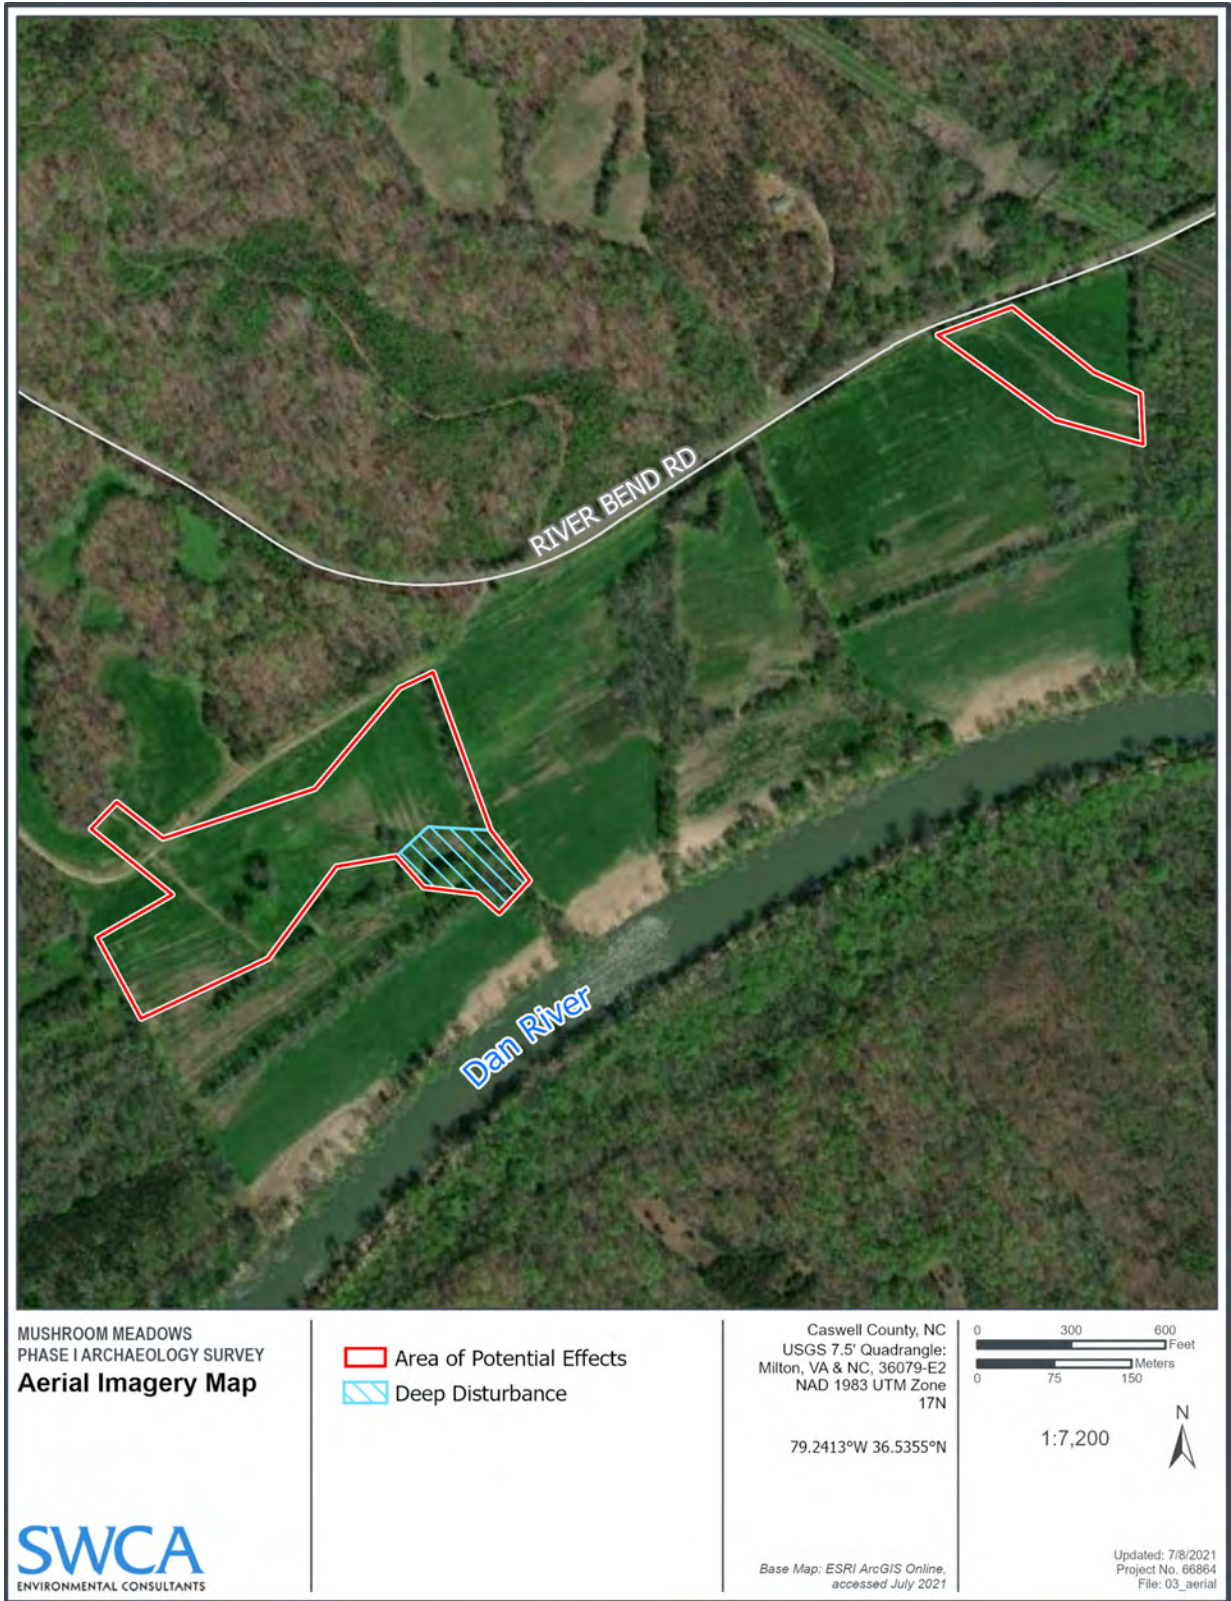
Figure 3. Project APE shown on aerial imagery.

The project is located 1.9 miles (3.1 kilometers [km]) west of Milton, North Carolina, on privately owned land, as shown on the 1997 Milton, Virginia, and North Carolina, 7.5-minute U.S. Geological Survey (USGS) quadrangle (Figure 2). At the time of the survey, the APE consisted of pasture with dense scrub and mature tree vegetation along established stream channels (Figure 3).

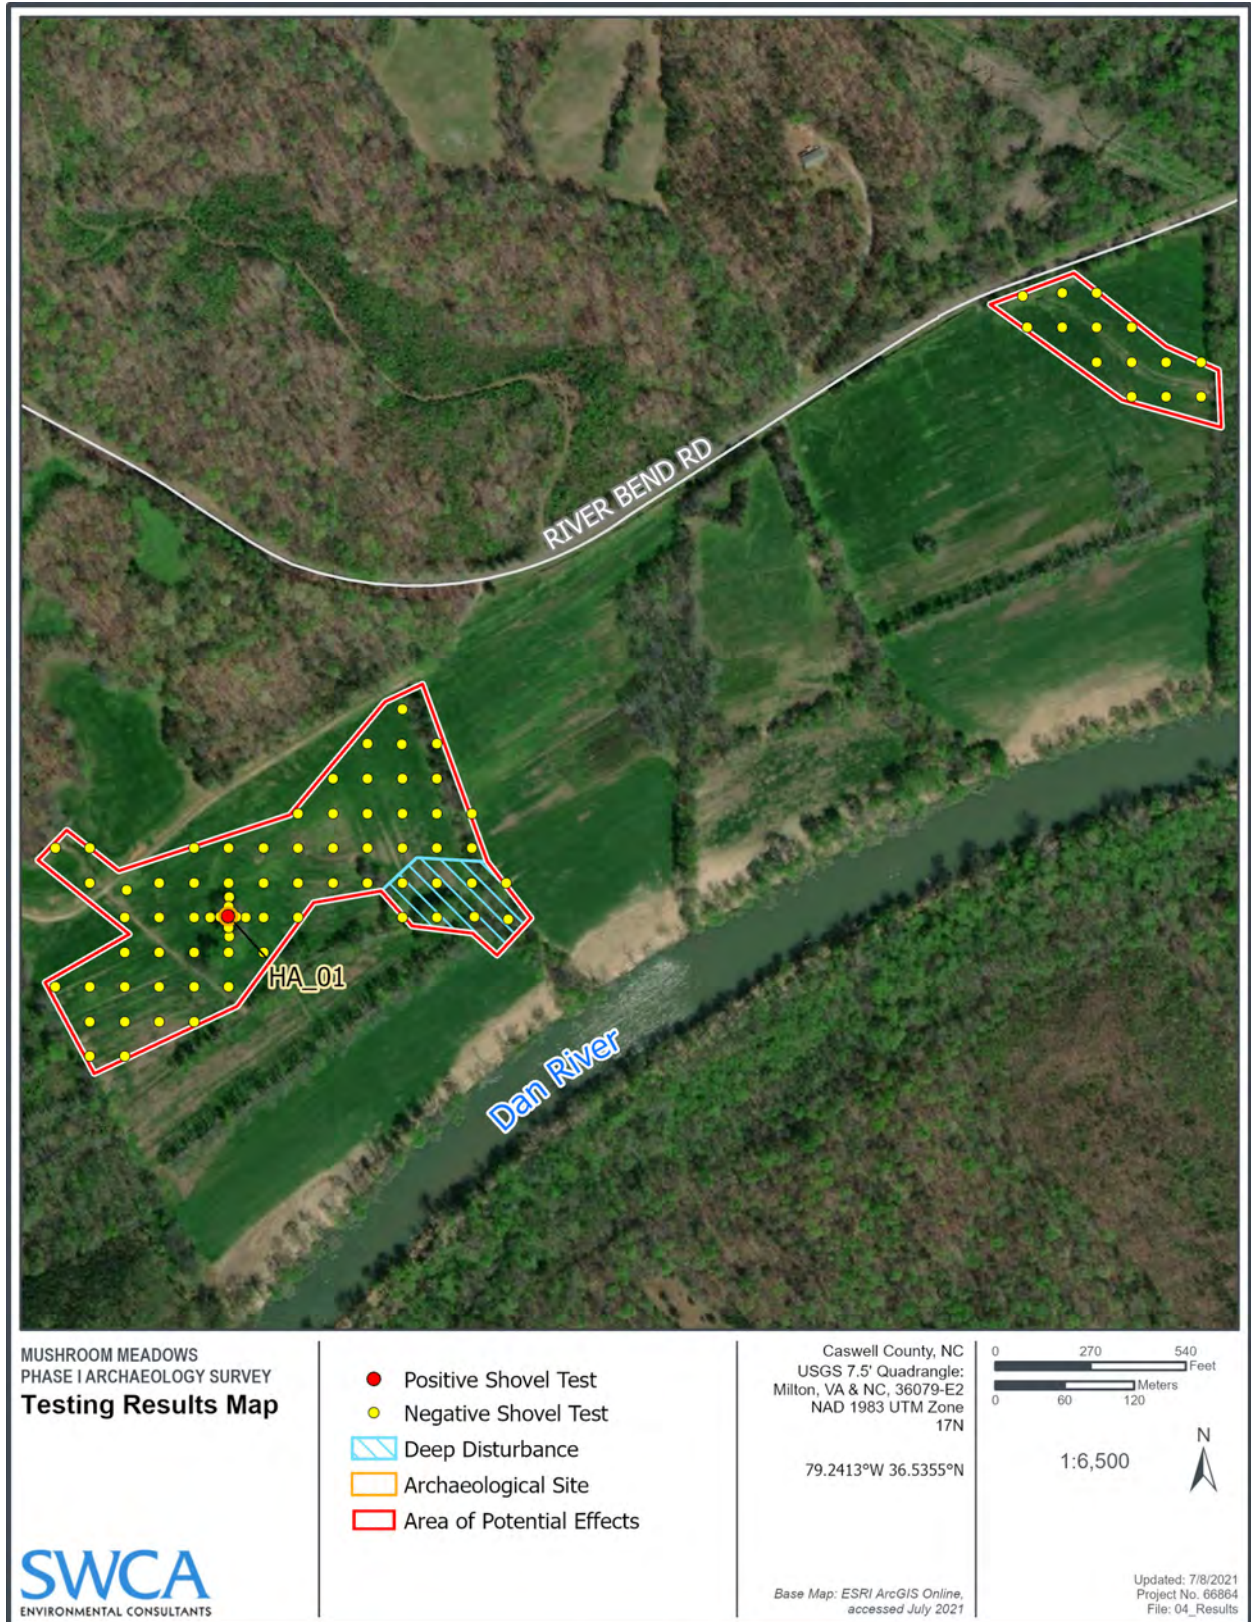
Figure 7. Project APE shown on aerial map with shovel test locations depicted.

SWCA conducted the field survey from June 21 and 24, 2021. As outlined in the methodology sections above, the entire 16.5 acres (12.8 hectares) of the APE for the Phase I archaeological survey was investigated (Figure 7). Due to the poor ground visibility present within the project area, systematic shovel testing was the primary survey method utilized during the Phase I survey. During the Phase I survey, 79 shovel tests were excavated (Appendix A). The typical soil profile consisted of one stratum overlying subsoil. Stratum I, the Ap horizon, consisted of a brown (10YR4/4) sandy loam. Subsoil for the area was a dark yellowish brown (10YR4/6) sandy clay. Overall, the soil profile identified through shovel testing matched closely with the USDA mapped soil units for the area. In the portion of the project area where construction will result in ground disturbance that will exceed 1 meter (see Figure 3), shovel testing identified Pleistocene aged soils (i.e., the Bw horizon) between 35 and 43 cm (14 and 17 inches) below ground surface. No evidence of deeply buried soil horizons was identified within the project APE.

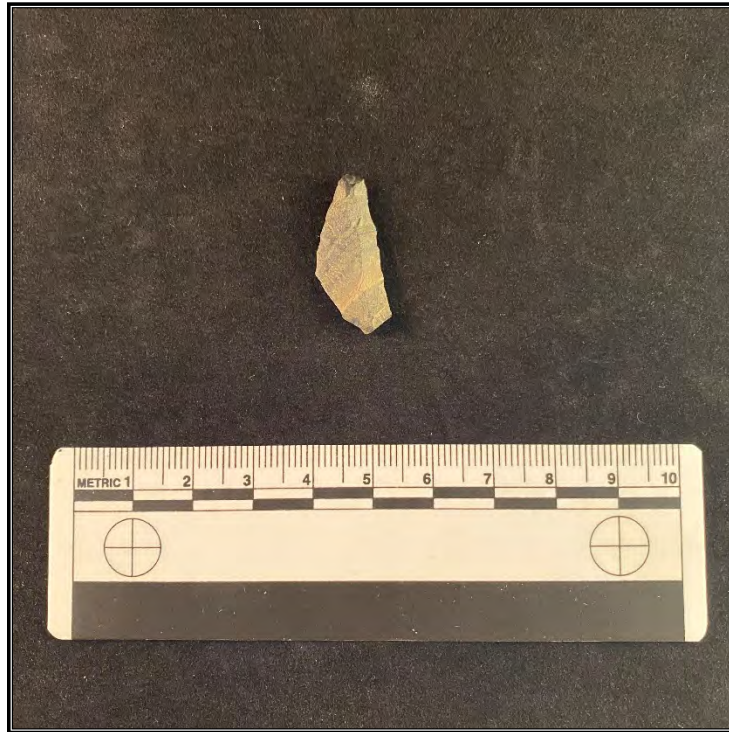
Figure 8. Rhyolite biface fragment recovered from Shovel Test A-20.

During the Phase I survey, investigators identified an isolated find consisting of an aphyric rhyolite biface fragment (Figure 8). The isolate is located within a grass-covered field approximately 0.4 km (0.2 mile) north of the Dan River (Figure 9). The find was identified in Stratum I, the Ap horizon, of Shovel Test A-20 between 0 and 34 cm (0 and 13 inches) below ground surface. The soil profile of Shovel Test A-20 consisted of one stratum over subsoil. Stratum I consisted of a brown (10YR4/3) loam and Stratum II, subsoil, consisted of a yellowish brown (10YR5/6) sandy loam (Figure 10). A total of 8 radial shovel tests were excavated around Shovel Test A-20 (Figure 11). No additional cultural material was recovered. The isolated find is not eligible for listing on the NRHP. The biface fragment will be returned to the landowner, per their request.

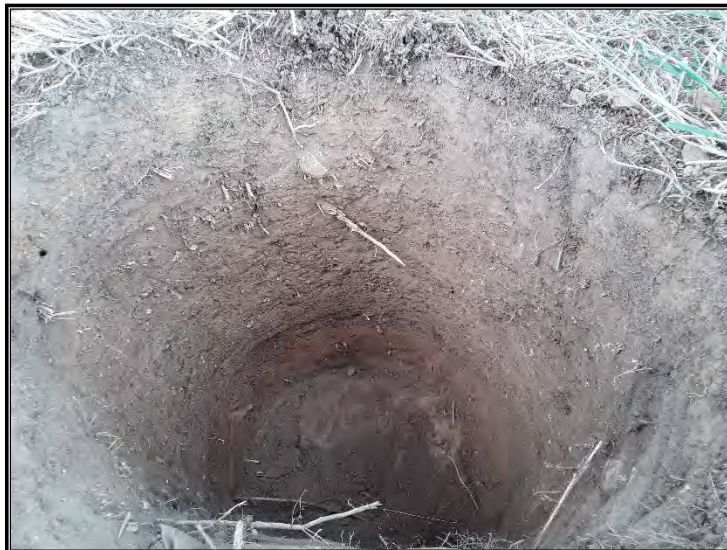
Figure 10. Shovel Test A-20 soil profile.

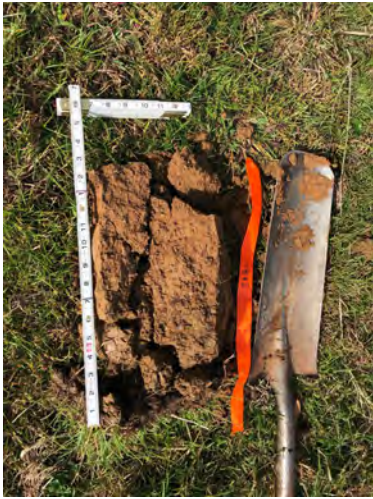
Soil Boring: SB1 hydric (F19) Date: 10/14/20
 Location: Mushroom Meadow Investigator(s): SJF
 County: Caswell NC Elev.: 366 ft
 Lat./Long.: 36.532500, -79.245833
 Parent Material: alluvium from metamorphic and acid crystalline rock Drainage (Wetness) Class: poorly drained effective drainage in place
 Moisture Status: moist Slope (%): < 2%
 Classification: Fine-loamy, mixed, active, nonacid, mesic Fluvaquentic Endoaquepts Vegetative Cover: pasture
 Soil Series: Hatboro Water Table: >24"
 Aspect: SE SHWT: <12"

Horiz.	Depth (in.)	Main Colors (moist)	Mottles	Texture	Grade	Structure			Moist & Wet Consist.	Ped Coatings	Horizon Boundary	Other Remarks
						Class	Type					
Ap	0-9	grayish brown (10YR 5/3)		st loam	weak	fine	granular		friable, silt stk/plst	-	-	fine roots
Btg1	9-16	light brownish gray (10YR 6/2)		st loam	weak	med	sub. blk.		friable, silt stk/plst	-	-	evidence of water movement 60% chroma 2
Btg2	16-24+	gray (10YR 6/1)	prom (10YR 5/8)	st loam	weak	med	sub. blk.		firm, silt stk/plst	-	-

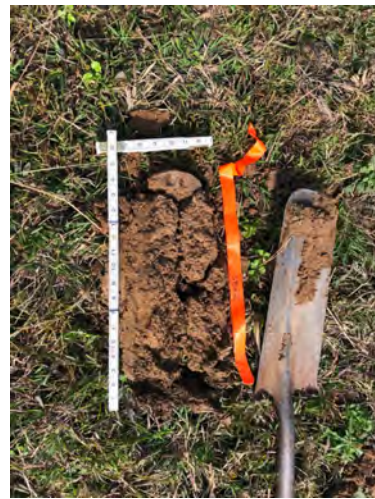
Soil Boring: SB2 hydric (F3 & F19) Date: 10/14/20
 Location: Mushroom Meadow Investigator(s): SJF
 County: Caswell NC Elev.: 364 ft
 Lat./Long.: 36.532778, -79.244817
 Parent Material: alluvium from metamorphic and acid crystalline rock Drainage (Wetness) Class: poorly drained effective drainage in place
 Moisture Status: moist Slope (%): < 2%
 Classification: Fine-loamy, mixed, active, nonacid, mesic Fluvaquentic Endoaquepts Vegetative Cover: pasture
 Soil Series: Hatboro Water Table: >24"
 Aspect: NW SHWT: <14"

Horiz.	Depth (in.)	Main Colors (moist)	Mottles	Texture	Grade	Structure			Moist & Wet Consist.	Ped Coatings	Horizon Boundary	Other Remarks
						Class	Type					
Ap	0-5	grayish brown (10YR 5/2) light brownish gray (10YR 6/2)		st loam	weak	fine	granular		friable, silt stk/plst	-	-	fine roots
Btg1	5-14	gray (10YR 6/1)		st loam	weak	med	sub. blk.		friable, silt stk/plst	-	-	evidence of water movement 60% chroma 2
Btg2	14-24+	gray (10YR 6/1)	prom (10YR 5/8)	st loam	weak	med	sub. blk.		firm, silt stk/plst	-	-
