Mitigation Plan

Mushroom Meadow Mitigation Site

Caswell County, North Carolina
Roanoke River Basin HUC 03010104
DMS Project ID No. 100192
Full Delivery Contract No. 200204-01
USACE Action ID No. SAW-2021-00348
NCDWR No. 20210400, V1

Prepared For: North Carolina Division of Mitigation Services
Raleigh, North Carolina
January 2023

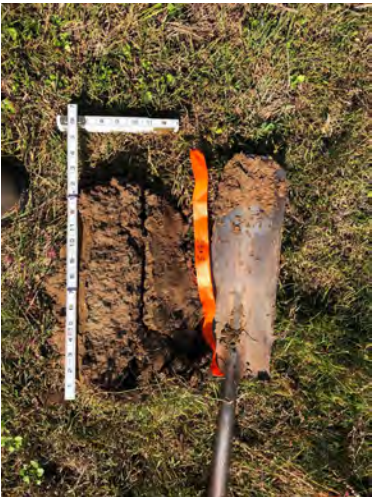
Soil Boring: SB3 hydric (F3 & F19) Date: 10/14/20
 Location: Mushroom Meadow Investigator(s): SJF
 County: Caswell NC Elev.: 365 ft
 Lat./Long.: 36.533900, -79.244125
 Parent Material: alluvium from metamorphic and acid crystalline rock Drainage (Wetness) Class: poorly drained effective drainage in place
 Moisture Status: moist Slope (%): < 2%
 Classification: Fine-loamy, mixed, active, nonacid, mesic Fluvaquent Endoaquepts Vegetative Cover: pasture
 Soil Series: Hatboro Water Table: >24"
 Aspect: SW SHWT: <12"

Horiz.	Depth (in.)	Main Colors (moist)	Mottles	Texture	Grade	Structure			Moist & Wet Consist.	Ped Coatings	Horizon Boundary	Other Remarks
						Class	Type					
Ap	0-9	grayish brown (10YR 5/2)		st loam	weak	fine	granular		friable, silt stk/plst	-	-	fine roots, oxidized root channels
Btg1	9-16	gray (10YR 5/1)	prom (10YR 5/8)	st loam	weak	med	sub. blk.		friable, silt stk/plst	-	-	evidence of water movement 60% chroma 2, oxidized root channels
Btg2	16-24+	gray (10YR 6/1)	prom (10YR 5/8)	st loam	weak	med	sub. blk.		firm, silt stk/plst	-	-

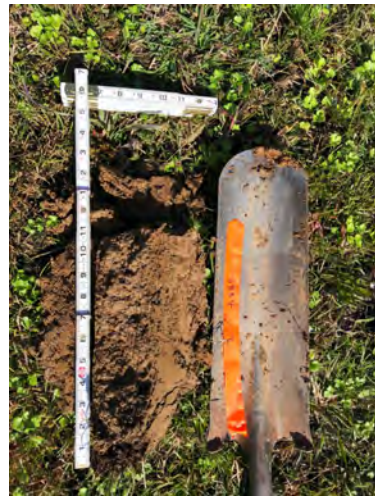
SB4

Parent Material: alluvium from metamorphic and acid crystalline rock Drainage (Wetness) Class: poorly drained effective drainage in place
 Moisture Status: moist Slope (%): < 2%
 Classification: Fine-loamy, mixed, active, nonacid, mesic Fluvaquent Endoaquepts Vegetative Cover: pasture
 Soil Series: Hatboro Water Table: >24"
 Aspect: SW SHWT: <12"

Horiz.	Depth (in.)	Main Colors (moist)	Mottles	Texture	Grade	Structure			Moist & Wet Consist.	Ped Coatings	Horizon Boundary	Other Remarks
						Class	Type					
Ap	0-2	grayish brown (10YR 5/2)		st loam	weak	fine	granular		friable, silt silt/plst	-	-	fine roots
Btg1	2-16	gray (10YR 5/1)	prom (10YR 5/8)	st loam	weak	med	sub. blk.		friable, silt silt/plst	-	-	evidence of water movement 60% chroma 2, oxidized root channels
Btg2	16-24+	gray (10YR 6/1)	prom (10YR 5/8)	st loam	weak	med	sub. blk.		firm, silt silt/plst	-	-

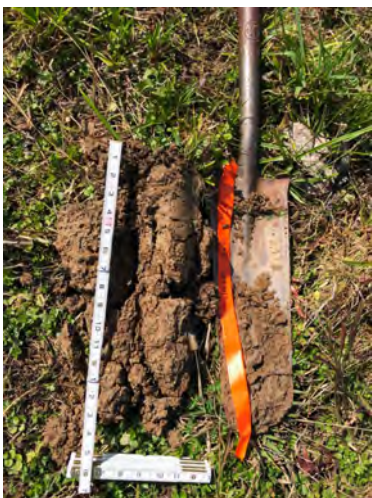
SB5

Parent Material: alluvium from metamorphic and acid crystalline rock Drainage (Wetness) Class: poorly drained effective drainage in place
 Moisture Status: moist Slope (%): < 2%
 Classification: Fine-loamy, mixed, active, nonacid, mesic Fluvaquent Endoaquepts Vegetative Cover: pasture
 Soil Series: Haboro Water Table: 14-20"
 Aspect: E SHWT: <12 "

Horiz.	Depth (in.)	Main Colors (moist)	Mottles	Texture	Grade	Structure			Moist & Wet Consist.	Ped Coatings	Horizon Boundary	Other Remarks
						Class	Type					
Ap	0-2	grayish brown (10YR 5/2)		st loam	weak	fine	granular		friable, silt stk/plst	-	-	fine roots
Btg1	2-16	light brownish gray (5YR)		st loam	weak	med	sub. blk.		friable, silt stk/plst	-	-	evidence of water movement 60% chroma 2
Btg2	16-24+	gray (10YR 6/1)	prom (10YR 5/8)	st loam	weak	med	sub. blk.		firm, silt stk/plst	-	-
