# ***Addendum #1 – REVISED MITIGATION PLAN***

## **NEIGHBORS BRANCH/WALTON CRAWLEY BRANCH STREAM AND WETLAND RESTORATION SITE**

McDowell County, North Carolina

EEP No. 92872

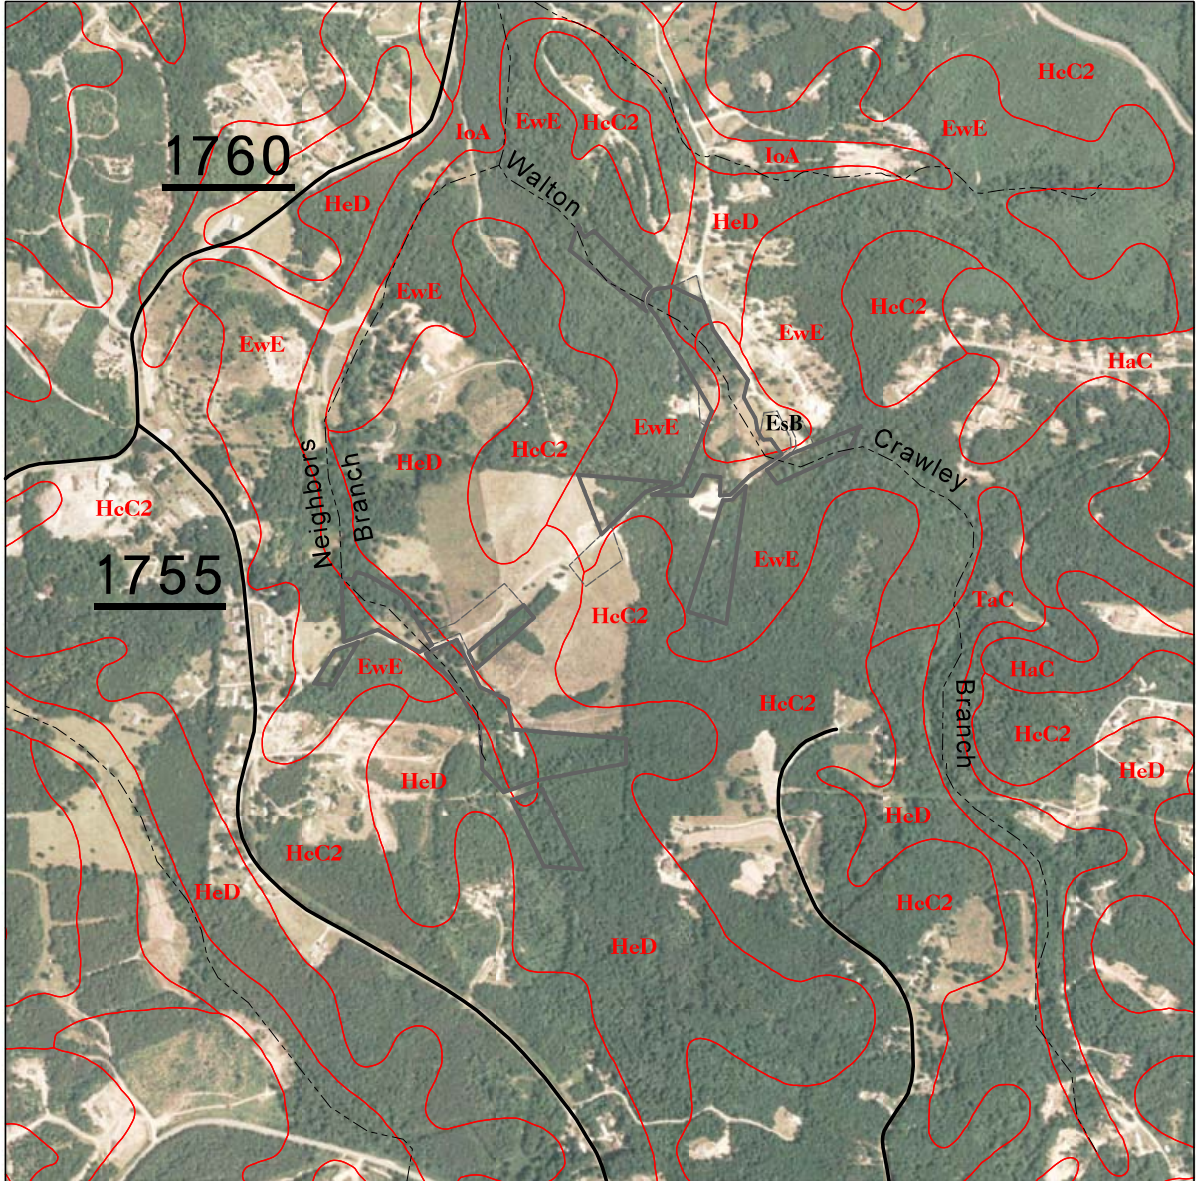
Figure: 2

Figure 2 (attached) shows an overview of the Project on a topographic map as well as a key to sheets (Sheets 1-5), which depict wetlands/hydric soils boundaries on 2008 aerial photography. Also included with Project figures are completed USACE Approved Jurisdictional Determination Forms (2007), completed U.S. Army Corps of Engineers (USACE) Routine Wetland Determination Data Forms (1987), USACE Stream Quality Assessment Worksheets, and NCDWQ Stream Identification Forms (Version 3.1). Locations where data forms were completed are depicted on Sheets 1-5. Locations where USACE worksheets and NCDWQ forms were completed are depicted on the attached stream form location maps.

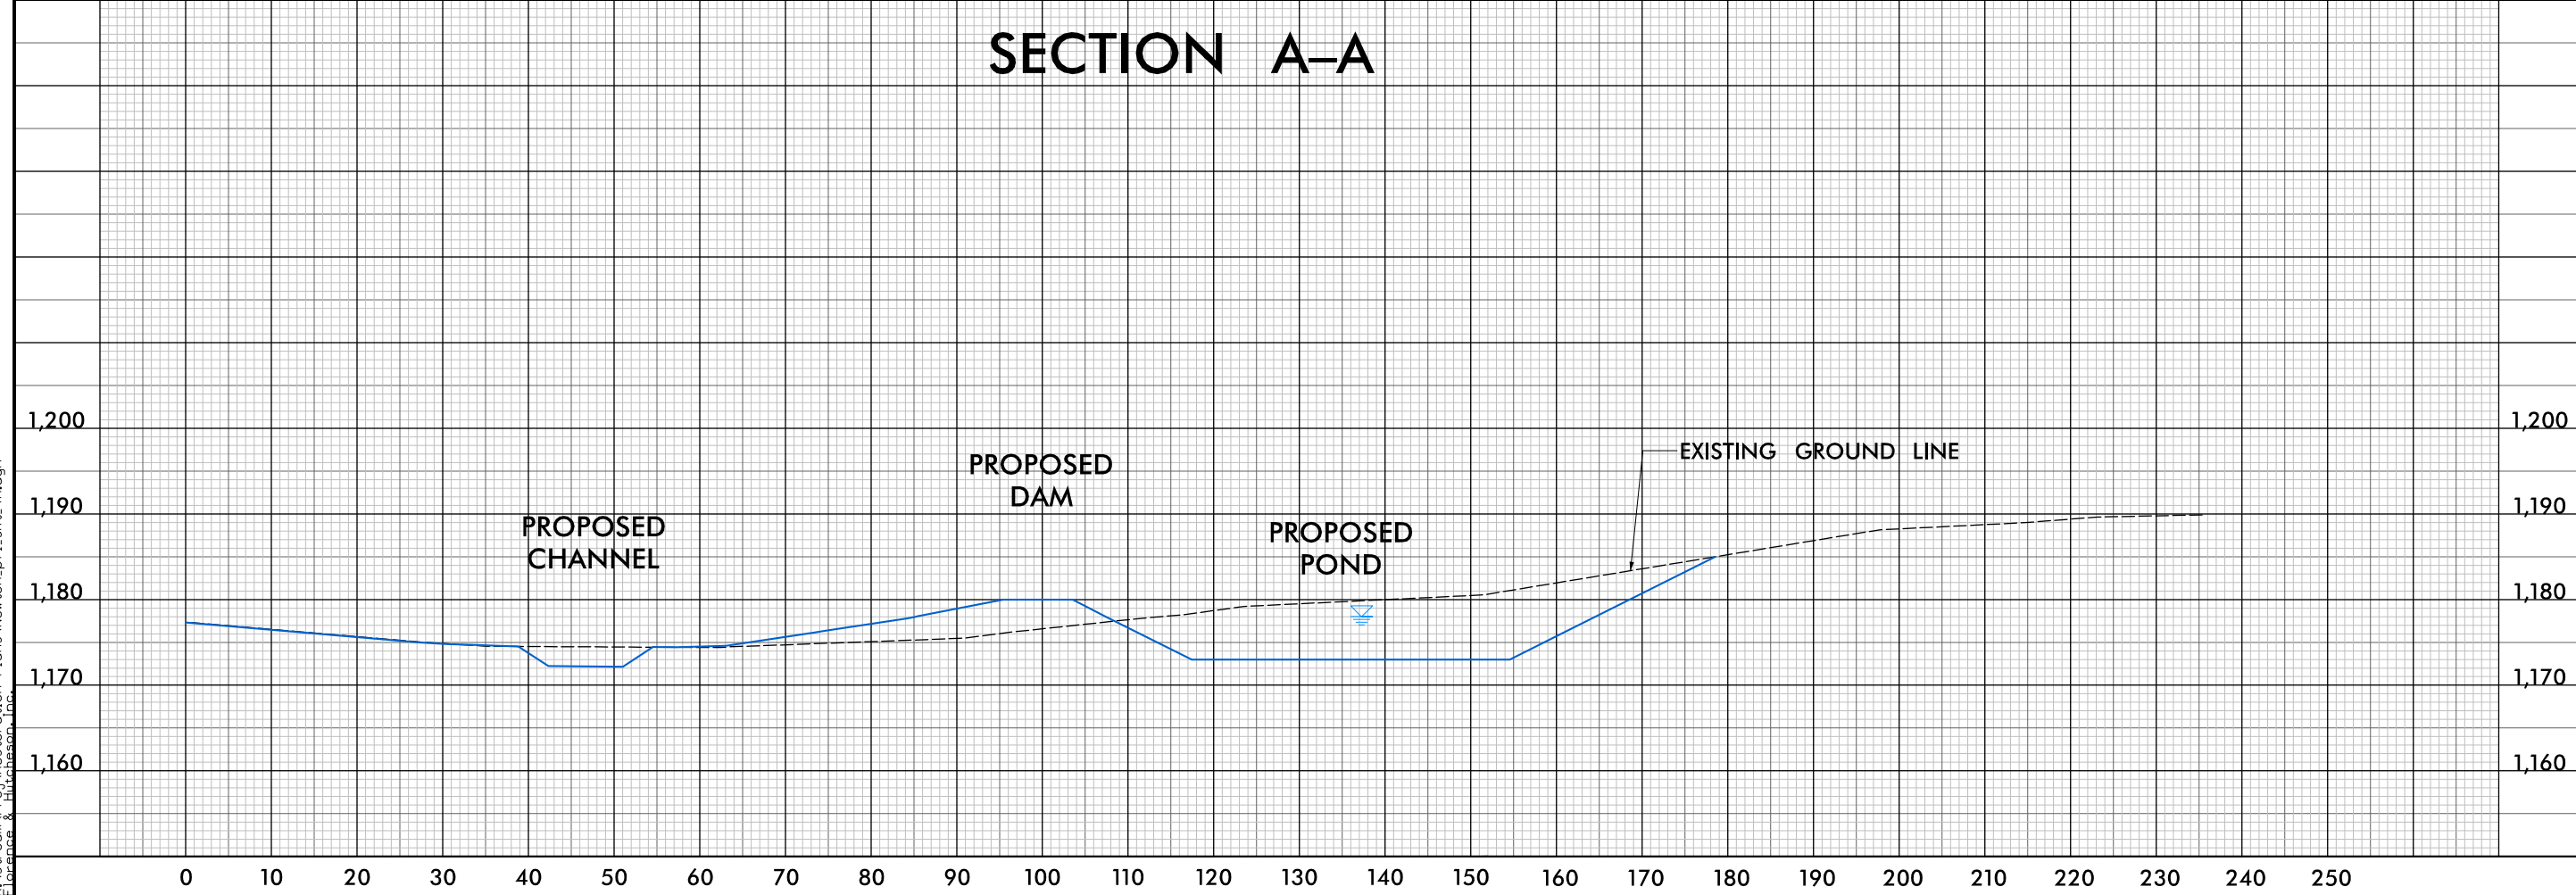
# SECTION A-A

WALTON CRAWLEY  
HEC-RAS ANALYSIS
