MITIGATION PLAN

NESBIT SITE

Union County, North Carolina

DMS Project ID No. 100121
Full Delivery Contract No. 7868
USACE Action ID No. SAW-2019-00832
DWR Project No. 2019-0862
RFP No. 16-007704 (Issued: 9/6/2018)

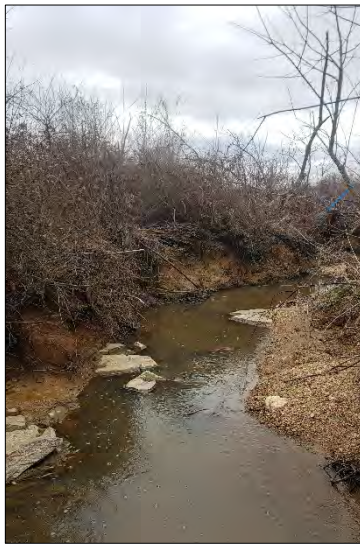
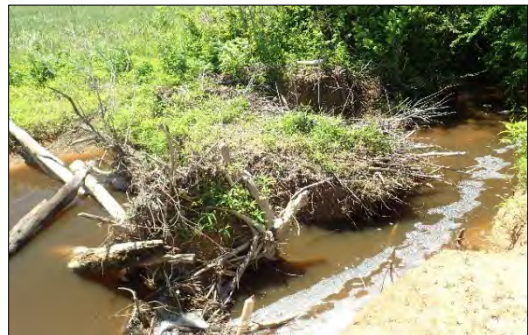
Glen Branch, the main receiving stream within the Site, has been dredged and straightened through the entire reach of the Site and pushed to the edge of the valley. The channel has a narrow fringe of successional vegetation primarily characterized by Chinese privet (*Ligustrum sinense*), black willow (*Salix nigra*), and blackberry (*Rhus* sp.). Glen Branch has three distinct reach including the upstream incised reach, a bedrock controlled middle section, and the downstream incised reach. The upstream reach is relatively incised and oversized as evidenced by a bank-height ratio ranging from 1.0 to 2.2 (averaging 1.8). The 1.0 bank height ratio is located near the middle, bedrock-controlled reach that is proposed for Enhancement (Level I). The upstream reach has frequent eroding banks and a resultant gravel substrate. The middle, bedrock-controlled reach has a forded crossing that will be removed, which

hold the channel bed and reduces scour and downward incision. The as the channel descends the valley bank-height ratios increase to an average of 1.7; however, frequent beaver dams have resulted in a series of low erosion areas upstream of the dams and extensive erosion below the dams. Control of the beavers and removal of the

dams have resulted in a denuded stream bank that is subject to establishment of opportunistic species such as Chinese privet and blackberry.

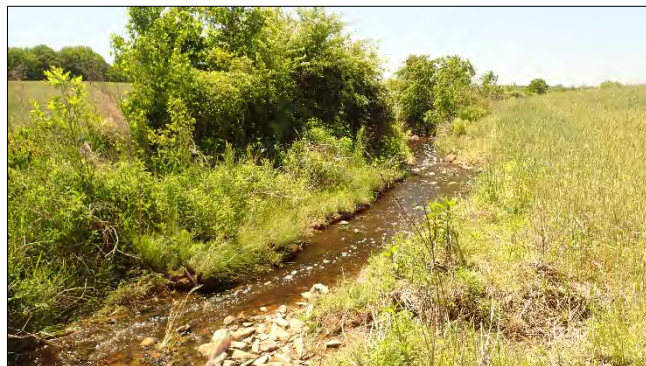
Similar to Glen Branch, UT 1 has been dredged and straightened through the entire reach of the Site. The valley for UT 1 is relatively narrow and the channel meanders as the valley migrates downstream. The upper reaches of the channel, as it leaves the upstream wooded property is characterized by a relatively

stable channel with cobble substrate; however, the channel is incised and quickly becomes unstable with eroding banks and a bank-height-ratio of 1.4 to 1.8. A short section of the channel located upstream of a forded crossing has been stabilized by the ford. This short reach is characterized by low slope and stable stream banks. However, below the ford the channel is characterized as incised and eroding. Similar to Glen Branch, a narrow fringe of successional vegetation has established adjacent to the channel that is largely composed of Chinese

privet, red maple (*Acer rubrum*), dog fennel (*Eupatorium capillifolium*), and blackberry. Substrate is a mixture of cobble and sand.

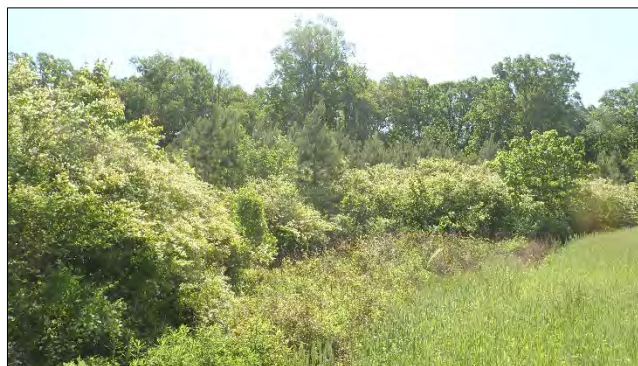
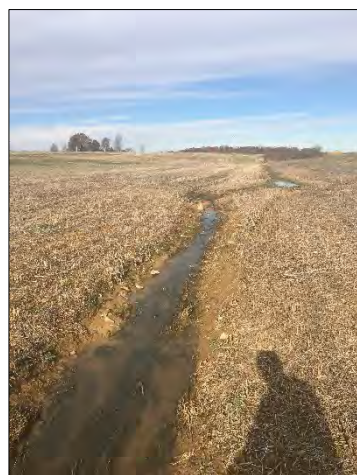
UT 1A is an intermittent channel (NCDWQ Form Score of 28) that originates immediately upstream from the project boundary and converges with UT 1 after flowing for approximately 300 linear feet. UT 1A has pine plantation on its right bank and row crops on its left bank. Due to the small drainage area, the channel remains relatively stable and is therefore proposed for Enhancement (Level II).

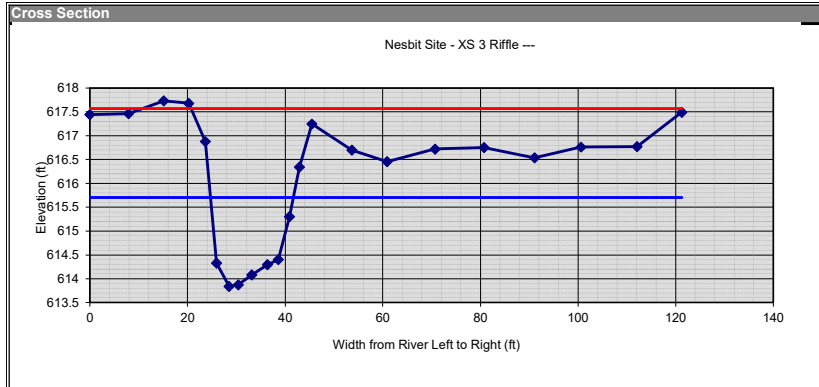
section: Nesbit Site - XS 3
Riffle

description: Nesbit Site - XS 3
height of instrument (ft): 700.00

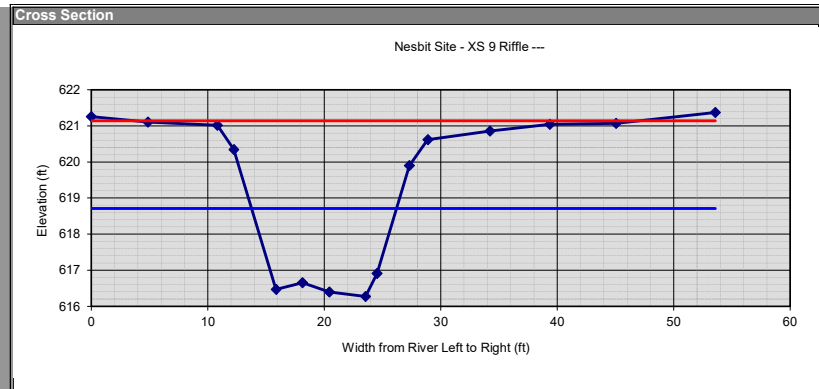
section: Nesbit Site - XS 9
Riffle

description: Nesbit Site - XS 9
height of instrument (ft): 700.00

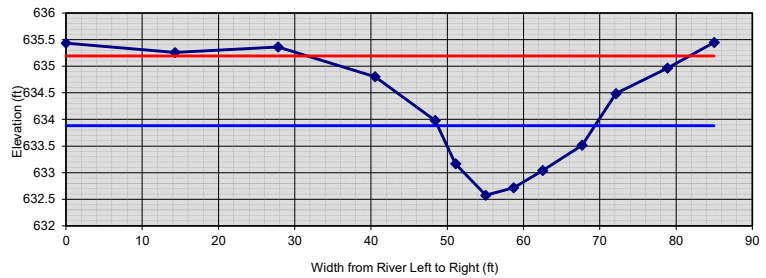
Nesbit Site - XS 17 Riffle ---

section: Nesbit Site - XS 17					
	Riffle				
description: Nesbit Site - XS 17					
height of instrument (ft):				700.00	
notes	omit pt.	distance (ft)	FS (ft)	elevation	Manning's "n"
	<input type="checkbox"/>	0	64.56646	635.4335	
	<input type="checkbox"/>	14.28445	64.74059	635.2594	
	<input type="checkbox"/>	27.81776	64.63427	635.3657	
	<input type="checkbox"/>	40.53477	65.19762	634.8024	
	<input type="checkbox"/>	48.40666	66.0199	633.9801	
	<input type="checkbox"/>	51.07525	66.83105	633.1689	
	<input type="checkbox"/>	55.04776	67.42298	632.577	
	<input type="checkbox"/>	58.70889	67.2854	632.7146	
	<input type="checkbox"/>	62.527	66.95919	633.0408	
	<input type="checkbox"/>	67.68139	66.48059	633.5194	
	<input type="checkbox"/>	72.12228	65.5128	634.4872	
	<input type="checkbox"/>	78.87478	65.03178	634.9682	
	<input type="checkbox"/>	84.98577	64.55444	635.4456

FS bankfull	FS top of bank	W fpa (ft)	channel slope (%)	Manning's "n"
66.115	64.63	50.0		
633.885	635.37

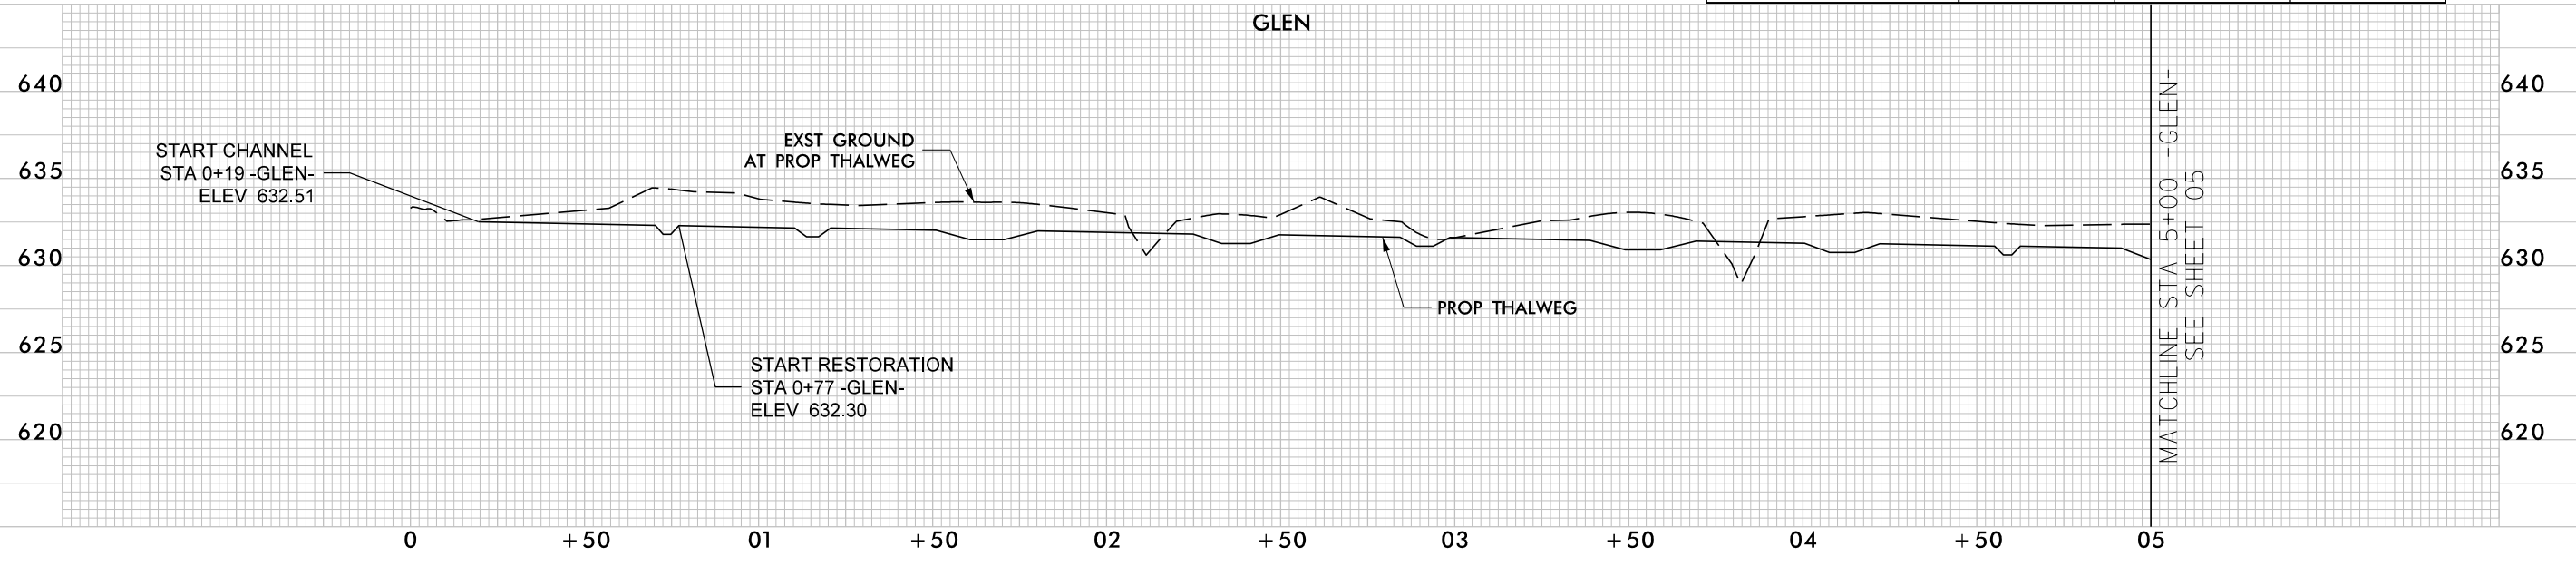
NESBIT
UNION COUNTY, NC
PLAN AND PROFILE

-GLEN- STRUCTURE LOCATIONS			
STR. TYPE	NORTHING	EASTING	Prop Elevation
CROSS VANE	421,847.05	1,504,567.15	631.45
CROSS VANE	421,701.08	1,504,569.32	631.00

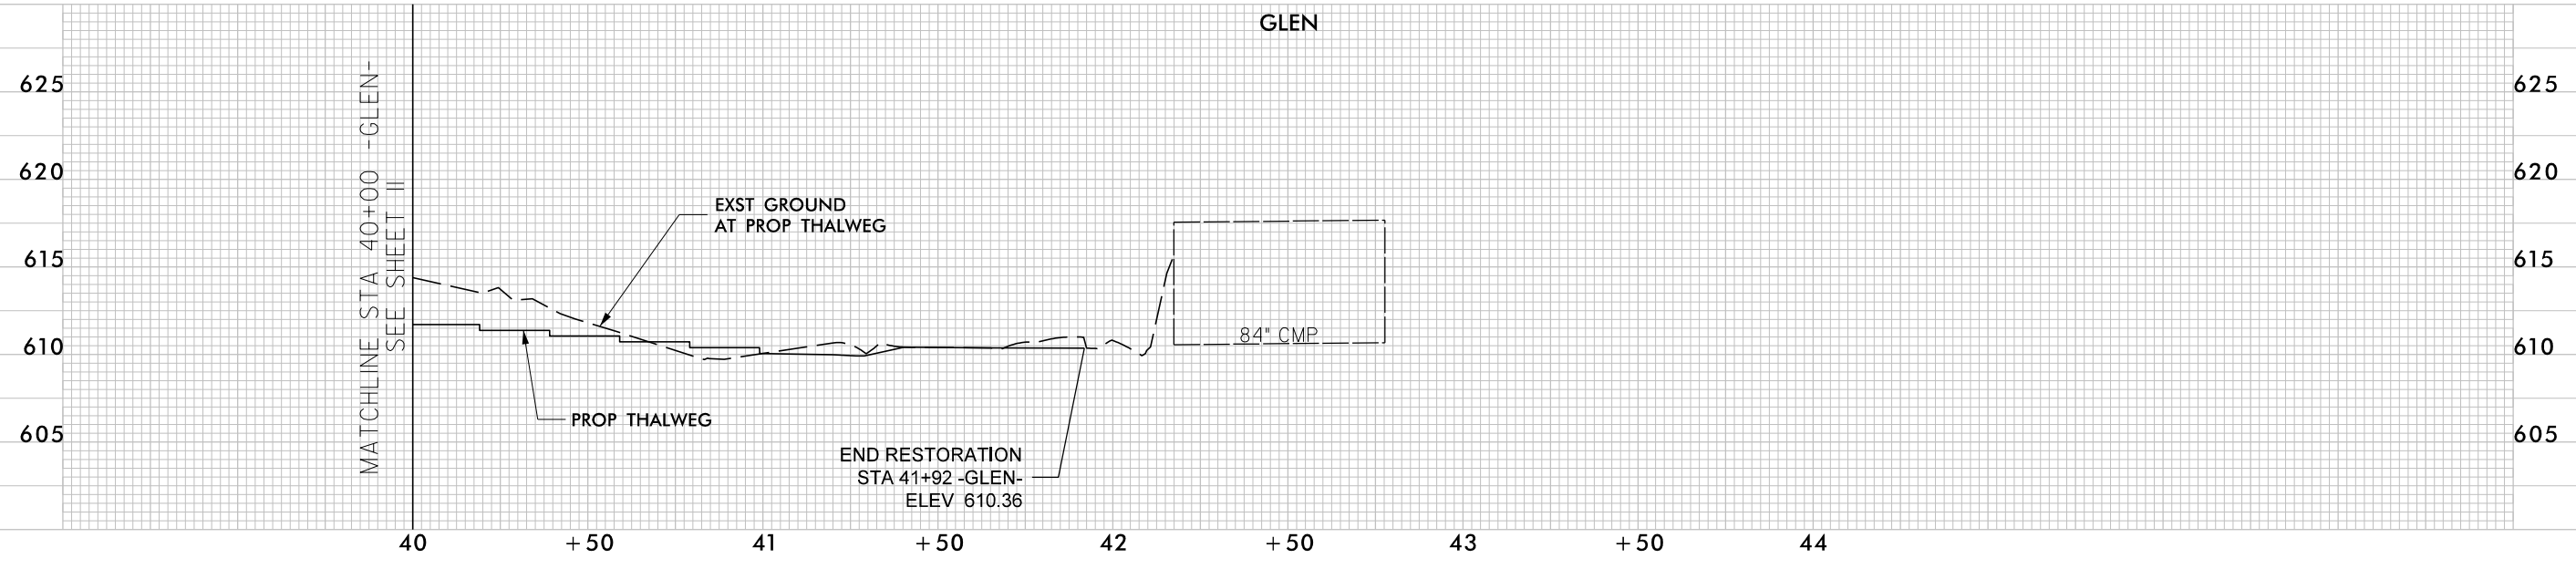
NESBIT
UNION COUNTY, NC
PLAN AND PROFILE

-GLEN- STRUCTURE LOCATIONS			
STR. TYPE	NORTHING	EASTING	Prop Elevation
DROP STRUCTURE	419,319.49	1,502,740.15	609.99
LOG VANE	419,332.39	1,502,698.02	610.37
