**Marston Mitigation Project
Jones County, North Carolina**

Year 5 Monitoring Report

October 2008

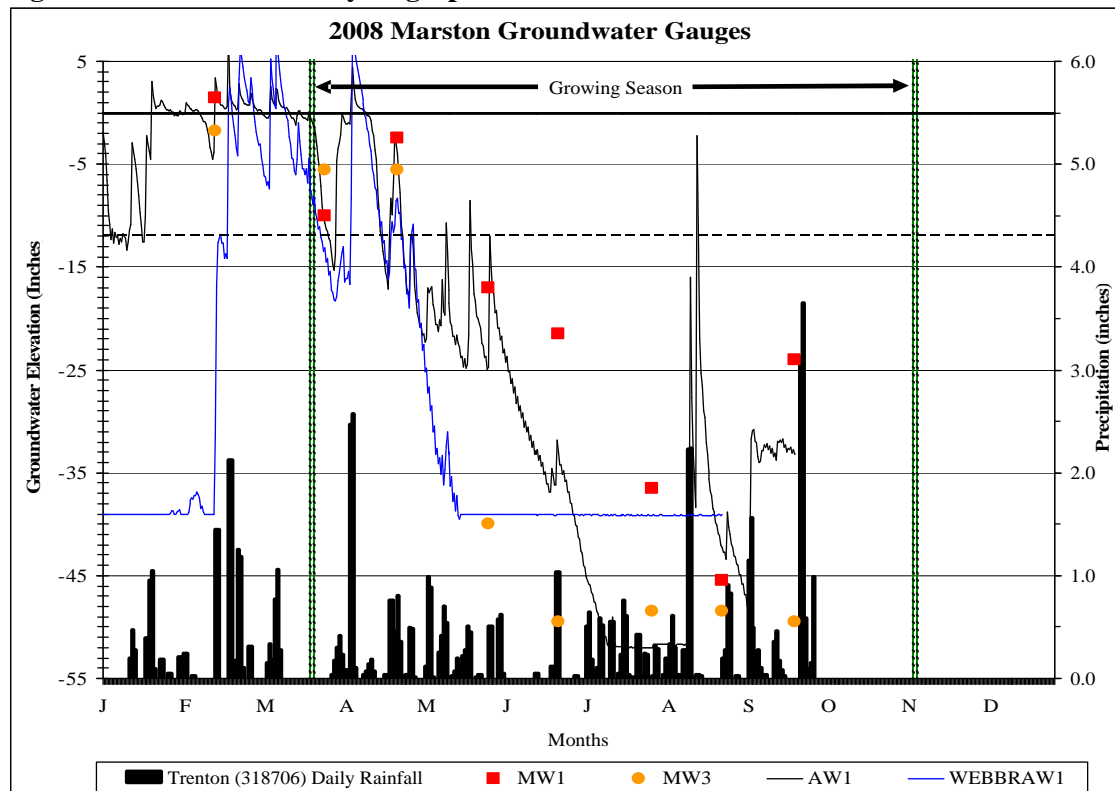
Figure 4a. Groundwater Hydrographs

The results of hydrology monitoring in 2008 are presented in **Table 4** and **Figures 4a and 4b**.

Data collected from all the groundwater monitoring gauges on the Marston Mitigation Site document that hydrologic success criteria have been met during the 2008 growing season. All gauges show consecutive saturated conditions within the 12 inches below soil surface for at least seven percent of the growing season (17 consecutive days), and cumulative soil saturation within 12 inches of the ground surface for over 12.5 percent of the growing season (35 days of the entire season). The groundwater gauge data is found in **Appendix C**.

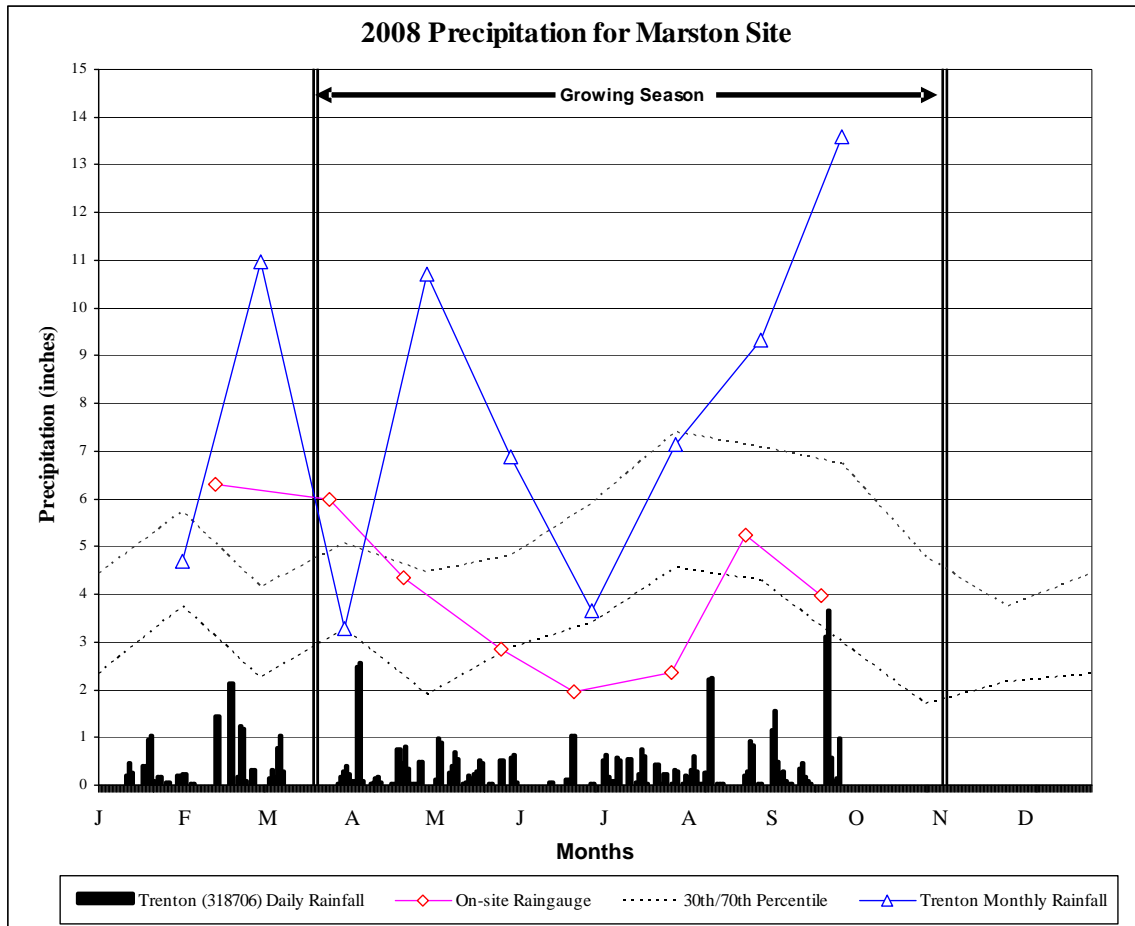
Figure 6. 2008 Precipitation for Marston

Comparisons of the 2008 monthly rainfall totals to historical precipitation for Jones County are shown in **Table 5** and **Figure 6**. Observed precipitation data were collected from an automated weather station in Trenton and an on-site manual rain gauge. For the 2008 growing season, on-site rainfall measurements correlate well with the Trenton gauge data, but were generally below the weather station data. The Trenton monthly rainfall amounts were above normal for the months of February, April, May, July, and August, but within normal limits for January, March, and June. Monthly rainfall data for September through December 2008 were not available at the time this report was compiled.

Trenton weather station rainfall data indicates that the 2008 growing season rainfall amounts were normal to above normal for the first part of the growing season, while the on-site rainfall was below normal to normal except for the months of February through April.

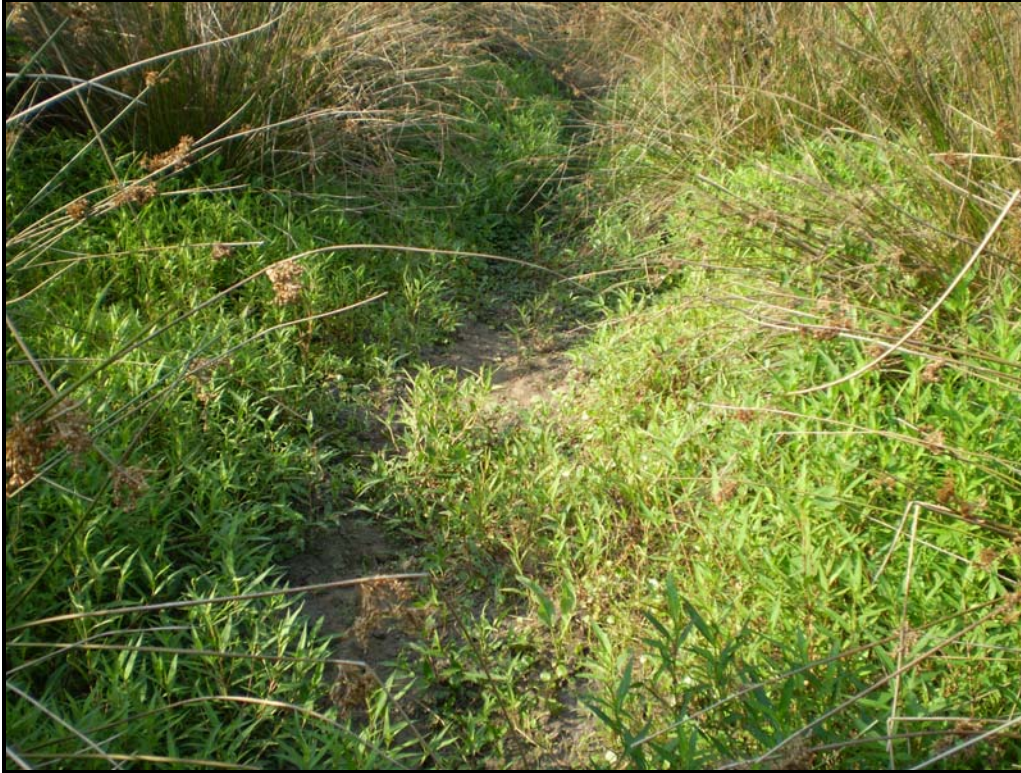
ID	Station	Feature	Problem	Severity	Recommended Action
SPA1	Reach 1-24+50	Old beaver dam-breached	Has resolved itself.	Negligible	None
SPA2	Reach 1-29+00	Log Vane	Washed under vane	Moderate	None
SPA3	Reach 1-32+90	Channel	Sand entering channel, deposition	Moderate	None
SPA4	Reach 1-40+00	Channel - right bank	Kudzu becoming established	Minor	Herbicide Treatment
SPA4	Reach 1-41+82	Channel - right bank	Kudzu becoming established	Minor	Herbicide Treatment

Old beaver dam breached @ station 24+50 (Reach 1).

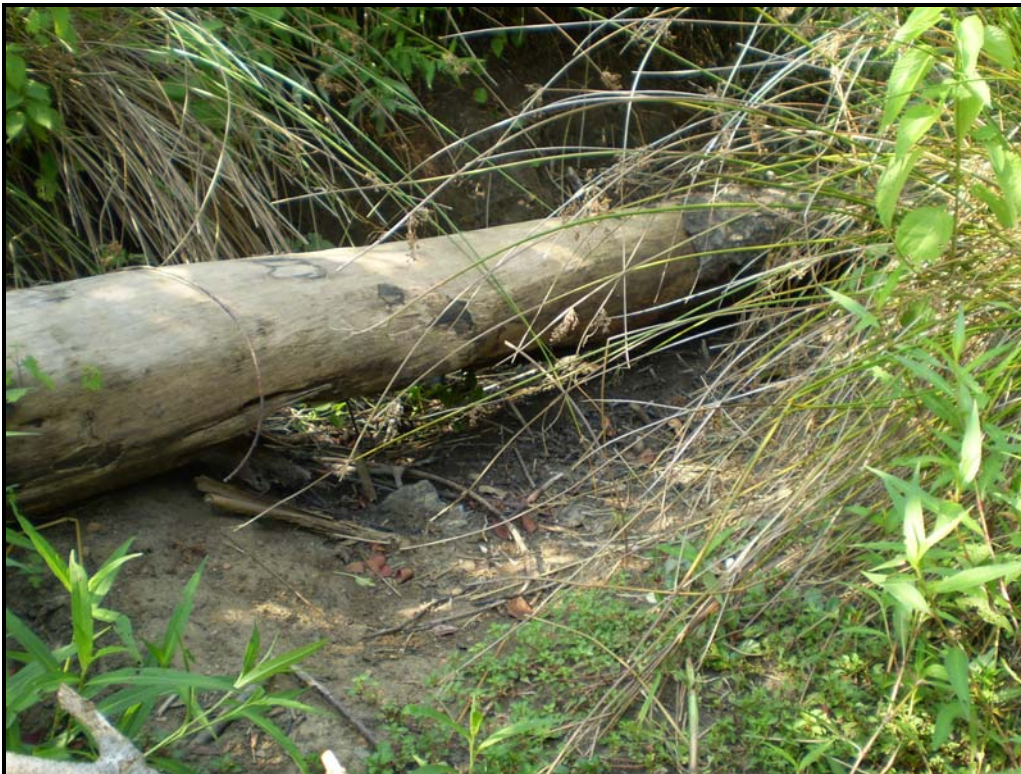
Log vane @ station 29+00 (Reach 1), channel is washing under the structure.

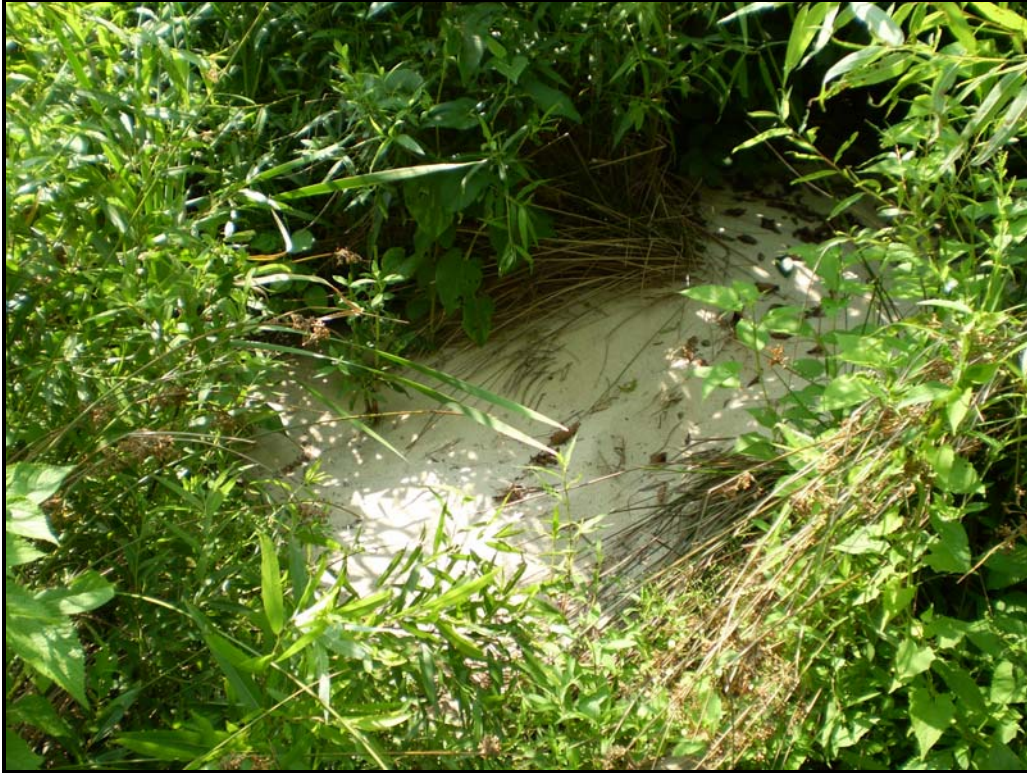
Sediment/sand entering channel @ station 32+90 (Reach 1) causing potential aggradation in channel.
