**Newtown Stream and
Wetland Restoration Site
Union County, North Carolina
RFP 16-001117, SCO ID# 002025**

**Restoration Plan
May 12, 2010**

The Newtown Stream and Wetland Restoration Site is located within the Catawba River Basin in Union County, North Carolina and contains Underwood Creek and one Unnamed Tributary to Underwood Creek. The restoration lengths of Underwood Creek and UT to Underwood Creek are 1331 and 3986 feet, respectively, for a total project length of 5317 feet. The area of riparian wetland to be restored is 3.38 acres and wetland preservation of 0.15 acres. The project site is owned by one property owner Mr. Frank W. Howey, Jr.

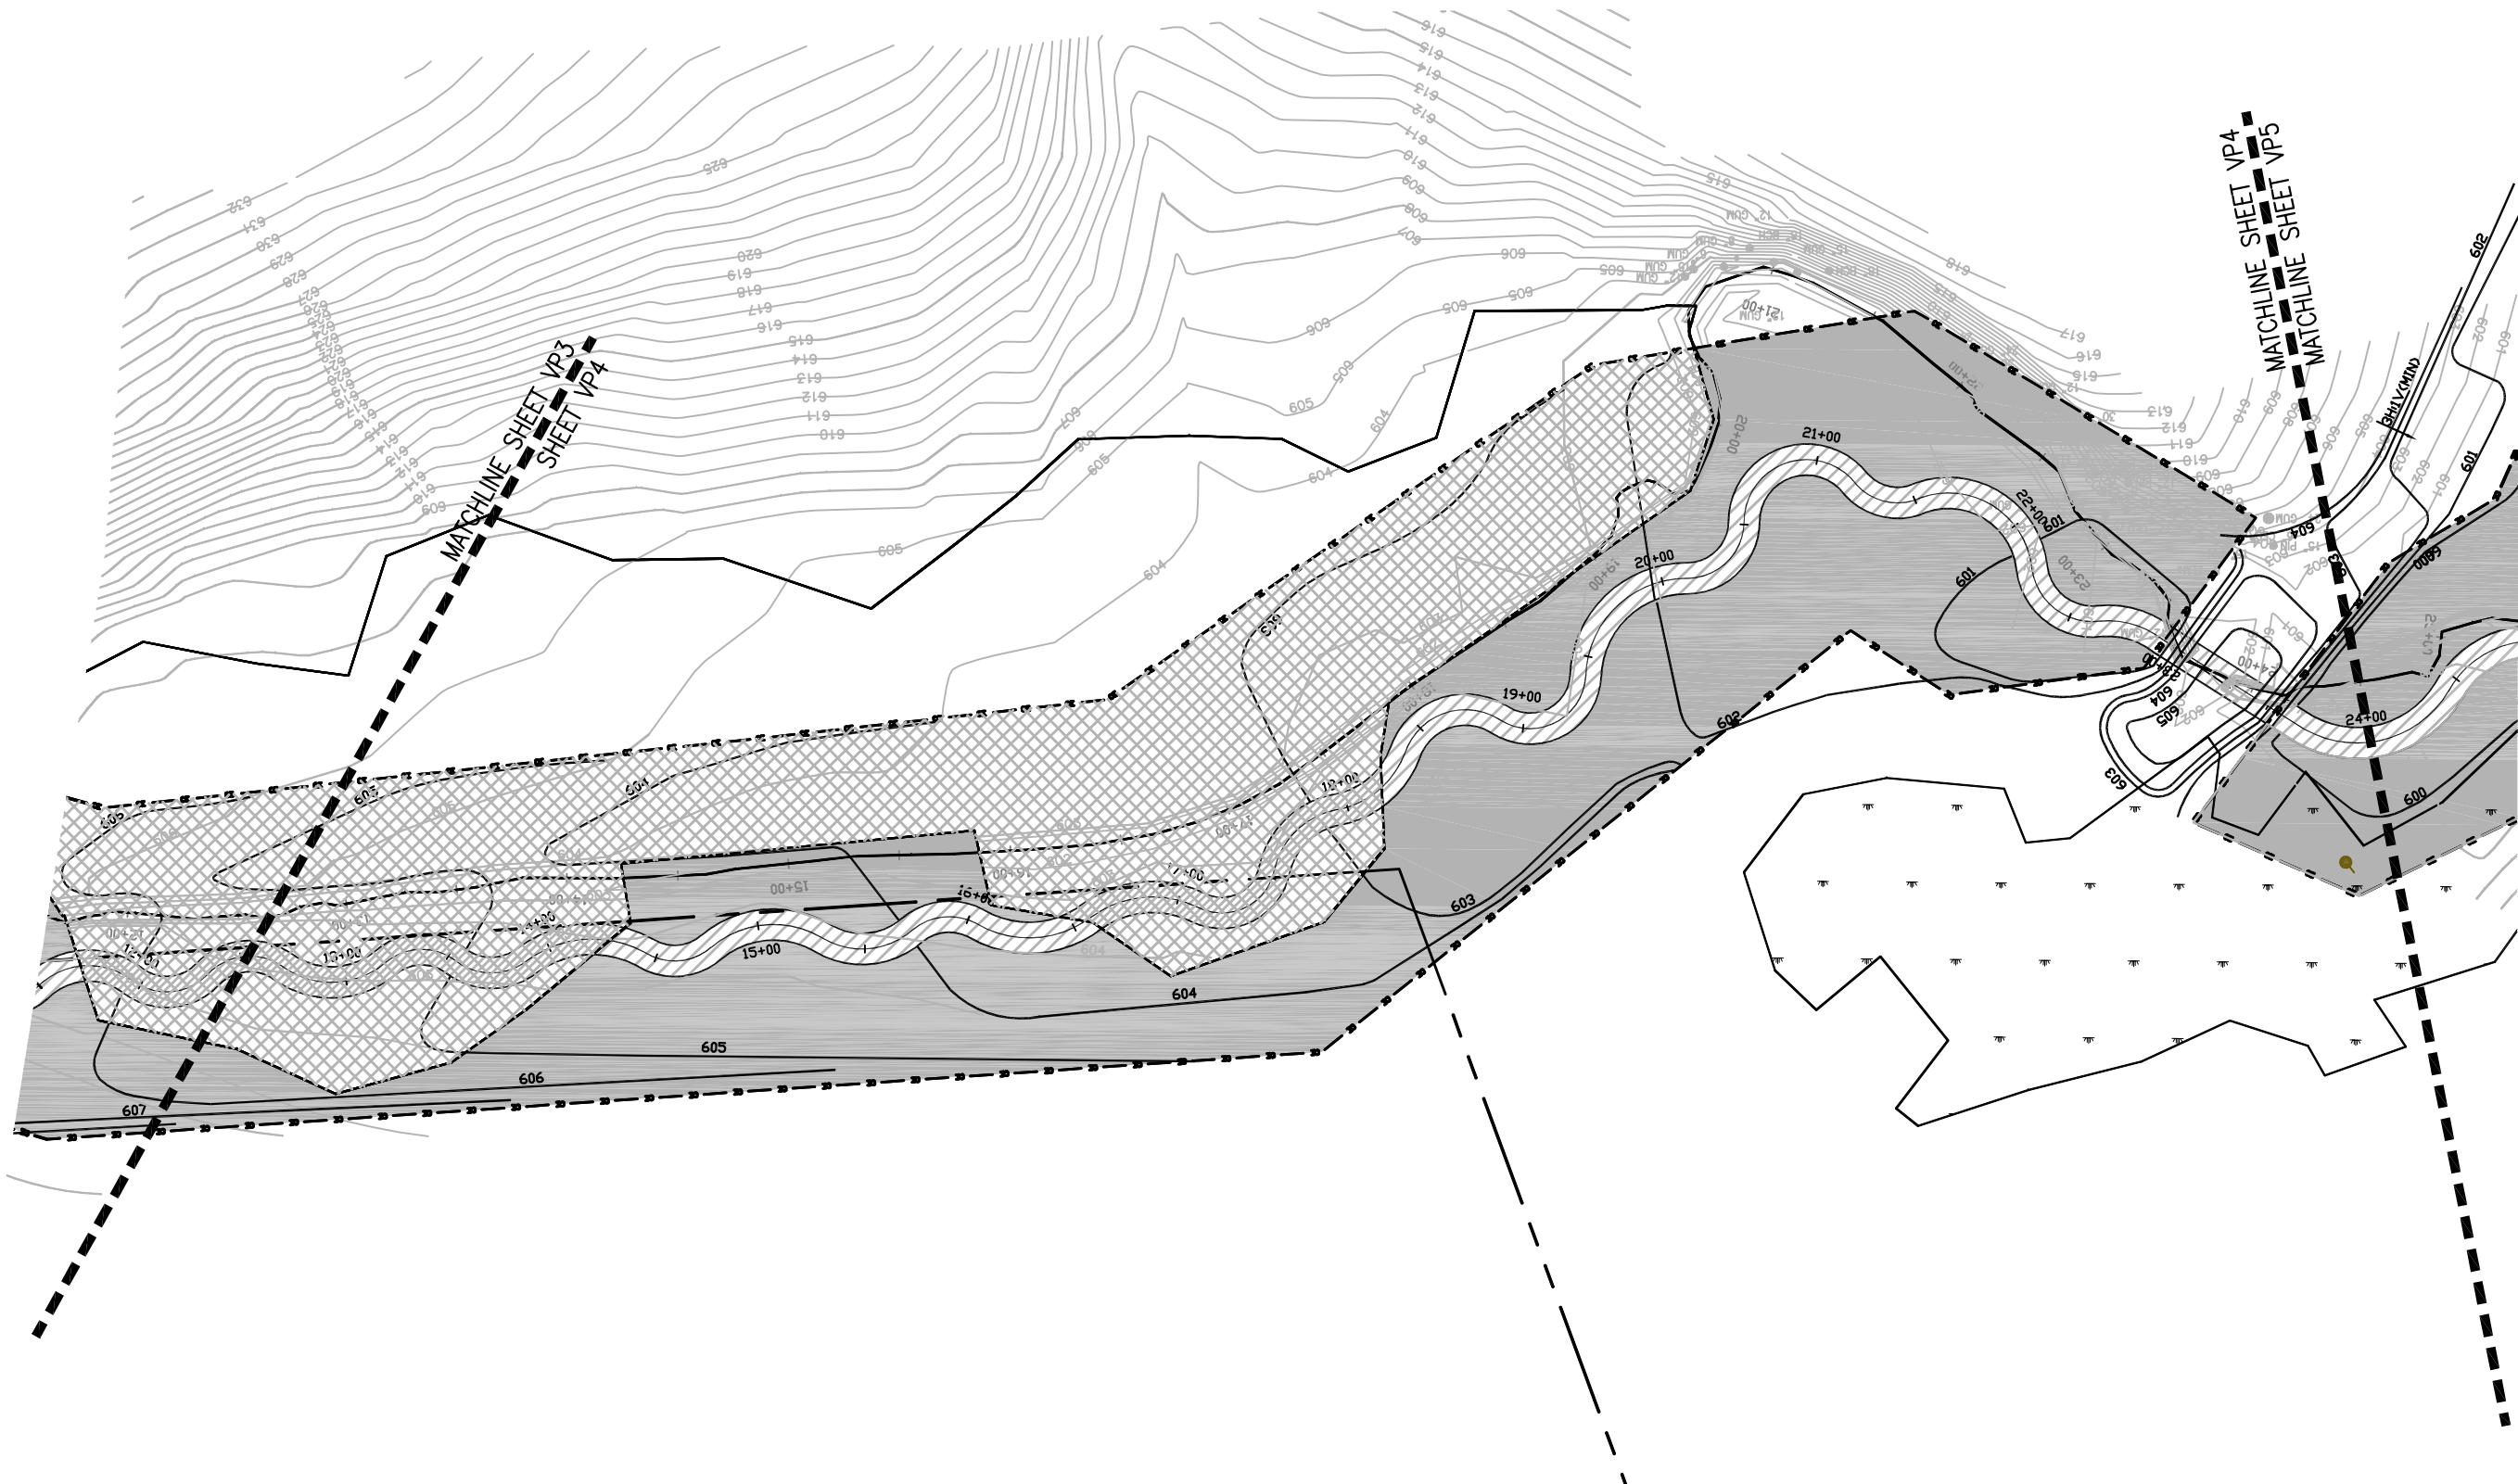
DATE: 01 MARCH 2010
REVISIONS:
PROJECT NAME: New Town Creek
DWG NAME: Planting Plan
SCALE: 1"=40'
PERMIT SET
SHEET NO. VP3

**NEWTOWN PLANTING PLAN
 STATION 0+00 TO 12+00
 UT TO UNDERWOOD CREEK
 UNION COUNTY, NORTH CAROLINA**

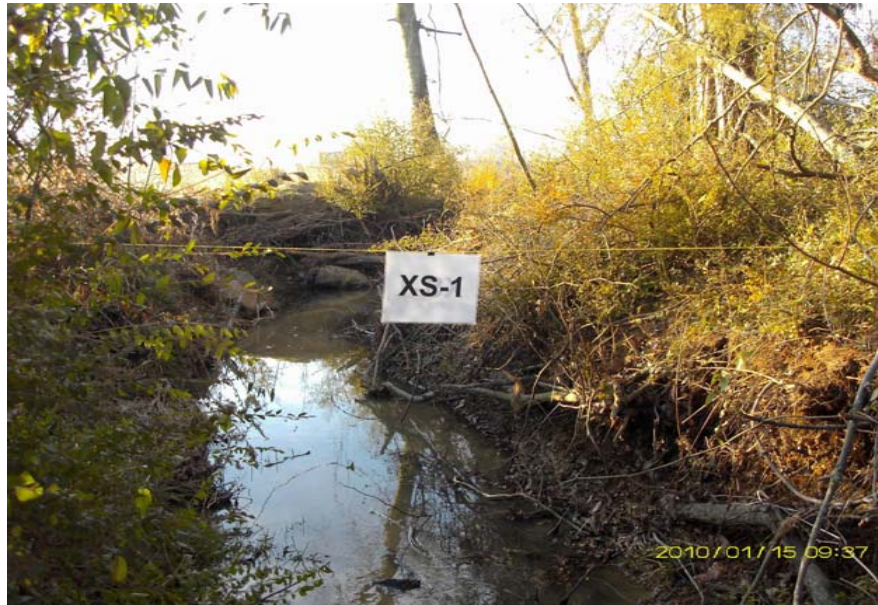
Cross Section 1 Station 5+36 Riffle

Baseline Section		
Station	Elevation	Notes
-41.12	600.00	TOPO
0.00	598.39	TOBL
1.20	596.79	Bankfull Left
1.18	596.79	X1
2.73	595.86	X1
4.13	594.81	X1 TOE
6.88	594.43	X1 TW
8.86	594.54	X1 TOE
10.22	597.77	X1 TOBR
11.41	598.33	X1
12.85	598.59	X1
116.88	600.00	0.00

Photo of XS-1, looking in the downstream direction

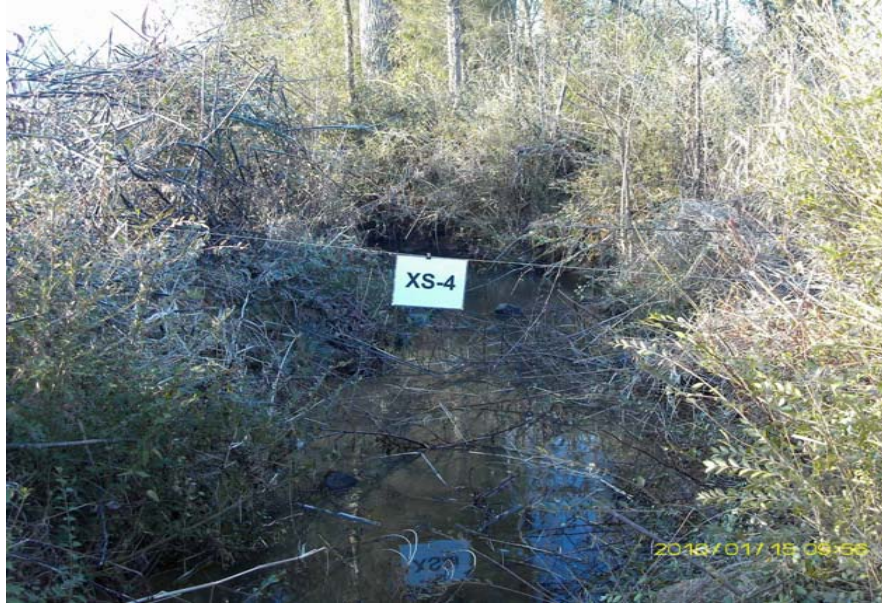
Cross Section 4 Station 7+79 Riffle

Project: New Town Main Channel
 Cross Section 4
 Feature: Riffle
 Station: 7+79
 Date: 13-Jan-10
 Crew: BW, RL, SV

Baseline Section		
Station	Elevation	Notes
-40.69	598.00	TOPO
0.00	596.67	X4
10.07	596.76	TOBL
14.05	596.09	X4
16.90	595.43	X4
18.15	594.57	Bankfull Left
19.76	593.29	X4 TOE
22.31	592.97	X4 TW
25.18	593.22	X4 TOE
27.31	594.51	Bankfull Right
30.97	594.88	X4
34.70	595.43	X4
92.31	598	TOPO

Photo of XS-4 looking in the downstream direction

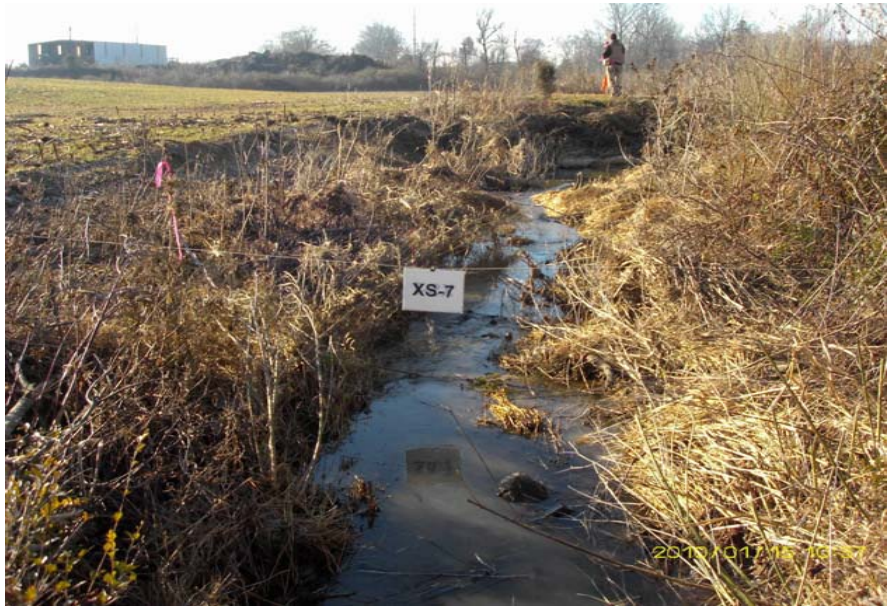
Cross Section 7 Station 9+65 Riffle

Project:	New Town Main Channel	Bankfull Summary	
Cross Section 7		A (BKF)	14.6
Feature	Riffle	W (BKF)	15.7
Station:	9+65	Max d	1.7
Date:	13-Jan-10	Mean d	0.9
Crew:	BW, RL, SV	W/D	16.8

Baseline Section			
Station	Elevation	Notes	
-18.74	596.00	TOPO	
0.00	595.27	X7	
7.15	595.64	TOBL	
10.39	595.38	X7	
14.69	594.01	X7	
17.50	593.21	X7	
18.87	592.76	X7	
20.09	592.43	X7TOE	
21.26	592.32	TW	
24.26	592.54	X7TOE	
25.97	593.15	X7	
27.02	593.54	Bankfull Right	
28.91	593.62	X7	
30.55	594.03	TOBR	
68.26	596	TOPO

Photo of XS-7, looking in the downstream direction

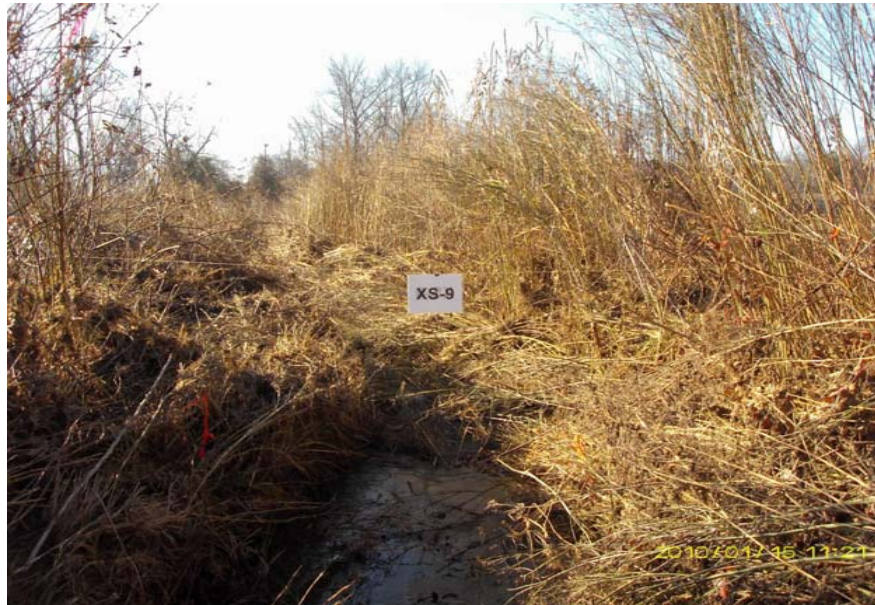
Cross Section 9 Station 13+66 Riffle

Project: New Town Main Channel
 Cross Section 9
 Feature: Riffle
 Station: 13+66
 Date: 13-Jan-10
 Crew: BW, RL, SV

Baseline Section		
Station	Elevation	Notes
0.00	592.96	X9
8.65	593.13	X9
13.44	592.98	X9
16.49	592.00	TOBL
18.11	591.27	Bankfull Left
19.56	590.88	X9
20.49	589.59	X9 TOE
22.32	589.37	X9 TW
24.29	589.54	X9
25.32	589.77	X9 TOE
26.71	591.12	Bankfull Right
27.53	591.76	X9 TOBR
31.87	592.70	X9
36.67	593.13	X9
47.52	592.79	X9

Photo of XS-9, looking in the downstream direction

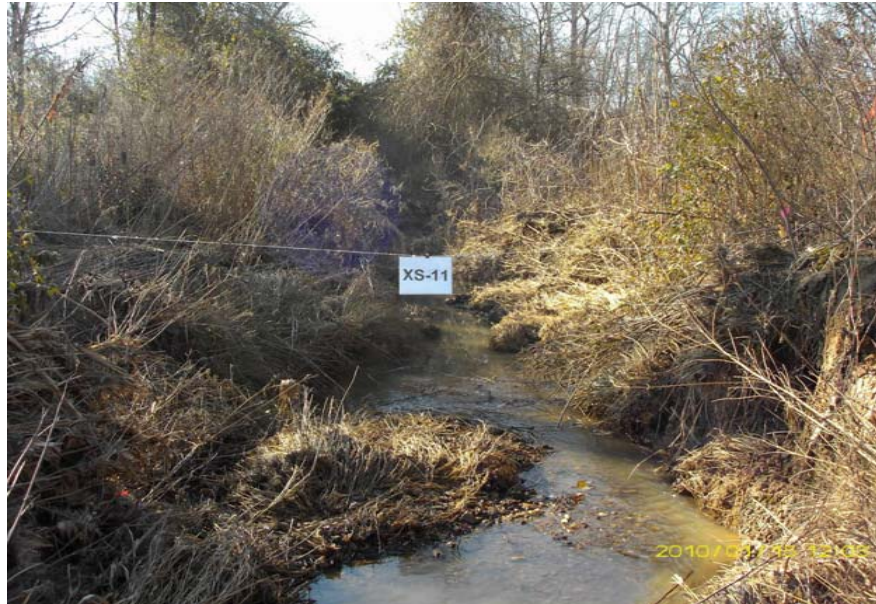
Cross Section 11 Station 16+08 Riffle

Project: New Town Main Channel
 Cross Section 11
 Feature: Riffle
 Station: 16+08
 Date: 13-Jan-10
 Crew: BW, RL, SV

Bankfull Summary	
A (BKF)	10.5
W (BKF)	8.3
Max d	1.6
Mean d	1.3
W/D	6.5

Photo of XS-11, looking in the downstream direction

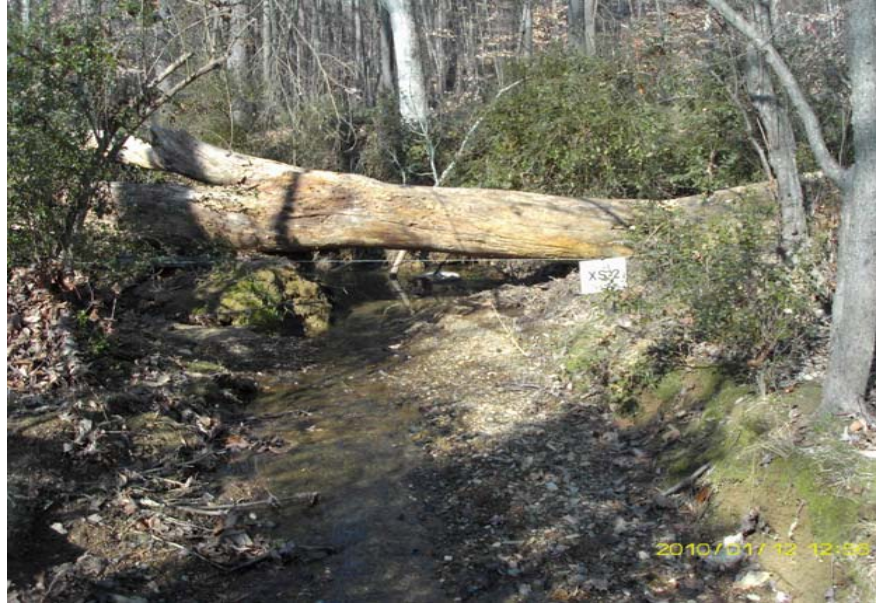
Cross Section 2 Station 1+52 Riffle

Project:	New Town Trib	Bankfull Summary	
Cross Section 2		A (BKF)	13.0
Feature	Riffle	W (BKF)	13.8
Station:	1+52	Max d	1.6
Date:	13-Jan-10	Mean d	0.9
Crew:	BW, RL, SV	W/D	14.7

Photo of XS-2, looking in the downstream direction

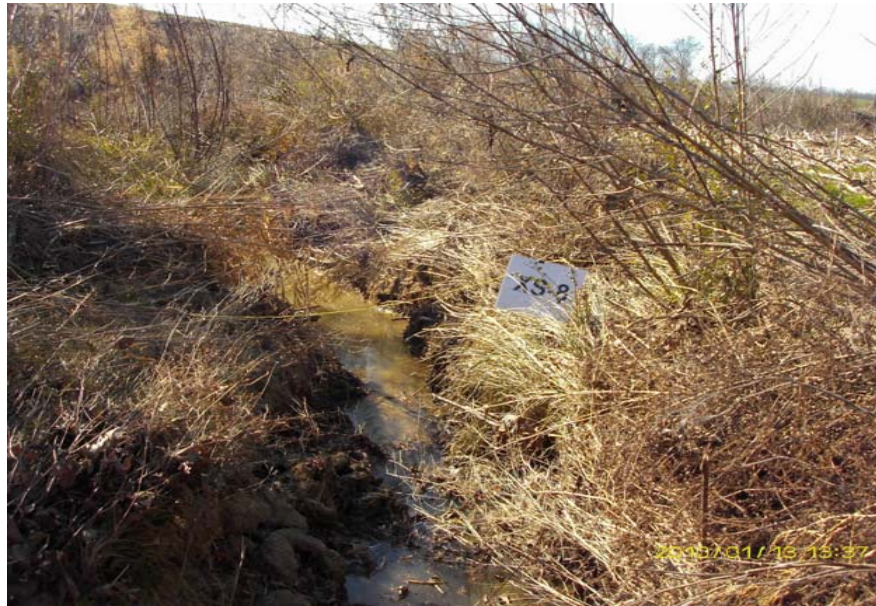
Cross Section 8 Station 9+24 Riffle

Project: New Town Trib
 Cross Section 8
 Feature: Riffle
 Station: 9+24
 Date: 13-Jan-10
 Crew: BW, RL, SV

Baseline Section		
Station	Elevation	Notes
0.00	608.72	X8
5.15	608.79	X8 TOBL
5.83	608.37	X8
7.63	607.92	X8
9.47	607.40	X8
10.34	606.79	Bankfull Left
10.66	606.70	X8
11.08	605.89	X8
11.78	605.73	X8
11.93	605.38	X8 TOE
12.82	605.30	TW
12.98	605.54	X8 TOE
14.23	606.82	X8
15.05	607.03	X8
16.91	607.38	X8
19.01	608.10	X8
27.47	608.71	X8

Photo of XS-8 looking in the downstream direction

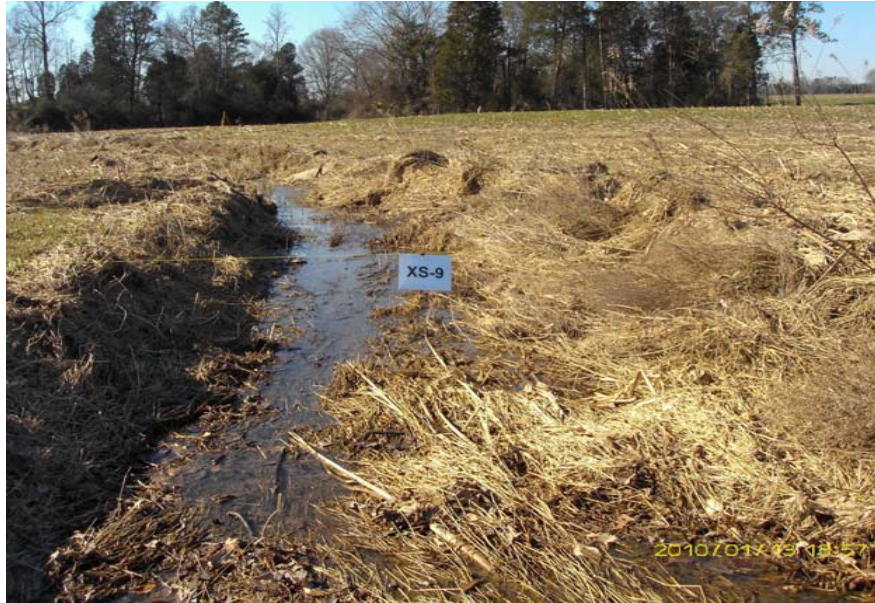
Cross Section 9 Station 16+49 Riffle

Project:	New Town Trib	Bankfull Summary	
Cross Section 9		A (BKF)	18.7
Feature	Riffle	W (BKF)	13.9
Station:	16+49	Max d	1.9
Date:	13-Jan-10	Mean d	1.3
Crew:	BW, RL, SV	W/D	10.3

Photo of XS-9, looking in the downstream direction

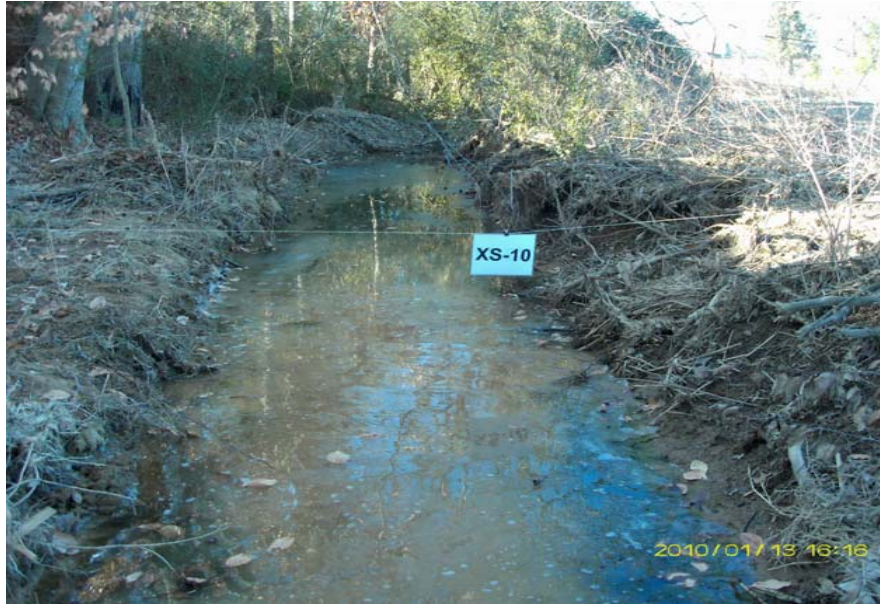
Cross Section 10 Station 21+64 Riffle

Project:	New Town Trib	Bankfull Summary	
Cross Section:	10	A (BKF)	14.1
Feature:	Riffle	W (BKF)	13.4
Station:	21+64	Max d	1.9
Date:	13-Jan-10	Mean d	1.1
Crew:	BW, RL, SV	W/D	12.8

Baseline Section		
Station	Elevation	Notes
0.00	602.50	X10
2.63	601.83	X10
3.46	601.60	Bankfull Left
5.29	601.41	X10
6.58	601.19	X10 TOBL
7.25	600.16	X10 TOE
10.22	599.72	X10 TW
12.79	599.97	X10
13.26	600.23	X10 TOE
15.21	600.98	Bankfull Right
17.36	601.86	X10 TOBR
22.11	602.14	X10
28.79	602.19	X10
35.10	602.24	X10

Photo of XS-10, looking in the downstream direction

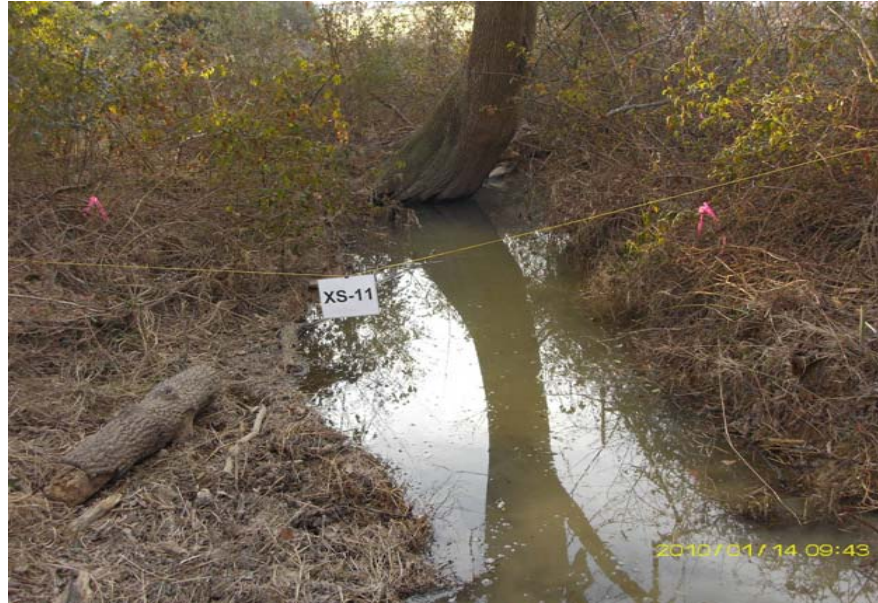
Cross Section 11 Station 26+54 Riffle

Project:	New Town Trib	Bankfull Summary	
Cross Section 11		A (BKF)	13.4
Feature	Riffle	W (BKF)	10.3
Station:	26+54	Max d	2.1
Date:	13-Jan-10	Mean d	1.3
Crew:	BW, RL, SV	W/D	8.0

Baseline Section		
Station	Elevation	Notes
0.00	600.81	X11
3.07	600.49	TOBL
5.61	599.22	Bankfull Left
6.81	598.85	X11
8.51	598.27	X11
9.24	597.40	X11TOE
12.74	597.11	X11TW
13.82	597.61	X11TOE
14.82	598.20	X11
15.92	599.28	Bankfull Right
16.76	600.01	TOBR
22.96	600.80	X11
27.37	601.21	X11

Photo of XS-11, looking in the downstream direction

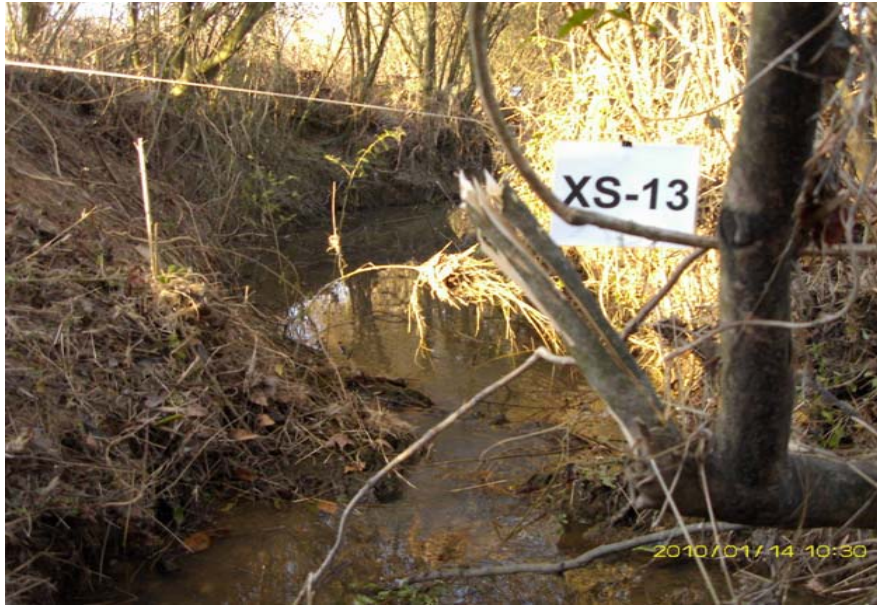
Cross Section 13 Station 29+16 Riffle

Project:	New Town Trib	Bankfull Summary	
Cross Section:	13	A (BKF)	8.6
Feature:	Riffle	W (BKF)	7.3
Station:	29+16	Max d	1.8
Date:	13-Jan-10	Mean d	1.2
Crew:	BW, RL, SV	W/D	6.2

Baseline Section		
Station	Elevation	Notes
0.00	598.67	X13
4.19	597.91	X13
8.01	598.16	X13
20.74	598.40	X13
29.89	597.39	TOBL
30.92	597.15	X13
31.58	596.54	X13
32.71	594.91	X13TOE
34.51	594.73	TW
37.00	594.78	X13TOE
37.68	595.49	X13
38.91	596.52	Bankfull Right
39.62	596.96	X13
41.00	597.55	TOBR
44.92	598.26	X13
46.57	598.89	X13

Photo of XS-13, looking in the downstream direction

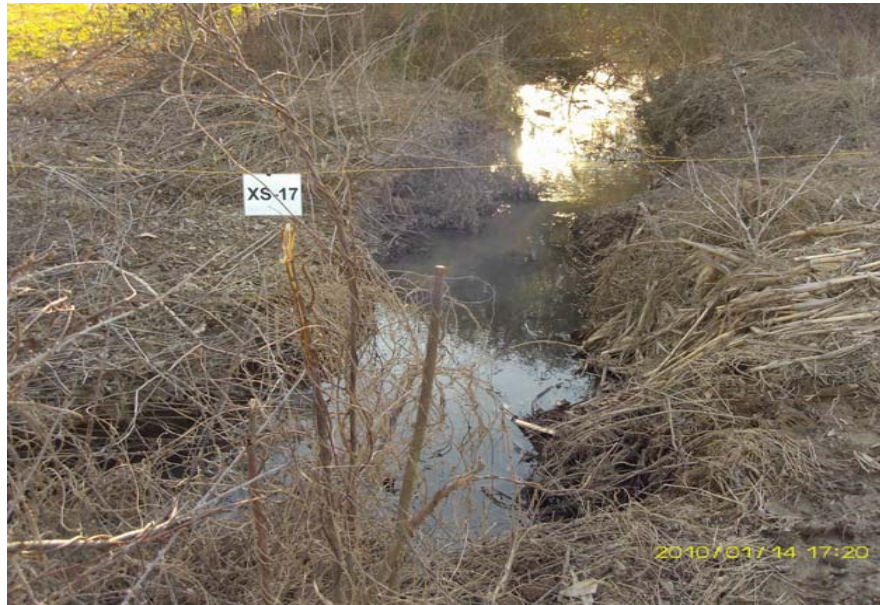
Cross Section 17 Station 35+86 Riffle

Project:	New Town Trib	Bankfull Summary	
Cross Section	17	A (BKF)	13.0
Feature	Riffle	W (BKF)	16.0
Station:	35+86	Max d	2.2
Date:	13-Jan-10	Mean d	0.8
Crew:	BW, RL, SV	W/D	19.9

Baseline Section		
Station	Elevation	Notes
0.00	595.48	X17
14.79	595.20	X17
24.36	594.77	X17
26.09	594.15	Bankfull Left
28.32	594.14	X17
30.59	593.47	X17
35.82	593.22	X17 TOBL
36.73	592.15	X17 TOE
37.47	591.92	X17 TW
39.22	592.33	X17 TOE
39.68	593.28	X17
40.33	593.81	X17
42.17	594.18	Bankfull Right
43.28	595.04	X17 TOBR
45.84	595.17	X17
55.46	595.32	X17

Photo of XS-17, looking in the downstream direction

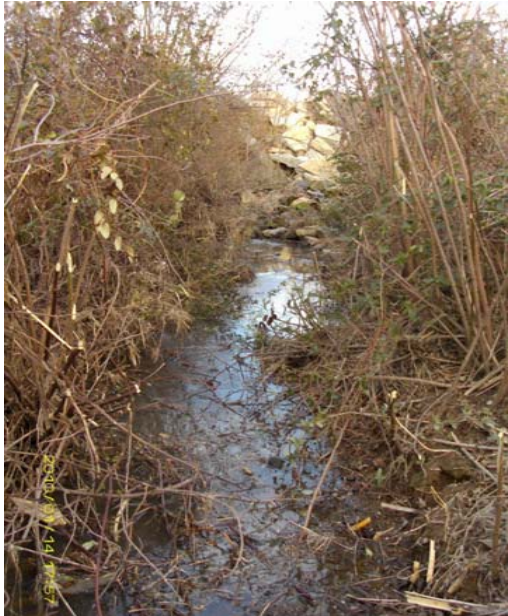
Project:	New Town Trib	Bankfull Summary	
Cross Section	18	A (BKF)	18.8
Feature	Riffle	W (BKF)	12.0
Station:	38+96	Max d	2.6
Date:	13-Jan-10	Mean d	1.6
Crew:	BW, RL, SV	W/D	7.7

Photo of XS-18, looking in the downstream direction

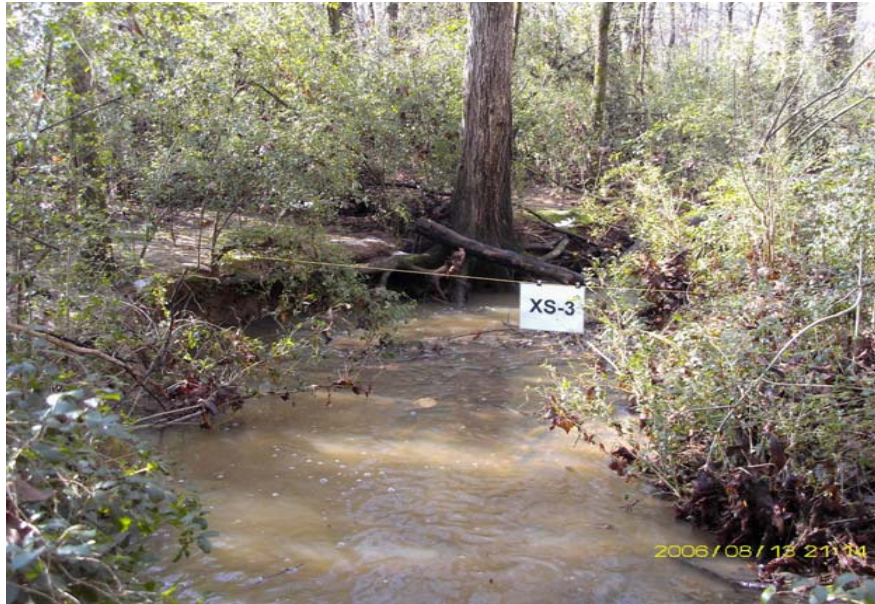
Photo of XS-3, looking in the downstream direction

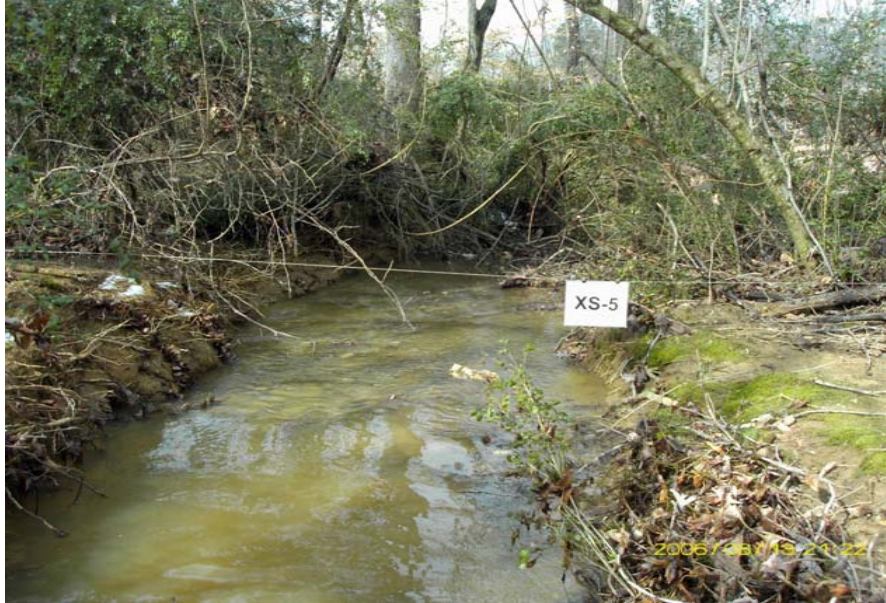
Project:	New Town Trib-Reference	Bankfull Summary	
Cross Section 5		A (BKF)	13.0
Feature	Riffle	W (BKF)	13.9
Station:	8+27	Max d	1.8
Date:	2-Feb-10	Mean d	0.9
Crew:	BW, RL, SV	W/D	14.8

Photo of XS-5, looking in the downstream direction

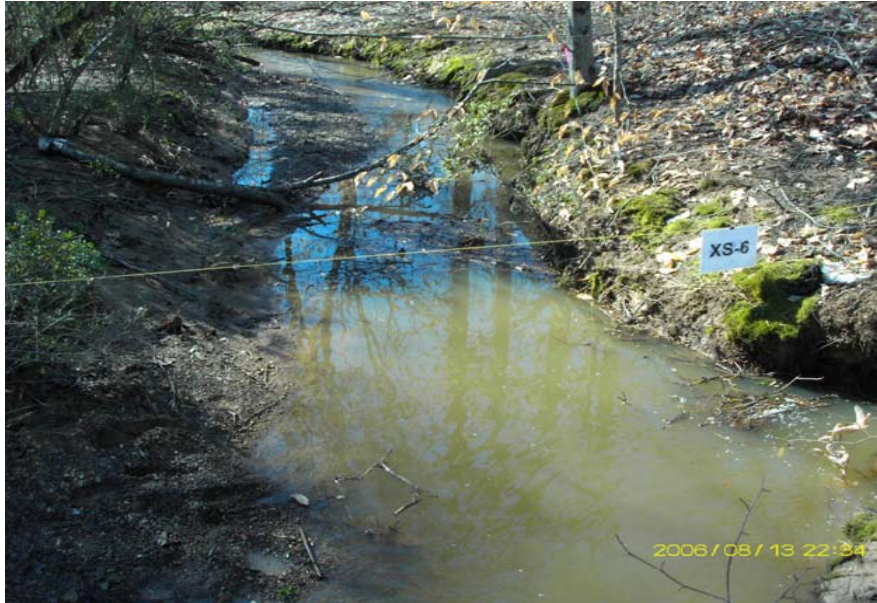
Project:	New Town Trib-Reference	Bankfull Summary	
Cross Section	6	A (BKF)	22.9
Feature	Riffle	W (BKF)	16.8
Station:	8+68	Max d	3.1
Date:	2-Feb-10	Mean d	1.4
Crew:	BW, RL, SV	W/D	12.3

Photo of XS-6, looking in the downstream direction
