**Newtown Stream and Wetland
Restoration Project
Union County, North Carolina
RFP 16-001117, SCO ID# 002025**

**Baseline Monitoring Document and As-Built Baseline Report
Final**

Data Collected: April 2011
Submitted: June 13, 2011

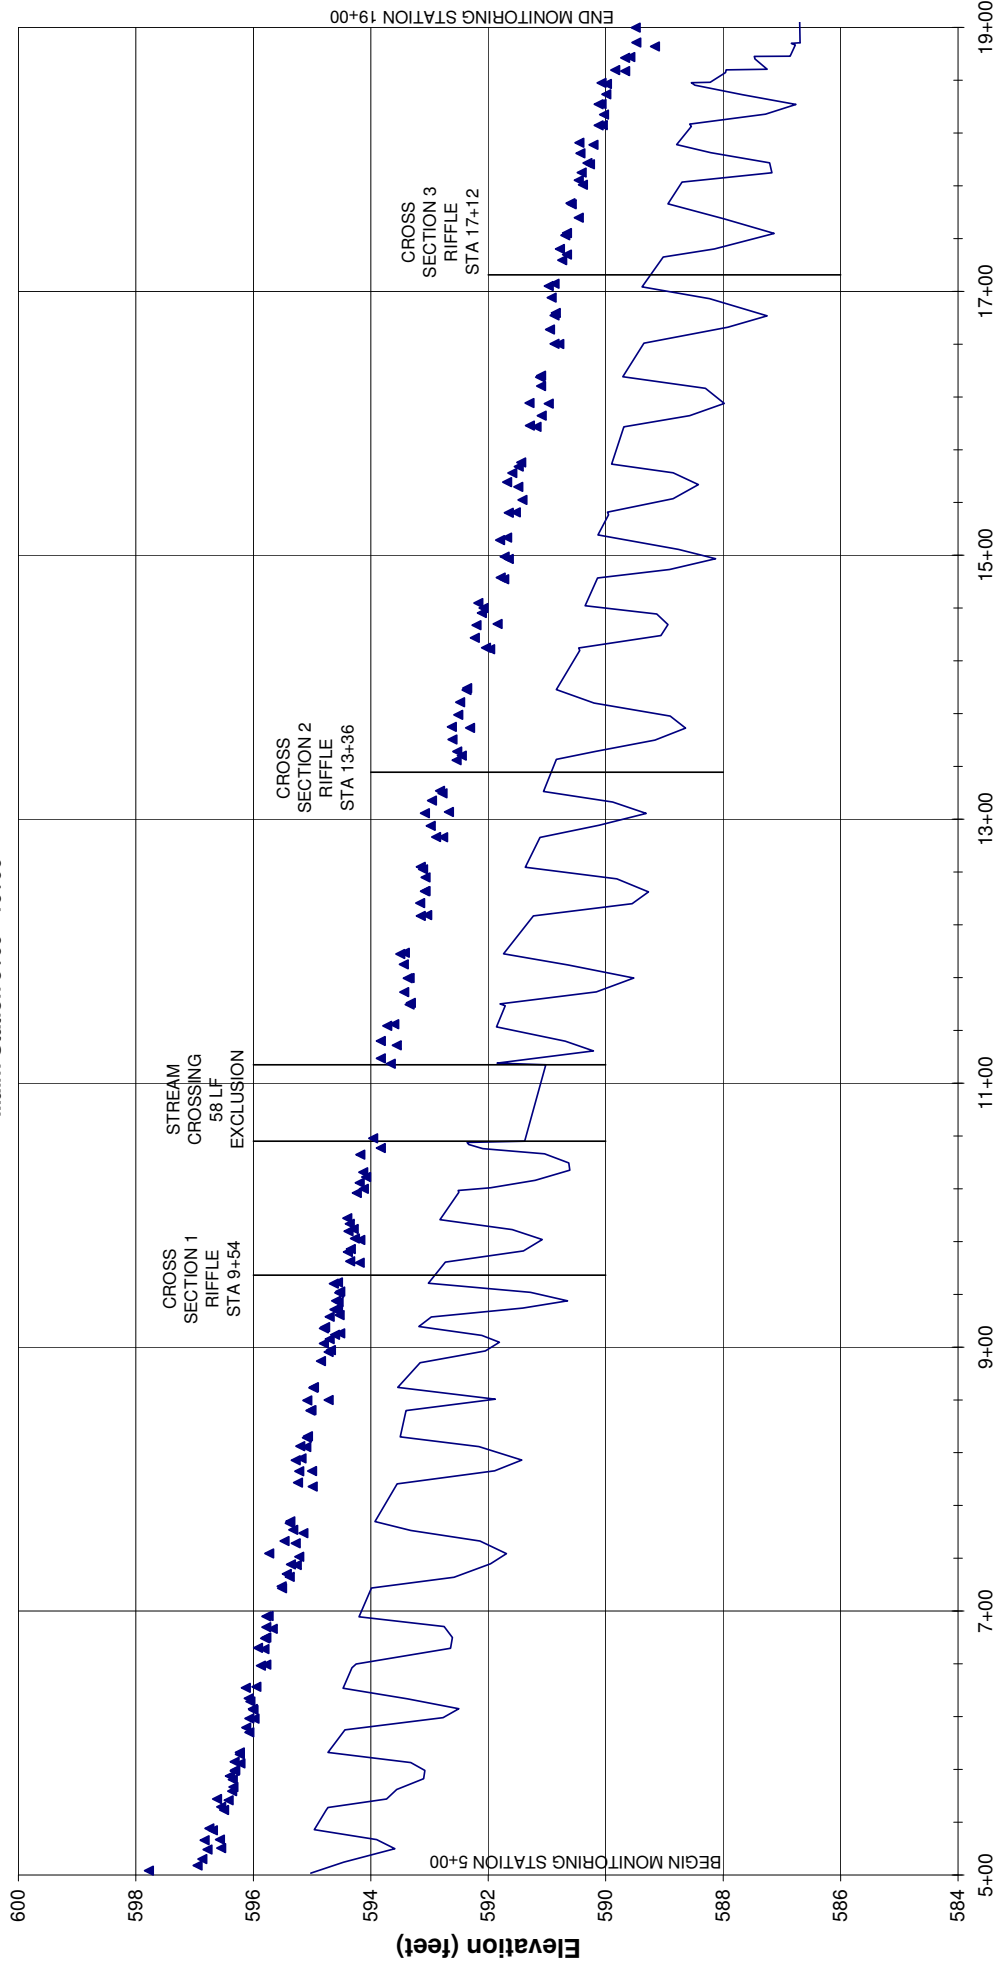
Underwood Creek (Newtown)
Longitudinal Profile
Main: Station 5+00 - 19+00

— TW MY-00 ▲ BKF MY-00

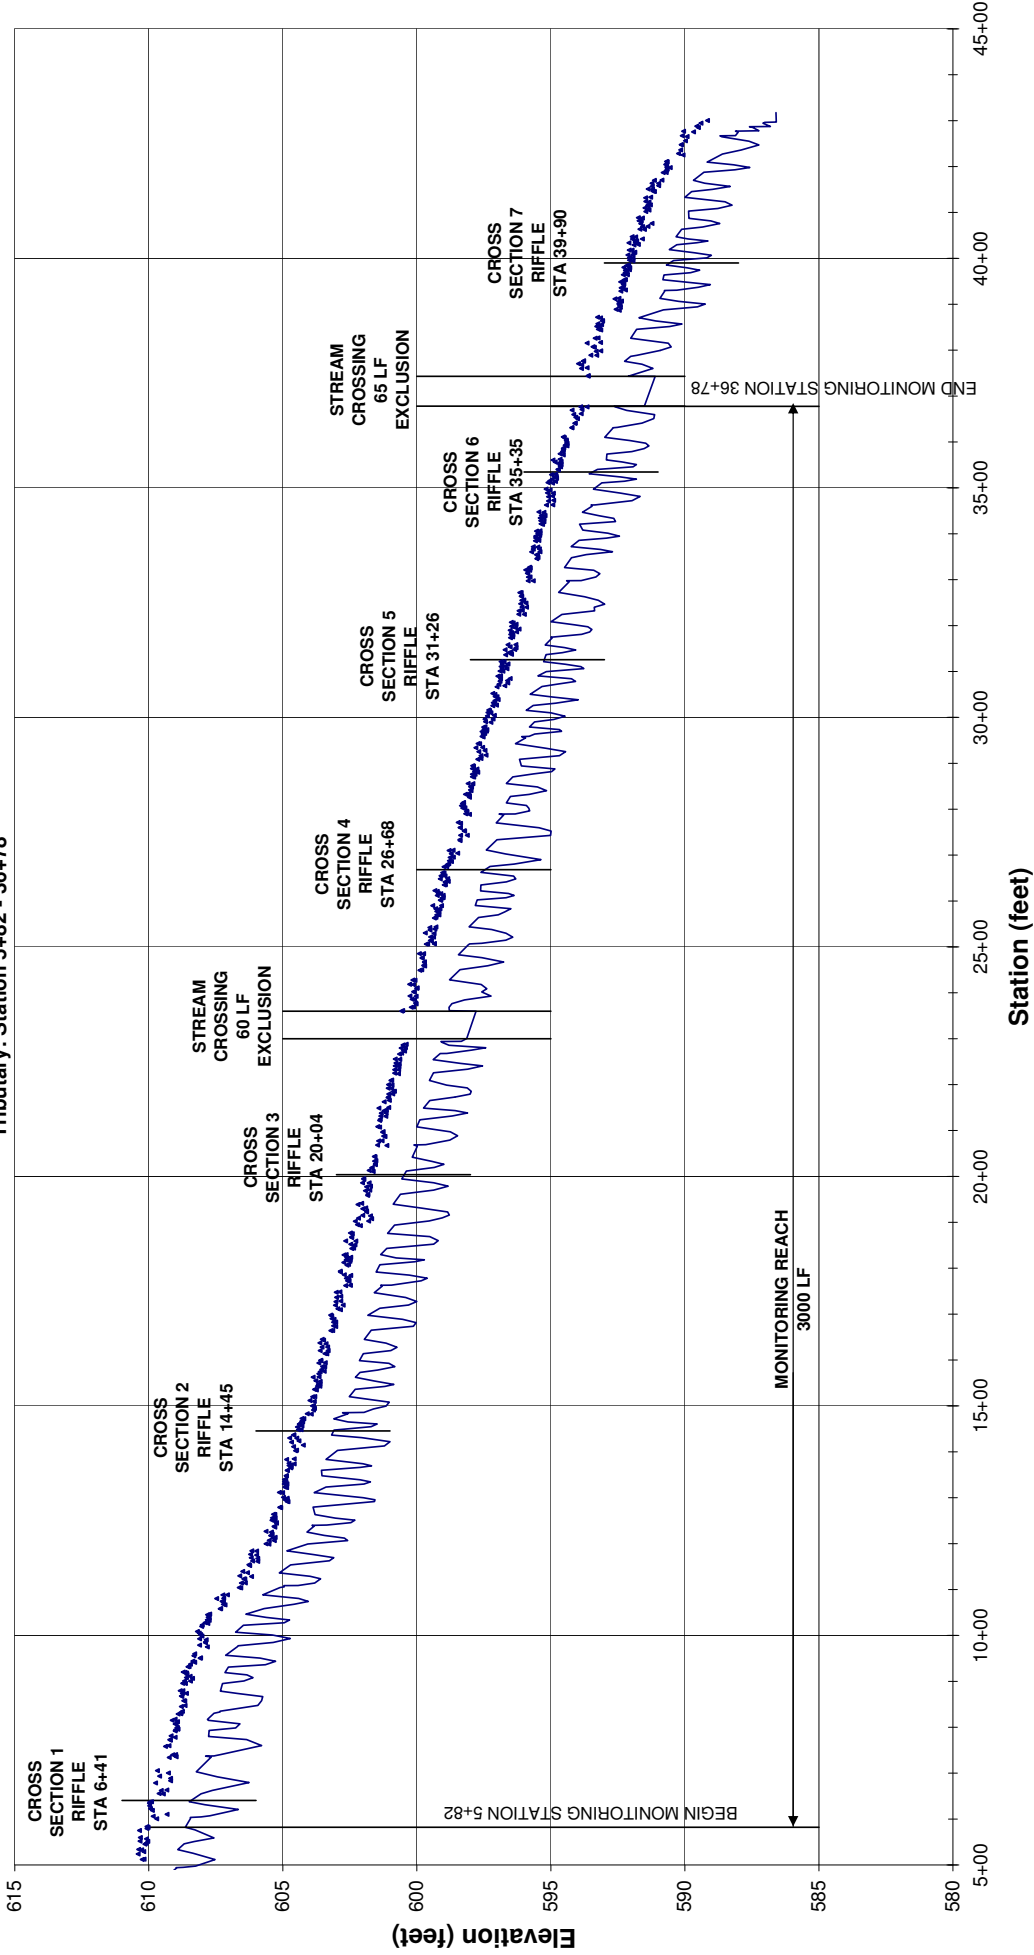
UT to Underwood Creek (Newtown)
 Longitudinal Profile
 Tributary: Station 5+82 - 36+78

— TW MY-00 · BKF MY-00

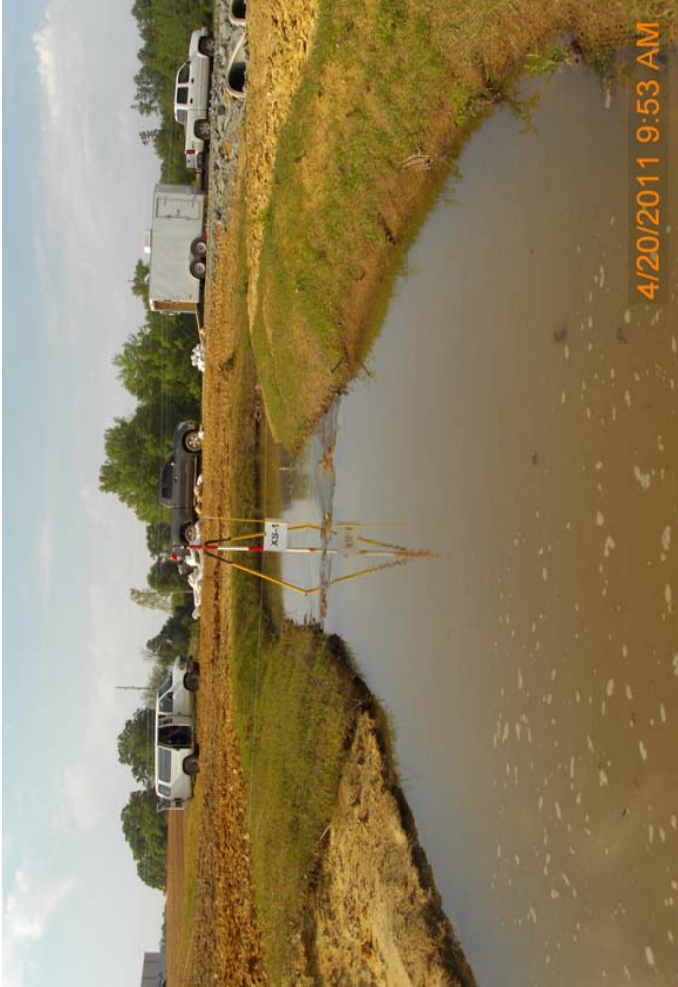
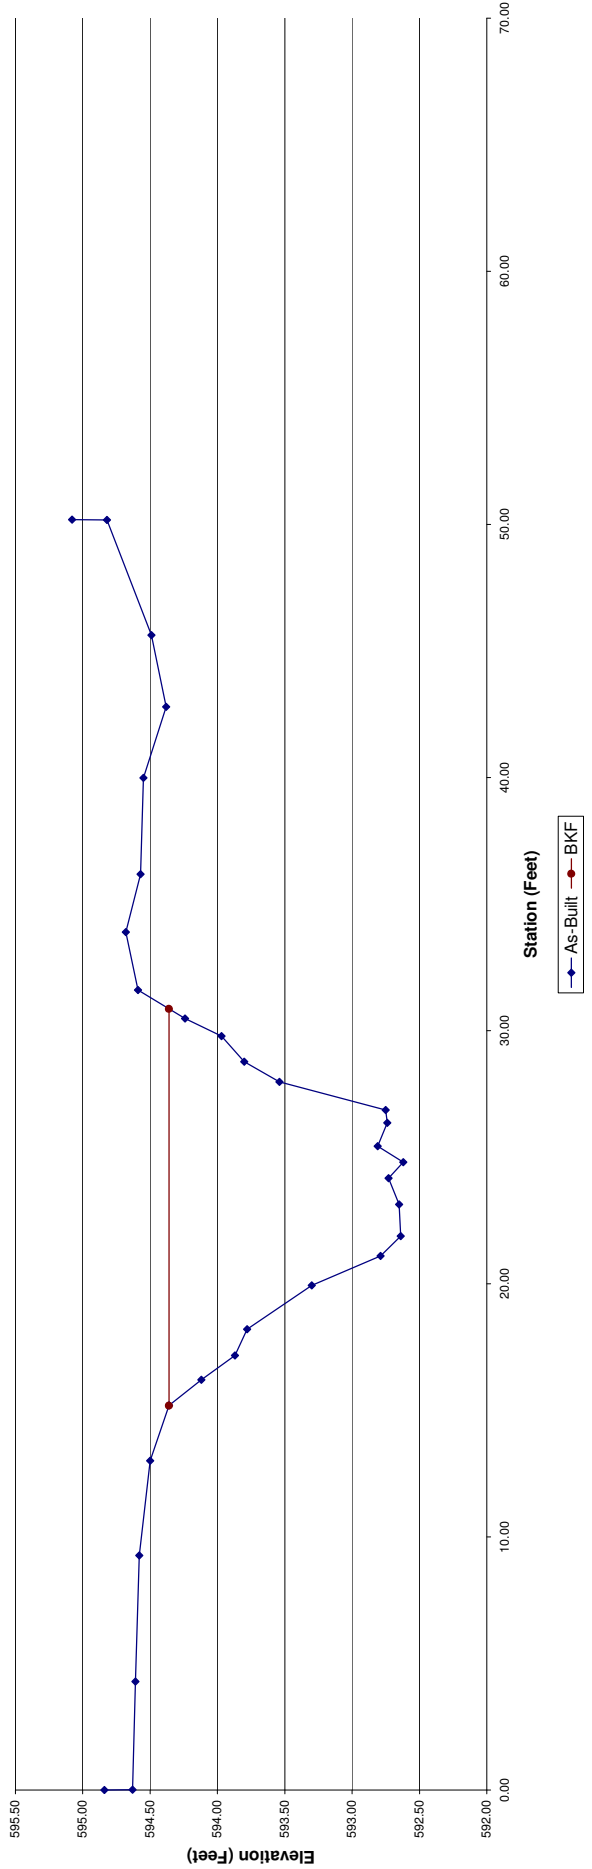
Underwood Creek Cross Section 1

Project: Underwood Creek		Summary (bankfull)	
Cross Section: Cross Section 1	MY0		
Feature: R/Rifle	A (BKF)	16.1	
Station: 9+54.47	W (BKF)	15.7	
Date: 4/22/11	Max d	1.7	
Crew: ZAP	Mean d	1.0	
	W/D	15.2

Photo of XS-1, looking in the downstream direction

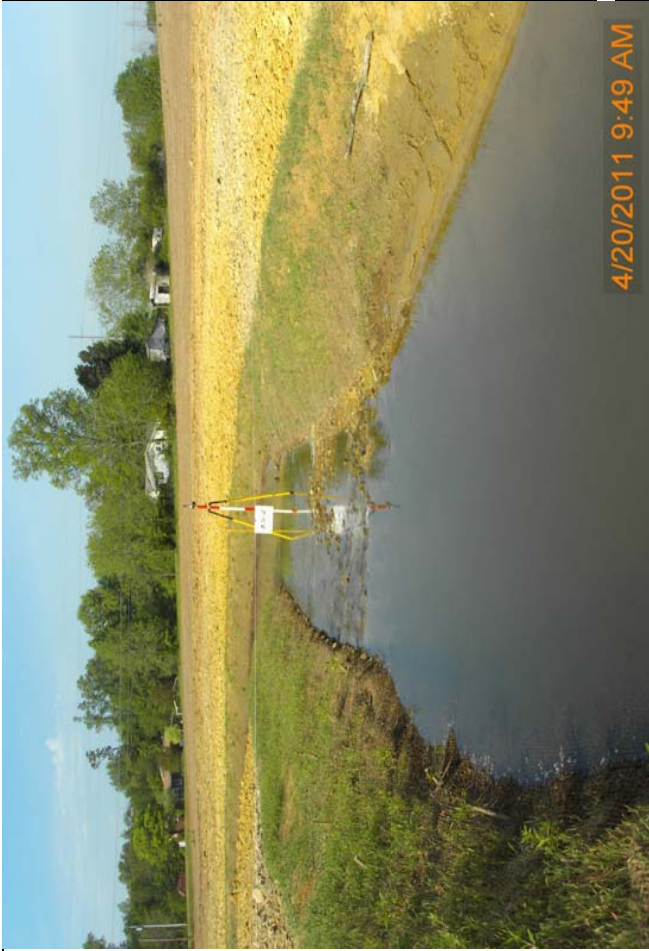
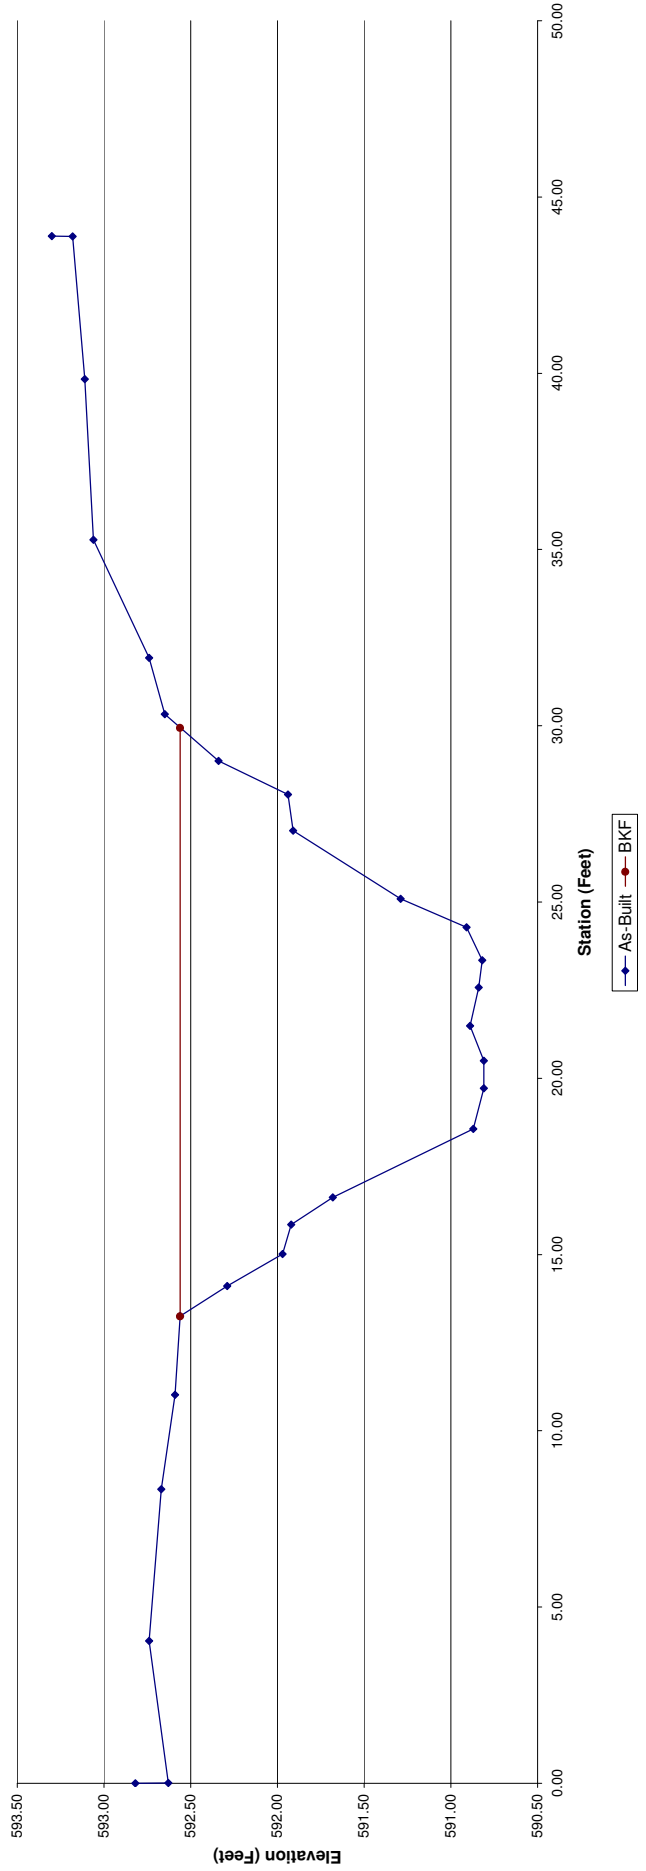
Underwood Creek Cross Section 2

Project: Underwood Creek		Summary (bankfull)	
Cross Section: Cross Section 2	MY0		
Feature: Riffe	A (BKF)	18.1	
Station: 13+35.70	W (BKF)	16.7	
Date: 4/22/11	Max d	1.8	
Crew: ZAP	Mean d	1.1	
	W/D	15.4

Photo of XS-2, looking in the downstream direction

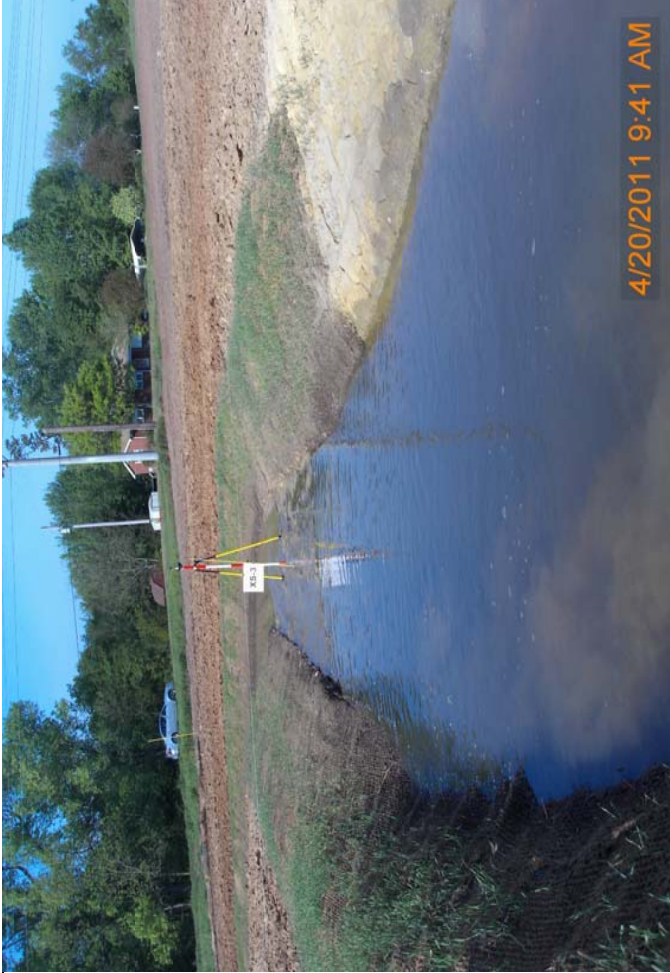
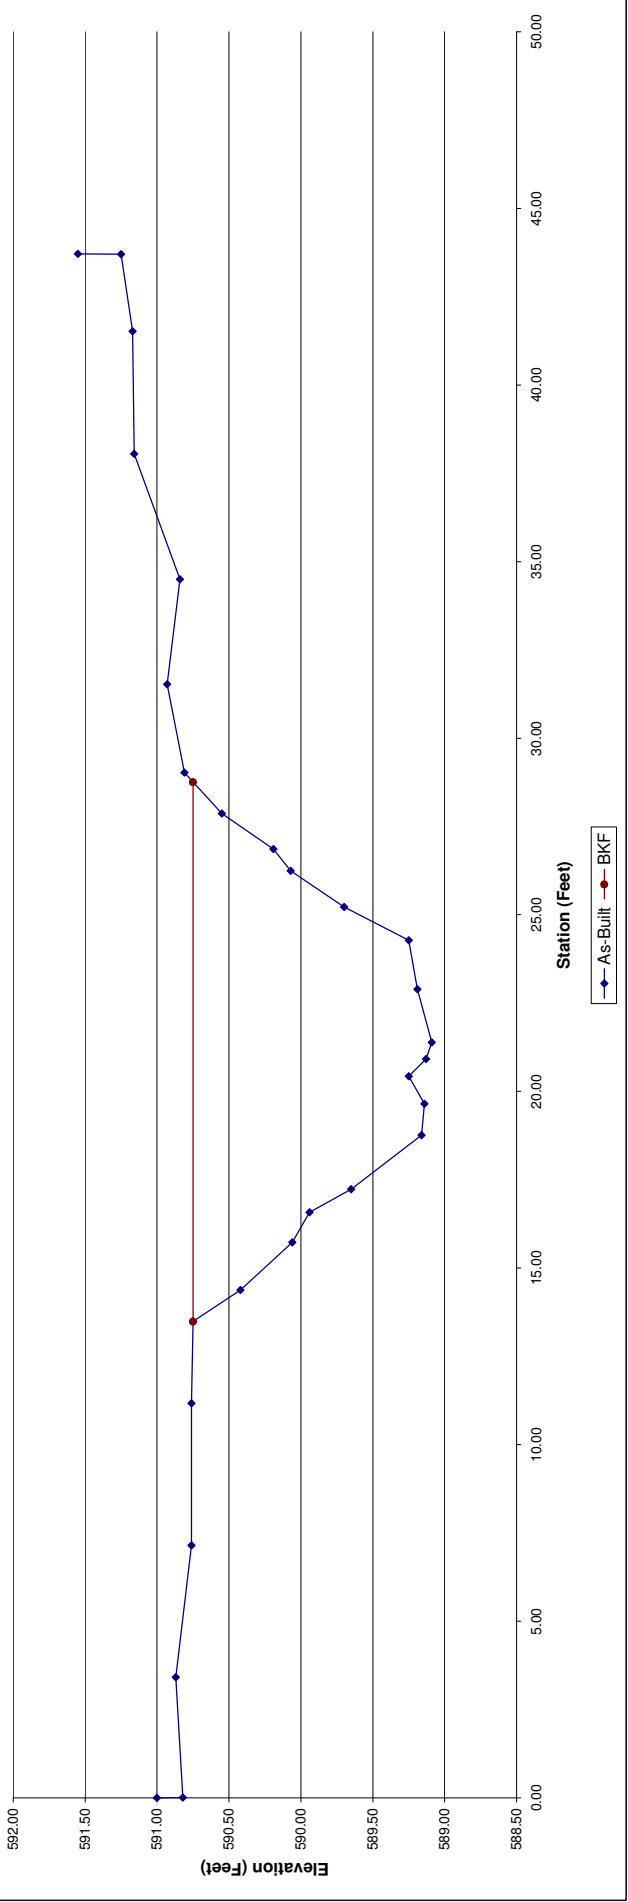
Underwood Creek Cross Section 3

Project: Underwood Creek		Summary (bankfull)	
Cross Section: Cross Section 3		MY0	
Feature: Riffe		15.8	
Station: 17+12.49		15.3	
Date: 4/22/11		1.7	
Crew: ZAP		1.0	
		14.8

Photo of XS-3 looking in the downstream direction

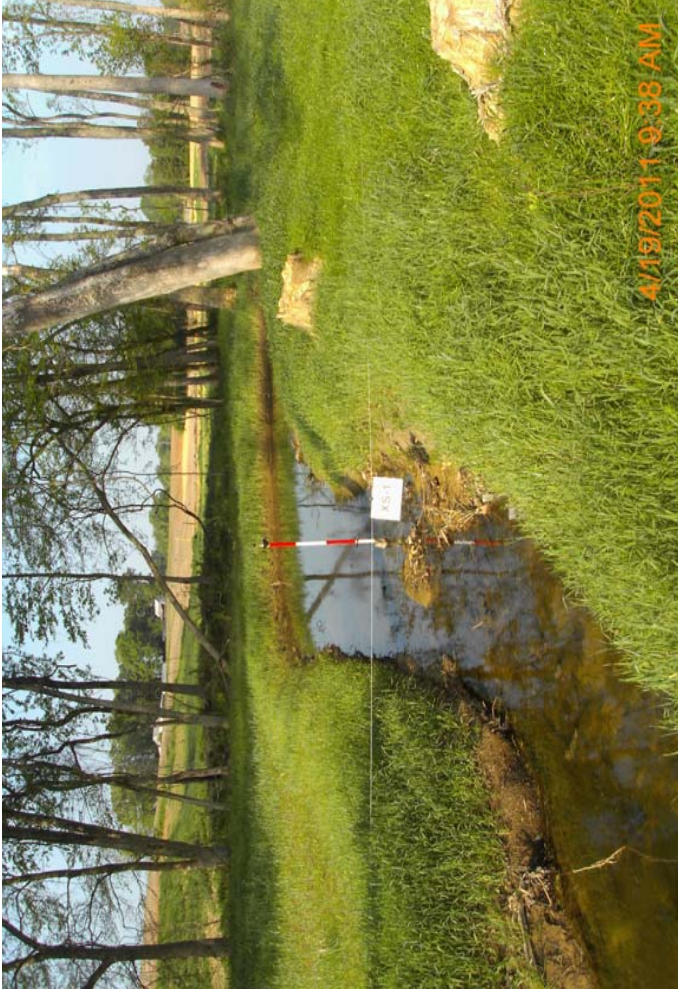
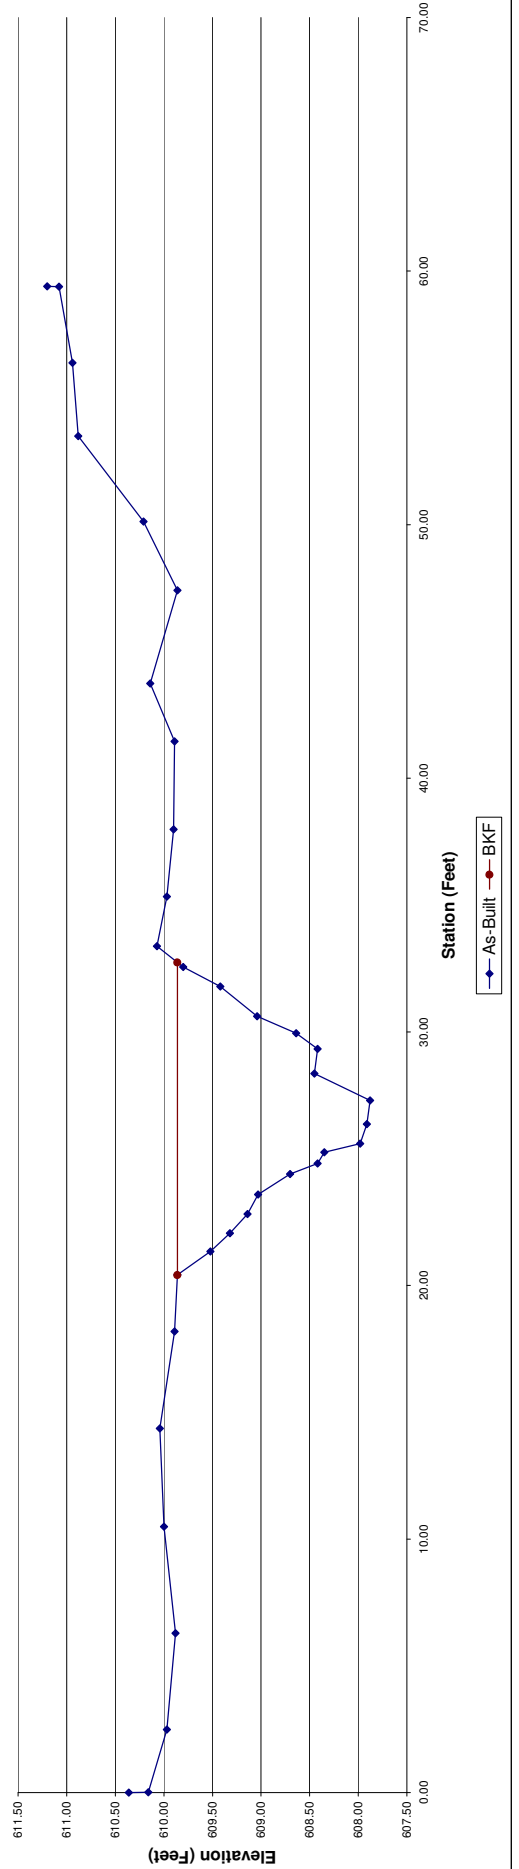
UT to Underwood Creek Cross Section 1

Project: UT to Underwood Creek		Summary (bankfull)	
Cross Section: Cross Section 1	MY0		
Feature: Riffe	13.1		
Station: 6+40.50	12.3		
Date: 4/22/11	Max d	2.0	
Crew: ZAP	Mean d	1.1	
	W/D	1.1.6

Photo of XS-1, looking in the downstream direction

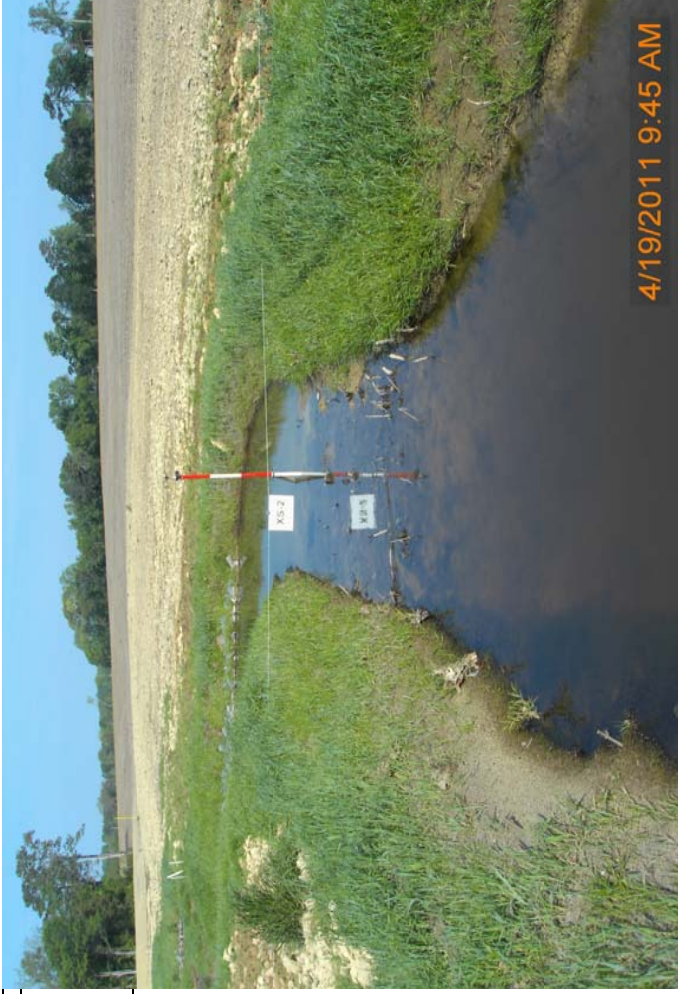
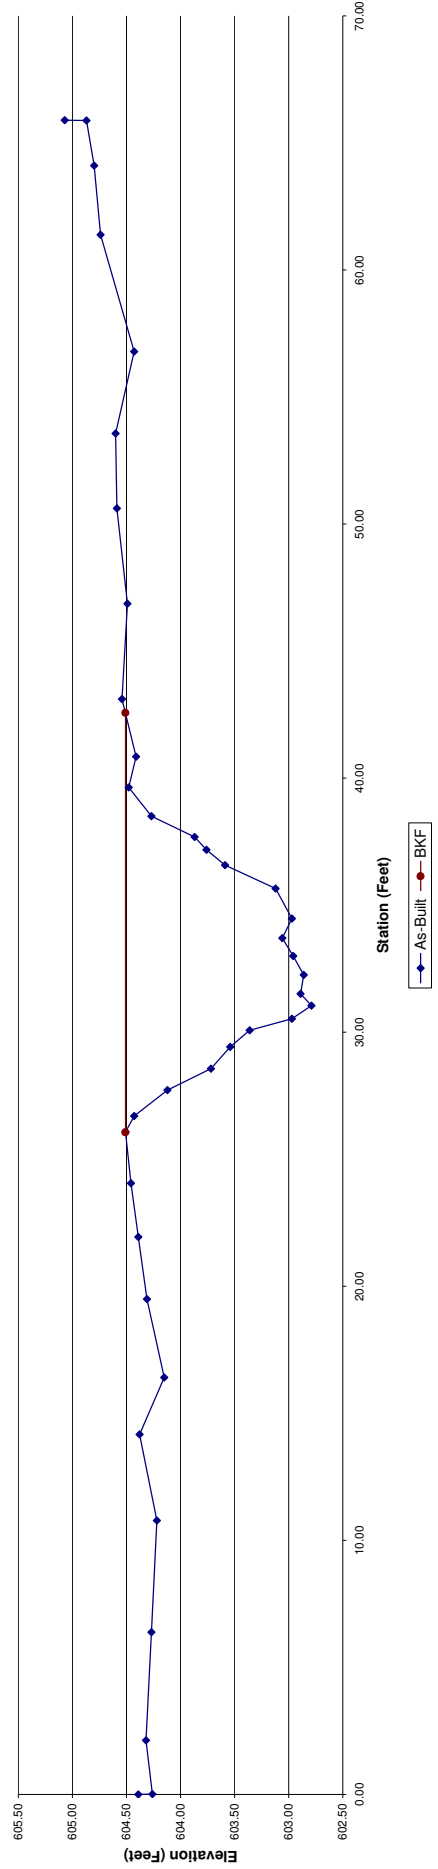
UT to Underwood Creek Cross Section 2

Project:	UT to Underwood Creek			
Cross Section:	Cross Section 2			
Feature:	Riffle			
Station:	14+45.49			
Date:	4/22/11			
Crew:	ZAP			
	Summary (bankfull)			
A (BKF)	MY0			
W (BKF)	13.4			
Max d	16.5			
Mean d	1.7			
W/D	0.8			
	20.4

Photo of XS-2, looking in the downstream direction

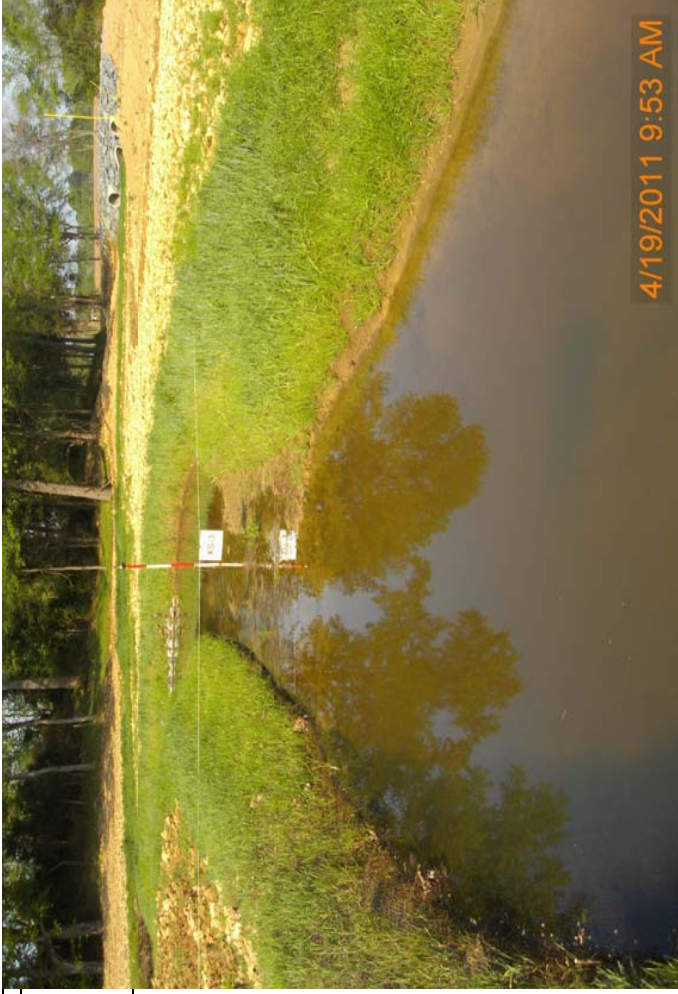
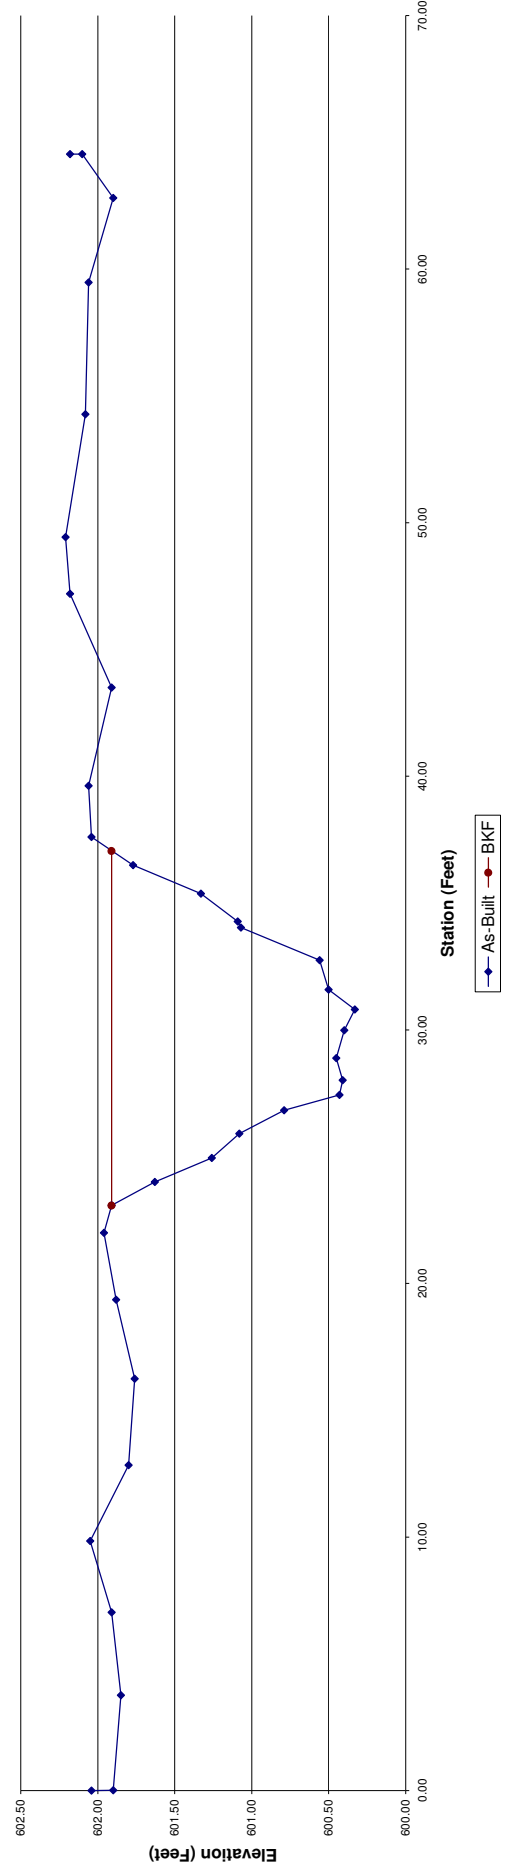
UT to Underwood Creek Cross Section 3

Project:	UT to Underwood Creek				
Cross Section:	Cross Section 3				
Feature:	Rifle				
Station:	20+03.76				
Date:	4/22/11				
Crew:	ZAP				
	Summary (bankfull)				
	MY0				
A (BKF)	13.6				
W (BKF)	14.0				
Max d	1.6				
Mean d	1.0				
W/D	14.4

Photo of XS-3 looking in the downstream direction

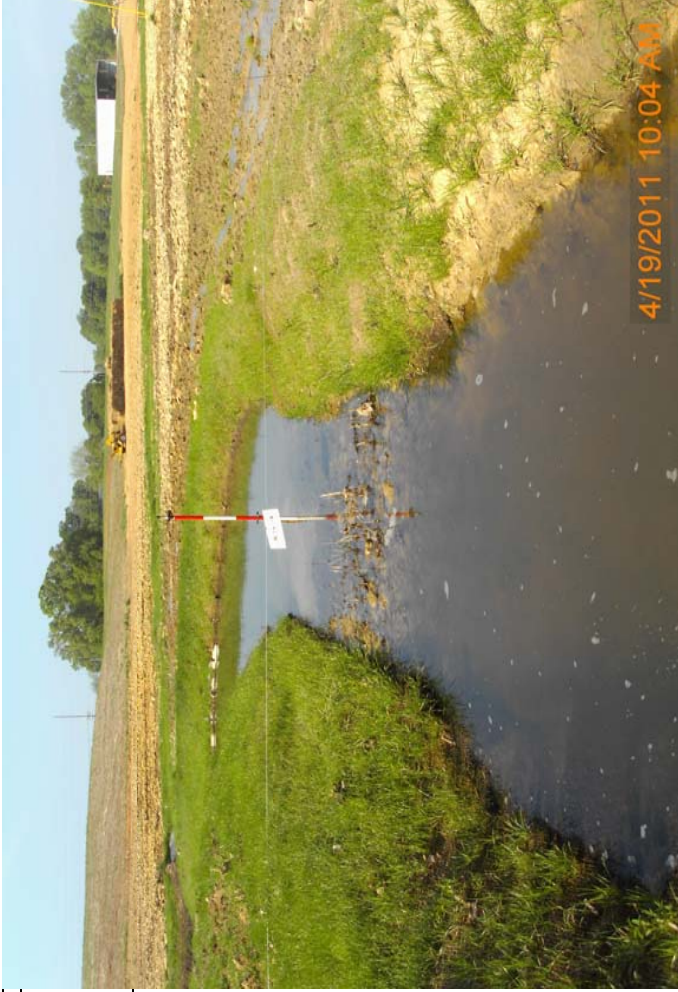
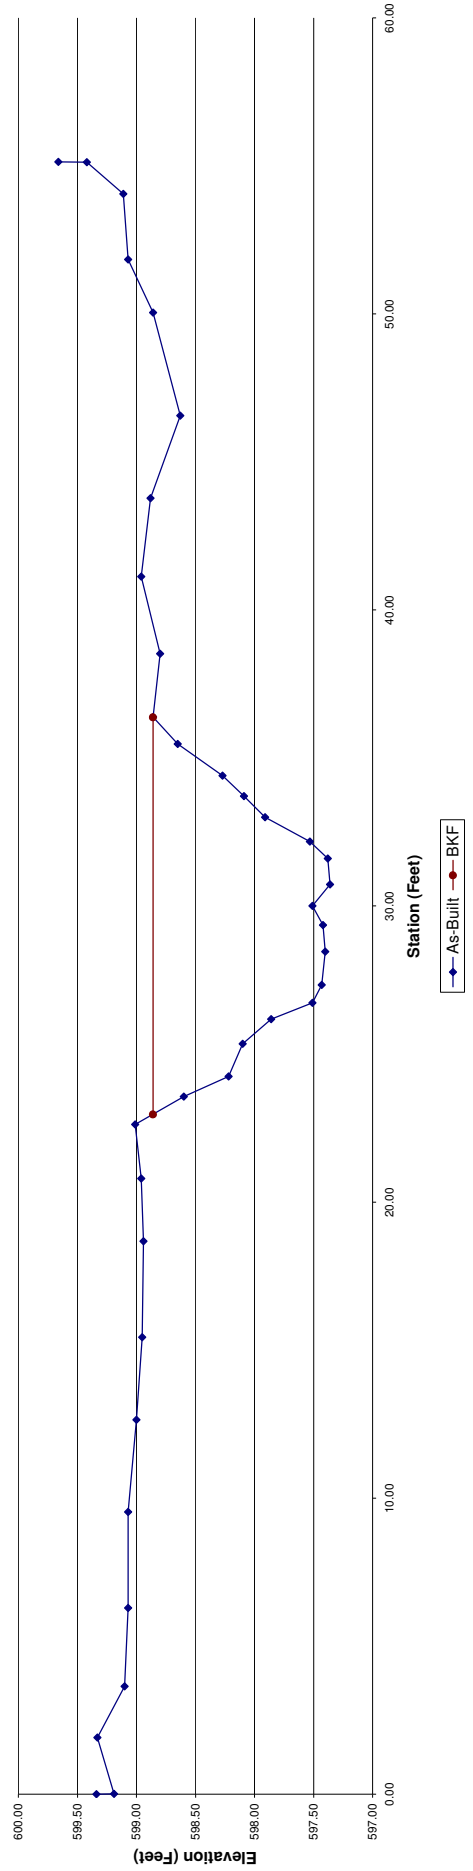
UT to Underwood Creek Cross Section 4

Project:	UT to Underwood Creek										
Cross Section:	Cross Section 4										
Feature:	Rifle										
Station:	26+68.31										
Date:	4/22/11										
Crew:	ZAP										
	Summary (bankfull)										
	MY0	MY1	MY2	MY3	MY4	MY5					
A (BKF)	12.9										
W (BKF)	13.4										
Max d	1.5										
Mean d	1.0										
W/D	13.9

Photo of XS-4, looking in the downstream direction

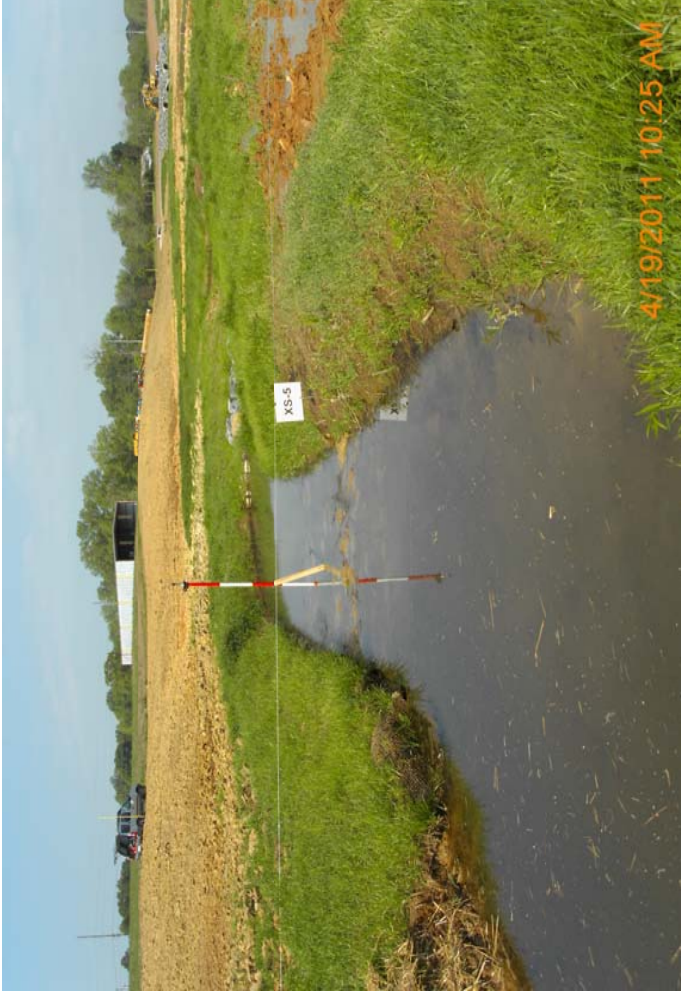
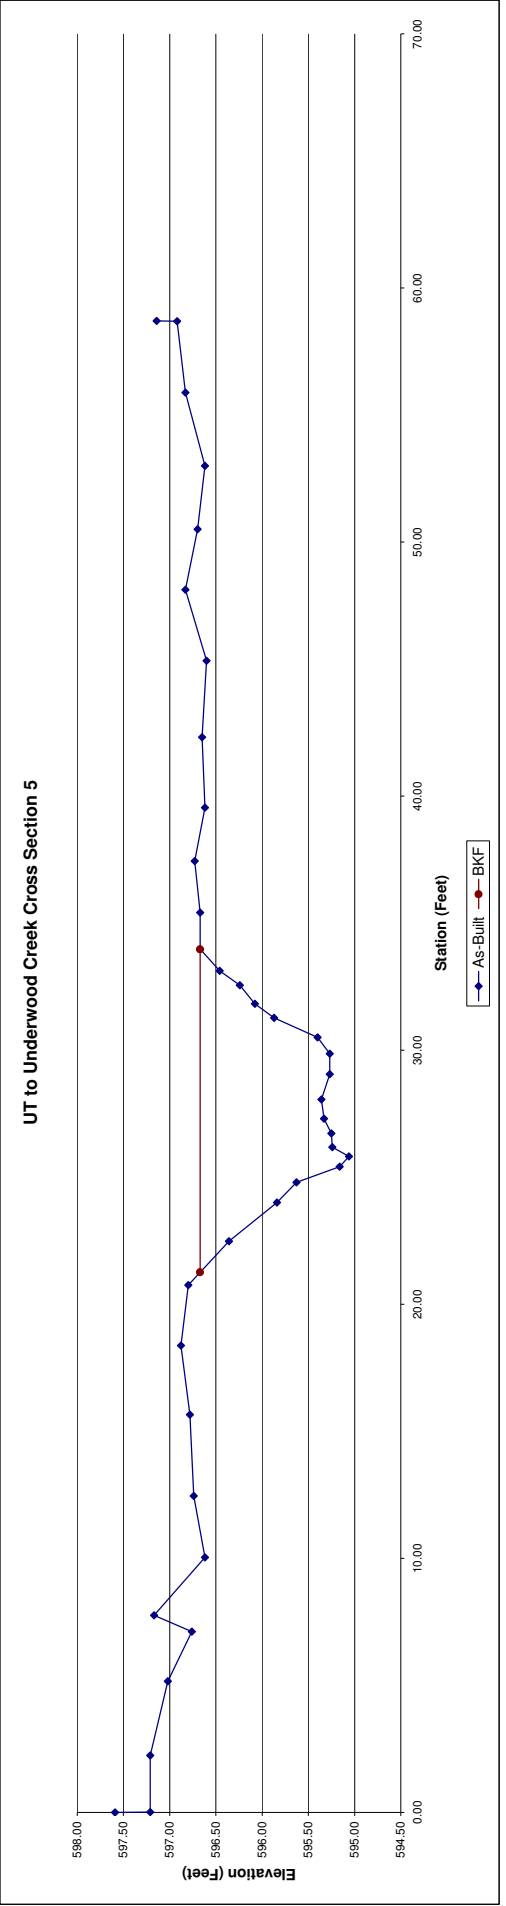
Project:	UT to Underwood Creek				
Cross Section:	Cross Section 5				
Feature:	Rifle				
Station:	31+25.66				
Date:	4/22/11				
Crew:	ZAP				
	Summary (bankfull)				
	MY0				
A (BKF)	11.6				
W (BKF)	12.7				
Max d	1.6				
Mean d	0.9				
W/D	13.9

Photo of XS-5, looking in the downstream direction

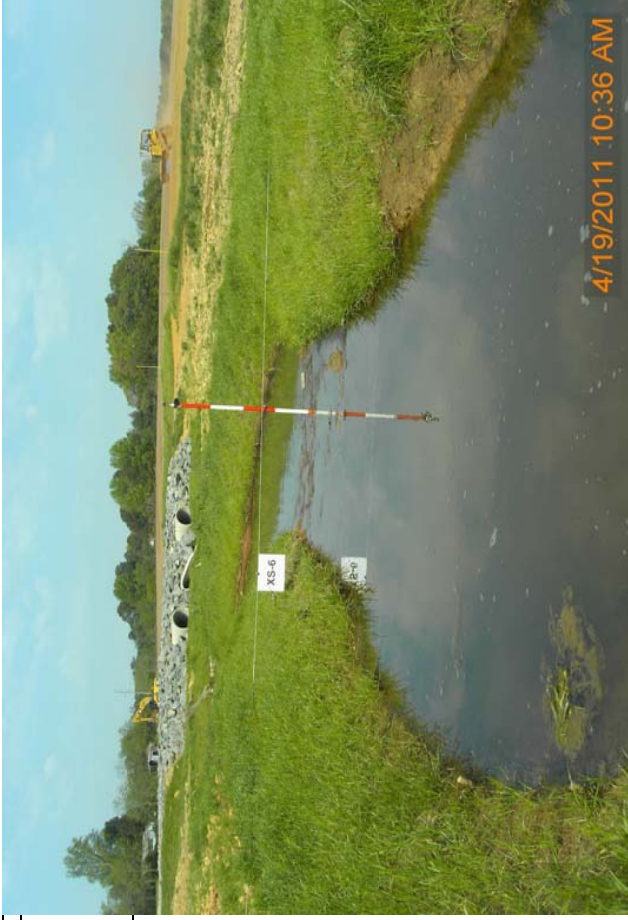
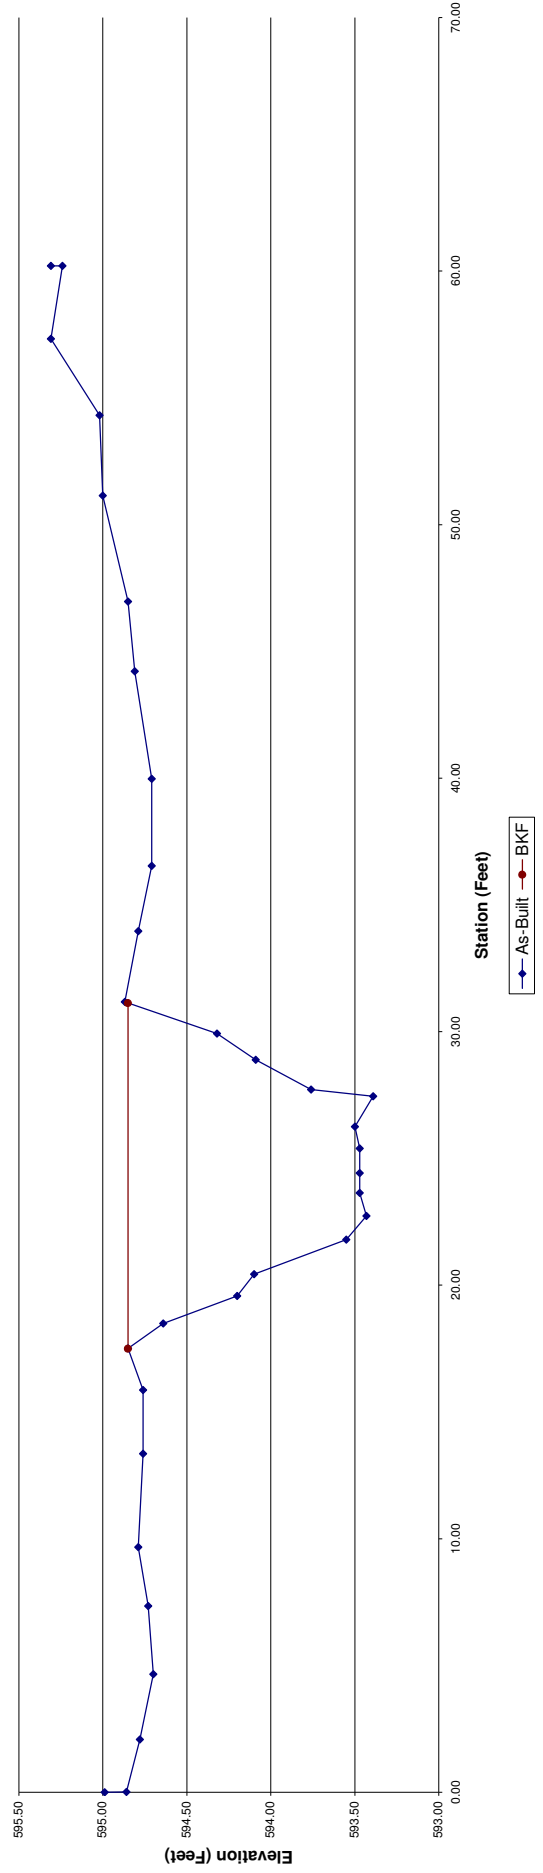
UT to Underwood Creek Cross Section 6

Project:	UT to Underwood Creek				
Cross Section:	Cross Section 6				
Feature:	Rifle				
Station:	35+34.55				
Date:	4/22/11				
Crew:	ZAP				
	Summary (bankfull)				
	MY0				
A (BKF)	12.8				
W (BKF)	13.6				
Max d	1.5				
Mean d	0.9				
W/D	14.5

Photo of XS-6, looking in the downstream direction

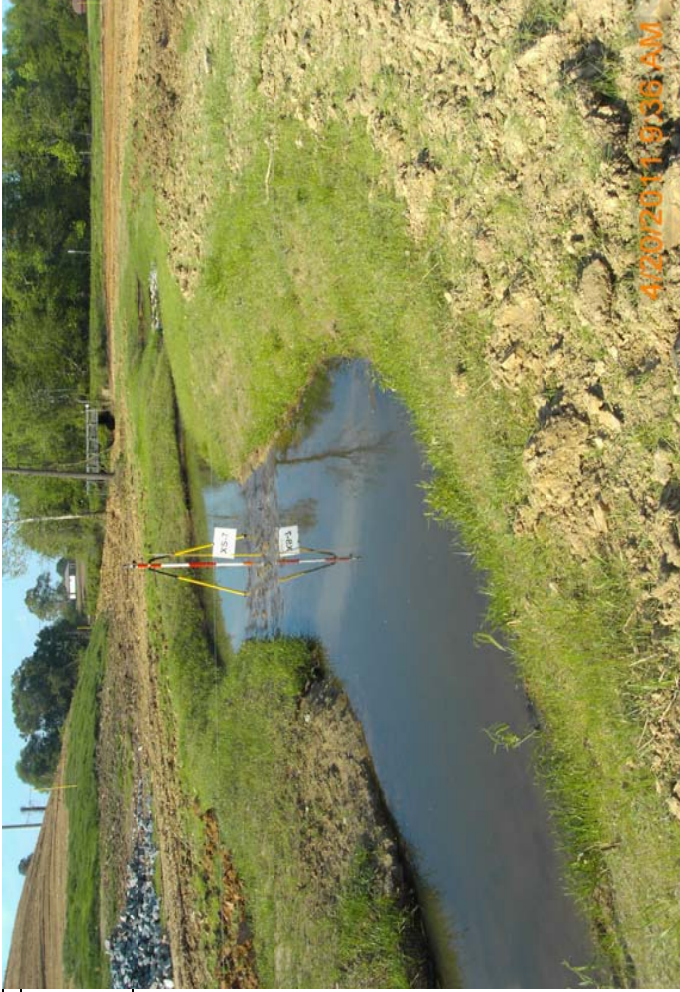
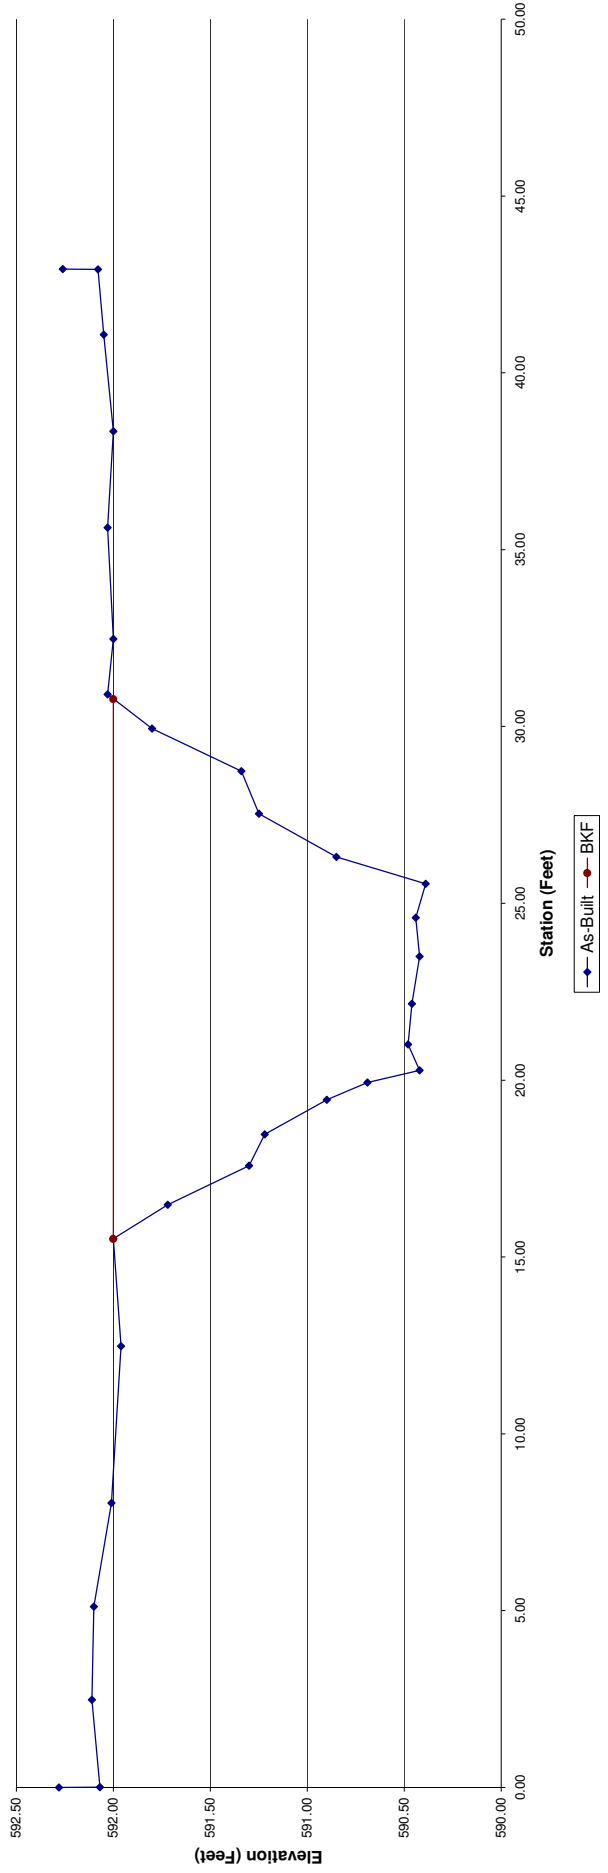
UT to Underwood Creek Cross Section 7

Project:	UT to Underwood Creek	Summary (bankfull)			
Cross Section:	Cross Section 7	MY0			
Feature:	Rifle	15.2			
Station:	39+30.06	15.3			
Date:	4/22/11	1.6			
Crew:	ZAP	1.0			
		15.3

Photo of XS-7, looking in the downstream direction
