**Newtown Stream and Wetland
Restoration Project
Union County, North Carolina
RFP 16-001117, SCO ID# 002025**

**Baseline Monitoring Document and As-Built Baseline Report
Final**

Data Collected: April 2011
Submitted: June 13, 2011

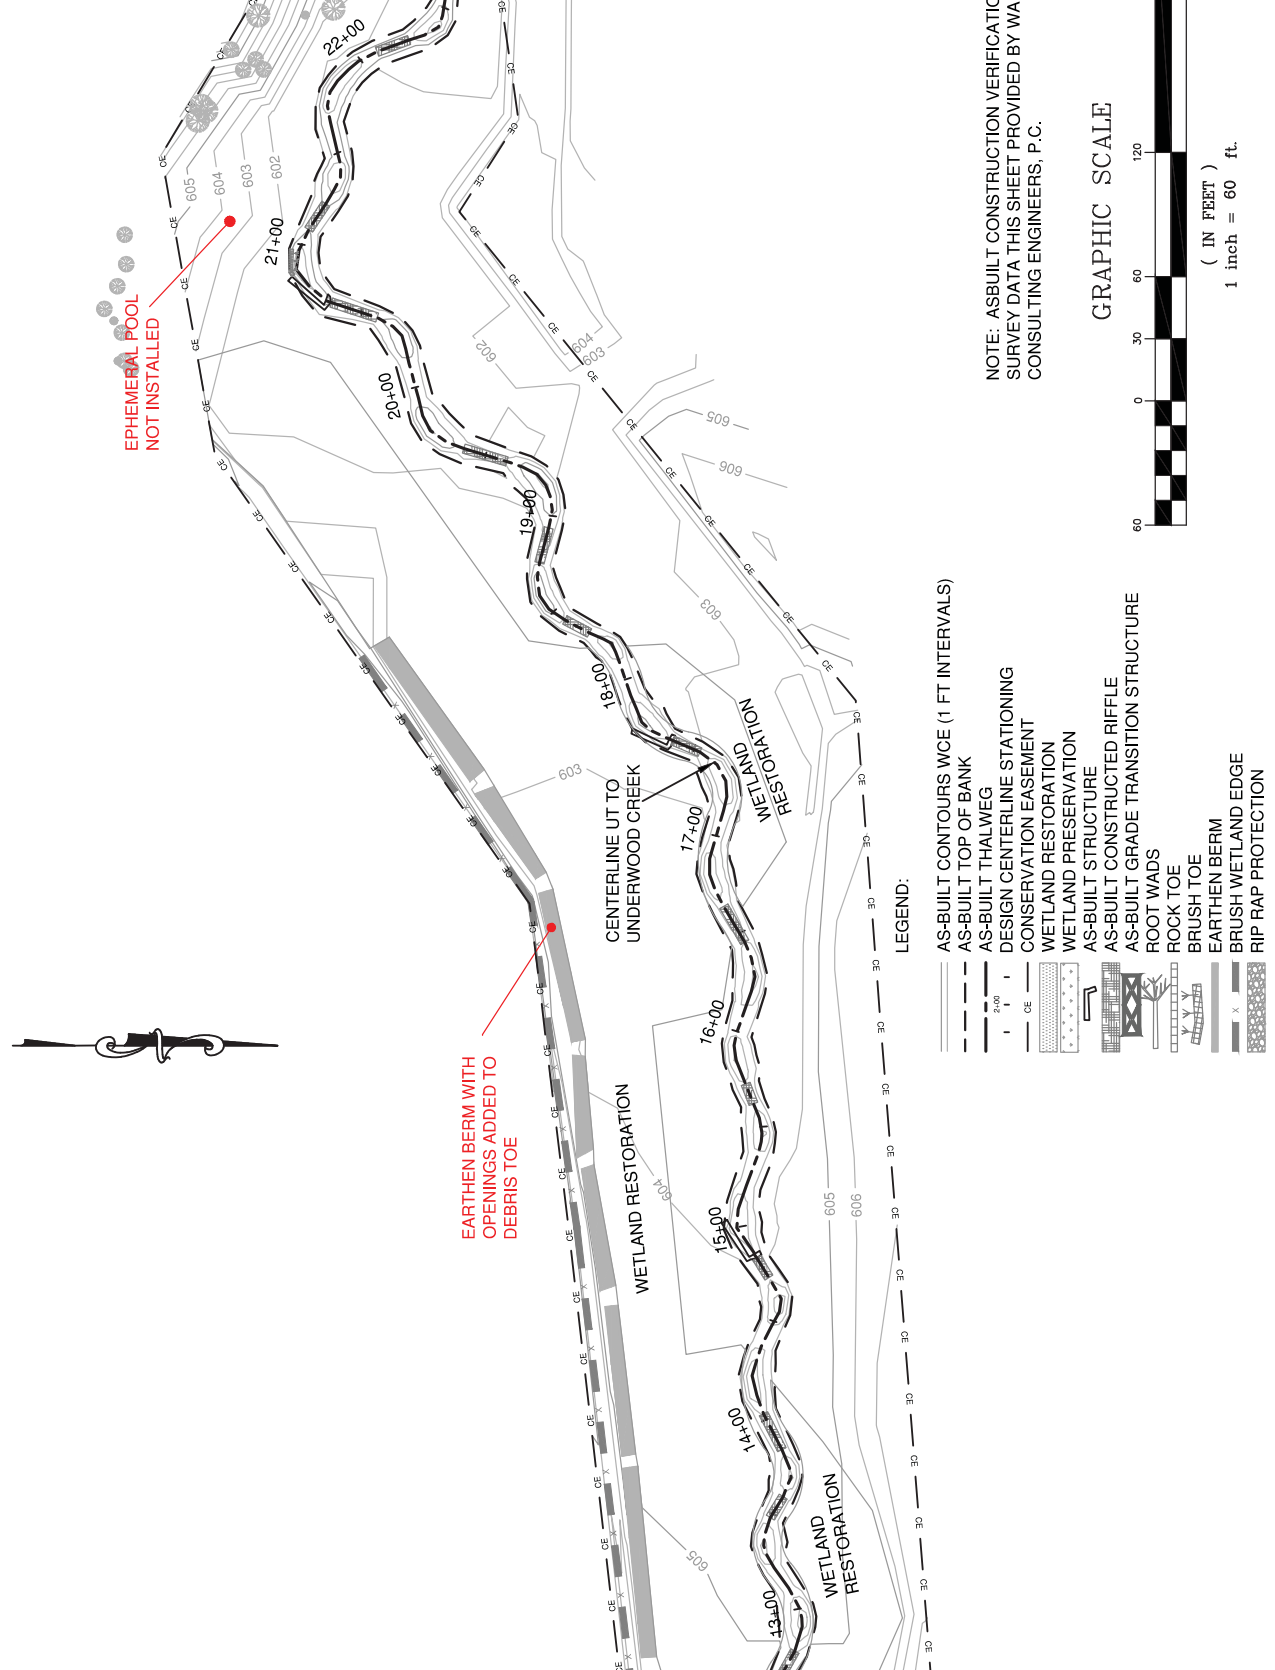
**EPHEMERAL POOL
 NOT INSTALLED**

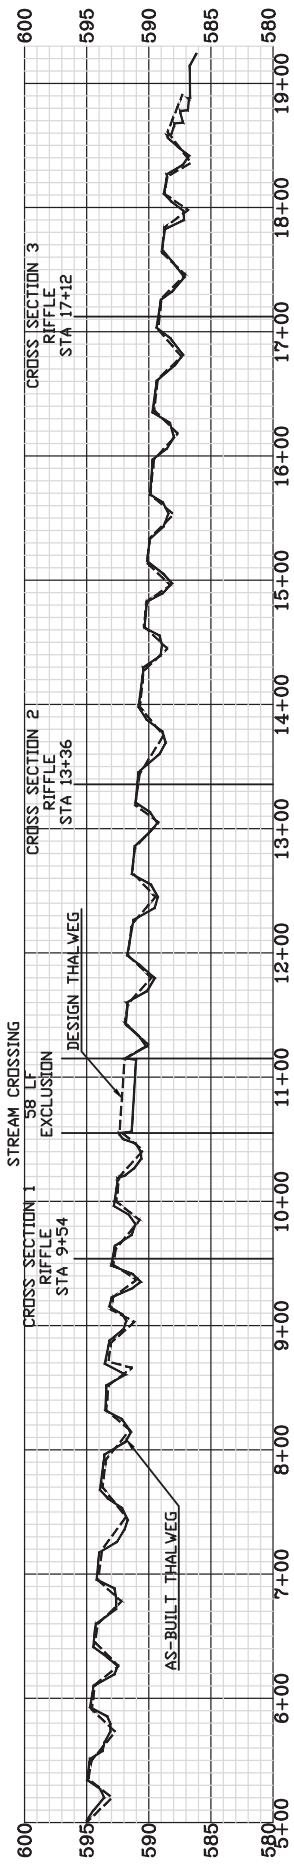
AS-BUILT UNDERWOOD CREEK (NEWTOWN)
LONGITUDINAL PROFILE
MAIN CHANNEL

SCALE:
 HORIZONTAL - 1" = 100'
 VERTICAL - 1" = 10'

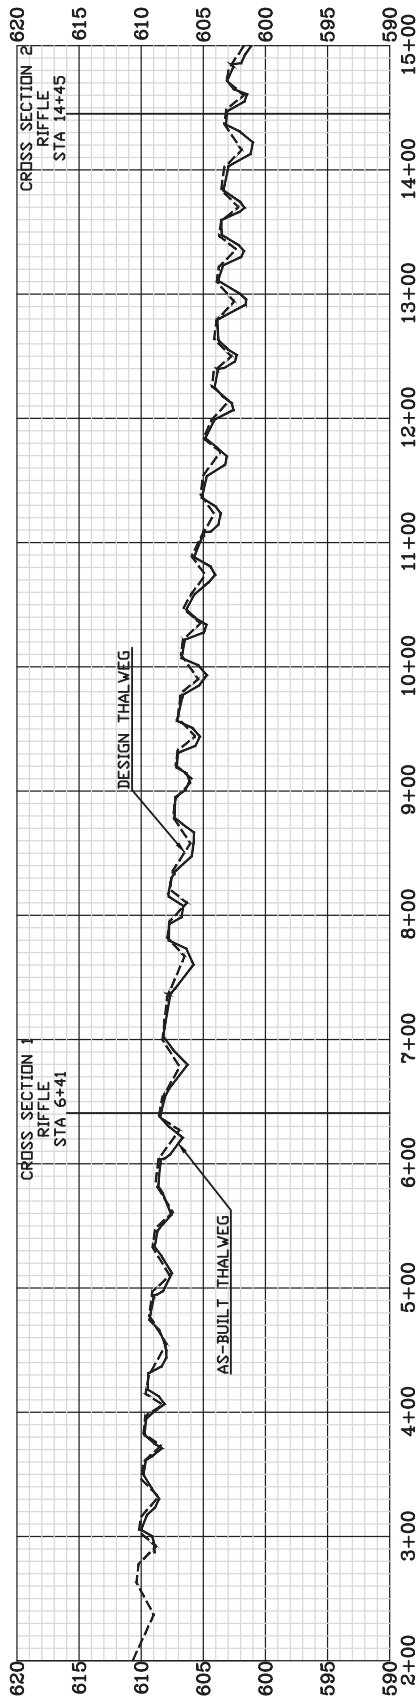
AS-BUILT UT TO UNDERWOOD CREEK (NEWTOWN)
LONGITUDINAL PROFILE
TRIBUTARY CHANNEL

SCALE:
HORIZONTAL - 1" = 100'
VERTICAL - 1" = 10'

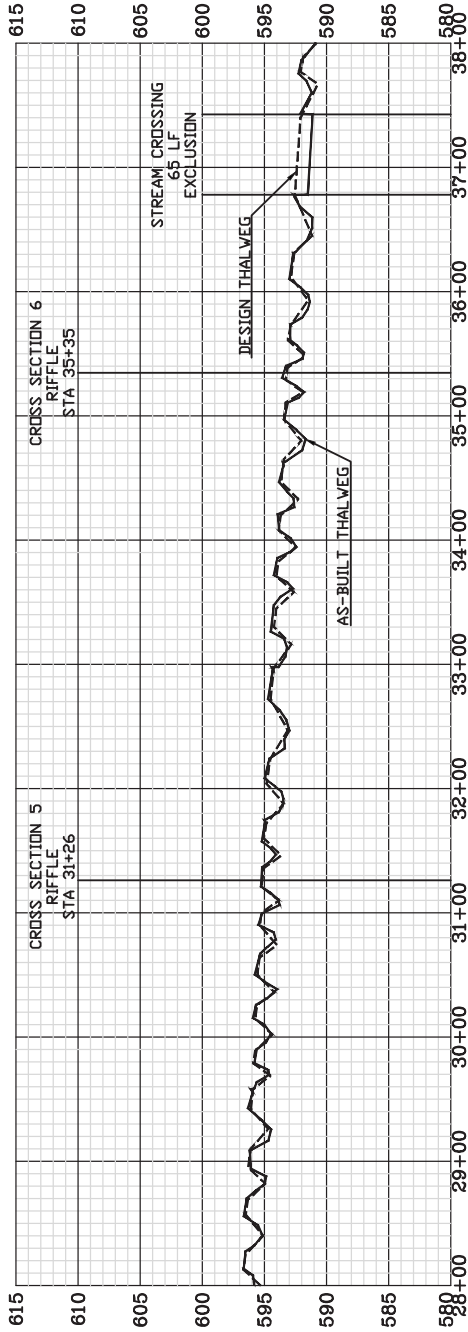
AS-BUILT UT TO UNDERWOOD CREEK (NEWTOWN)
LONGITUDINAL PROFILE
TRIBUTARY CHANNEL

SCALE:
HORIZONTAL - 1" = 100'
VERTICAL - 1" = 10'
