RESTORATION PLAN (FINAL)

**NICHOLLS FARM WETLAND ENHANCEMENT SITE
BERTIE COUNTY, NORTH CAROLINA
CHOWAN RIVER BASIN CATALOGING UNIT 03010203**

March 2008

DESIGN FIRM: ECOSCIENCE CORPORATION
Project Manager: Jens Geratz (geratz@ecosciencenc.com)
1101 Haynes Street, Suite 101
Raleigh, North Carolina 27604
Office: (919) 828 3433
Fax: (919) 828 3518

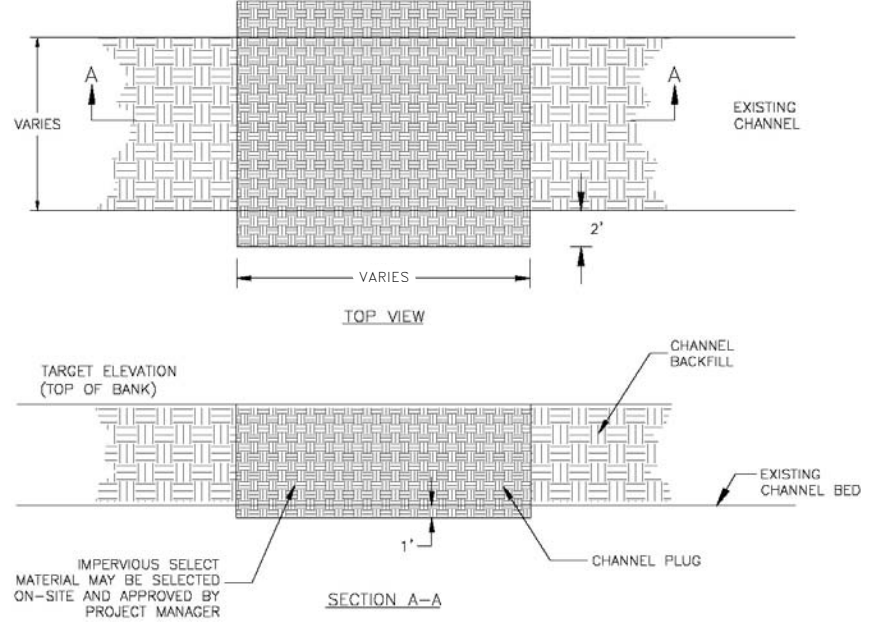
EXAMPLE DITCH PLUG DETAIL

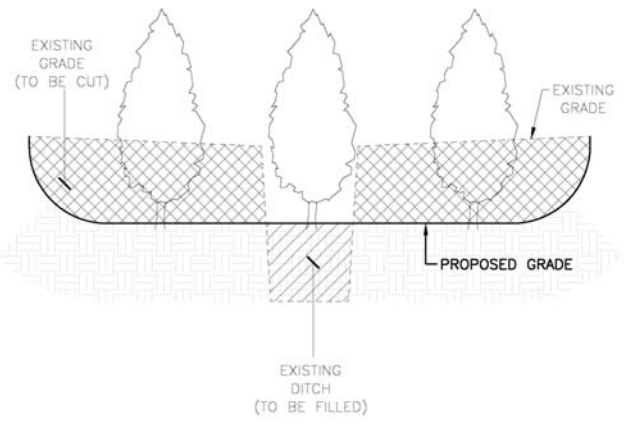
EXAMPLE CONSTRUCTED DEPRESSION

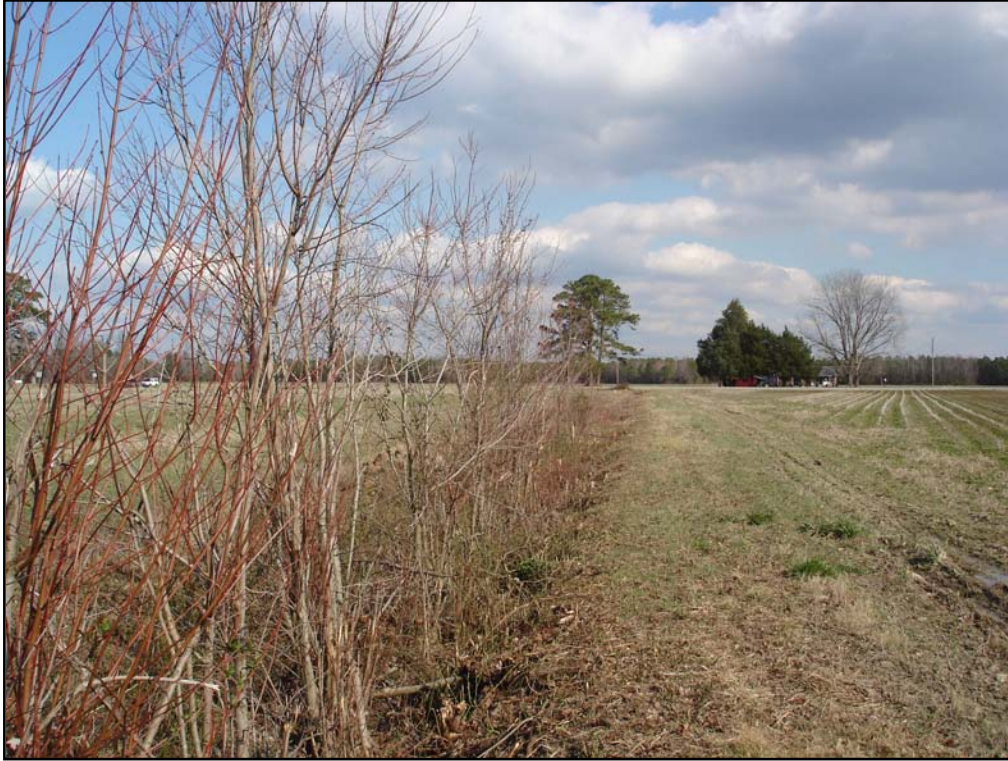
Photo 1. Field ditch looking east toward Old Merry Hill Road (SR 1540)

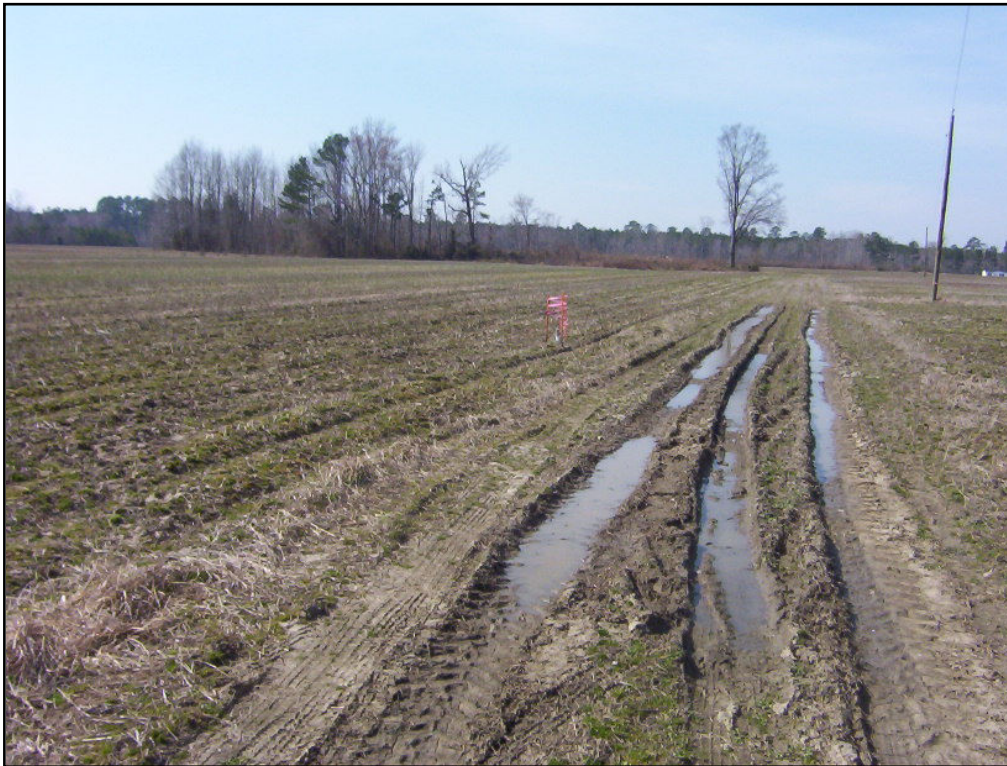
Photo 5. Hydric soils directly east of SR 1540. Note Groundwater Gauge 1 in center of photo

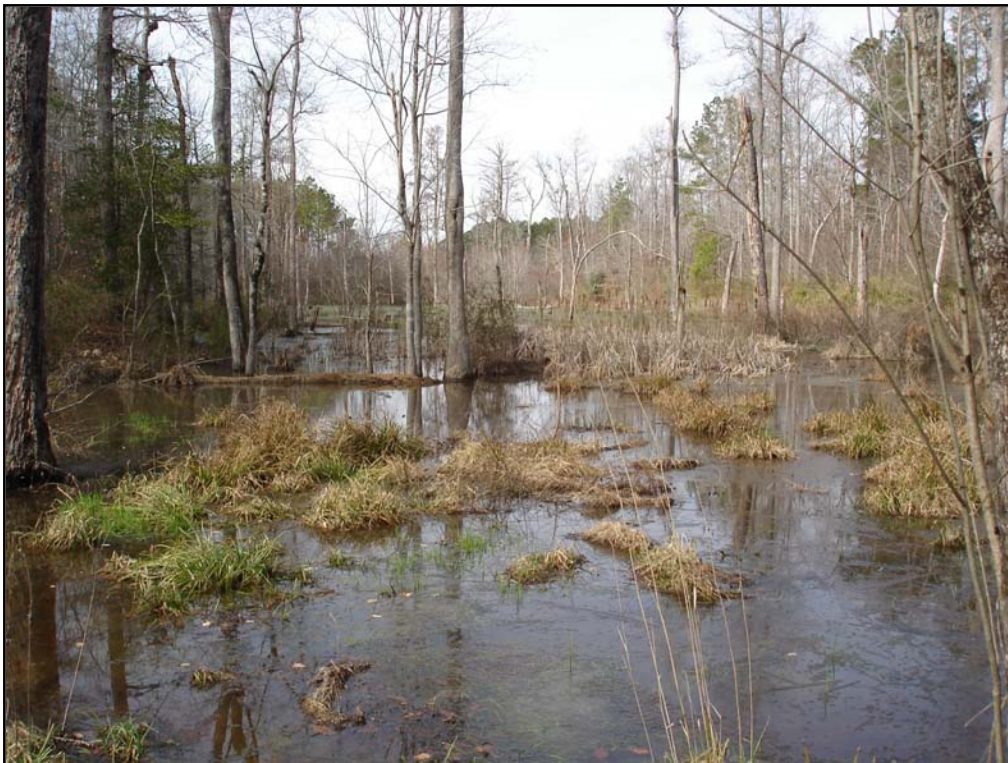
Photo 8. Semi-permanent impoundment from beaver activity

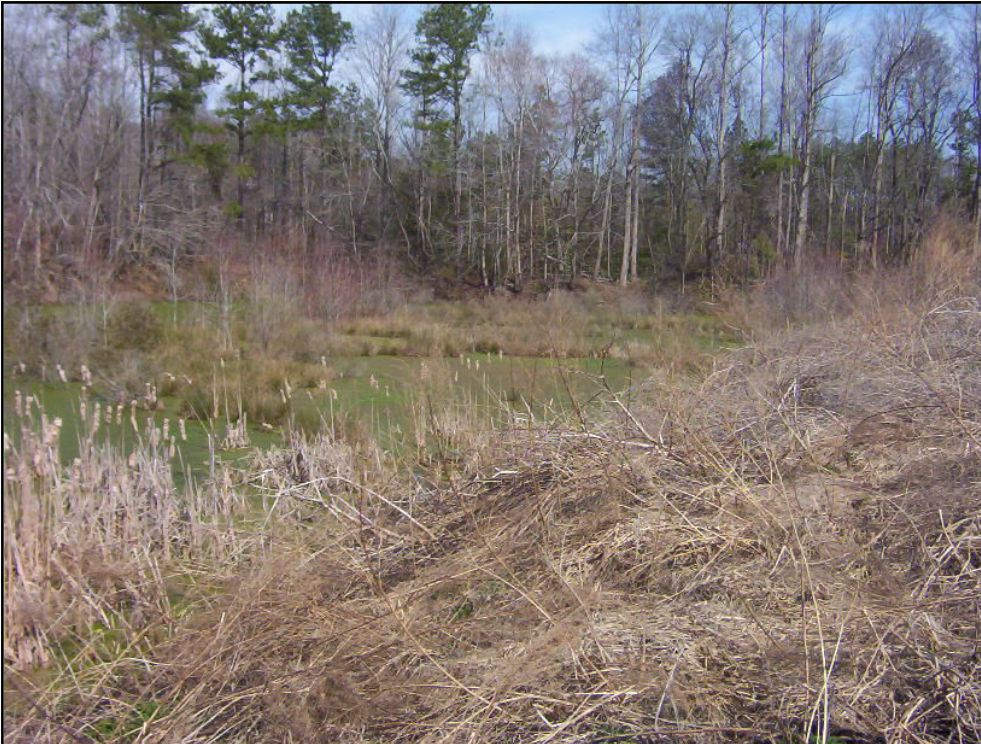
Photo 10. Naturalized borrow pit with emergent vegetation. Note stabilized cotton gin waste deposited on side slopes.

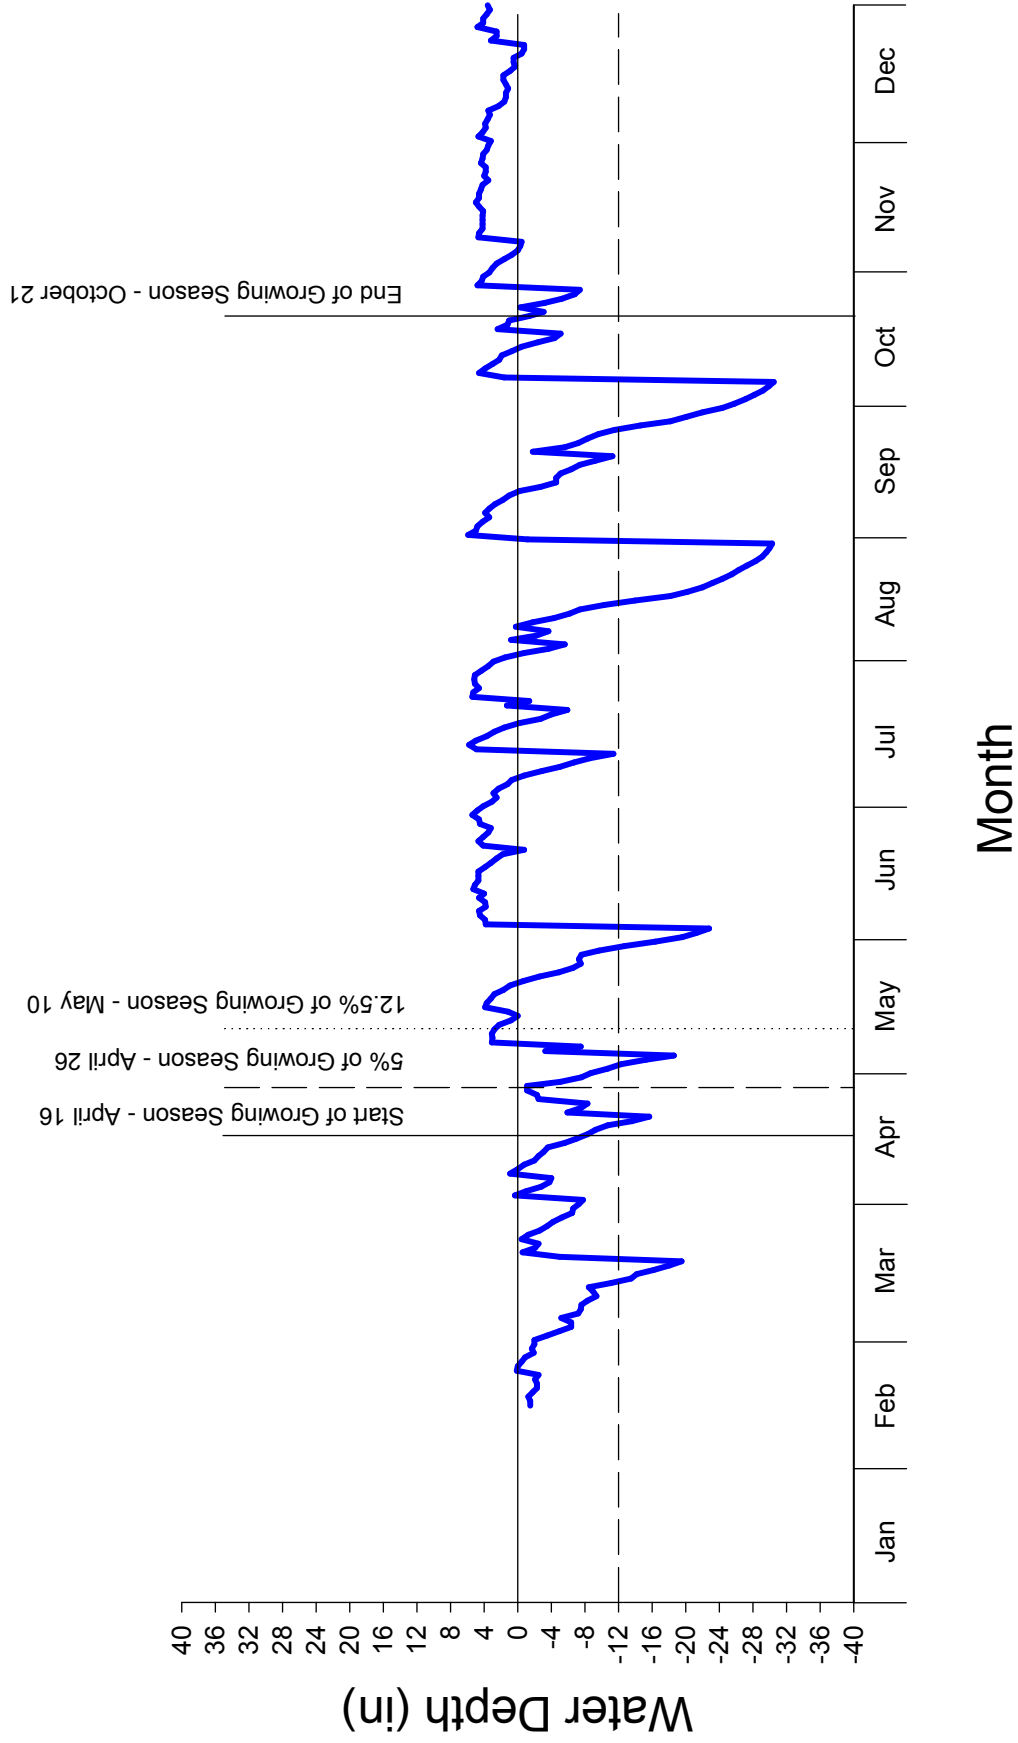
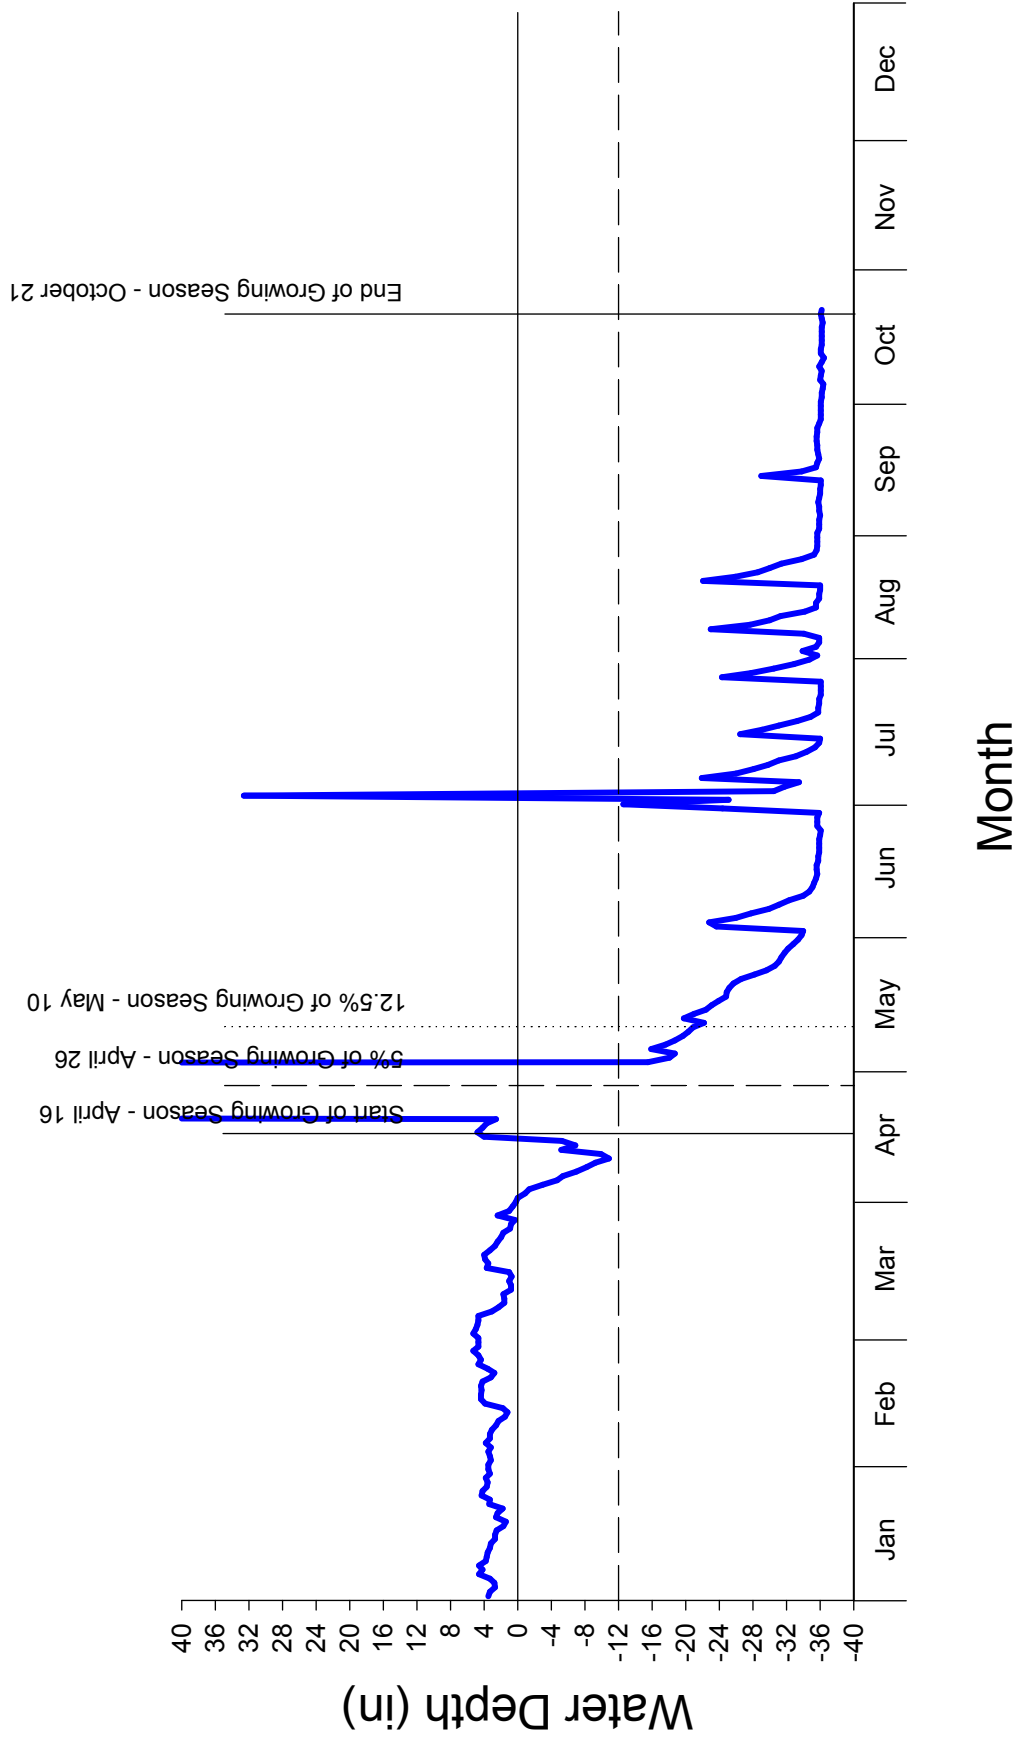
Monitoring Gauge 6- A28A308

*Well malfunction 4/21/07-5/2/07

To investigate the potential degradation to wetland caused by the drainage ditch bisecting the headwater system, six continuous recording gauges were installed in February 2006. Groundwater gauge locations are provided in Appendix D. Nested gauges (Gauges 2-3 and Gauge 4-6) were placed perpendicular to the ditch to measure lateral drainage effects.

Nested groundwater gauges (Gauges 4-6) installed at the Site show a modest groundwater drawdown in locations directly adjacent to the drainage ditch. Gauge hydrographs are provided in Appendix D. The current on-site trend shows a decrease in the depth of groundwater table from Gauge 6 (furthest from the ditch) to Gauge 4 (closest to the drainage ditch). However, while the data shows a lateral drainage affect from the ditch, the results suggest that these effected areas continue to exhibit wetland hydrology above jurisdictional limits. This finding is corroborated by the jurisdictional delineation performed at this location. The gauge data results in combination with the jurisdictional confirmation has discounted these hydric soil areas from wetland restoration consideration. However, the proposed removal (i.e. filling) of the drainage ditch may increase the existing wetland hydroperiod and provide a functional lift to the headwater system including increase in water storage capacity, residence times, and aquatic resources.
