Monitoring Report

Norman's Pasture Restoration Site
DMS Contract 005010
DMS Project Number 95717

Norman's Pasture II Restoration Site
DMS Contract 5787
DMS Project Number 96310

Monitoring Year 03

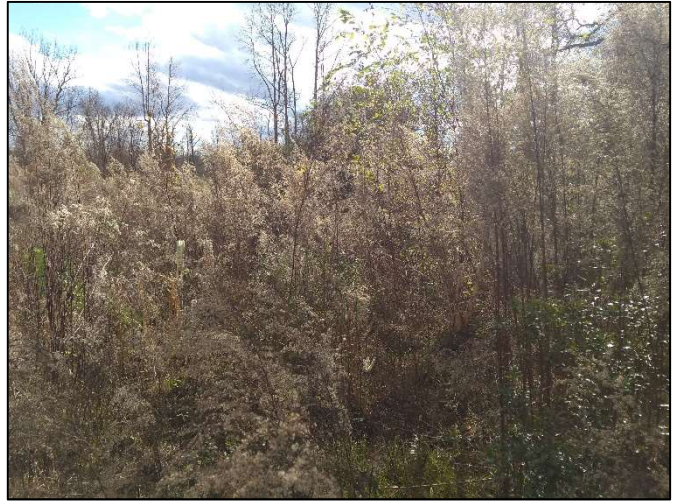
PP01 – MY-03 – 12/5/18

A yearly visual assessment of the enhanced stream on NPII will occur every year. The third year monitoring visual assessment found the stream to be in good condition. As the photos show, there has been a high survival rate of live stakes and herbaceous streamside vegetation is thriving. One small area of erosion developed shortly after construction and was repaired before the end of the first growing season. Despite numerous large flow events, the stream has shown no additional signs of erosion since. The stream corridor is also showing signs of a higher water table, which was a goal of raising the streambed elevation. This is evidenced by more standing surface water compared to pre-construction conditions and the gauge data from the adjacent monitored wetlands.
