Monitoring Report

Norman's Pasture Restoration Site
DMS Contract 005010
DMS Project Number 95717

Norman's Pasture II Restoration Site
DMS Contract 5787
DMS Project Number 96310

Monitoring Year 04

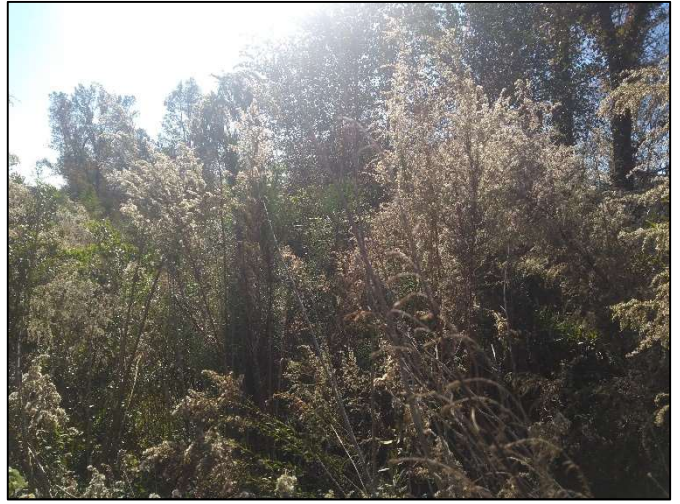
PP01 – MY-04 – 11/13/19

A yearly visual assessment of the enhanced stream on NPII will occur every year. The fourth year monitoring visual assessment found the stream to be in good condition. As the photos show, there has been a high survival rate of live stakes and herbaceous streamside vegetation is thriving. One small area of erosion developed shortly after construction and was repaired before the end of the first growing season. Despite numerous large flow events, the stream has shown no additional signs of erosion since. The stream corridor is also showing signs of a higher water table, which was a goal of raising the streambed elevation. This is evidenced by more standing surface water compared to pre-construction conditions and the gauge data from the adjacent monitored wetlands.

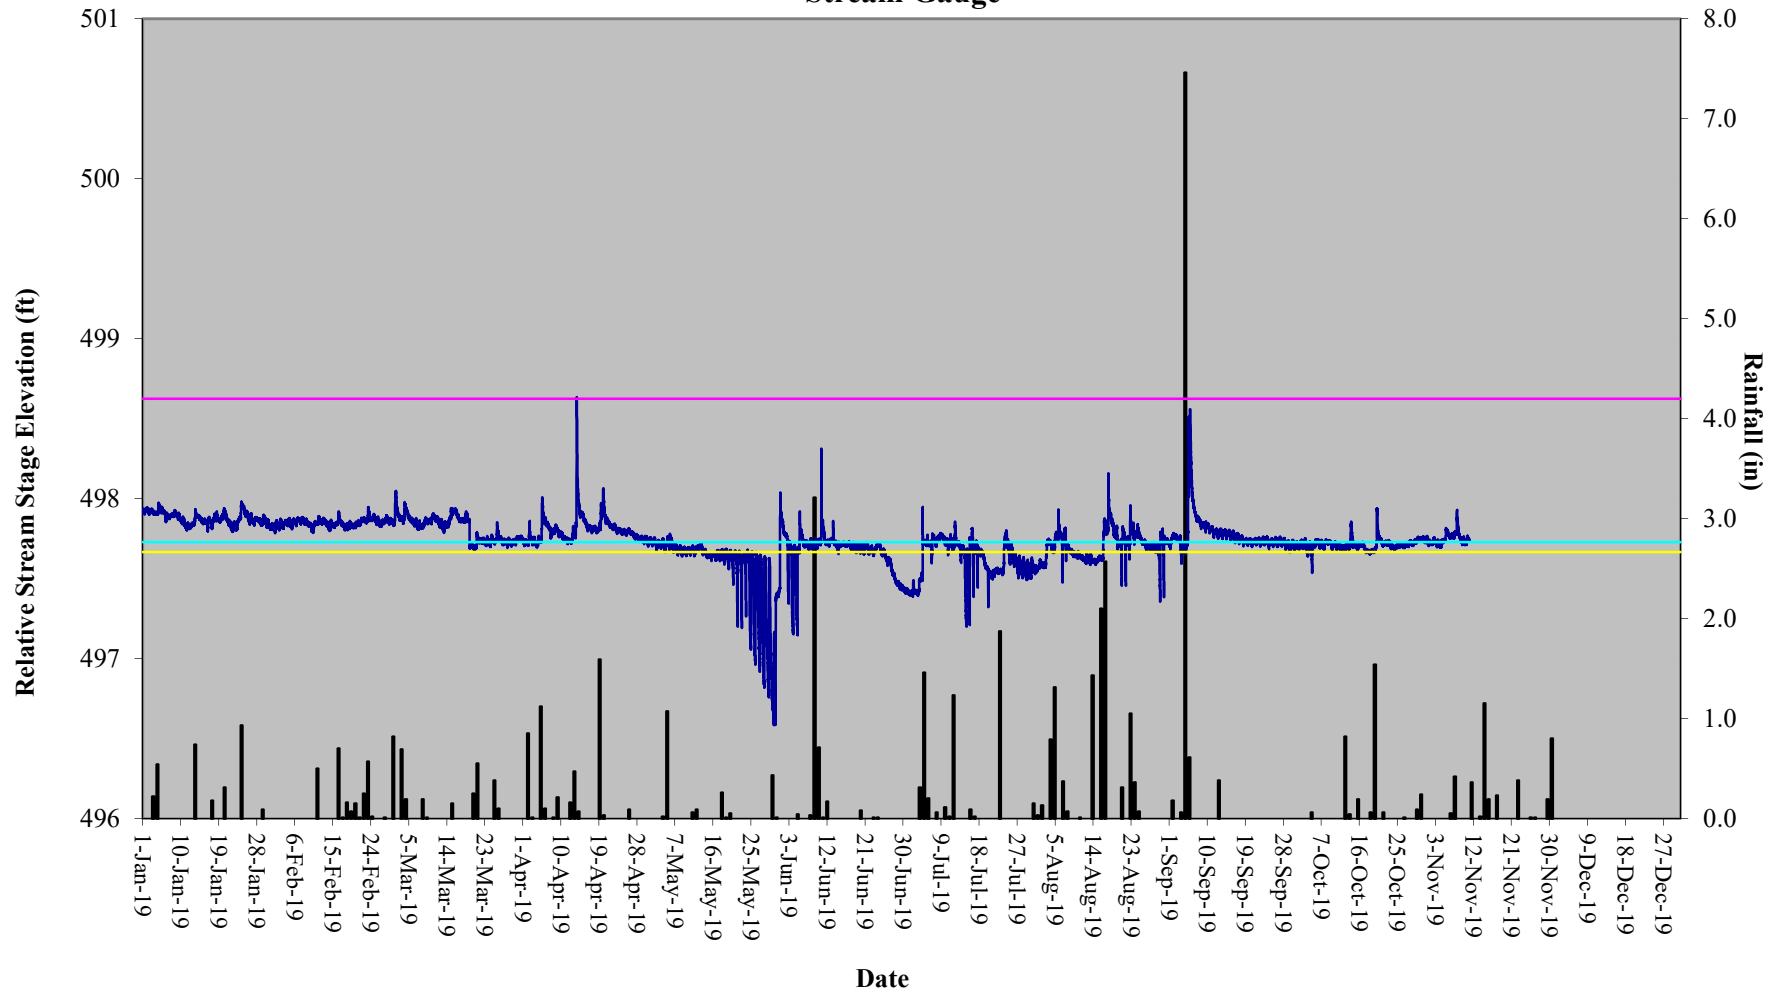
Norman's Pasture II Restoration Site Hydrograph Stream Gauge

As part of the site success criteria the stream must experience two bankfull events in separate years. The stream experienced several bankfull events in all four monitoring years, including one in 2019, and has met this criteria. See Table 7 in Appendix D.
