Monitoring Report

Norman's Pasture Restoration Site
DMS Contract 005010
DMS Project Number 95717

Norman's Pasture II Restoration Site
DMS Contract 5787
DMS Project Number 96310

Monitoring Year 05

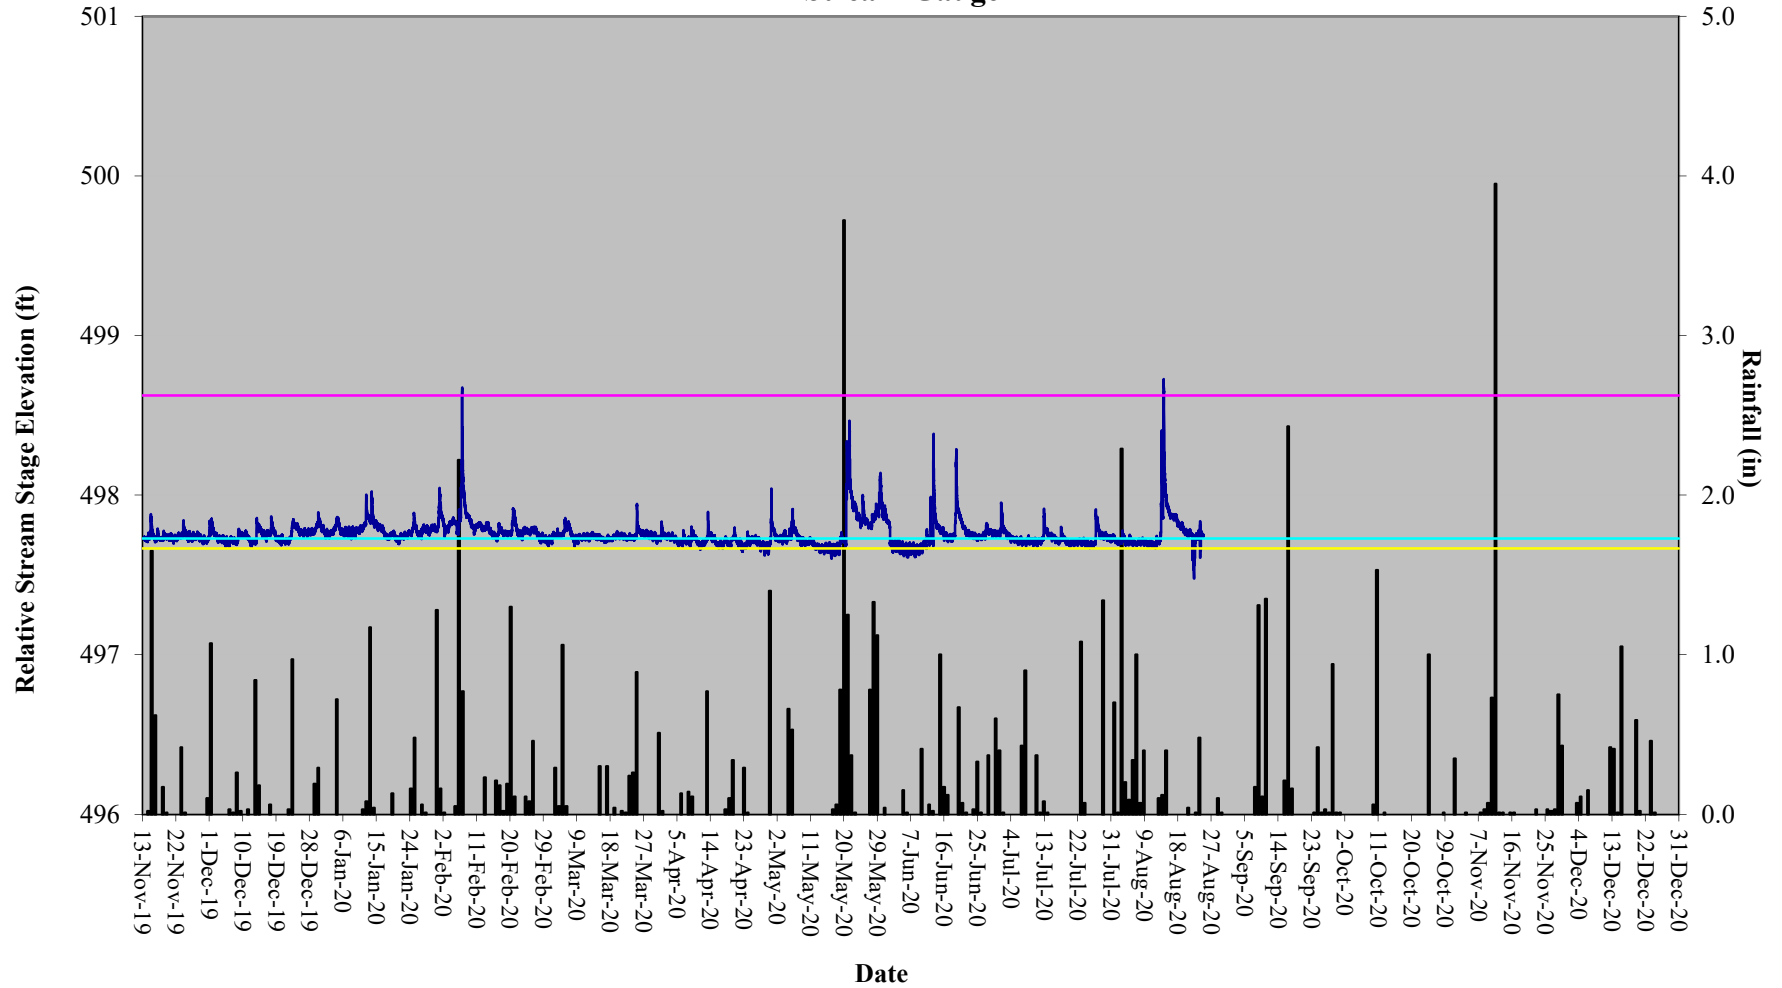
Norman's Pasture II Restoration Site Hydrograph Stream Gauge

As part of the site success criteria the stream must experience two bankfull events in separate years. The stream experienced several bankfull events in all five monitoring years, including two in 2020, and has met this criteria. See Table 7 in Appendix D.

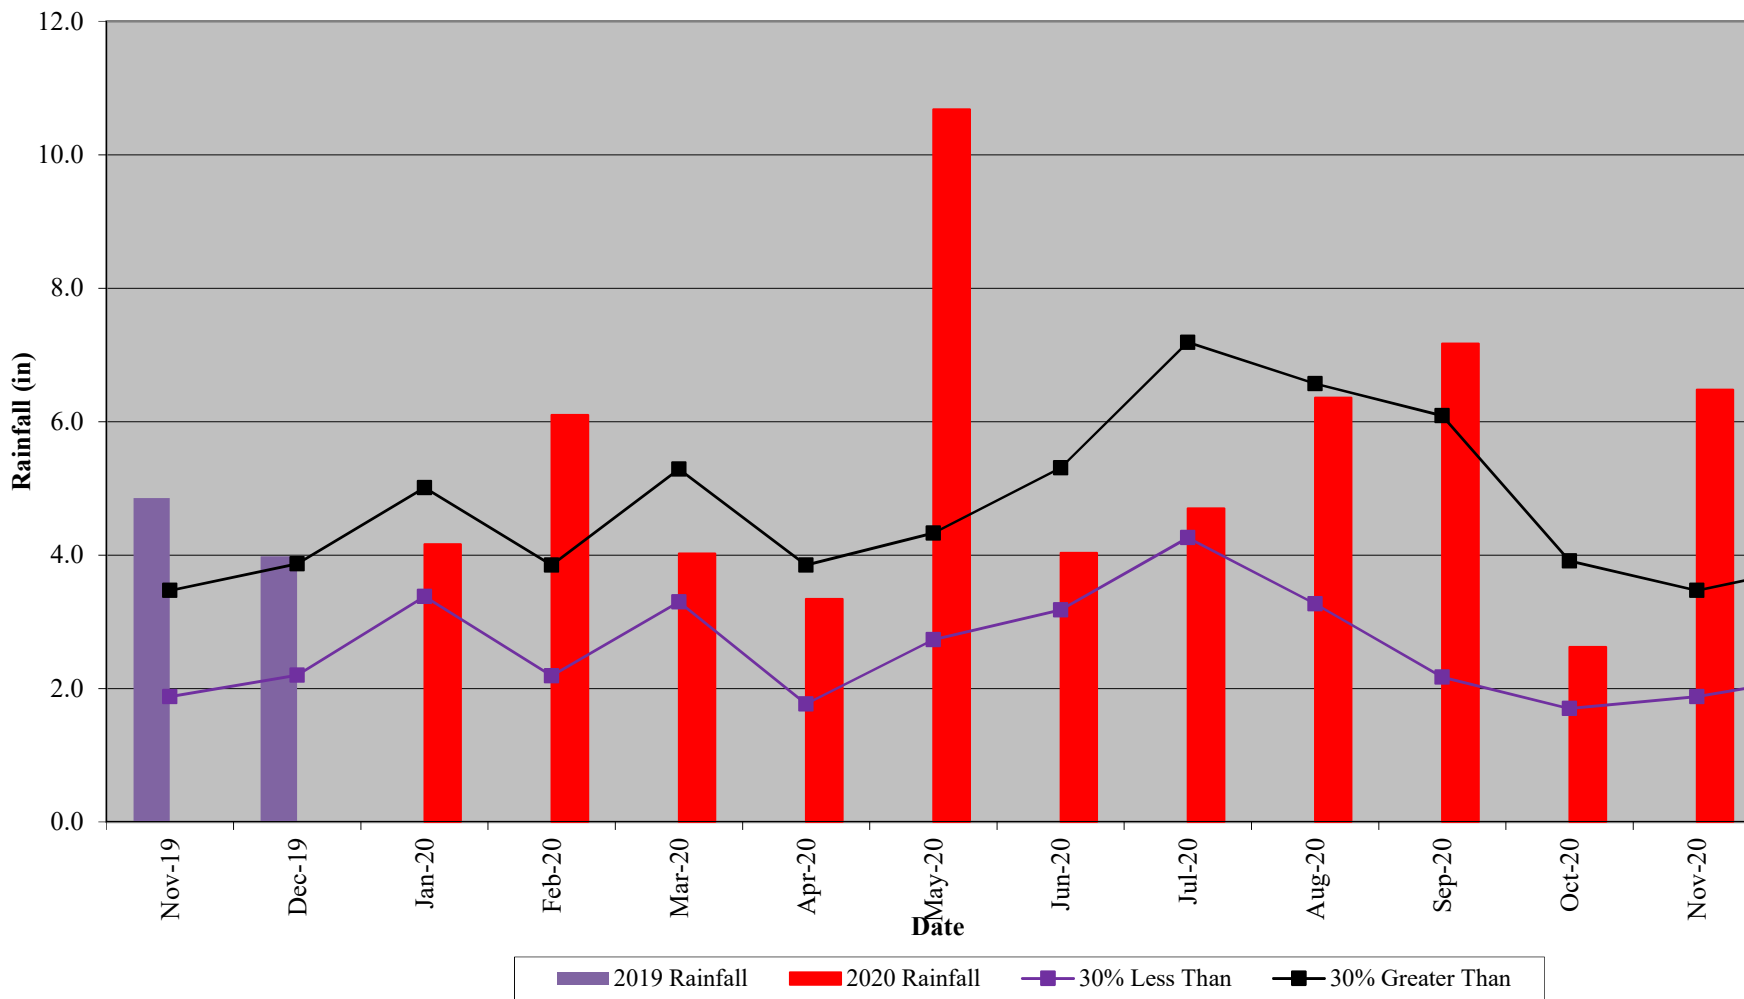
**Norman's Pasture Wetland Restoration Site
30-70 Percentile Graph
WETS Station Name: Clinton, NC**

The daily rainfall data was obtained from a local weather station in Clinton, NC; provided by the NC State Climate Office. For the 2020-year, the months of February, May, September, and November experienced above average rainfall, January, March, April, June, July, August, and October experienced average rainfall. No months recorded below average rainfall for the site. Overall, the area experienced above average rainfall during the 2020 growing season.

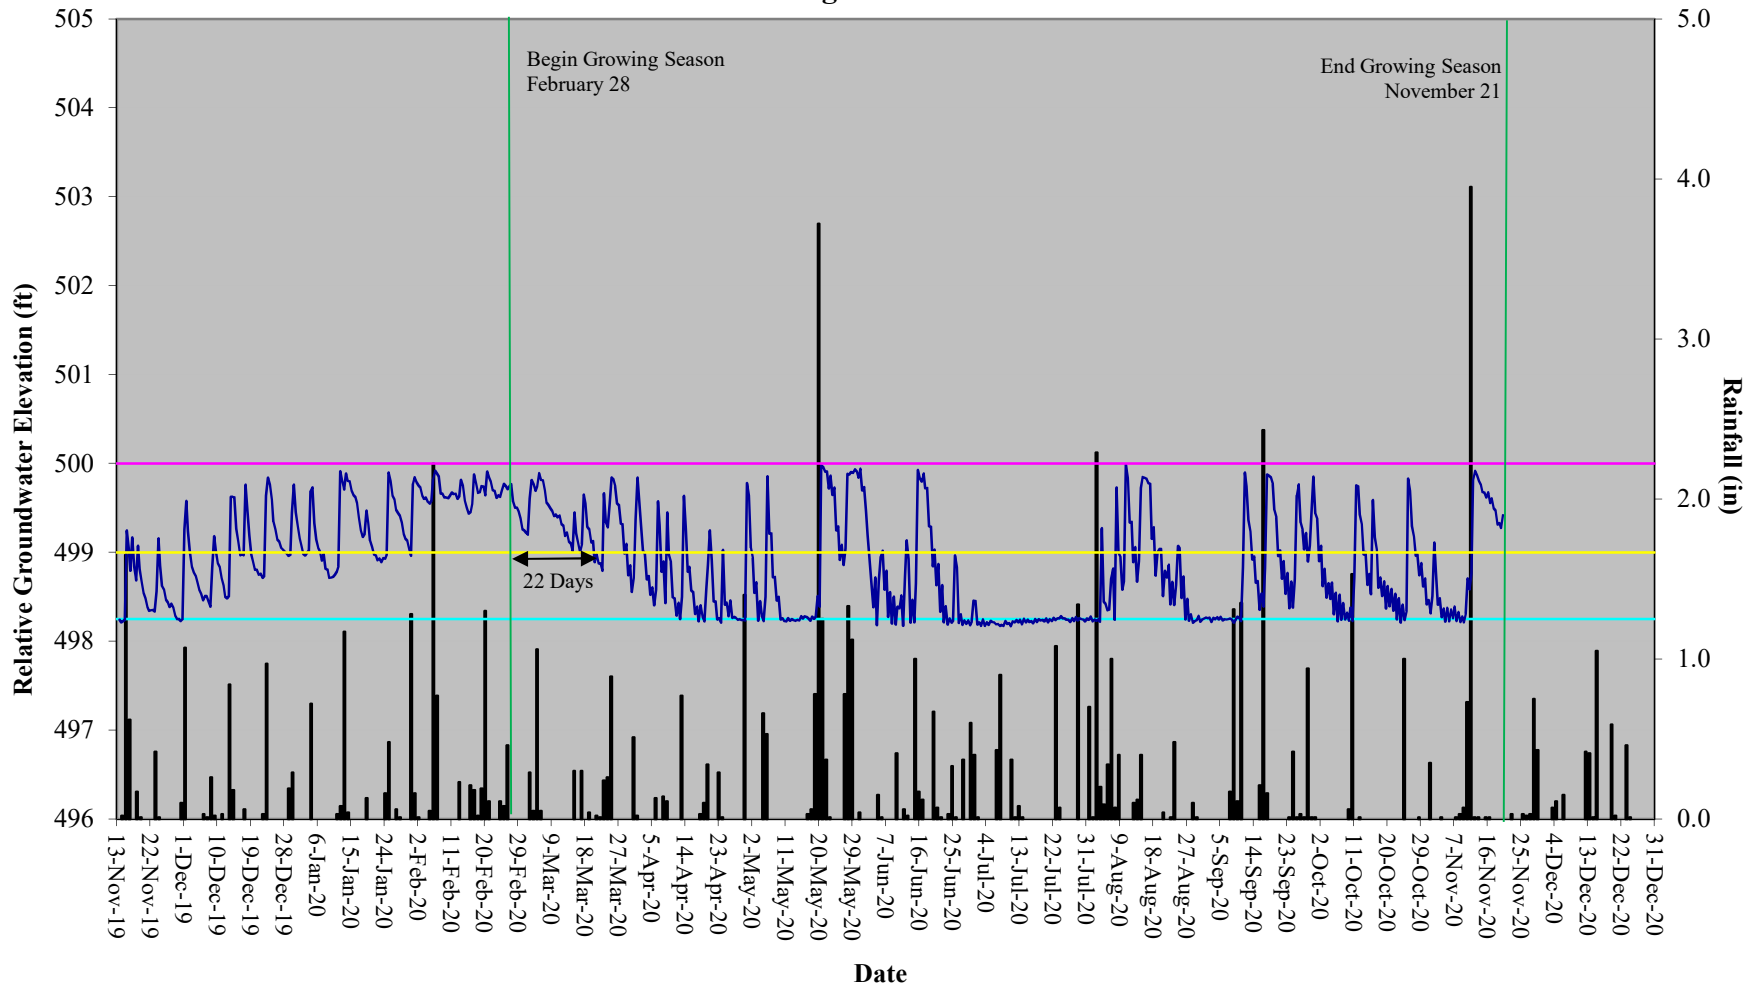
Norman's Pasture II Restoration Site Hydrograph Wetland Gauge 8 - Headwater Forest

3. NP11-8 has not met hydrologic success of 9% in all 5 years. During the October 2019 IRT site visit a delineation of at risk areas and/or an adaptive management plan to offset the loss around the gauge(s) by picking up additional wetland area in other locations on site was discussed. Last year KCI stated in the response to DMS comments that "KCI is aware that the area around NP11-8 represents credits at risk and is taking steps to determine the extent of the at-risk area." Has this been completed, and if so, what is the area? Has additional wetland area been determined for any other location on site to offset the at risk area? Site assets are reported as 9.733 WMUs and KCI is under contract to deliver 9.43 WMUs, so payment is not likely to be affected. DMS simply needs to ensure that we do not debit more wetland credits than the site will deliver.

KCI Response: On January 29, 2021, KCI performed a detailed investigation of the area around Gauge NP11-8. After examining the vegetation, soils, and visual indicators of wetland hydrology in this area, KCI marked off the area of lower hydrology in the field and surveyed it with a handheld GPS. The results of this investigation was an area of 0.067 acres being marked as "at-risk." This area have been added to the CCPV.
