NORTH FORK MOUNTAIN CREEK STREAM AND WETLAND RESTORATION

RESTORATION PLAN

Catawba County, North Carolina

Status of Plan: Final
Submission Date: May 31, 2011

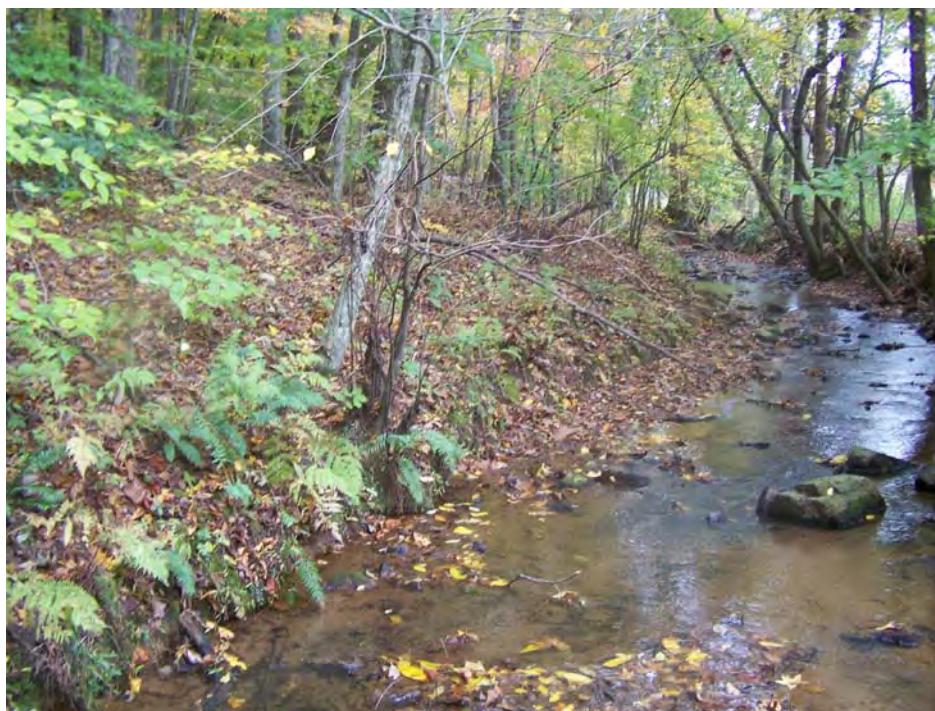
Photo 5 - General area where *Hexastylis sp.* was observed (right bank Reach 4)

Both the NC Natural Heritage Program and the US Fish and Wildlife Service list the *Hexastylis naniflora* as a threatened species in Catawba County. *Hexastylis* species were observed outside of the project easement. In a letter addressed to USFWS on Oct. 26, 2009, it was stated that during field reconnaissance *Hexastylis* species were observed in a small, confined area on a steep northwest-facing slope in a mature forest community outside this project easement. Appropriate soil characteristics were not present in this area for *Hexastylis naniflora*; however, it was not possible to determine whether the *Hexastylis* species found were in fact *H. naniflora* or one of the more common species due to the lack of fruits or flowers at the time of the field visit. Following the guidelines outlined by the U.S. Fish and Wildlife Service, the project will be implemented without disturbing the area containing the plants; therefore, the biological conclusion for *Hexastylis naniflora* (dwarf-flowered heartleaf) is "no effect".
