# North Muddy Creek Mitigation Report

McDowell and Burke Counties, North Carolina

Project ID No. 16-D06115

April 2009

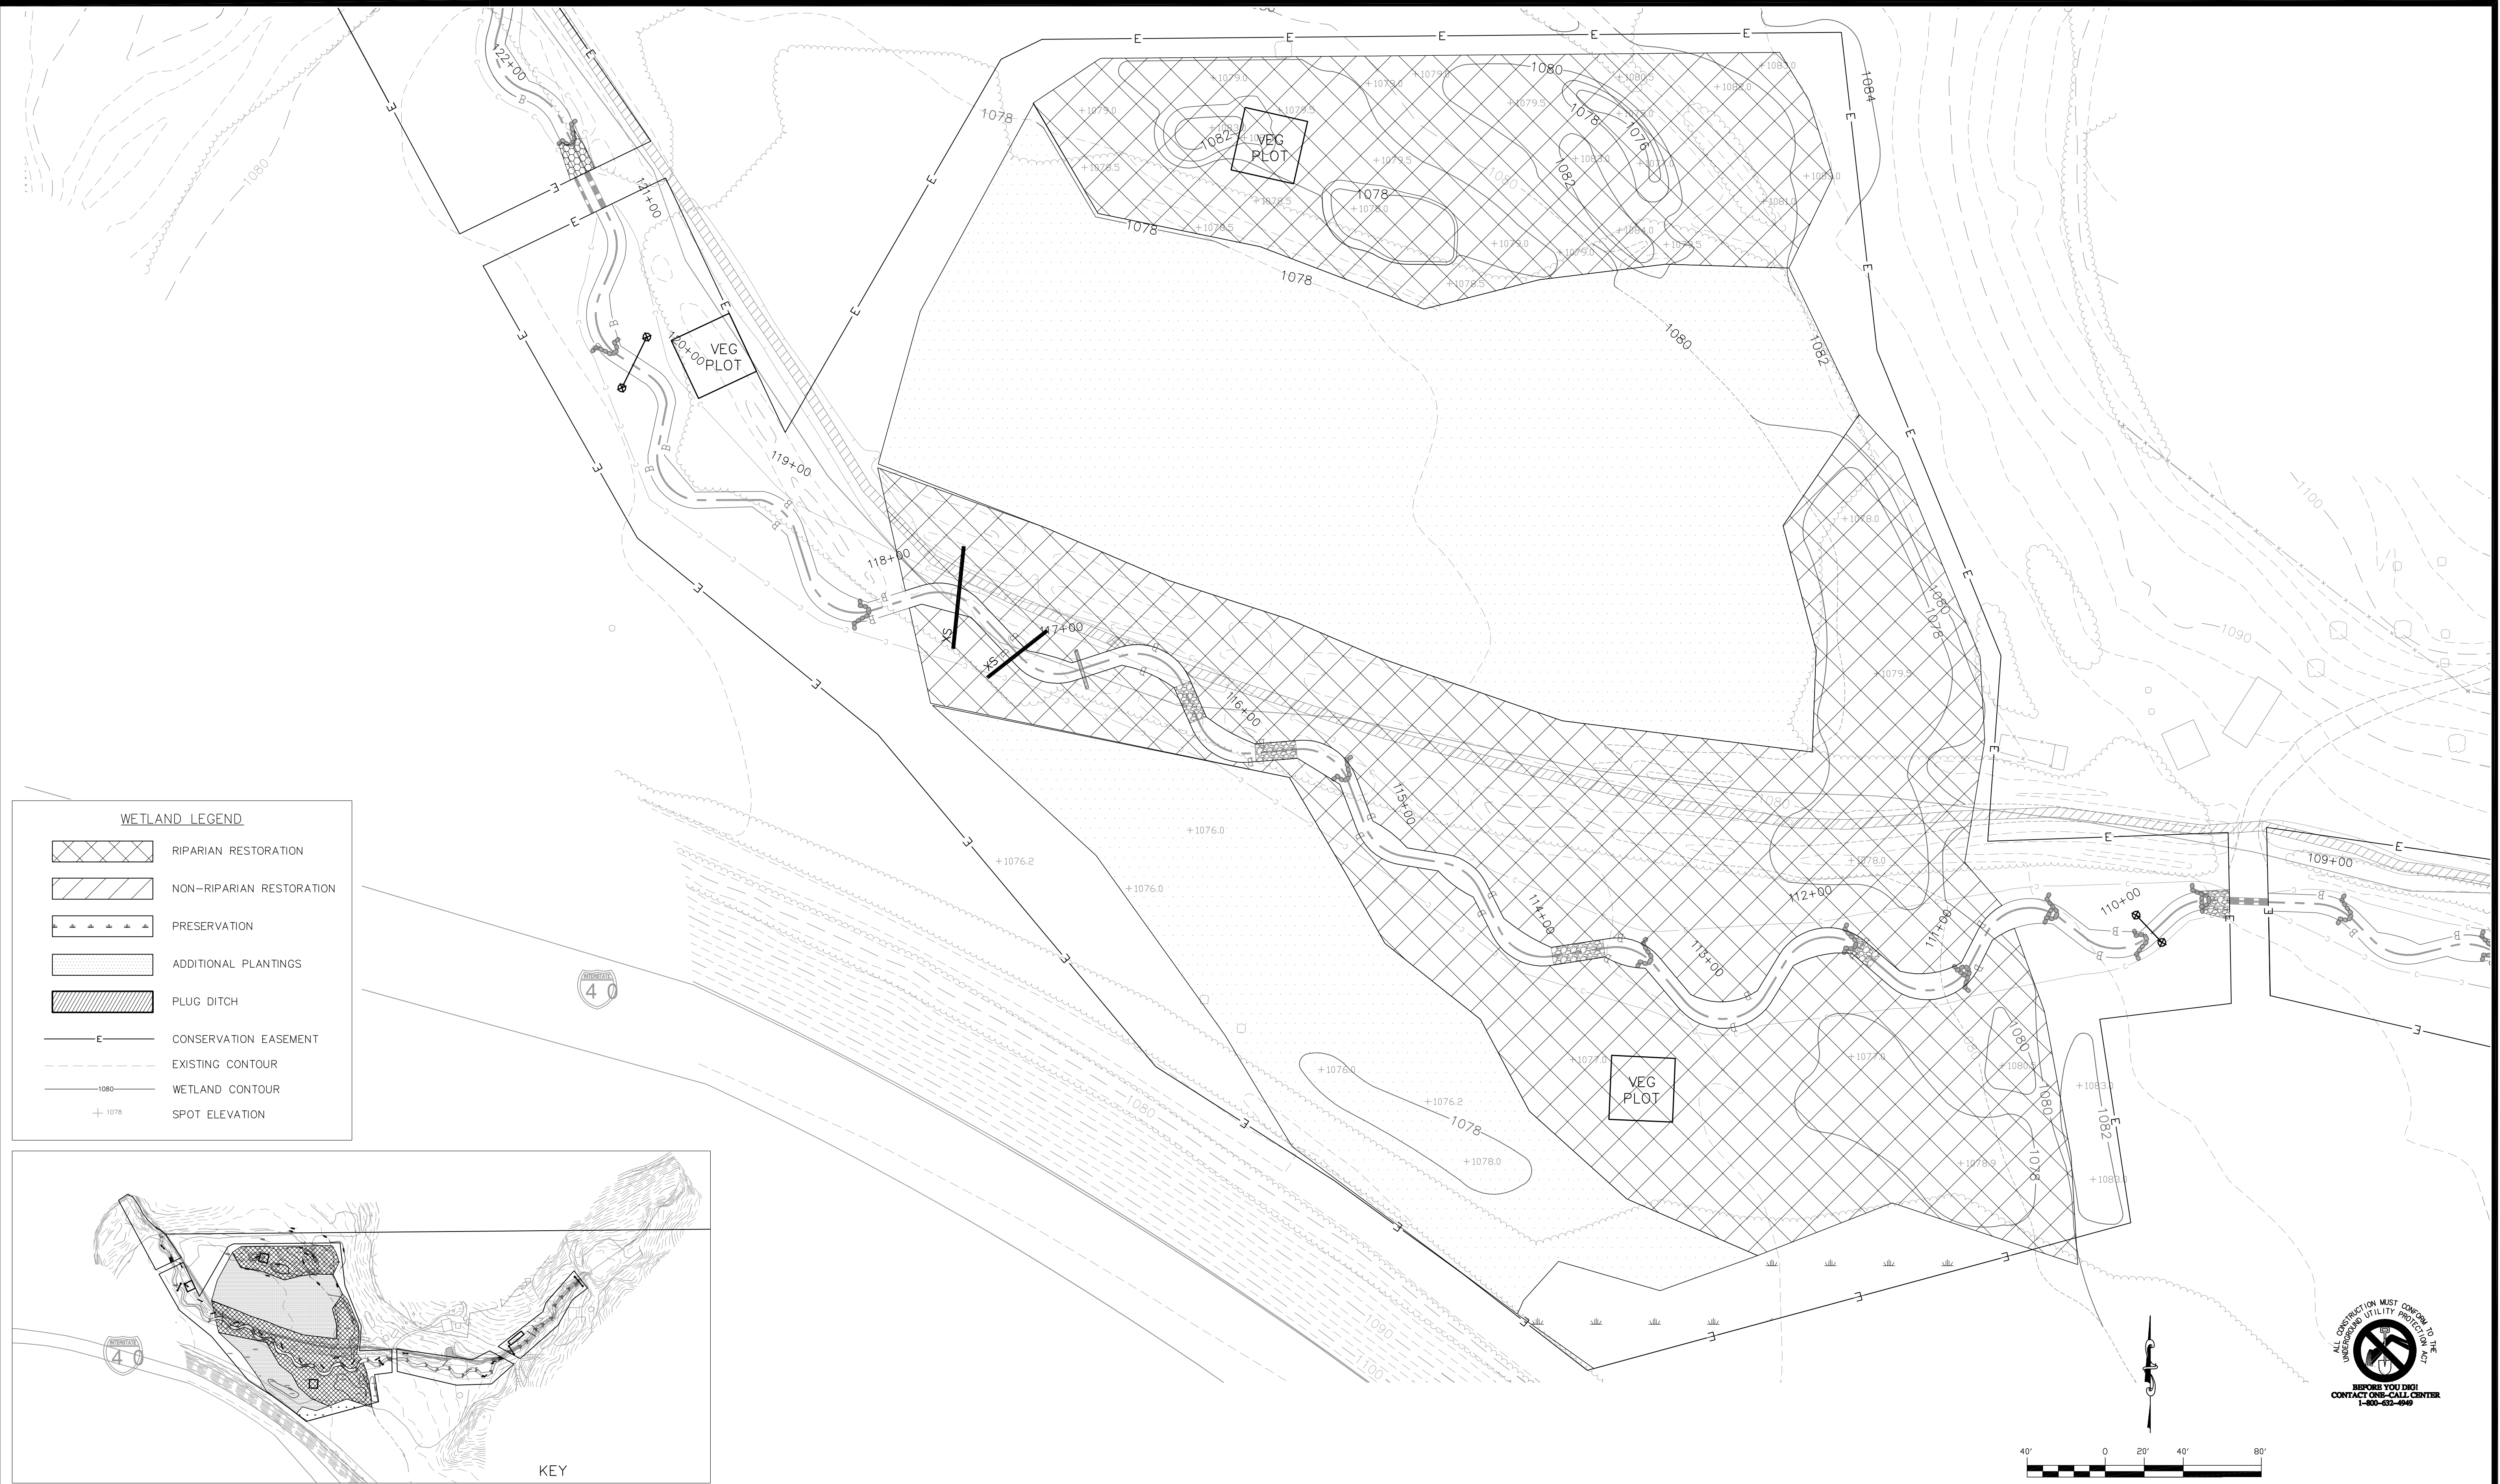
**WETLAND LEGEND**

RIPARIAN RESTORATION
	NON-RIPARIAN RESTORATION
	PRESERVATION
	ADDITIONAL PLANTINGS
	PLUG DITCH
	CONSERVATION EASEMENT
	EXISTING CONTOUR
	WETLAND CONTOUR
	SPOT ELEVATION

Wetland restoration areas located in UT1 and UT6 were modified by grading (a maximum of 6 inches) to bring the ground elevation within a foot of the mean growing season water table. The land surface was reshaped to allow over-bank flows to route through the wetland. The grading also created microtopography to increase ponded water detention and infiltration times. The areas that were open fields were revegetated with woody species, thereby increasing hydraulic roughness of the floodplain, leading to an increase in the duration of flooding in these areas. Restoring the streams and backfilling the ditches will restore the local ground water table and increase the frequency and duration of flooding from smaller storm events.

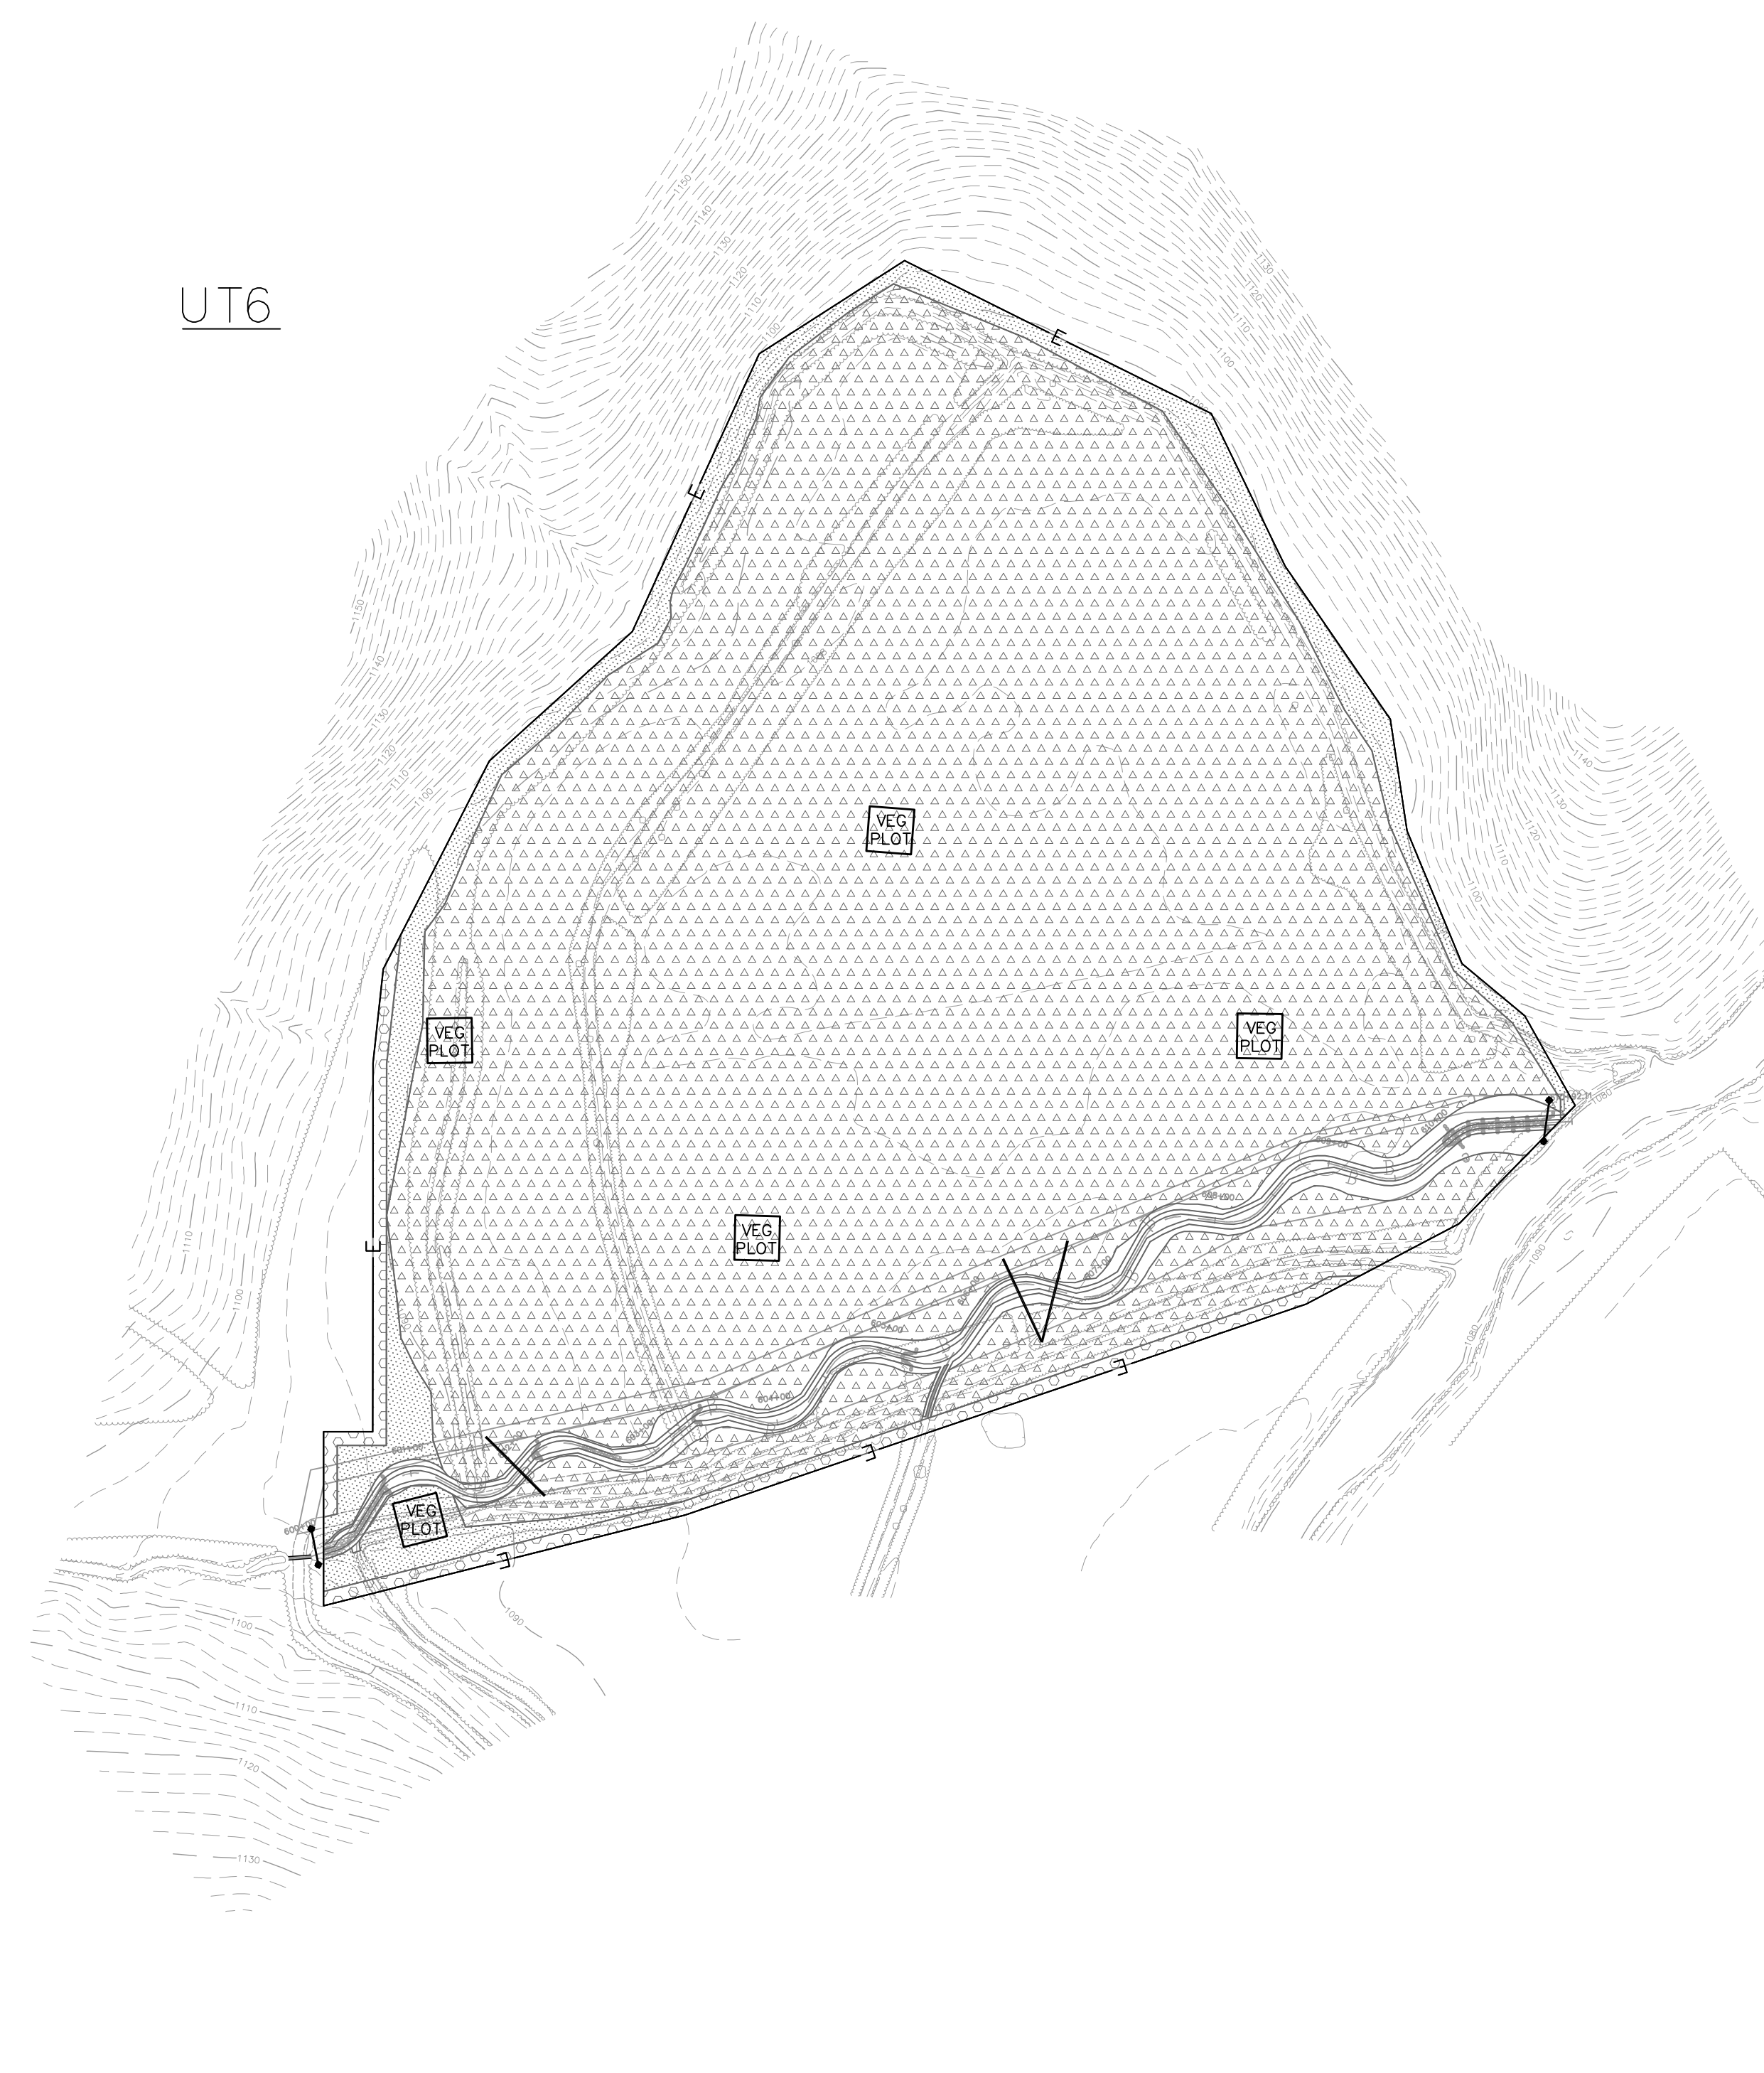
UT6

-   -ZONE 1 Stream Bank
-   -ZONE 2 Riparian/Bankfull Bench
-   -ZONE 3 Transitional
-   -ZONE 4 Wetland/Bottomland Hardwood
-   -ZONE 5 Supplemental Plantings

The riparian buffer of the entire easement was planted in five zones. Zone 1, the stream bank zone, consisted of planted tree and shrub species and seeded native herbaceous species typically found along stream banks in the region. Zone 2, a forested riparian area, consisted of selected tree and shrub species that are tolerant of inundation and saturation. Zone 3 was a transitional zone between the other zones and the conservation easement. It included a mixture of light-tolerant, canopy, and understory species. Zone 4, a wetland/bottomland hardwood zone, covered planting zones in the wetland restoration areas where the inundation or saturation occurs for a long enough period of time during the growing season to select species more adapted to hydric conditions. Zone 5 included areas that already had appropriate native forest vegetation. In these areas, supplemental tree and shrub species were planted as needed. Zone 1 was planted with live stakes, and Zones 2 through 5 were planted with bare root seedlings. Plant spacing was determined according to planting type.
