NORWOOD GAINNEY RIPARIAN BUFFER RESTORATION

2007 Annual Monitoring Report
Year 1 of 5

NCEEP Project Number 628

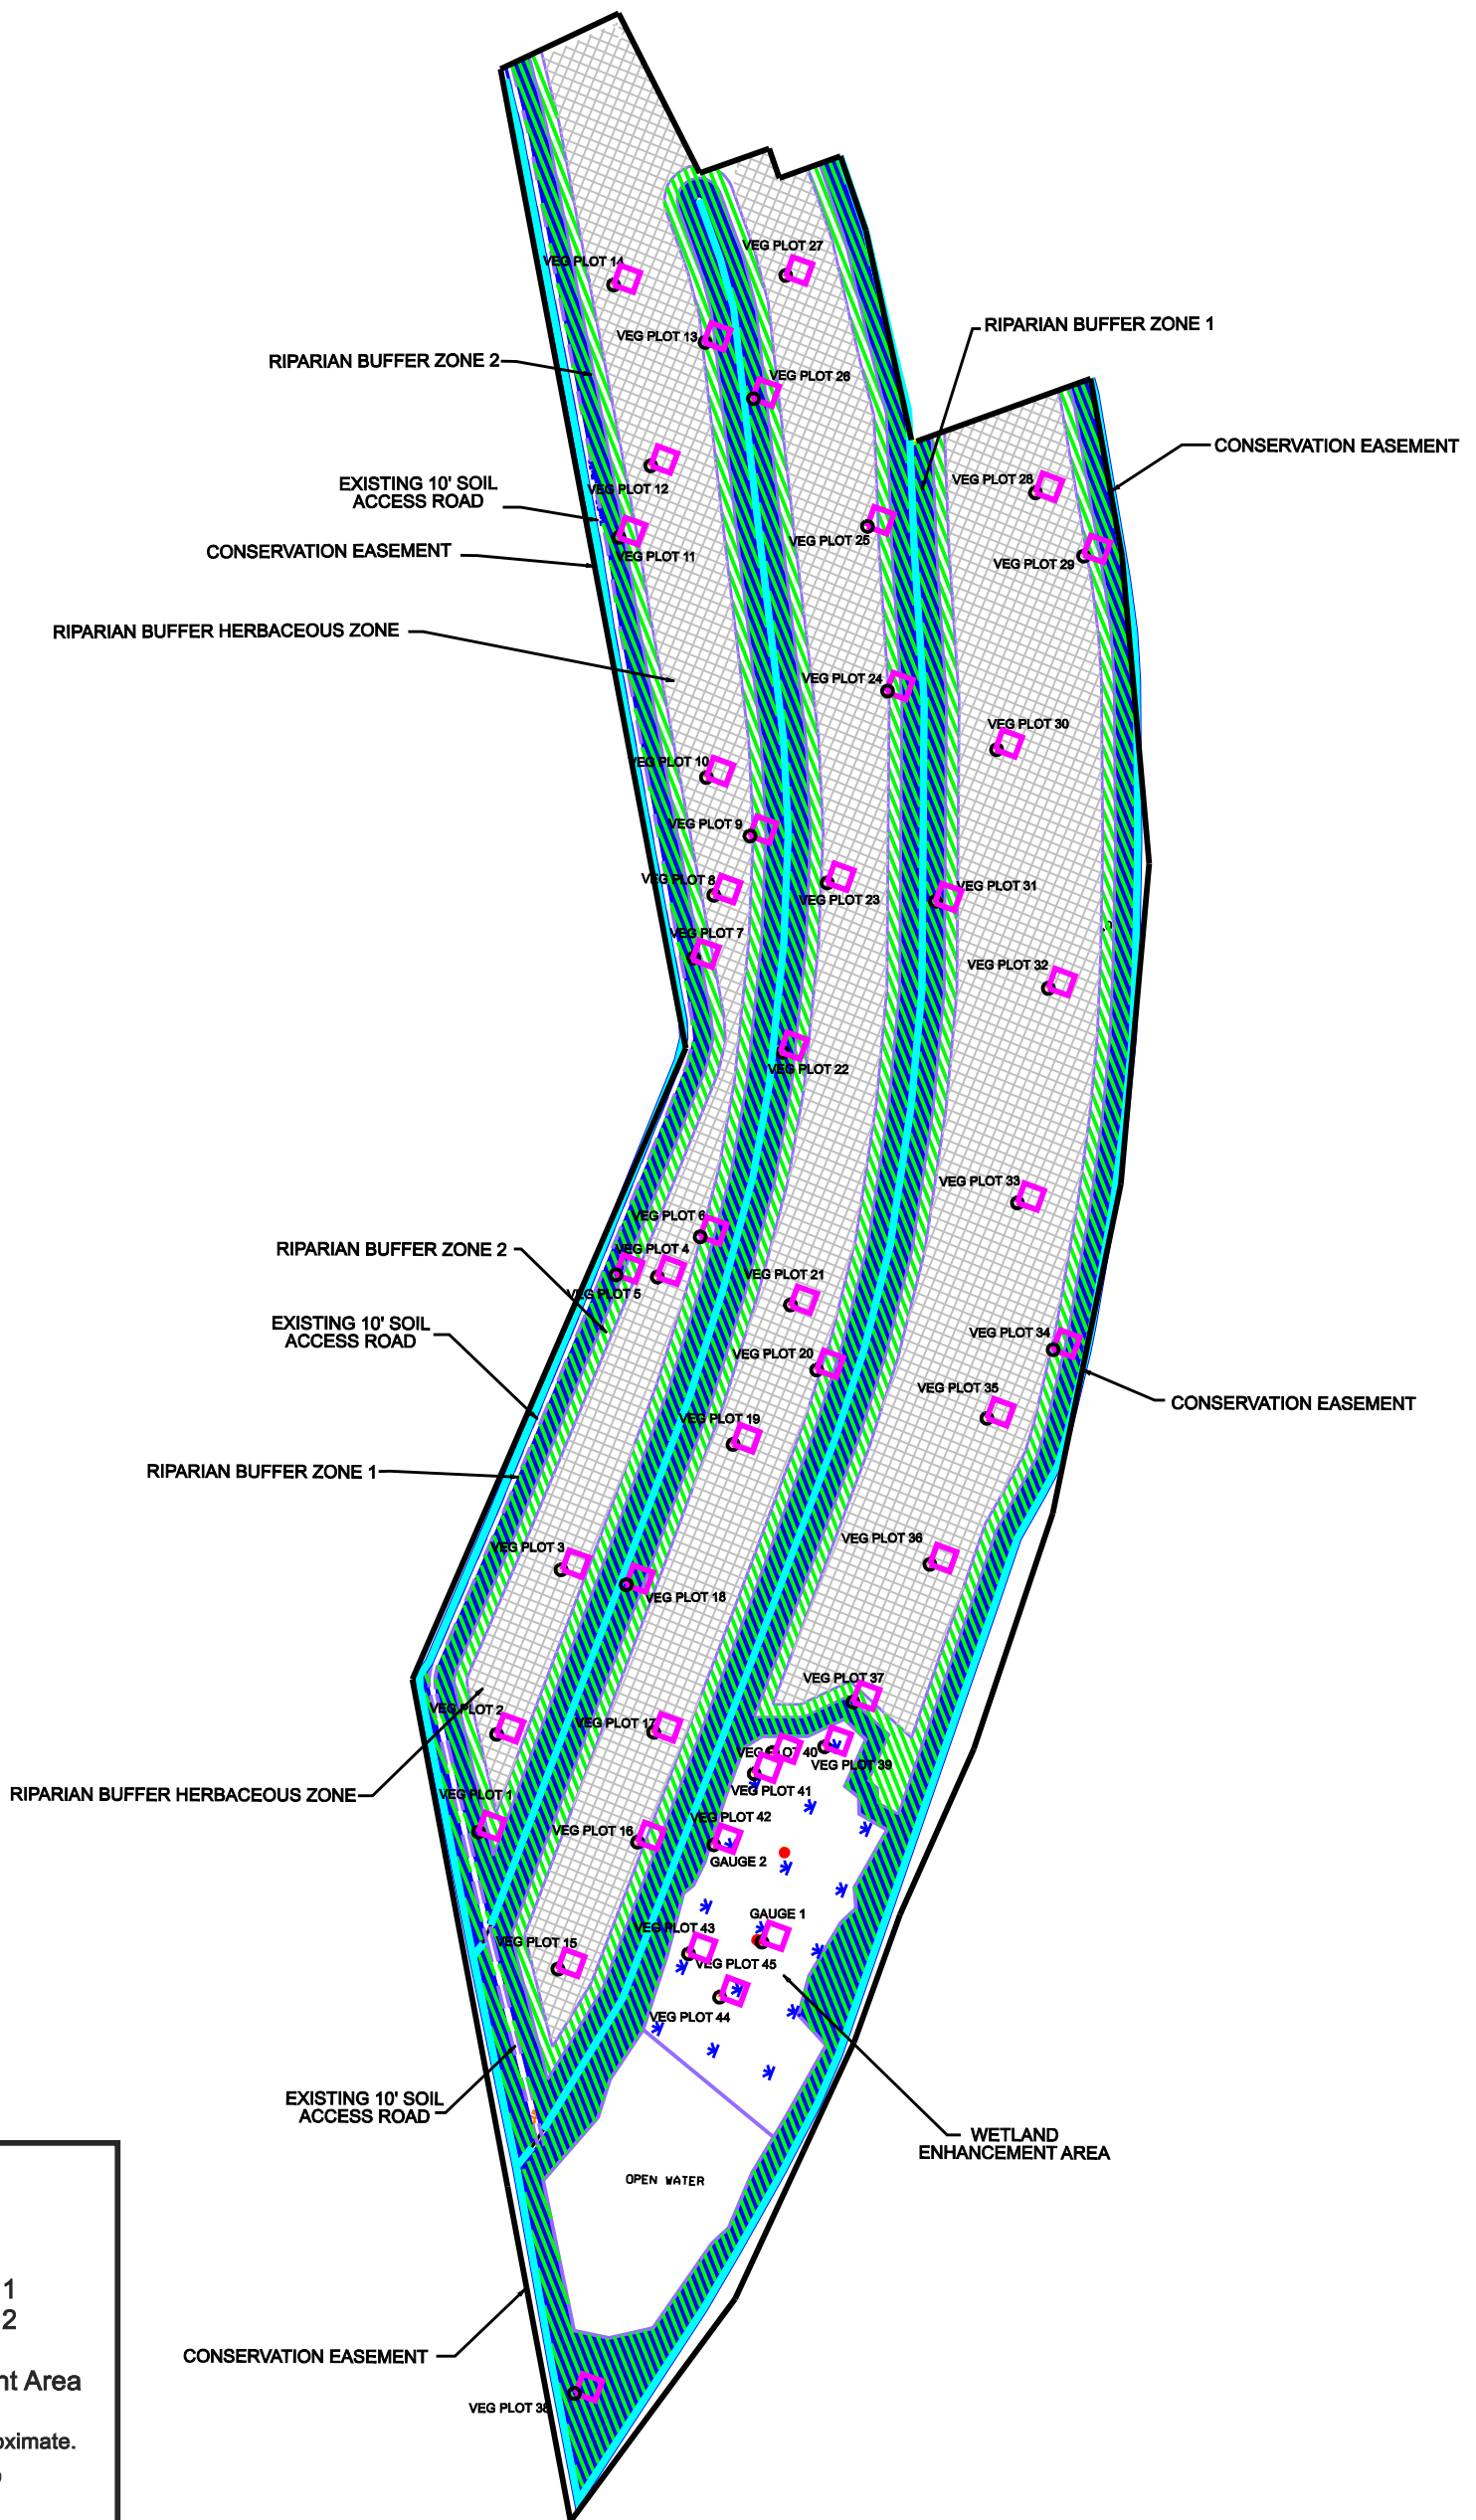
| Figure: | 2 |

Figure 2 provides a plan view of the site showing the location of all monitoring features including groundwater gauges, vegetation plots, and photo points.

Monitoring Plan View
Norwood Gainey Riparian Buffer Restoration Site EEP # 628
 Wayne County, North Carolina
 Monitoring Report Year 1

Using CVS-EEP Protocol for Recording Vegetation Version 4.0 (Lee), eighteen (10 m X 10m) plots were established within the 50-ft riparian buffer zone. Seven (10m X 10m) plots were established within the wetland enhancement area. The location of the plots is based on representative conditions for the mitigation type as a whole. For each plot, species composition and density are recorded to determine if vegetative success criterion is met. Twenty (10m X 10m) plots were established within the herbaceous zone. The 20 vegetation plots within the herbaceous zone will be monitored concurrently with the riparian buffer zone. The percent coverage of planted and naturally recruited vegetation will be visually estimated. Herbaceous coverage is not tied directly to success criteria, although coverage of at least 80% is desirable. Representative photographs of all vegetative plots will be taken and included in monitoring reports.

In 2007, hydrologic monitoring was initiated in the wetland enhancement area. Environmental Services, Inc. installed two groundwater gauges in the wetland enhancement area. No monitoring is proposed for the open water area adjacent to the wetland enhancement area. Groundwater monitoring is conducted onsite to determine if the hydrologic success criterion for a wetland mitigation site is being met.

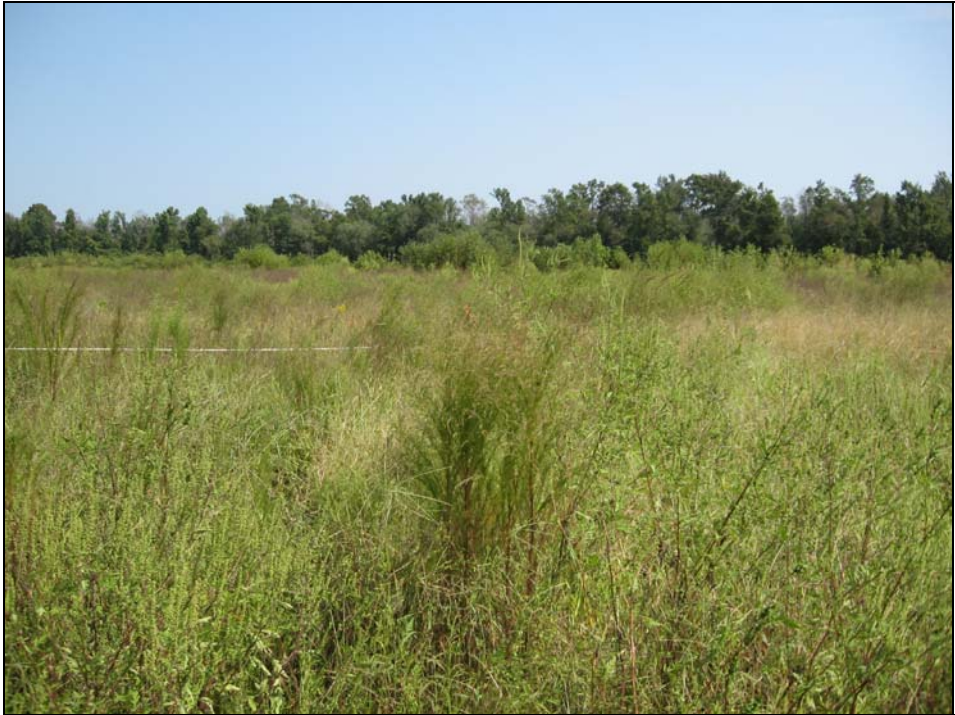
Plot 7 did not meet the success criterion with nine stem deaths. Drought conditions during the 2007 growing season likely contributed to the high mortality rate in this plot.

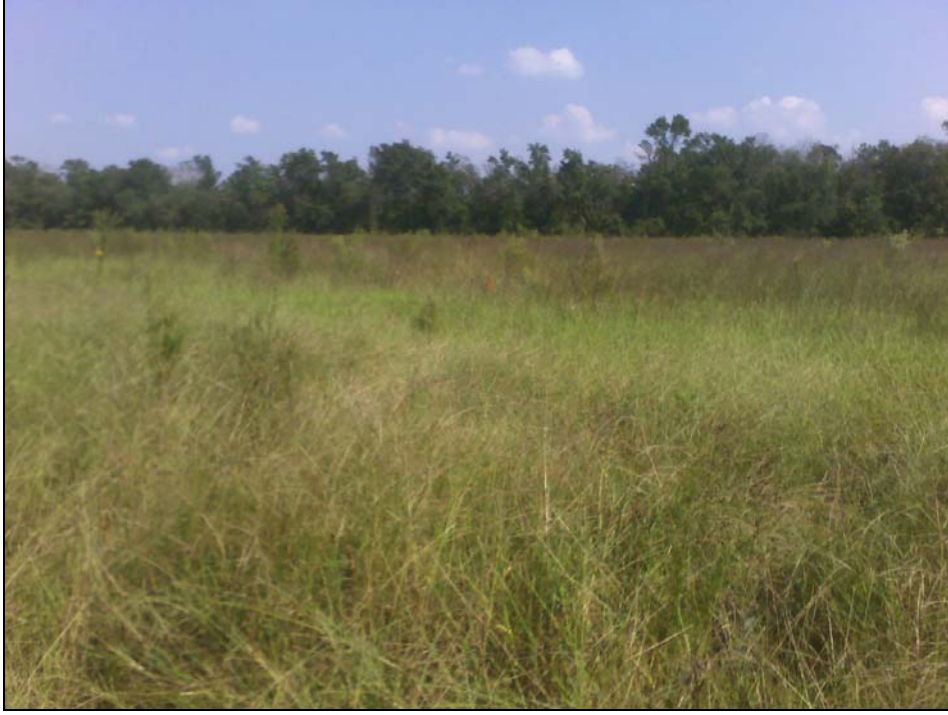
plots which experience relatively few stem deaths. Plot 22 did not meet the success criterion for Year 3 with four stem deaths. However, four stem deaths is less than the 4.3 stem deaths average for the riparian buffer area.

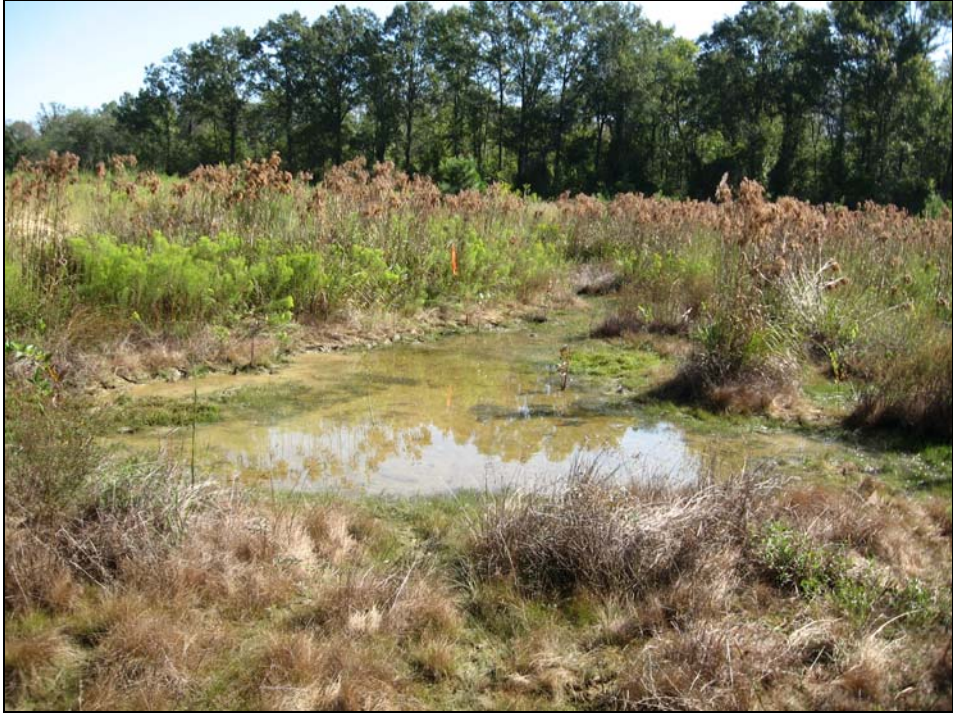
Plot 40 did not meet the Year 3 vegetative success criterion with seven stem deaths. Plot 40 is located in an area which experienced higher water levels during the 2007 growing season potentially contributing to the high stem death rate.

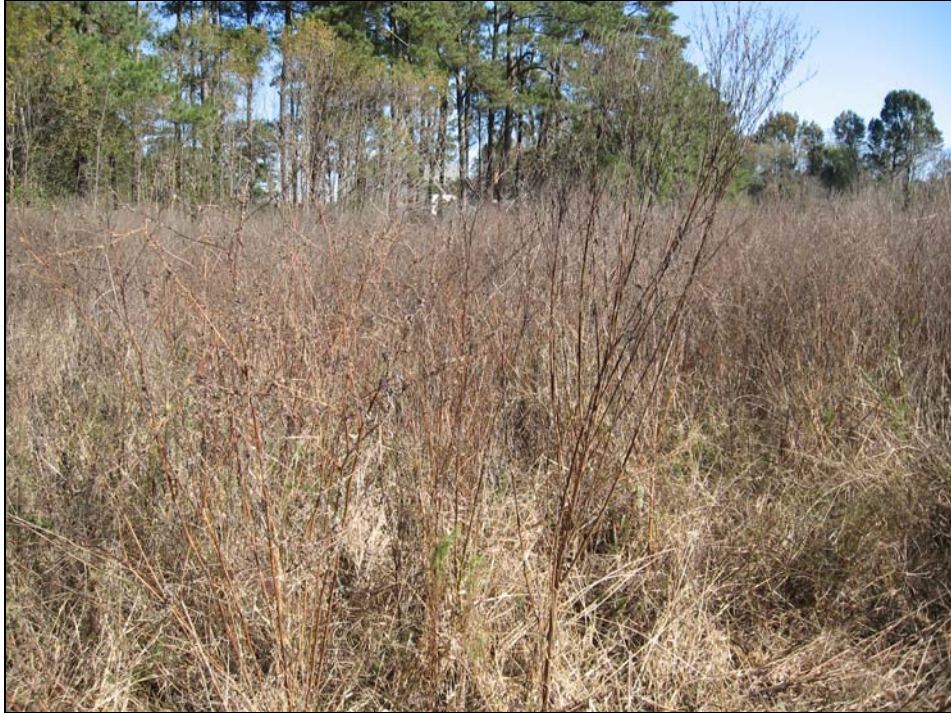
Plot 14

| Herbaceous Plot | | |
|---|---|---|
| 14 | 70 | N |

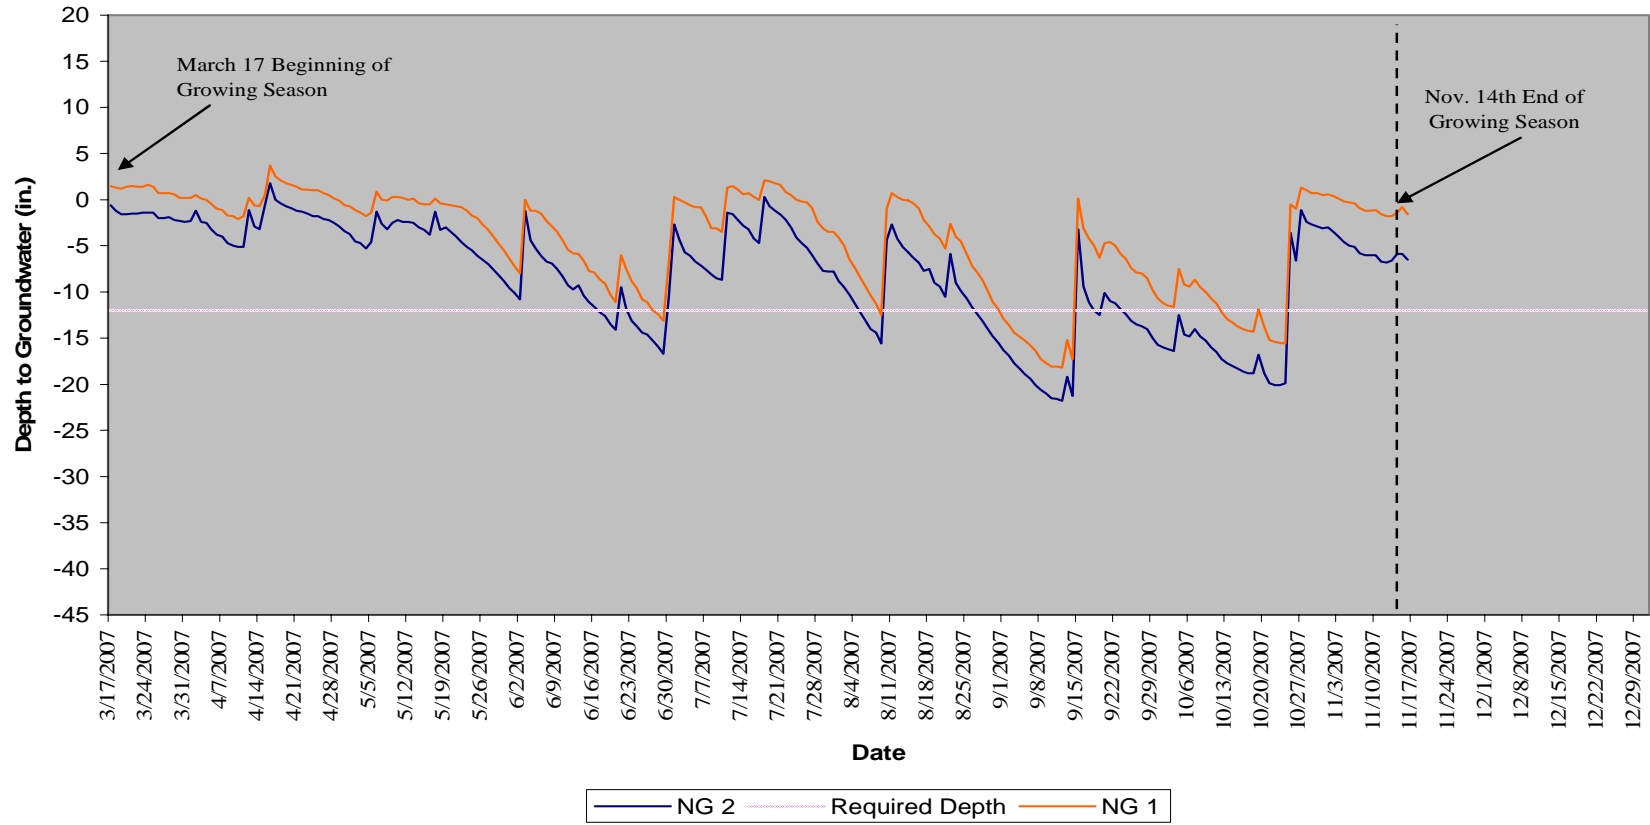
Norwood Gainey Gauges 1 and 2

During the 2007 monitoring period, the two monitoring gauges met the hydrology success criterion (Table VI), a 100.0% success rate. Hydrographs for the individual monitoring gauges can be found in Appendix B.

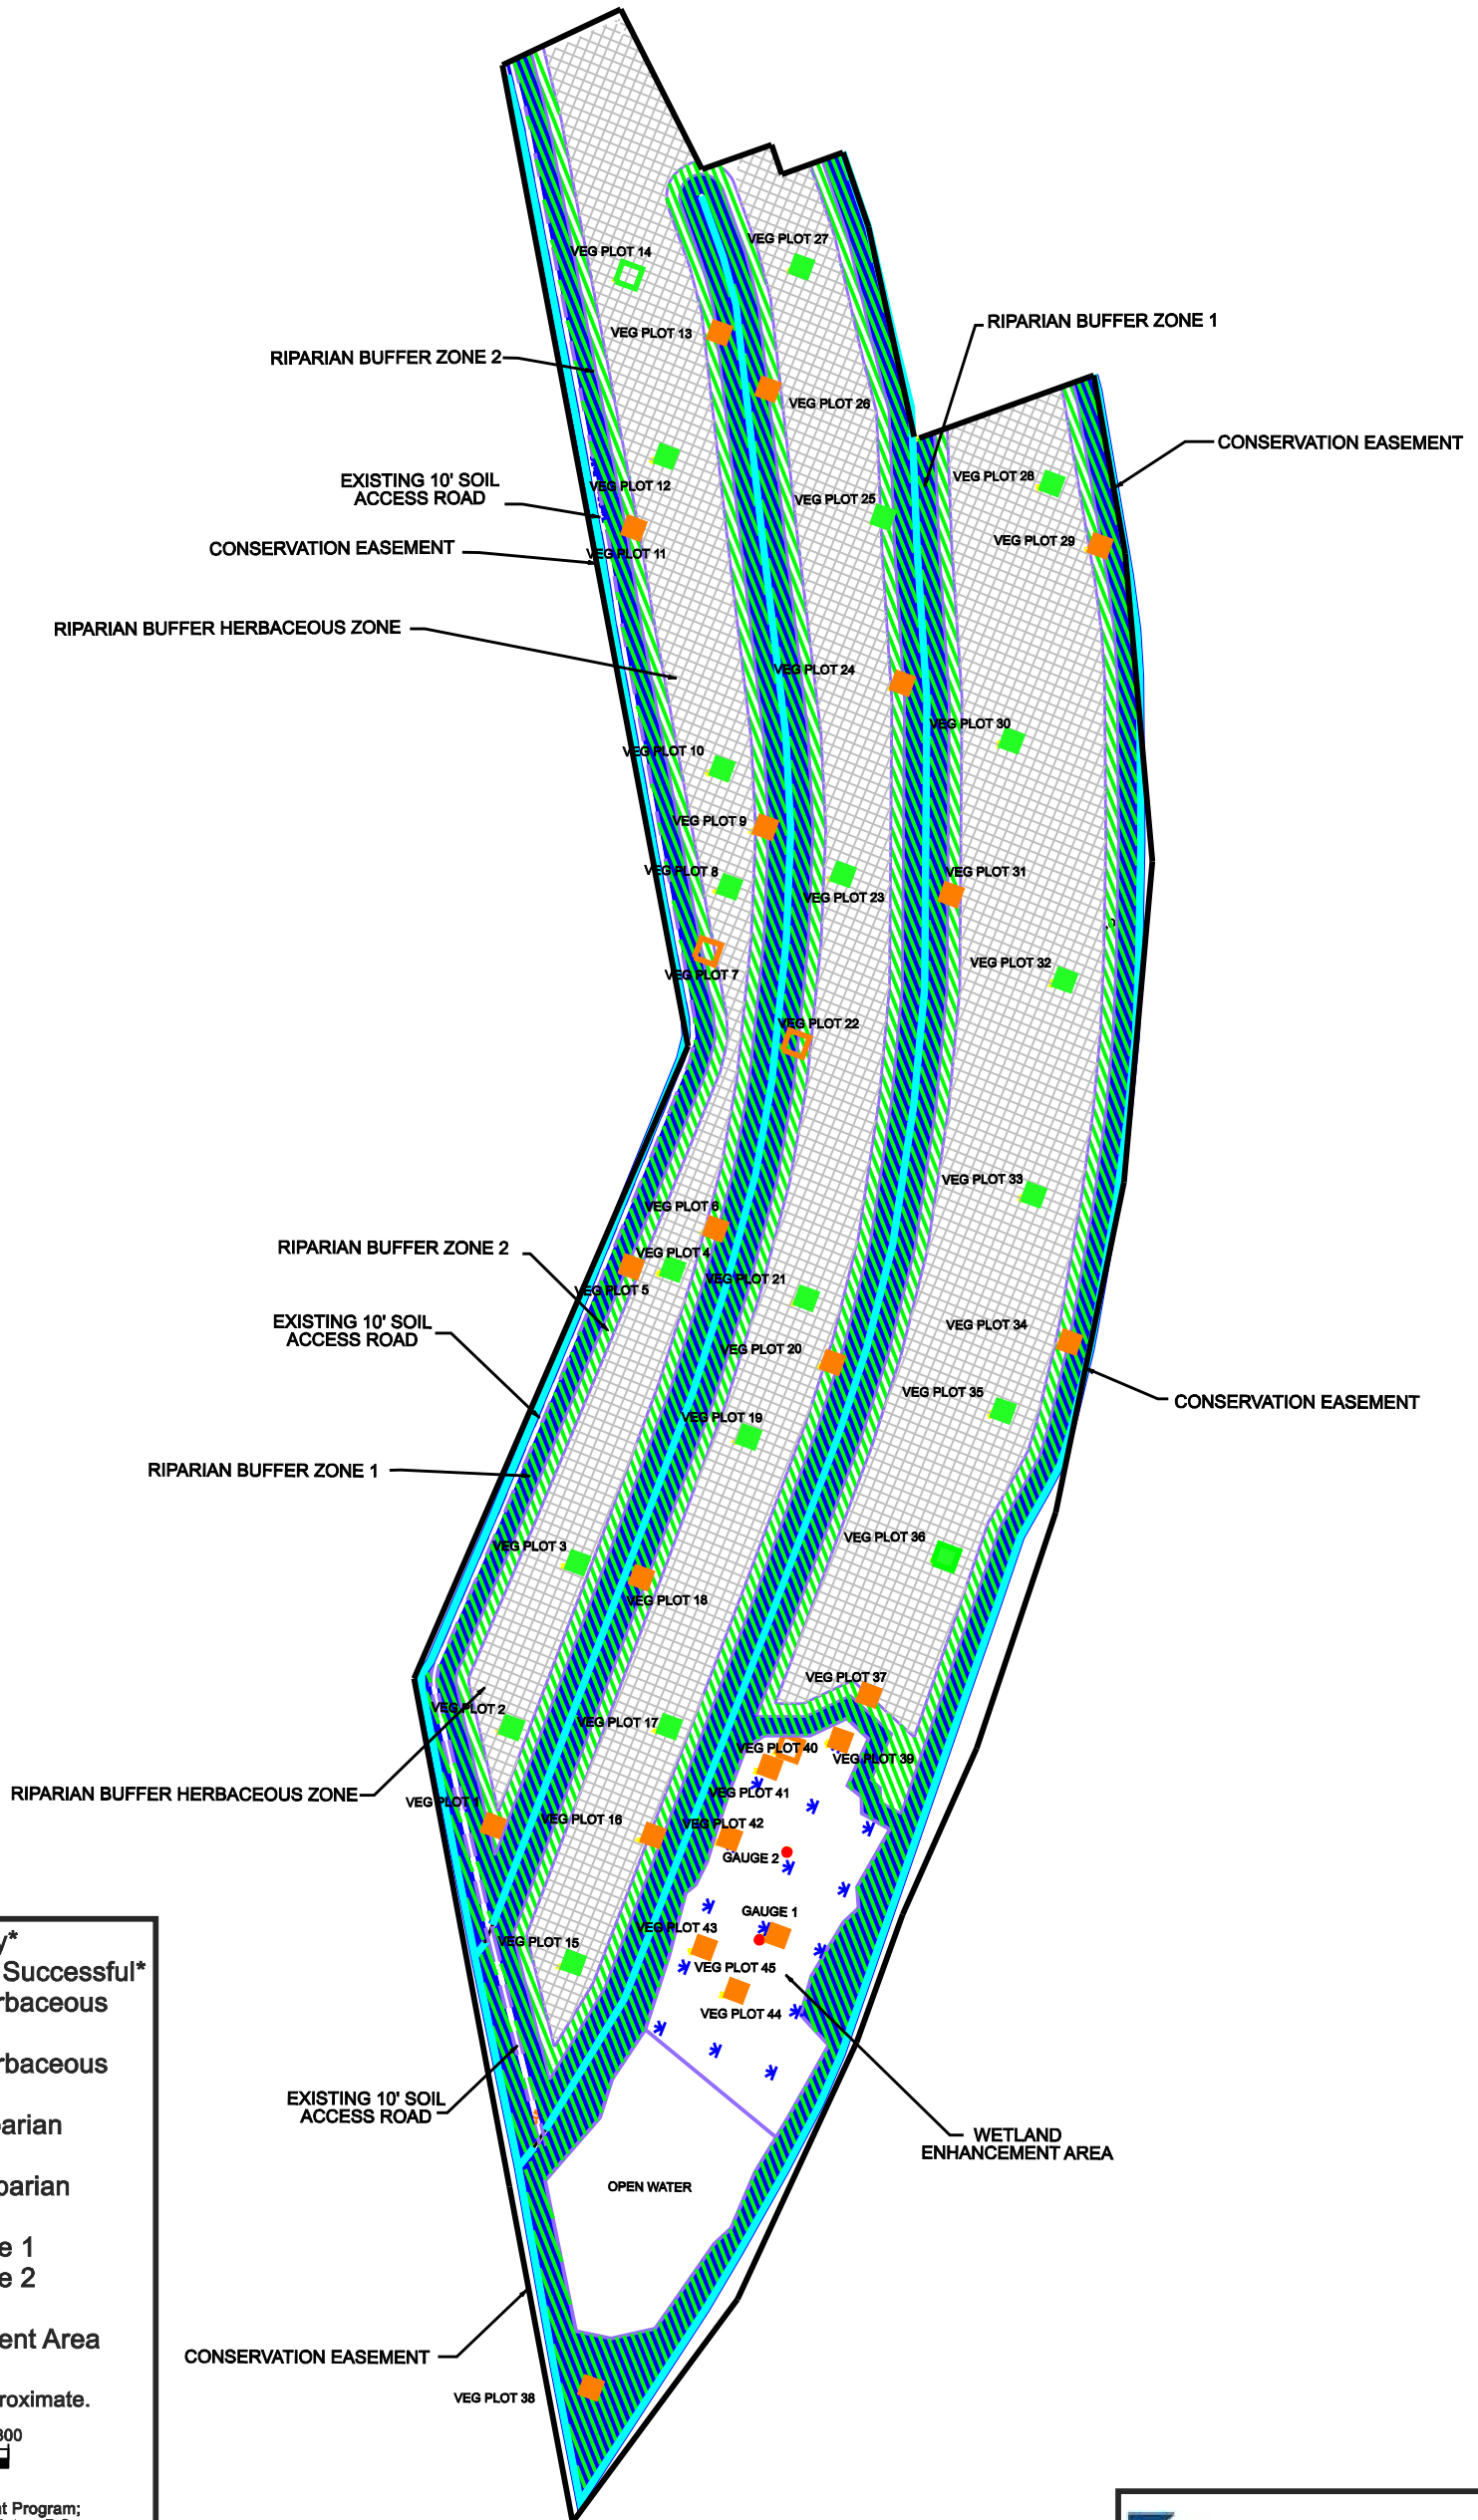
Appendix C
Integrated Overview

- Easement Boundary*
- Monitoring Gauge - Successful*
- Vegetation Plot, Herbaceous - Successful*
- Vegetation Plot, Herbaceous - Unsuccessful*
- Vegetation Plot, Riparian - Successful*
- Vegetation Plot, Riparian - Unsuccessful*
- Riparian Buffer Zone 1
- Riparian Buffer Zone 2
- Herbaceous Zone
- Wetland Enhancement Area
- Ditch*
