**ANNUAL MONITORING REPORT
NORWOOD GAINEY**

**RIPARIAN BUFFER RESTORATION AND WETLAND ENHANCEMENT
WAYNE COUNTY, NORTH CAROLINA
(EEP Project Number 628)**

Monitoring Year 3 of 5 (2009)

Prepared by:
Axiom Environmental, Inc.
20 Enterprise Street, Suite 7
Raleigh, North Carolina 27607

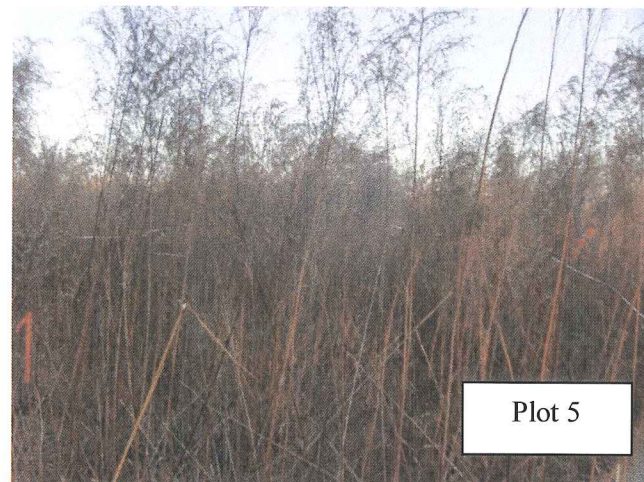
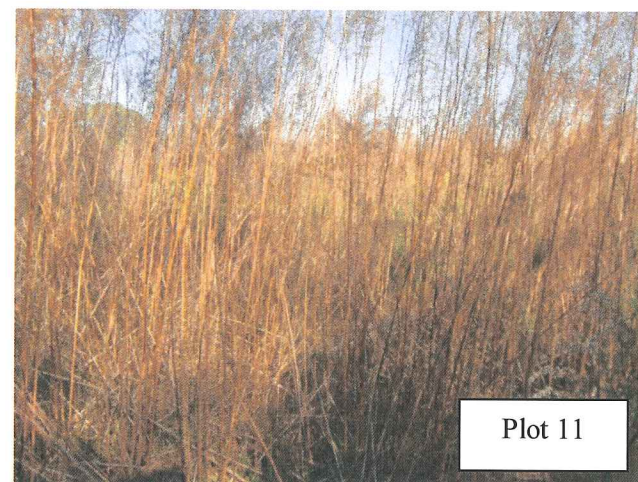
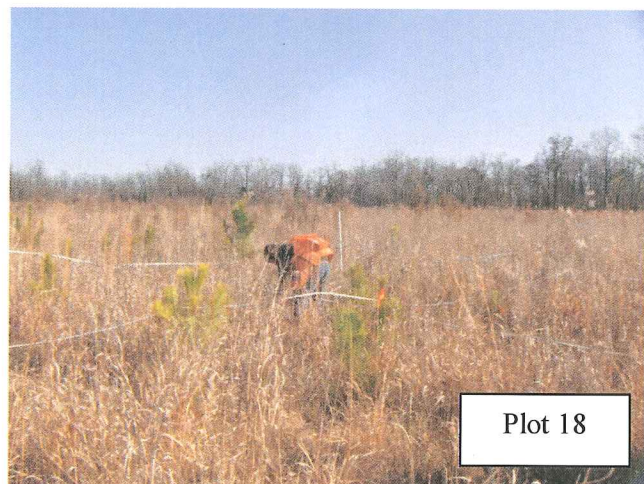
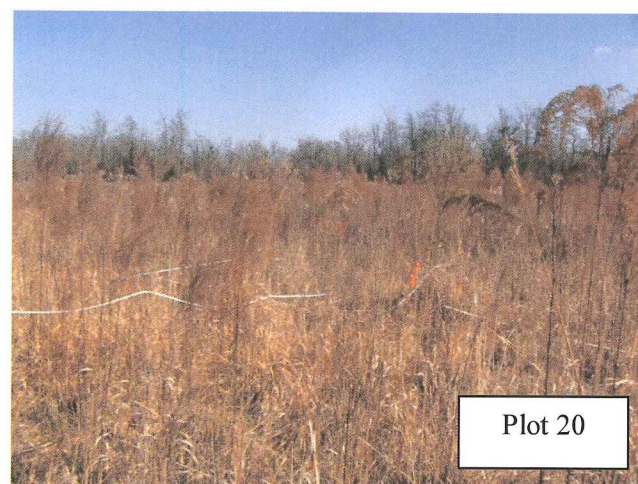
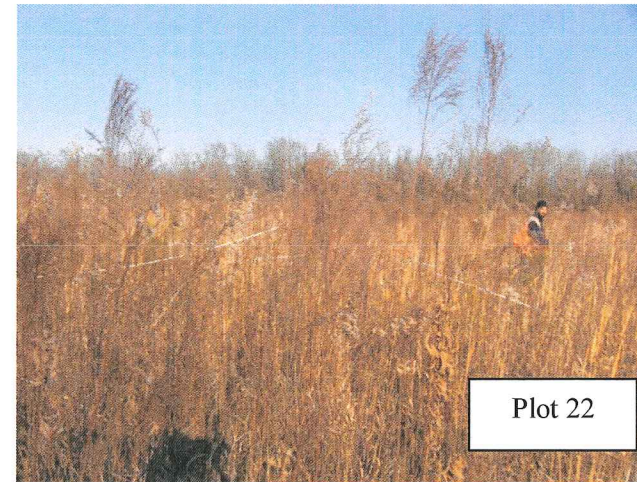
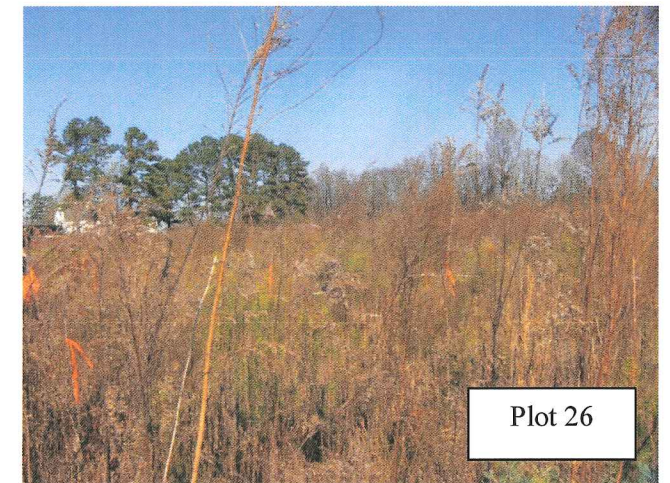
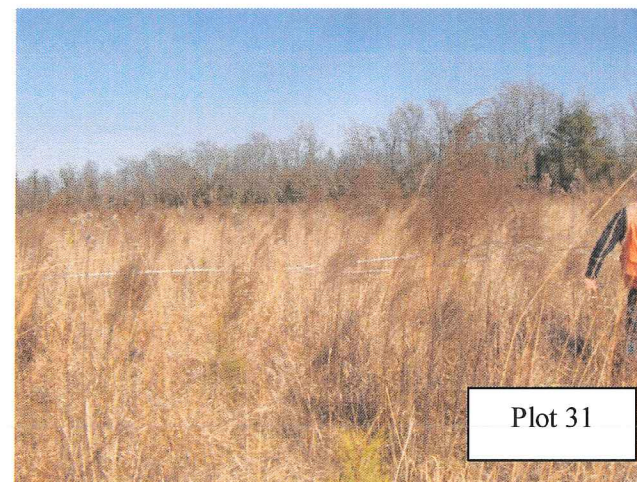
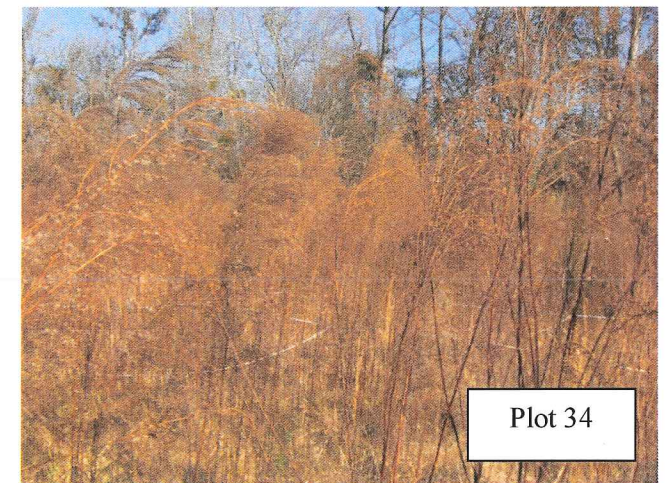
**Vegetation Monitoring Photographs
Taken December 2009**

Vegetation Plot ID	Vegetation Survival Threshold Met?	Tract Mean
5	Yes	100%
11	Yes	
18	Yes	
20	Yes	
22	Yes	
26	Yes	
31	Yes	
34	Yes

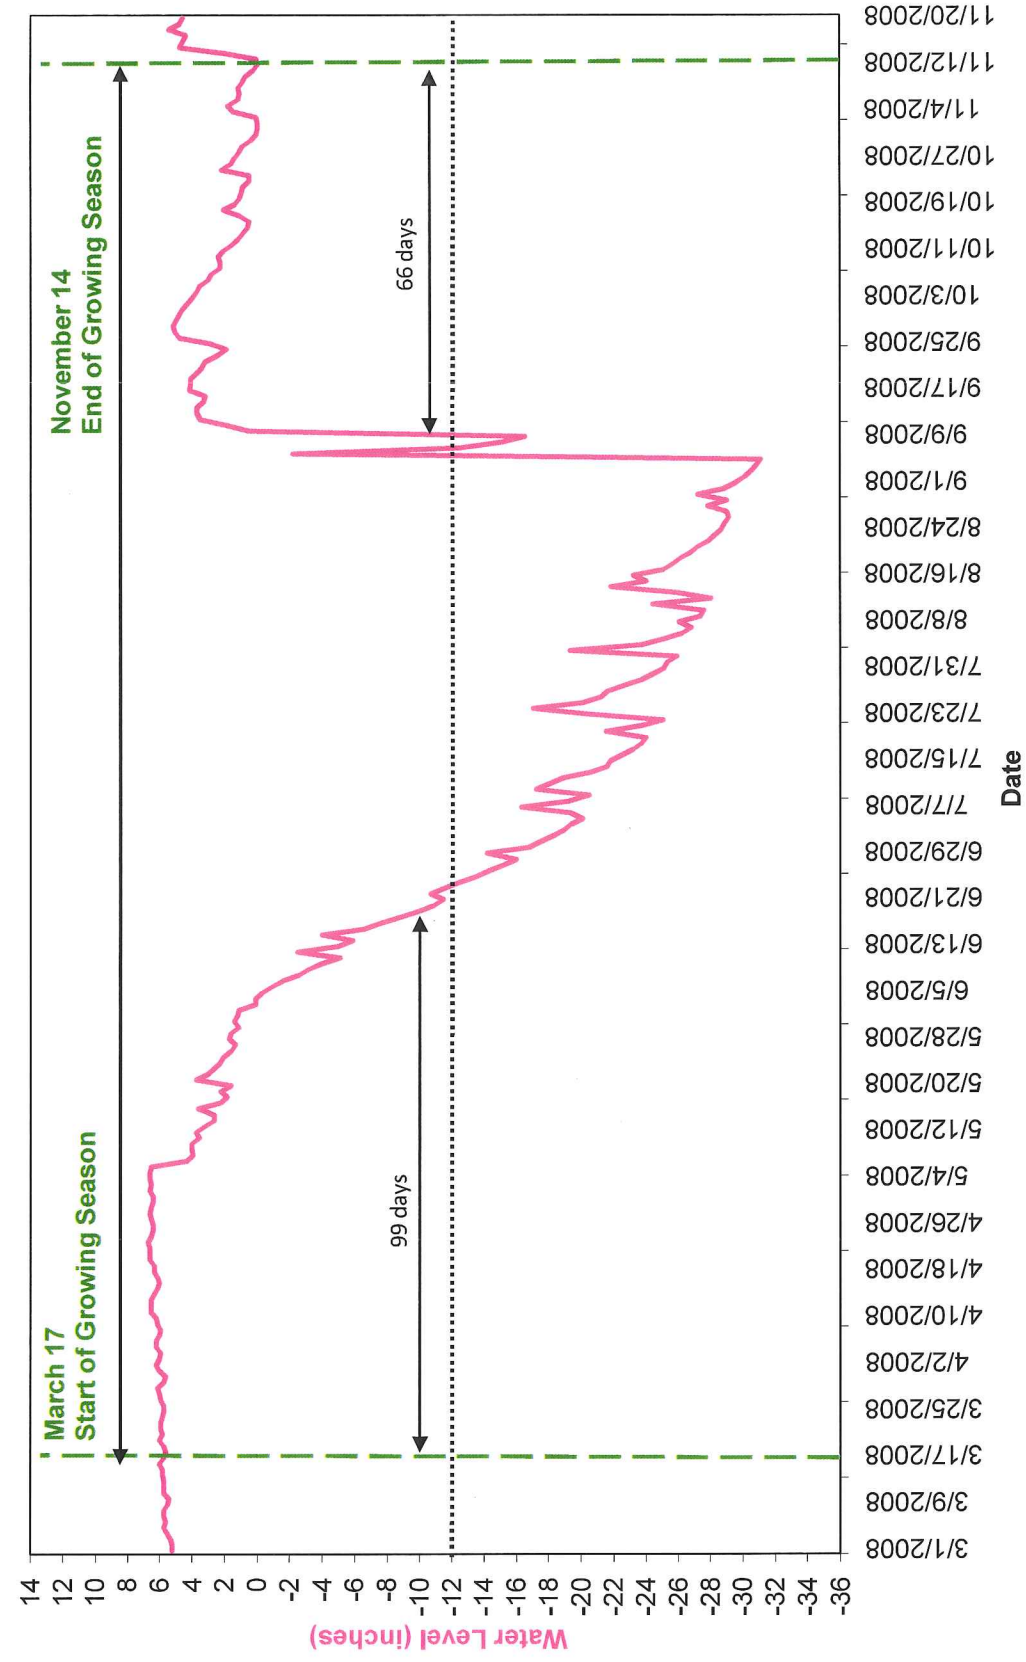
Norwood Gainey GW1
Year 2 (2008 Gauge Data)

Gauge	Success Criteria Achieved/Max Consecutive Days During Growing Season (Percentage)				
	Year 1 (2007)	Year 2 (2008)	Year 3 (2009)	Year 4 (2010)	Year 5 (2011)
1	Yes/92 days (37.9%)	Yes/99 days (40.7%)	Yes/243 days (100%)		
2	Yes/103 days (42.4%)	Yes/101 days (41.6%)	Yes*
