**FINAL  
ANNUAL MONITORING REPORT  
NORWOOD GAINEY**

**RIPARIAN BUFFER RESTORATION AND WETLAND ENHANCEMENT  
WAYNE COUNTY, NORTH CAROLINA  
(EEP Project Number 628)**

Monitoring Year 5 of 5 (2011)

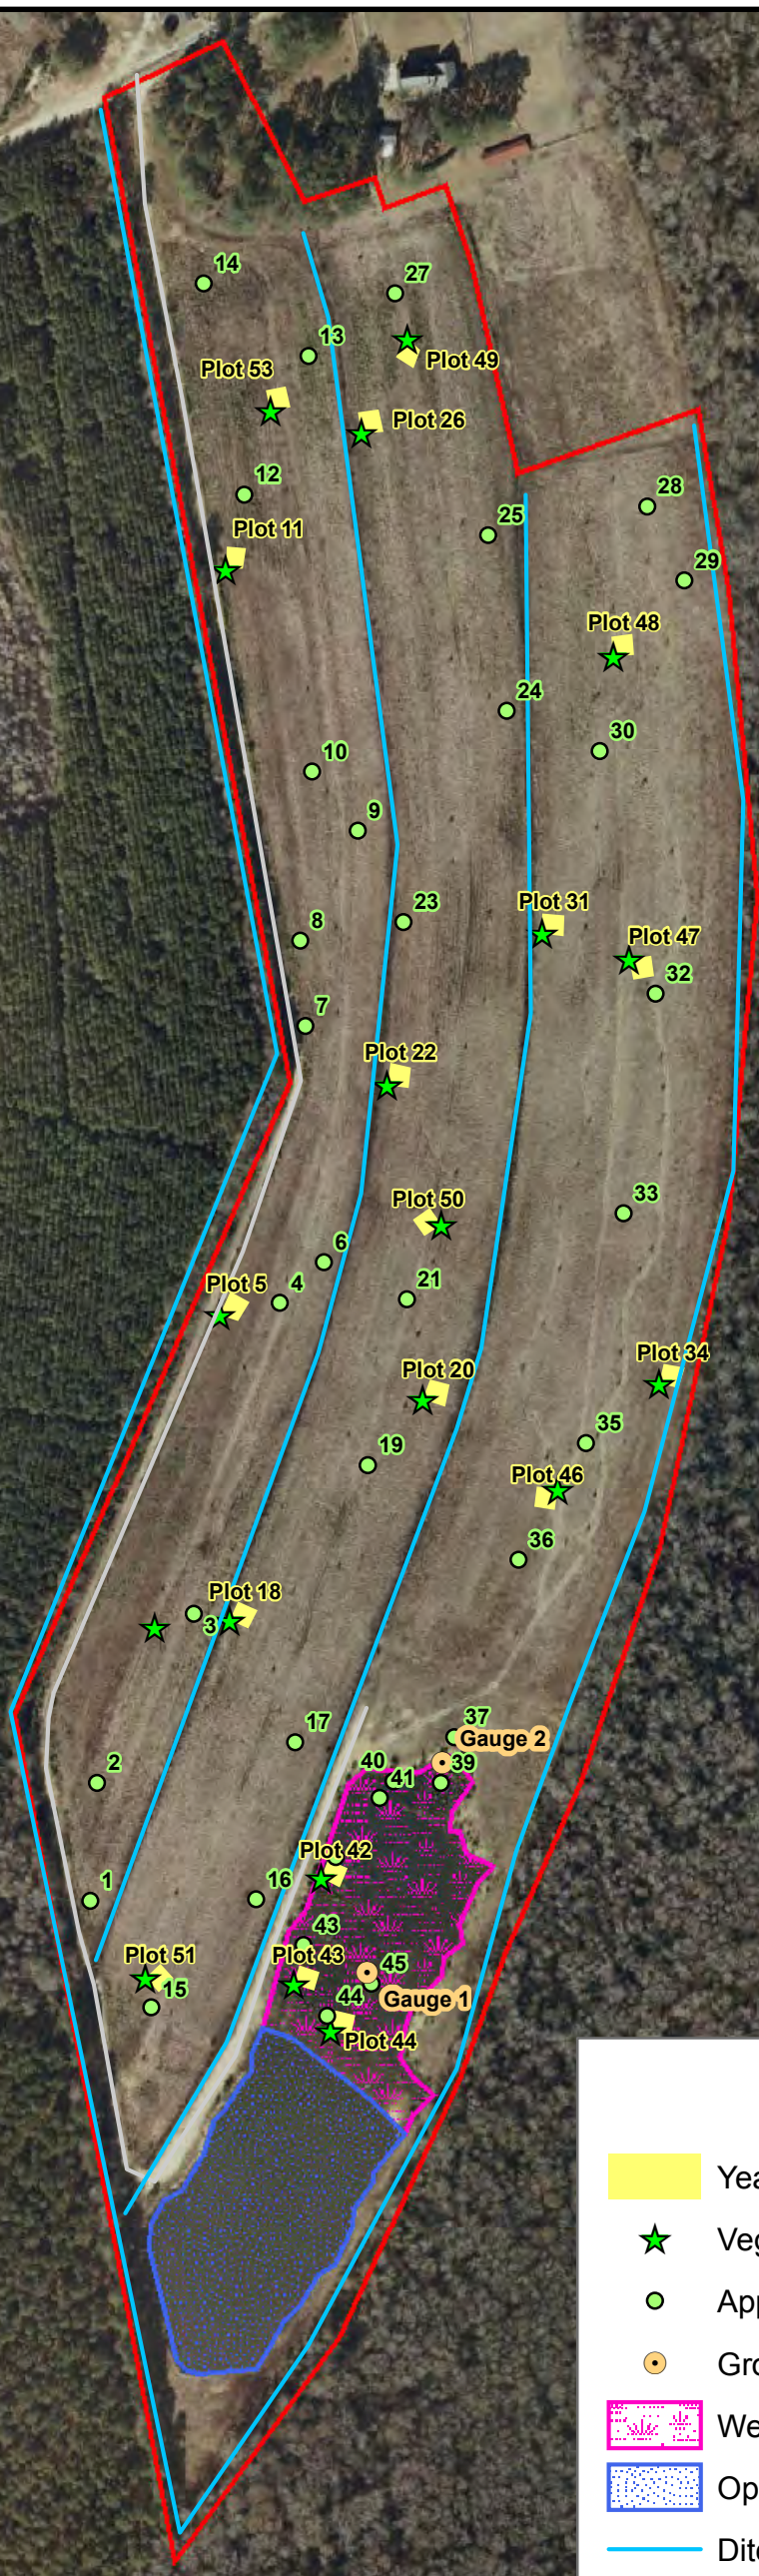
**MONITORING PLAN VIEW**  
**NORWOOD GAINERY RESTORATION SITE**  
 Wayne County, North Carolina

Following planting 45 vegetation plots (18 plots within riparian buffer restoration areas 0-50 feet from the waterways, 7 plots within the wetland enhancement area, and 20 within herbaceous riparian buffer areas greater than 50 feet from the waterways) were established within the Site as depicted on Figure 2 (Current Conditions Plan View) in Appendix A. The plots are 10 meters square and are located randomly within the Site. All 45 plots were monitored in year 1 (2007); no vegetation monitoring occurred in year 2 (2008). In year 3 (2009) 8 plots within riparian restoration areas 0-50 feet from the waterways were monitored and in late 2009 areas greater than 50 feet from ditches were planted and 8 new plots were established in these areas. In years 4-5 (2010-2011) 8 plots within riparian restoration areas 0-50 feet from the waterways, 3 plots within the wetland enhancement area, and 8 within riparian buffer areas greater than 50 feet from the waterways were monitored in late August 2010 using the *CVS-EEP Protocol for Recording Vegetation, Version 4.0* (Lee et al. 2006) (<http://cvs.bio.unc.edu/methods.htm>); results are included in Appendix C. The taxonomic standard for vegetation used for this document was *Flora of the Carolinas, Virginia, Georgia, and Surrounding Areas* (Weakley 2007).

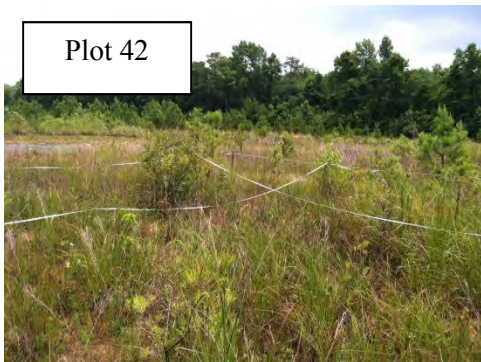
Plot 42

Death of planted stems within wetland enhancement areas has occurred as the result of excessive inundation due to beaver and small animal herbivory that occurred during and just after planting. Beaver management is now occurring on the Site and will continue as necessary. Within wetland enhancement areas, natural recruits of loblolly pine, red maple, and sweetgum that had established during the drier summer months during the 2010 monitoring period have died as the result of inundation. In addition,

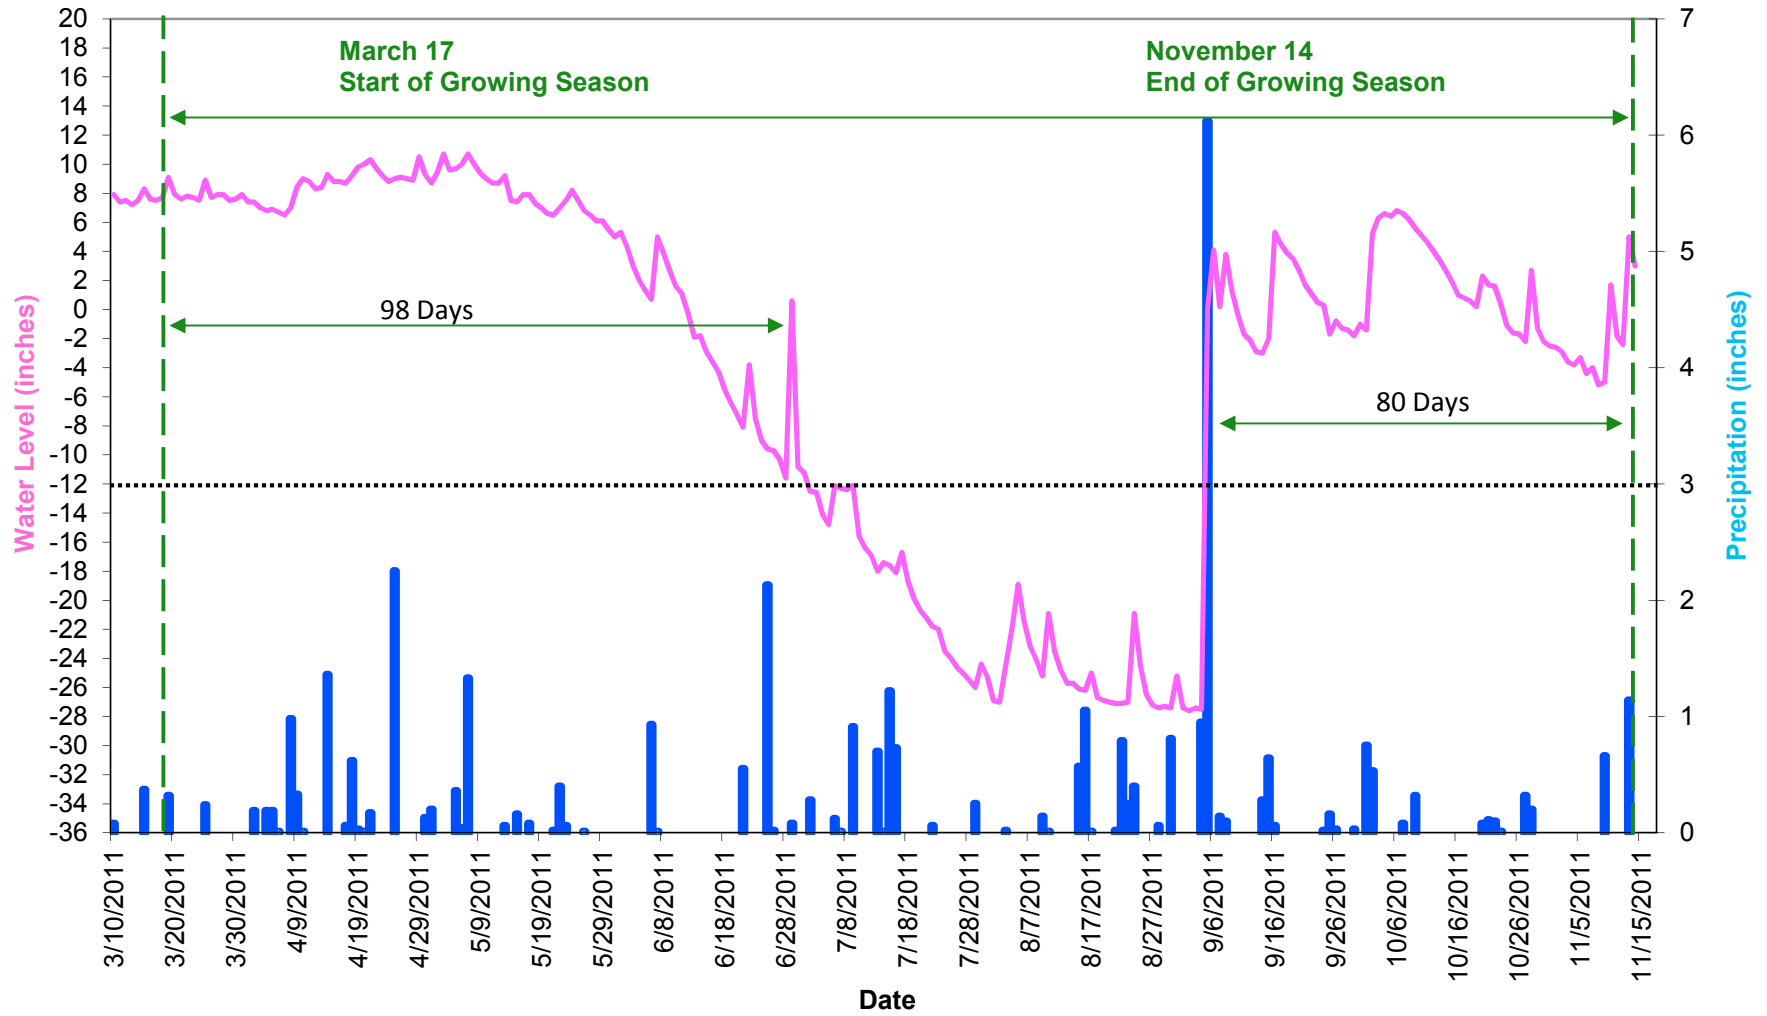
# Norwood Gainey Gauge 1 Year 5 (2011 Data)

Gauge	Success Criteria Achieved/Max Consecutive Days During Growing Season (Percentage)				
	Year 1 (2007)	Year 2 (2008)	Year 3 (2009)	Year 4 (2010)	Year 5 (2011)
1	Yes/92 days (37.9%)	Yes/99 days (40.7%)	Yes/243 days (100%)	Yes/93 days (38.3%)	Yes/98 days (40.3%)
2	Yes/103 days (42.4%)	Yes/101 days (41.6%)	Yes*	Yes/100 days (41.2%)**	Yes/86 days (35.3%)**

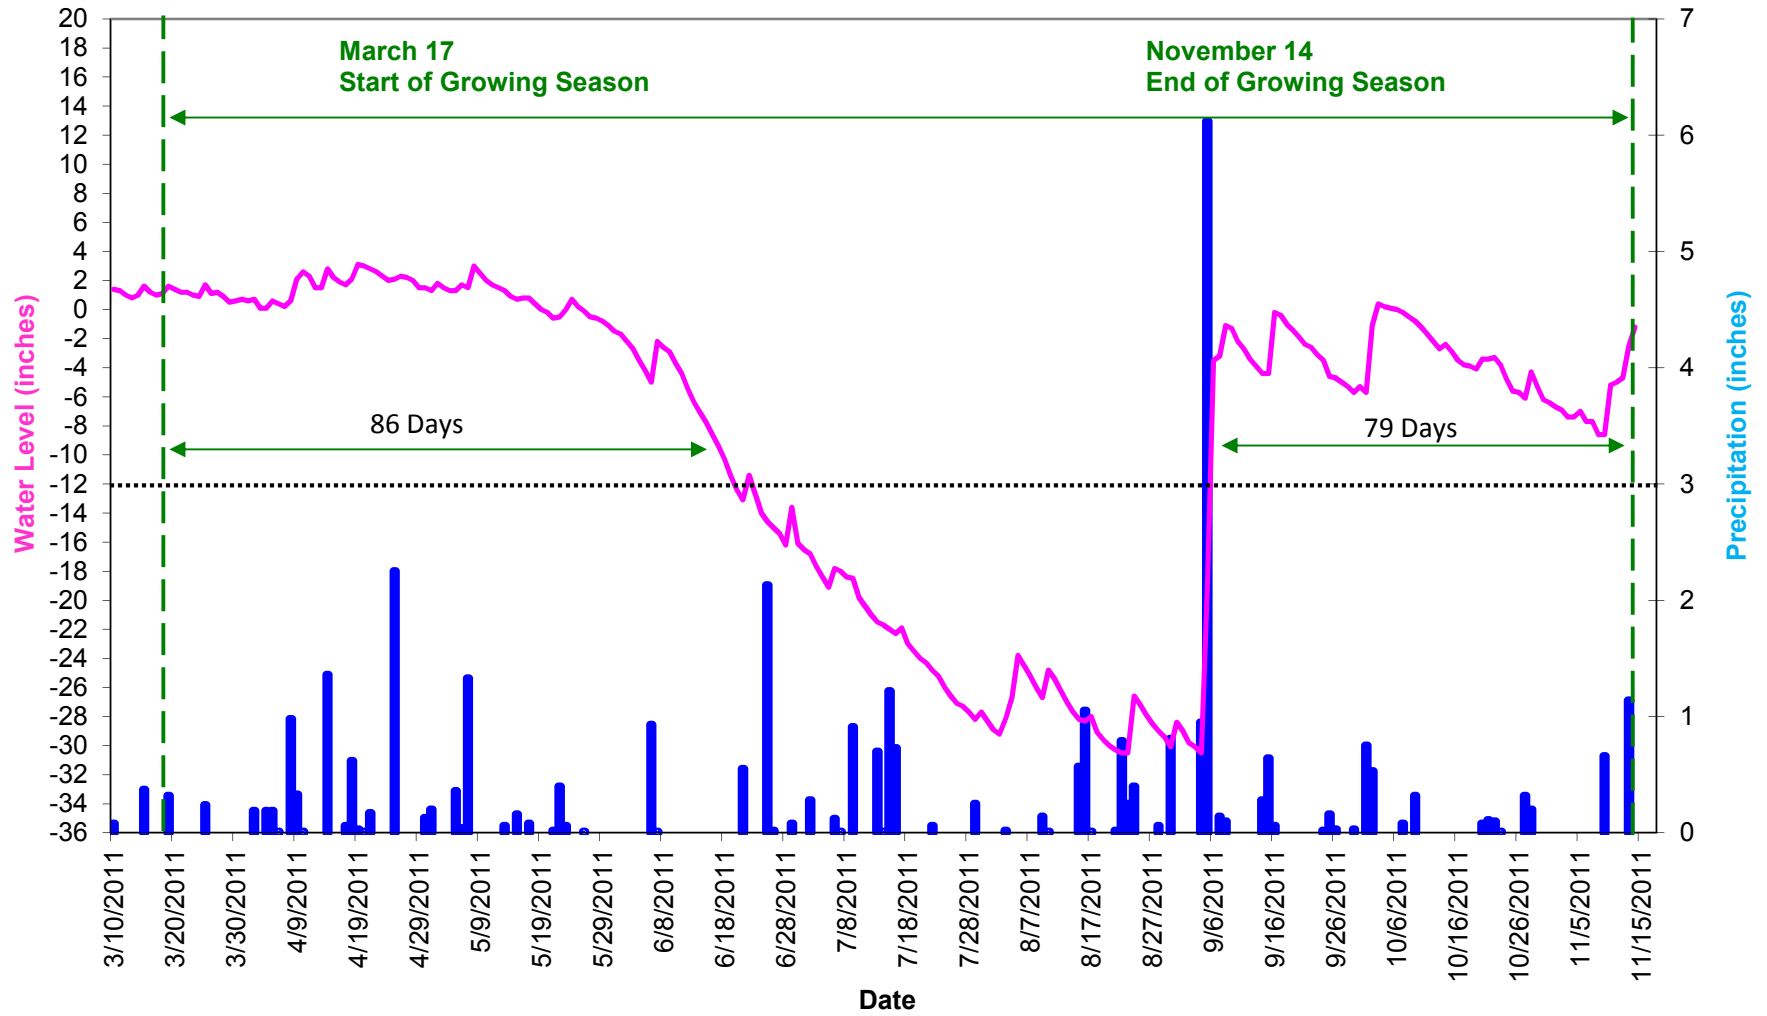
### Norwood Gainey Gauge 2 Year 5 (2011 Data)

\*\* Gauge 2 was located in an inundated area and it was impossible to reinstall the gauge until water levels dropped below the soil surface. Therefore, manual water level readings were taken monthly until the gauge could be installed on July 12, 2010.

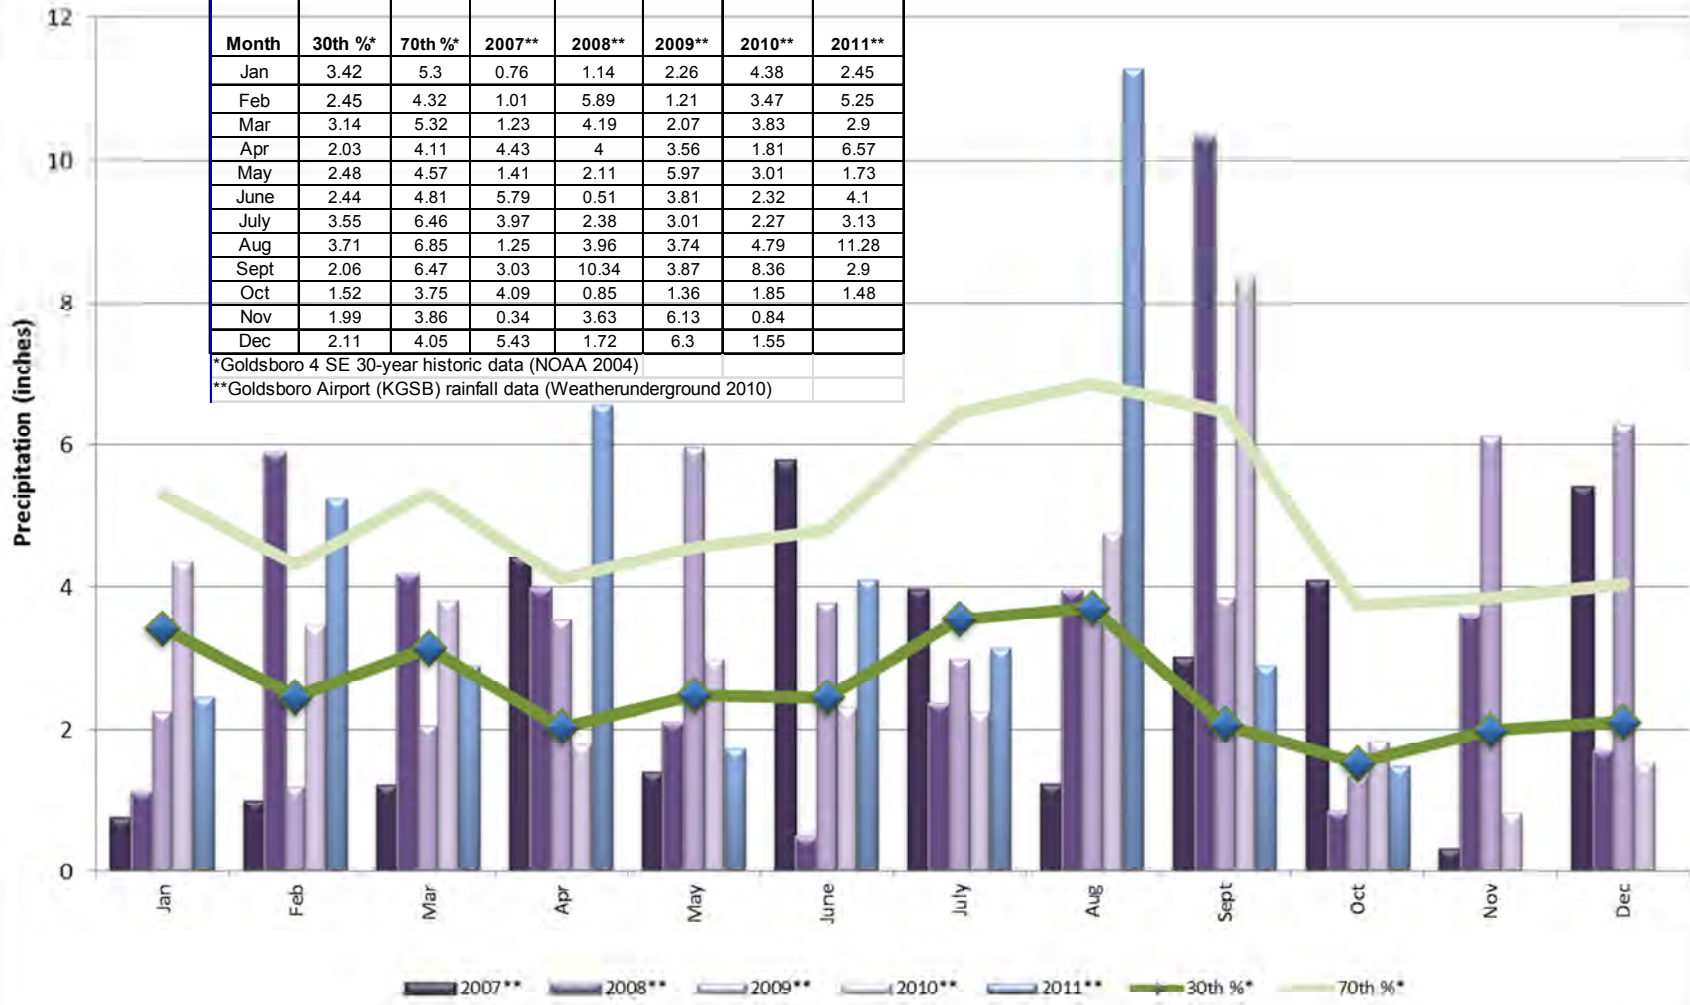
Figure 3. Annual Climatic Data vs. 30-year Historic Data

\*Goldsboro 4 SE 30-year historic data (NOAA 2004)  
 \*\*Goldsboro Airport (KGSB) rainfall data (Weatherunderground 2010)
