MITIGATION PLAN

OAK HILL DAIRY MITIGATION SITE

Gaston County, NC
NCDEQ Contract No. 7867
DMS ID No. 100120

Catawba River Basin
HUC 03050102

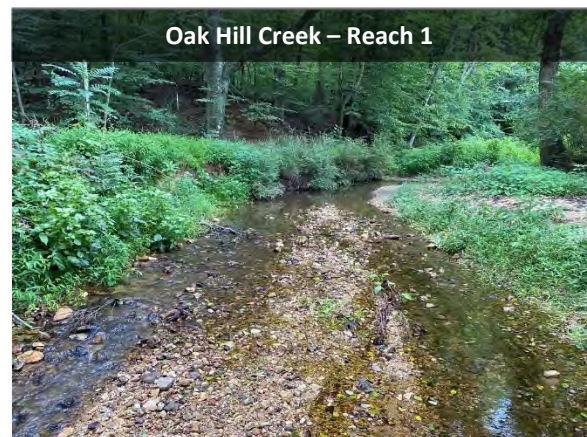
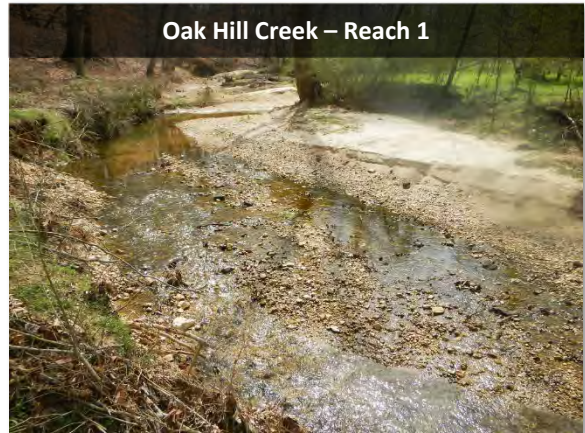
Oak Hill Creek Reach 1 begins at the upstream property boundary and terminates at a sanitary sewer crossing. An advancing headcut has been arrested by a concrete-encased sewer crossing. The reach has a meandering geometry with consistent and severe outer meander bend erosion. A high existing terrace has eroded on the left bank and the valley wall on the right. Due to mid- and side-channel bar formation in the ever-widening channel bottom, erosion of the lower bench was also observed. Hydraulic modeling shows that this bench is not activated by flows less than the 10-year event. The reach is bordered by a semi-wooded to forested buffer on the right bank, where it is against the forested valley wall in many cases. The buffer along the left floodplain is fragmented, consisting of a broad fallow field with a few clusters of mature trees. The

reach lacks consistent woody vegetation and rooting depth along the left bank. The right bank lacks canopy shading in places allowing for competition from invasive species establishment.

The channel classified as a Rosgen B4c-type channel due to the benches that have formed within the overwide, incised channel; and is confined to one-third of its original floodprone area due to moderate entrenchment.

Instream habitats include riffles and pools, undercut banks with root mats, woody debris, and leaf packs. Tree of heaven (*Ailanthus altissima*) and privet were commonly observed throughout the reach along both banks. Japanese knotweed (*Polygonum cuspidatum*) and kudzu (*Pueraria montana*) are present in the lower portion of the reach near the sanitary sewer crossing.

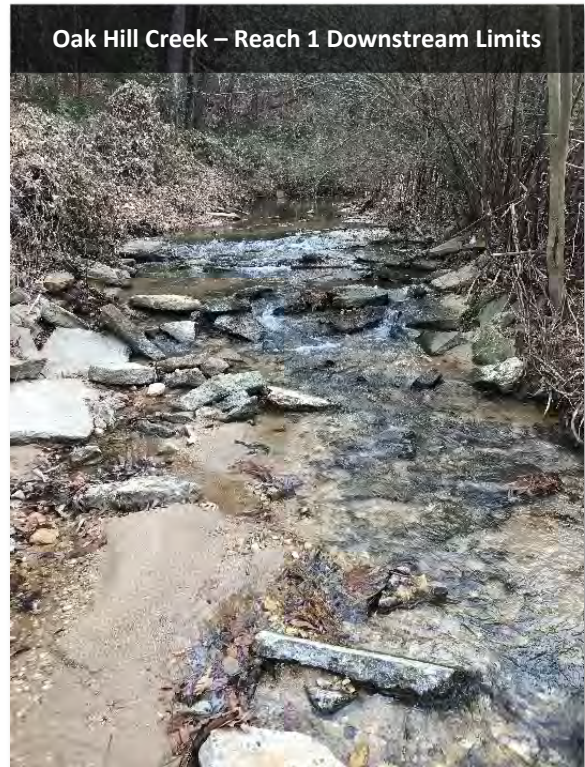
Table 4: Oak Hill Creek (OHC) Reach 1 Attribute Table

Reach Summary Information	
Parameters	Oak Hill Creek
Length of Reach (Linear Feet)	581
Valley confinement (Confined, moderately confined, unconfined)	Moderately confined
Drainage area (acres)	608
Perennial, Intermittent, Ephemeral	Perennial
NCSAM Score/Stream Function	Medium
NCDWR Water Quality Classification	C
Width to Depth Ratio (ft/ft)	14.4
Bank Height Ratio (ft/ft)	2.4
Gradient (ft/ft)	0.0070
Reachwide d50 (mm)	22.6
Stream Classification (Existing and Proposed)	B4c/C4
Evolutionary Trend	V – aggradation and widening
FEMA Zone Classification	AE

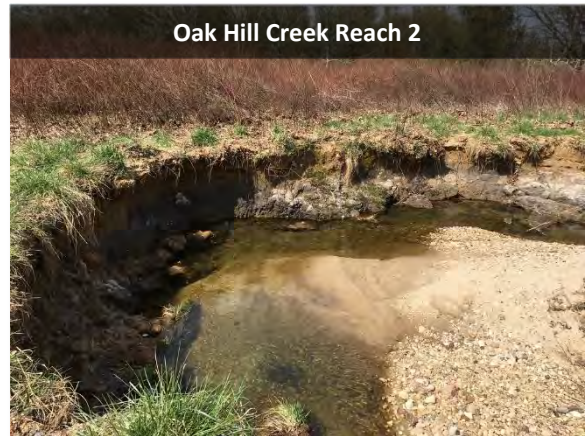
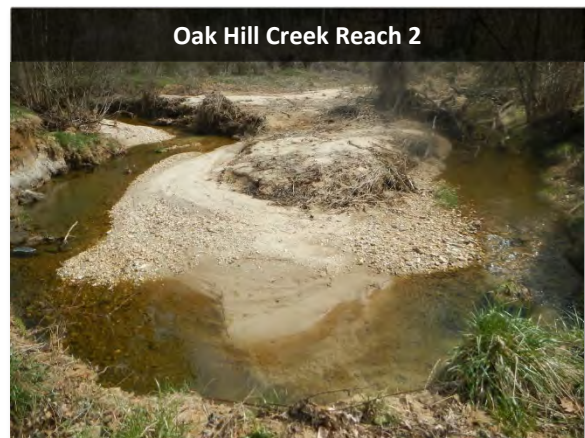
Oak Hill Creek Reach 2 begins downstream of the sanitary sewer easement where a riprap/concrete nick point is present; the reach extends downstream to the confluence with UT1. As discussed in Section 6.7, the reach was ditched prior to 1950 based on visual interpretation of aerial photography (Appendix 1). Reach 2 is actively widening as a result of severely eroding outside bends. Reach 2 has a high bank height ratio and relative confinement except for the building point and side channel bars. Both banks lack deep-rooted vegetation and point bars are infested with kudzu. Closer to the confluence, Chinese privet is dominant along the banks. Pockets of other invasive species, including tree of heaven and Japanese knotweed, were also observed. Mixed with the privet, some mature vegetation is present in a

narrow buffer along the tops of banks. Large woody debris is sparse along Reach 2. Riffles and pools are present, but of poor quality due to embeddedness with fines.

A linear wetland (Wetland B) is located along the left valley toe of Oak Hill Creek Reach 2. Based on soil borings and review of aerial photography (1984, 1993, Appendix 1), this wetland appears to be the remnants of a ditch that used to drain the proposed wetland re-establishment areas and which likely extended the length of the valley down to Robert Road. The linear feature drains into UT1 Reach 2. In the same vicinity, a wood tile drain empties into Oak Hill Creek at the tortuous outside bend.

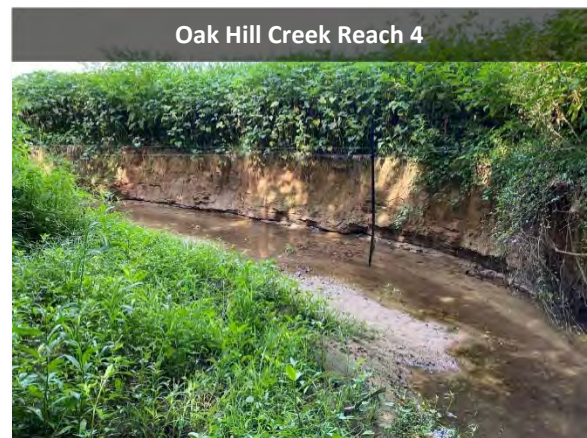
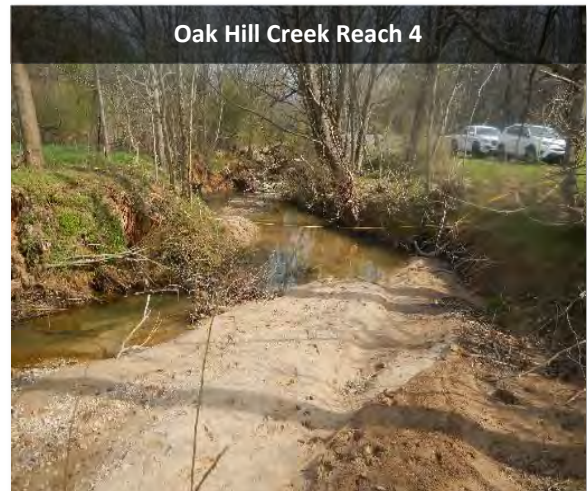
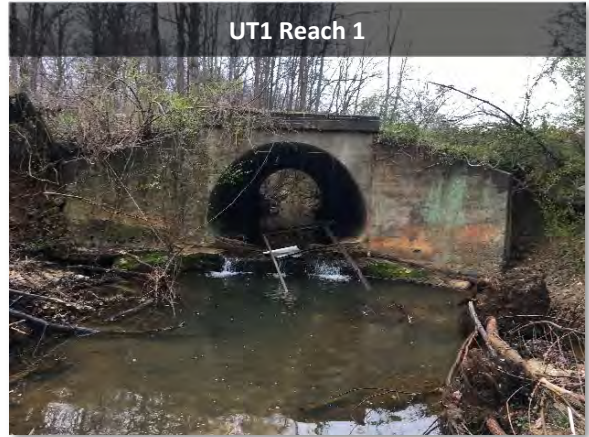
UT1 Reach 1 enters the Site from a perched culvert under Roy Eaker Road. An overhead electric line and power pole are present on the left top of bank at the top of the reach. The stream drops 9 inches over the culvert outlet and is incised with eroding areas downstream of the culvert. Alternating lateral bars are forming within the incised channel, and varied habitats are present although they are embedded with fines from bank erosion. Very little woody debris is present in the reach. Although cattle are currently fenced from the stream, the fencing is near the top of bank and cattle are actively grazing and impacting the left riparian zone. The left bank has infestations of Chinese privet. The right riparian zone has a row of trees but is impacted by kudzu within the trees and in the adjacent areas. Large sand and mud deposits are present at and below the UT1/UT1A confluence due to the large volume of fine sediment supply coming from the UT1A intensive cattle operations on the uplands, and from UT1A instream erosion. Downstream of UT1A, UT1 Reach 1 shifts across to the right side of the valley where it is joined by UT1B from the right bank. The UT1B confluence is surrounded by an existing wetland area (Wetland F) with cattails along the right floodplain of UT1 Reach 1.

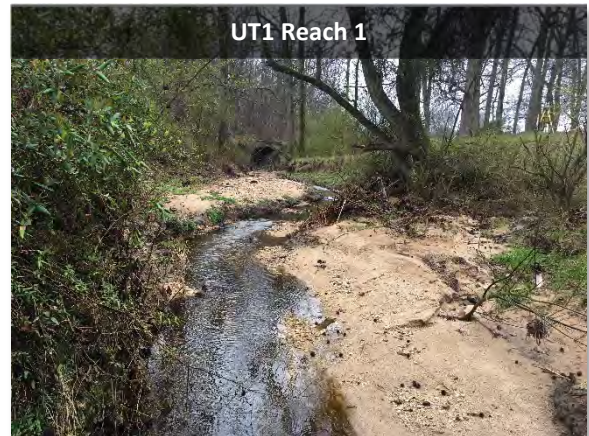
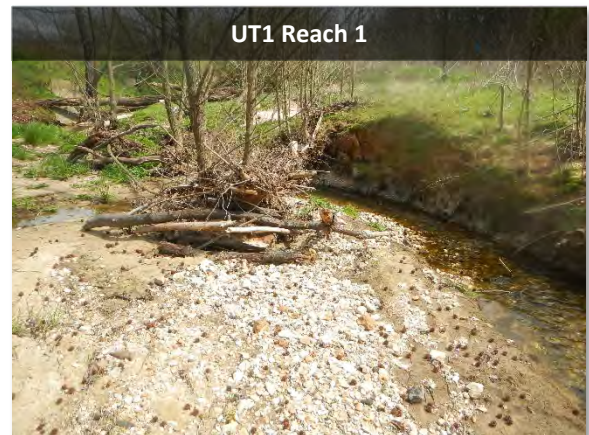
The project reach is classified as a Rosgen F4-type stream channel and is laterally and vertically unstable with headcuts present in the lower reaches of Reach 1 and upper reaches of Reach 2. It is incised and overwide in many areas. Short steep, riffles were observed in tight, actively eroding meander bends.

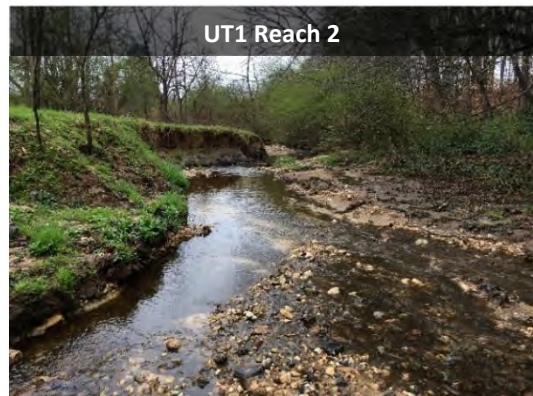
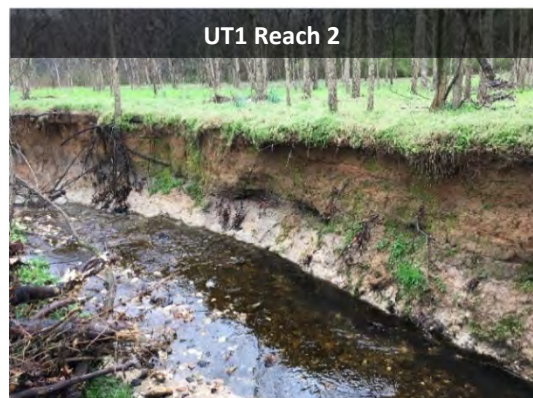
The stream was classified as a Rosgen G4-type channel based on its degree of incision. Privet along the banks throughout much of the reach appears to have slowed the rate of channel widening over time; however, the channel is vertically unstable with several advancing headcuts in the upper half of the reach and laterally unstable where it has previously undermined privet and other bank vegetation. While the valley is broad throughout the reach corridor, channel pattern is minimal. Meander pools should be present but are rare, and pool spacing is tight. Riffles and pools typically occur in locations inconsistent with stable planform geometry.

Habitat along UT1 consists of riffles with some overhanging roots and pools. Riffles are often embedded with fines and large woody debris is scarce. Riparian vegetation consists of a single line of mature vegetation at the top of bank, with maintained crop fields to the left and fallow fields and black walnuts (*Juglans nigra*) to the right. The understory and banks are dominated by privet and the right valley wall and floodplain edge has a severe infestation of English ivy (*Hedera helix*).

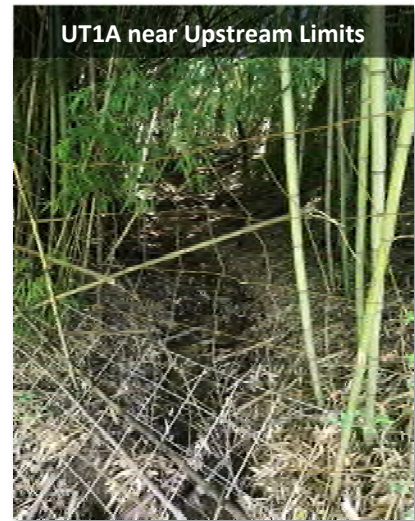
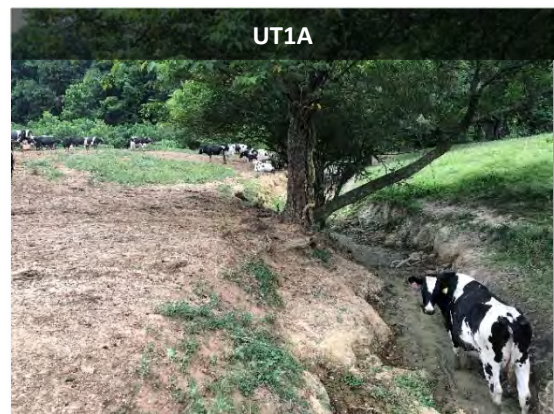
The Site was extended upstream from the location originally specified in the DMS technical proposal and initial NCIRT site walk and currently encompasses the UT1A jurisdictional stream boundary which is in a bamboo thicket (*Phyllostachys aurea*). At this location, UT1A drops approximately two feet at an existing knickpoint. As it emerges from the thicket downstream, it bisects a small wetland area (Wetland J), likely a result of erosion and cattle wallowing immediately below the existing fence line. An existing residence on the right floodplain is occupied and must remain – the easement has been set 10 feet off the residence. UT1A flows within the primary feedlot for the dairy and is utilized by cattle for drinking; the adjacent areas are impacted by the concentrated activity. Except for a few stand-alone trees, UT1A is devoid of riparian vegetation and a shaded canopy. The stream is incised and overly wide, and the bed and banks are severely trampled with toe and valley slope erosion. In the bamboo section, some bedform and habitat is present, but these give way to silted and braided runs with no bedform throughout the remainder of the reach. Fine sediments are embedding any underlying bedform material from consistent erosion and sedimentation of the adjacent upland areas. At the lower limits of the reach, UT1A flows through a marshy, herbaceous area influenced by debris and sediment trapped by the existing fence.

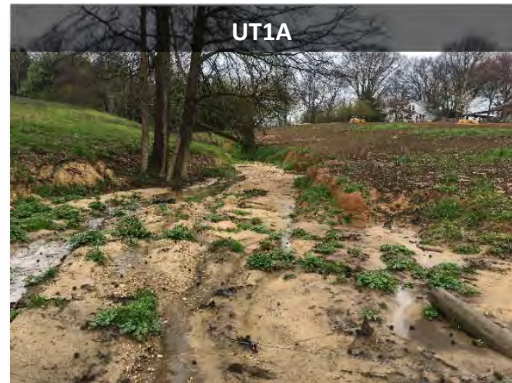
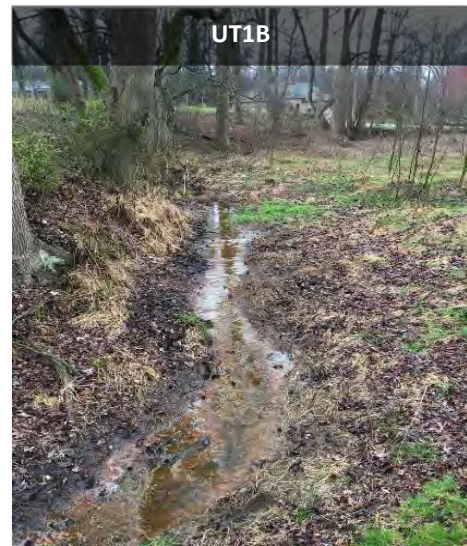
UT1B enters the Site as an intermittent stream, dropping approximately two feet from the culvert under Roy Eaker Road. The reach classifies as a stable Rosgen Cb type channel, has low banks and is connected to the floodplain. The stream flows along the right valley wall, paralleling UT1, and becomes perennial approximately 100 LF upstream of the stream’s confluence with UT1. Leaf packs dominate instream habitat, with some small gravels and sand for substrate. A patch of kudzu is present in the floodplain along Roy Eaker Road. The right valley wall has a single row of mature woody species, and the left floodplain is predominantly grasses and early successional woody species as well as privet. UT1B drops over several small headcuts as it enters UT1.

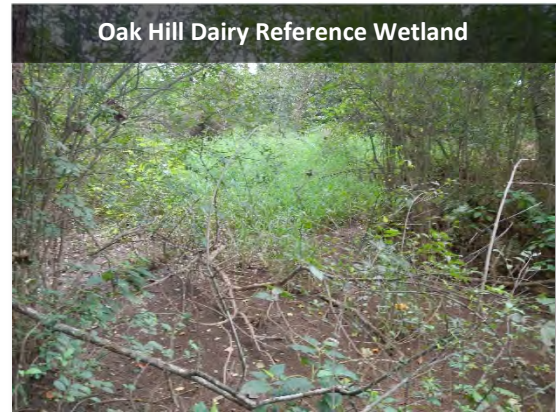
6.7.2 Reference Wetlands

An existing wetland approximately 7 miles from the Site, and adjacent to Wildlands' Owl's Den Mitigation Site in Lincoln County, is a mature Piedmont Bottomland Forest reference within the floodplain of Howards Creek. Review of historical aeriels and field conditions reveal no recent disturbance to the wetland. Mature vegetation is established and the natural flooding regime has been preserved. The hydrology of this system is intermittently, temporarily, or seasonally flooded. While the hydrology data collected at the Owl's Den reference site indicates that it is wetter than what is anticipated at Oak Hill Dairy, the vegetation provides a good reference on a site that exhibits similar soil types and topographic form to the Oak Hill Site.

The vegetation at the reference site is being used as a basis for the planting plan for the wetland restoration and creation on the project Site. The existing vegetation communities at the reference site are typical of a Bottomland Hardwood Forest and include mature canopy tree species, subcanopy and shrub species, as well as an herbaceous layer. Dominant canopy species include river birch, green ash, sycamore, box elder, and red maple. Understory species include ironwood and spicebush. The herbaceous layer within the reference wetland includes arrow arum, jewelweed, and lizard's tail, with microstegium also present.

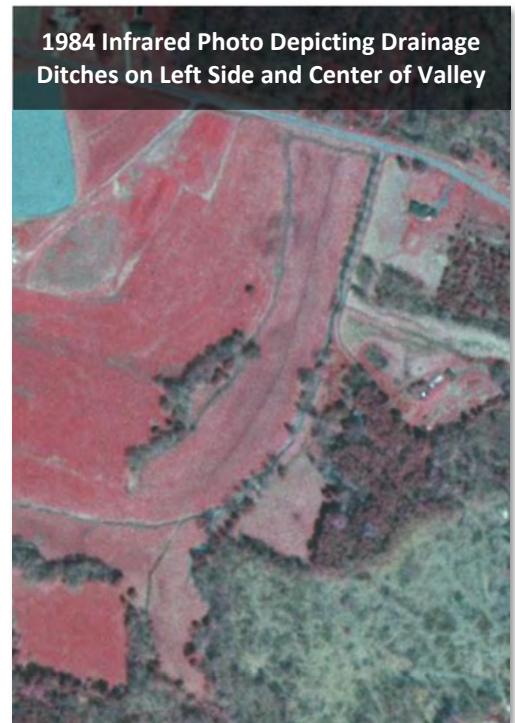
6.7.5 Proposed Wetland Design

The proposed stream work and wetland grading will restore wetland hydrology to filled and drained areas of the site. Priority 1 stream restoration of profile and cross-section will increase the frequency of overbank flooding. This stream restoration approach will also reduce groundwater flow gradient from the toe of slope and floodplain wetland areas to the stream, resulting in less drawdown in the water table across the Site. Grading to remove ditches and subsurface drainage features within the Site will also improve the wetland hydrology. The proposed grading will eliminate linear ditches and plug ditch outlets to the stream, remove or reduce side cast material from ditch and stream banks, and remove areas of field fill and crowning. This work will promote a more natural infiltration and groundwater flow regime through the site and remove overburden from buried hydric soils. Wetland vegetation establishment will be enhanced by addressing soil compaction and any poor-quality soils that are found during construction. Compaction will be addressed by loosening or roughening the ground with available equipment and poor-quality soils will be addressed with soil amendments or with the re-application of harvested topsoil.

In all wetland rehabilitation and re-establishment areas (areas credited at both 1:1 and 1.5:1 ratios), grading cuts of greater than 12 inches account for 16.8% of the area. These cut areas are mostly relegated to the berms and sidecast piles found in the left floodplain of Oak Hill Creek Reaches 3 and 4 and the right floodplain of UT1 as shown in Figure 10. Grading in these areas was dictated by the stream design, where the proposed stream bankfull was placed at the existing low point in the valley. Sidecast piles from maintenance of the existing stream and the wetland toe ditch created high points on either side of the proposed stream greater than 12 inches. These high points will be removed to connect the proposed stream to existing wetlands and to allow the stream access to a majority of the floodplain during flood stages. Creation wetland areas contain more extensive grading with areas of grading greater than 12 inches accounting for about 31.8% of the total creation area.

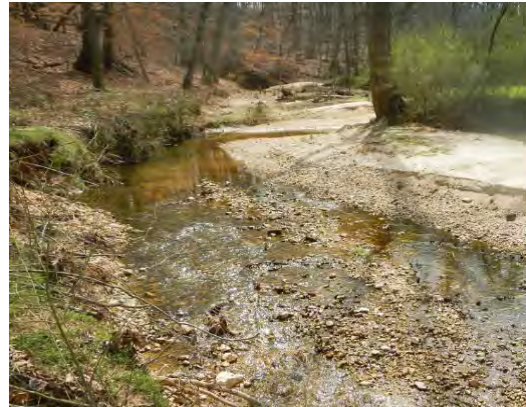
Cross Section 2, OHC Reach 1

Bankfull Dimensions

- 44.2 x-section area (ft.sq.)
- 24.5 width (ft)
- 1.8 mean depth (ft)
- 3.5 max depth (ft)
- 26.8 wetted perimeter (ft)
- 1.6 hyd radi (ft)
- 13.6 width-depth ratio
- 1.7 low bank height ratio

View Upstream

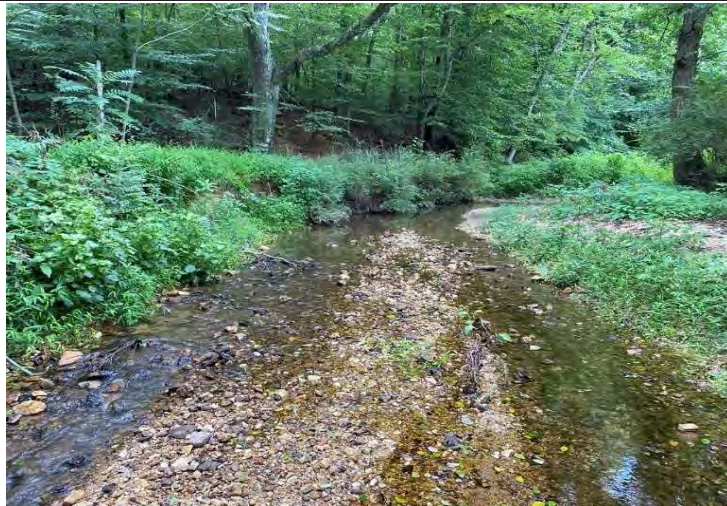
Cross Section 3, OHC Reach 2

Bankfull Dimensions

27.5	x-section area (ft.sq.)
19.9	width (ft)
1.4	mean depth (ft)
1.7	max depth (ft)
20.8	wetted perimeter (ft)
1.3	hyd radi (ft)
14.4	width-depth ratio
40.0	W flood prone area (ft)
2.0	entrenchment ratio
2.4	low bank height ratio

View Upstream

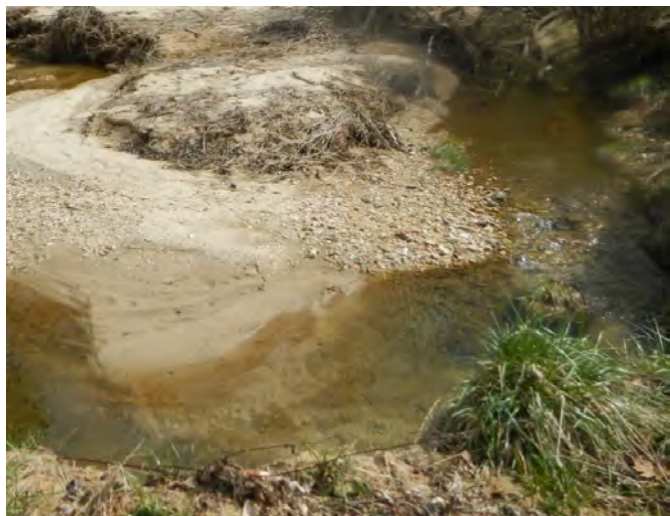
Cross Section 4, OHC Reach 2

Bankfull Dimensions

- 28.1 x-section area (ft.sq.)
- 14.6 width (ft)
- 1.9 mean depth (ft)
- 3.0 max depth (ft)
- 16.4 wetted perimeter (ft)
- 1.7 hyd radi (ft)
- 7.6 width-depth ratio
- 79.0 W flood prone area (ft)
- 5.4 entrenchment ratio
- 2.0 low bank height ratio

View Upstream

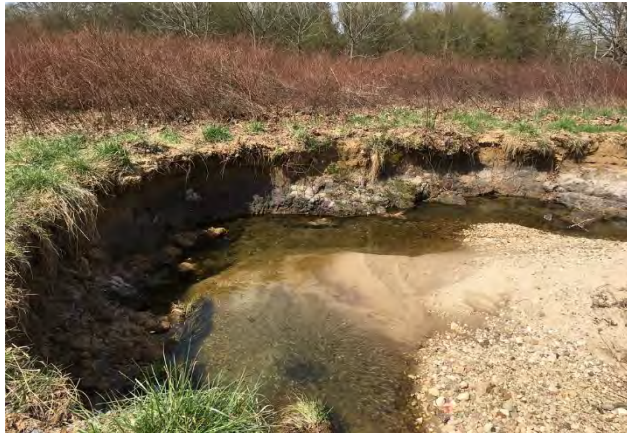
Cross Section 5, OHC Reach 3

Bankfull Dimensions

- 59.1 x-section area (ft.sq.)
- 18.7 width (ft)
- 3.2 mean depth (ft)
- 4.4 max depth (ft)
- 21.7 wetted perimeter (ft)
- 2.7 hyd radi (ft)
- 5.9 width-depth ratio
- 1.0 low bank height ratio

View Downstream

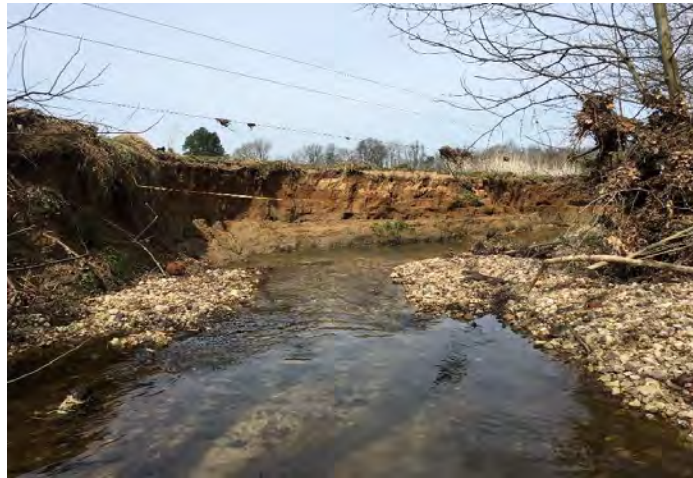
Cross Section 6, OHC Reach 3

Bankfull Dimensions

- 29.1 x-section area (ft.sq.)
- 19.3 width (ft)
- 1.5 mean depth (ft)
- 2.2 max depth (ft)
- 20.4 wetted perimeter (ft)
- 1.4 hyd radi (ft)
- 12.8 width-depth ratio
- 49.8 W flood prone area (ft)
- 2.6 entrenchment ratio
- 2.6 low bank height ratio

View Downstream

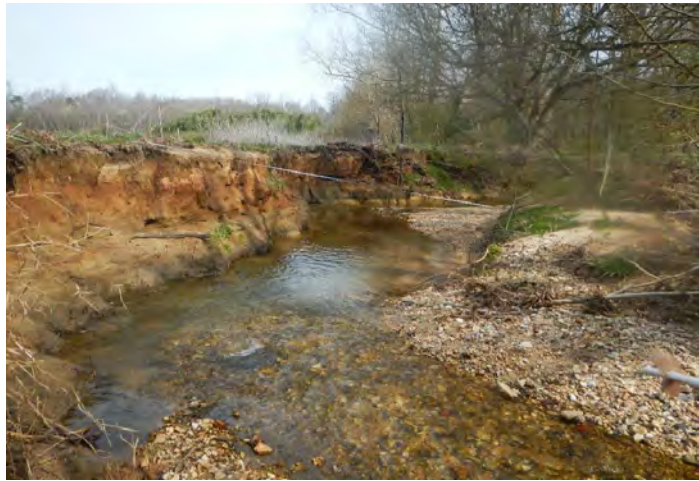
Cross Section 7, OHC Reach 4

Bankfull Dimensions

29.9	x-section area (ft.sq.)
13.7	width (ft)
2.2	mean depth (ft)
3.7	max depth (ft)
16.9	wetted perimeter (ft)
1.8	hyd radi (ft)
6.3	width-depth ratio
122.1	W flood prone area (ft)
8.9	entrenchment ratio
2.0	low bank height ratio

View Downstream

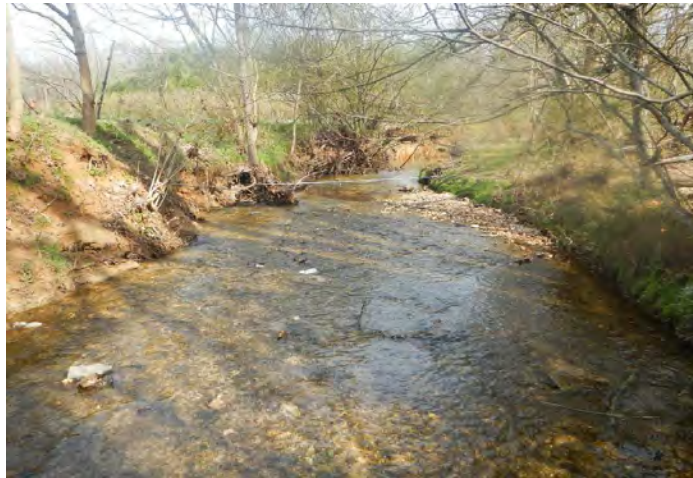
Cross Section 8, OHC Reach 4

Bankfull Dimensions

35.1	x-section area (ft.sq.)
19.8	width (ft)
1.8	mean depth (ft)
2.3	max depth (ft)
22.3	wetted perimeter (ft)
1.6	hyd radi (ft)
11.2	width-depth ratio
90.7	W flood prone area (ft)
4.6	entrenchment ratio
2.3	low bank height ratio

View Downstream

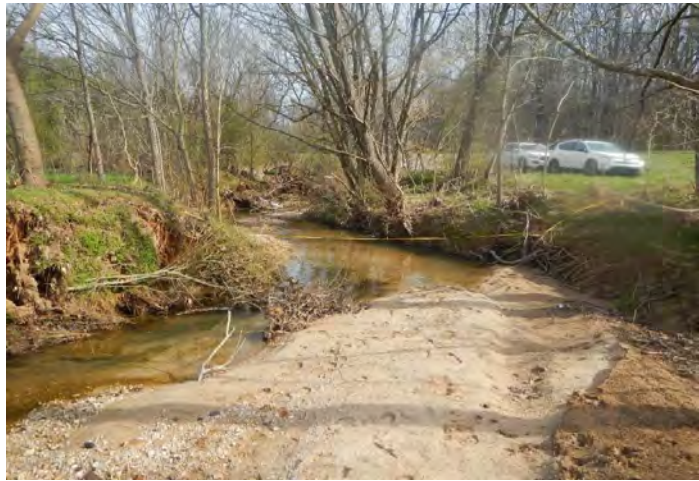
Cross Section 9, UT1 Reach 1

Bankfull Dimensions

40.3	x-section area (ft.sq.)
17.9	width (ft)
2.3	mean depth (ft)
3.1	max depth (ft)
21.0	wetted perimeter (ft)
1.9	hyd radi (ft)
8.0	width-depth ratio
68.5	W flood prone area (ft)
3.8	entrenchment ratio
2.1	low bank height ratio

View Downstream

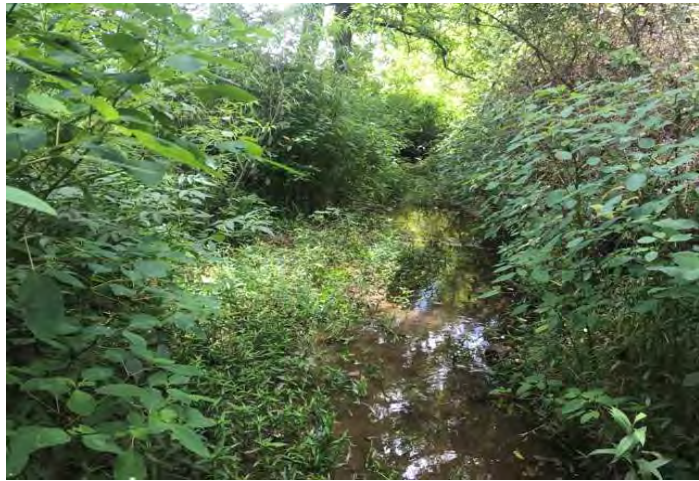
Cross Section 10, UT1 Reach 1

Bankfull Dimensions

- 13.5 x-section area (ft.sq.)
- 16.2 width (ft)
- 0.8 mean depth (ft)
- 1.7 max depth (ft)
- 16.9 wetted perimeter (ft)
- 0.8 hyd radi (ft)
- 19.5 width-depth ratio
- 23.8 W flood prone area (ft)
- 1.5 entrenchment ratio
- 2.8 low bank height ratio

View Downstream

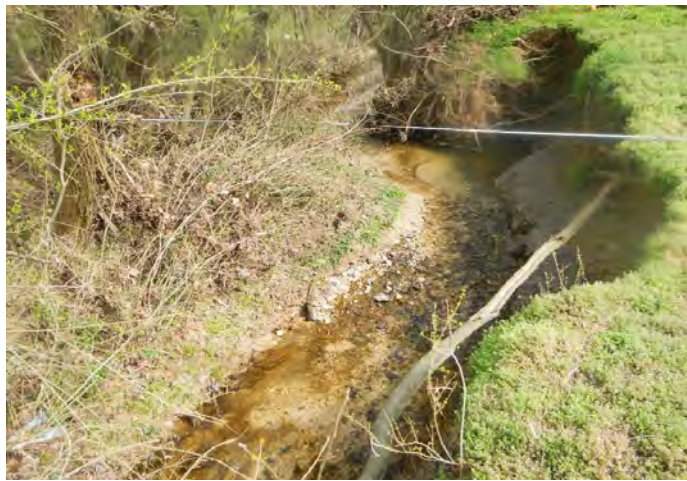
Cross Section 12, UT1 Reach 2

Bankfull Dimensions

- 14.1 x-section area (ft.sq.)
- 9.1 width (ft)
- 1.5 mean depth (ft)
- 2.2 max depth (ft)
- 10.1 wetted perimeter (ft)
- 1.4 hyd radi (ft)
- 5.9 width-depth ratio
- 16.2 W flood prone area (ft)
- 1.8 entrenchment ratio
- 2.4 low bank height ratio

View Downstream

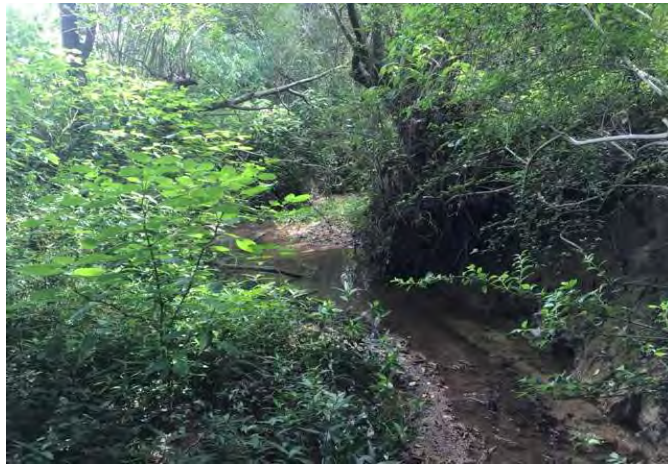
Cross Section 13, UT1A

Bankfull Dimensions

- 17.9 x-section area (ft.sq.)
- 12.9 width (ft)
- 1.4 mean depth (ft)
- 3.0 max depth (ft)
- 14.7 wetted perimeter (ft)
- 1.2 hyd radi (ft)
- 9.2 width-depth ratio
- 2.8 entrenchment ratio
- 1.8 low bank height ratio

View Downstream

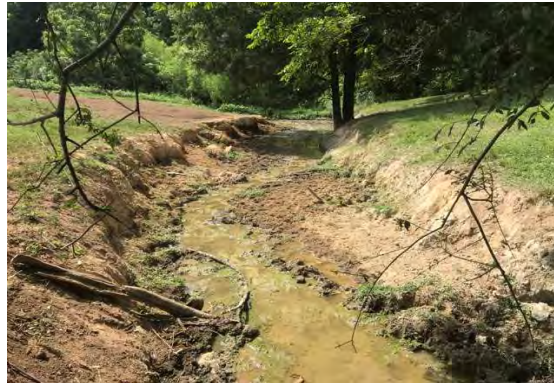
Bankfull Dimensions

- 1.9 x-section area (ft.sq.)
- 9.9 width (ft)
- 0.2 mean depth (ft)
- 0.4 max depth (ft)
- 10.1 wetted perimeter (ft)
- 0.2 hyd radi (ft)
- 51.0 width-depth ratio
- 12.2 W flood prone area (ft)
- 1.2 entrenchment ratio
- 9.6 low bank height ratio

View Downstream
