OAKLEY CROSSROADS STREAM AND WETLAND RESTORATION

FINAL RESTORATION PLAN

Pitt County, North Carolina
SCO Project Number 050659701

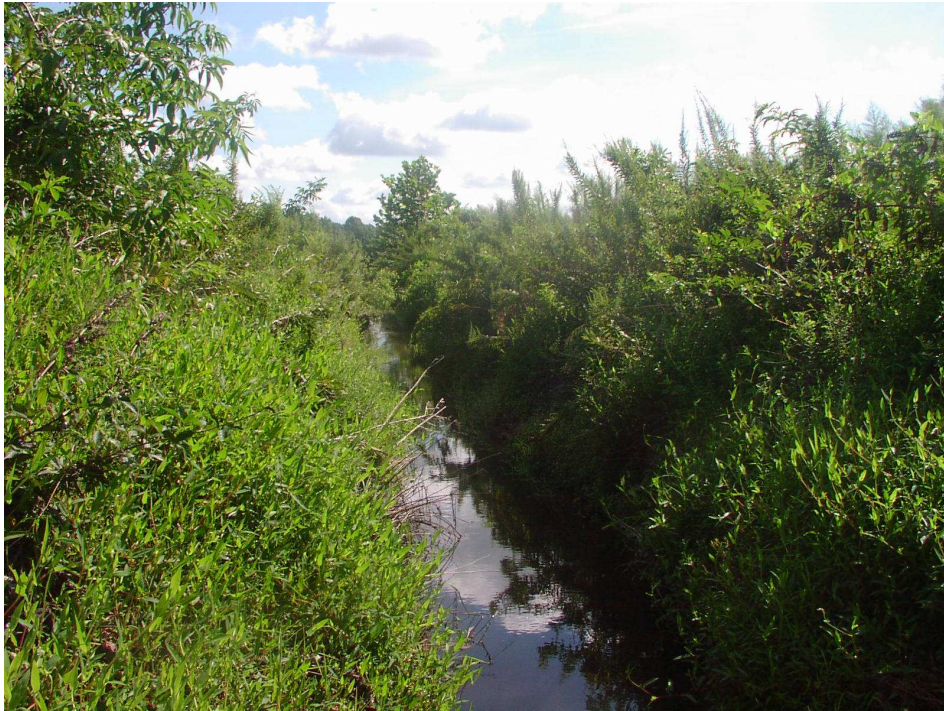
Photo 1. UT Tranter's Creek (Upstream Reach)
Showing Narrow and Deep G5c Channel.

The unnamed tributary to Tranters Creek on the Oakley Crossroads Site is shown on both the USGS Robersonville West topographic quadrangle and the Soil Survey of Pitt County. The tributary is a third order stream that lies along the natural contours of the landscape. Regular maintenance (vegetation removal, channel bed material removal, and grade alteration) has created the current dimension, pattern, and profile. See Appendix 1 for photos of existing conditions.

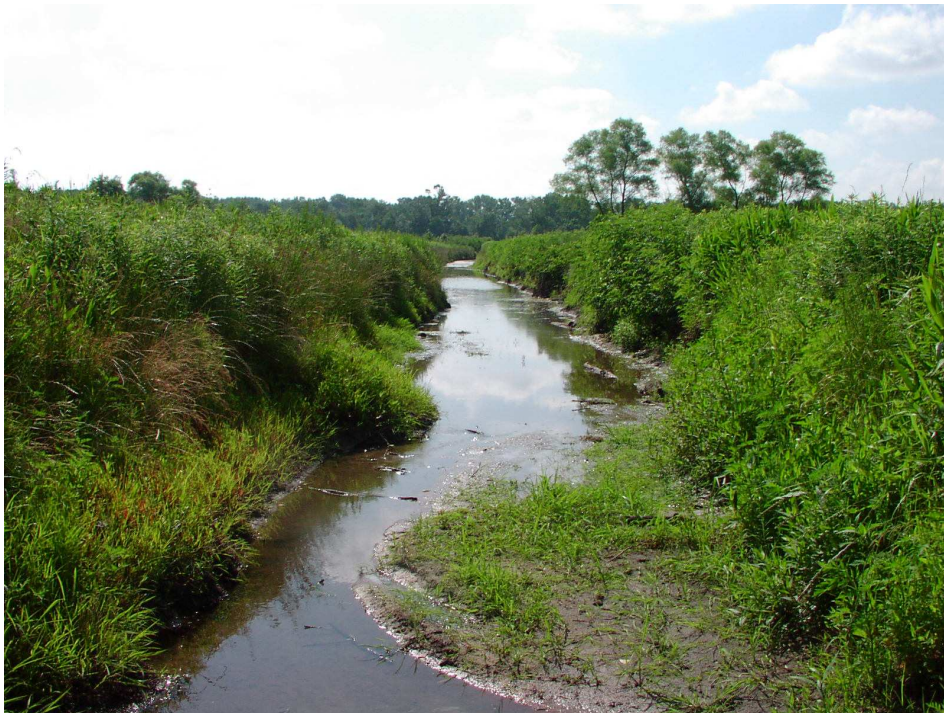
Photo 2. UT Tranter's Creek (Downstream Reach) Showing Backwater
Influence of Flashboard Riser Weir and Aggradation Processes

Due to straightening, the channel is much shorter than the natural condition. The slope of the streambed and the energy of the stream have been increased due to channelization. However, the installation of the flashboard riser system and the presence of beaver dams within the lower reach create a backwater effect in the channel. The streambanks are vegetated with black willow (*Salix nigra*) and American sycamore (*Platanus occidentalis*) saplings, rushes (*Juncus sp.*), sedges (*Carex sp.*) and a variety of herbaceous species. The channel is entrenched making it difficult for the flood flows to access the original floodplain. The existing channel data is presented in Table 10.4.

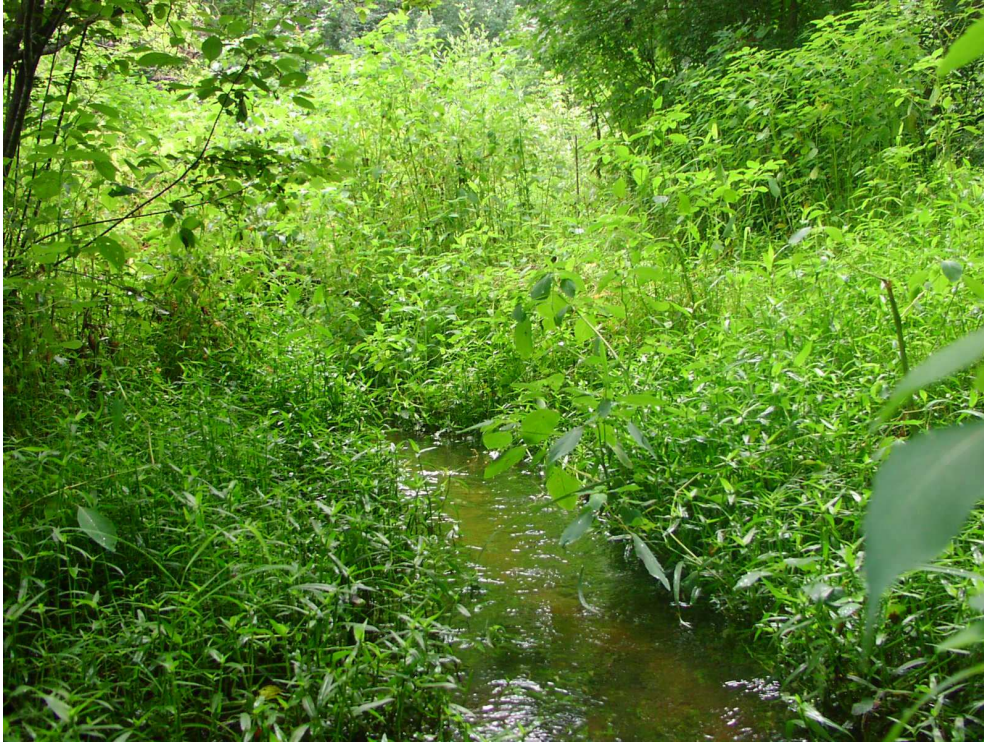
Photo 1. Shepherd Run Reference Reach (Looking Upstream)
E5 Stream Type with a Well-established Riparian Buffer

The Shepherd Run reference reach was classified as an E5 stream type based upon the survey data (Table 10.4). The reach is transporting its sediment supply without aggrading or degrading while maintaining its dimension, pattern, and profile. The reach used for the detail survey totals 389 feet. The survey included a longitudinal profile, cross-sections, bed material evaluation, buffer establishment, and system stability evaluation

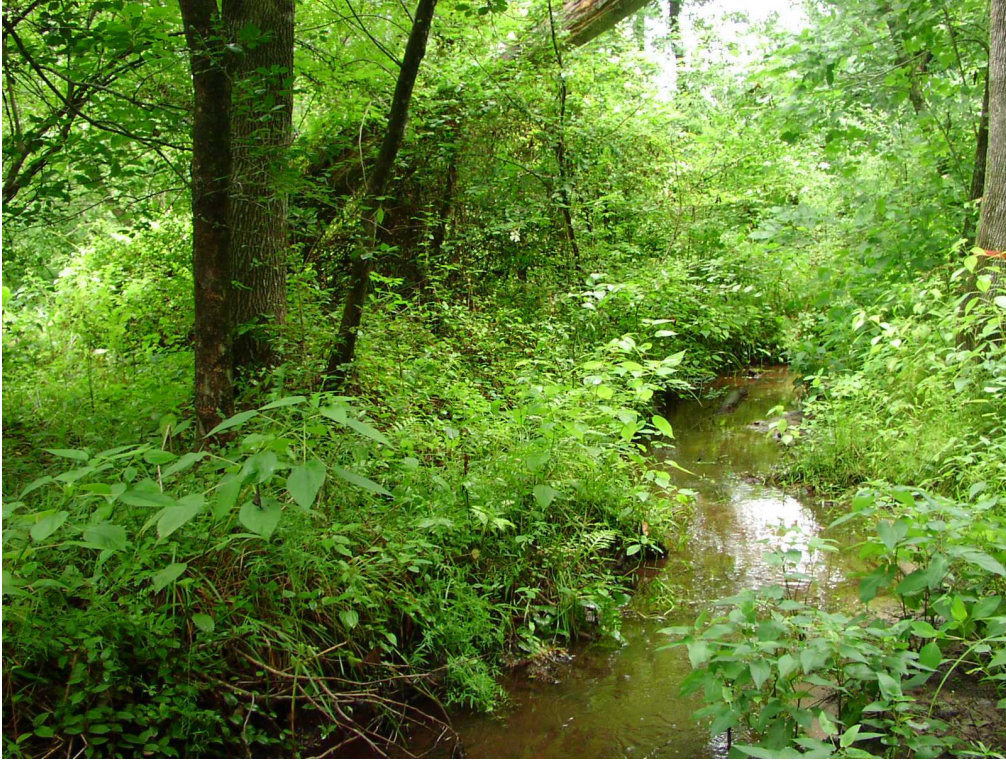
Photo 3. UT to Tyson Creek Reference Reach (Looking Upstream) with C5 Stream Type with Well-established Buffer and Meandering Pattern

The unnamed tributary to Tyson Creek reference reach was characterized as a C5 stream type based on the 2002 survey (Table 10.4). The reach used for the survey totals 445 feet. The survey included a longitudinal profile, cross-sections, bed material evaluation, buffer establishment, and system stability evaluation. Historically, the reach was transporting its sediment supply without aggrading or degrading while maintaining its dimension, pattern, and profile. However, as observed in the May 2006 site visit, the reference reach has been flooded by beavers.
