Mitigation Plan

Odell's House Mitigation Project

Johnston County, North Carolina

FINAL VERSION

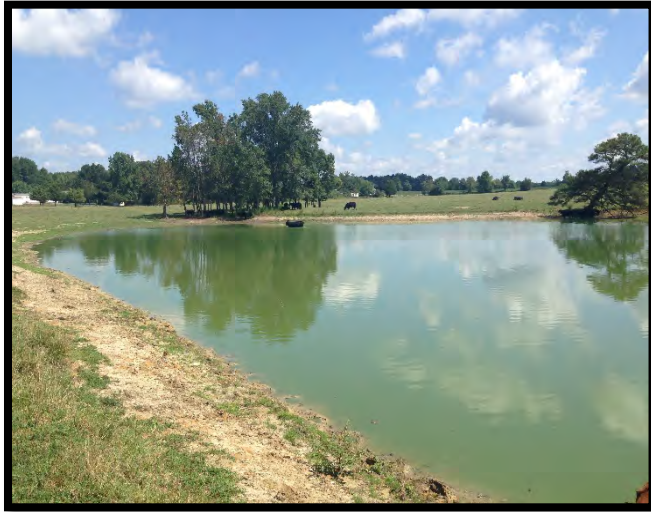
Photo of R1 showing a man-made farm pond with cattle wallowing and no riparian buffer vegetation.

R1: R1 is a small headwater tributary that is currently experiencing backwater effects from a man-made farm pond dam located approximately 400 feet down valley before the stream flow exits at a pipe outlet. R1 has a stream valley length of approximately 400 feet and a drainage area of 43 acres.

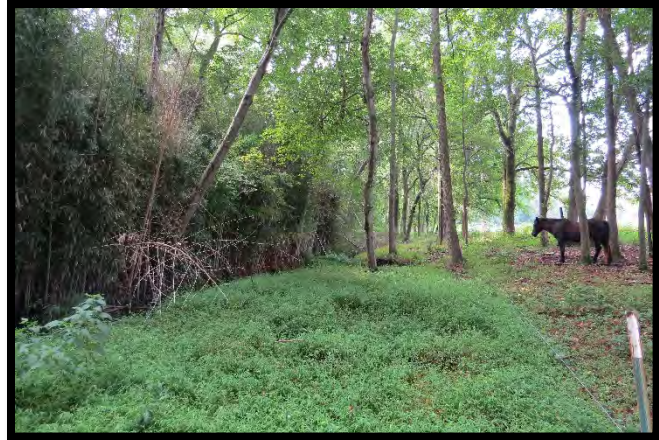
Looking downstream at stable bed and bank conditions along R2. Note the lack of understory vegetation and the invasive species vegetation (bamboo) along the left stream bank.

R2 appears to have been historically manipulated. This is evidenced by the straightened pattern of the existing channel. The riparian buffer on the right bank consists of limited understory and some large trees within the floodplain. The riparian buffer on the left valley slope consists of some mature trees with little understory vegetation and a dense cluster of golden bamboo species. R2 has mature trees interspersed along the streambanks; any trees of significance will be saved and incorporated as part of the restoration design. Based on the existing conditions and medium sand bed materials, R2 is classified as a Rosgen 'C5' stream type.

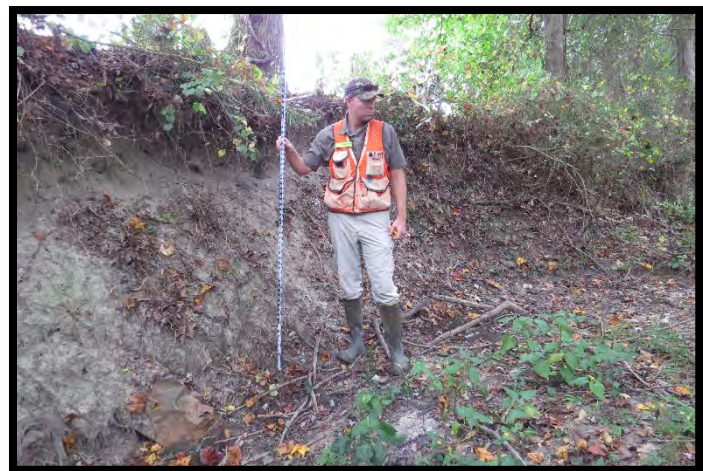
Photo depicts degraded stream channel conditions and minimal riparian buffer vegetation along R3.

The existing stream appears to be located in center of the valley and has a sinuosity of 1.20. The valley slope is approximately 1.6 percent, and the drainage area is 83 acres. Stream bank erosion and vertical instability were observed throughout the reach, and the stream does not appear to have natural floodplain connection. The entire reach is subject to active water quality stressors, mainly resulting from bank erosion and little to no riparian buffer along the right stream bank. Based on the existing conditions and medium sand bed materials, R3 is classified as a Rosgen 'G5' stream type.

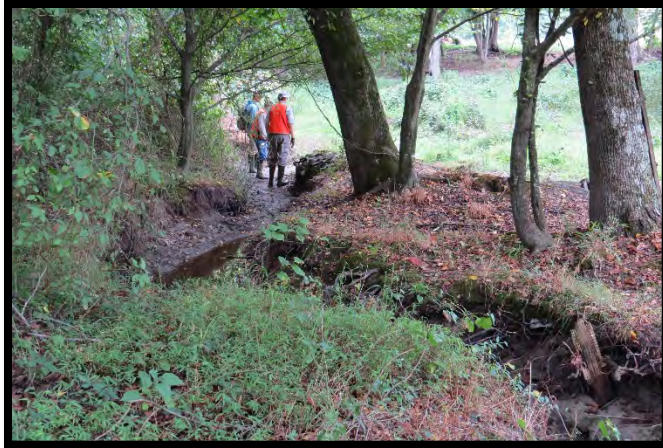
R4 looking downstream towards the bottom of the project limits. Note the lack of adequate riparian buffer along the right floodplain.

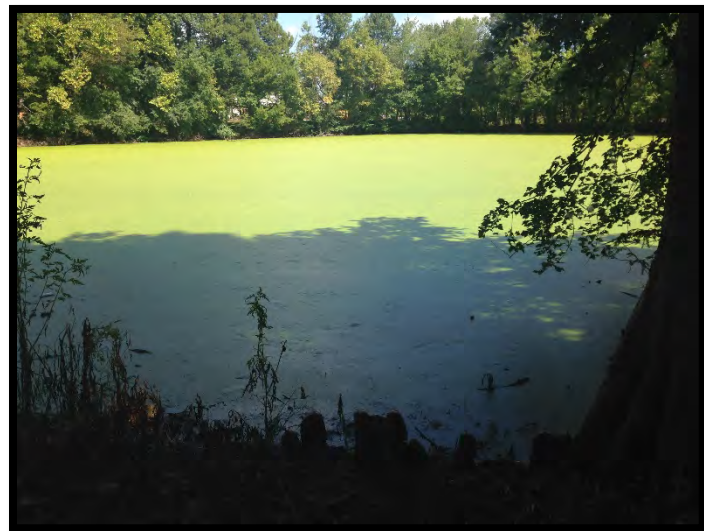
Looking at man-made pond along R5. Cattle have unrestricted access to this impoundment area.

R5 is actively subject to water quality stressors, mainly in the form of cattle wallowing and minimal riparian buffer widths. Based on the poor channel conditions and historic anthropogenic disturbances, R5 was not classified along its length.

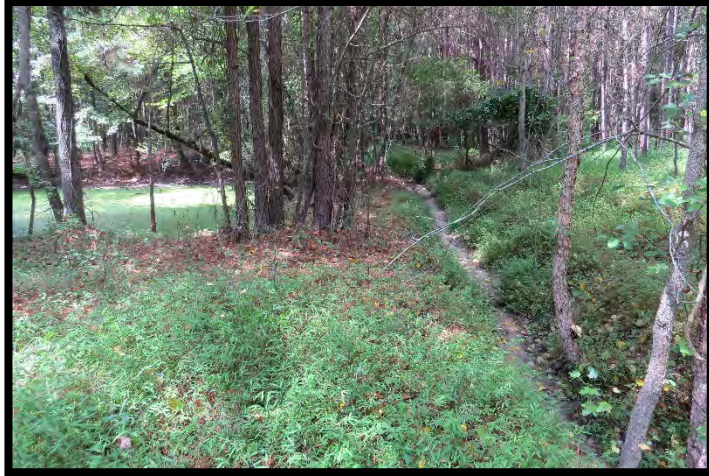
Looking downstream at bottom of R6 with channelized conditions and a small farm pond located in the existing floodplain.

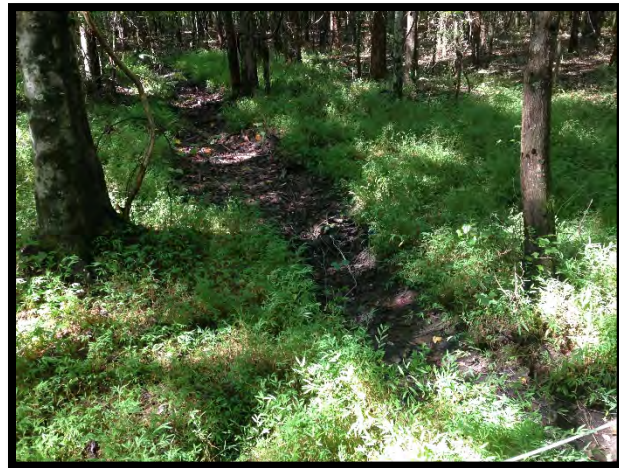
Looking at stable conditions along lower R7. Note mature riparian buffer vegetation and natural bed features.

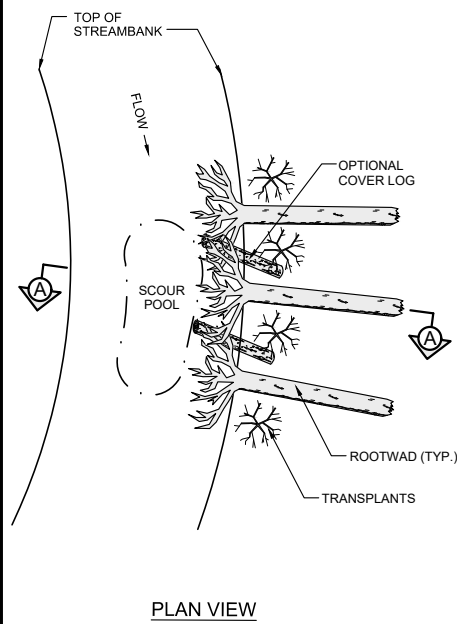
ROOTWADS
 NOT TO SCALE

NOTES:
 1. THE TRENCHING METHOD REQUIRES THAT A TRENCH BE EXCAVATED FOR THE LOG PORTION OF THE ROOTWAD. A COVER LOG SHOULD BE INSTALLED UNDERNEATH THE ROOTWAD IN A TRENCH EXCAVATED PERPENDICULAR TO THE BANK AND BELOW THE RESTORED STREAMBED, ONE-THIRD OF THE ROOTWAD SHOULD REMAIN BELOW NORMAL BASE FLOW CONDITIONS.
