Mitigation Plan

Owen Farms Mitigation Site
Transylvania County, NC

NCDMS Project No. 100064
USACE ID: SAW-2018-01165

January 31, 2020

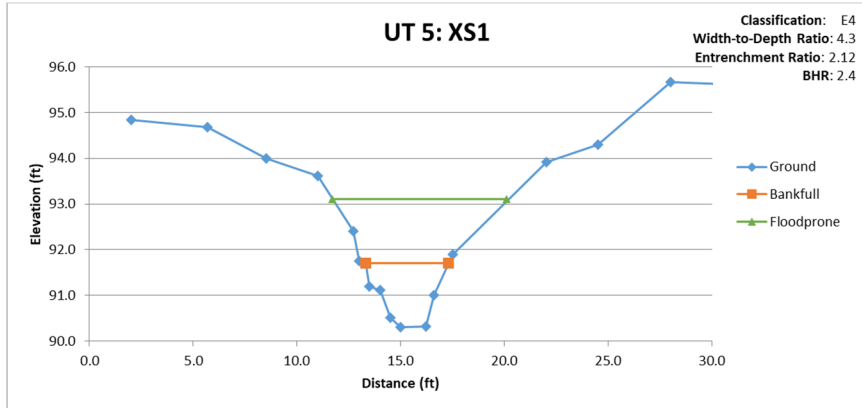
UT 5 is a perennial, sand and gravel bed stream that originates off-site and enters the Site through a culvert under Silverstein Road. UT 5 flows into a pond immediately downstream of the culvert. UT 5 has been straightened and channelized downstream of the pond, creating a relatively uniform plan and bed form.

Bankfull flows are entrenched and unable to access the historic floodplain causing high stress on the channel banks. UT 5 flows into a relic meander scroll prior to its confluence with WFFBR. The channel loses a defined bed and bank within the meander scroll as the feature becomes an emergent wetland (W3).
