Mitigation Plan
Pen Dell Mitigation Project
Johnston County, North Carolina
FINAL VERSION

NCDEQ DMS Project Identification # 97079
NCDEQ DMS Contract # 6824
Neuse River Basin (Cataloging Unit 03020201)
USACE Action ID Number: SAW-2016-00885
Contracted Under RFP # 16-006477

3 Baseline Information and Existing Conditions Assessment

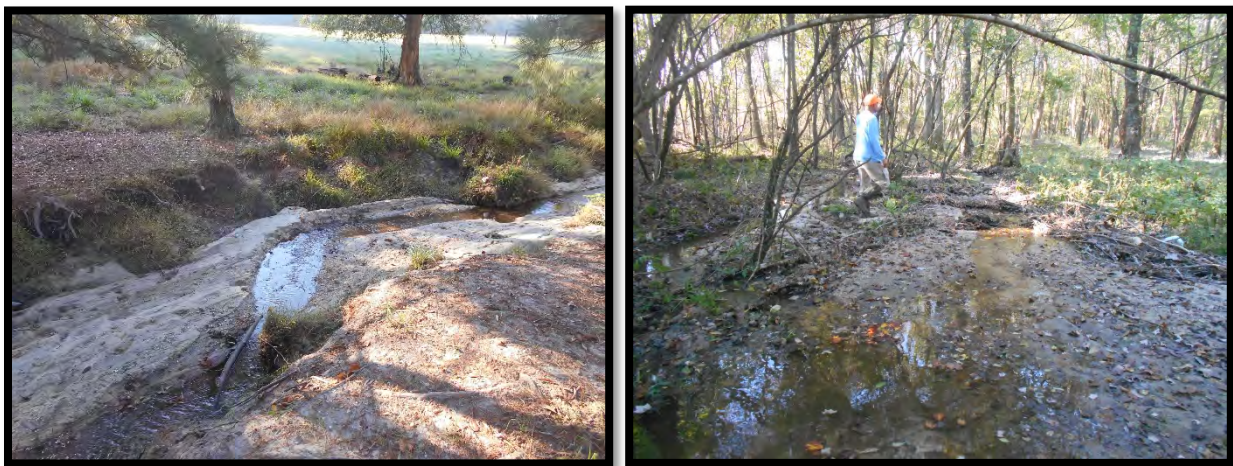
Sediment deposition areas (left photo of R4, right photo of R5) after Hurricane Matthew 2016.

Hurricane Matthew Observations: On October 8th, 2016, Hurricane Matthew delivered over 10" of rain to the project site in less than 12 hours. Locally, the recurrence interval was estimated to be greater than a 500-year storm event (NOAA, NWS, 2016). After Hurricane Matthew and prior to subsequent rain events, WLS visited the site on October 20th, 2016 to measure sediment deposits in two distinct depositional areas or sinks, consisting of mostly fine sand material. The depositional areas were measured below the existing farm pond (Reach R3) and Lake Wendell Road crossing (Reach R5) to quantify the approximate sediment deposited by the storm event. For better accuracy, depositional areas were delineated using existing conditions survey basemap and grid areas/cross-sections were measured and compared with a cloth tape and hand-augured borings. The cubic footage was then converted to cubic yards to estimate tonnage. The total sediment yields were estimated to be approximately 43 tons, indicating the size of the pulse of sediment was mobilized through the system as a result of Hurricane Matthew.

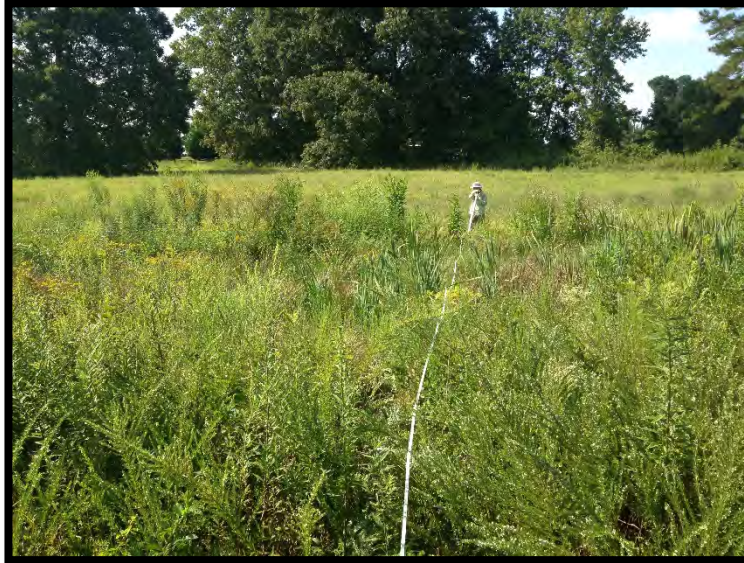
Photo of R1 showing lack of mature riparian buffer vegetation.

R1 is a small intermittent headwater tributary that extends from the upstream terminus of the project site, downstream to the confluence with R2. R1 has a stream length of approximately 1,017 feet, valley slope of 2.1 percent, and drainage area of 63 acres. R1 originates near the northern property line and flows southwest to a culverted pipe crossing at the Wendell Road right-of-way. The channel is not incised and currently experiencing mostly stable conditions along its entire length. The R1 riparian buffer has been degraded through the removal of the woody riparian buffer vegetation along the both banks.

According to the landowner, the channel was historically manipulated in this area to accommodate agricultural drainage, however it appears to fall within the natural valley signature as shown on the LiDAR Map (Figure 6). The channel formation is somewhat poor and the degree of incision is low, with bank height ratios near 1.0 and a very low sinuosity ($k=1.03$). Since mature woody vegetation is absent along the entire length of R1, the reach is actively subject to water quality stressors, mainly in the form of direct nutrient inputs and minimal riparian buffer widths. Based on the existing channel conditions and anthropogenic disturbances, R1 resembles a Rosgen C5 stream type.

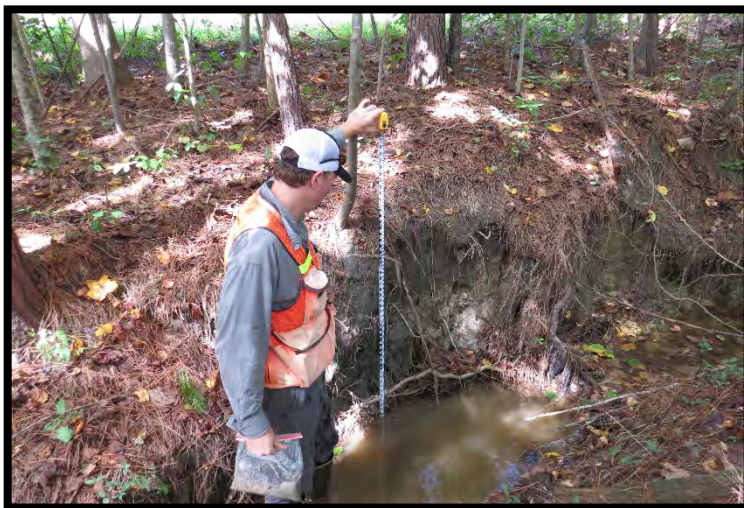
Photo illustrates active bank erosion and headcut migration along upper R2.

R2 begins downstream of R1 at a culverted pipe crossing near the Wendell Road right-of-way and continues to flow southwest for approximately 526 feet toward an existing farm pond. The valley slope in this area is approximately 1.7 percent and the drainage area is 73 acres. R2 appears to be vertically and laterally unstable prior to reaching the backwater conditions created from a man-made dam. An active headcut is present in the upper section and bank height ratios range from 1.3 to greater than 2.0. The active erosion was observed on 20 to 30 percent of the streambanks. Most of the erosion is in the form of bed and bank scour caused by high erosive forces

exiting the culvert during storm flows. Prior to reaching the existing farm pond further downstream, the channel sinuosity is approximately 1.07. Currently, the pond appears to intercept some overland flow and helps to attenuate storm events, while reducing sediment supply and transport capacity to the downstream reaches. Cattle and horses do not have direct access to R2, however the riparian buffer is infrequently narrow (less than 50 feet) across 50 percent of its length. Based on the existing conditions and coarse sand/fine gravel substrate, R2 is classified as an incised E5 stream type.

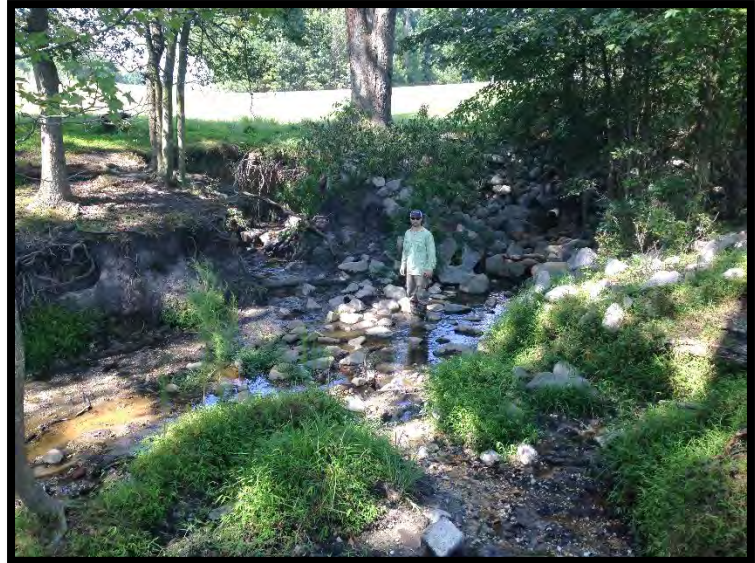
Photo of upper R3 below pond outlet showing cattle access and severely degraded stream banks.

R3 is actively subject to water quality stressors, mainly in the form of cattle access, nutrient and sediment inputs, and minimal riparian buffer widths. R3 is classified as an incised E5/F5 stream type in the upstream section, however the condition improves as the valley slope flattens and stream bed and banks become more stable. This is a direct result from channel aggradation above an existing culverted stream crossing.

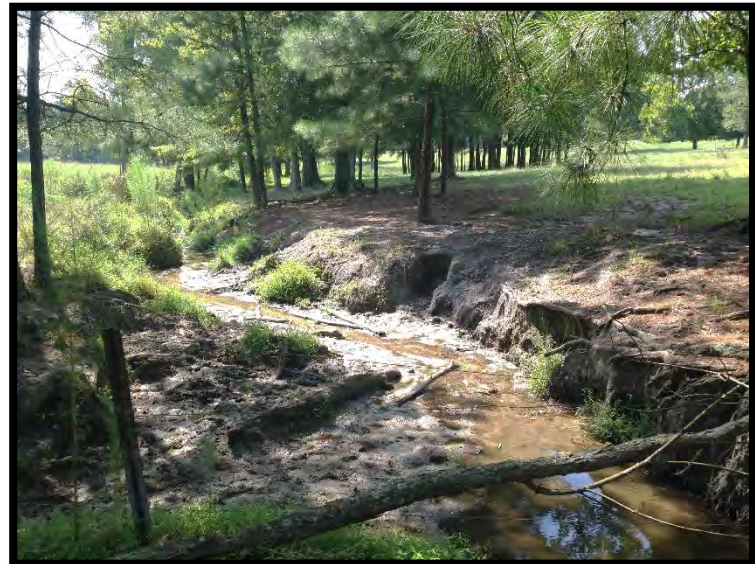
Photo of R4 (upper) looking downstream showing cattle access and severely degraded stream banks.

R4 has a valley slope of 1.2 percent and drainage area of 134 acres. The valley floor widens in this area and a majority of the upper section has a connection to its active floodplain. The channel is vertically stable along much of its upper length, however the channel has been straightened/ moved to right valley edge and riparian buffer vegetation width is less than 30 feet on both sides of the streambanks. Additionally, some areas along R4 are experiencing heavy bank trampling and hoof shear as well as localized streambank erosion along a few meander bends.

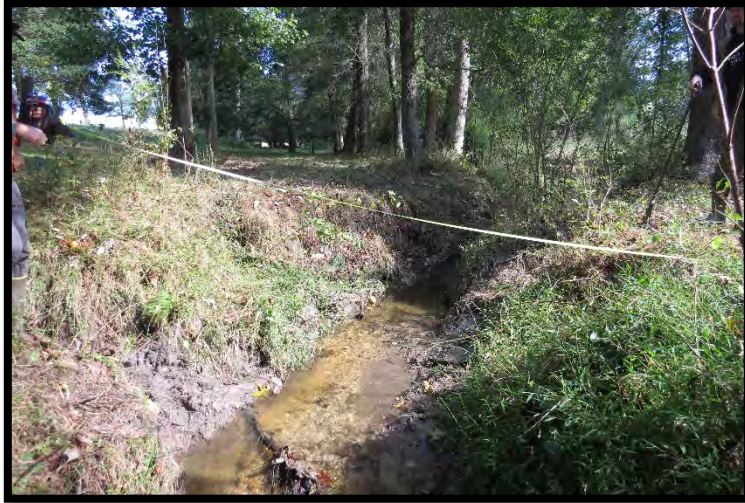
Photo looking upstream at R4(lower) stream conditions. The incised channel has eroding banks and narrow buffer widths.

ponded in the lower reach section. Reach R4 is laterally unstable and actively degrading as evidenced by a headcut migrating up the channel as well as moderate bank erosion.

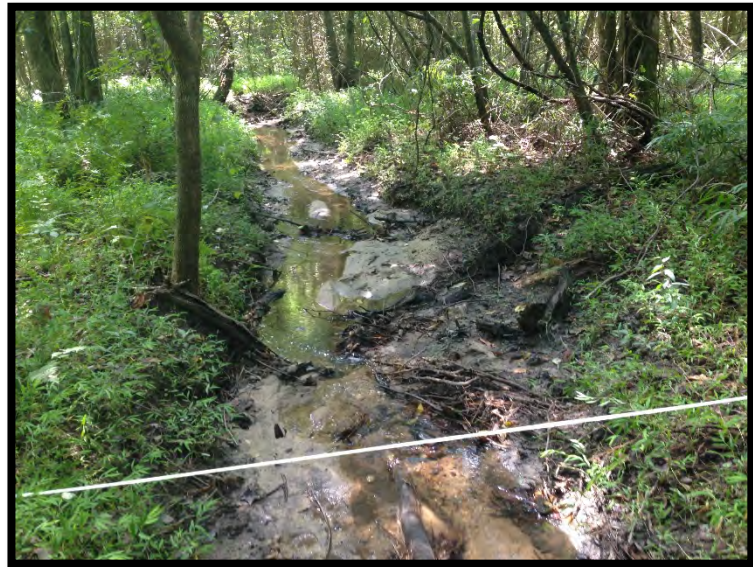
Photo looking downstream along R5 preservation area. Note the stable banks, bedform diversity, and native wood recruitment.

way and flows for approximately 1,197 feet to its confluence with Buffalo Creek. R5 has a drainage area of approximately 156 acres, a 1.17 sinuosity and a valley slope of 1.1 percent. The channel is mostly stable along its entire length and the width of the native woody riparian buffer vegetation corridor is greater than 50 feet on both sides of the channel. The bank erosion is very low and minimal bed scour was observed along the reach. The stream channel has a natural connection to its floodplain in this area and existing riparian wetlands were observed throughout the reach. Cattle do not have access to this reach and historically this area has remained relatively undisturbed. The bank height ratios range from 1.0 to 1.2 and the channel is classified as a Rosgen E5 stream type.

Further downstream, the channel has experienced past manipulation and excess aggradation was observed prior to an active headcut near an existing fenceline. At this location, the channel is actively downcutting and becomes moderately to severely incised with bank height ratios ranging from 1.5 to 2.0. R4 is actively subject to water quality stressors, mainly in the form of cattle access, sediment and nutrient inputs, and minimal riparian buffer widths. The channel is classified as an incised Rosgen E5/F5 stream type.

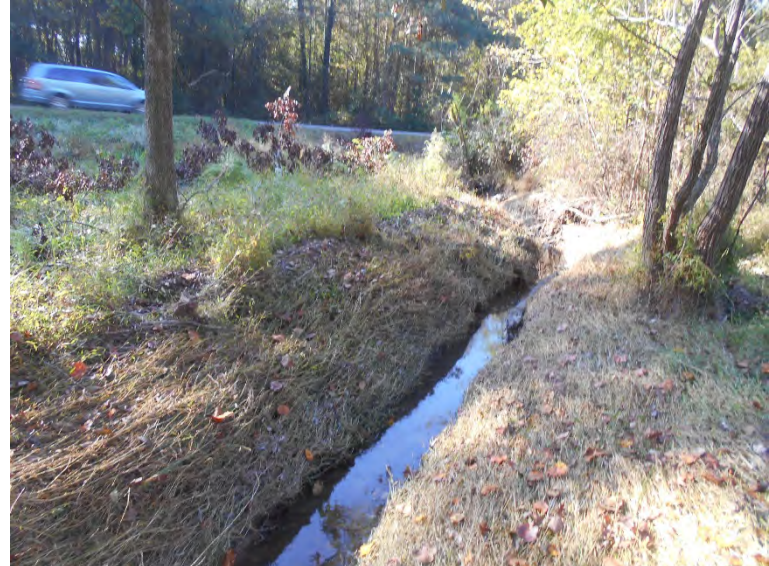
Reach R4- After Hurricane Matthew (10/19/16)

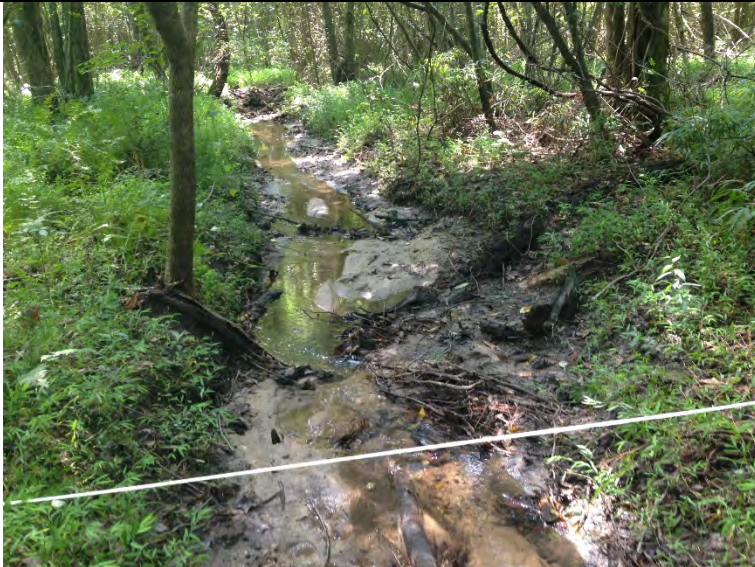
Reach R5- Looking downstream at stable condition (9/1/15)

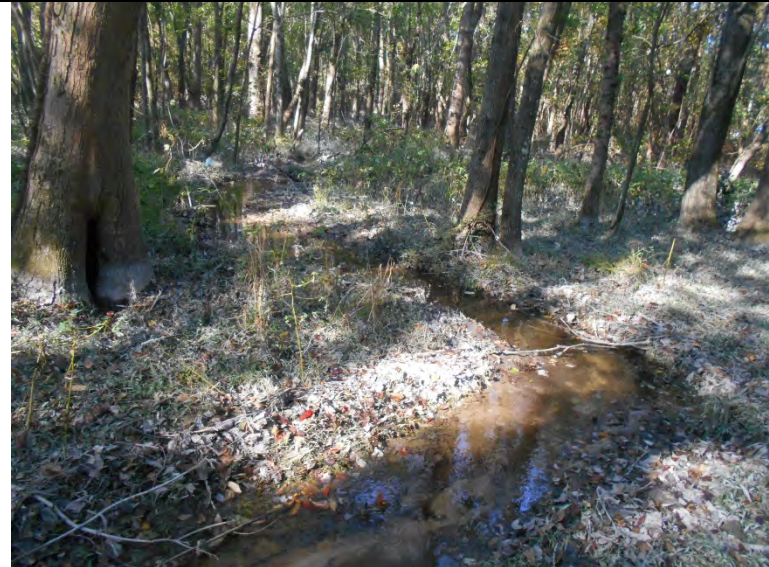
Reach R5- After Hurricane Matthew (10/19/16)

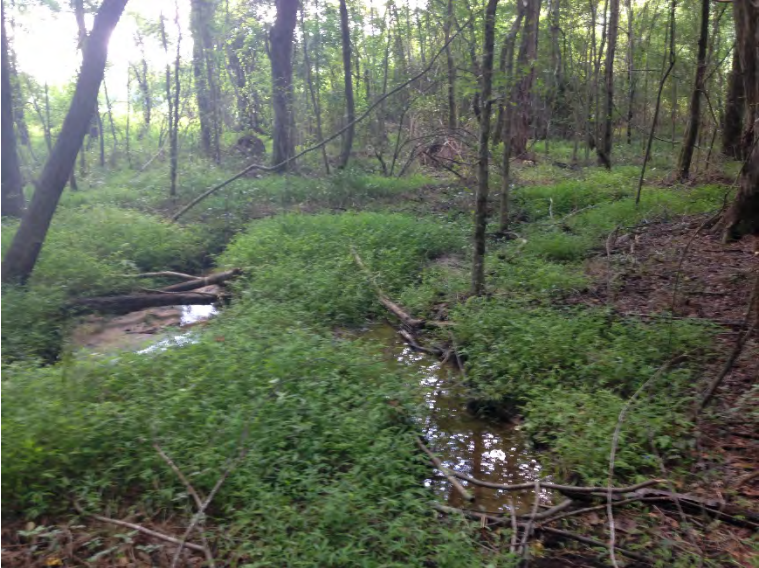
Reach R5- Stable condition (9/1/15)

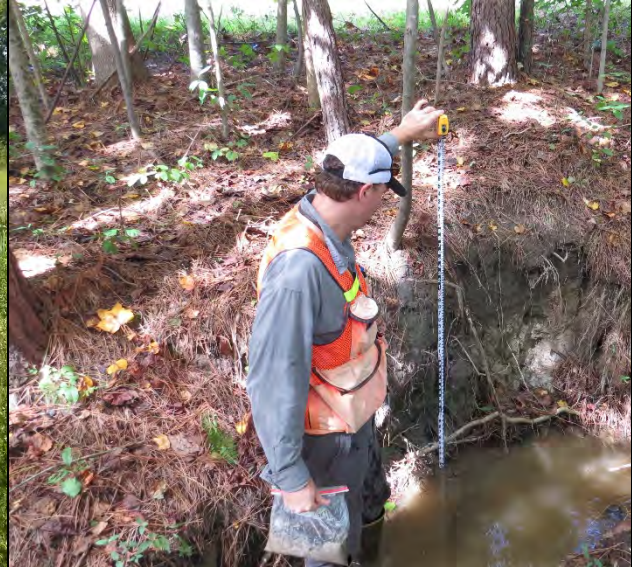
Active bank erosion and headcutting along R2.

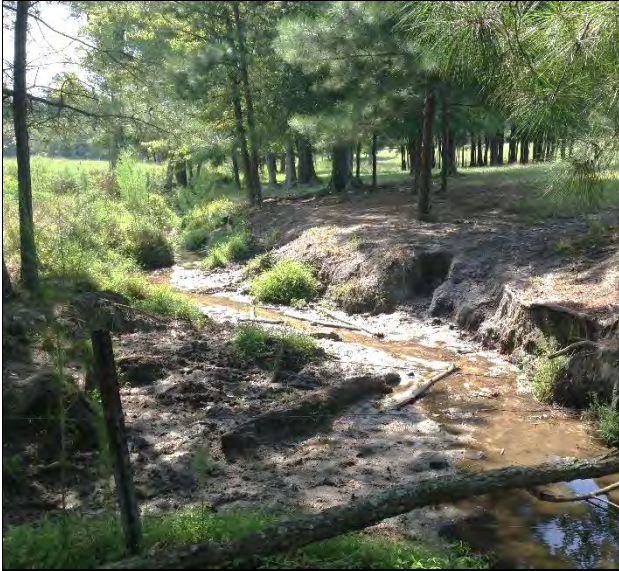
Looking downstream showing cattle access and severely degraded stream banks along R3.
